Subject: Addendum to Geologic Hazards Study
Shadow Run Ranch, Draft EIR
Project Issue Item Nos. 20-2 through 20-5
County Project Numbers: TM 5223; MUP 00-30; BC 00-0205
URS Project No. 27661027.10000

Project Issue Item Nos. 20-2 through 20-5 pertain to our previous report "Update Geologic Hazards Study – Shadow Run Ranch Pauma Valley, California" dated September 29, 2009". Our previous study was performed for the project draft EIR. The County's comments pertain to our geologic hazards assessment of the existing water supply reservoir at the site. The purpose of this addendum is to respond to these comments.

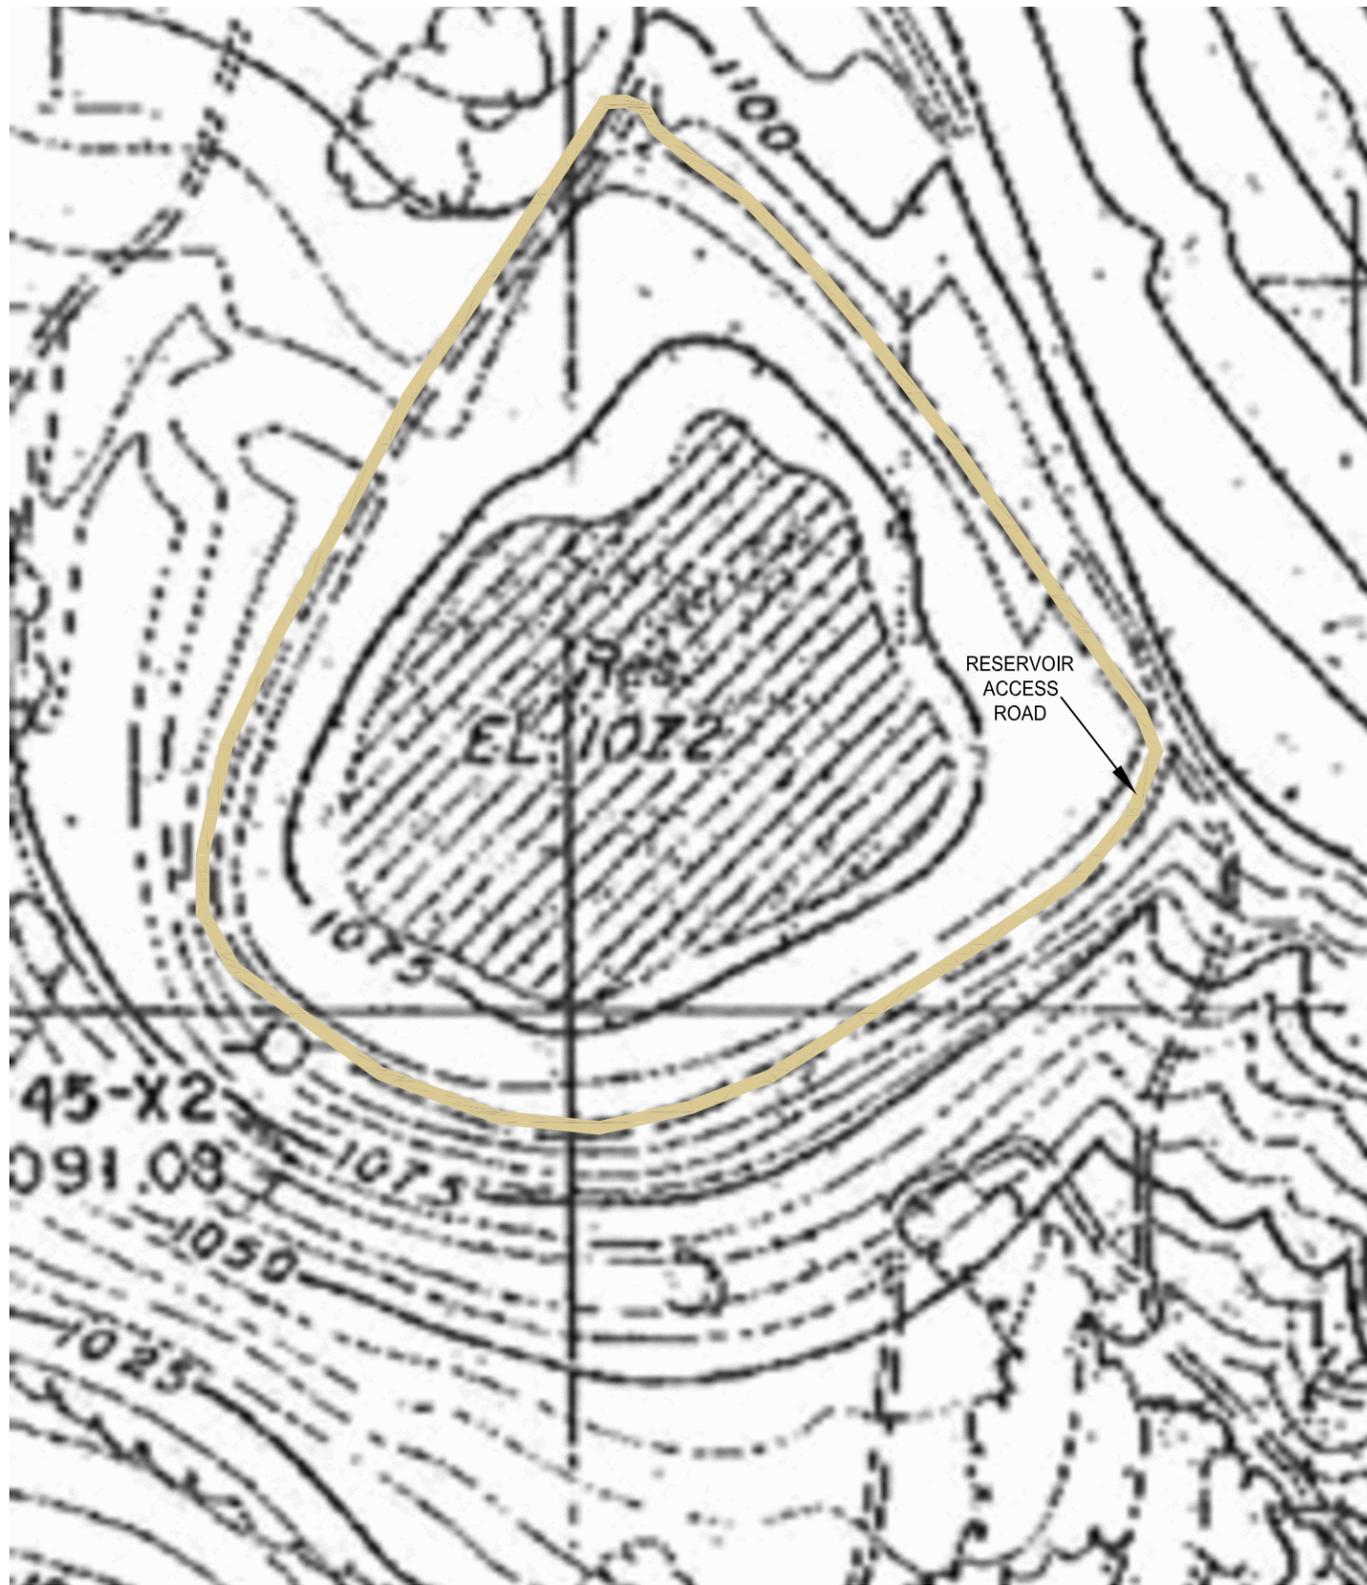
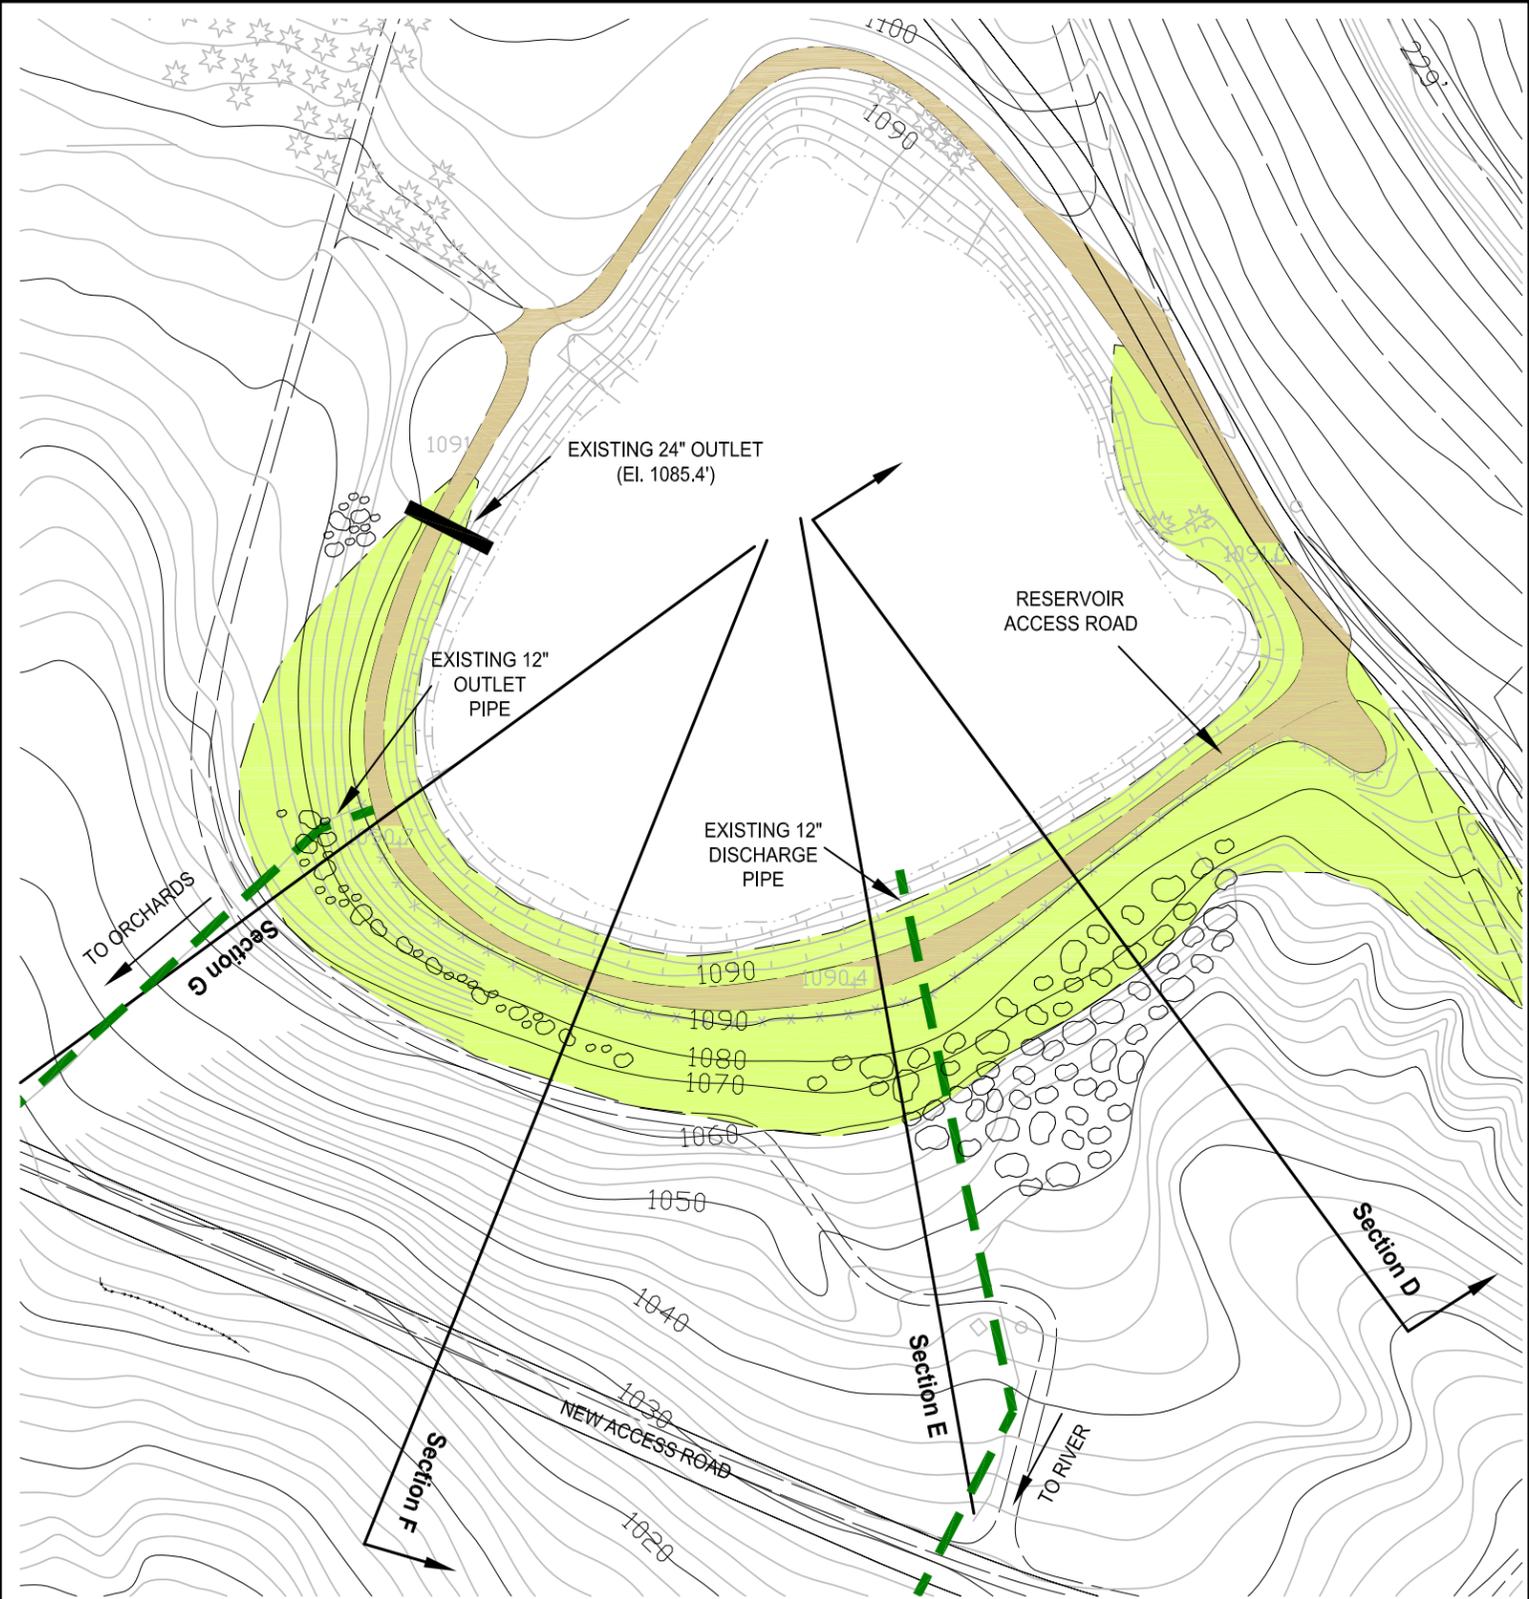
**TOPOGRAPHIC MAPS
EXISTING RESERVOIR
SHADOW RUN RANCH**

As described in our previous report, the existing reservoir was constructed in the early 1960's by making a shallow, bowl-shaped cut into the alluvial fan deposits underlying the mesa top and creating a low earth-fill embankment around the margins of the reservoir. A layer of bentonite was placed along the bottom of the reservoir to improve water retention. The topography of the reservoir area is shown on Figure 9 from our previous report (attached).

The bowl-shaped excavation made to create the reservoir is evident on the 1961 topographic map (see Figure 9). The fill creating the low embankment slope around the west and south part of the reservoir (see current topography, Figure 9) appears to have been constructed at a later date.

The new spillway will be about 20 feet wide and can accommodate up to about 2,000 cubic feet per second, according to Masson & Associates. If water flowed into the spillway during a seismic event, the spillway would direct flow away from the proposed residences into a natural drainage course below the southeast part of the reservoir. The drainage course feeds into proposed catch basins. Existing stockpiled boulders on the slope below the proposed spillway (see Figure 9) would help disperse flow.

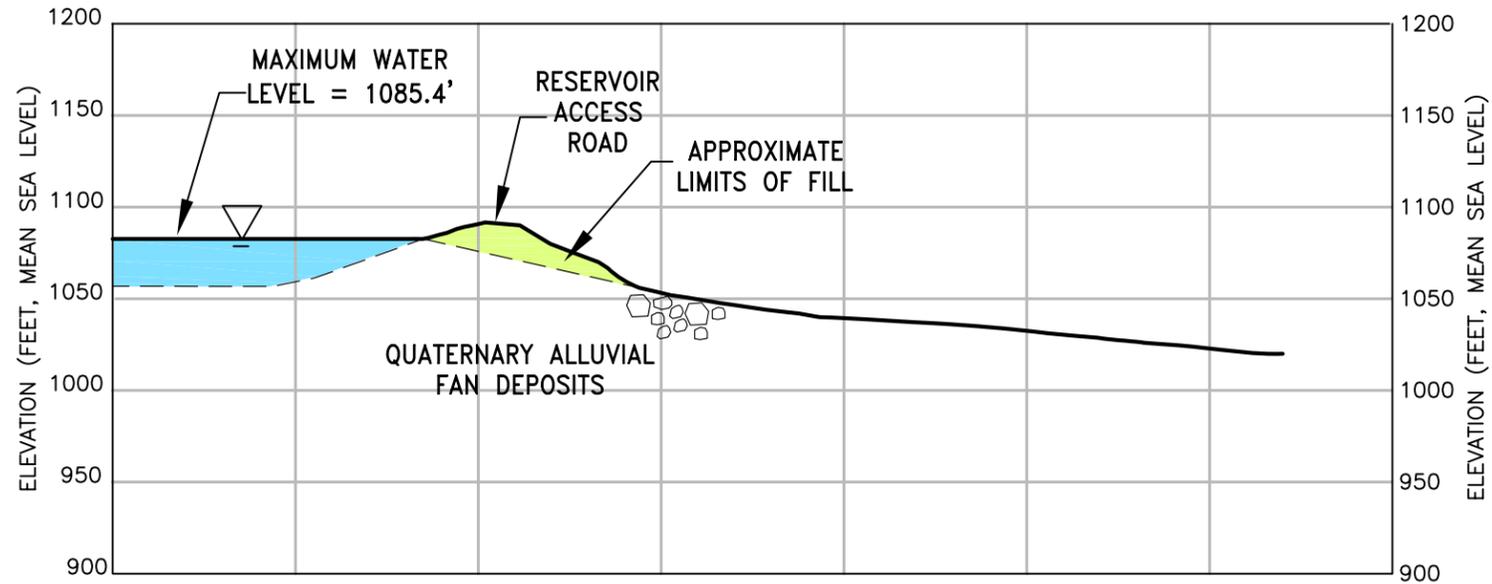
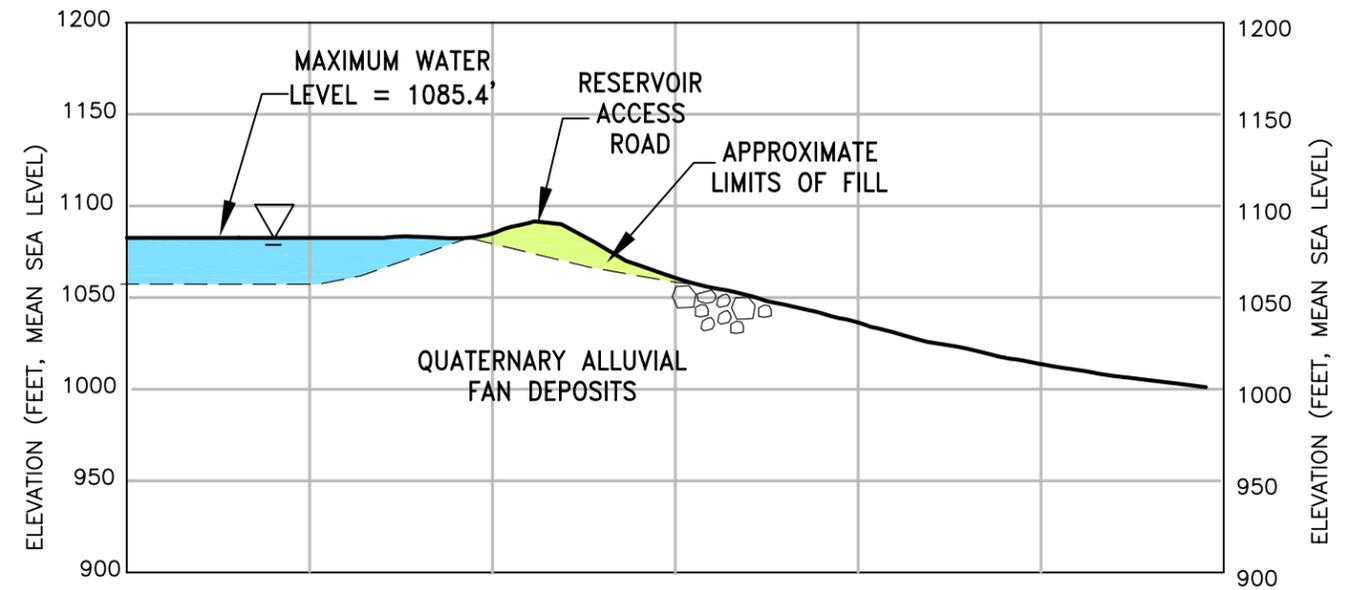
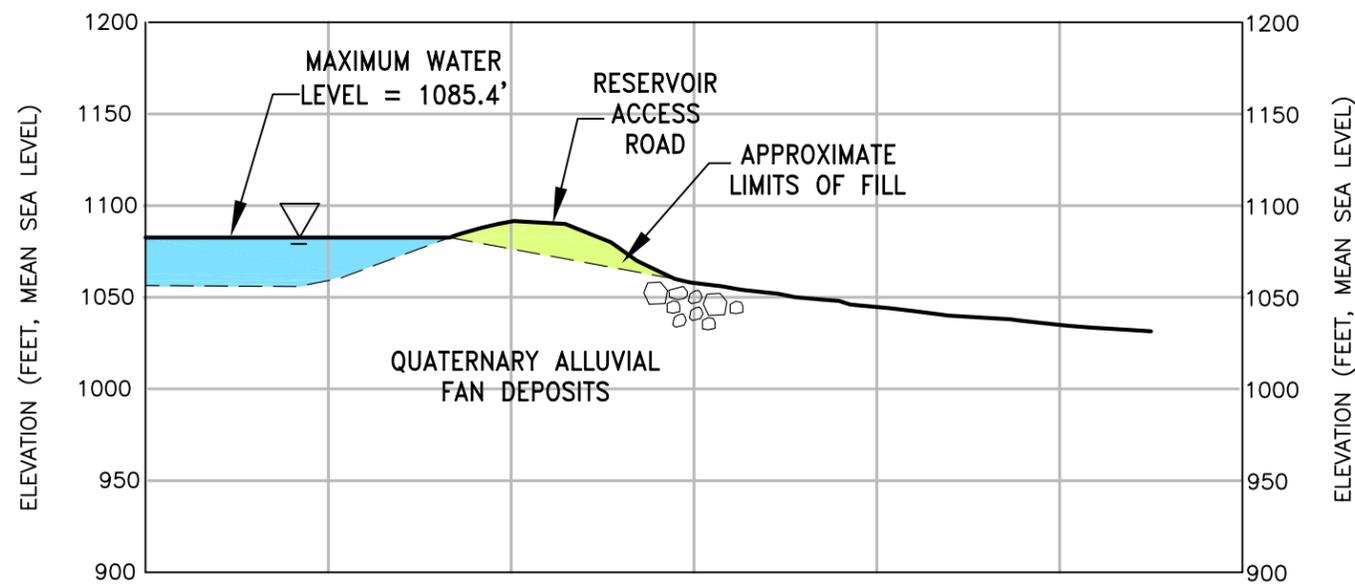
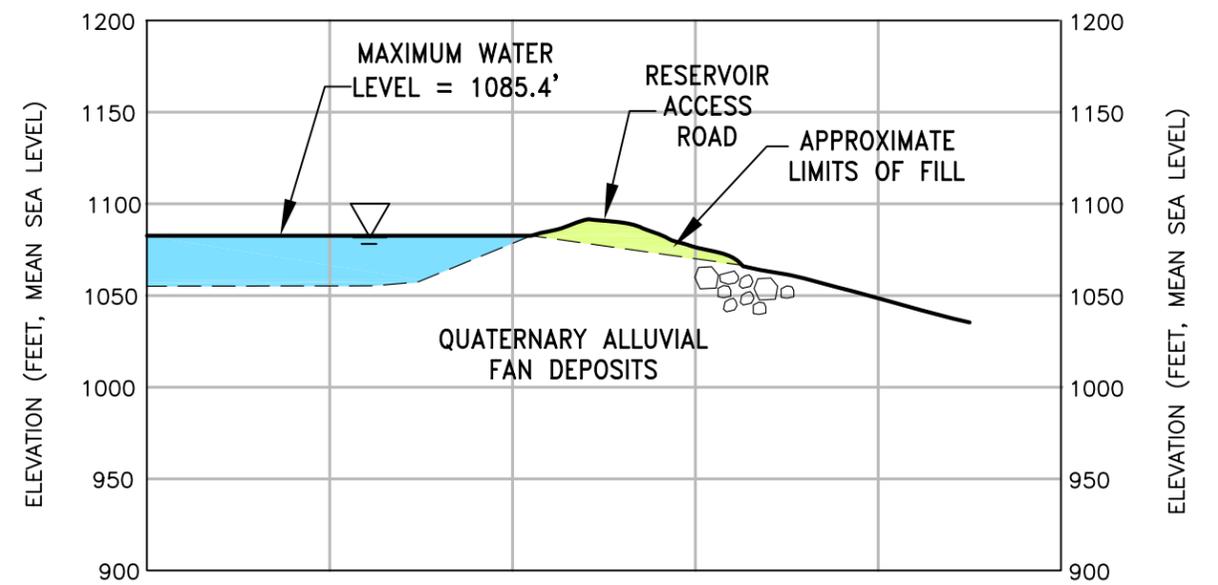
GENERALIZED CROSS SECTIONS D, E, F AND G EXISTING RESERVOIR SHADOW RUN RANCH

Cross sections are shown on Figure 10 from our previous report (attached). Note the water level is planned to be about 3 feet lower than the level shown on Figure 10.

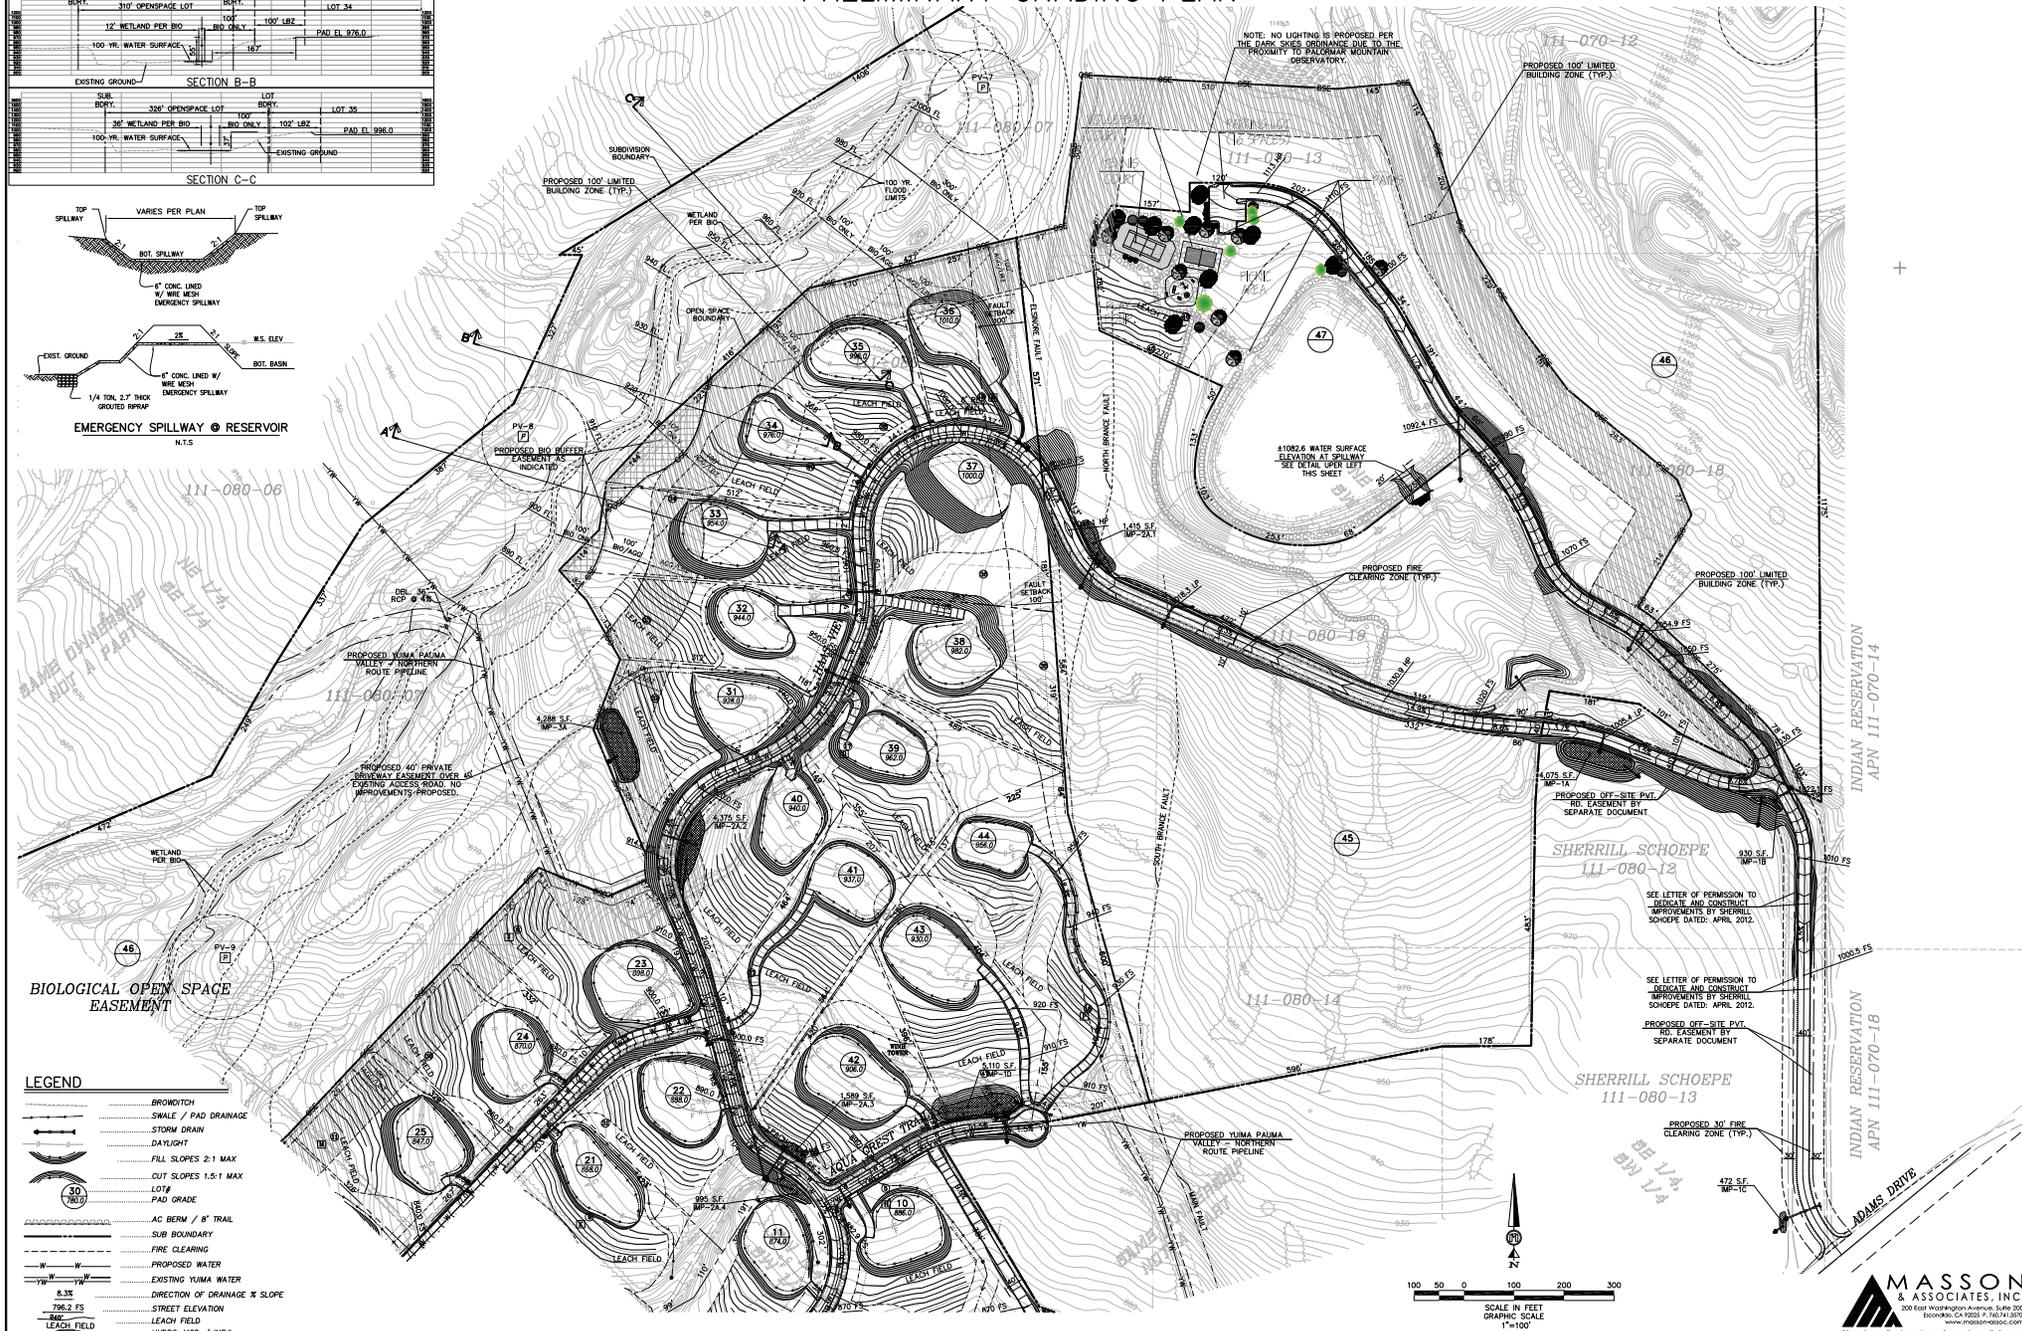
Attachment A- Preliminary Grading Plan

At the time of our previous study, an existing 24-inch outlet pipe maintained the reservoir water level at below about 1,085.4 feet Mean Sea Level (MSL). However, according to the preliminary grading plan prepared by Masson & Associates, Inc. a new spillway is proposed at elevation 1,082.6 feet MSL. The preliminary grading plan is included as Attachment A.

According to the preliminary grading plan (Attachment A), the project preliminary design includes new drainage features at and in the area below the reservoir, including: the new spillway, roadway brow ditches, earth swales, and hydromodification catch basins.

As shown on the attached preliminary plans, the new access road below the reservoir includes 3-foot wide brow ditches on the upslope side and several catch basins. The proposed catch basins are storm water IMP (Integrated Management Practice) bioretention facility features, which include overflow risers between 36- and 48-inches in diameter. These are primarily water quality treatment basins, which are also designed to accommodate the runoff from the 100-year storm. The overflow risers could be up-sized if necessary.

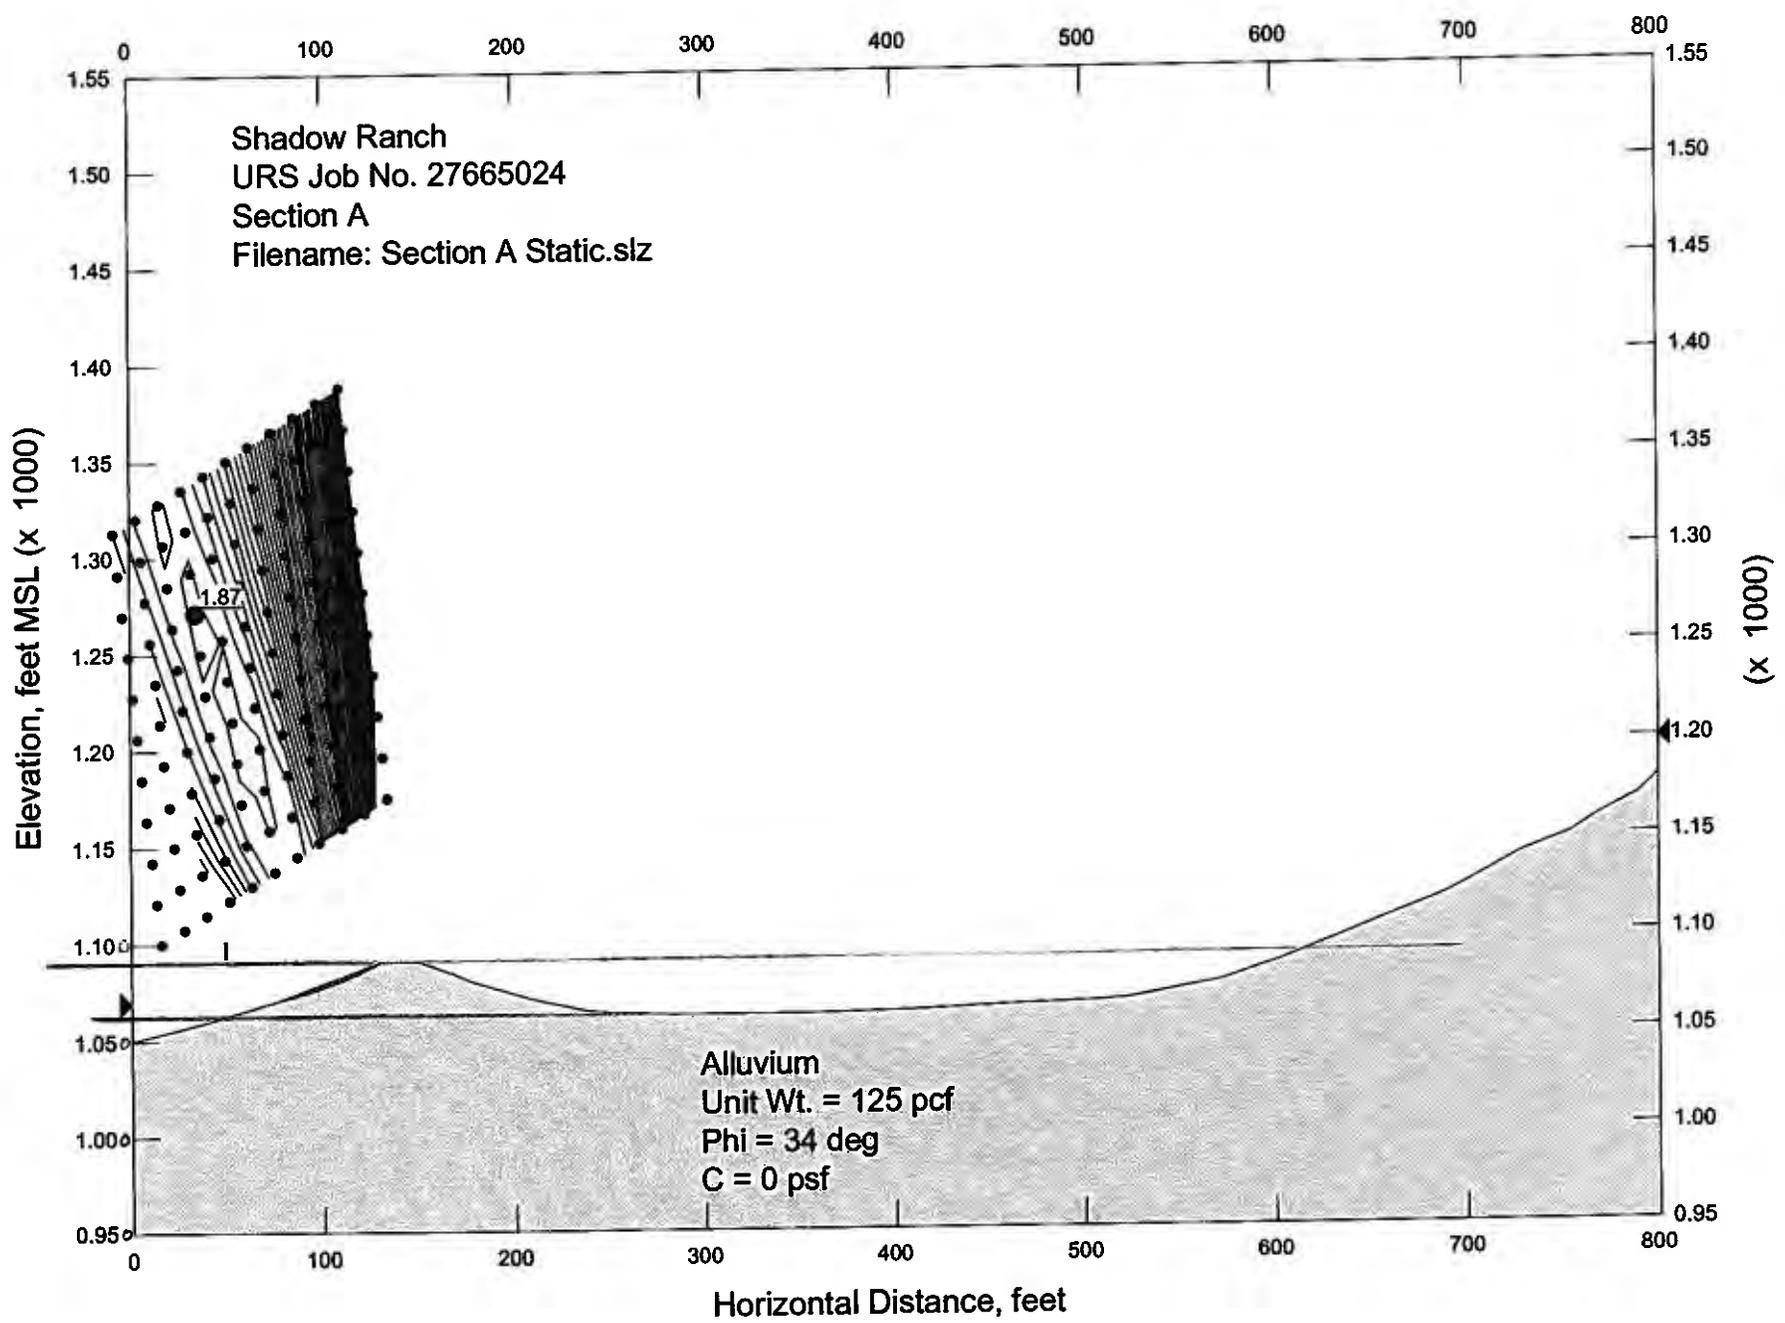
CASE No. 1a

Case No.	Section	Minimum Factor of Safety (FS)		Location of Minimum FS
1a	A-A'	1.87	Static Case	West/Downstream
1b	A-A'	1.12	Pseudo-Static Case	West/Downstream
2a	A-A'	1.89	Static Case	West/Upstream
2b	A-A'	1.13	Pseudo-Static Case	West/Upstream
3a	B-B'	1.65	Static Case	South/Downstream
3b	B-B'	1.07	Pseudo-Static Case	South/Downstream
4a	B-B'	2.25	Static Case	South/Upstream
4b	B-B'	1.27	Pseudo-Static Case	South/Upstream
