Campo Sewer Service Area Sewer Master Plan

January 2013

Prepared For:

ATKINS

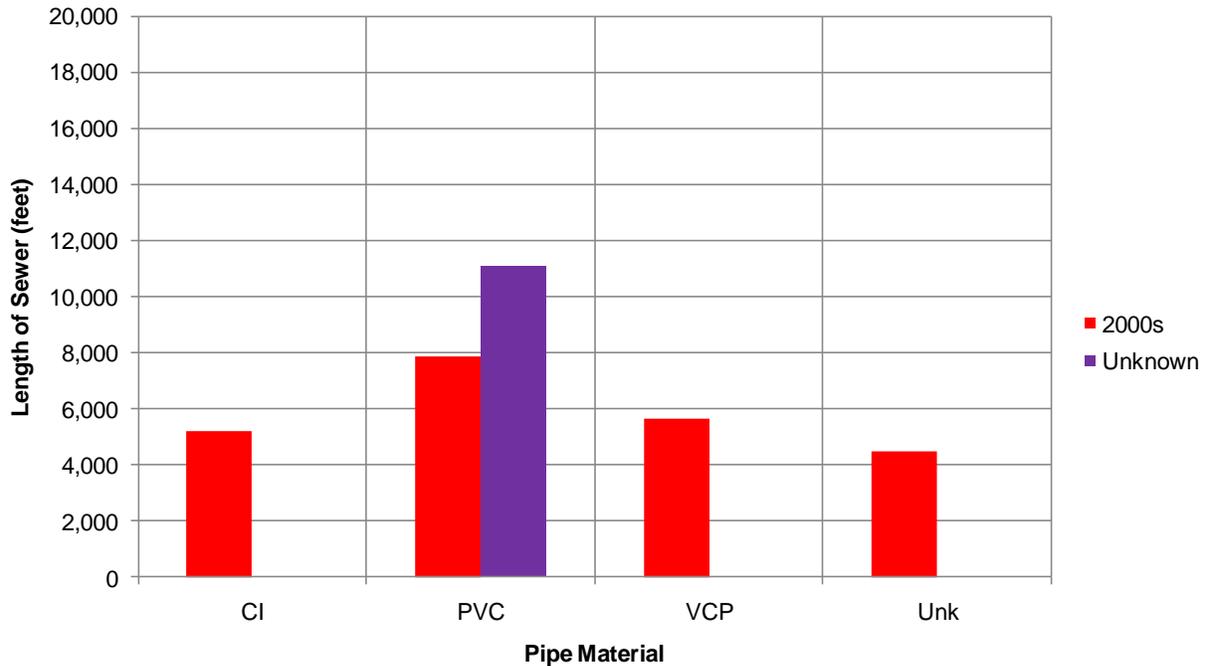
Figure 5-1 Campo SSA Gravity Pipeline Length of Material by Age

As may be determined from Table 5-1 and Figure 5-1, over 45 percent of the Campo SSA system constructed in the 1940s was VCP and CI and approximately 20 percent is of unknown material. It can also be determined that at least 30 percent of the Campo SSA system was constructed in the 2000s. Historically, VCP pipe has a life span ranging from 50-70 years. Based on the assumed installation period for the CI, VCP and pipe of unknown material as presented above, the majority of the Campo SSA system has reached the initial years of the pipe material life cycle. Therefore, as the wastewater collection system continues to age, routine inspection is critical for monitoring and establishing the condition of the pipelines and identifying methods to extend its service life.

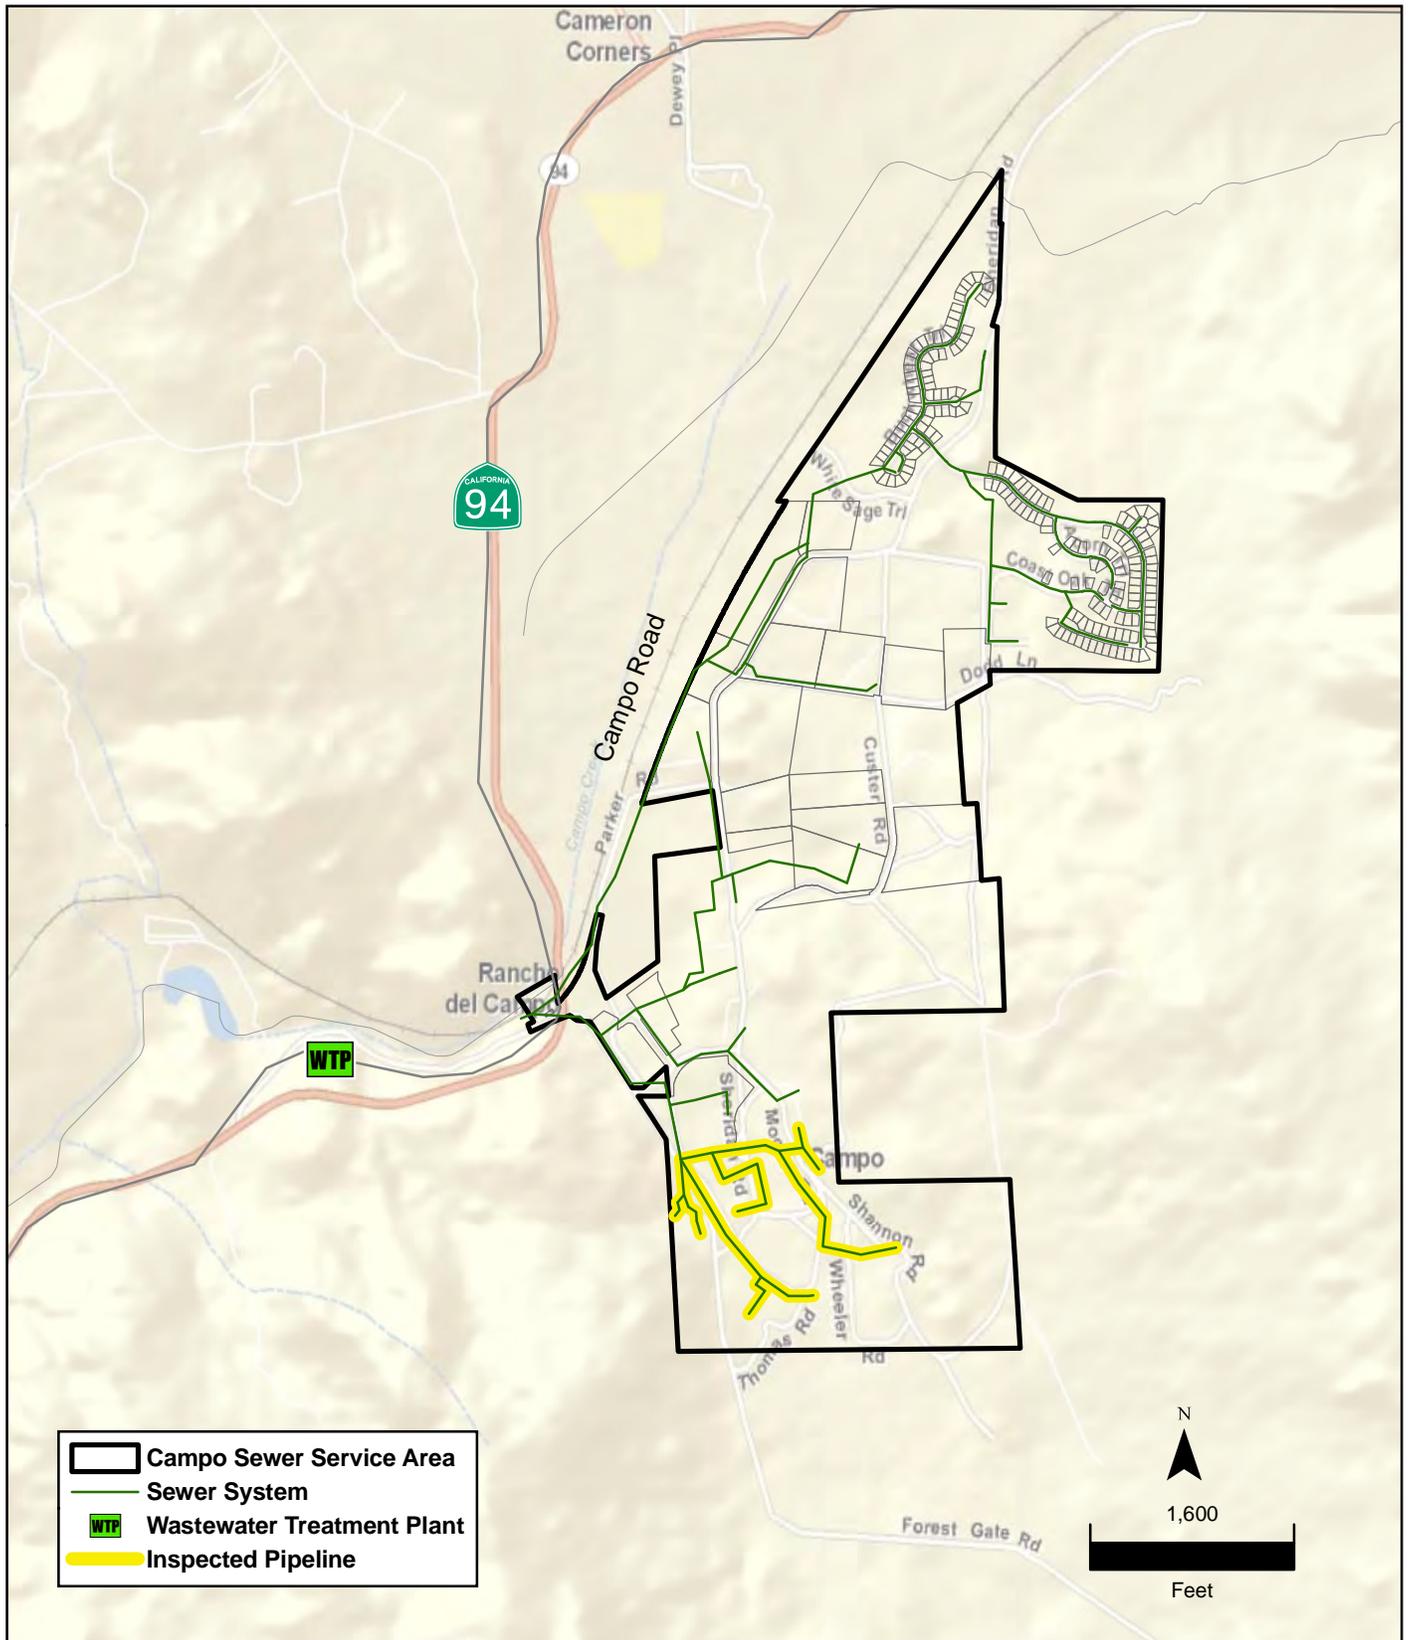
INSPECTED AND ASSESSED PIPELINES

Closed circuit television cameras offer valuable insight to the structural and maintenance condition of underground infrastructure. Video inspection of sewer pipelines is used to identify and evaluate the existence and severity of defects including cracks, misaligned joints, accumulation of roots or silt, and potential sources of infiltration. Figure 5-2 shows the location of the pipelines in the Campo SSA that were inspected and assessed.

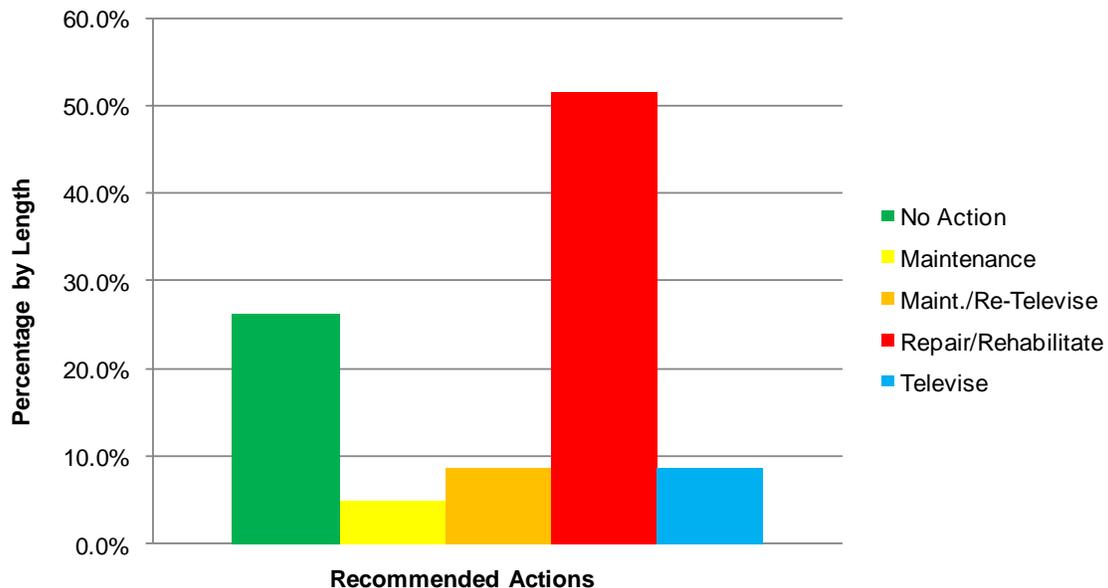
Figure 5-3 Pipeline Inspection and Assessment Findings by Percentage of Length

Overall, the pipe segments inspected are generally in fair condition with over 25 percent of the pipelines inspected identified as requiring No Action, approximately 13 percent requiring maintenance, and over 50 percent as requiring some form of repair or rehabilitation. Table 5-5 includes a summary of the recommended actions based on the number of pipe segments and pipe length inspected and assessed. Table 5-6 includes a summary of the criticality rankings based on the number of pipe segments and pipe length inspected and assessed. Figure 5-3 graphically presents the pipeline inspection and assessment findings by percentage of length.

Although Table 5-5 illustrates that over 50 percent of the inspected pipelines were identified as requiring repair or rehabilitation, Table 5-6 illustrates that over 20 percent (1,476 linear feet) of the deficiencies documented should be further evaluated for implementation within the next 2 years. Pipelines that were not inspected due to accessibility constraints were not rated for rehabilitation and are noted as N/A.

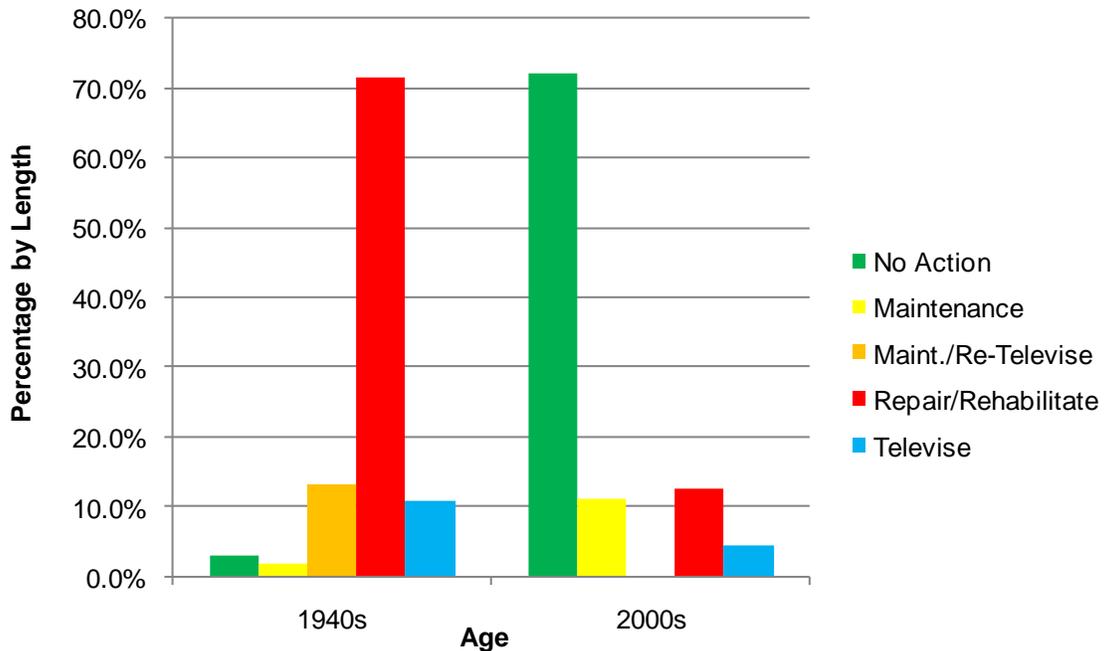
Figure 5-4 Pipeline Inspection and Assessment Findings by Age

Figure 5-4 illustrates the recommendations for the pipelines within the SSA that were inspected and assessed based on age and includes the repair and rehabilitation findings for all criticality ratings from A through E.

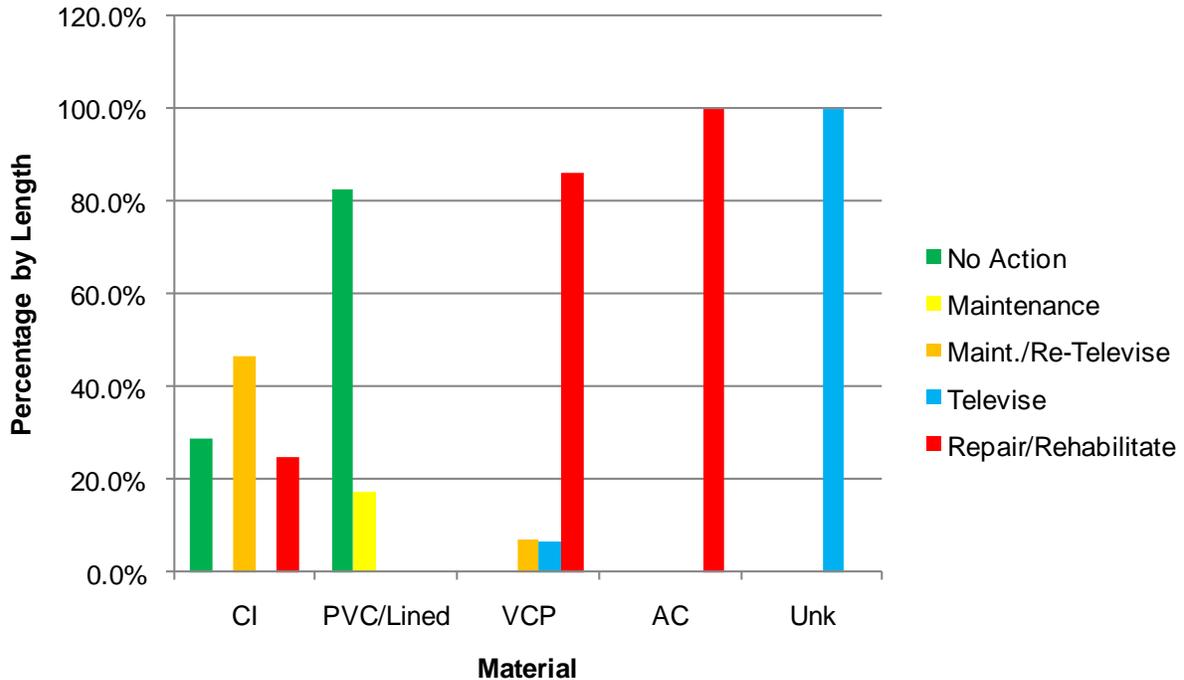
Figure 5-5 Pipeline Inspection and Assessment Findings by Material

Furthermore, Figure 5-5 illustrates the recommendations for the inspected pipelines based on material type.

Based on the inspection of approximately 20 percent of the Campo SSA collection system, it appears that 85 percent of the VCP, 25 percent of the CI, and pipe identified as AC pipe material may require a form of rehabilitation or repair. Applying these percentages by material type to the length of pipe in the SSA that was assumed to be constructed in the 1940s (Table 5-1) serves to extrapolate the length of VCP and CI pipe in the system that may require improvements. The extrapolation results presented in Table 5-9 indicates that approximately 6,100 feet (1.2 miles), which equates to approximately 18 percent of the wastewater collection system, may potentially require rehabilitation or repair. The extrapolation was not applied to the PVC as it is assumed that it may include pipe installed in the 1960s and 1970s nor to the pipe of unknown material as it may include pipe previously lined and date of improvement was not documented. Table 5-9 summarizes the projected length of rehabilitation or repair for the two material types in the SSA.

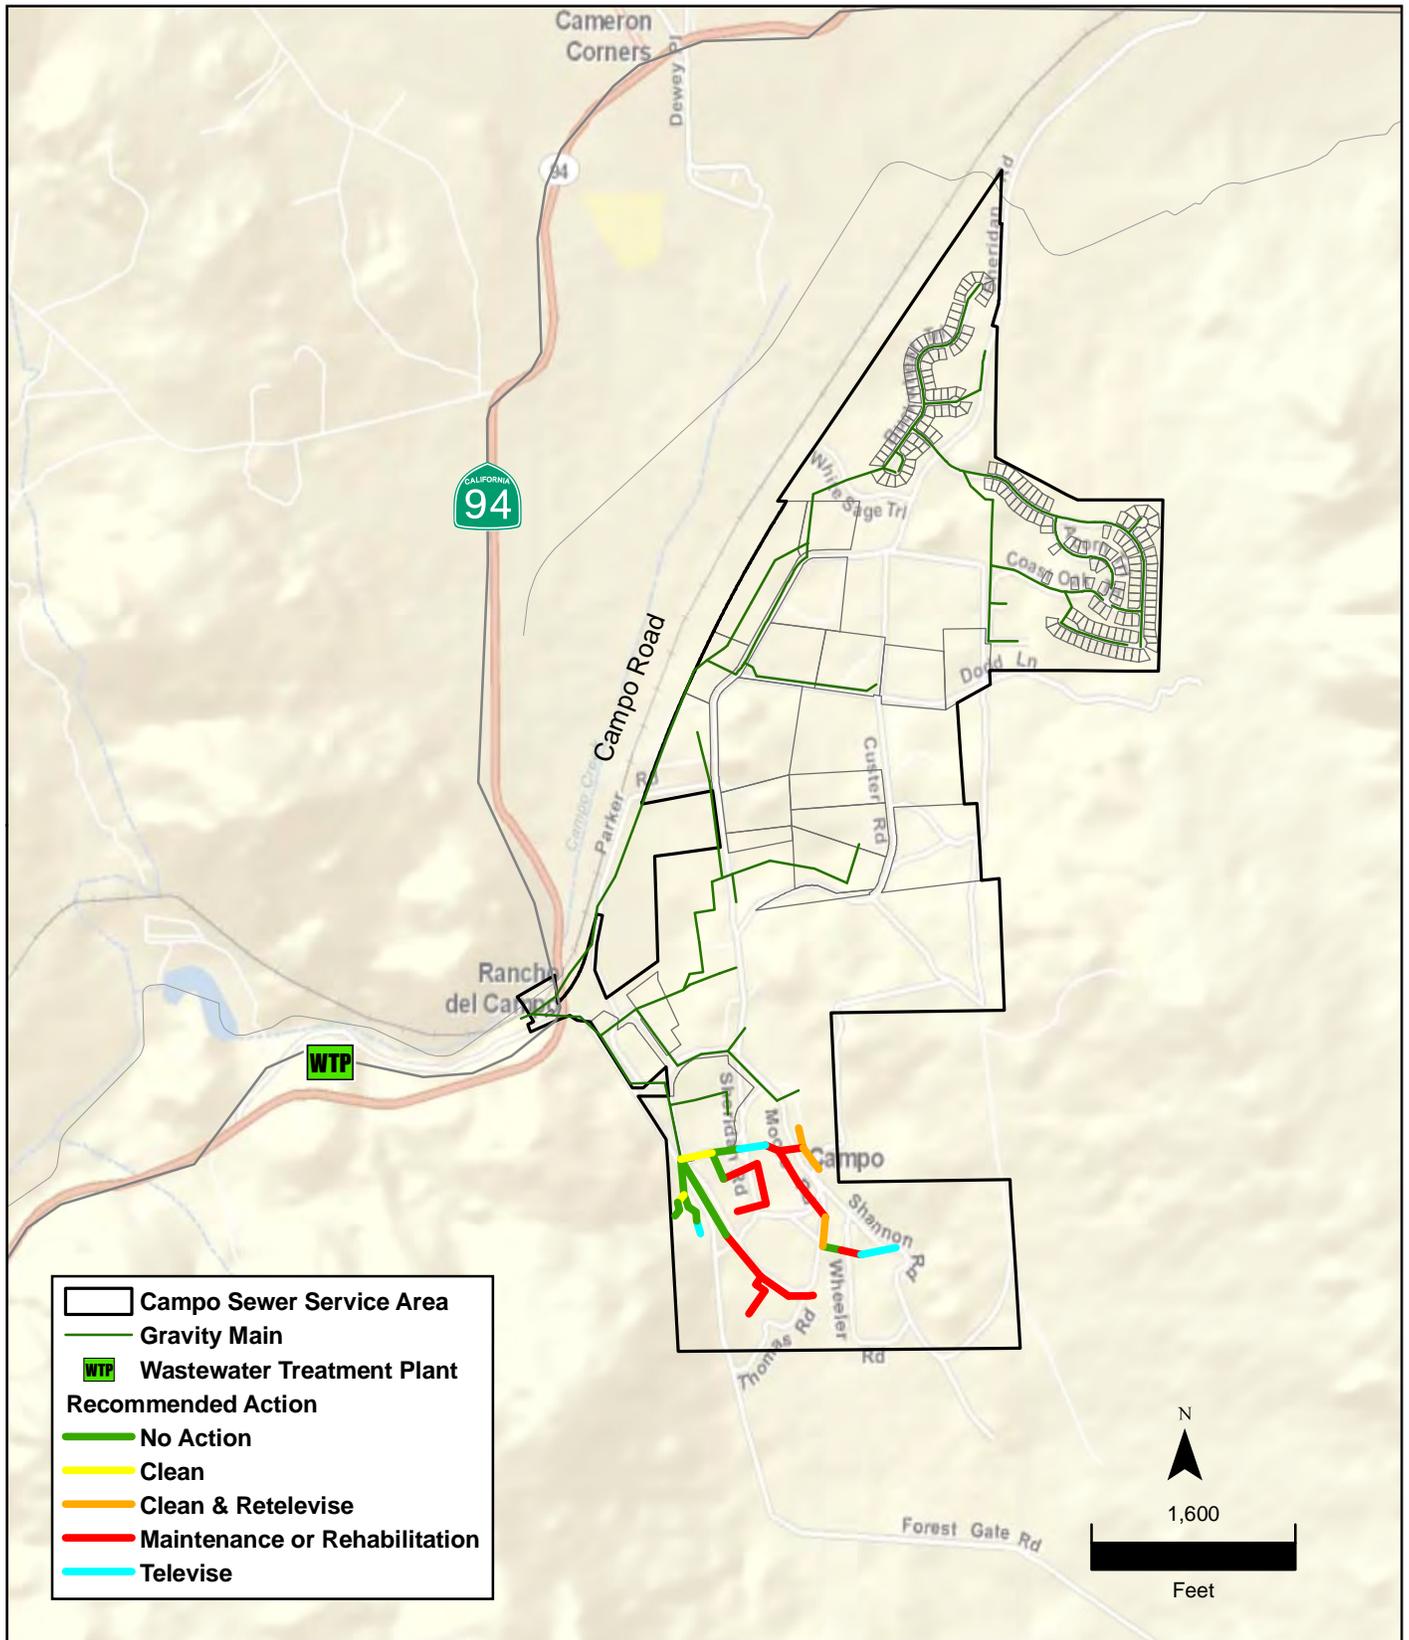
Figure 5-6 illustrates the locations of the recommended actions in the Campo SSA. The recommendations include No Action, Maintenance, Maintenance and Re-Televise, Televise, and Repair/Rehabilitate. Detailed pipeline recommendations are included in Appendix L.

RECOMMENDED ACTION
