State of California -- The Resources Agency  
DEPARTMENT OF PARKS AND RECREATION  
PRIMARY RECORD

Page 1 of 4 \*Resource Name or #: (Assigned by recorder) 9007 West Lilac Road

P11. Report Citation (Cite survey report and other sources, or enter "none".) Anticipated title: Cultural Resources Inventory and Assessment: Lilac Hills Ranch, Escondido, San Diego County, California. KIVA Project: 09-011253; Case Number 3992-10-025 (MPA) by Mary Robbins-Wade and Andrew Giletti, Affinis, 2012.

# BUILDING, STRUCTURE, AND OBJECT RECORD

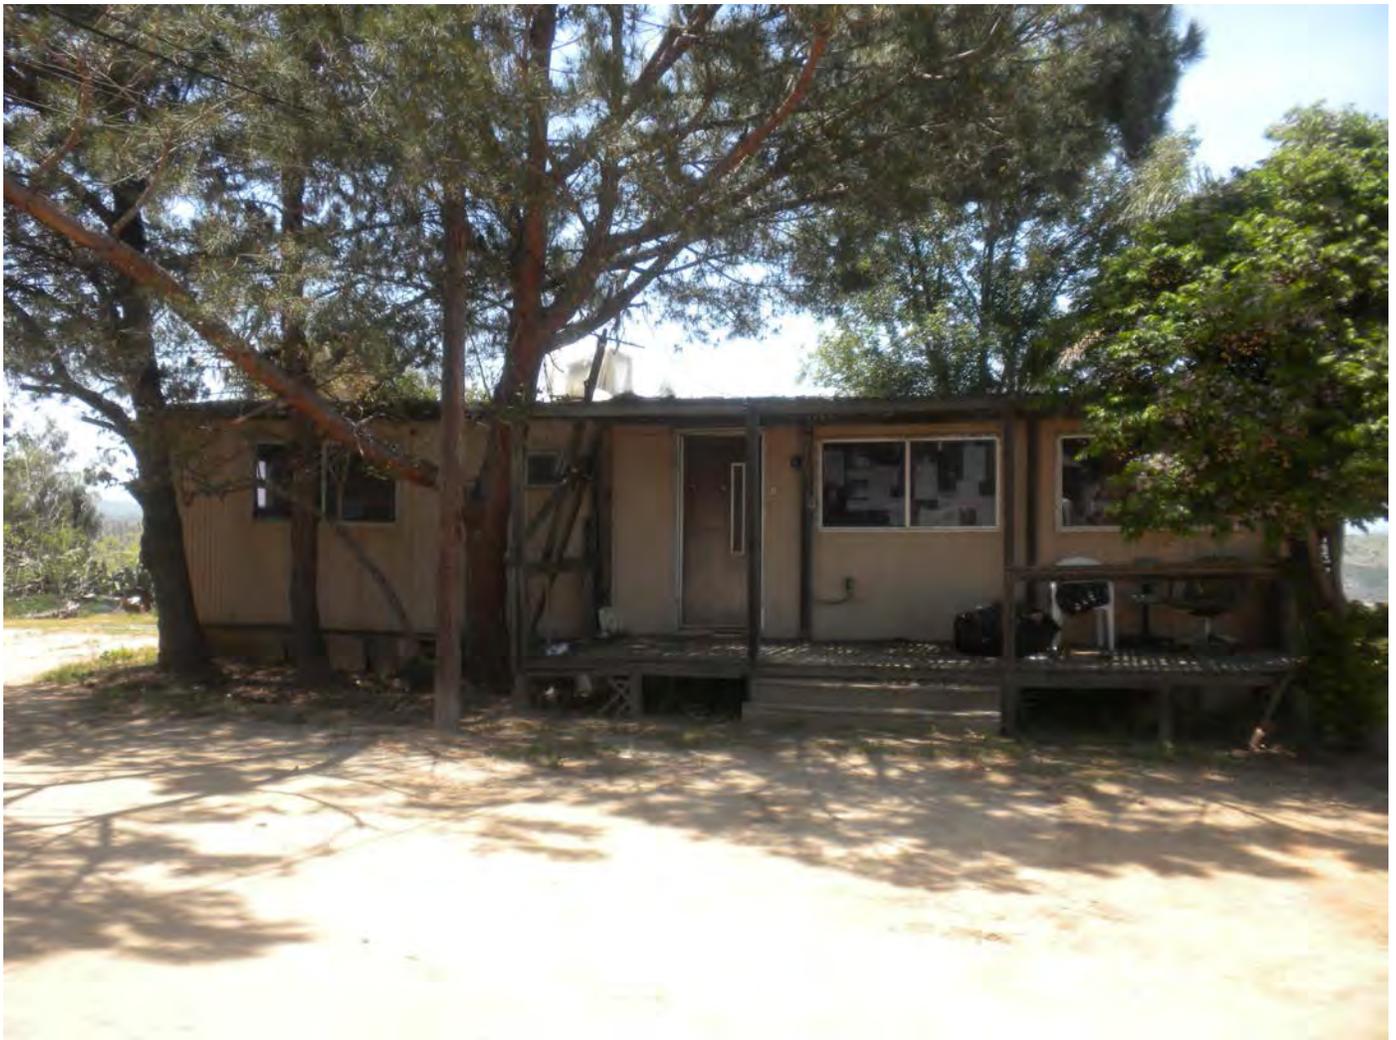
View of residence looking W
