**APPENDIX G  
LIMITED AGRICULTURAL CHEMICAL SAMPLING  
LABORATORY REPORT AND CHAIN OF CUSTODY**

At the request and authorization of Accretive Investments, Inc. (“Client”), EEI conducted a Phase I Environmental Site Assessment (ESA) for the property located at 8709 West Lilac Road, Escondido, California. The purpose of this Phase I ESA was to assess the presence or likely presence of an existing, historical, or threatened release of any hazardous substances or petroleum products into structures, soil, and/or groundwater beneath the subject property, to the extent practical (i.e., *recognized environmental conditions* as delineated in ASTM E1527-05).

We have performed a Phase I Environmental Site Assessment (ESA) in conformance with the scope and limitations of ASTM Designation E1527-05 for the subject property identified as APN 127-072-38, -40, -41, and -46, at 8709 West Lilac Road, Escondido, California. Any exceptions to, or deletions from, this practice are described in Section 7.0 of this report. Phase I ESA has revealed no evidence of recognized environmental conditions in connection with the property.

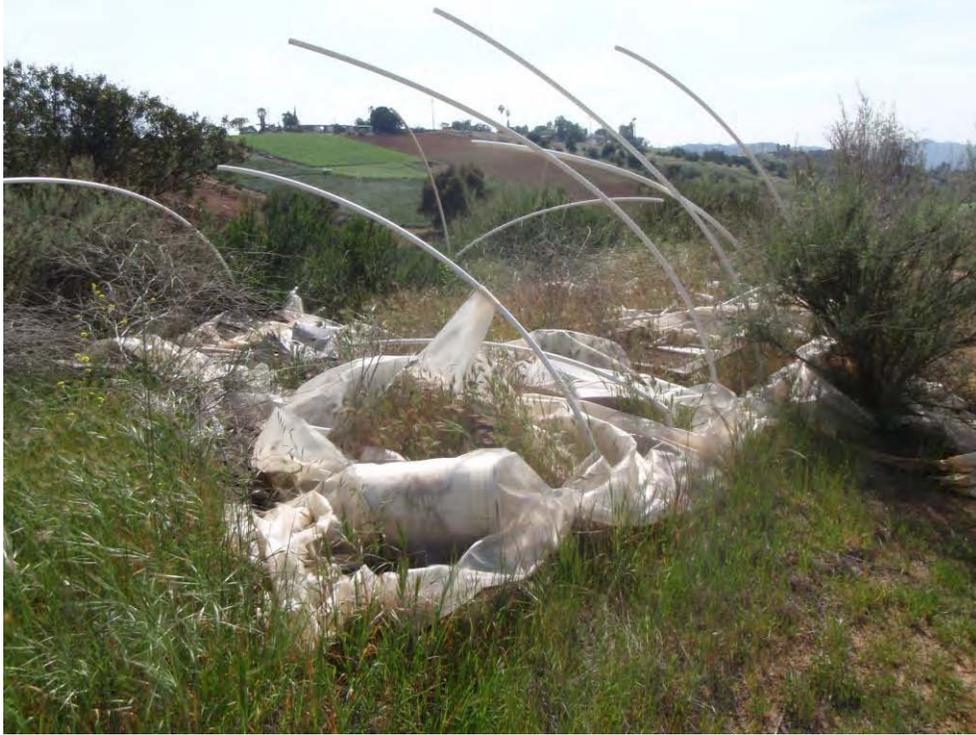
**Photograph 9** – View of the abandoned hoop house located on the northwest portion of the property.

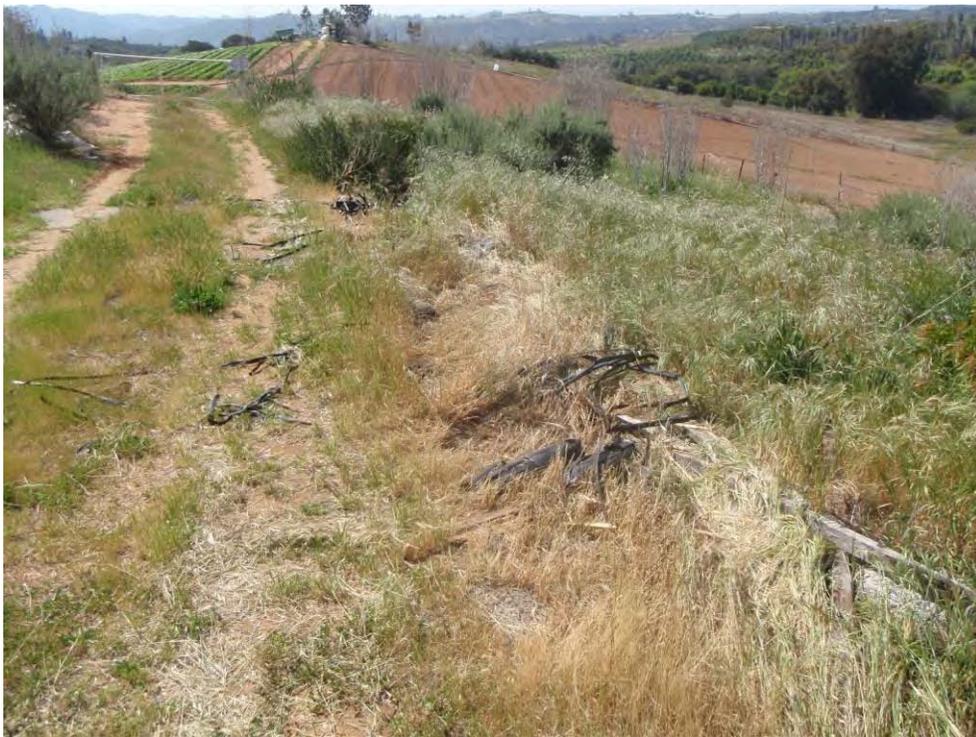
**Photograph 10** – View of irrigation supplies located on the northwest portion of the property.
