**EDGEMOOR GERIATRIC HOSPITAL  
ADAPTIVE RE-USE STUDY**

**Magnolia Avenue  
Santee, California**

**Prepared for the  
County of San Diego, California**

**June 1<sup>st</sup>, 2008**

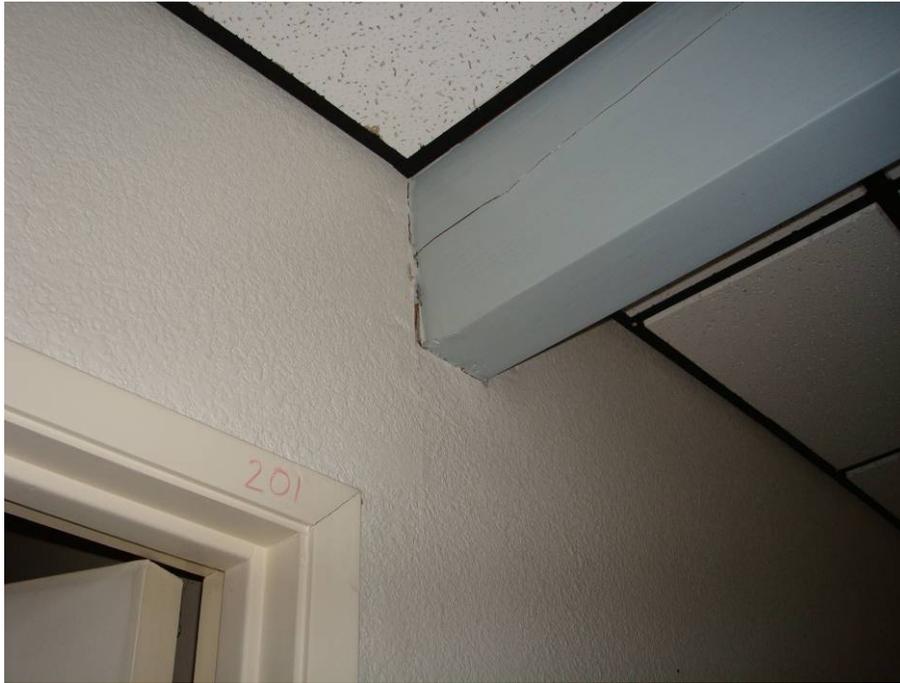
*Figure 5. Horizontal Check in Beam in Building 2.*

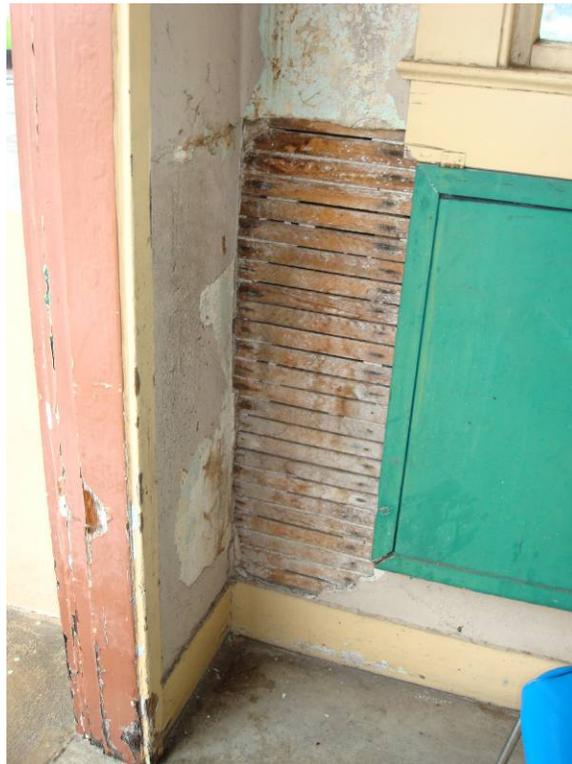
*Figure 8. Wood lath and damaged plaster finish on exterior wall of Building 3.*

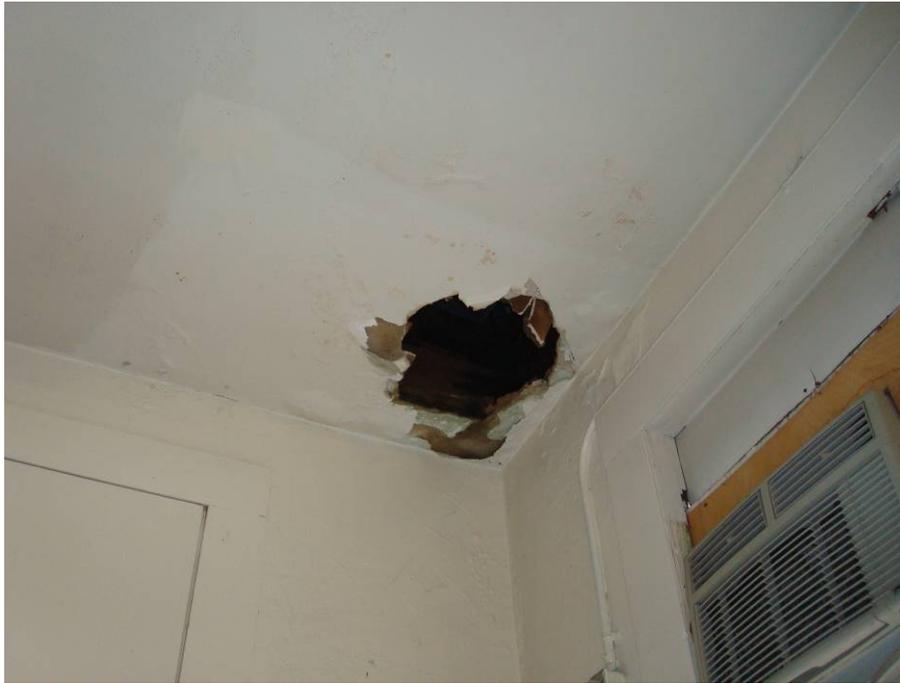
*Figure 11. Water Damage to the ceiling of Building 3.*

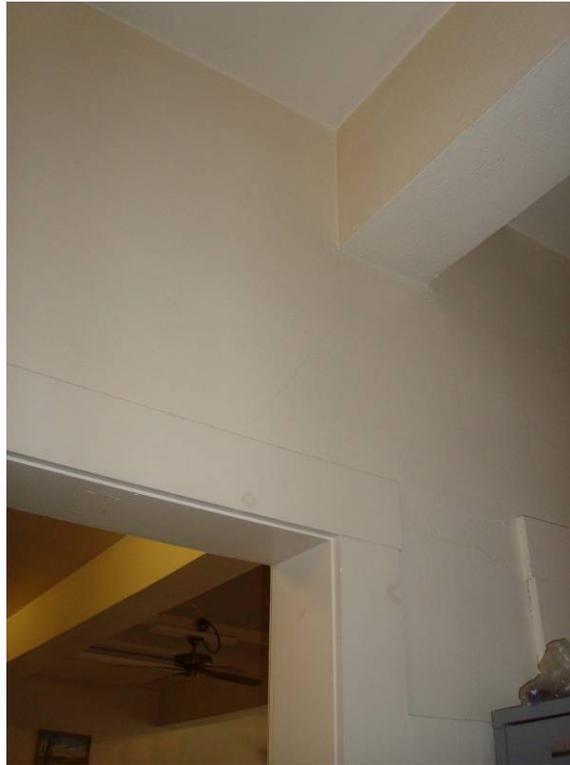
*Figure 13. Small plaster cracks above a door opening in Building 3.*

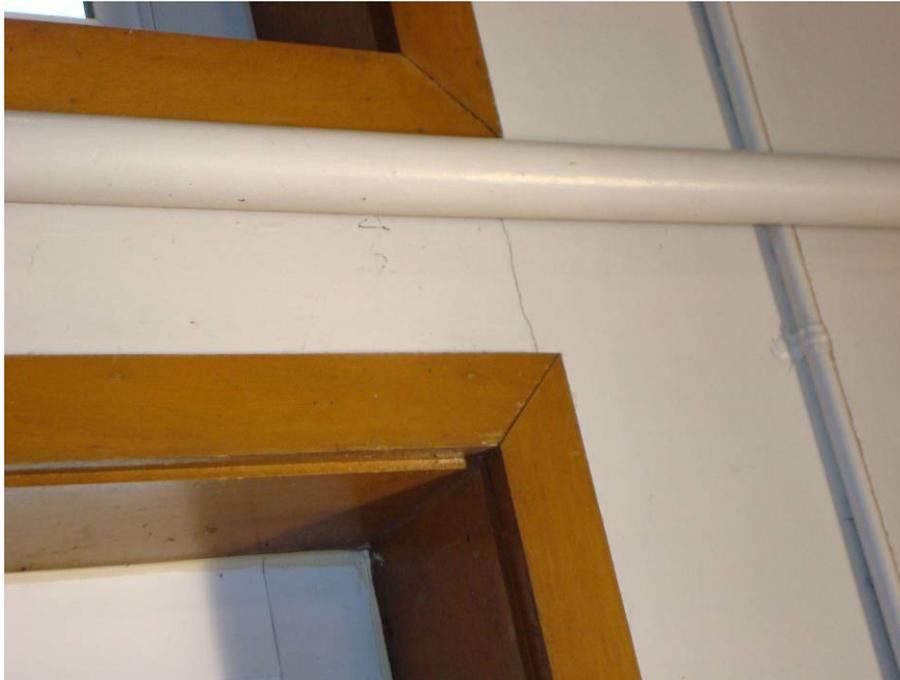
*Figure 22. Typical cracks in the concrete walls near window openings in Building 16.*

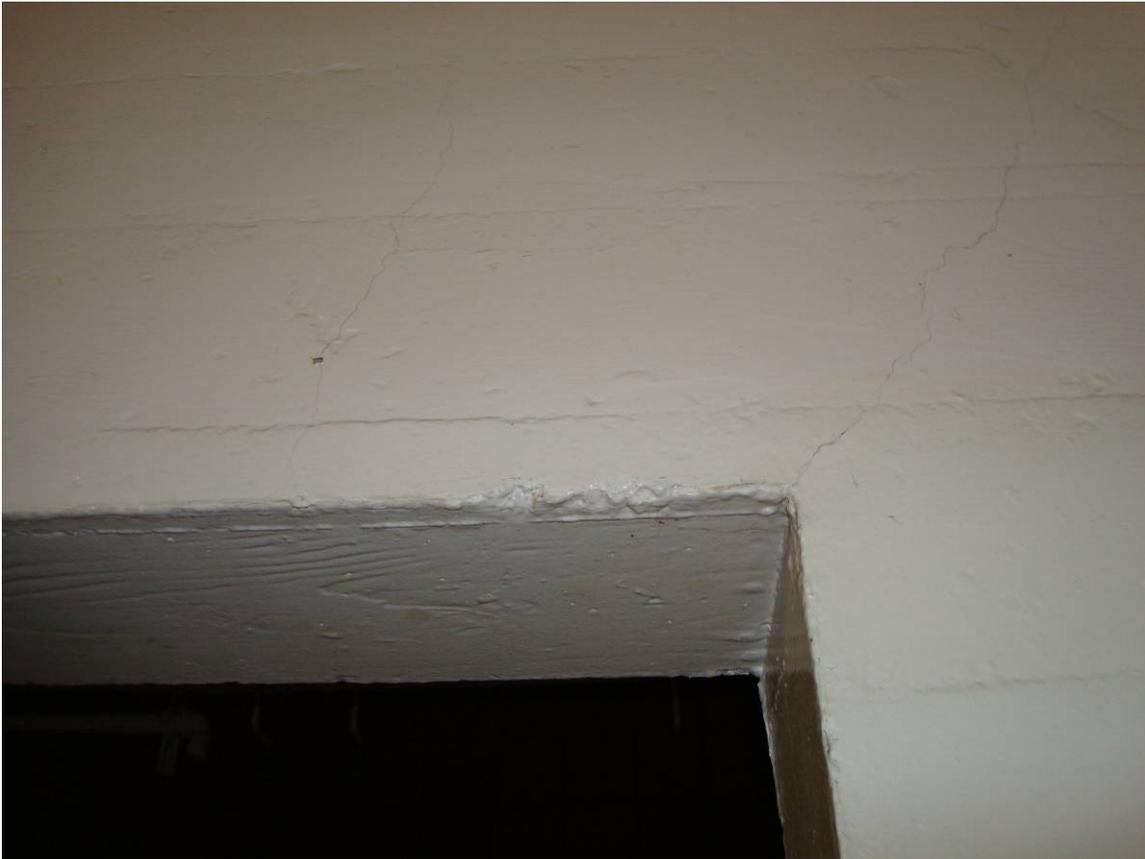
*Figure 23. Typical cracks in the concrete walls at door openings in Building 16.*

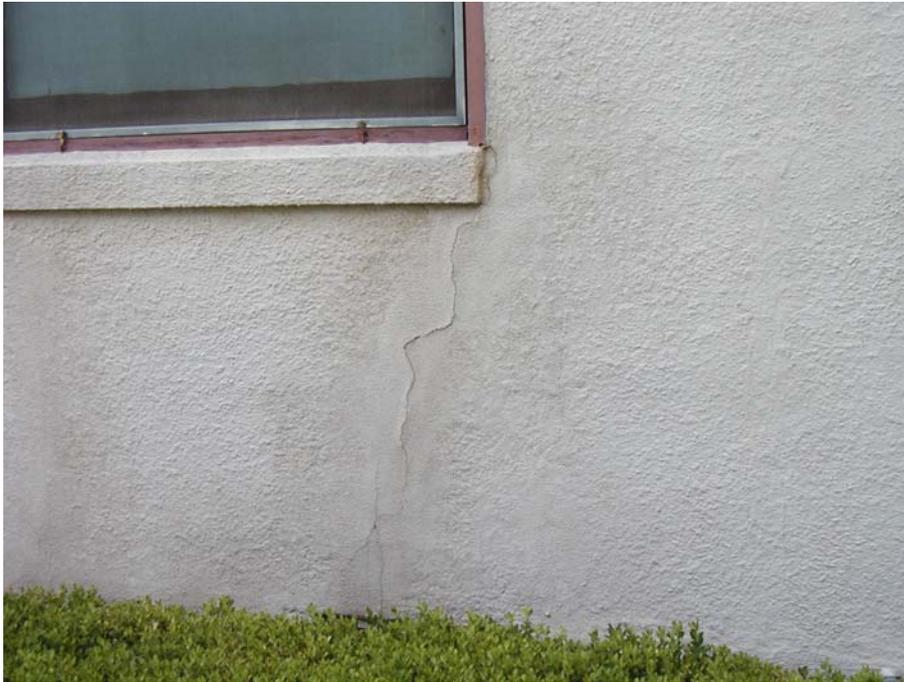
*Figure 3. View of Water Damage of Building 2.*

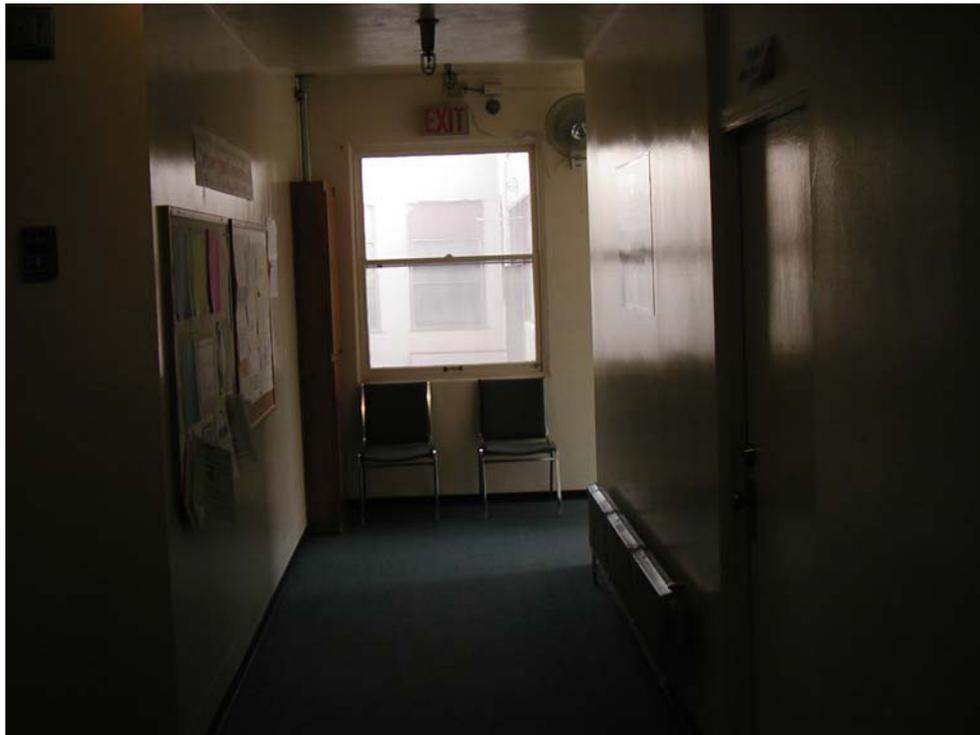
*Figure 5. View of Wood Windows of Building 2.*

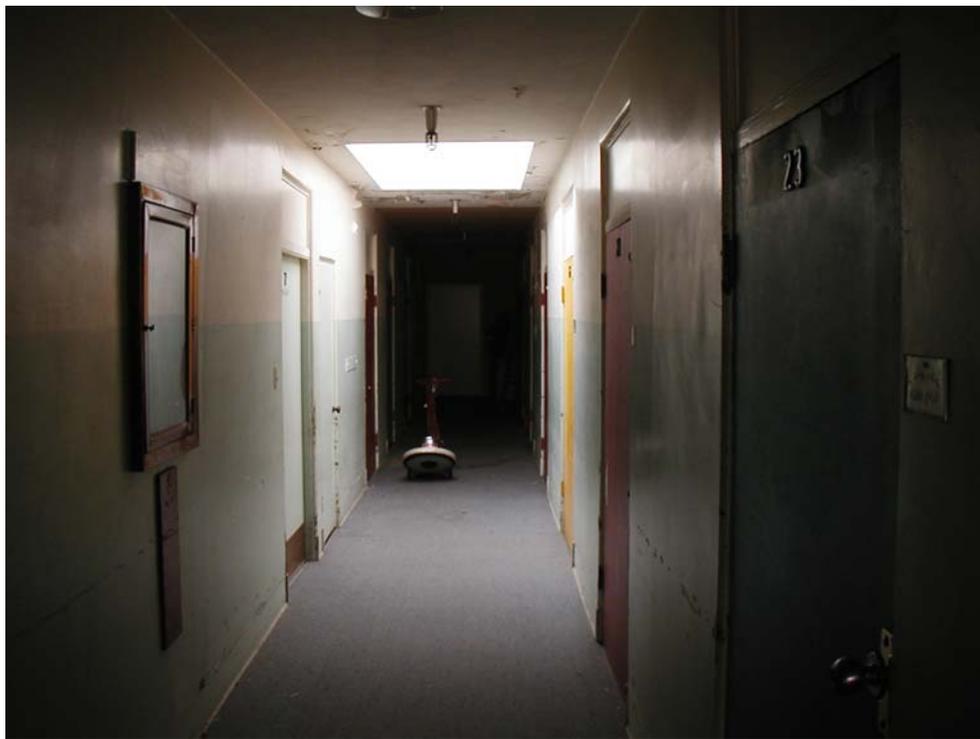
*Figure 6. View of Interior Finishes of Building 2.*

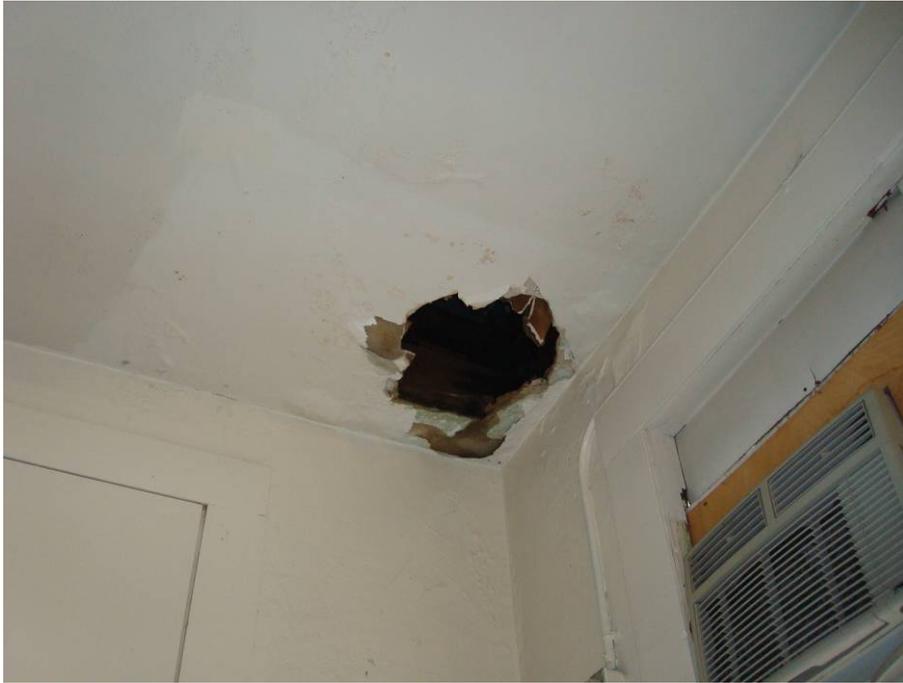
The interior finishes are in fair to poor condition (Figures 13, 16 and 19). Water damage is evident at portions of the ceiling, as well as numerous obvious patch repairs throughout. The interior doors will need to be increased in width (minimum 29½ inches clear opening per CHBC) and provided with ADA hardware. The vinyl flooring is worn out. The only restroom is located in one of the additions to be removed, and is insufficient. The fire sprinkler system would require replacement due to its age and effective coverage. Suspect signs of asbestos were observed in the flooring and lead paint is assumed to exist on some or all of the exterior and interior surfaces.

*Figure 13. Water Damage to the ceiling of Building 3*

If the building was to be remodeled and brought up to current codes, several items would need to be corrected to the interior. All flooring should be replaced, the interior walls should be repainted, the aged and worn wood doors should be replaced with new doors (and updated ADA hardware) and the ceilings should be removed and replaced throughout with gypsum board. While the ceiling area is exposed, the new updated fire sprinkler system should be placed in the attic area. Surface mounted electrical items (Figure 17) should be removed and run inside the cavities of the walls. One men's and one women's restroom shall be required to be added to the building.

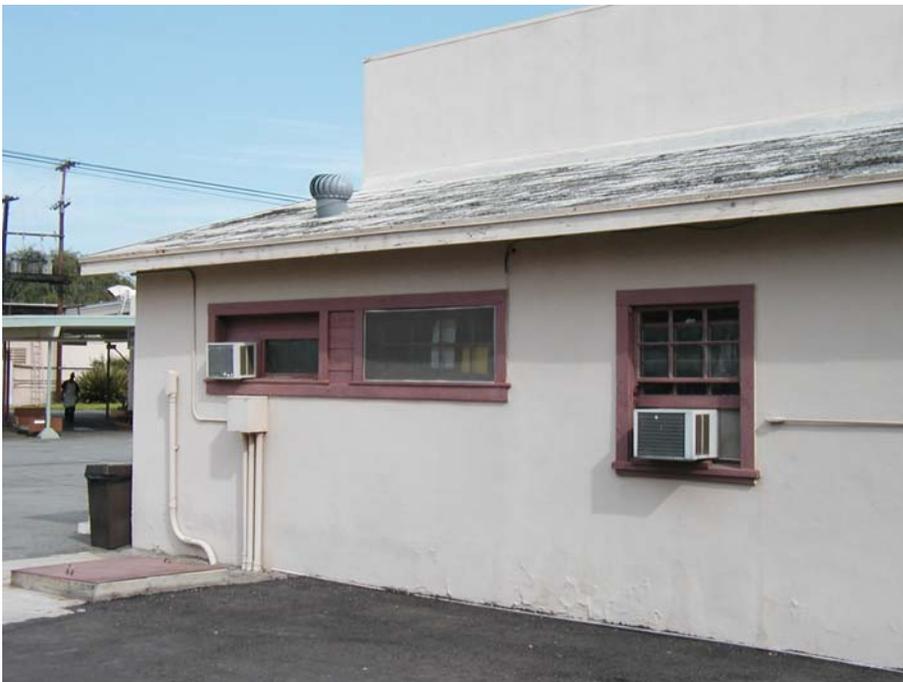
*Figure 14. View of Asphalt Shingles of Building 3.*

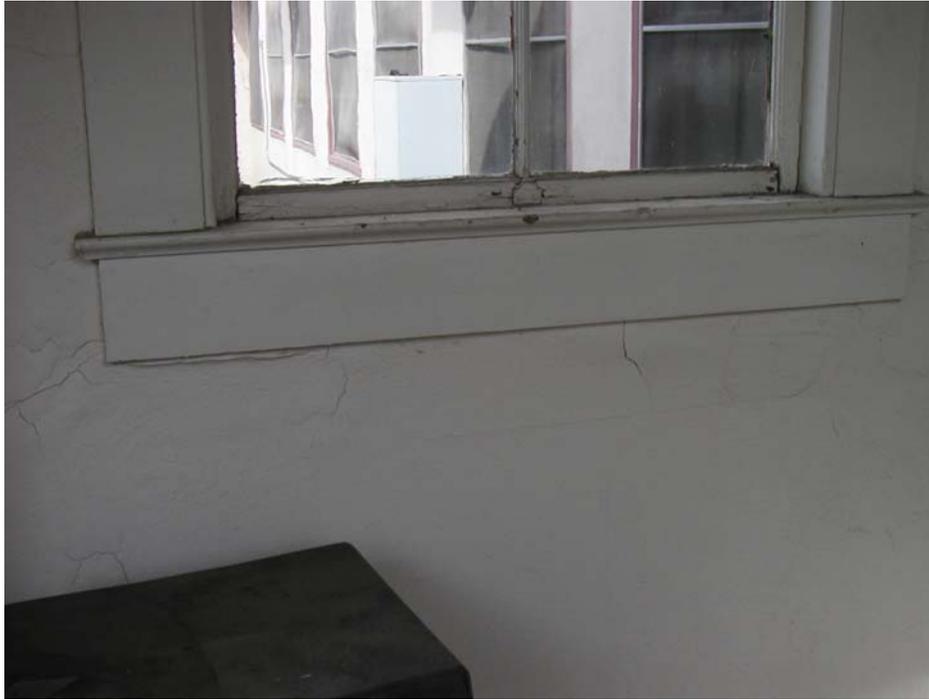
*Figure 15. View of Windows of Building 3.*

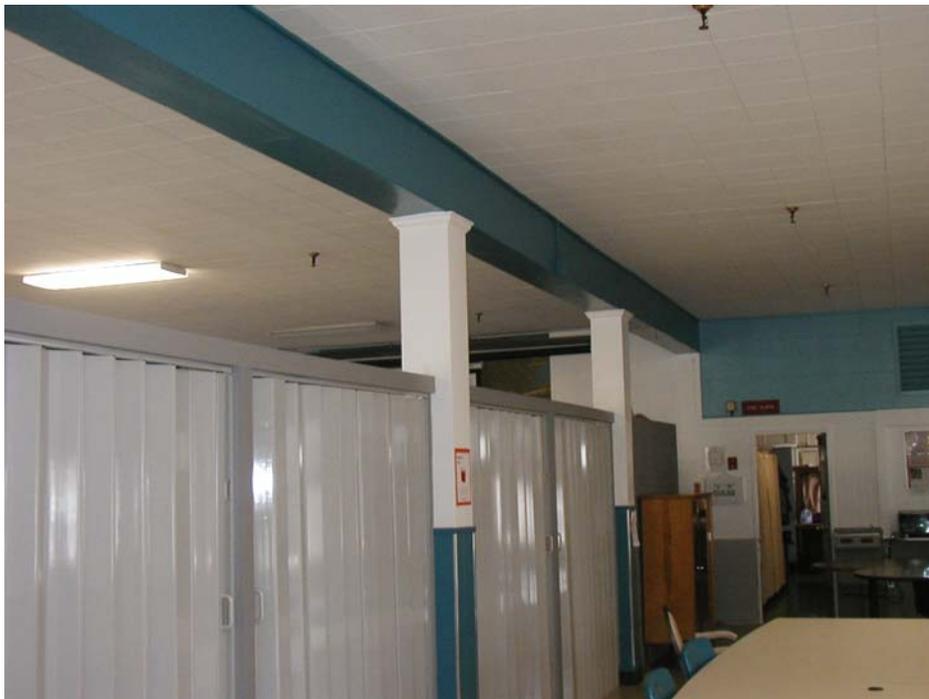
*Figure 16. View of Interior Finishes of Building3.*

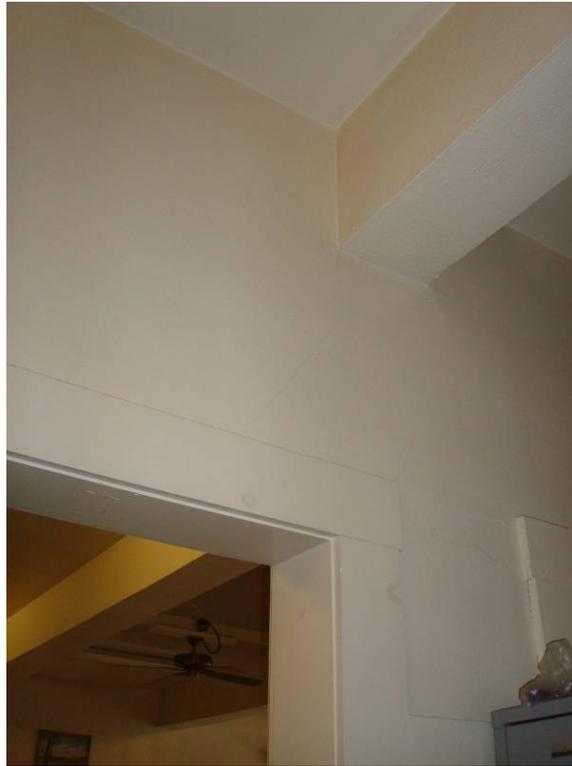
*Figure 19. Small cracks above a door opening in Building 3.*

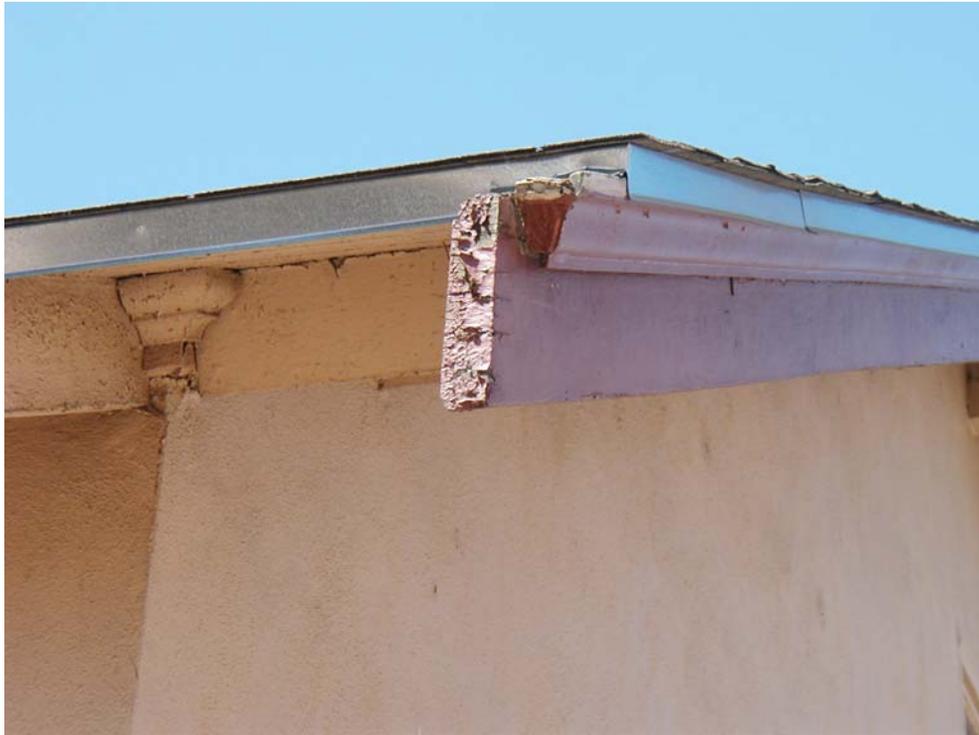
*Figure 27. View of Wood Eave Rot of Building 8.*

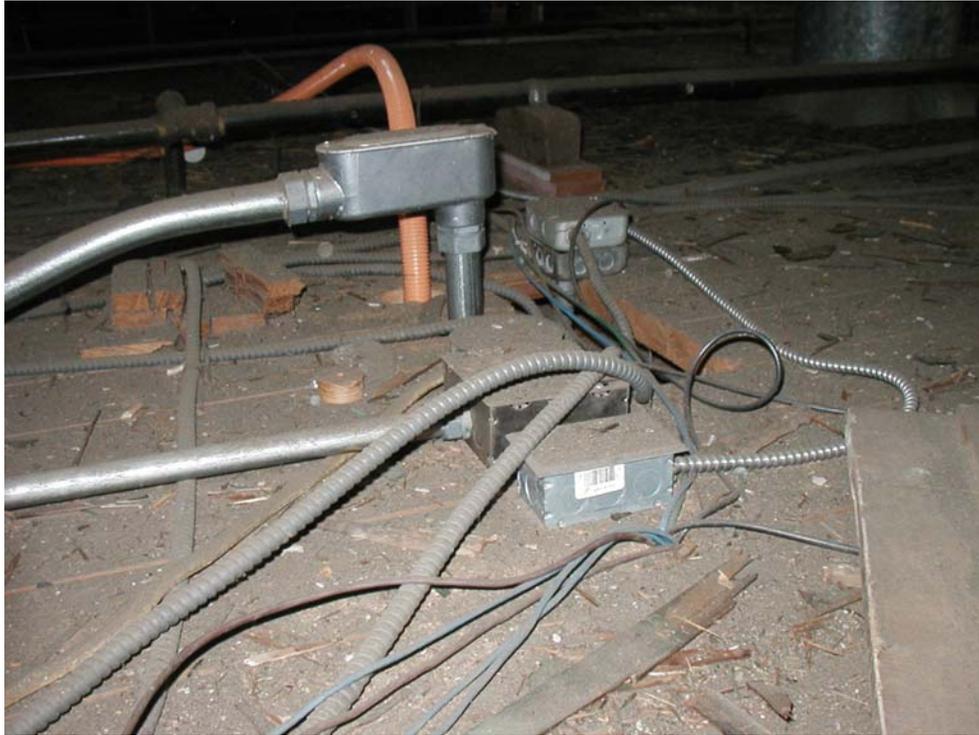
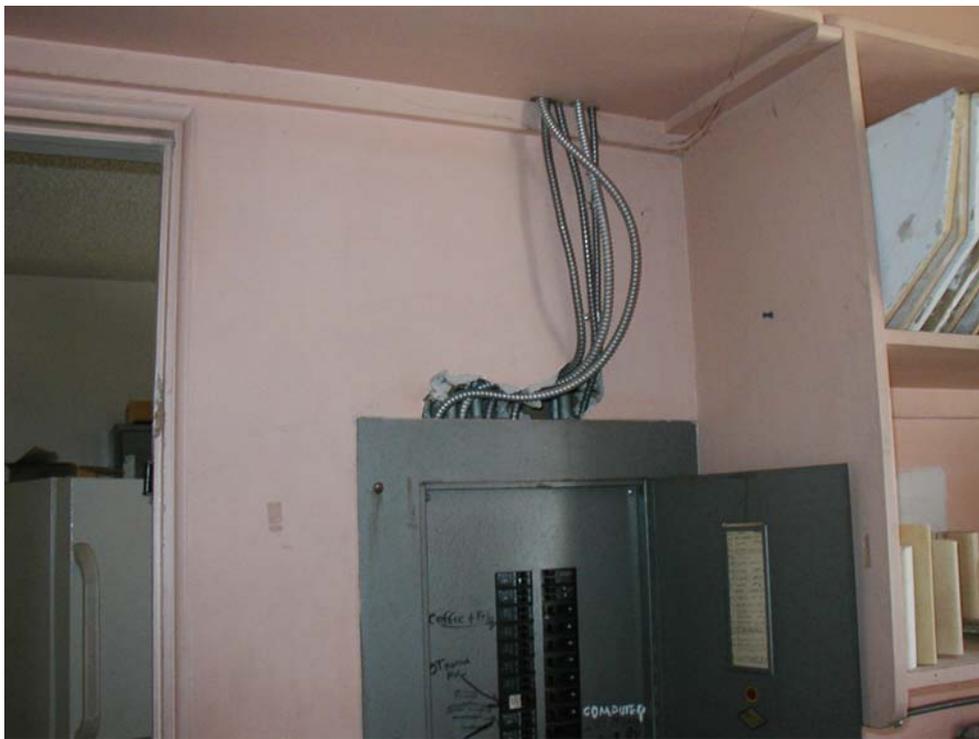
*Figure 29. View of Old Electrical Wiring of Building 8.*

*Figure 30. View of Old Electrical Wiring of Building 8.*

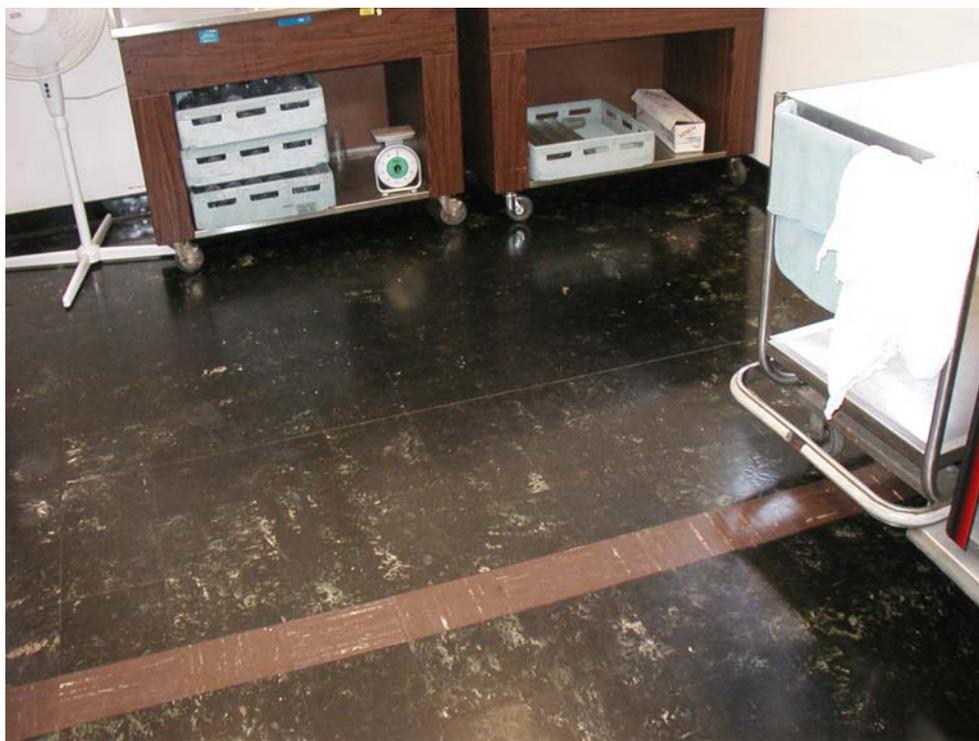
*Figure 32. View of Asbestos Flooring of Building 8.*

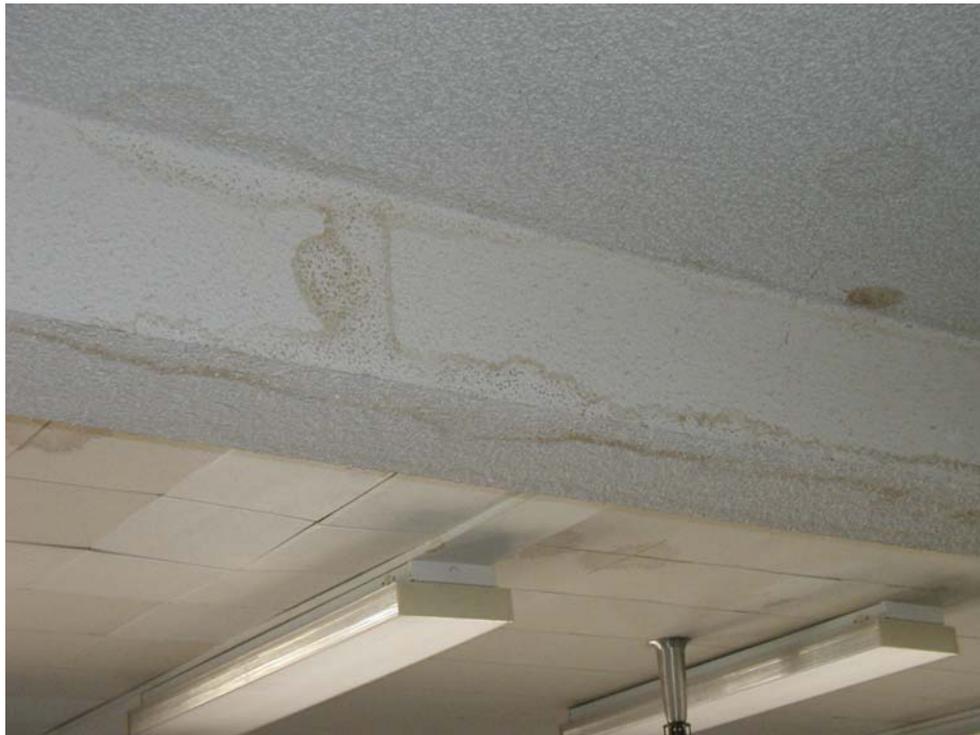
*Figure 33. View of Asbestos Ceiling of Building 8.*

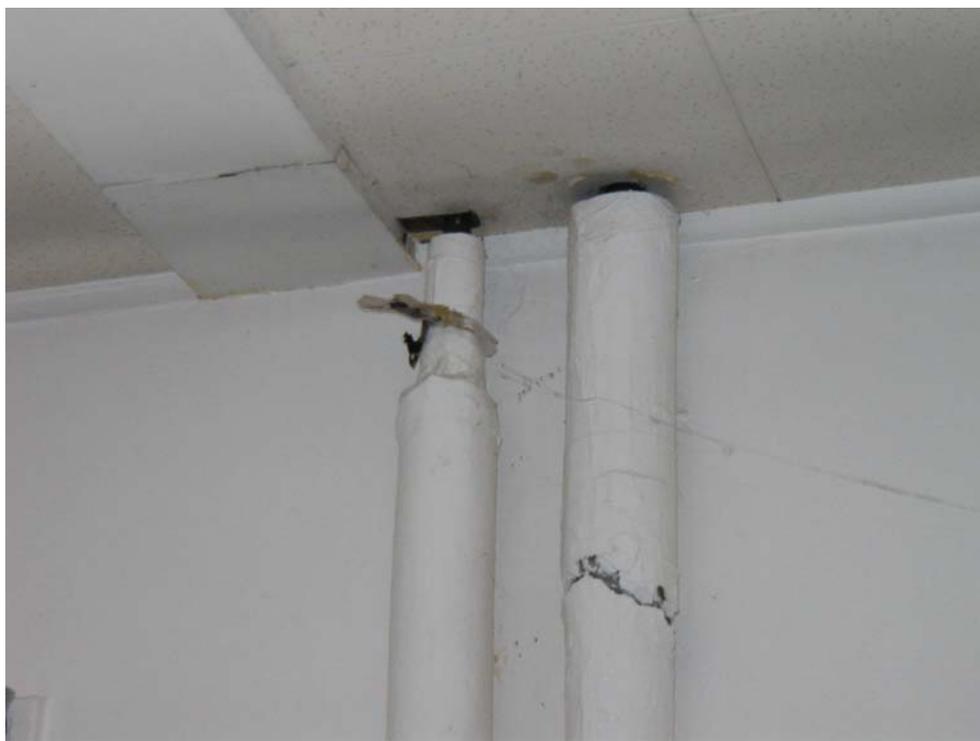
*Figure 34. View of Asbestos Wall in Building 8.*

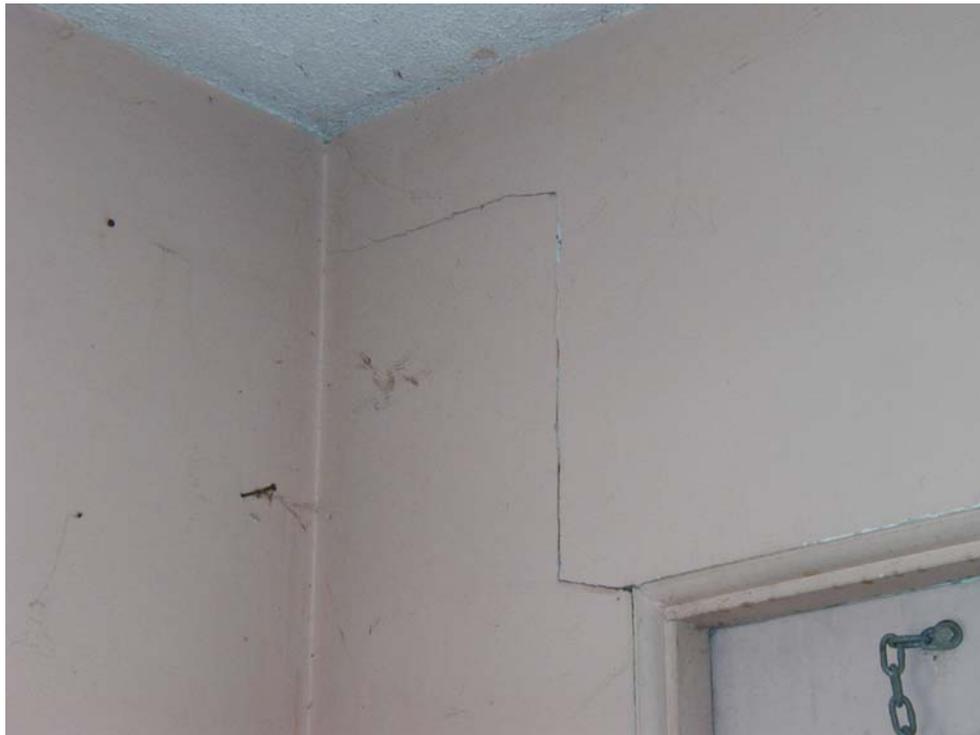
*Figure 35. View of Interior Lead Paint in Building 8.*

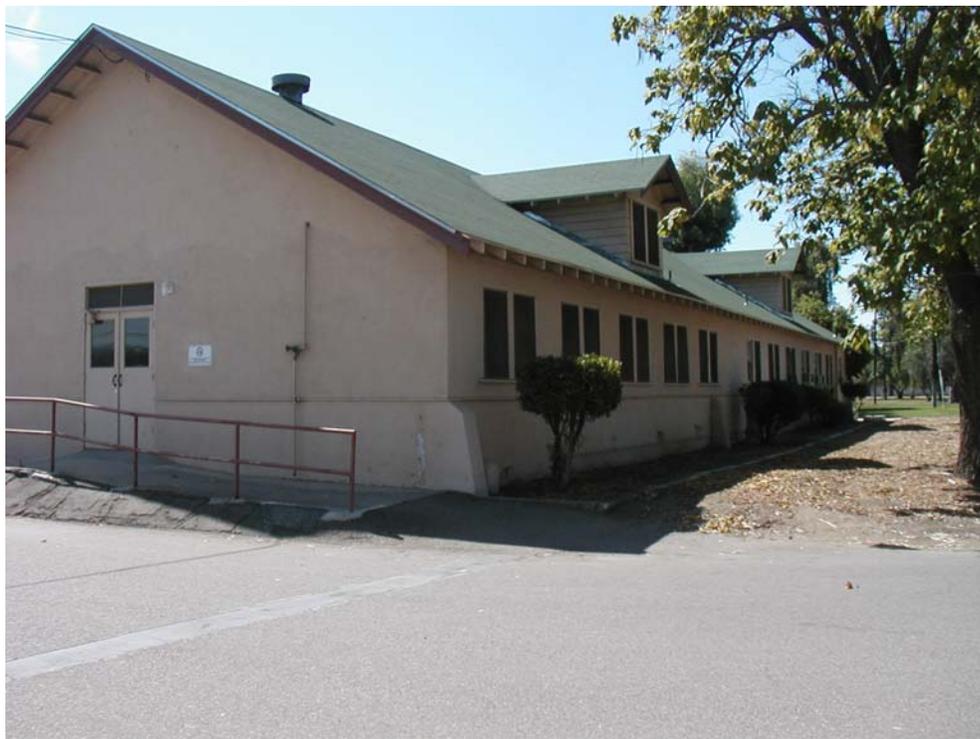
*Figure 36. View of Exterior Lead Paint in Building 8.*

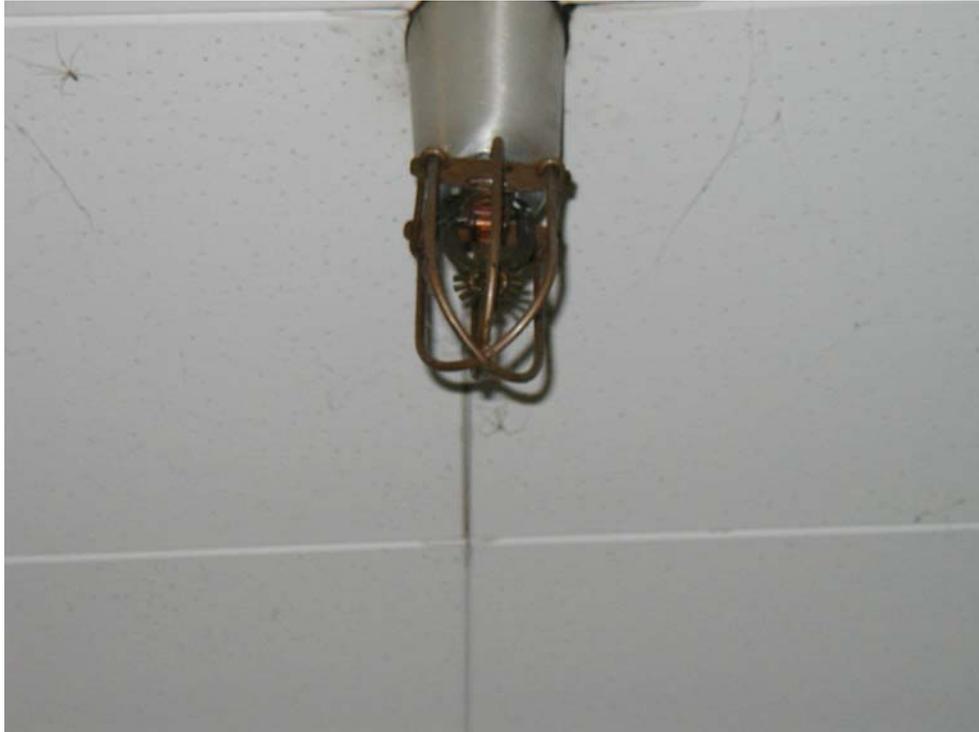
*Figure 37. View of Outdated Fire Sprinkler of Building 8.*

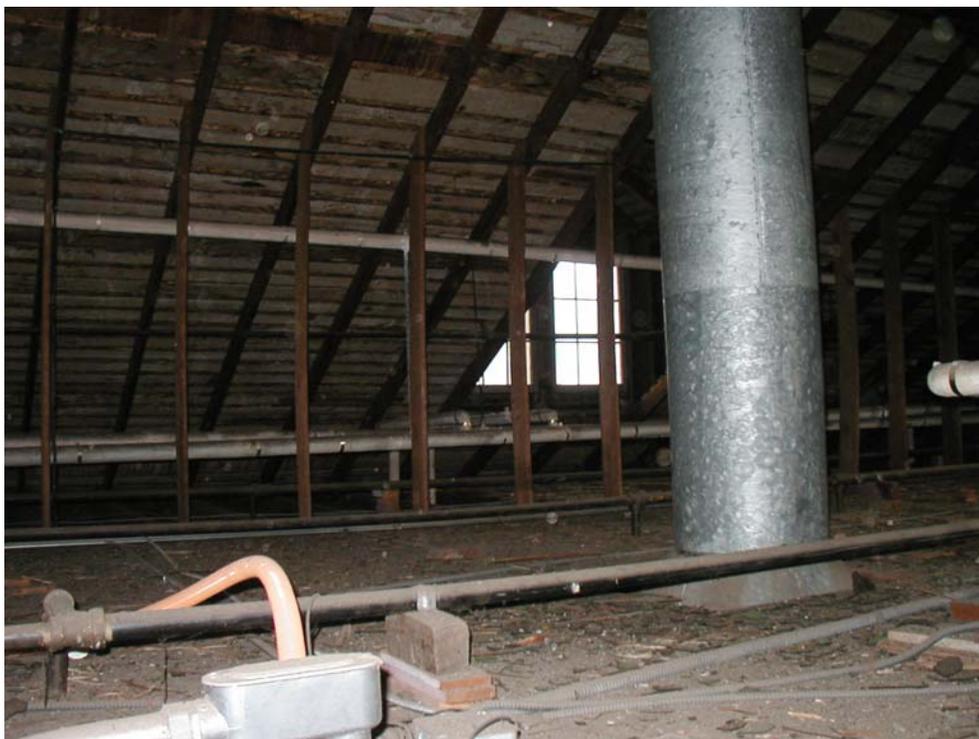
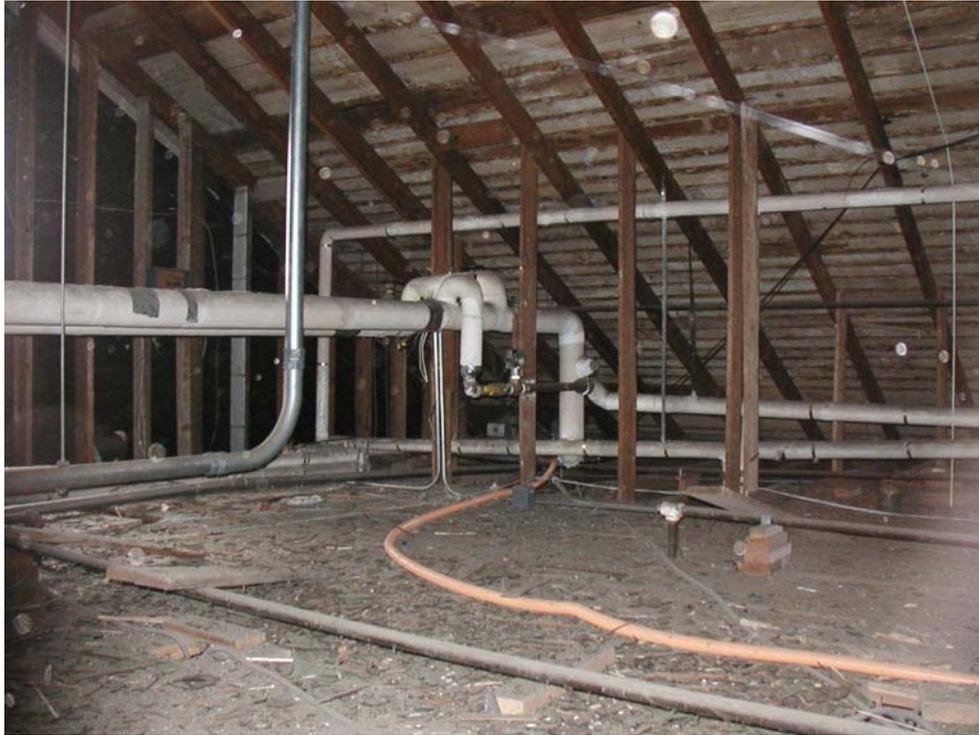
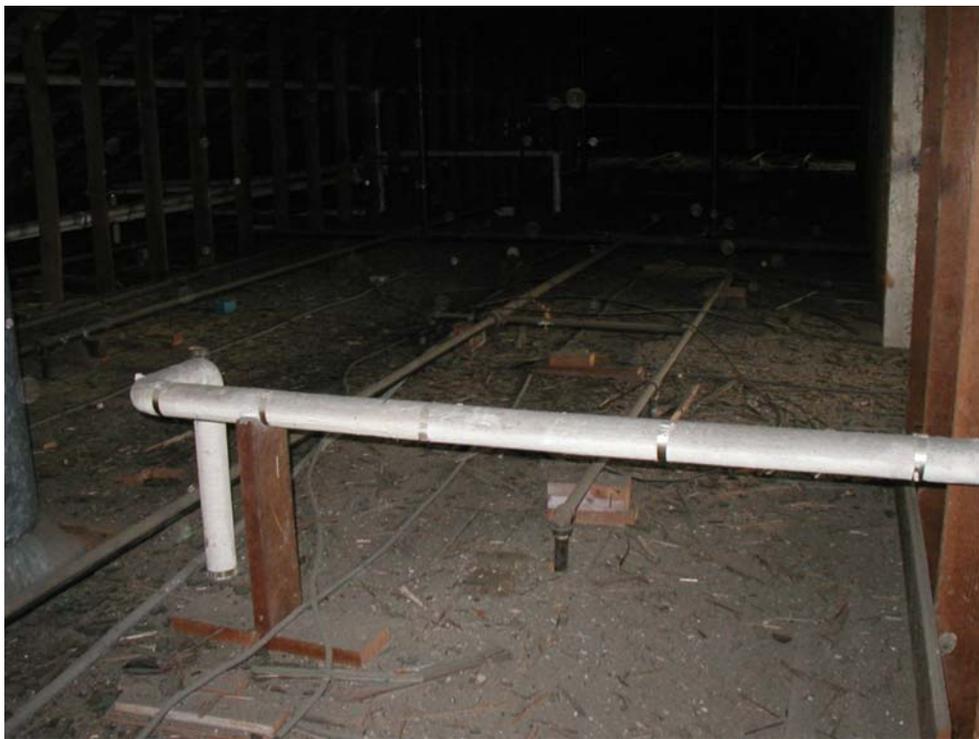
*Figure 38. View of Attic Debris Fire Hazard of Building 8.*

*Figure 39. View of Attic Debris Fire Hazard of Building 8.*

*Figure 40. View of Attic Debris Fire Hazard of Building 8.*

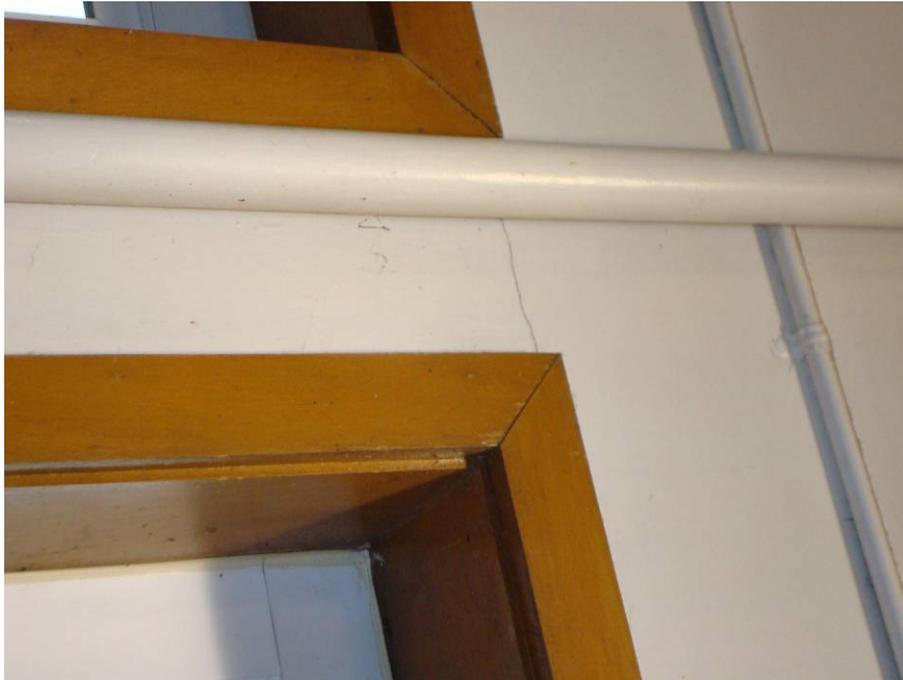
*Figure 44. Typical cracks in the concrete walls near window openings in Building 16.*

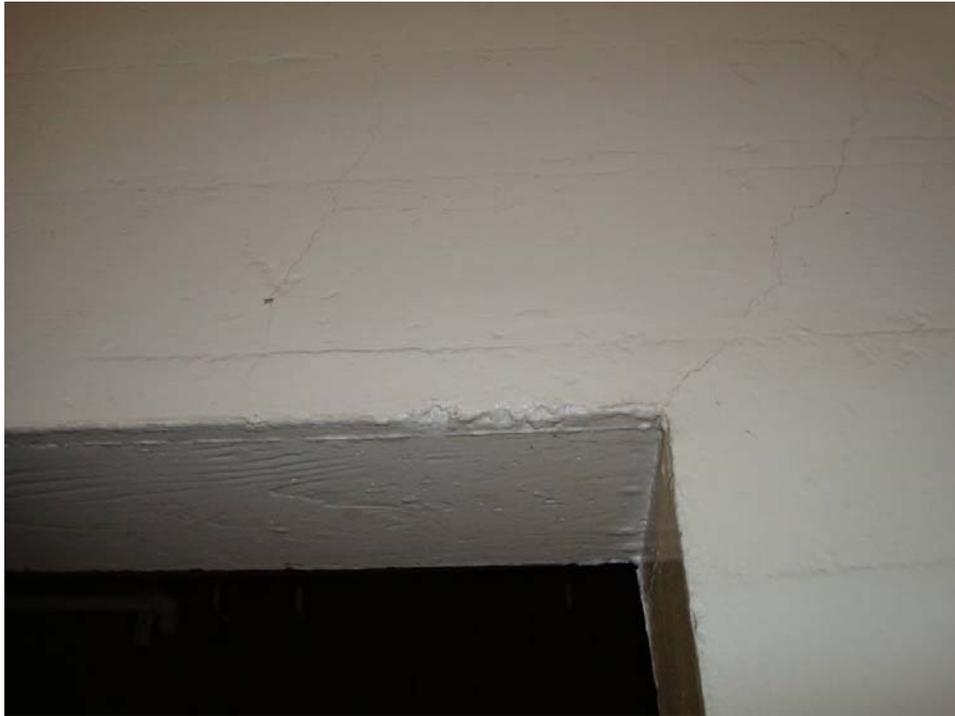
*Figure 45. Typical cracks in the concrete walls at door openings in Building 16.*

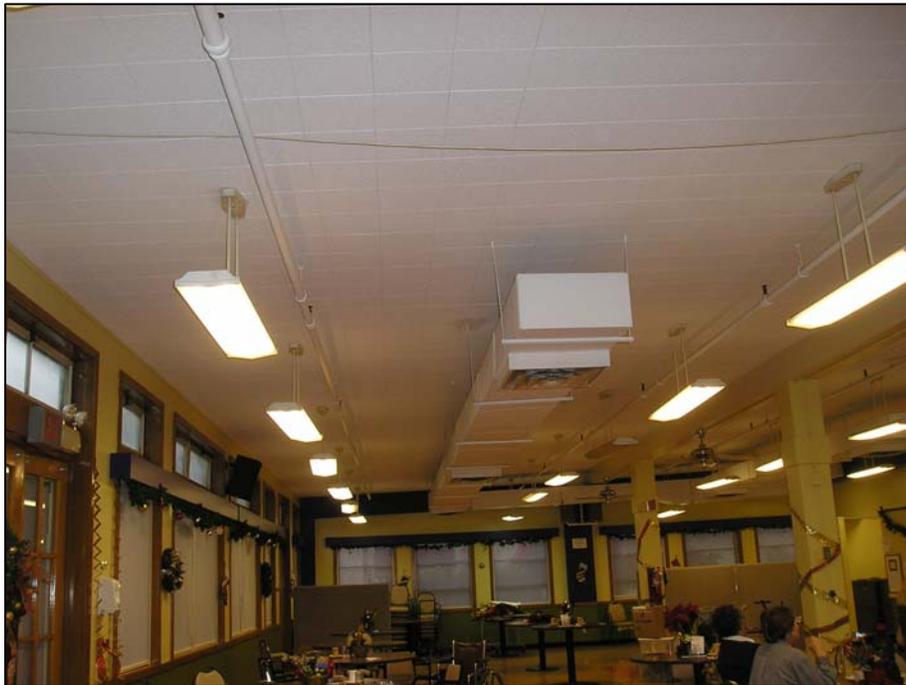
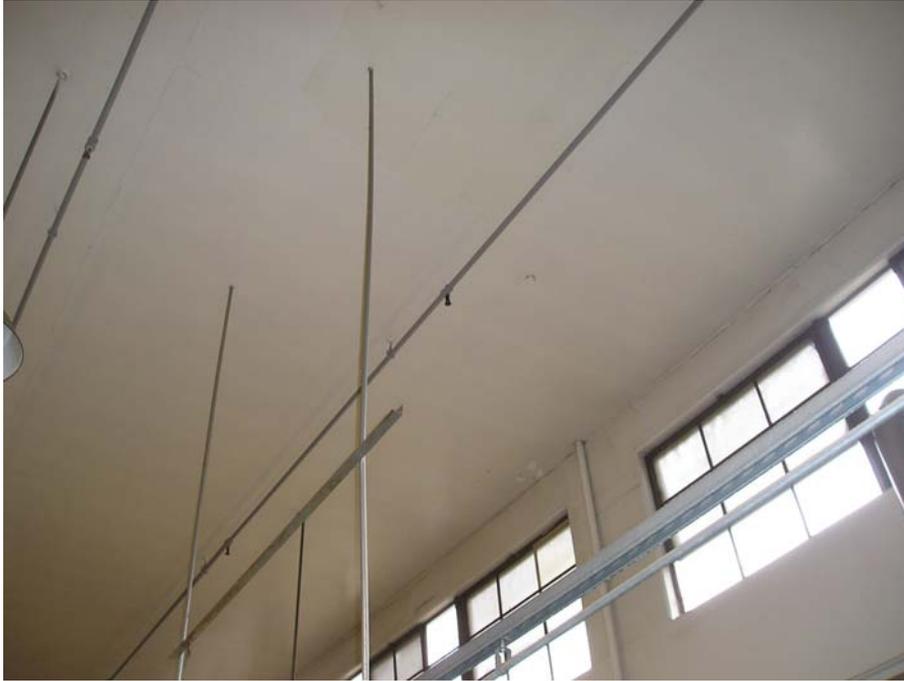
*Figure 50. View of Outdated Fire Sprinkler System of Building 16.*

*Figure 51. View of Outdated Fire Sprinkler System of Building 16.*

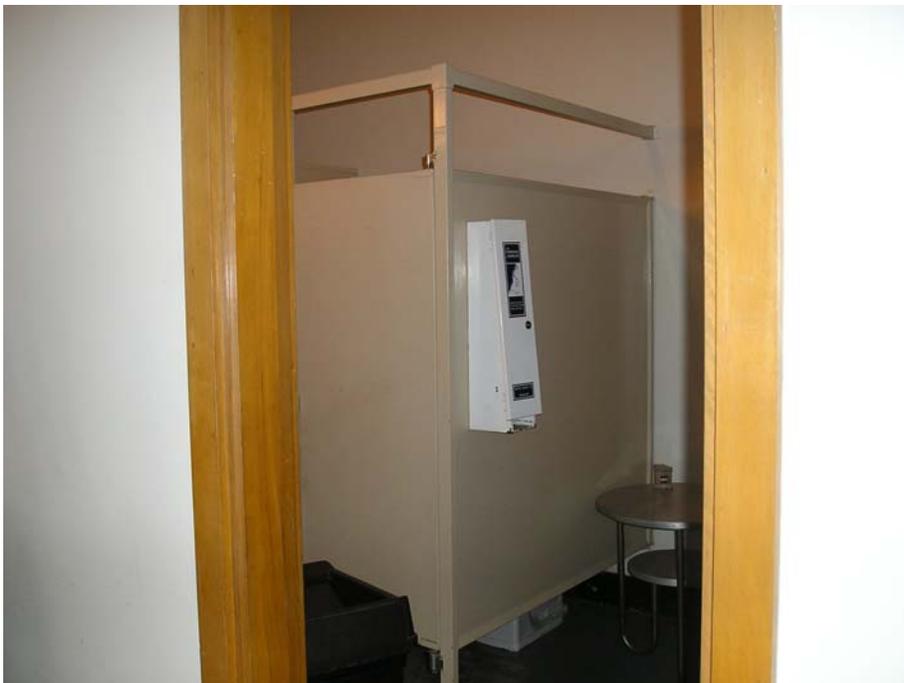
*Figure 52. View of Non-ADA Compliant Women's Restroom of Building 16.*
