County of San Diego Department of Public Works  
**Fiber Reinforced Asphalt Concrete (FRAC) Pilot Project**  
**Pilot Study Report Work Plan( 18 Month Review 10/22)**

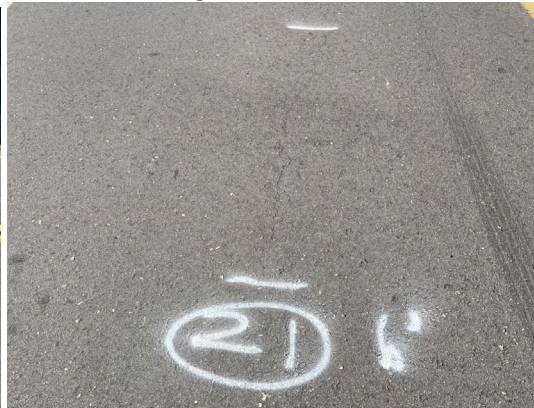
**18 Month Summary:** Minor hairline cracks are starting to develop in all sections. This appears to be the start of reflective cracking. Cracks are hard to identify visually. Next review will focus on the progression and the percentage of road affected.. Representative photographs were taken to document the condition and compare visually to future reviews.

Photo 2-1-4; Skyline TT 18 Months- closeup of hairline cracking

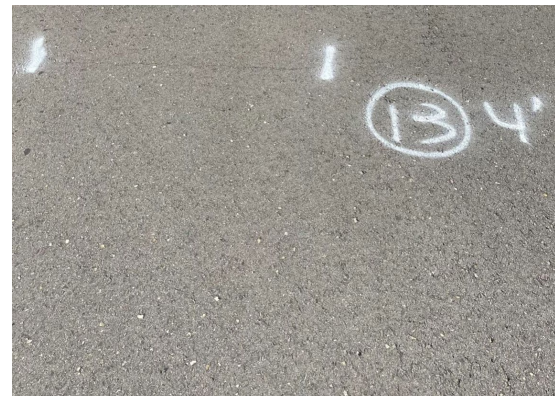
Photo 2-2-4; Skyline TT 18 Months- closeup of hairline cracking

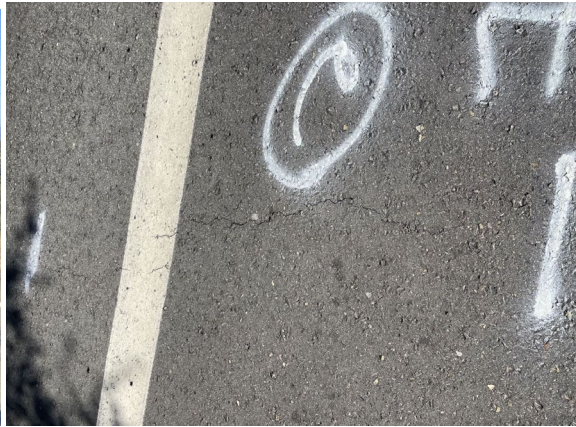
Photo 2-3-4: Skyline TT 18 Months. Representative hairline cracking

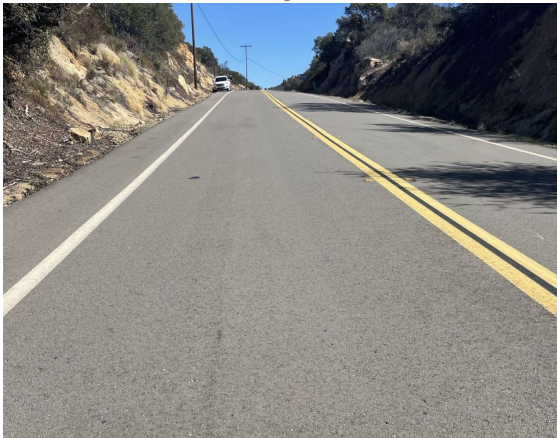
Photo 2-4-3: Skyline TT 18 Months.  
Overall, the road is in good condition

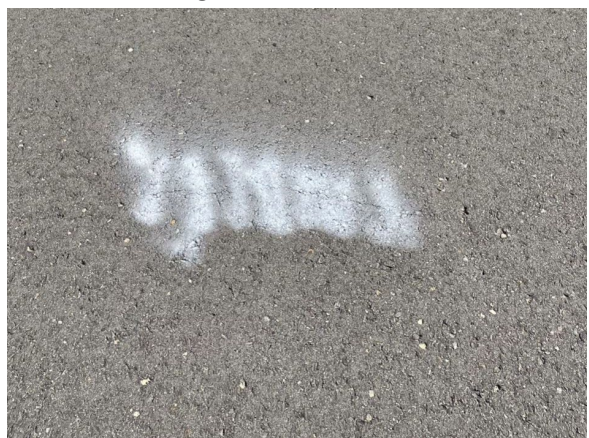
Photo 2-4-4: Skyline TT 18 Months Close up of  
Hairline cracking

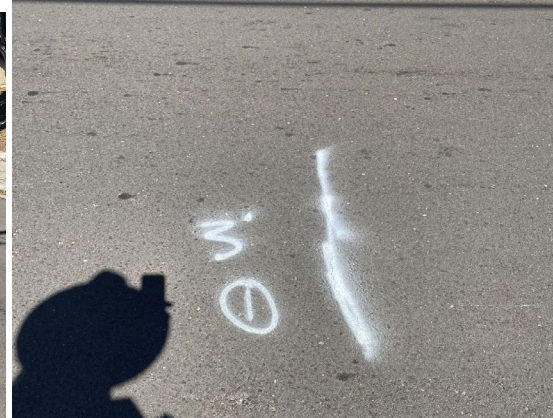
**18 Month Summary:** Locations 2-6 continue to perform well with no signs of cracking or other distress. Pavement starting to age, but no concerns at this time. Two hairline cracks are starting to develop at location 1 ( St George St, (FRAC) Orville Street had 3 distressed areas identified during the 12 month review. Those areas are continuing to fail at a faster rate than expected. Two of these locations are adjacent to commercial driveways. There is a large amount of delivery trucks using these driveways which likely contributed to the accelerated failure. Since these distresses presented shortly after

Photo 3-1-4: 18 M Hairline Cracking

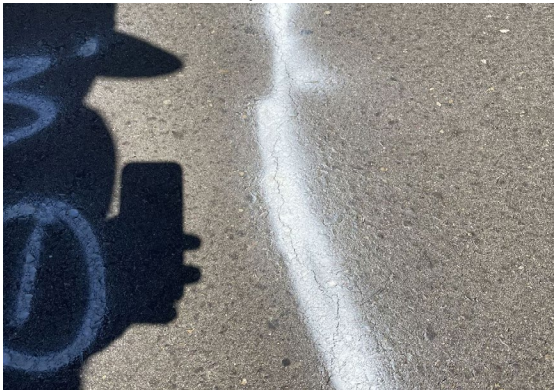
Photo 3-1-5: Close Up of Crack #1 (18 M)

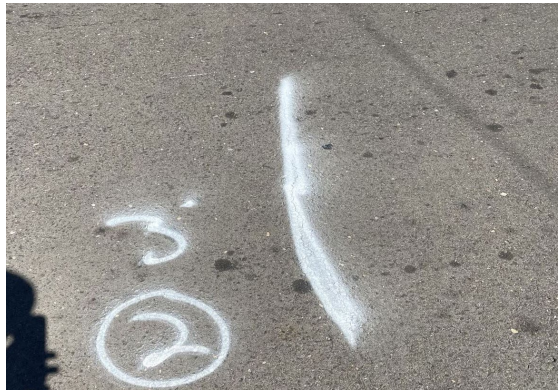
Photo 3-1-5: 18 M Hairline Crack #2

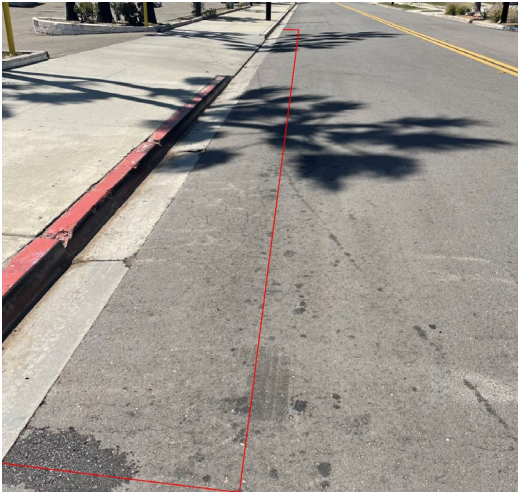
**12 Month Summary:** The majority of the roads we in a similar condition to the roads at 6 months. The black color is starting to fade but there were no signs of cracking with the exception of Orville St. Orville Street has 3 distinct areas that showed signs of fatigue related failures. Two of these locations are adjacent to commercial driveways. There is a large amount of delivery trucks using these driveways which likely contributed to the accelerated failure. Since these distresses presented shortly after construction and none of the other locations in the area have commercial driveways this study will disregard these spot areas and focus the comparison at locations similar in character to the other study roads.

Photo 3-7-3: 12M Distress Area 1 (6'x100')

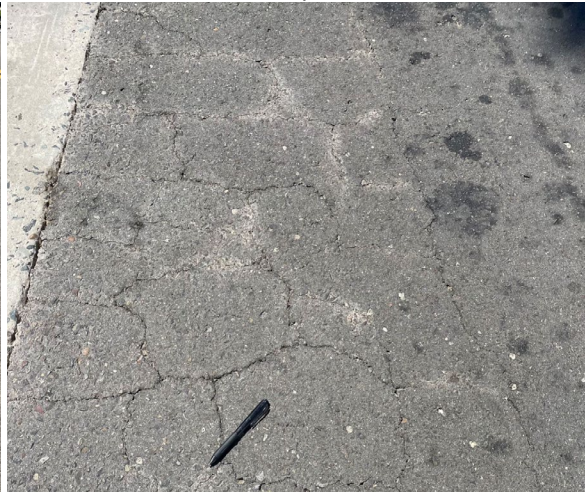
Photo 3-7-4: 12M Closeup DA#1

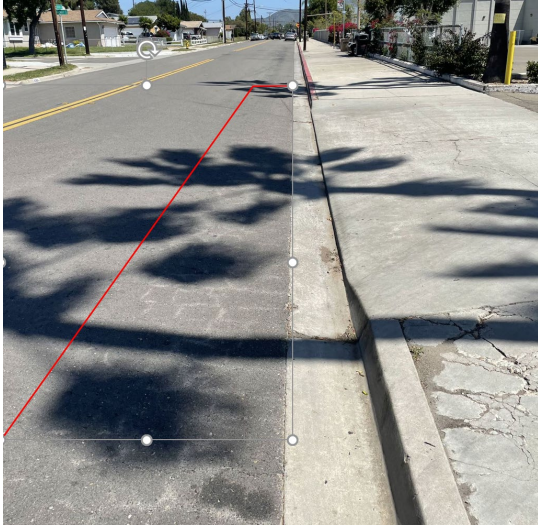
Photo 3-7-5: 12M Distress Area 2 (6'x50')

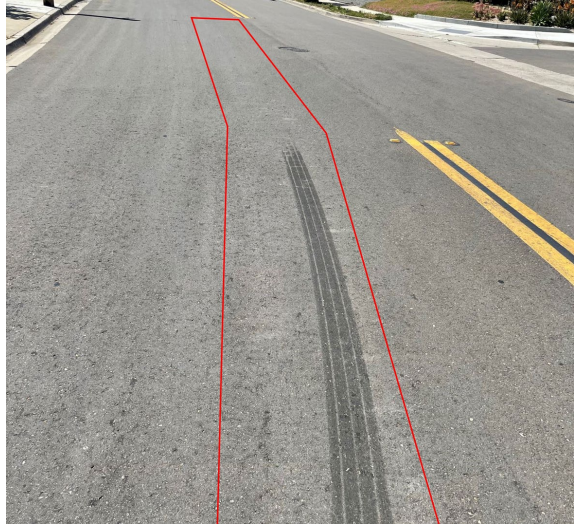
Photo 3-7-6: 12M Distress Area 3 (6'x75')

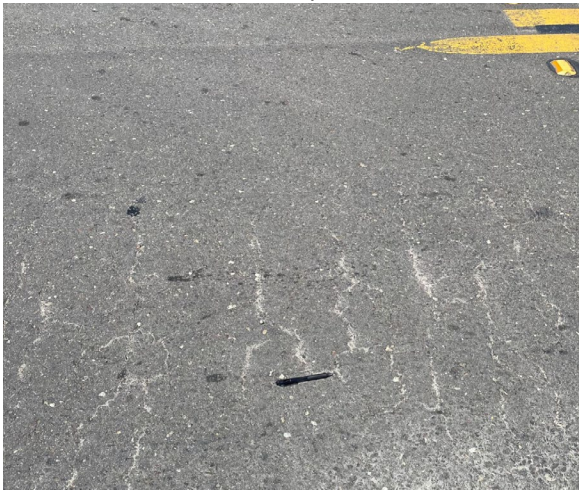
Photo 3-7-5: 12M Close Up DA#3)

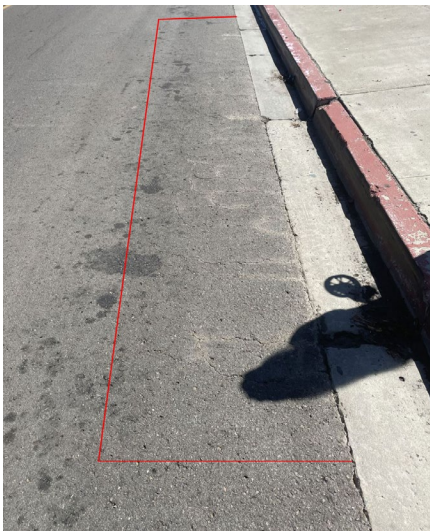
Photo 3-7-7: 18 M DA #1

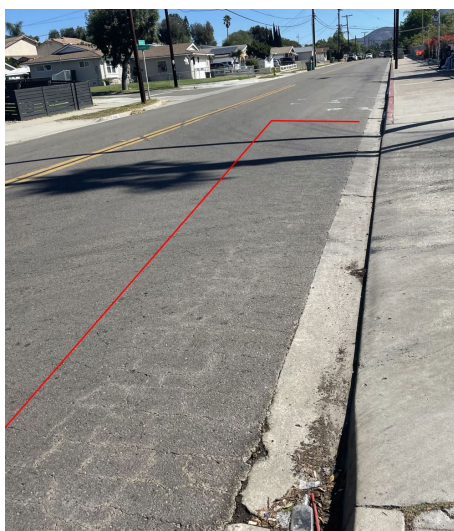
Photo 3-7-8: 18 M DA #2
