PHOTOGRAPHIC RECORD

Newland Sierra, LLC

10618.002

Subject: Geomorphic Observations of Natural Drainages, Contributing Areas of POC 13B (Reach B and C), POC 19, and POC 26
Newland Sierra, San Diego County, California

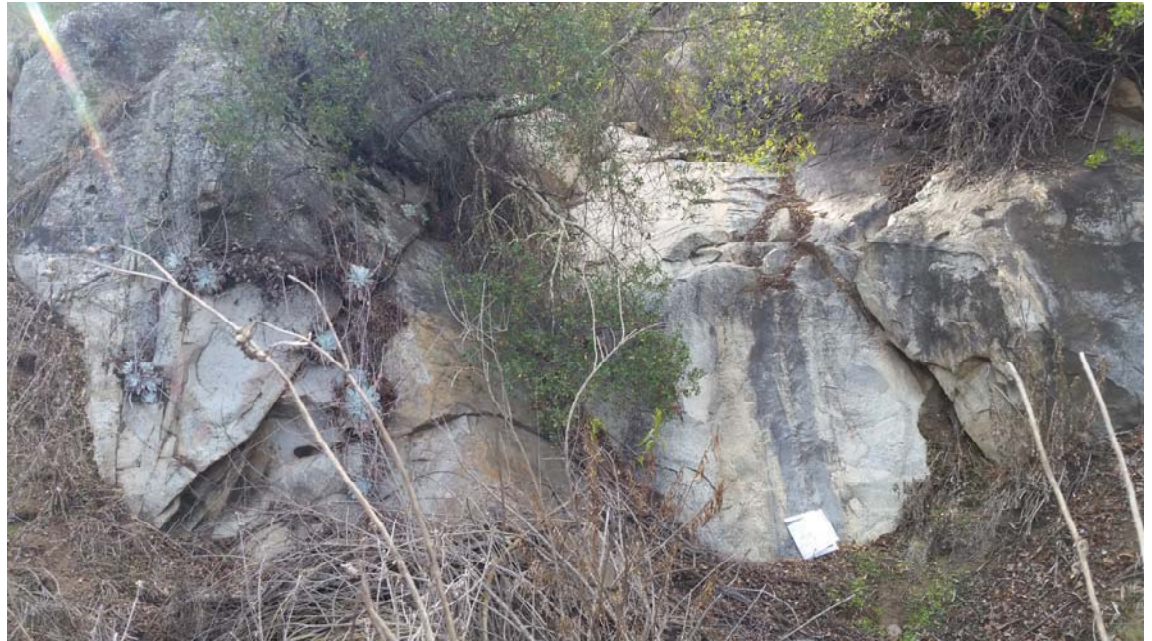
Photo No. 1

View of POC 19, hard
rock waterfall and
resulting grade
control structure.

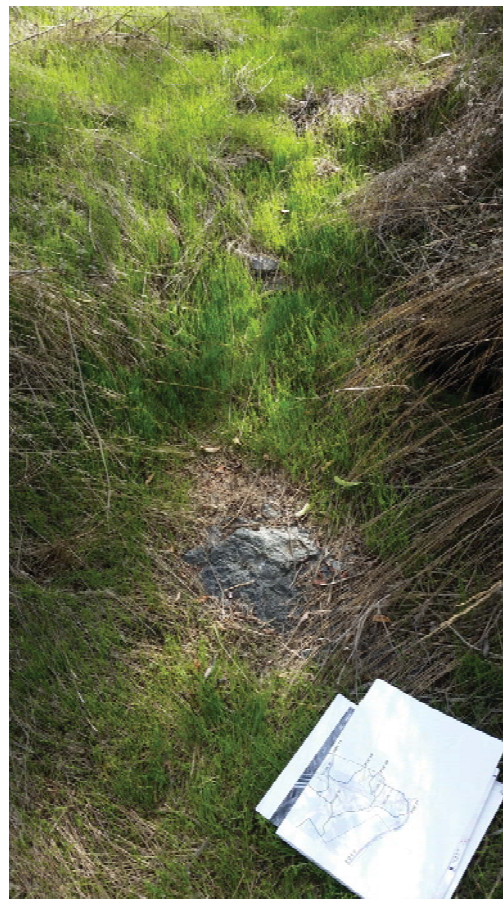
Photo No. 2

View of POC 19,
Grass growing in
hard rock channel
with hard bedrock
visible at surface of
channel

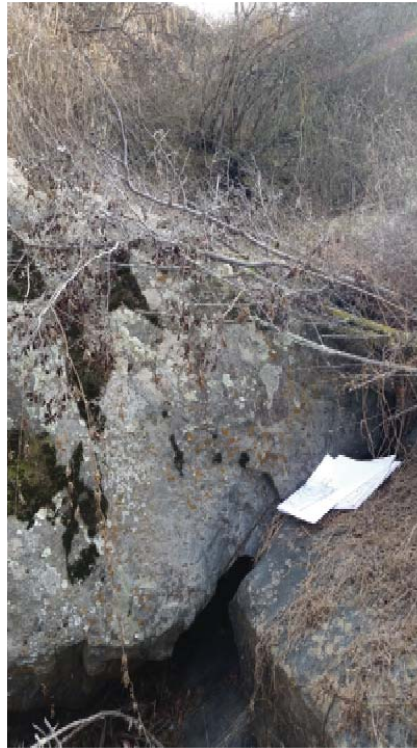
Photo No. 3

View of POC 19, Hard rock pile and resulting waterfall grade control structure.

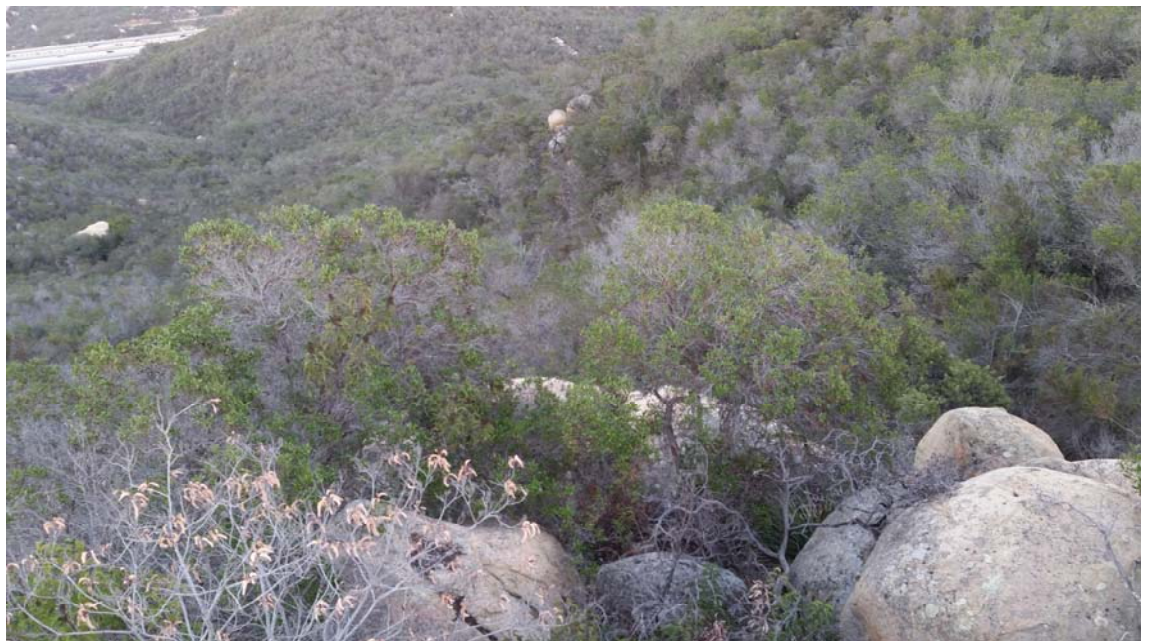
Photo No. 4

View of upper POC 13B Reach C with large boulders.

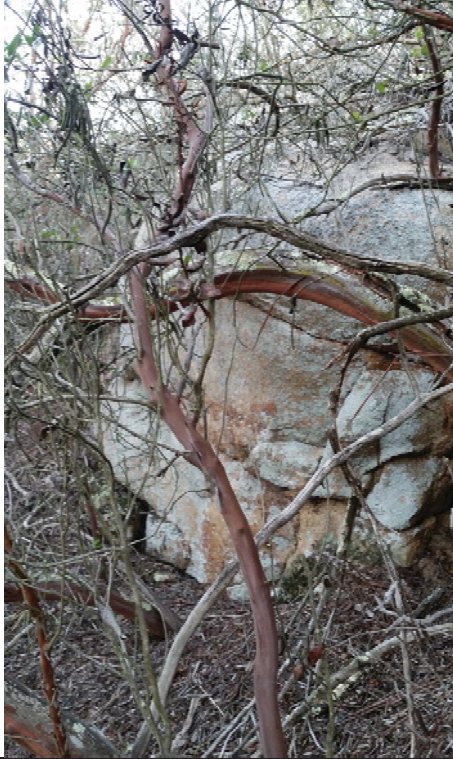
Photo No. 5

View Direction of Photo: South		
Description: View of upper area of POC 13B Reach C, dense brush, large boulder control structure, dense brush and leaves

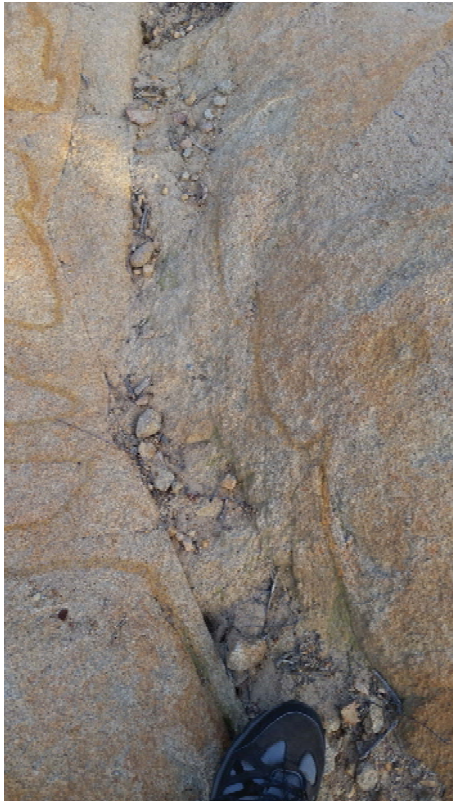
Photo No. 6

View Direction of Photo: South		
Description: View of upper area of POC 13B Reach C, where very hard bedrock is exposed in channel bottom. Note a lack of sediment to sample.

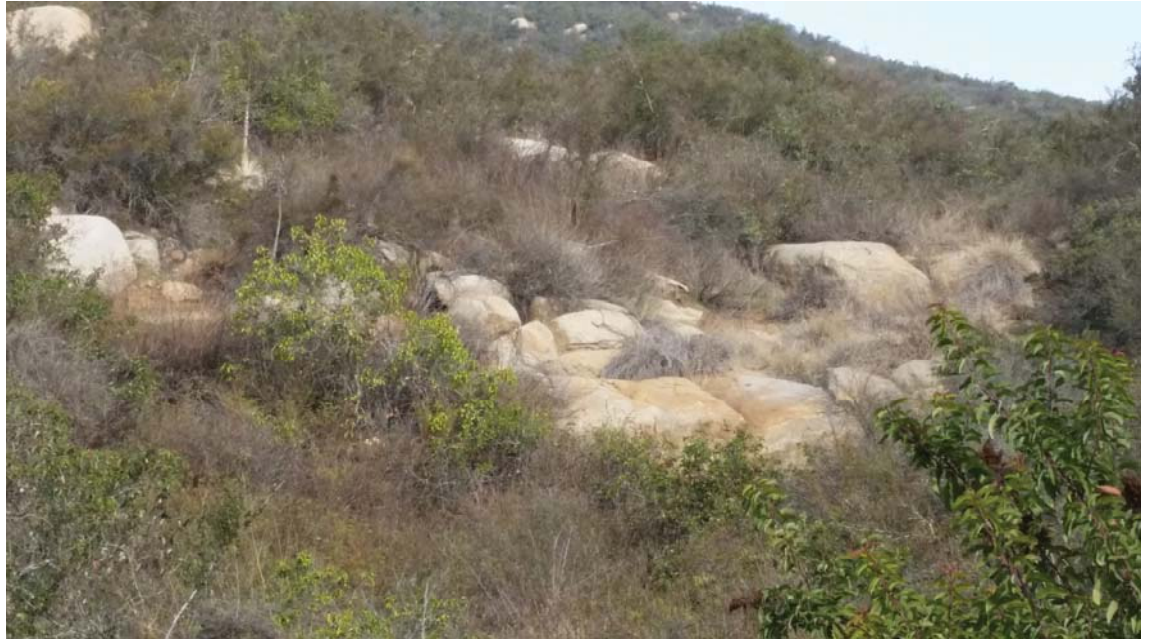
Photo No. 9

View of upper portion of POC 26, note large bedrock exposures at surface of channel creating a control structure. Also note very dense brush and a lack of sediment.

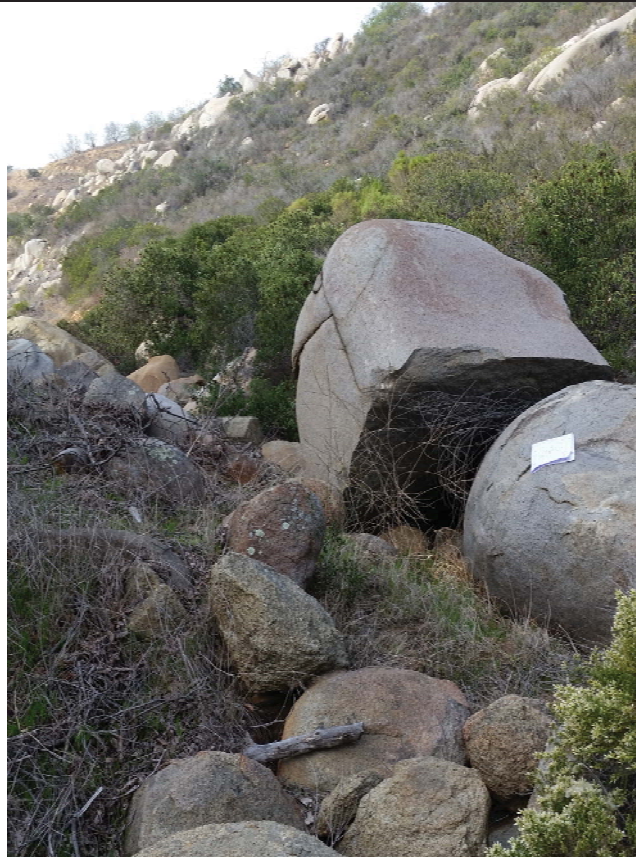
Photo No. 10

View of POC 26, note large boulders in channel creating a massive control structure through out the drainage. Also note very dense brush and a lack of sediment.

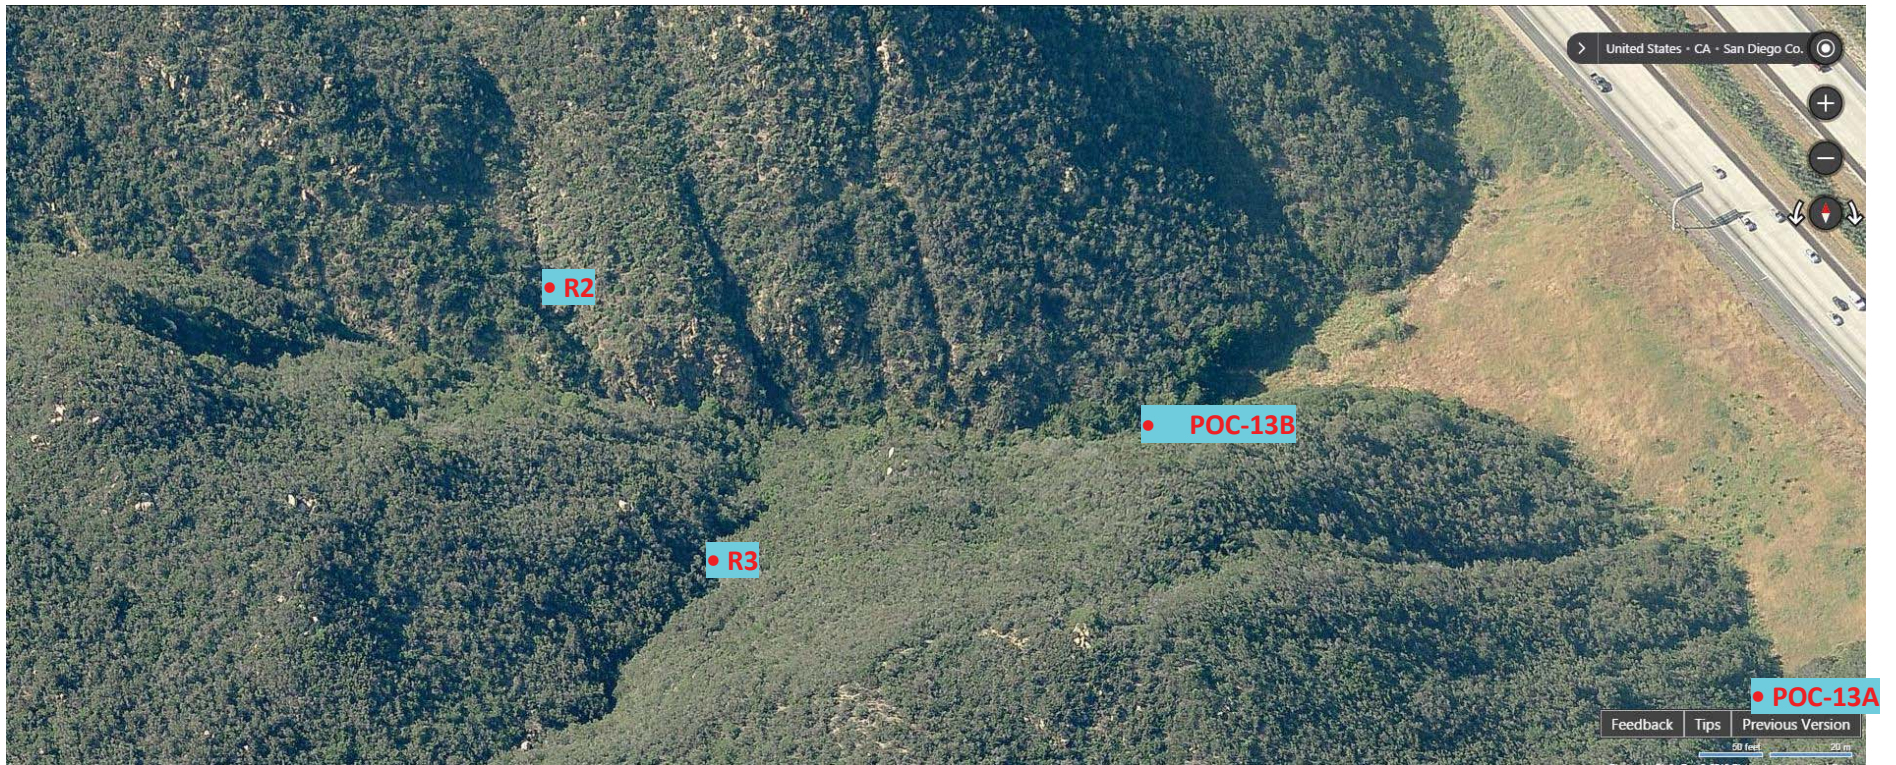
Aerial View of POC-13B + POC-A Location. Notice thick vegetation and rocks visible even from aerial picture. Also, noticed location of R2 and R3.

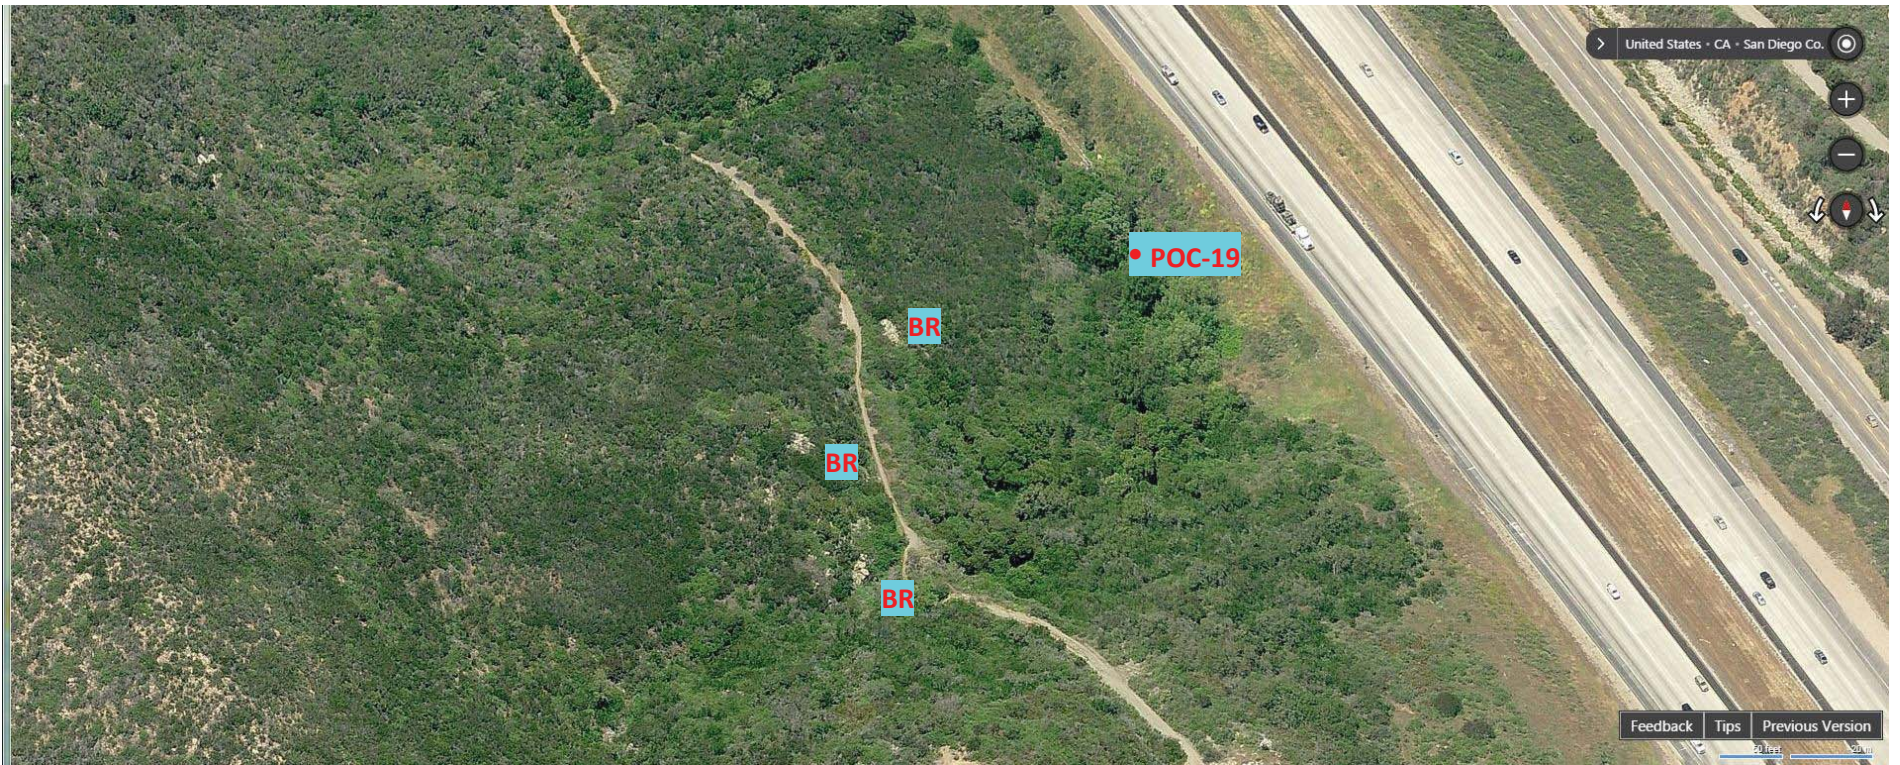
Aerial View of POC-19 Location. Notice thick vegetation and Bed-rock showing (BR).

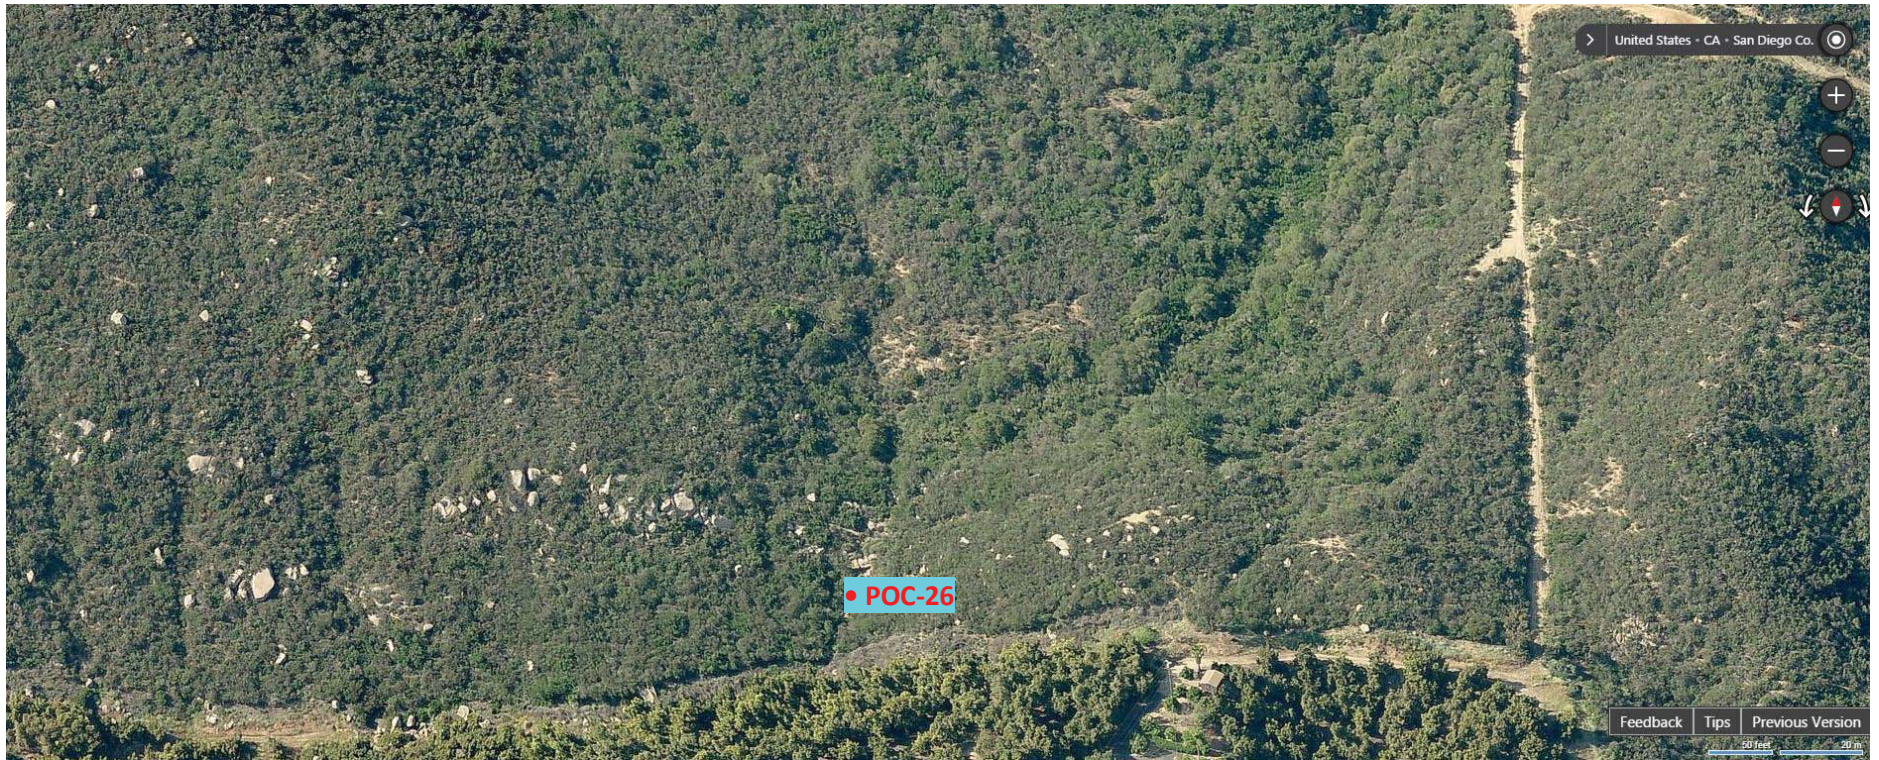
Aerial View of POC-26. Notice thick vegetation and rocks visible even from aerial picture.
