# **Asbestos Building Inspection and Lead-Based Paint Testing**

**Ranch Property (APN 661-060-12)  
JVR Energy Park Project  
45346 Old Highway 80  
Jacumba, California 91934**

**Aurora Industrial Hygiene  
San Diego, California**

Date: July 2, 2019

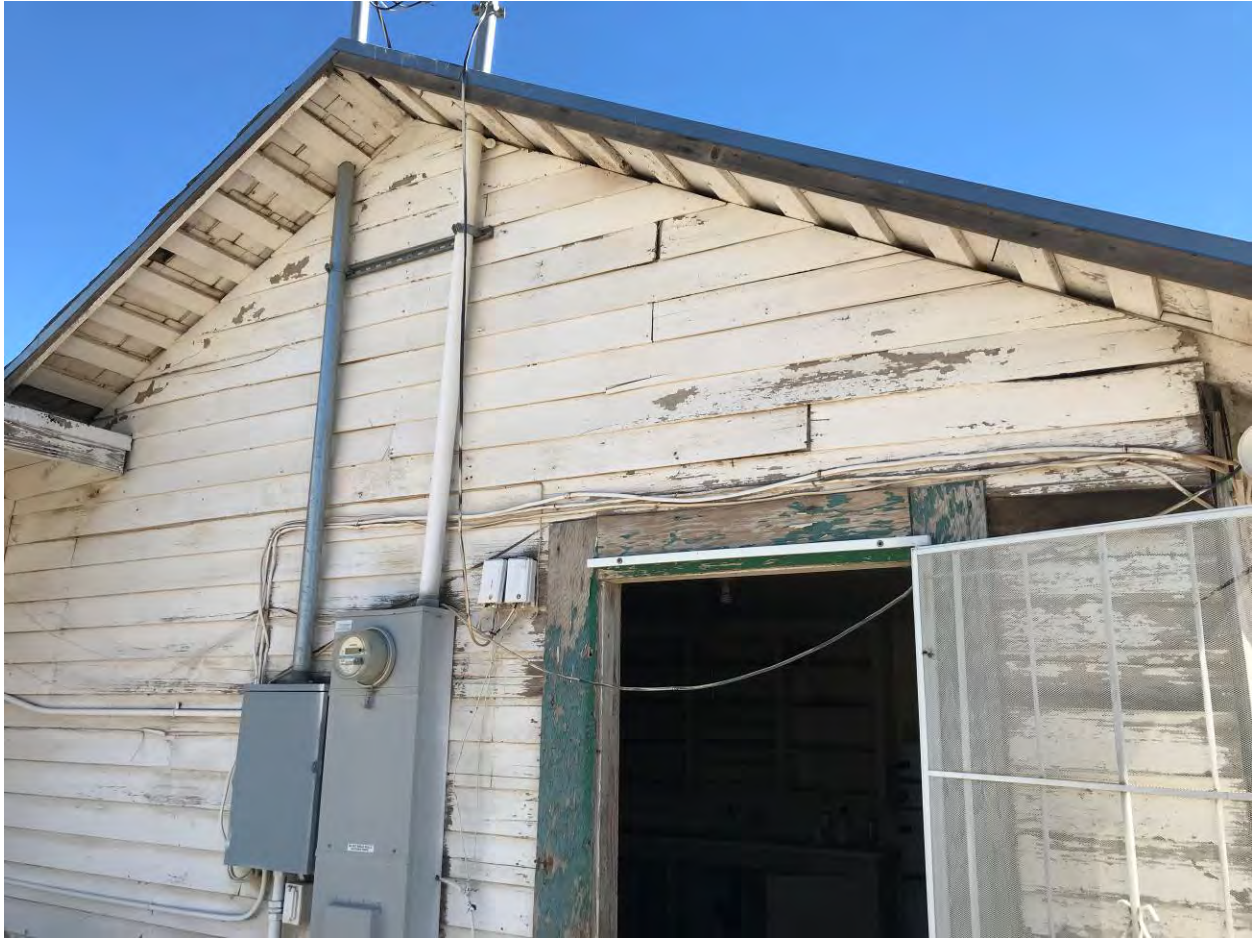
**Photo Five** – Close up photo of wood siding and eaves on exterior of building 5 that were found to contain elevated lead levels.

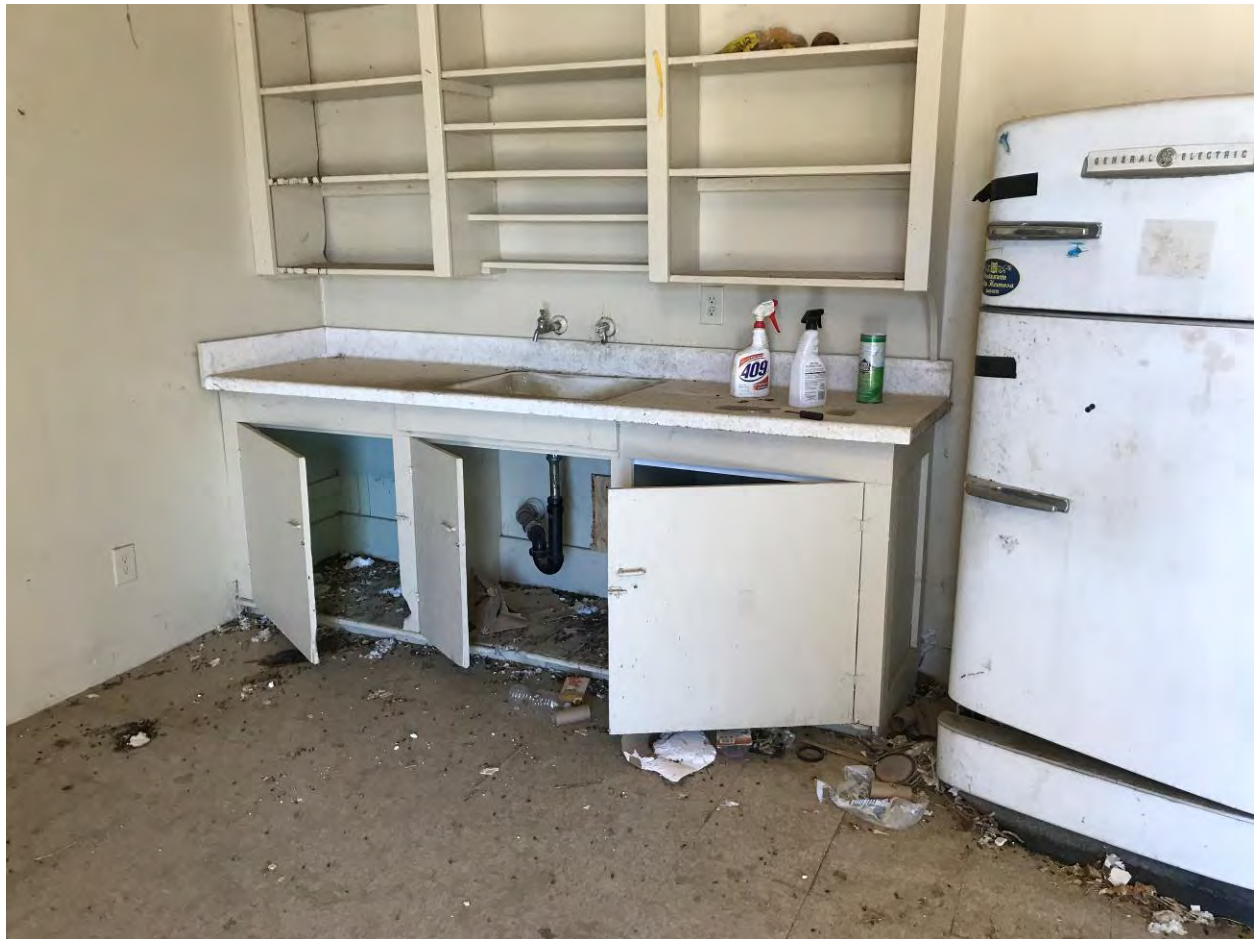
**Photo Six** – Photo of porcelain sink on side B of kitchen in building 5 that was found to contain elevated lead levels. The joint compound located throughout the building was found to contain asbestos.

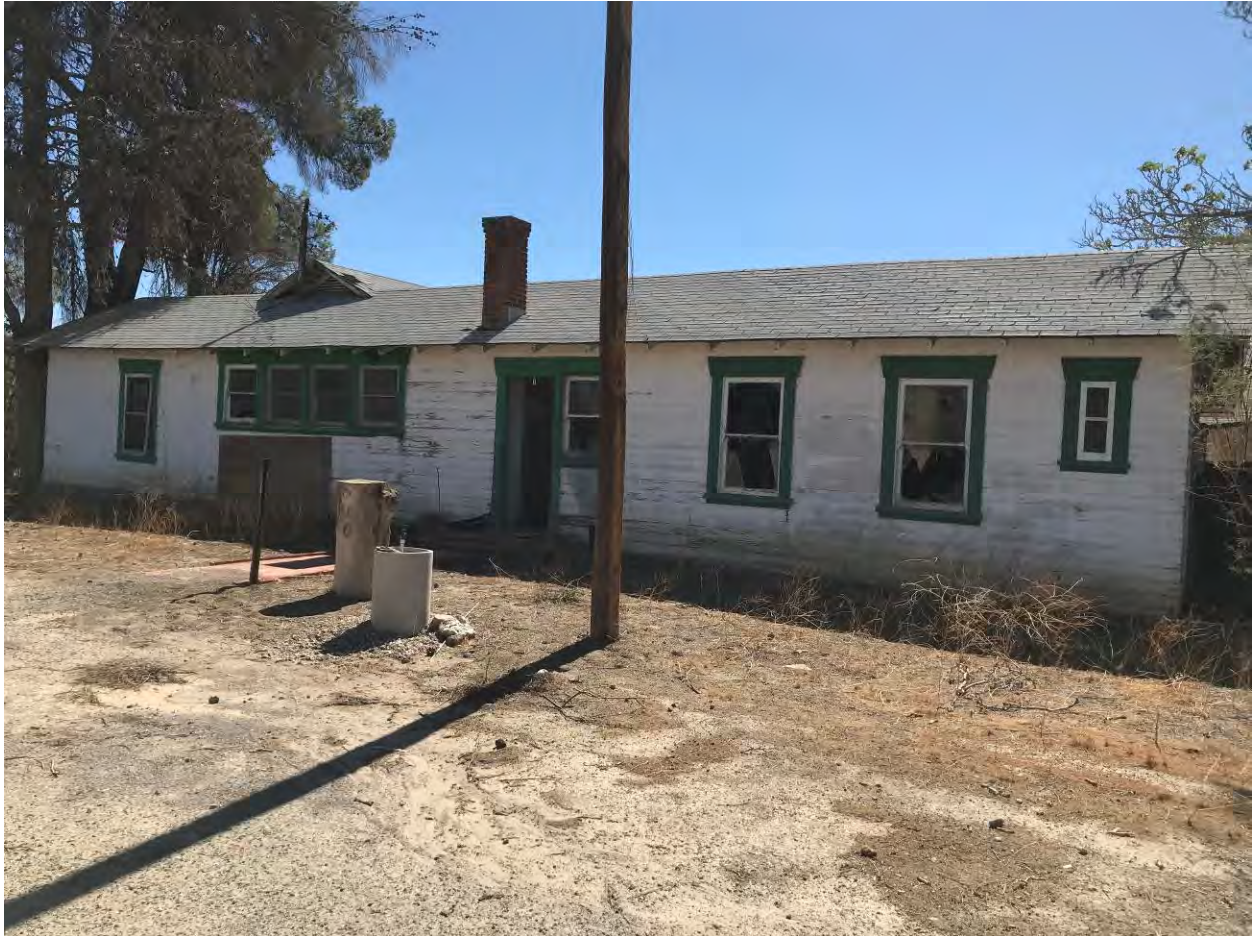
**Photo Seven** – Ground level view of the north side of Building 6. The windows, window frames, window sills, doors, door frames, wood siding, eaves, fascia, trim, and vents on exterior of the building were all found to contain elevated lead levels. Photos not included of upper shelves on sides B and C of living room closet and lower portions of walls covered with wallpaper in south hallway closet inside building 6 that were also found to contain elevated lead levels.

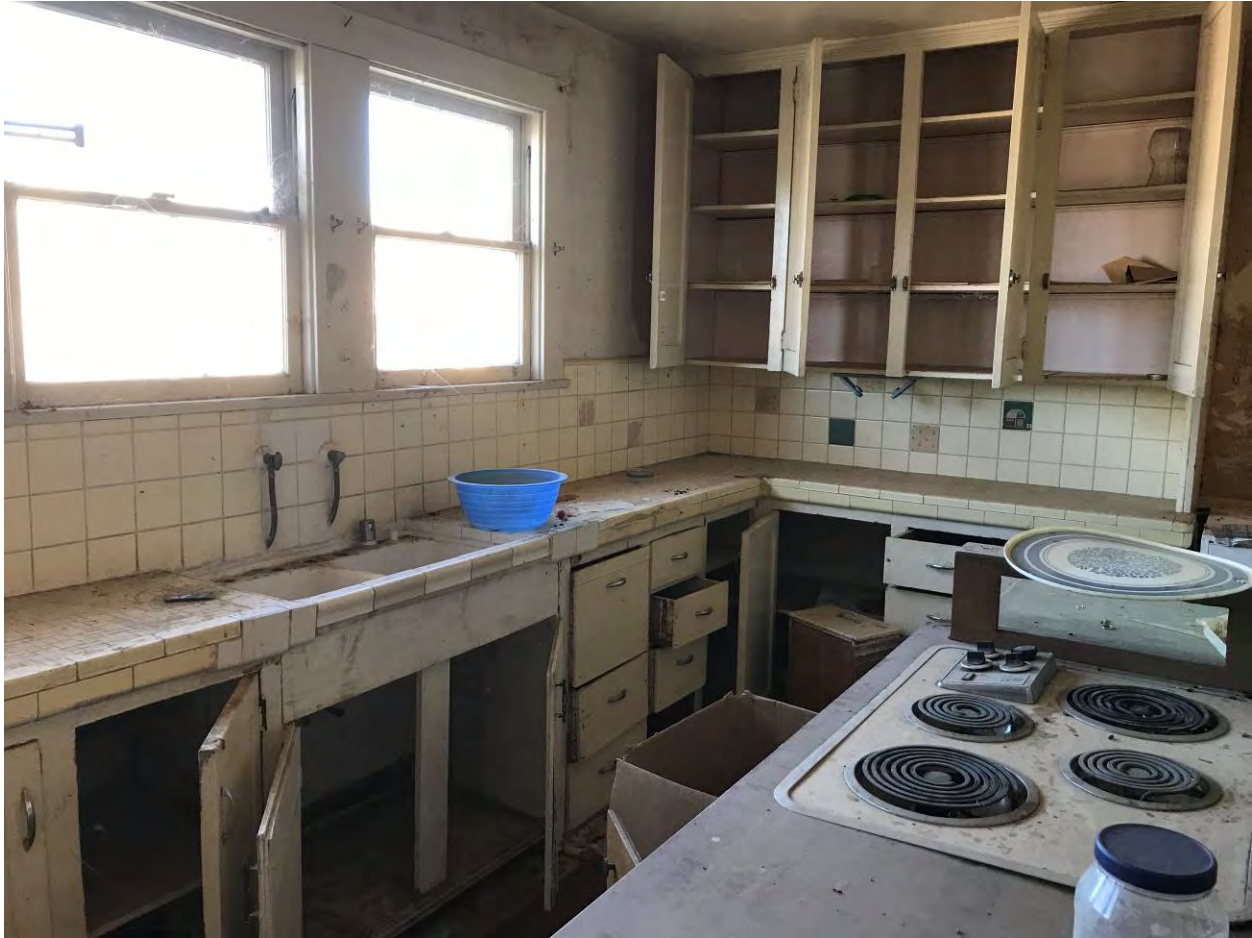
**Photo Eight** – Photo of ceramic wall tile and tile along the edge of the counter tops on sides A and B, and windows, window frames and window sills on side A of kitchen in building 6 that were found to contain elevated lead levels.

Photo not included of similar ceramic tile on wall above tub in the north restroom that was also found to contain elevated lead levels. Joint compound was found to contain asbestos, however composite of wall system (drywall, joint compound, off-white compound and drywall tape) located throughout the building was found to contain less than 1% of asbestos.

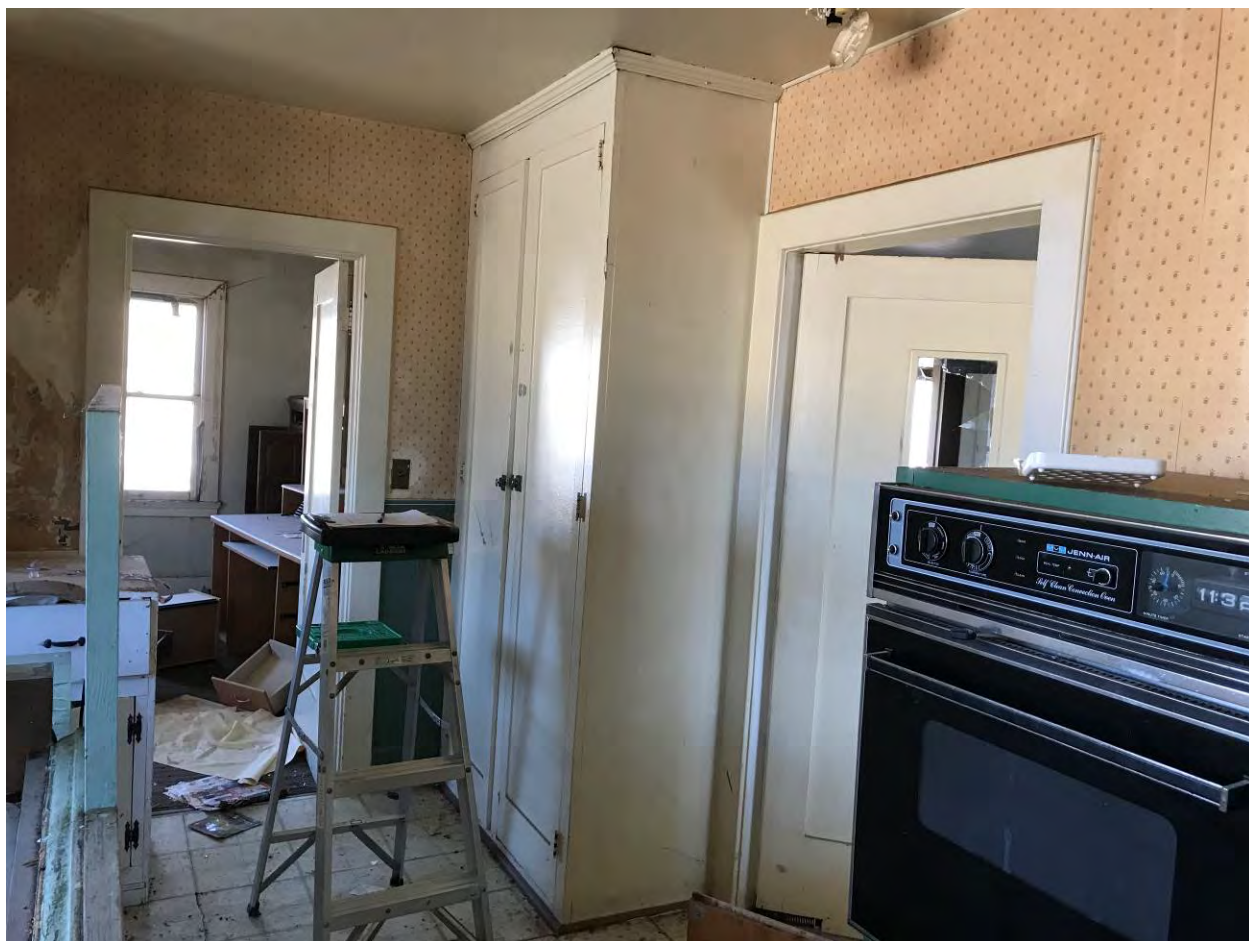
**Photo Nine** – Photo of pantry walls on side C, and doors, and door frames on sides B and C of kitchen in building 6 that were found to contain elevated lead levels.

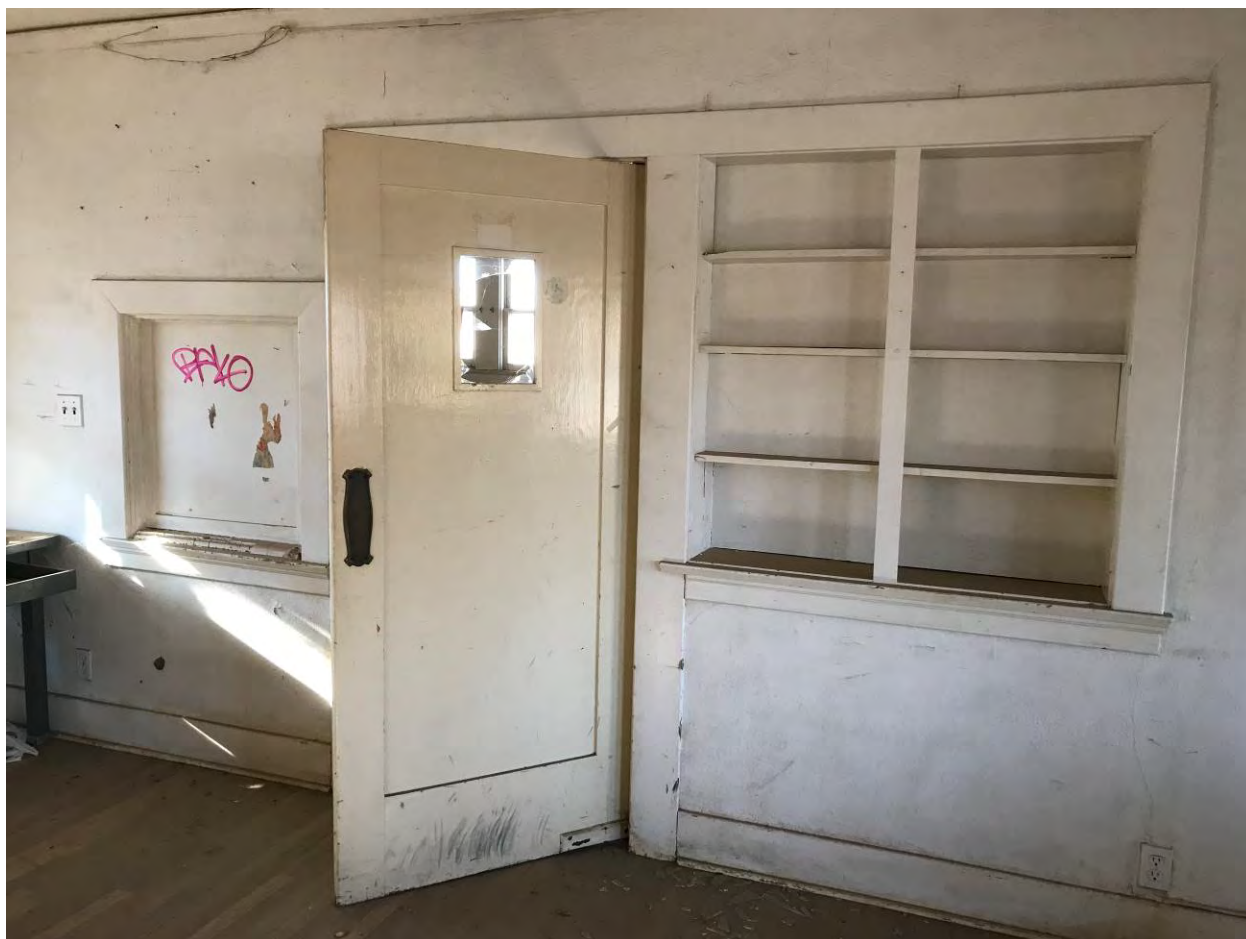
**Photo 10** – Photo of access window, shelves, baseboard, door, and door frame on side A of dining room in building 6 that were found to contain elevated lead levels.

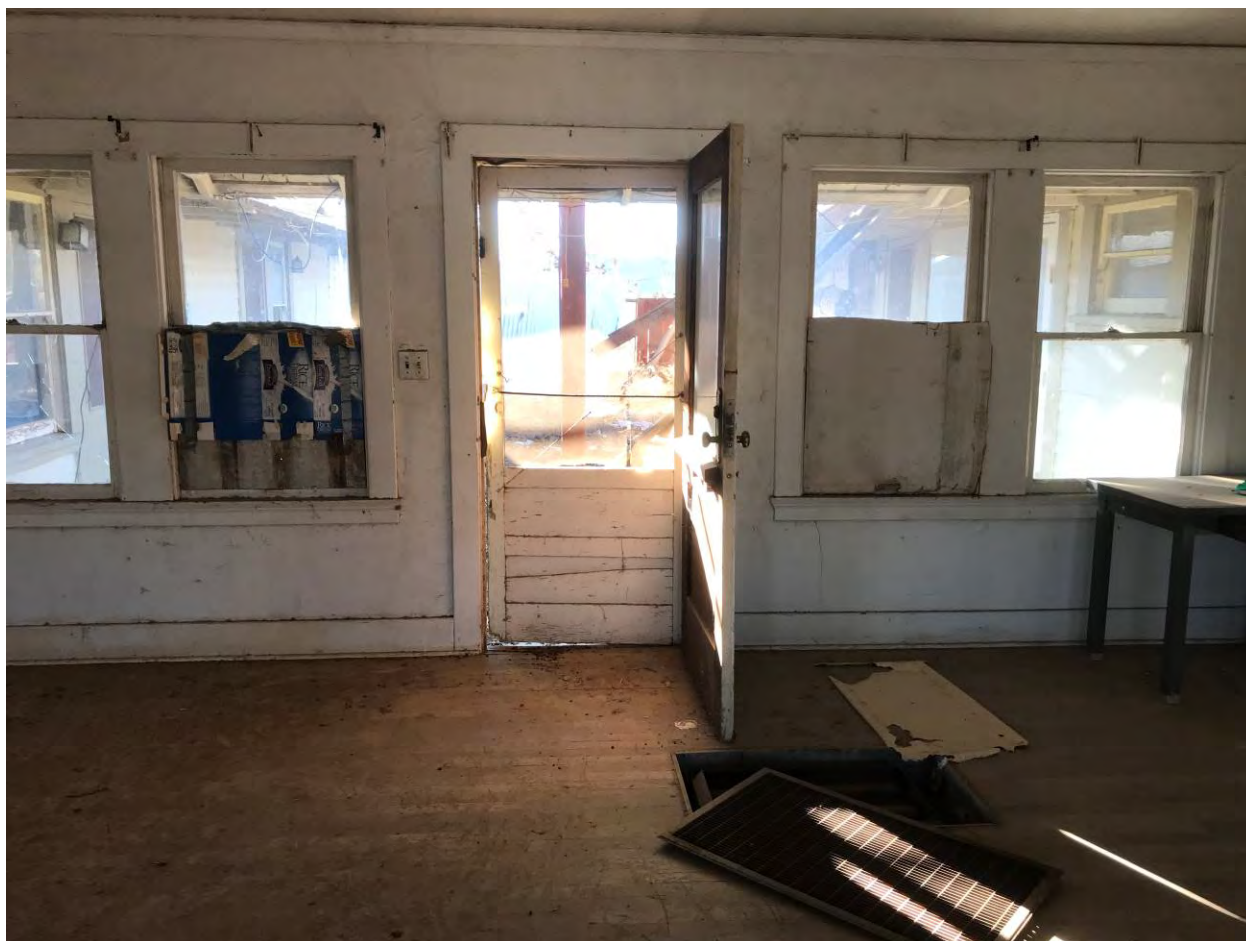
**Photo 11** – Photo of windows, window frames, window sills, crown molding, baseboard, screen door, and door frame on side B of dining room in building 6 that were found to contain elevated lead levels.

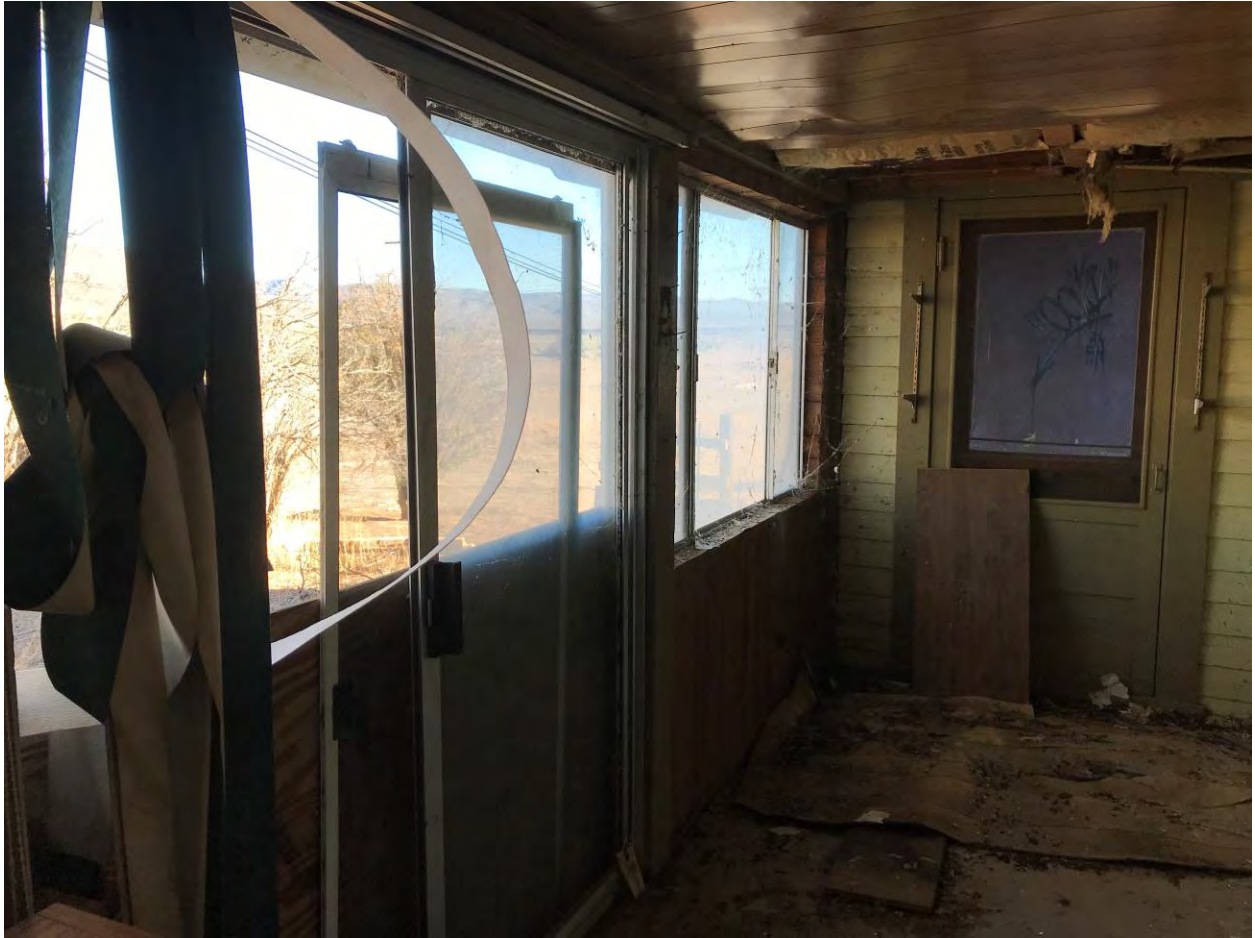
**Photo 12** – Photo of posts on side B, and wood siding, door, and door frame on side C of porch in building 6 that were found to contain elevated lead levels.

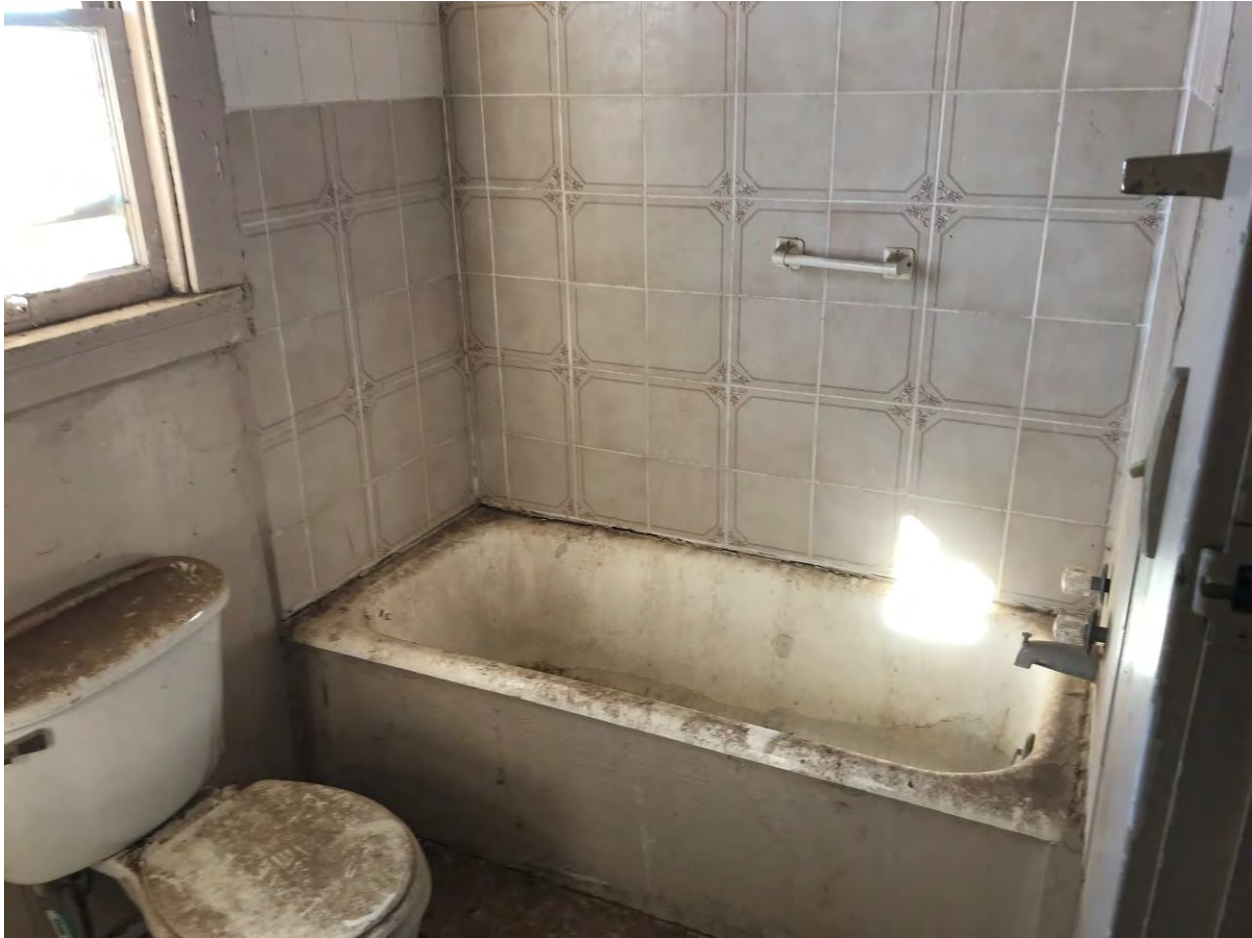
**Photo 13** – Photo of porcelain tub and ceramic wall tile around tub on side D, and windows, window frames and window sills on side C of southeast restroom in building 6 that were found to contain elevated lead levels.

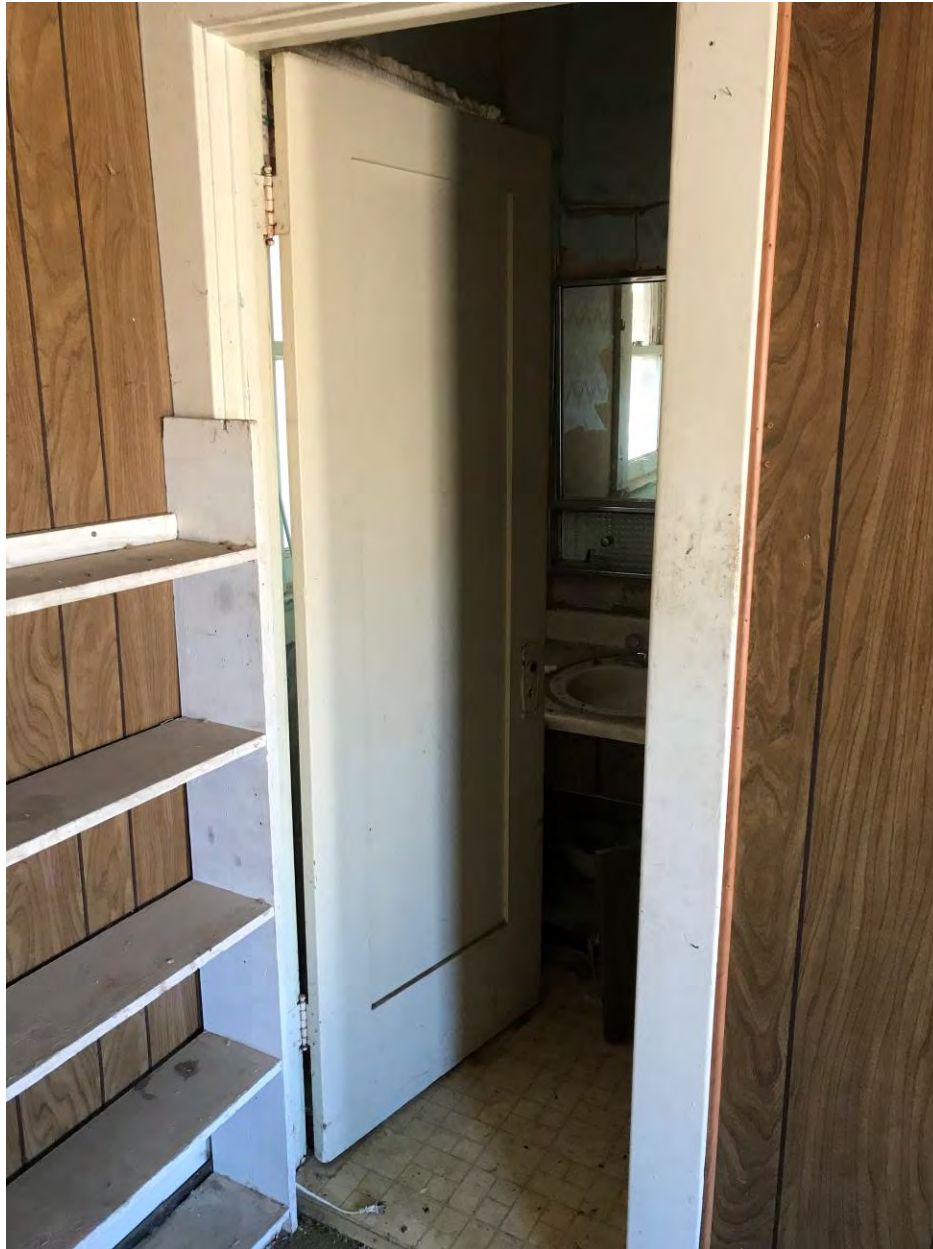
**Photo 14** – Photo of vinyl sheet flooring in north restroom of building 6 that was found to contain asbestos. The black mastic behind the wood paneling located in the living room was also found to contain asbestos. Photo not included of the vinyl sheet flooring in the north entry that had asbestos containing black mastic below it.

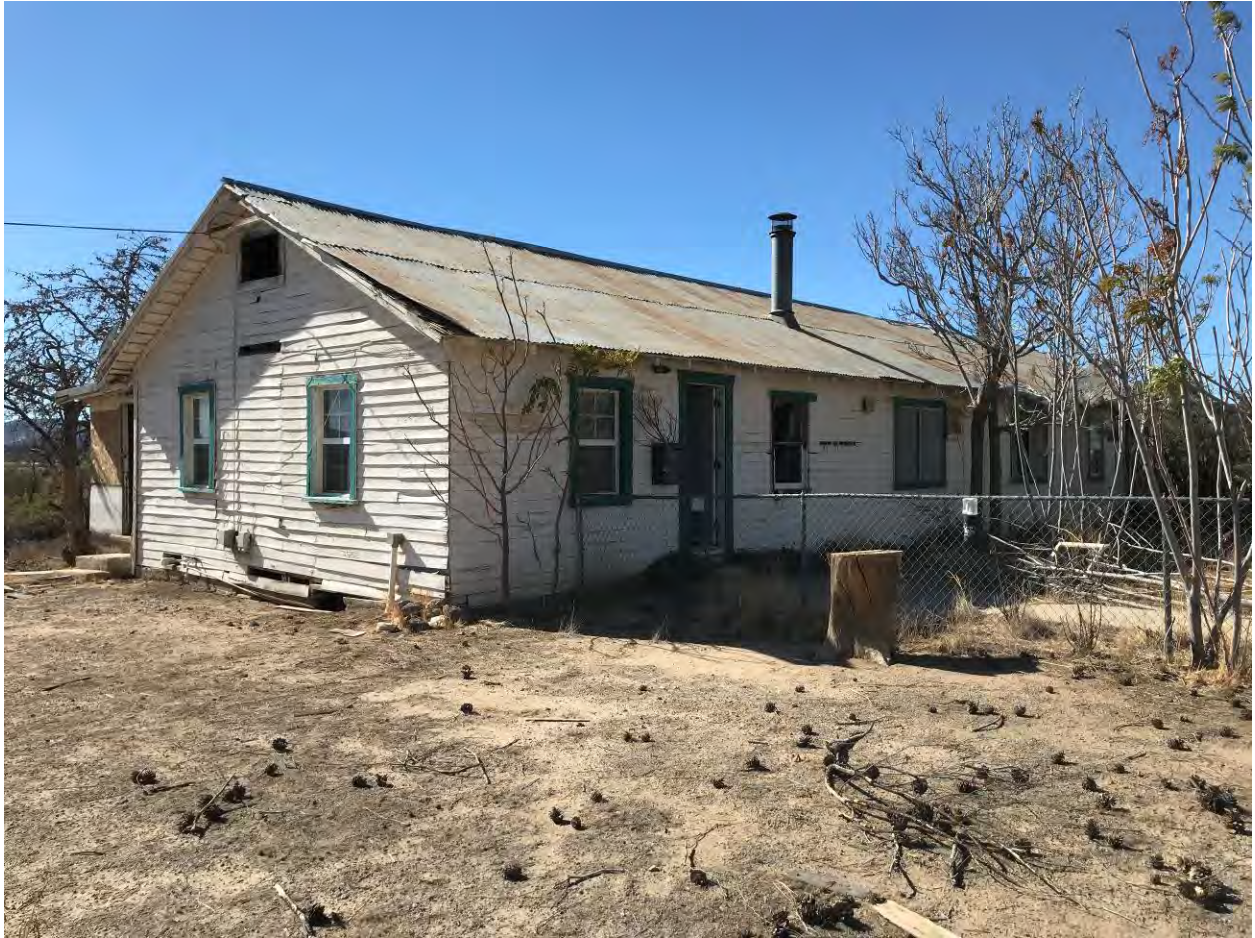
**Photo 15** – Ground level view of the north and east sides of Building 7. The old windows on side A, and wood siding and eaves on all four sides of the building were all found to contain elevated lead levels. Photos not included of door frame on side A of east porch and door on side A of west restroom inside building 7 that were also found to contain elevated lead levels.

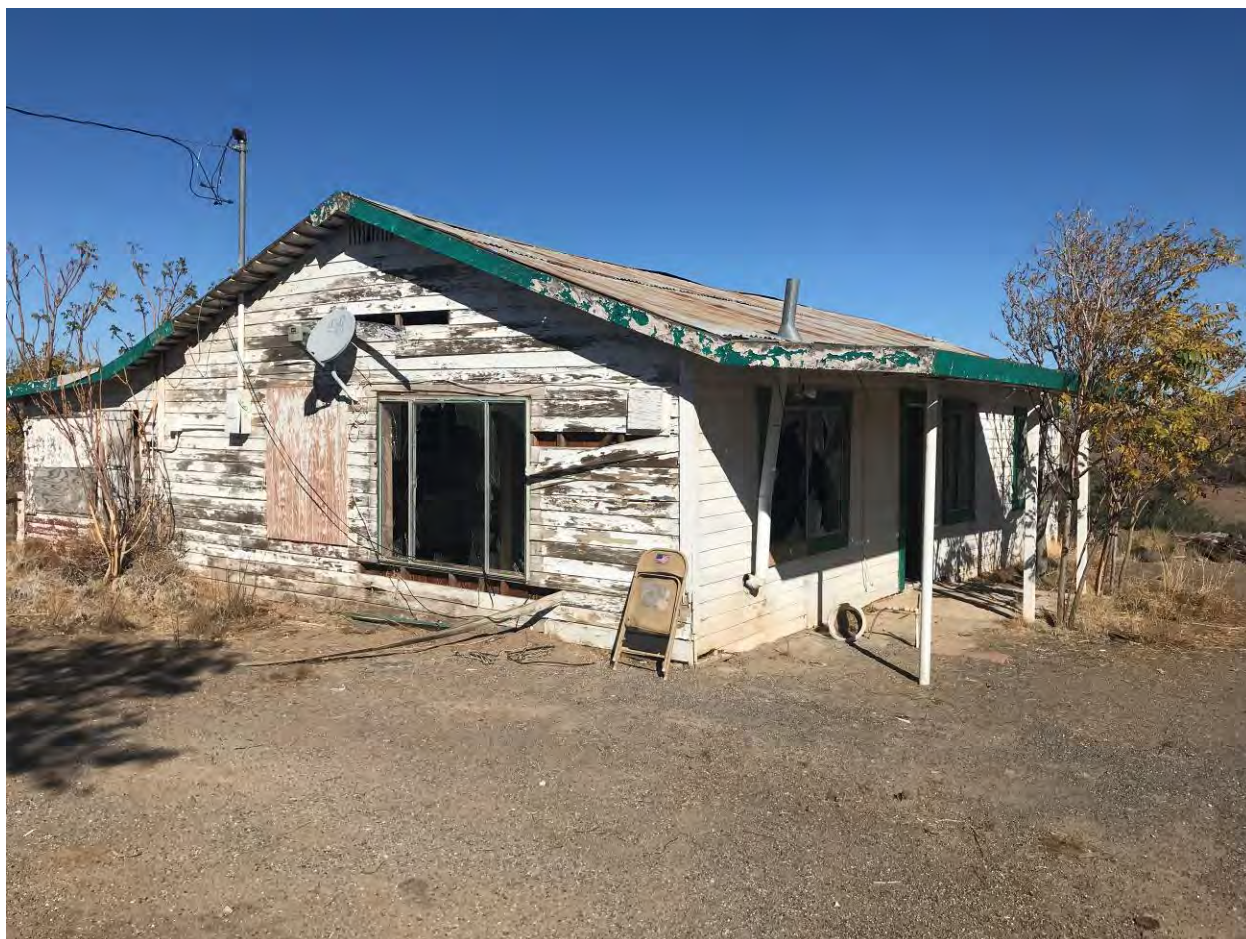
**Photo 16** – Ground level view of the north and east sides of Building 2. The window frames, eaves, and wood siding on all four sides of the building were all found to contain elevated lead levels. Photo not included of hall opening on side D and door and door frame on side A in living room; window on side D in kitchen; window, window frame, and window sill on side B in porch; closet door on side C in hall; and door on side B in restroom; window frame on side A in bedroom 1 on inside building 2 that were also found to contain elevated lead levels. Joint compound was found to contain asbestos, however composite of wall system (drywall, joint compound, off-white compound and drywall tape) located throughout the building was found to contain less than 1% of asbestos .

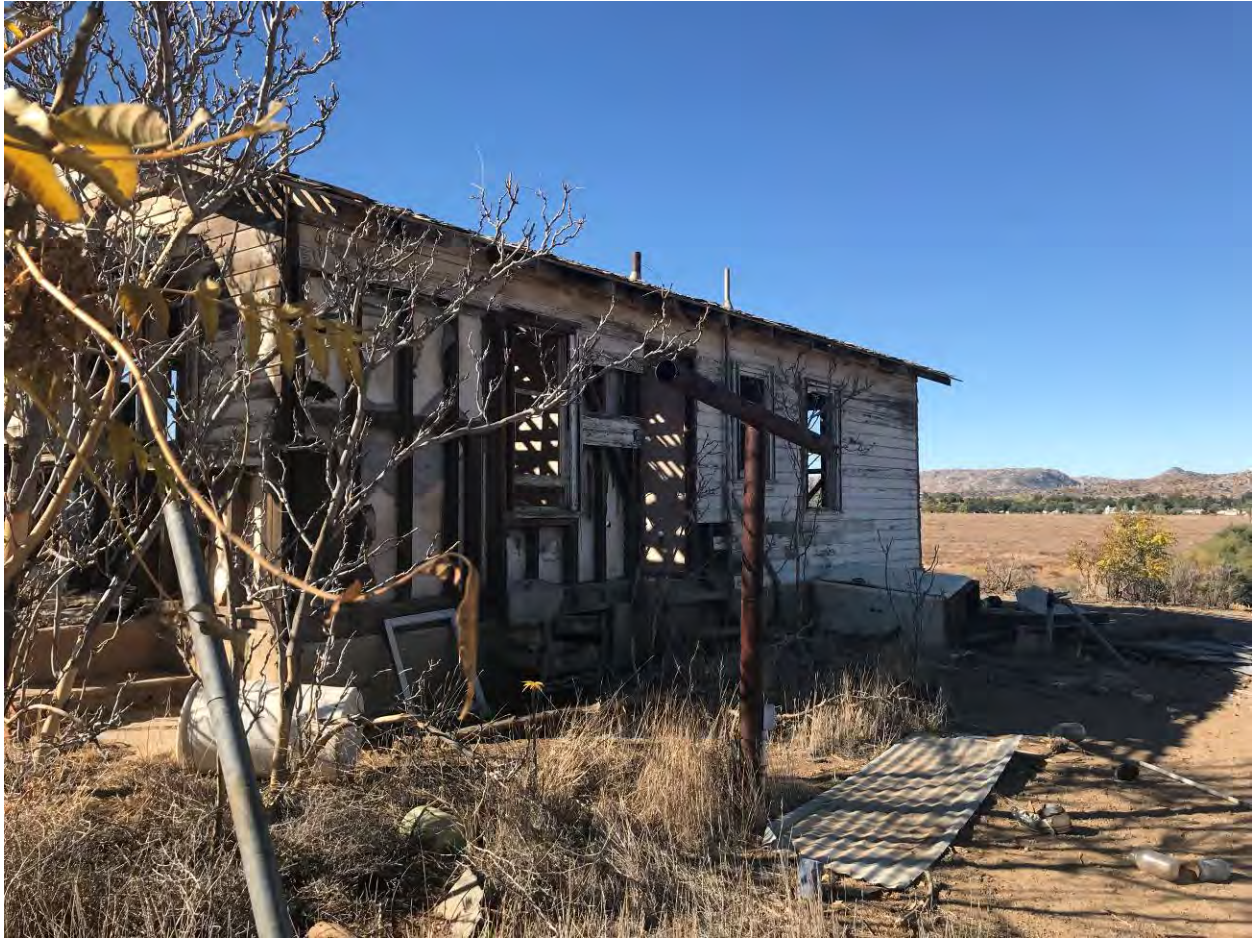
**Photo 17** – Ground level view of the east side of Building 1. The windows, window frames, door frames, and wood siding on all four sides of the building were all found to contain elevated lead levels. Photo not included of windows, window frames, doors and door frames in laundry room and door on side B and window frame on side A in bedroom 2 on inside building 1 that were also found to contain elevated lead levels. The window putty located on the exterior of the building was found to contain asbestos. Joint compound was found to contain asbestos, however composite of wall system (drywall, joint compound, off-white compound and drywall tape) located throughout the building was found to contain less than 1% of asbestos.

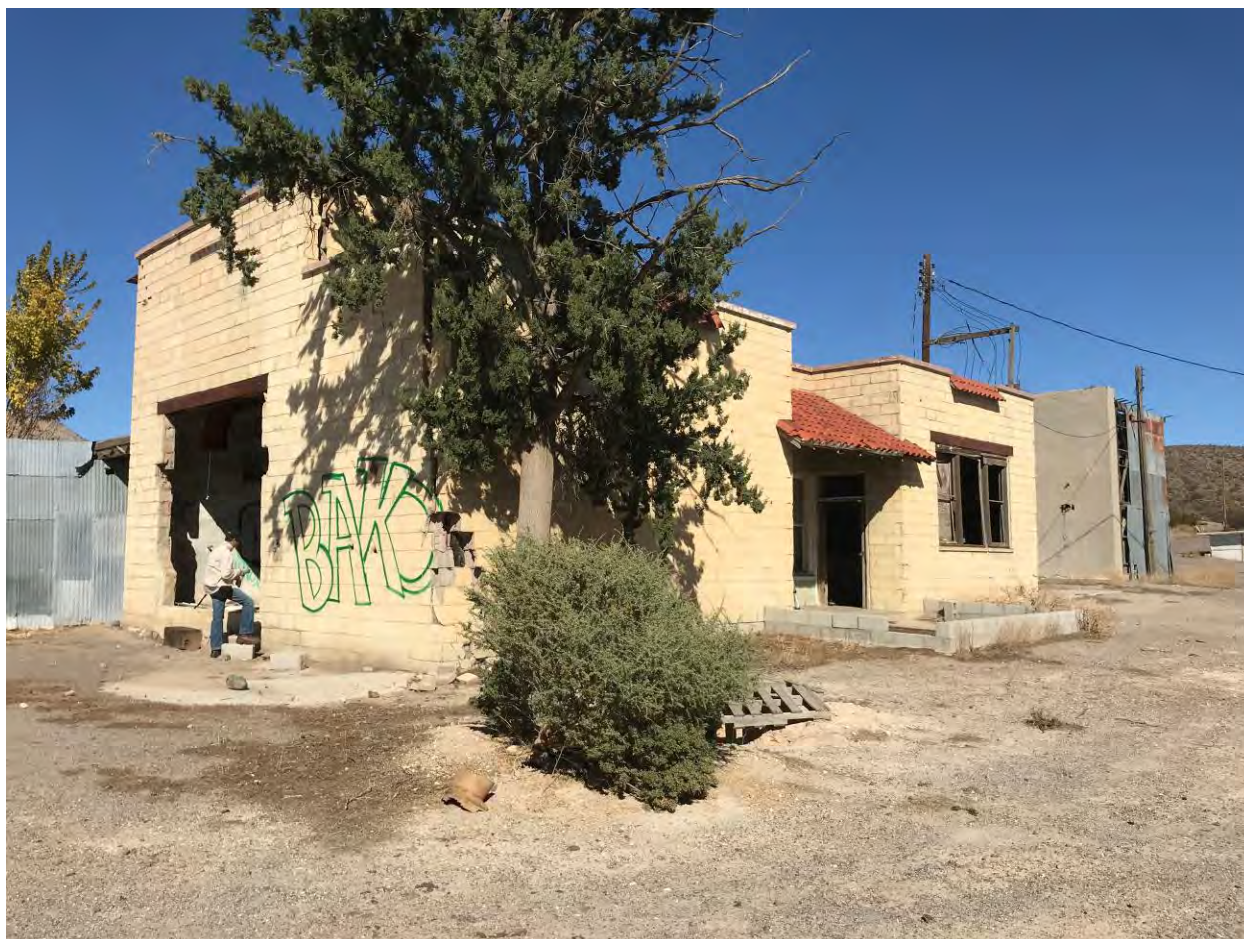
**Photo 20** – Ground level view of the south and west sides of Building 4C. The windows, window frames, door frames, eaves, and eave beams on all four sides of the building were all found to contain elevated lead levels. Photo not included of concrete walls on all 4 sides, and door frame on side D, and window and window frame on side C in room 1; concrete wall on side B, door frame on side D, windows, window frames on side C, and stucco ceiling in room 3; plaster walls on all 4 sides, and door frame on side B in room 4; windows in chemical storage room; and window frames steps to overlook on inside of building 4C that were also found to contain elevated lead levels.

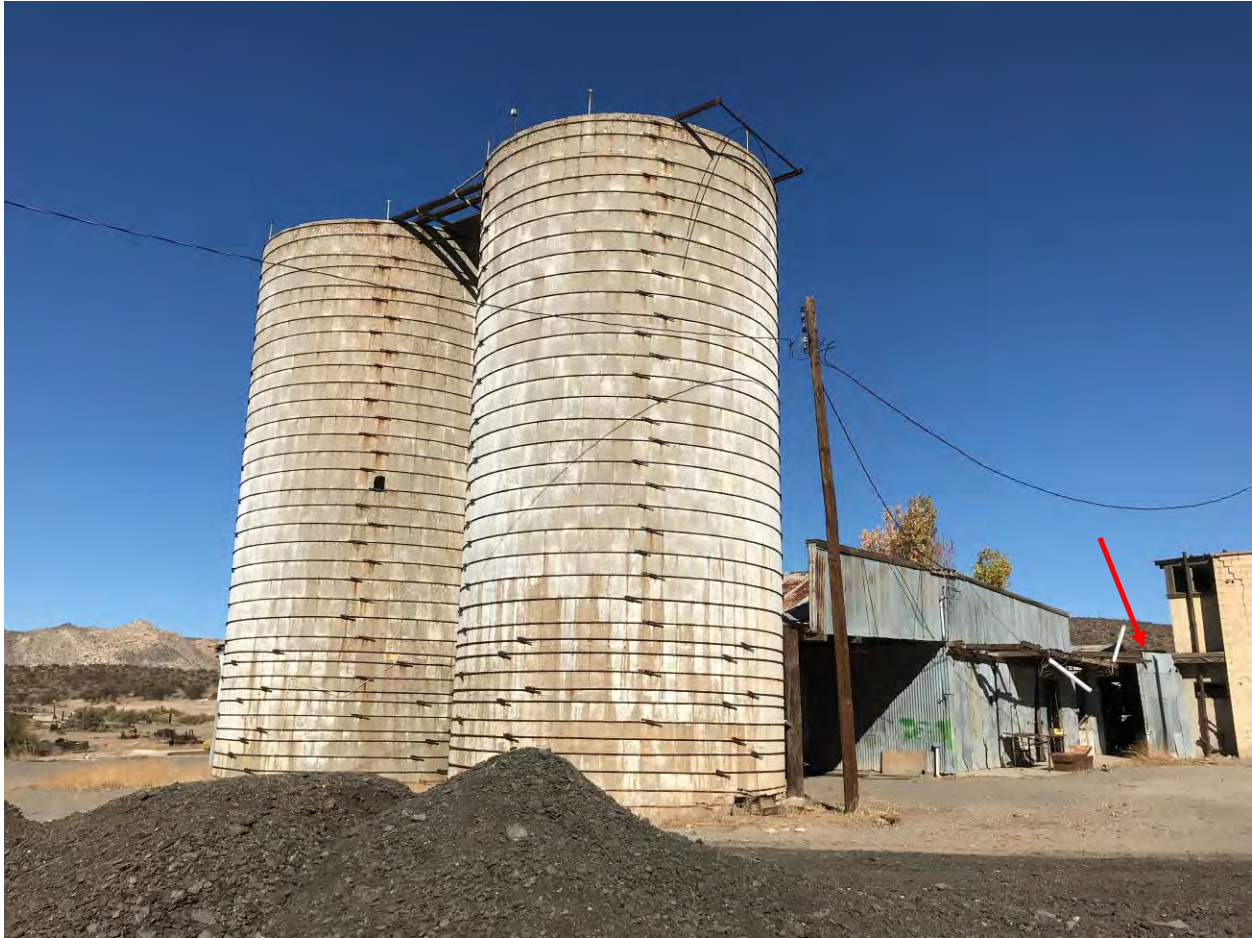
**Photo 21** – Ground level view of the south side of Building 4D and the north and south silos that are on the west end of 4D. The red arrow points to the location of the layered roofing material on room 6 of building 4D that was found to contain asbestos.

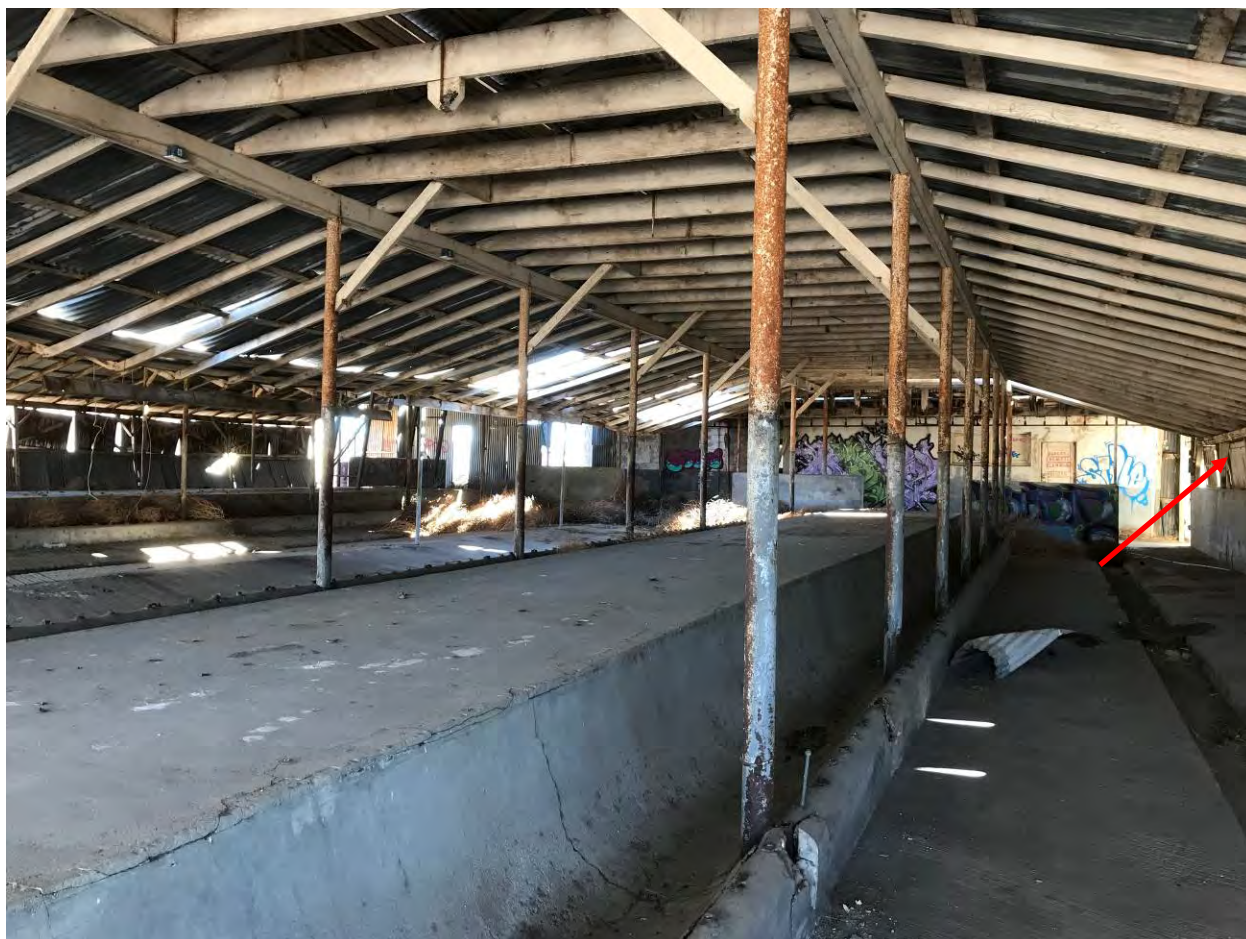
**Photo 22** – Ground level view of the inside of room 6 in Building 4D. The wall framing on side D (red arrow) and metal posts throughout the center of the room were all found to contain elevated lead levels.

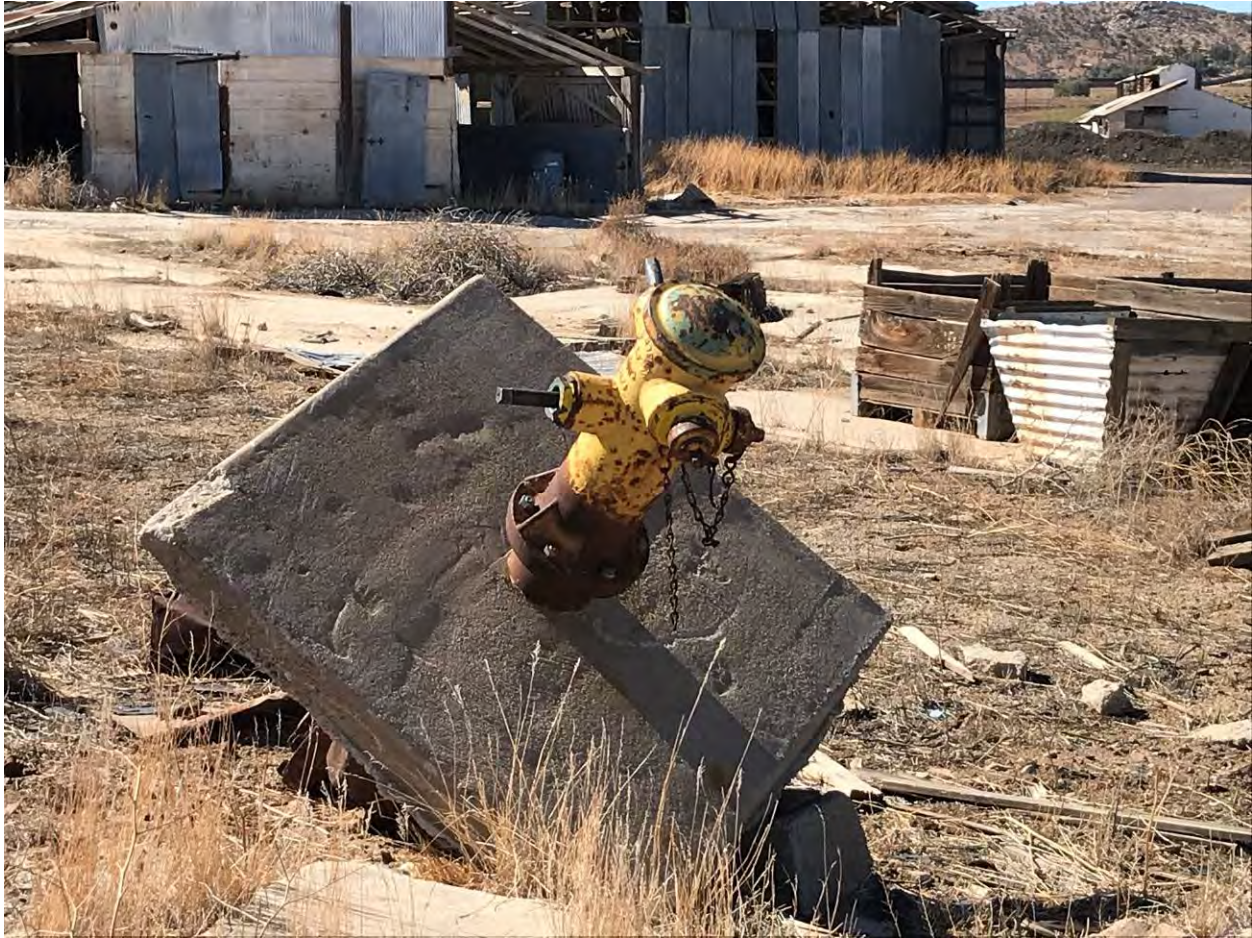
**Photo 25** – Ground level view of the concrete pads north of Area 4. The fire hydrant was found to contain elevated lead levels.

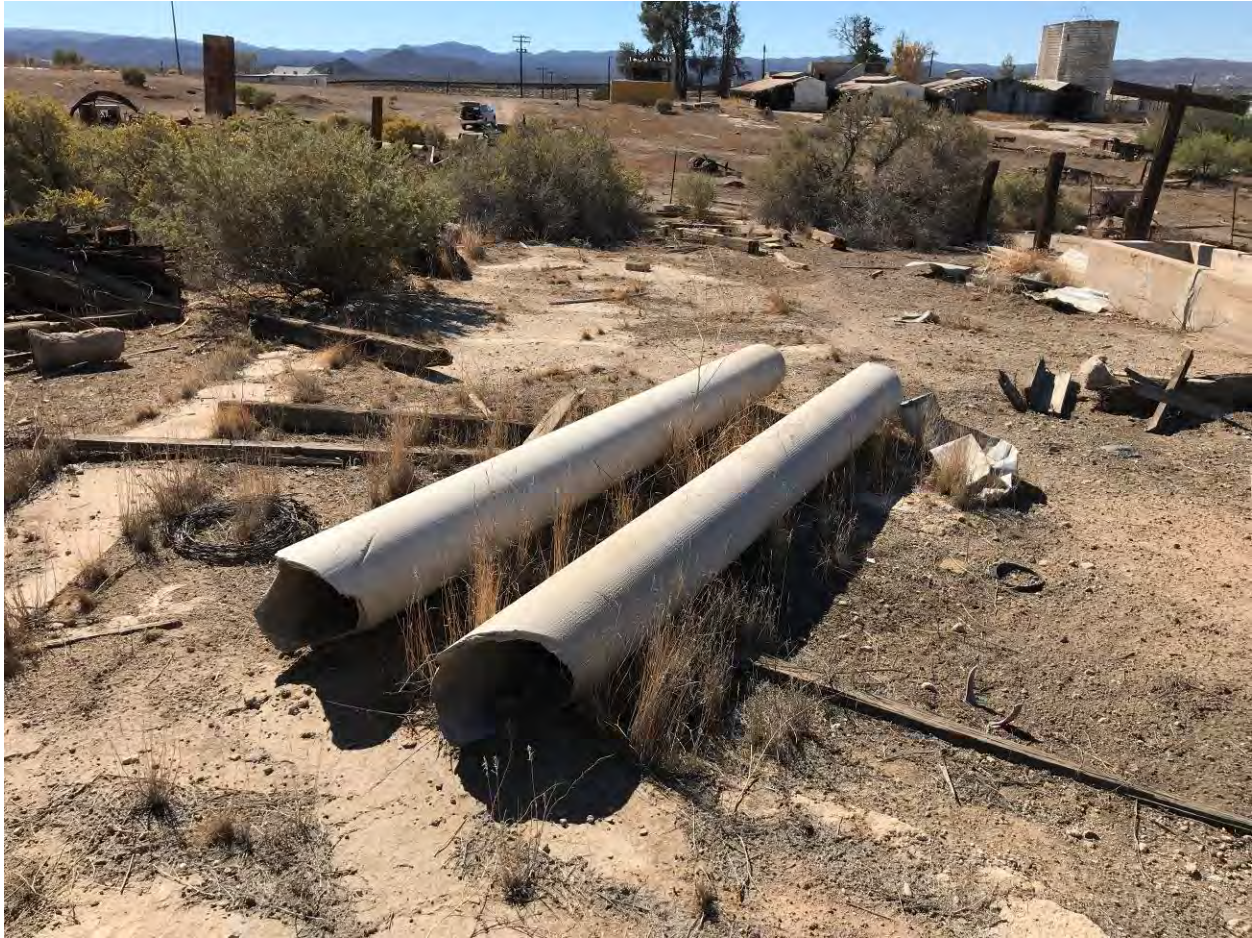
**Photo 27** – The transite pipe located in several debris piles north of the structures were found to contain asbestos.
