# **Asbestos Building Inspection and Lead-Based Paint Testing**

**Ranch Property (APN 661-060-12)  
JVR Energy Park Project  
45346 Old Highway 80  
Jacumba, California 91934**

**Aurora Industrial Hygiene  
San Diego, California**

Date: July 2, 2019

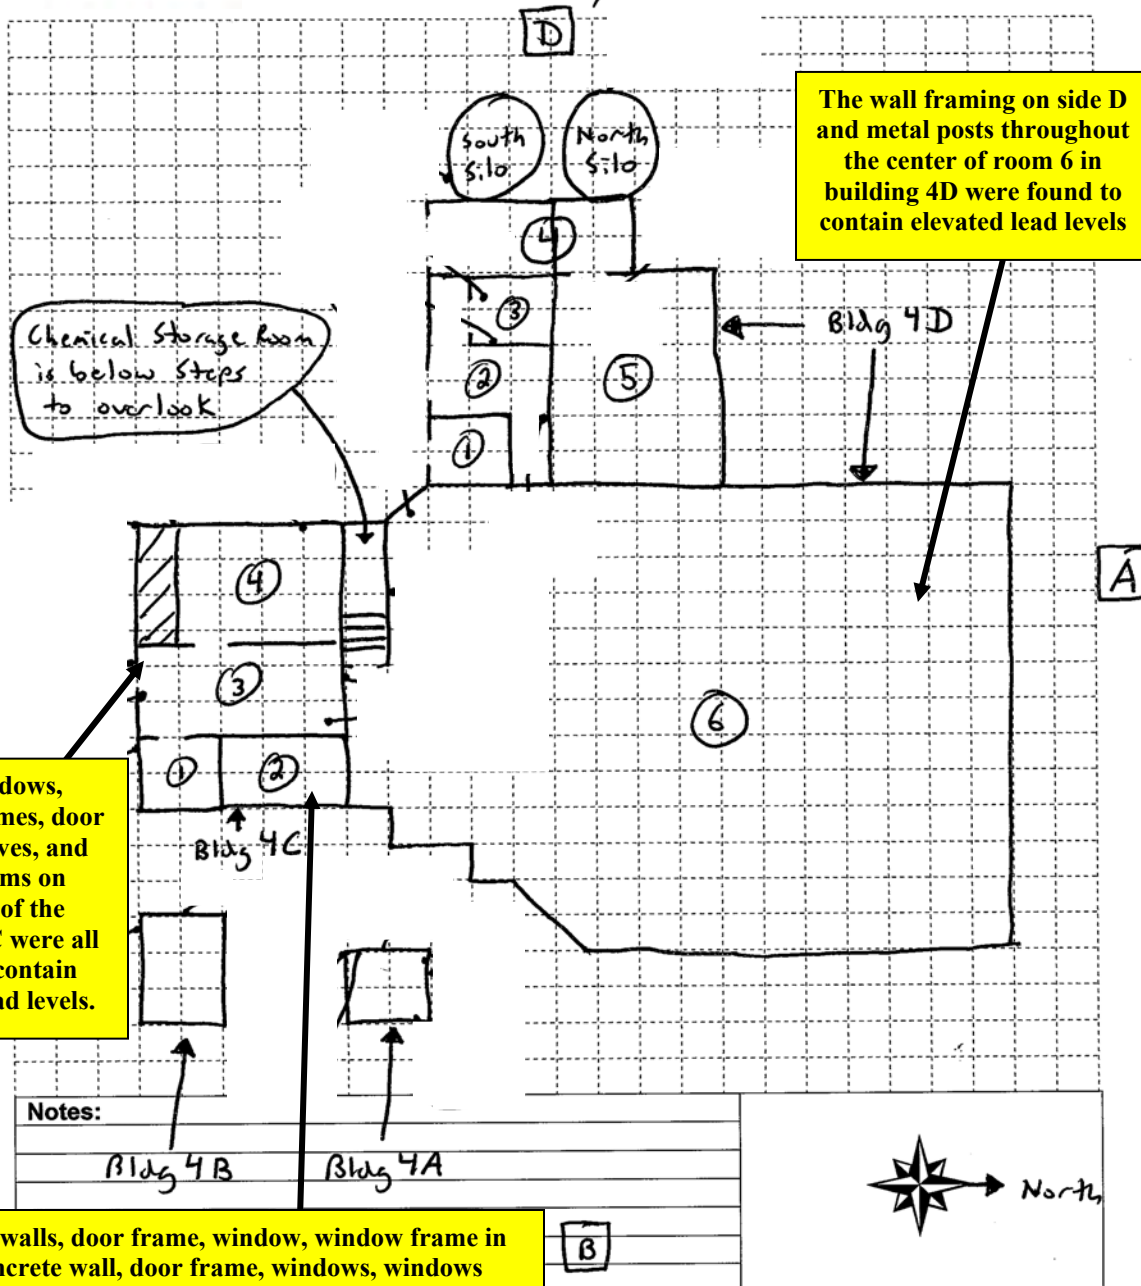
Bldg 4B

The windows, window frames, door frames, eaves, and eave beams on exterior of the building 4C were all found to contain elevated lead levels.

The concrete walls, door frame, window, window frame in room 1; concrete wall, door frame, windows, windows frames, and stucco ceiling in room 3; plaster walls and door frame in room 4; windows in chemical storage room; and window frames steps to overlook on inside of building 4C were found to contain elevated lead levels

The wall framing on side D and metal posts throughout the center of room 6 in building 4D were found to contain elevated lead levels
