Asbestos Building Inspection and Lead-Based Paint Testing

Ranch Property (APN 661-060-12)

JVR Energy Park Project

Date: July 2, 2019

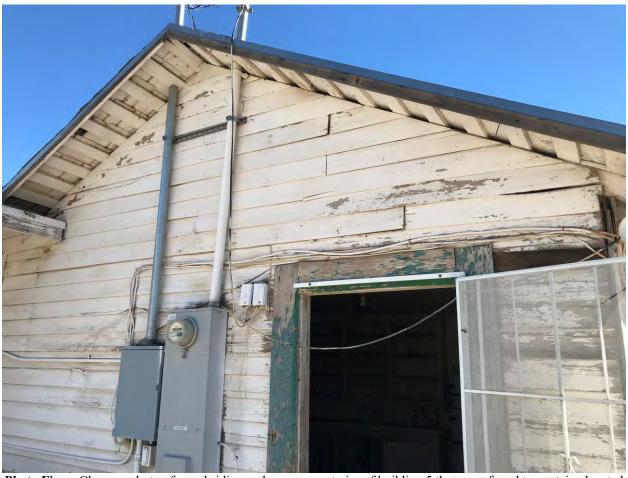
Photo Five – Close up photo of wood siding and eaves on exterior of building 5 that were found to contain elevated lead levels.

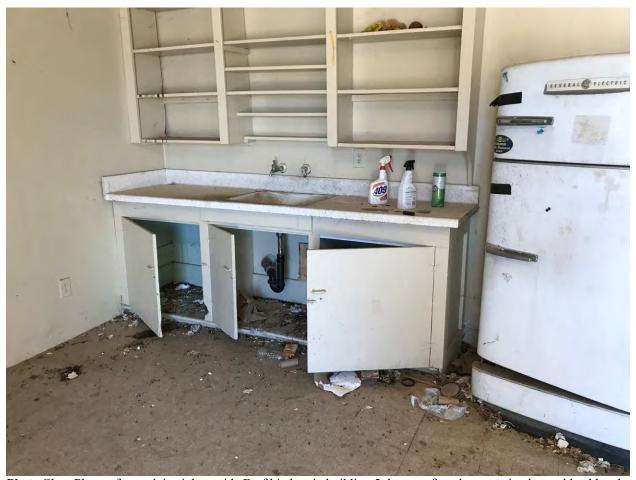
Photo Six – Photo of porcelain sink on side B of kitchen in building 5 that was found to contain elevated lead levels. The joint compound located throughout the building was found to contain asbestos.

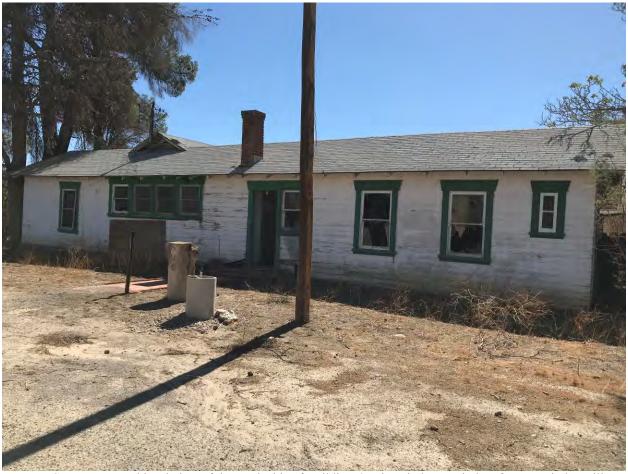
Photo Seven – Ground level view of the north side of Building 6. The windows, window frames, window sills, doors, door frames, wood siding, eaves, fascia, trim, and vents on exterior of the building were all found to contain elevated lead levels. Photos not included of upper shelves on sides B and C of living room closet and lower portions of walls covered with wallpaper in south hallway closet inside building 6 that were also found to contain elevated lead levels.

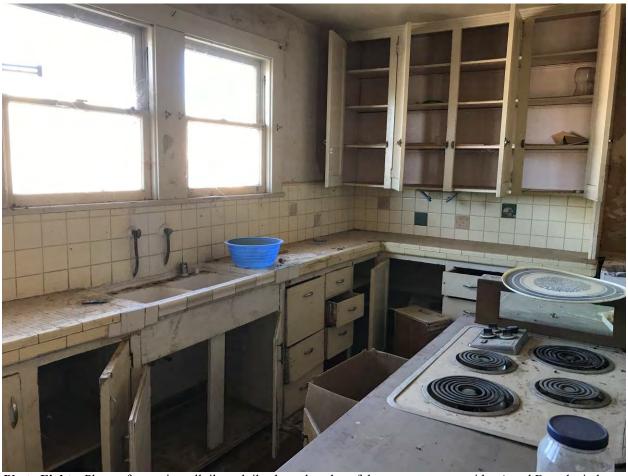
Photo Eight – Photo of ceramic wall tile and tile along the edge of the counter tops on sides A and B, and windows, window frames and window sills on side A of kitchen in building 6 that were found to contain elevated lead levels. Photo not included of similar ceramic tile on wall above tub in the north restroom that was also found to contain elevated lead levels. Joint compound was found to contain asbestos, however composite of wall system (drywall, joint compound, off-white compound and drywall tape) located throughout the building was found to contain less than 1% of asbestos.

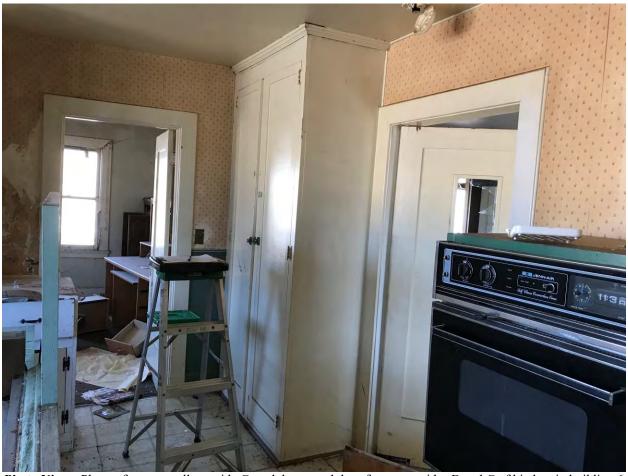
Photo Nine – Photo of pantry walls on side C, and doors, and door frames on sides B and C of kitchen in building 6 that were found to contain elevated lead levels.

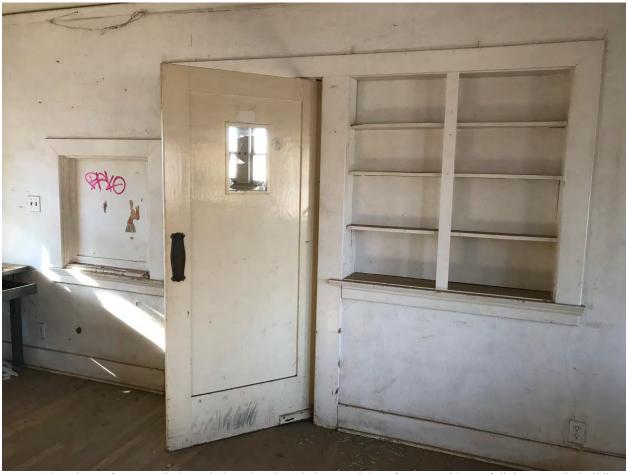
Photo 10 – Photo of access window, shelves, baseboard, door, and door frame on side A of dining room in building 6 that were found to contain elevated lead levels.

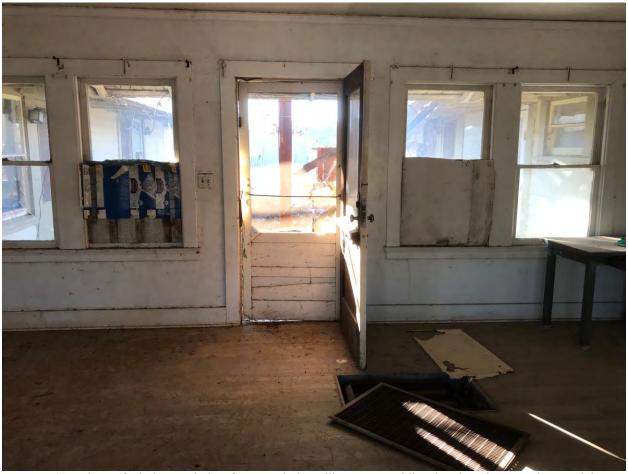
Photo 11 – Photo of windows, window frames, window sills, crown molding, baseboard, screen door, and door frame on side B of dining room in building 6 that were found to contain elevated lead levels.

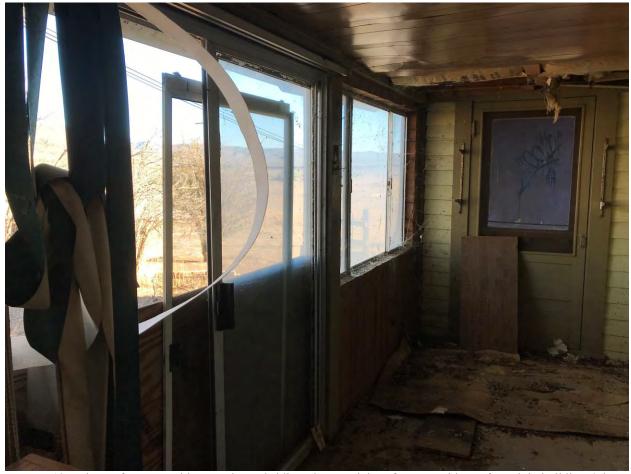
Photo 12 – Photo of posts on side B, and wood siding, door, and door frame on side C of porch in building 6 that were found to contain elevated lead levels.

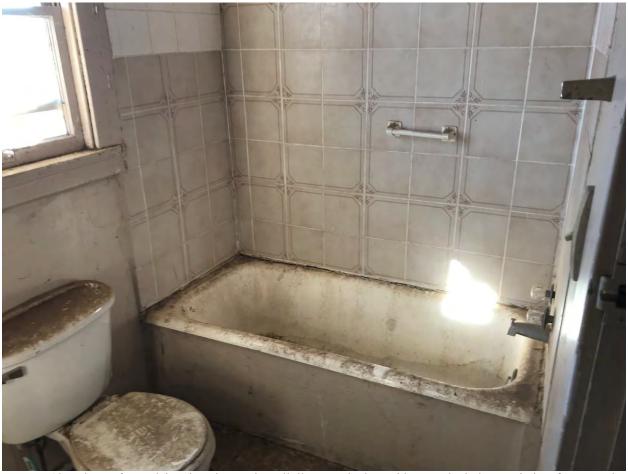
Photo 13 – Photo of porcelain tub and ceramic wall tile around tub on side D, and windows, window frames and window sills on side C of southeast restroom in building 6 that were found to contain elevated lead levels.

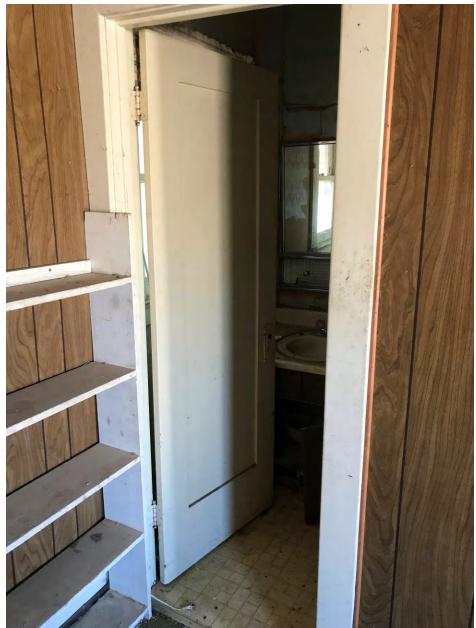
Photo 14 – Photo of vinyl sheet flooring in north restroom of building 6 that was found to contain asbestos. The black mastic behind the wood paneling located in the living room was also found to contain asbestos. Photo not included of the vinyl sheet flooring in the north entry that had asbestos containing black mastic below it.

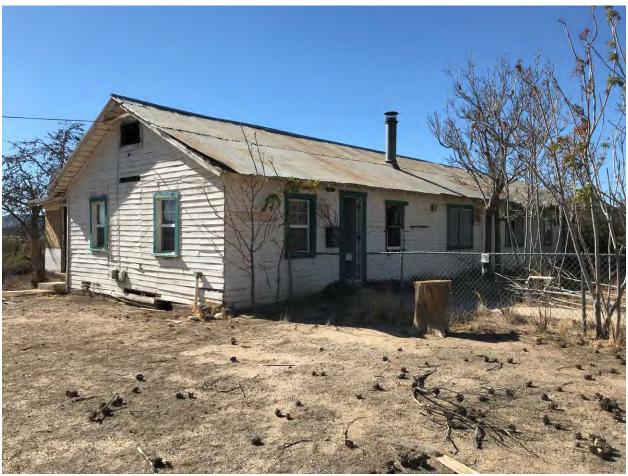
Photo 15 – Ground level view of the north and east sides of Building 7. The old windows on side A, and wood siding and eaves on all four sides of the building were all found to contain elevated lead levels. Photos not included of door frame on side A of east porch and door on side A of west restroom inside building 7 that were also found to contain elevated lead levels.

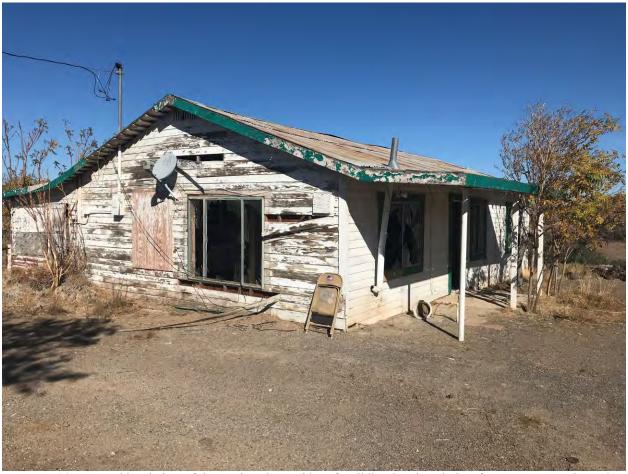
Photo 16 – Ground level view of the north and east sides of Building 2. The window frames, eaves, and wood siding on all four sides of the building were all found to contain elevated lead levels. Photo not included of hall opening on side D and door and door frame on side A in living room; window on side D in kitchen; window, window frame, and window sill on side B in porch; closet door on side C in hall; and door on side B in restroom; window frame on side A in bedroom 1 on inside building 2 that were also found to contain elevated lead levels. Joint compound was found to contain asbestos, however composite of wall system (drywall, joint compound, offwhite compound and drywall tape) located throughout the building was found to contain less than 1% of asbestos.

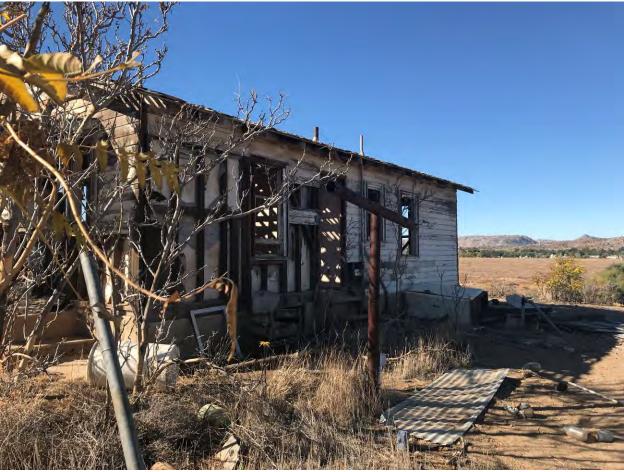
Photo 17 – Ground level view of the east side of Building 1. The windows, window frames, door frames, and wood siding on all four sides of the building were all found to contain elevated lead levels. Photo not included of windows, window frames, doors and door frames in laundry room and door on side B and window frame on side A in bedroom 2 on inside building 1 that were also found to contain elevated lead levels. The window putty located on the exterior of the building was found to contain asbestos. Joint compound was found to contain asbestos, however composite of wall system (drywall, joint compound, off-white compound and drywall tape) located throughout the building was found to contain less than 1% of asbestos.

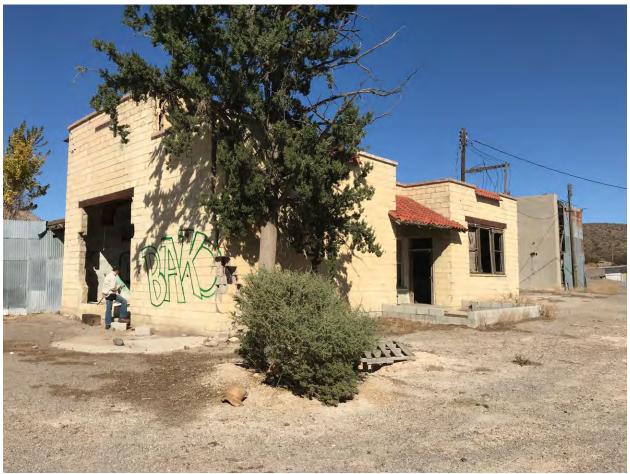
Photo 20 – Ground level view of the south and west sides of Building 4C. The windows, window frames, door frames, eaves, and eave beams on all four sides of the building were all found to contain elevated lead levels. Photo not included of concrete walls on all 4 sides, and door frame on side D, and window and window frame on side C in room 1; concrete wall on side B, door frame on side D, windows, window frames on side C, and stucco ceiling in room 3; plaster walls on all 4 sides, and door frame on side B in room 4; windows in chemical storage room; and window frames steps to overlook on inside of building 4C that were also found to contain elevated lead levels.

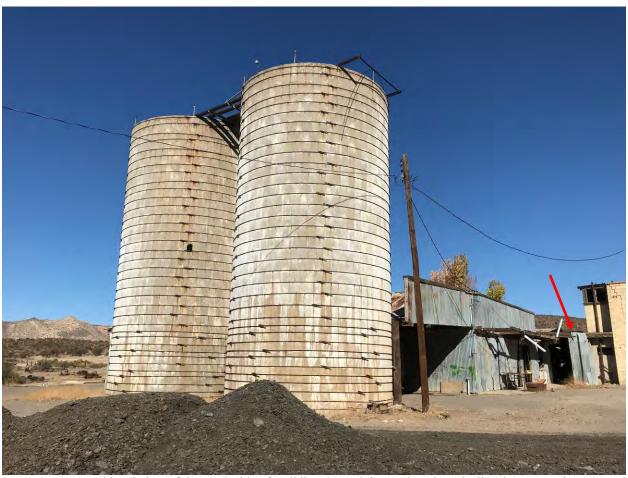
Photo 21 – Ground level view of the south side of Building 4D and the north and south silos that are on the west end of 4D. The red arrow points to the location of the layered roofing material on room 6 of building 4D that was found to contain asbestos.

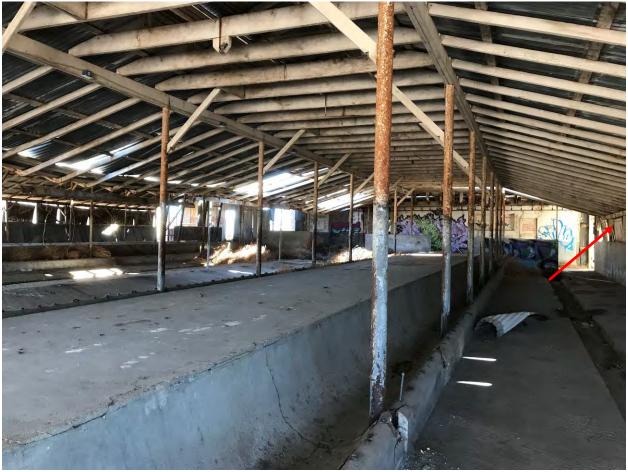
Photo 22 – Ground level view of the inside of room 6 in Building 4D. The wall framing on side D (red arrow) and metal posts throughout the center of the room were all found to contain elevated lead levels.

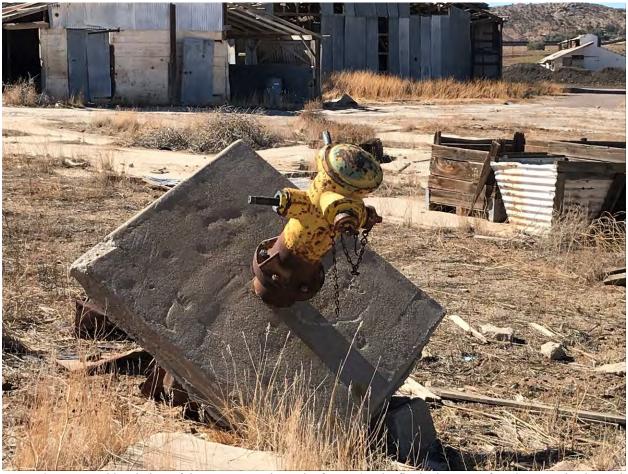
Photo 25 – Ground level view of the concrete pads north of Area 4. The fire hydrant was found to contain elevated lead levels.

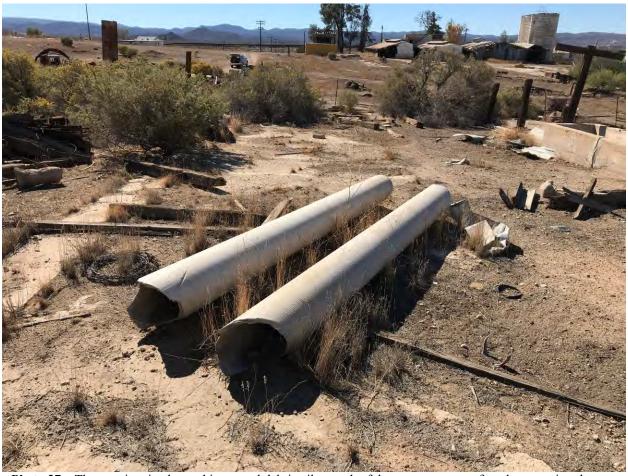
Photo 27 – The transite pipe located in several debris piles north of the structures were found to contain asbestos.
