**PHASE I ENVIRONMENTAL SITE ASSESSMENT
PARCEL 99, OTAY RANCH
CHULA VISTA, CALIFORNIA**

PHASE I ENVIRONMENTAL SITE ASSESSMENT
PARCEL 99, OTAY RANCH
CHULA VISTA, CALIFORNIA

**PHASE I
ENVIRONMENTAL SITE ASSESSMENT
Resort Site Open Space
North of Otay Lakes Road
and East of Upper Otay Reservoir
Chula Vista, California**

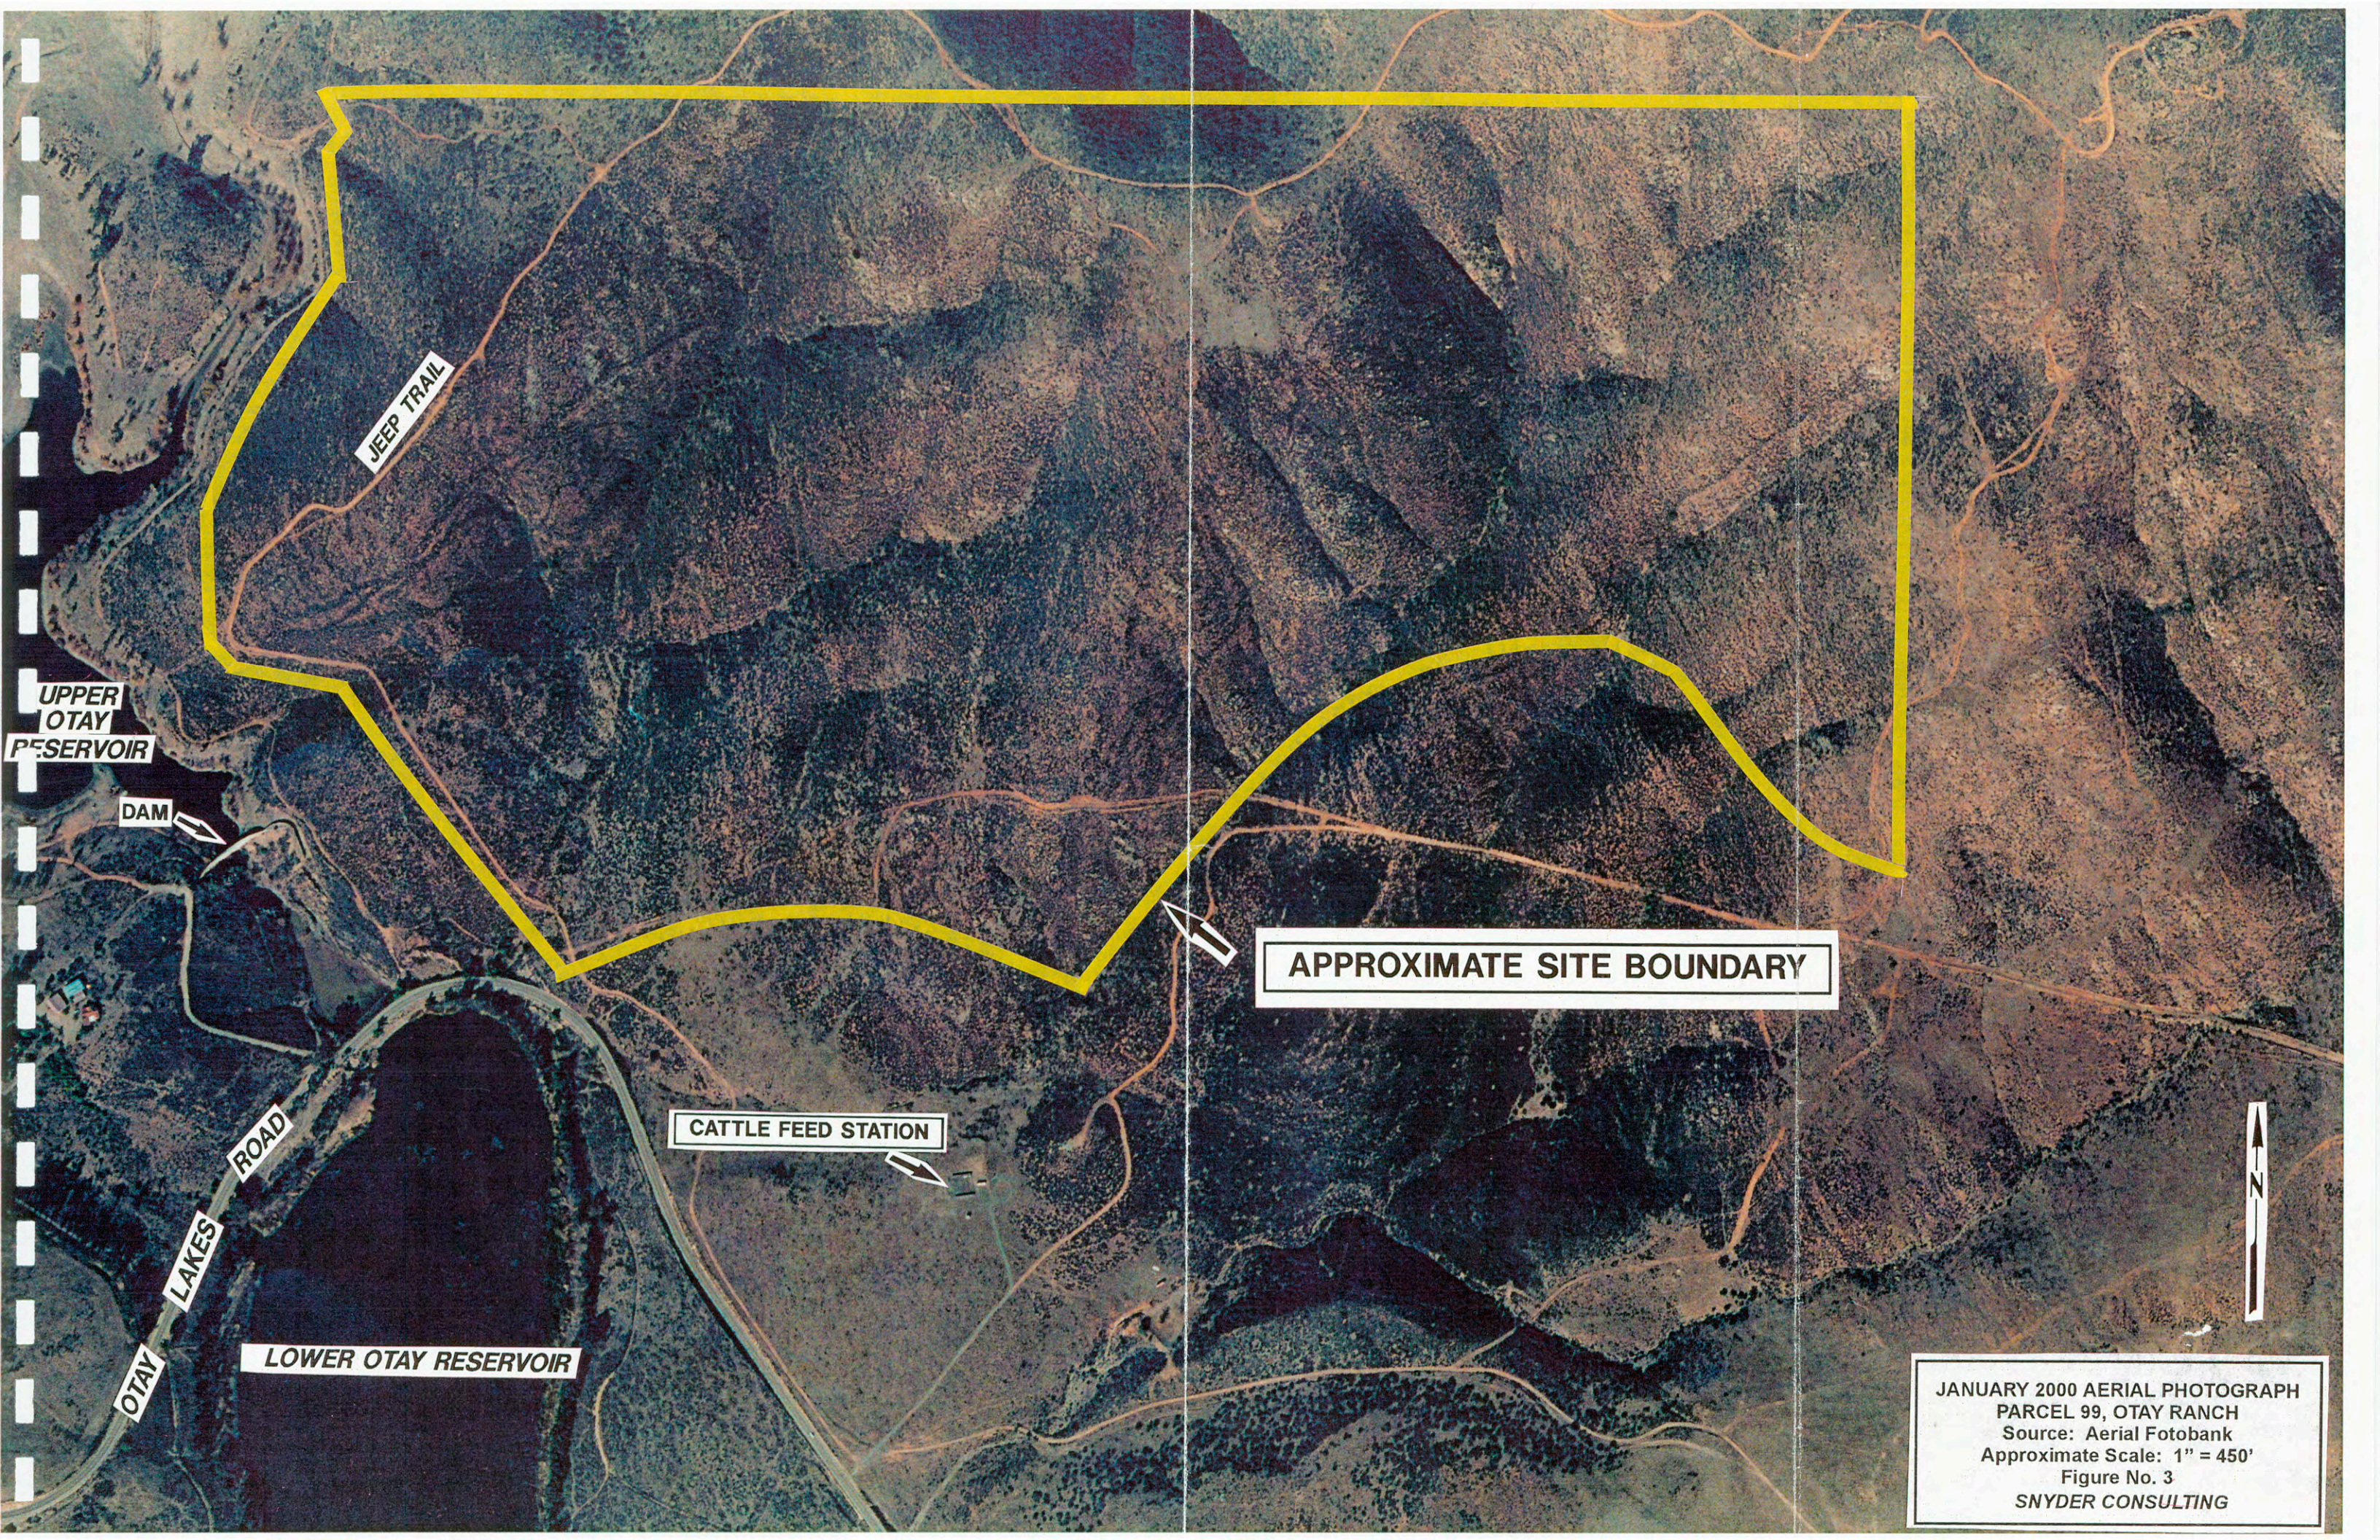
JANUARY 2000 AERIAL PHOTOGRAPH
PARCEL 99, OTAY RANCH
Source: Aerial Fotobank
Approximate Scale: 1" = 450'
Figure No. 3
SNYDER CONSULTING

Historical aerial photographs were reviewed at Aerial Fotobank and the County Cartographic Services Department. The reviewed photographs cover the years 1928, 1964, 1978, 1989, 1997 and 2000. The 2000 aerial photograph of the vicinity is enclosed as Figure 3.

According to aerial photographs, the Property as well as the adjoining properties (Figure 2) have never been developed and have always been used as rangeland (cattle grazing) since before 1928. From 1989 until recently, Mr. Adams has grazed longhorn cattle on the land. Mr. Kilkenny said the cattle were removed a few months ago. Mr. Adams said to his knowledge, insecticides or herbicides have never been applied to the Property. There are no indications that hazardous materials have ever been used on the Property or adjoining properties.

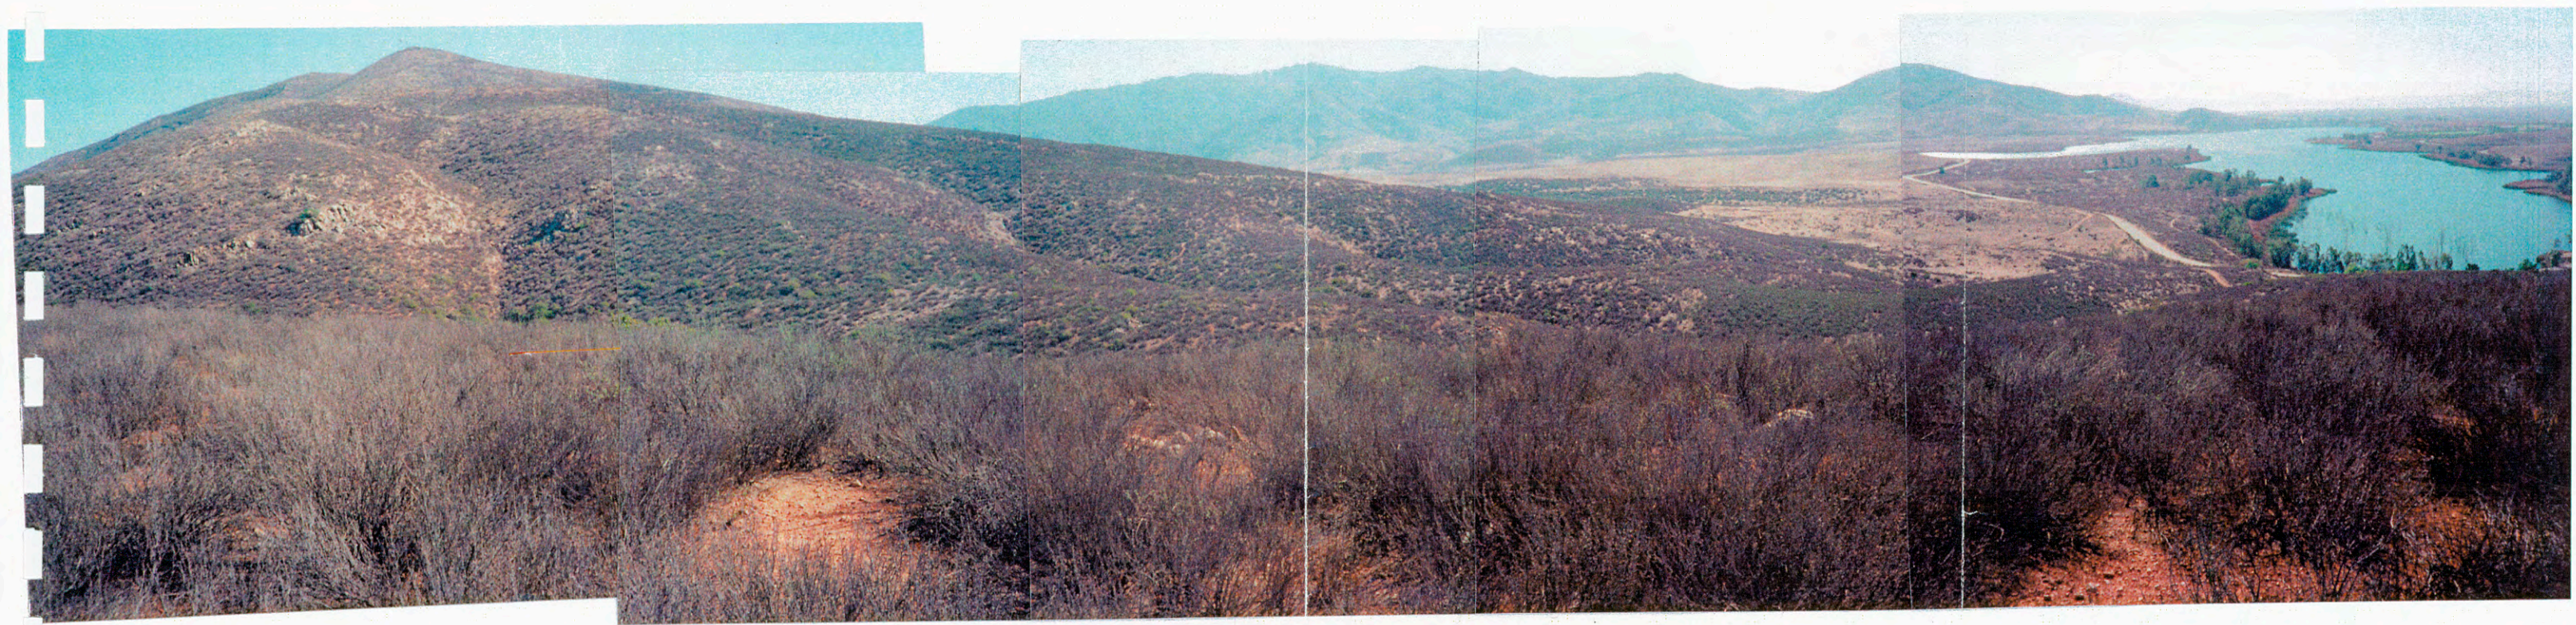
PHOTOGRAPH 1.
PANORAMIC VIEW FROM HIGH POINT ON WESTERN PART OF THE
PROPERTY, LOOKING FROM SOUTH (RIGHT) TO EAST. LOWER
OTAY RESERVOIR AND OTAY LAKES ROAD ARE VISIBLE ON THE
RIGHT.

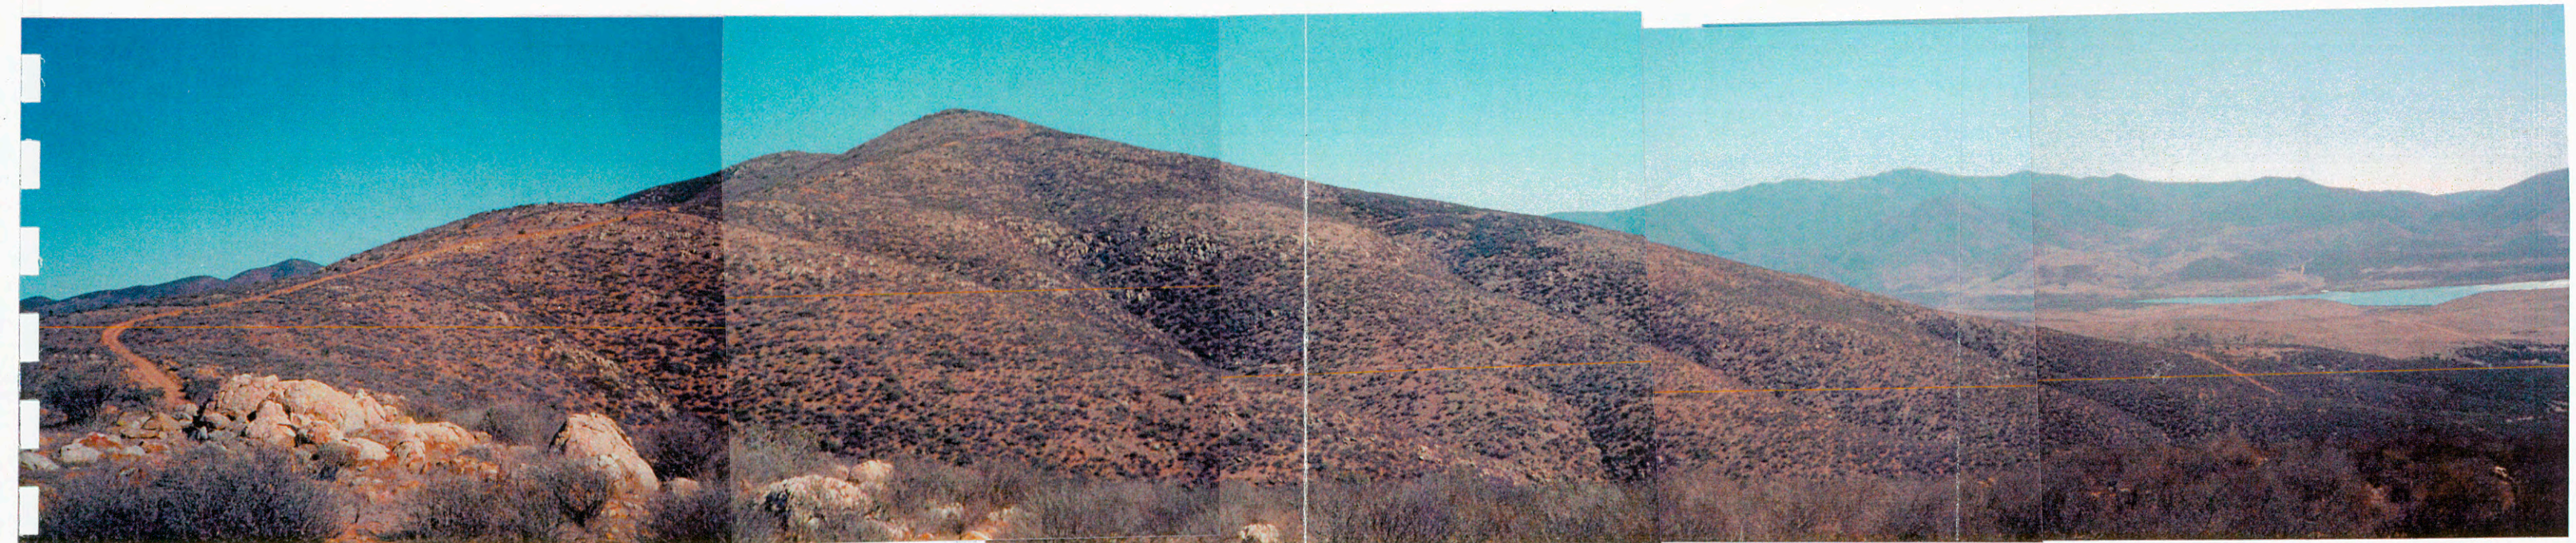
PHOTOGRAPH 2.
PANORAMIC VIEW FROM HIGH POINT MIDWAY ALONG NORTHERN
BOUNDARY, LOOKING SOUTH (RIGHT) TO EAST. LOWER OTAY
RESERVOIR IS IN THE DISTANCE.

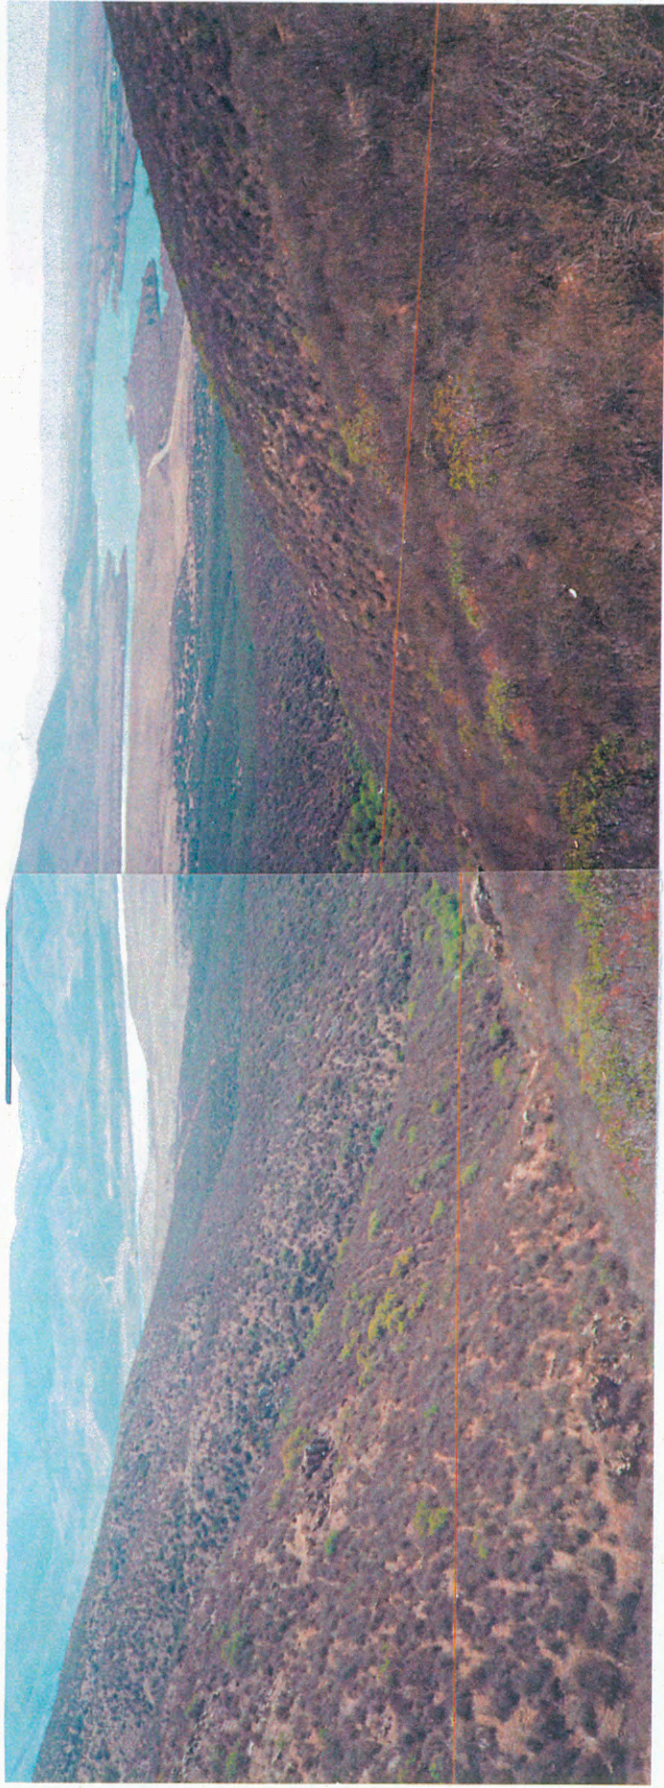
PHOTOGRAPH 3.
VIEW LOOKING SOUTH DOWN THE MAIN VALLEY ON THE PROPERTY.

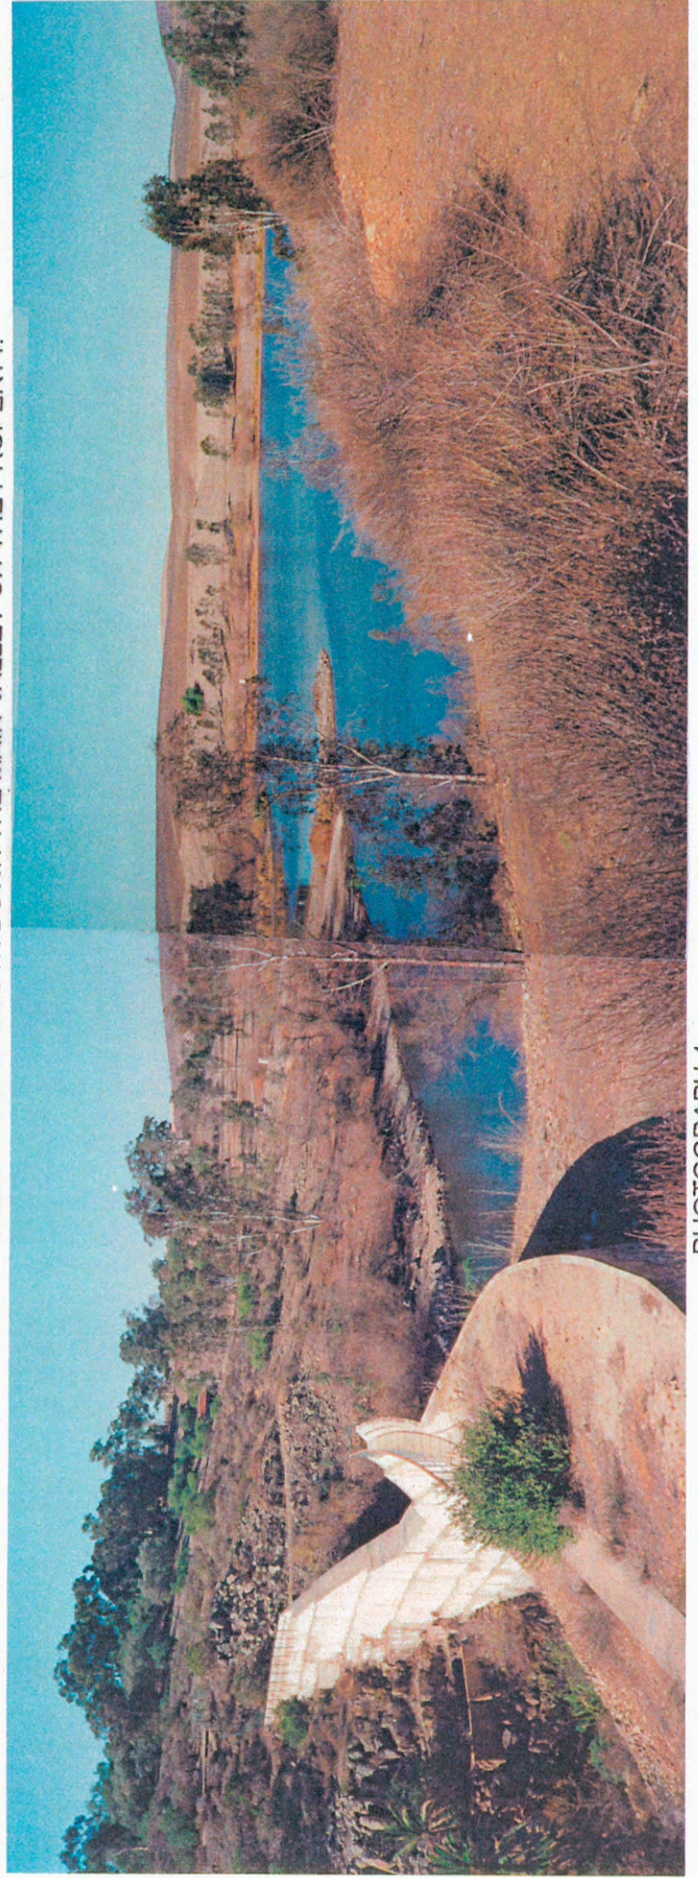
PHOTOGRAPH 4.
VIEW OF DAM AND UPPER OTAY RESERVOIR LOCATED
IMMEDIATELY WEST OF THE PROPERTY.
