GEOTECHNICAL EVALUATIONS EXISTING WATER STORAGE RESERVOIR PROPOSED SHADOW RUN RANCH RESIDENTIAL DEVELOPMENT PAUMA VALLEY, NORTH SAN DIEGO COUNTY, CALIFORNIA

URS Project No. 27661027.10000

November 25, 2013
Revised December 31, 2013

Subject: Geotechnical Evaluation
Existing Water Storage Reservoir
Proposed Shadow Run Ranch Residential Development
Pauma Valley, North San Diego County, California
URS Project No. 27661027.00001

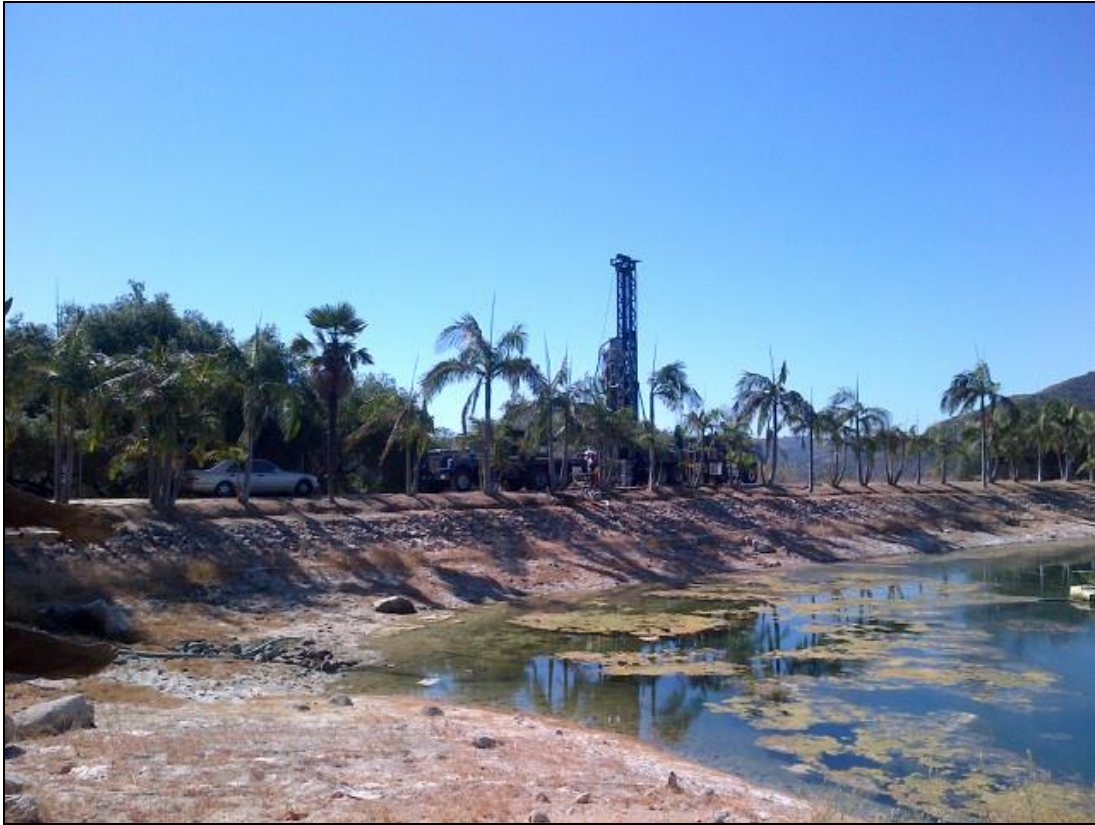
Becker hammer drill rig at Boring B-2. The reservoir level is about at the proposed final level.

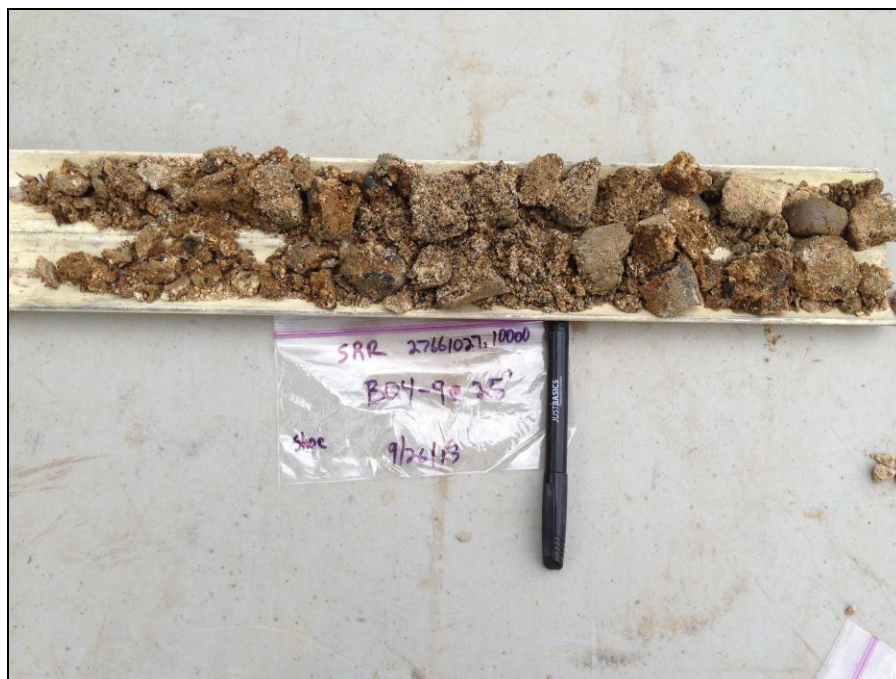
Boring B-4: Sample 9 collected with an SPT sampler at 25 feet. Highly/completely weathered granitic rock about 6 feet below the dam foundation

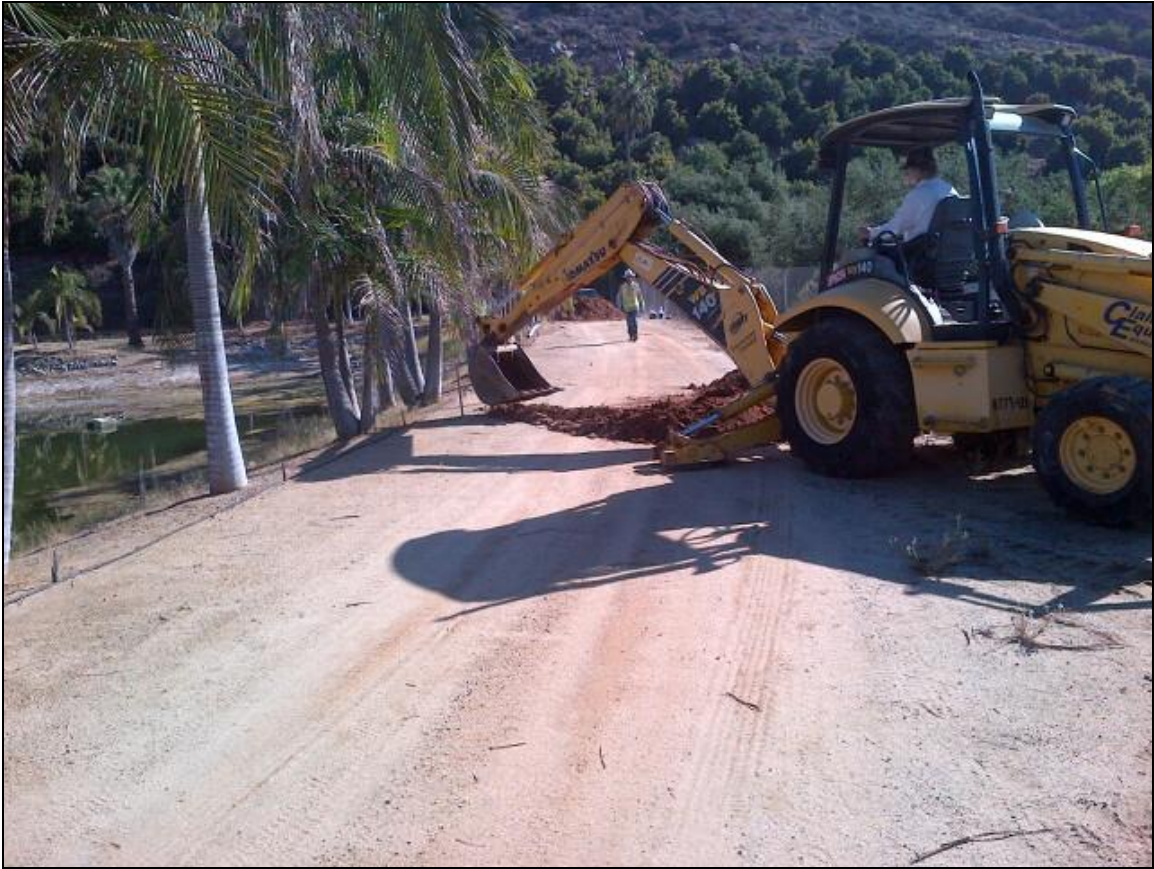
Backhoe test pits were excavated at the top of the embankment. This is Test Pit TP-2, looking east.
