PRELIMINARY GEOTECHNICAL INVESTIGATION NEWLAND SIERRA SAN DIEGO COUNTY, CALIFORNIA

Project No. 10618.002

June 29, 2015 (Revised November 6, 2015)

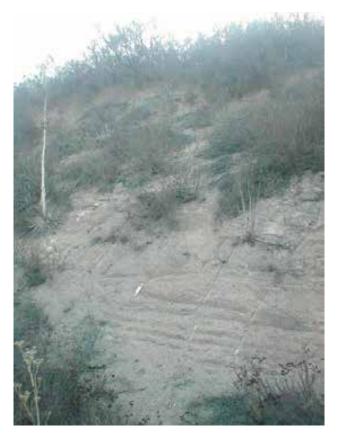
Figure P1: Weakly jointed granite (Kgr) near the surface, characteristic ridgeline exposure.

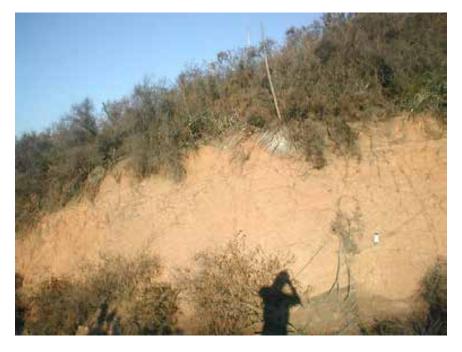
Figure P2: Weakly jointed granite (Kgr), with minimal topsoil, characteristic ridgeline exposure.

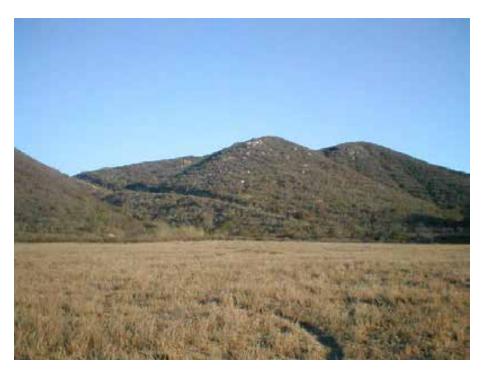
Figure P3: Alluvium (Qal) (generally light colored grass area) within southern canyon.

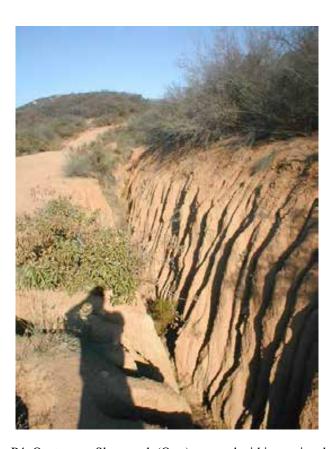
Figure P4: Quaternary Slopewash (Qsw) exposed within erosional gully.

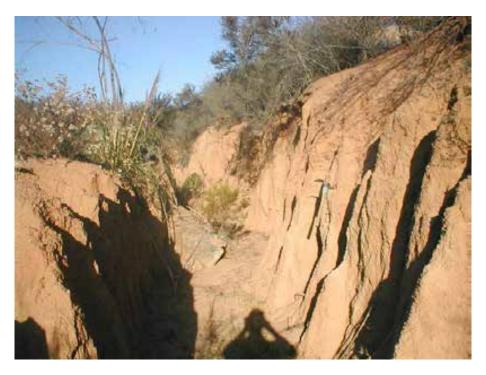
Figure P5: Quaternary slopewash (Qsw) exposed within erosional gully.

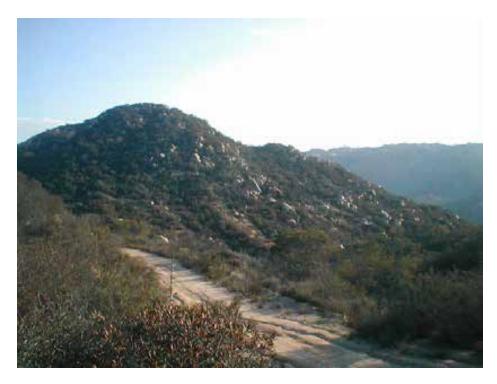
Figure P6: Granite boulders perched on natural hillslope, representative view.

site grading. Mitigation of rockfill areas could include grading of these areas to remove dangerous boulders, providing support for boulders to remove the hazard, or construction of a deflection/catchment berm or fence.

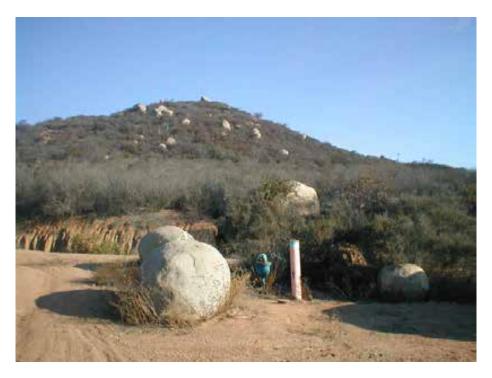
Figure P7: Granite boulders at base of sloped area.

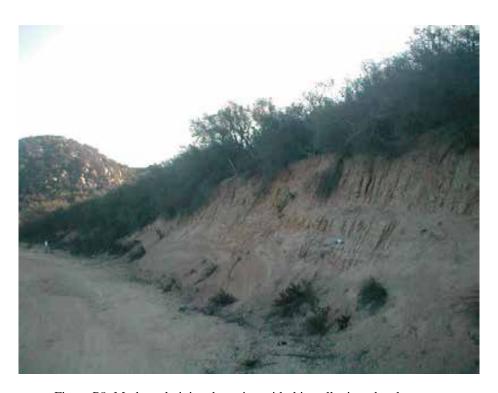
Figure P8: Moderately jointed granite, with thin colluvium development.
