SOIL AND GEOLOGIC RECONNAISSANCE

SWEETWATER VISTAS LOTS 1, 2, AND 3 JAMACHA AND SWEETWATER SPRINGS BOULEVARDS SPRING VALLEY, CALIFORNIA

**AUGUST 10, 2015
REVISED APRIL 20, 2017
PROJECT NO. G1869-42-01**

Subject: SOIL AND GEOLOGIC RECONNAISSANCE
SWEETWATER VISTAS LOTS 1, 2, AND 3
JAMACHA AND SWEETWATER SPRINGS BOULEVARDS
SPRING VALLEY, CALIFORNIA

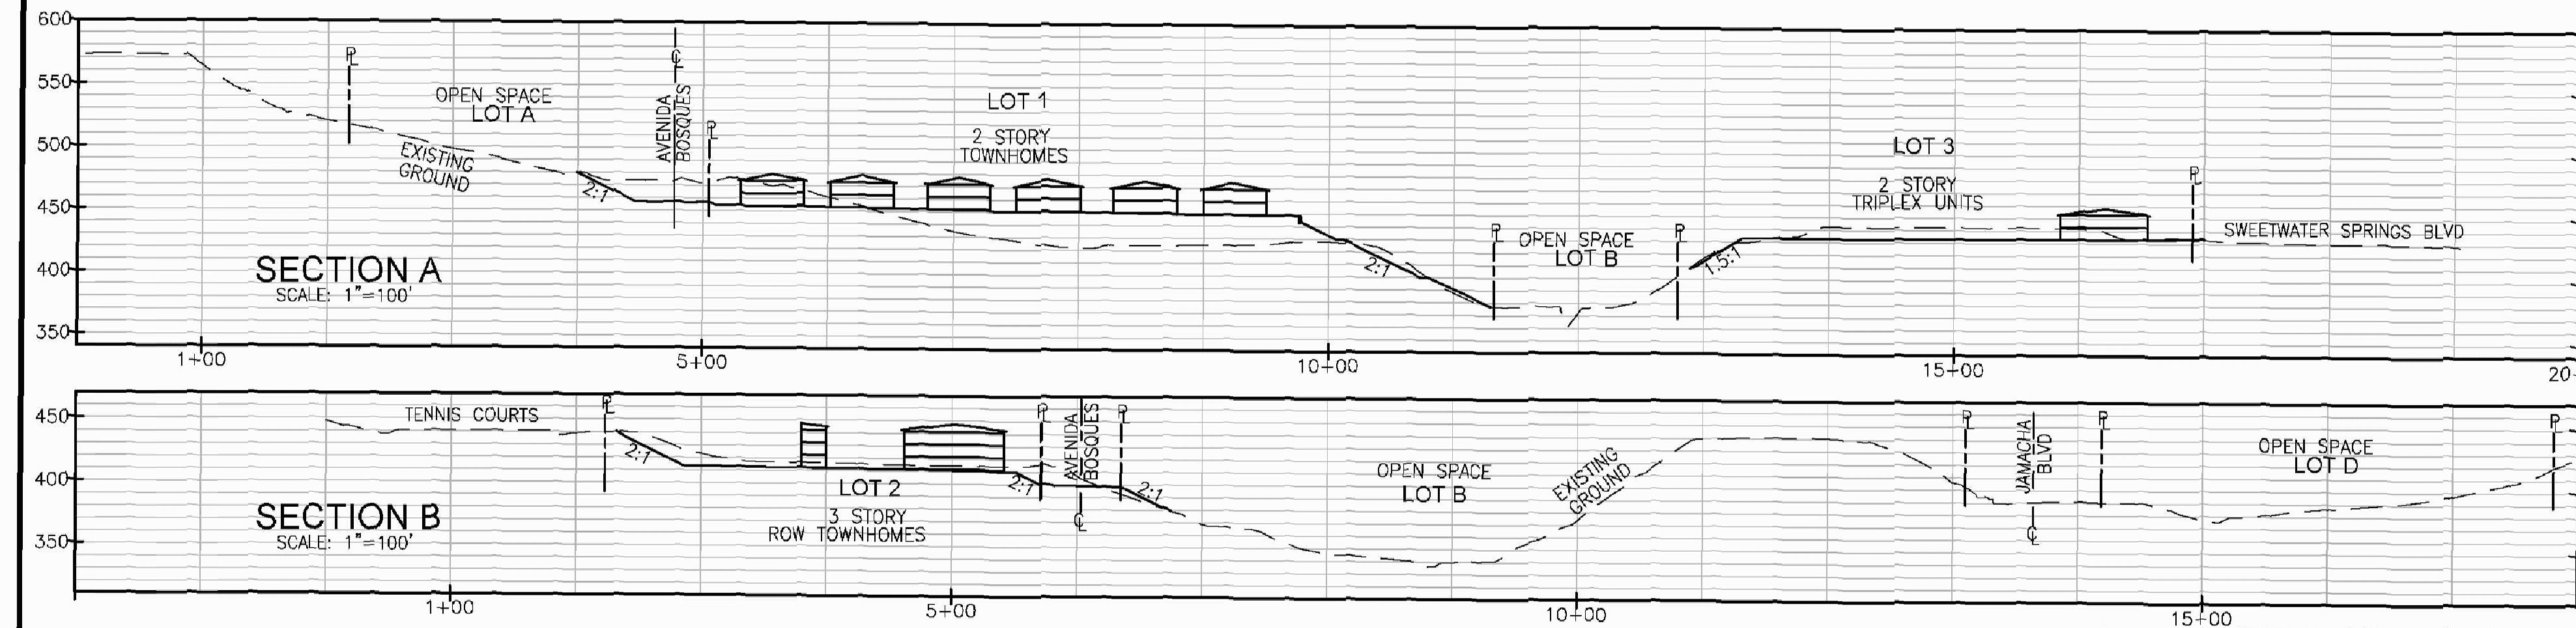
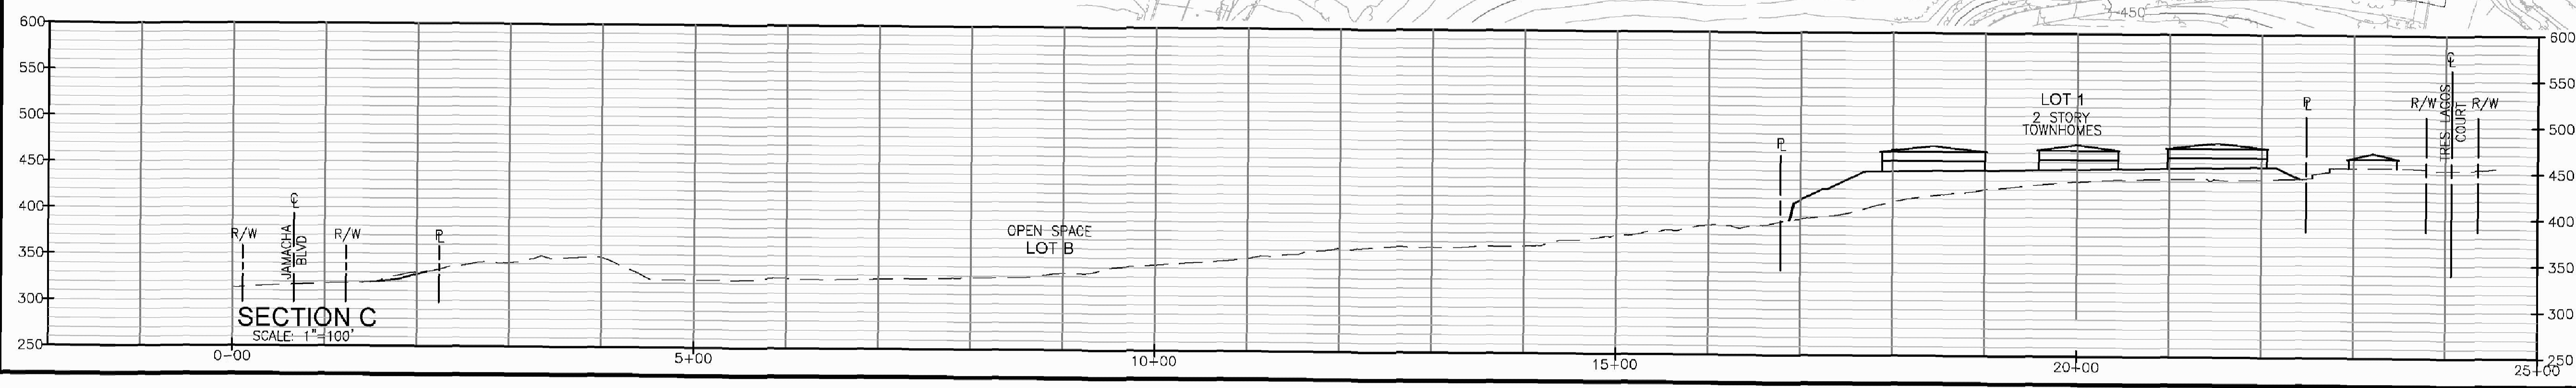
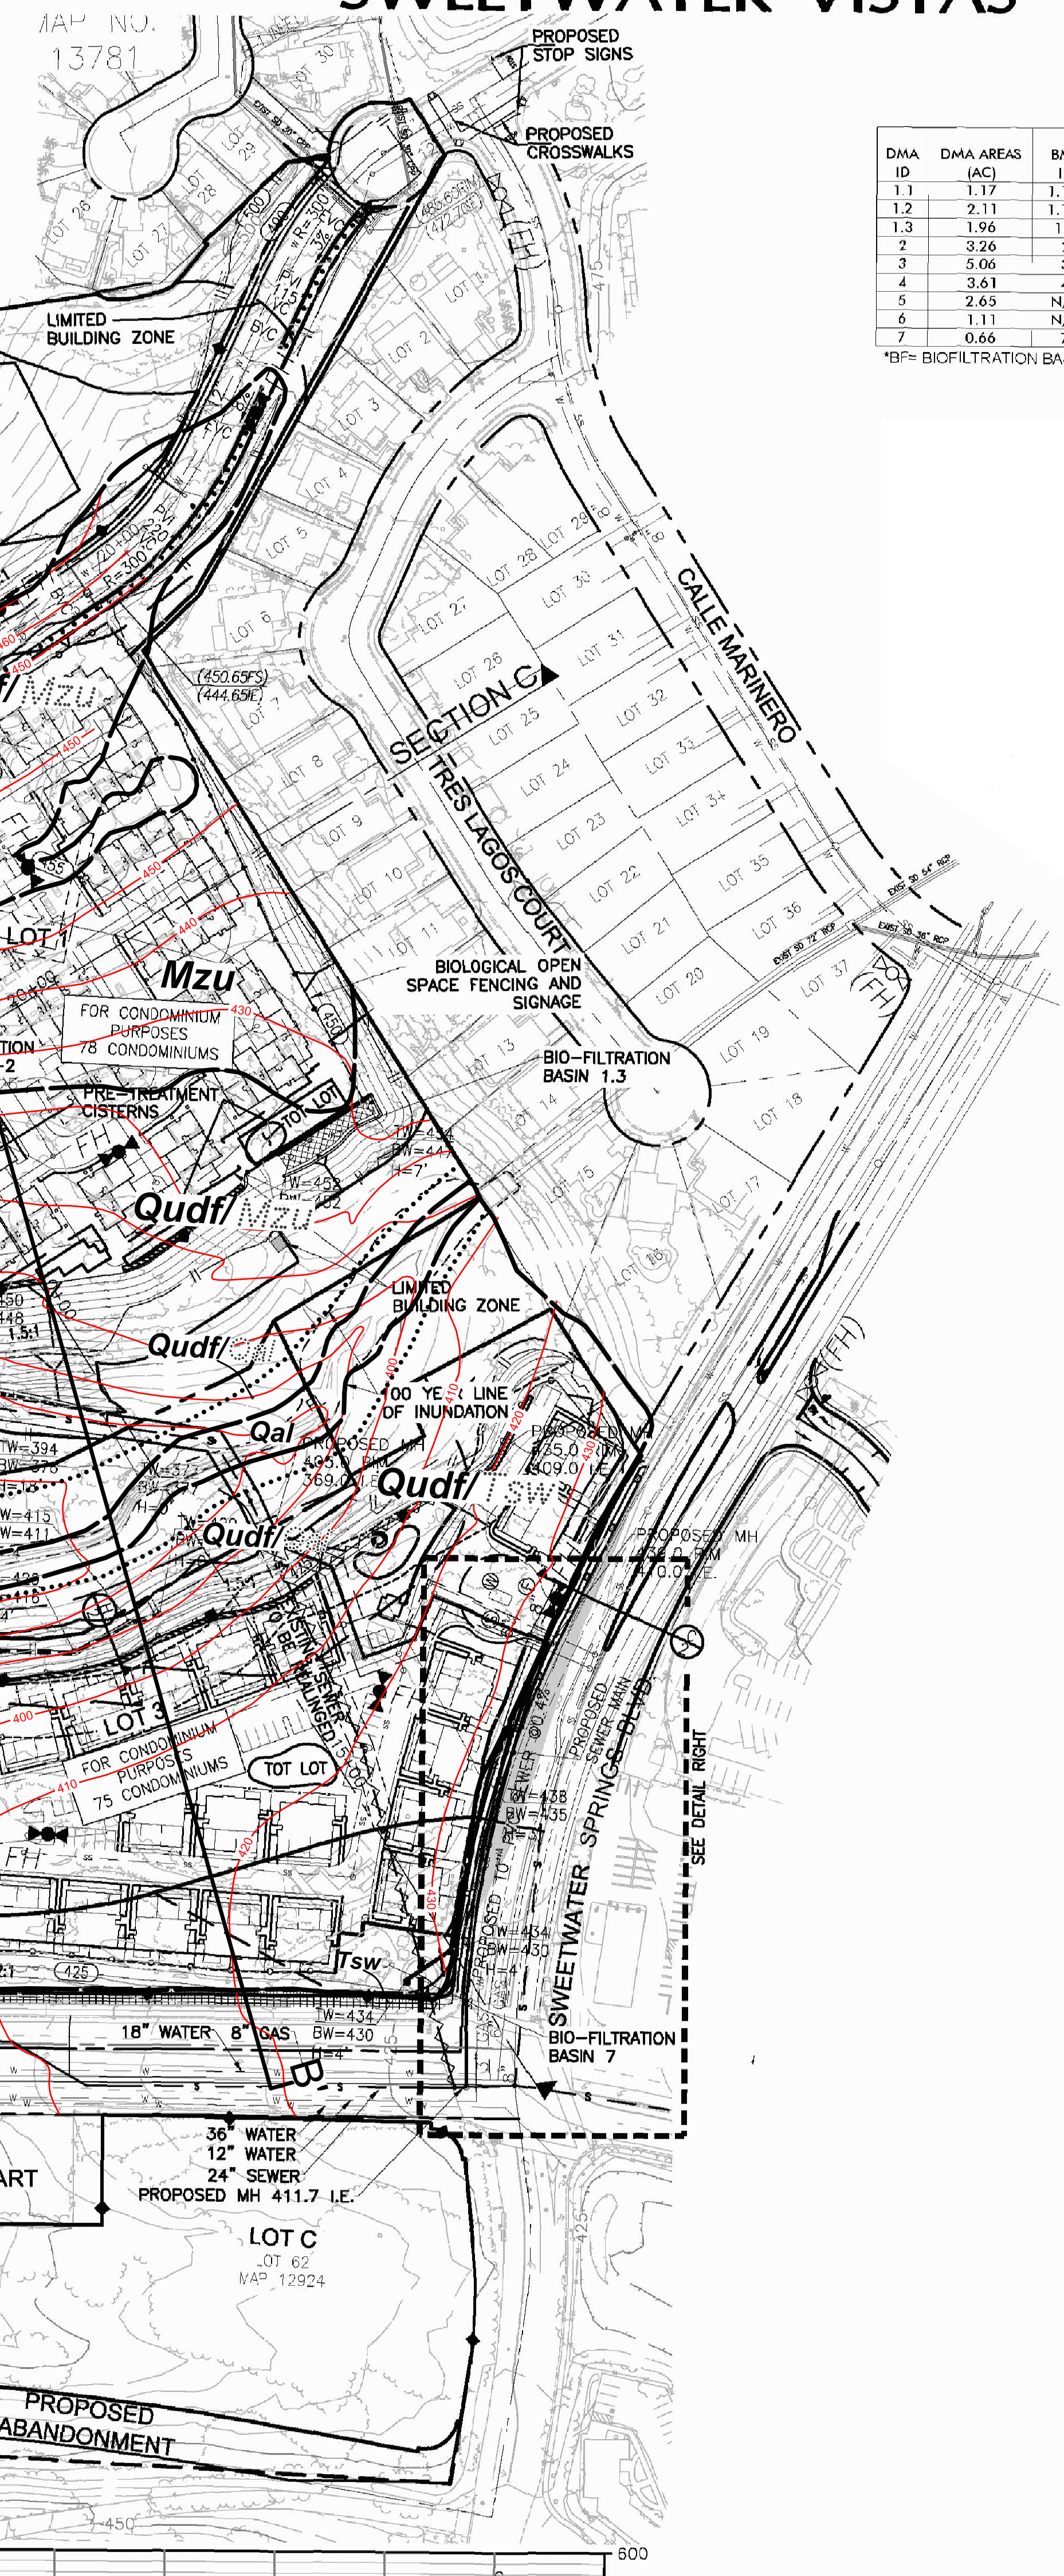
FIGURE 2

Mesozoic-age Undivided Metamorphic Rock (formerly identified as Santiago Peak Volcanics). The units encountered are described below in order of increasing age. Their approximate mapped extent based on existing data and our reconnaissance is shown on the *Geologic Map*, and the *Geologic Cross Sections* attached as Figures 2 and 3.

Undocumented fill underlies all of Lot 3 and parts of Lots 1 and 2. This unit is expected to consist of loose to medium dense, dry to moist, brown, silty, clayey, fine to very coarse sand with gravel, cobble, and extensive amounts of rock. We estimate the undocumented fill soil has a thickness between 3 and 15 feet in Lots 1 and 2 and from 10 to 50 feet in Lot 3. Extensive amounts of piled cobbles and rocks were observed overlying Lots 1, 2, and 3. Similarly, extensive cobbles and rocks were exposed on the face of the fill slopes on Lot 3. Undocumented fill is unsuitable for support of structural improvements and will require remedial grading to remove and replace as structural fill.

Alluvium is exposed at the bottom of the existing canyon drainage. This unit typically consists of loose to medium dense, damp to saturated, dark gray brown, clayey, fine to very coarse sand with varying amounts of gravel and cobble. This unit is unsuitable for support of structural improvements. However, the alluvium is located far away from proposed development and should not have any impact on proposed graded pads.

The Sweetwater Formation laps onto the basement rock of the Santiago Peak Volcanics in Lot 3. The Sweetwater Formation consists of claystones, sandstones, and angular conglomerates in this area. Bentonitic clays in the Sweetwater Formation are typically highly expansive and possess a low shear strength. Soil of the Sweetwater Formation is exposed in Lot 3, along Jamacha Boulevard. Where these clays are exposed at finish grade or in cut slopes, remedial grading in the form of undercuts

- 6.3.1 The grading recommendations herein are preliminary and intended to provide general criteria to assist in overall planning. Detailed recommendations should be provided in a future geotechnical investigation report based on subsurface explorations and laboratory testing programs.
- 6.3.2 Site preparation should begin with removal of deleterious material and vegetation. The depth of removal should be such that material exposed in cut areas and soil to be used for fill is relatively free of organic matter. Material generated during stripping and/or site demolition should be exported from the site.
- 6.3.3 Undocumented fill and topsoil within proposed structural improvement areas should be removed and recompact.
