# **GEOLOGIC RECONNAISSANCE**

## **RANCHO GUEJITO TASTING FACILITY AND EVENT CENTER SAN DIEGO COUNTY, CALIFORNIA**

**APRIL 28, 2021  
PROJECT NO. 07841-32-09**

Subject: GEOLOGIC RECONNAISSANCE  
RANCHO GUEJITO TASTING FACILITY AND EVENT CENTER  
SAN DIEGO COUNTY, CALIFORNIA

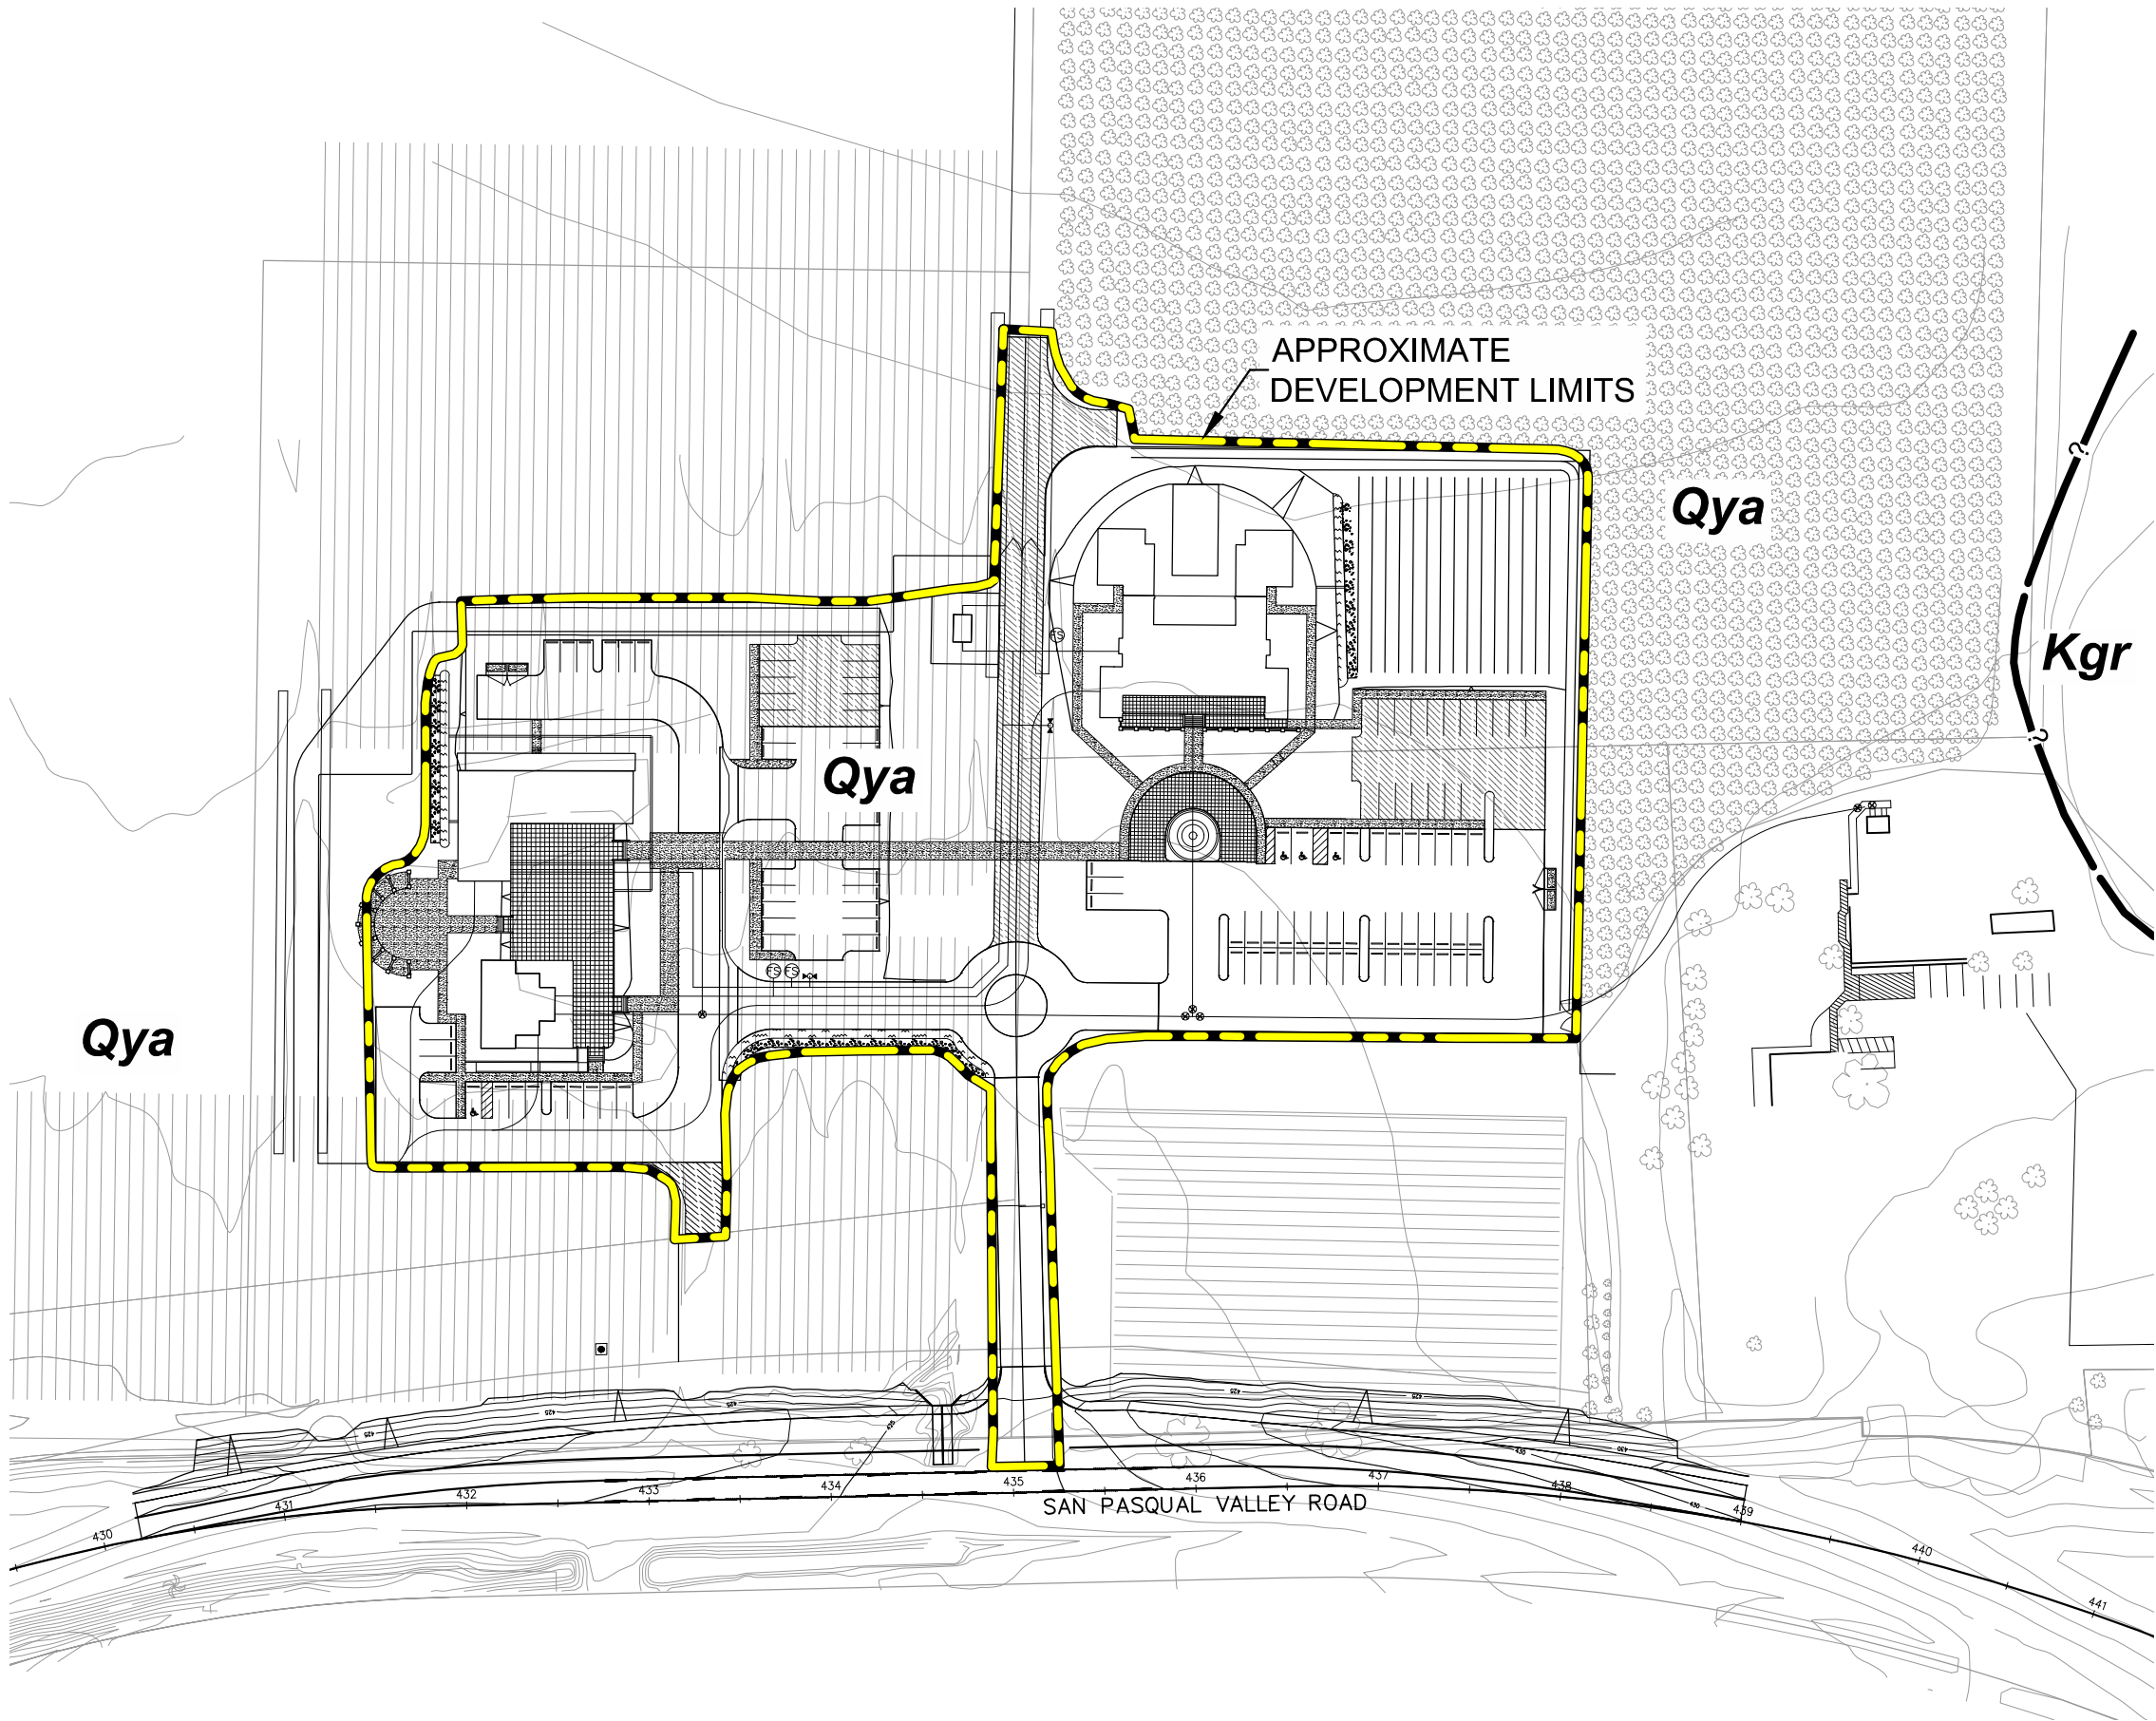
**GEOLOGIC MAP**

Based on our observations during the site reconnaissance, the property is underlain by younger alluvium as discussed below. The estimated extent of this unit is shown on the Geologic Map, Figure 2.

Young alluvial deposits are present beneath the site with an estimated thickness of approximately 100 feet. The alluvial deposits may be liquefiable and compressible when subjected to additional loads. Remedial grading of the upper portion of this unit should be anticipated.
