## Groundwater Resources Investigation Report Rugged Solar Farm Project

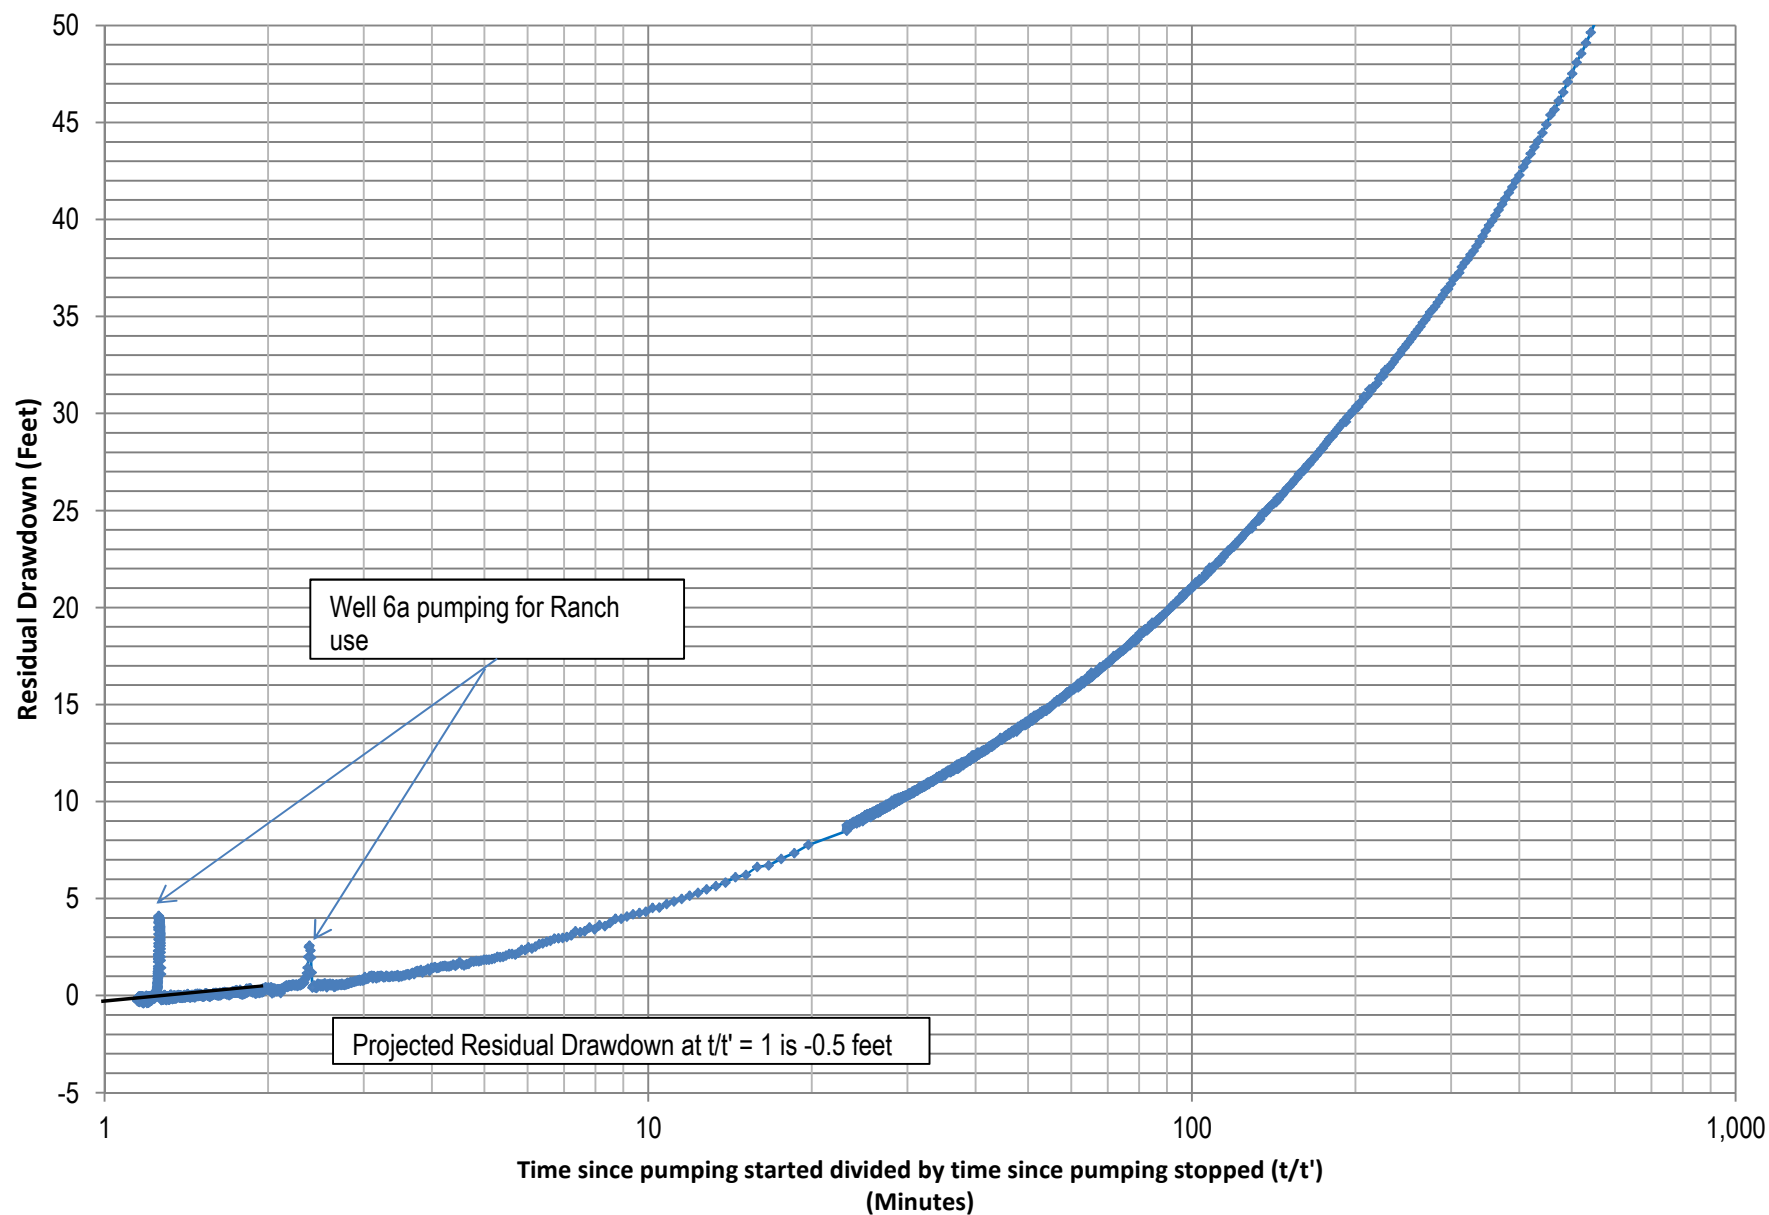
Figure 27. Well 6B Recovery Analysis, Well 6A/6B 72 Hour Constant Rate Test

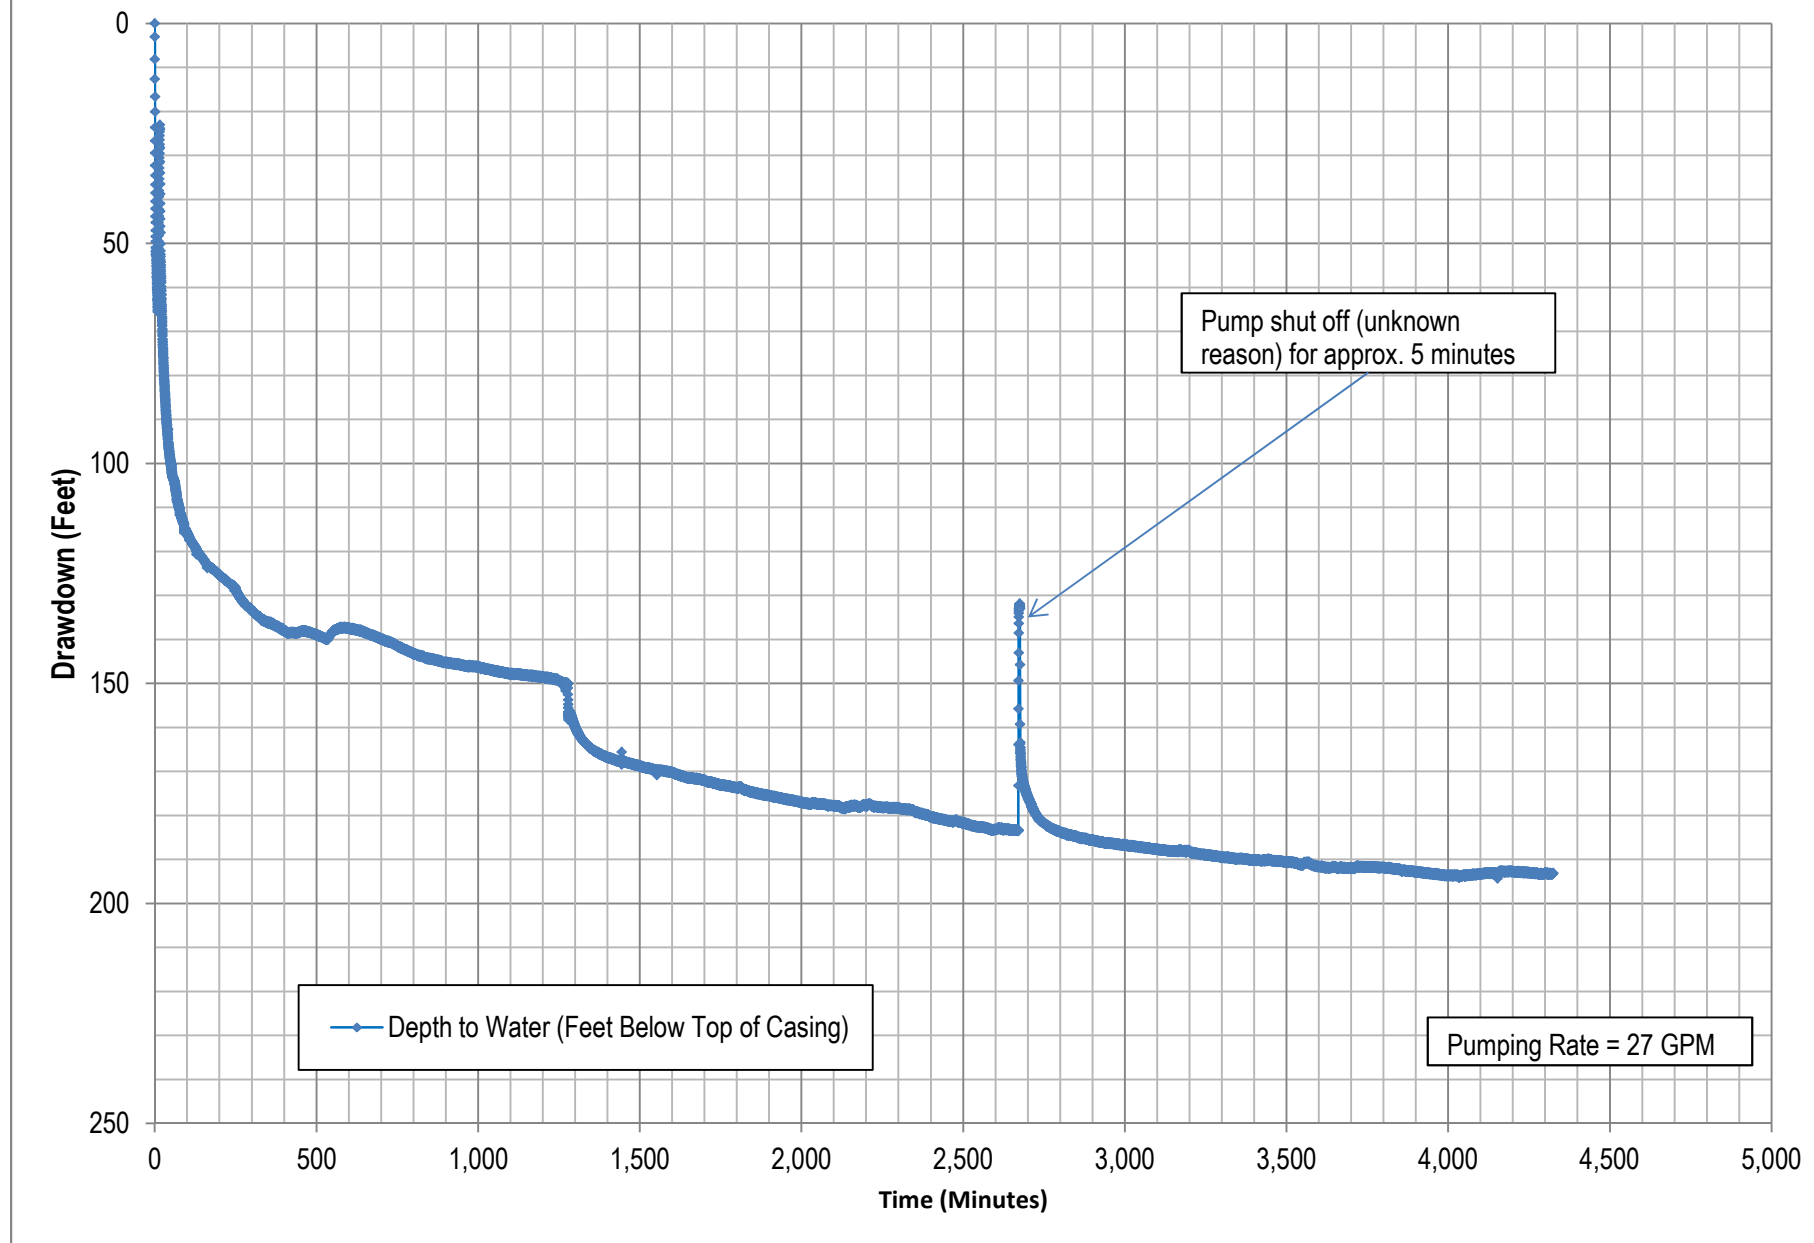
Figure 28. Well 8 72 Hour Constant Rate Test Water Level Drawdown

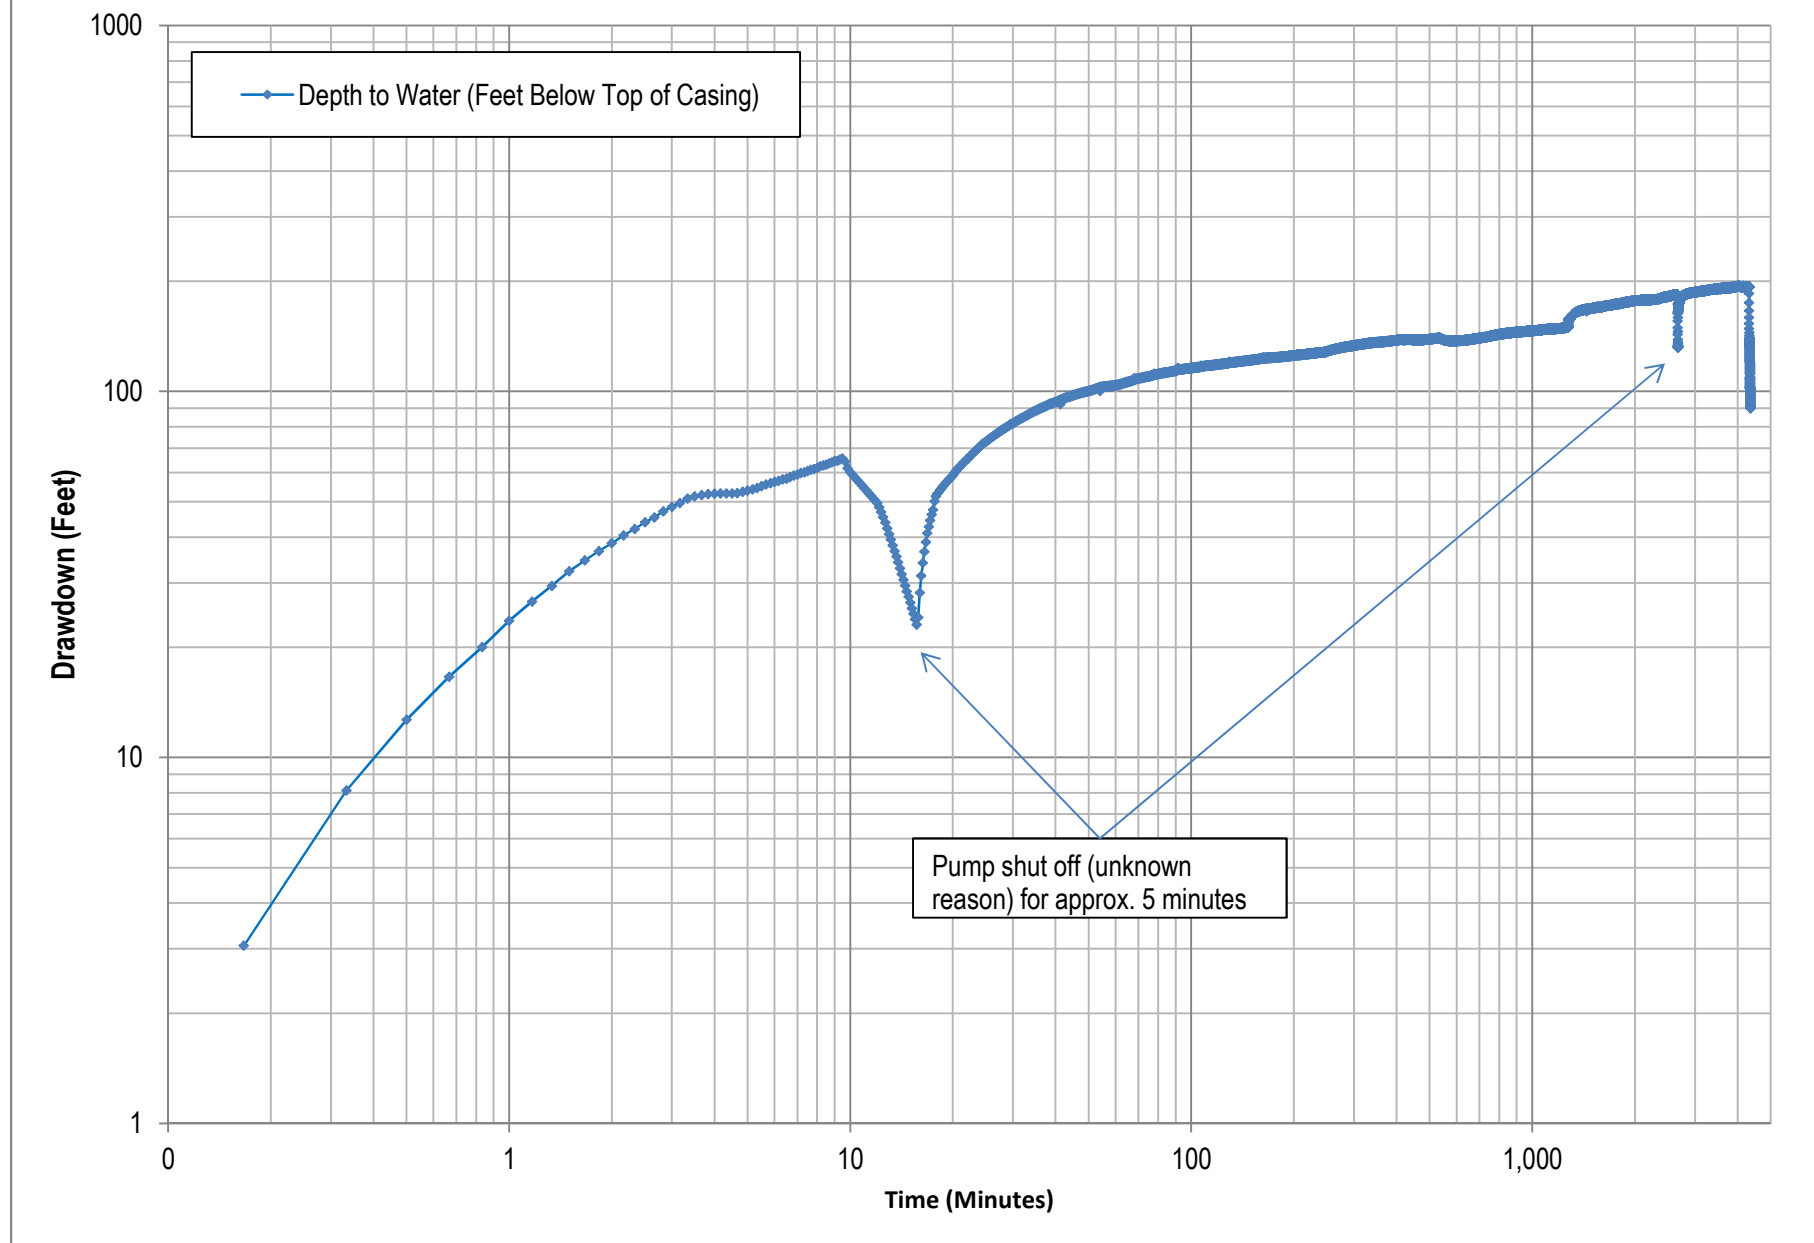
Figure 29. Well 8 72 Hour Constant Rate Test Log Water Level Drawdown

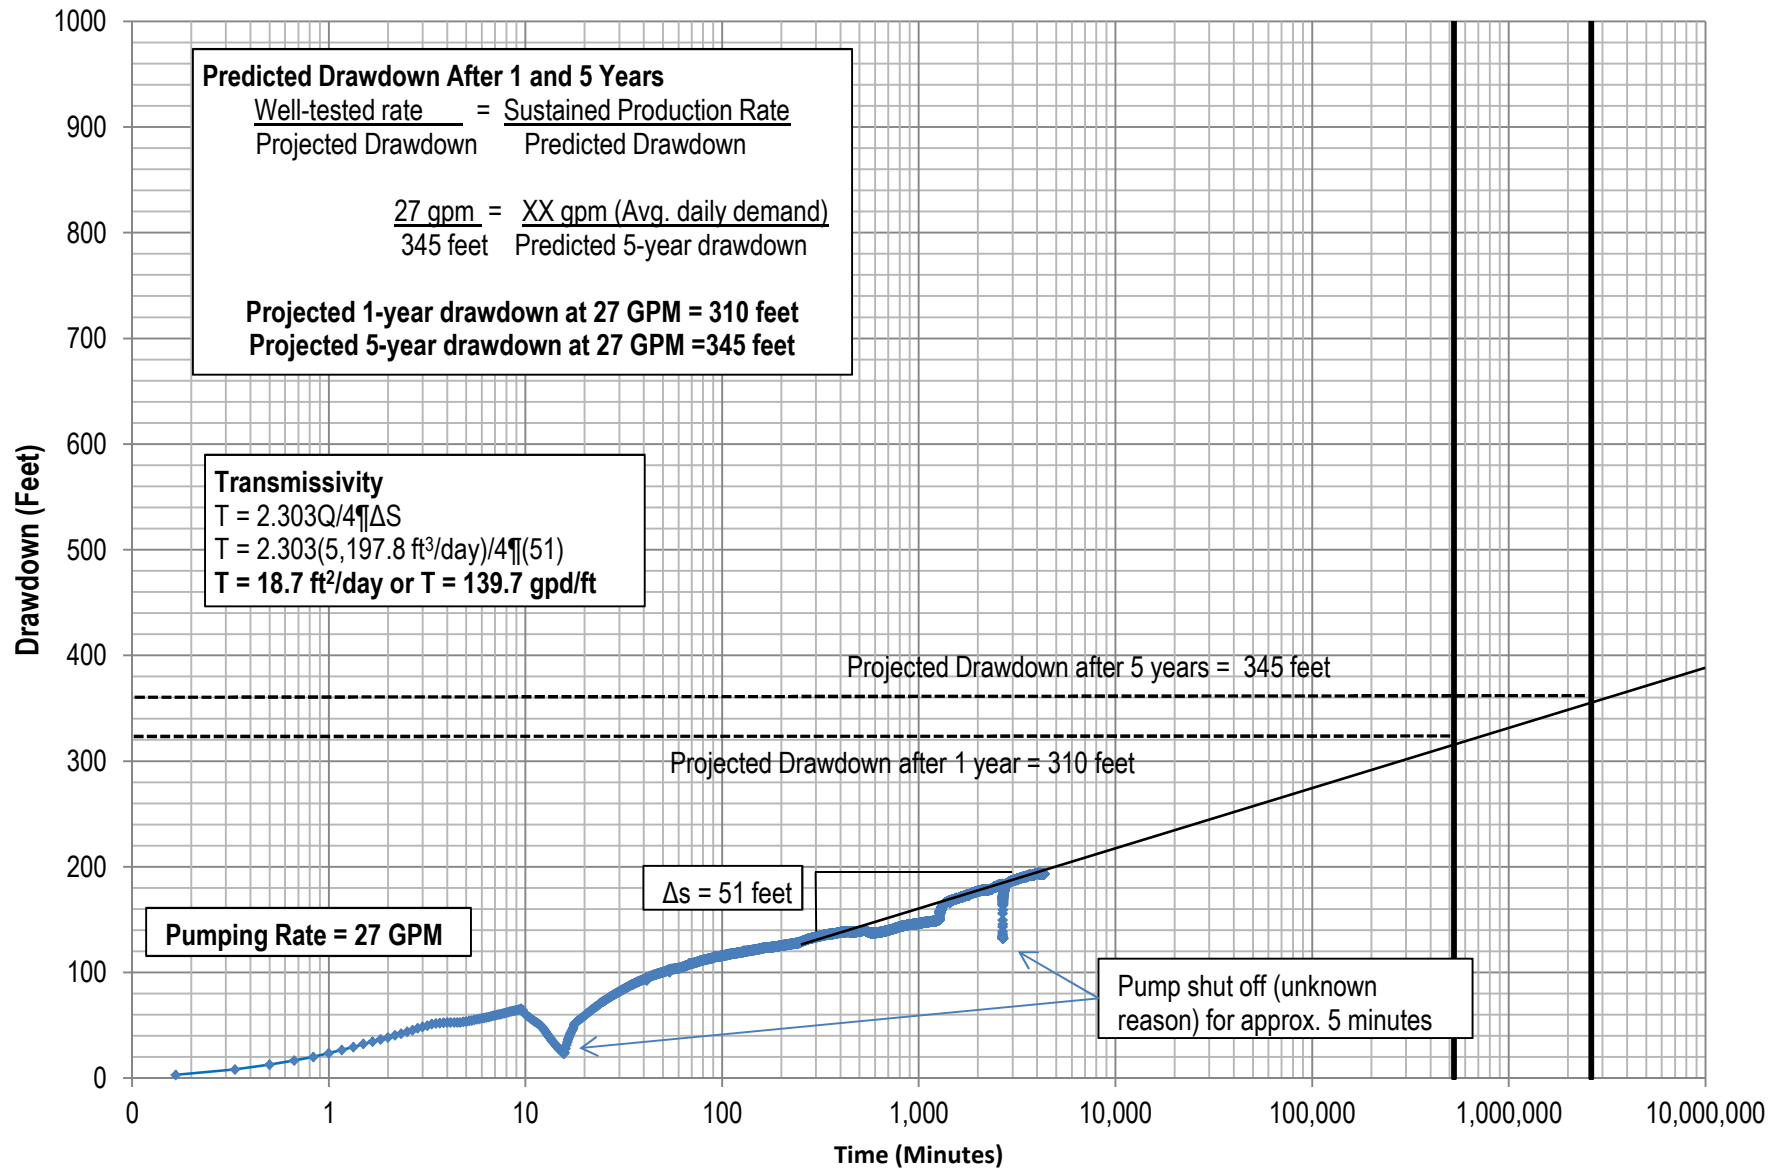
**Figure 30. Well 8 Cooper-Jacob Straight Line Test  
Well 8 72 Hour Constant Rate Test**

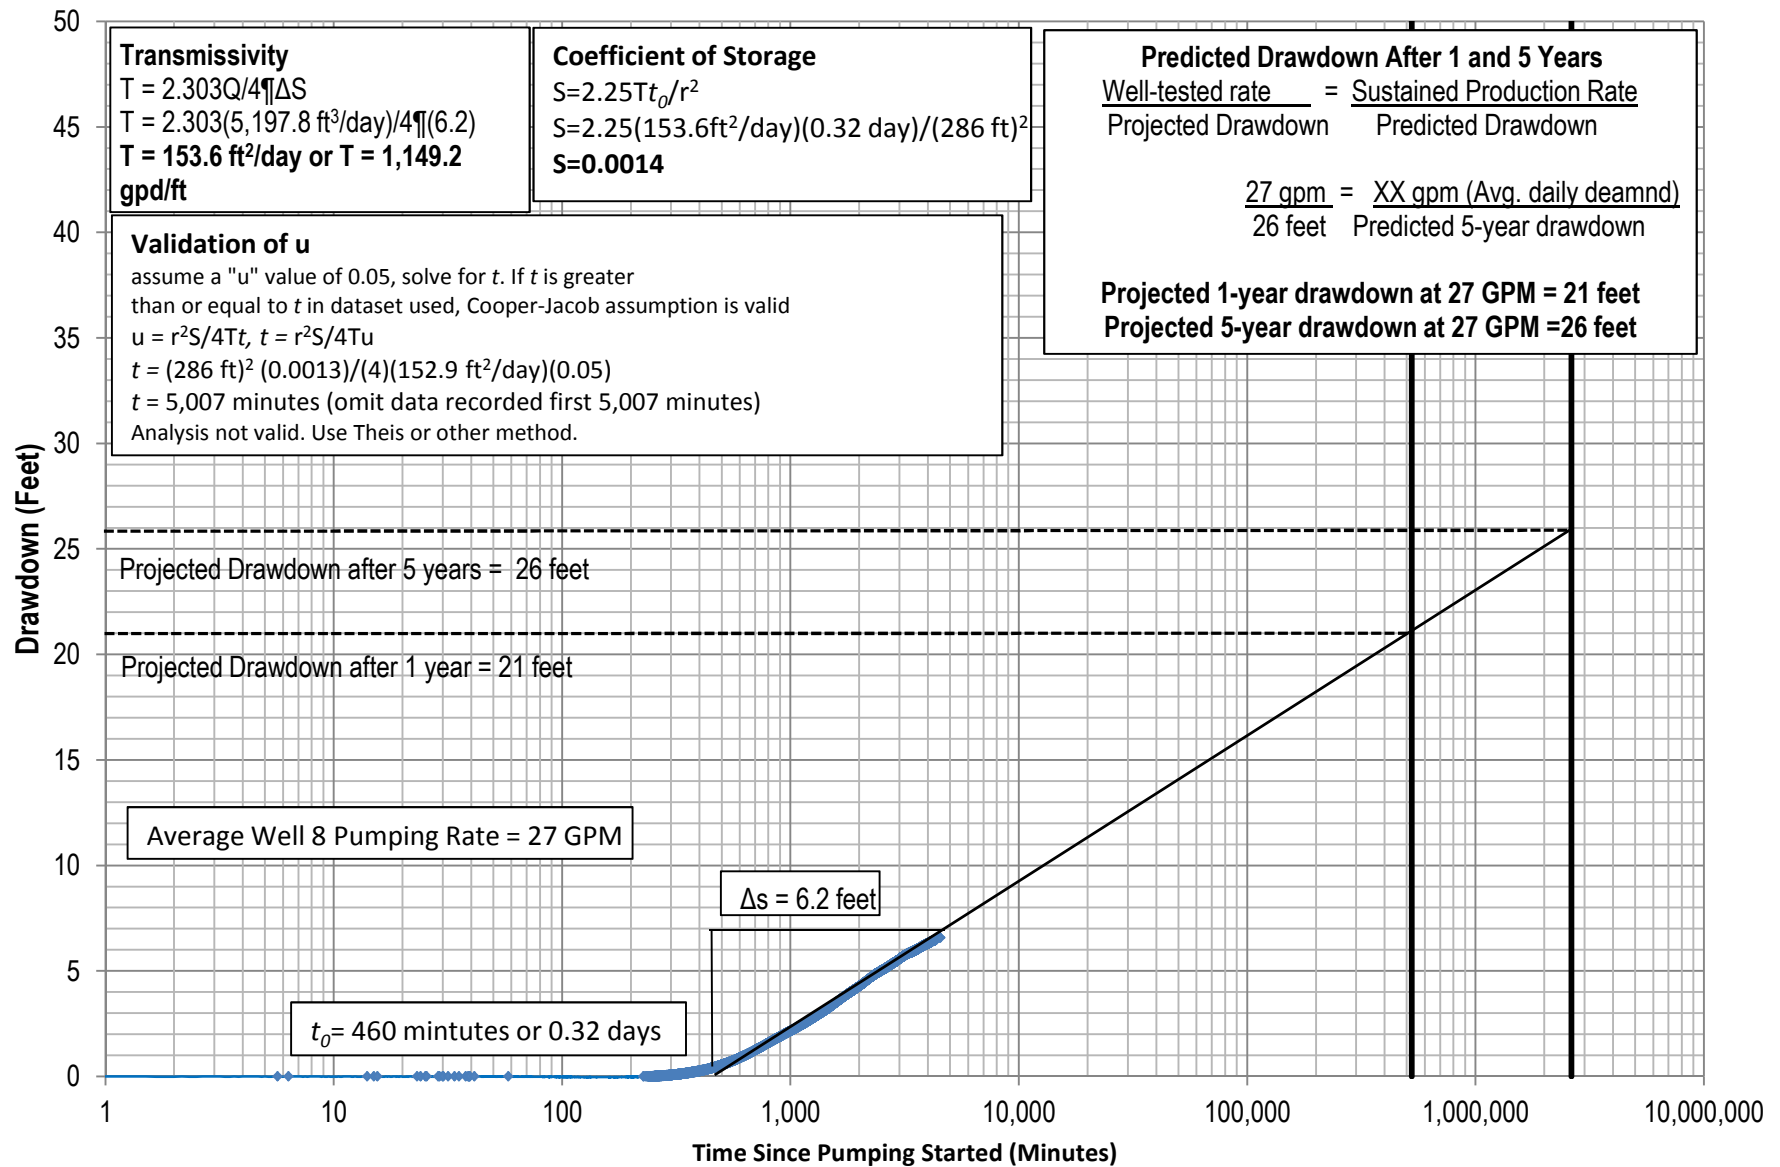
**Figure 31. Well 8a Cooper-Jacob Straight Line Test  
Well 8 72 Hour Constant Rate Test**

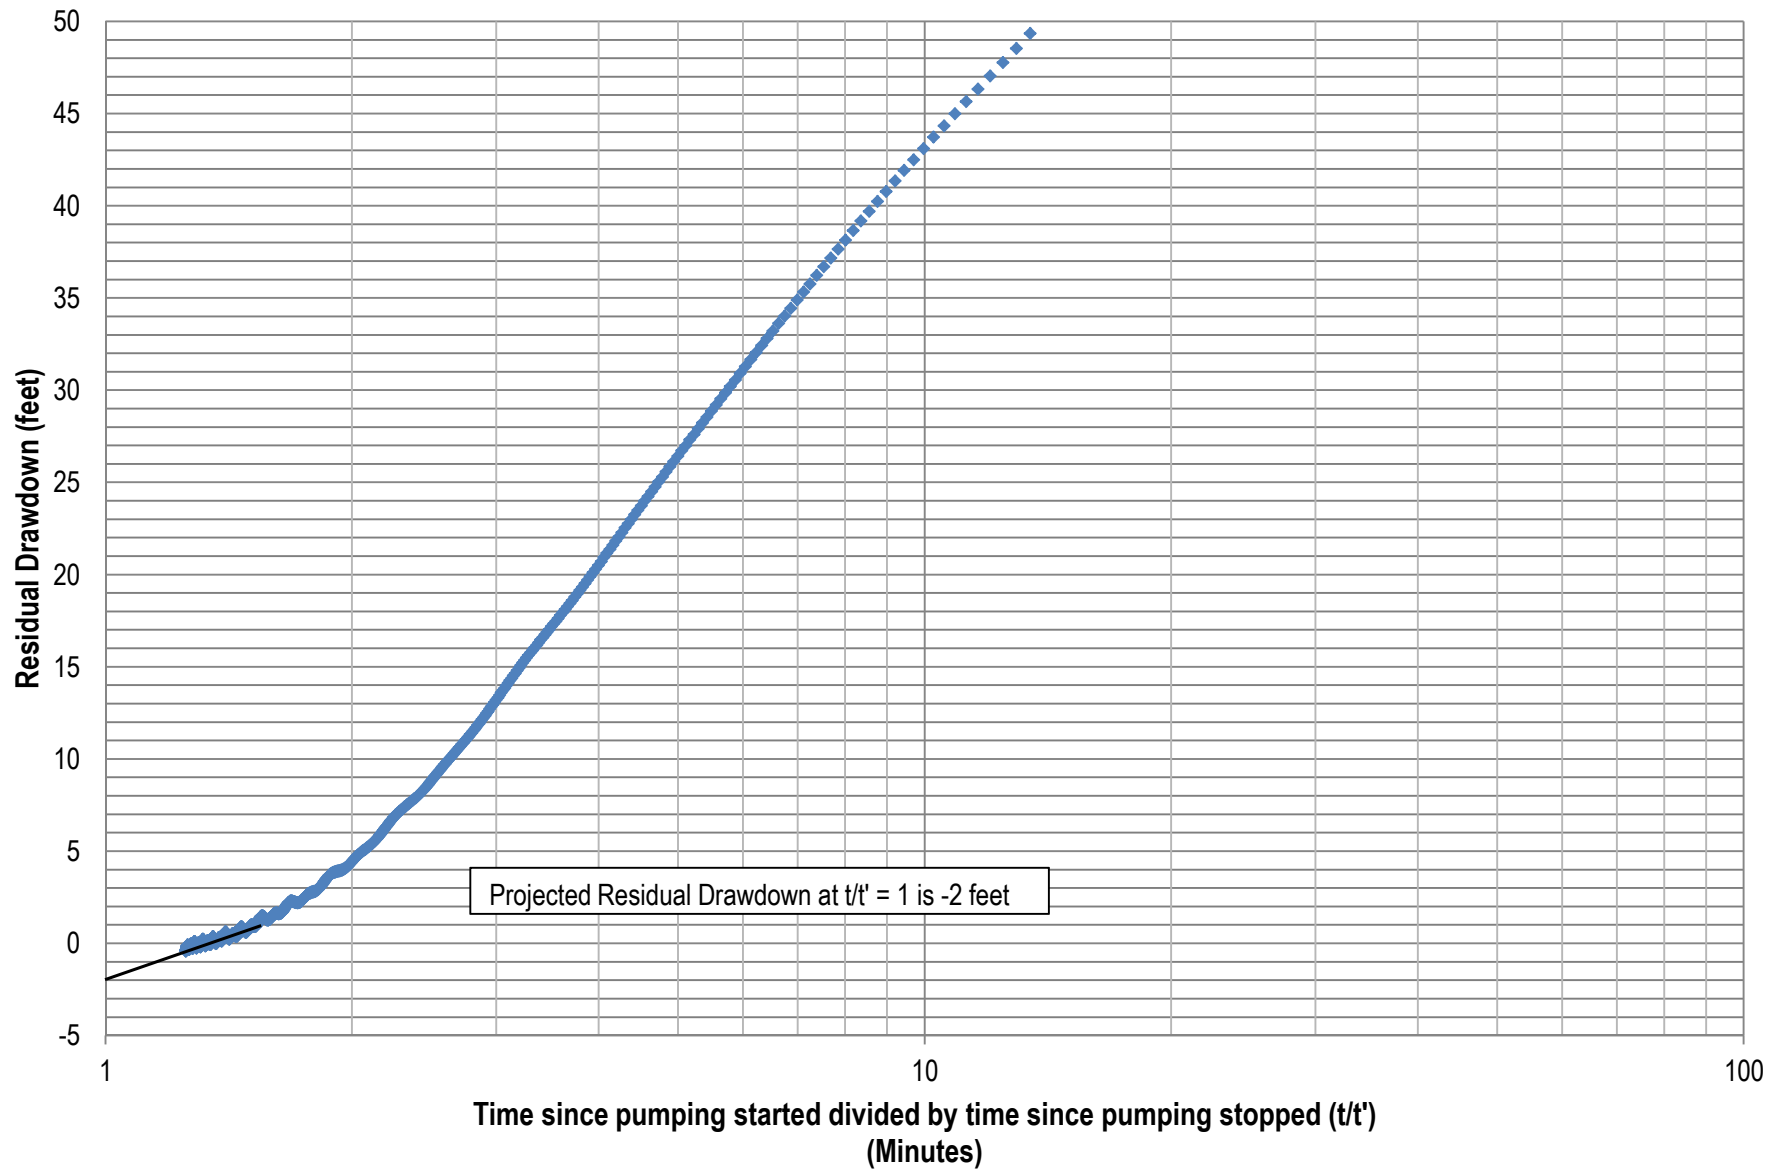
**Figure 32. Well 8 Recovery Analysis,  
Well 8 72 Hour Constant Rate Test**
