Phase II Environmental Site Assessment

**1535 Lone Oak Rod
Vista, California**

Rincon Consultants, Inc.
November 7, 2013

**Phase II Environmental Site Assessment
1535 Lone Oak Road
Vista, California**

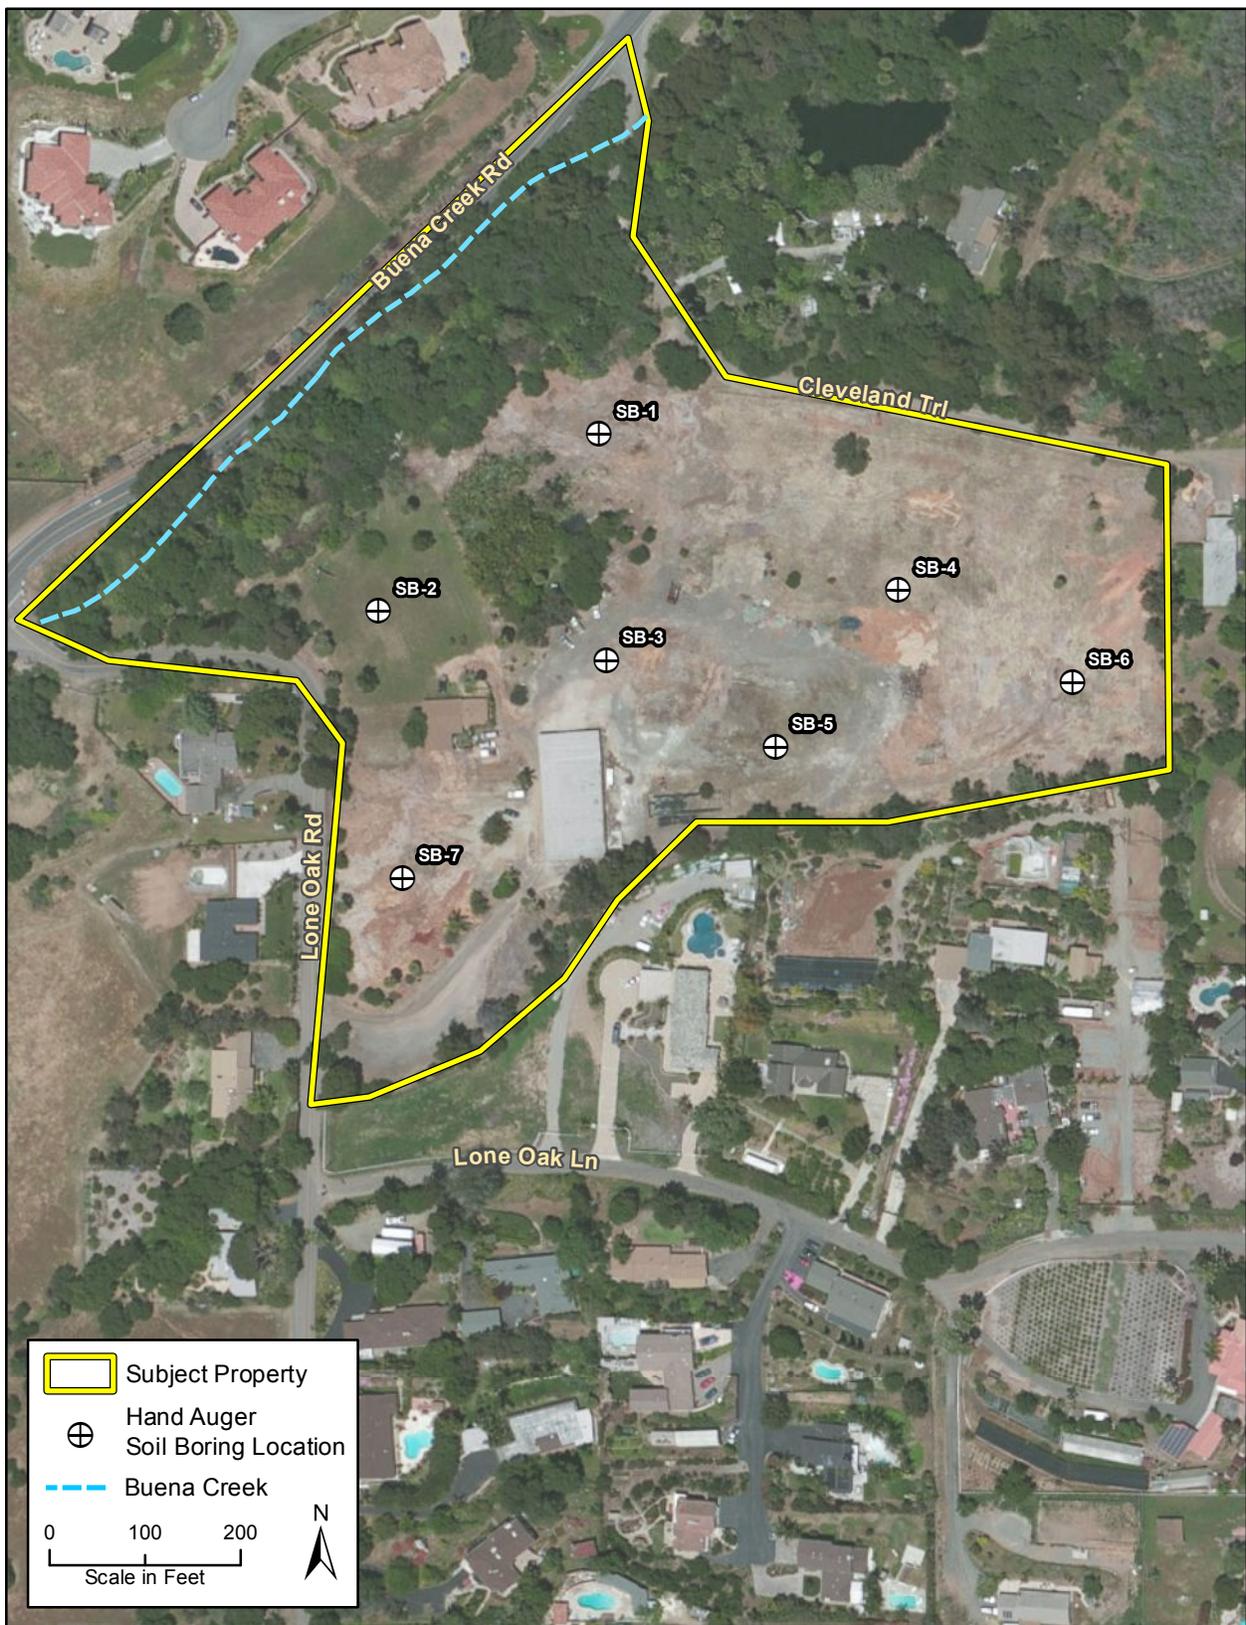
Figure 2

Soil Sampling Location Map

- **Soil Sampling.** Using a hand auger, Rincon advanced 7 soil borings throughout the subject property and collected two soil samples from each soil boring for a total of 14 soil samples. One sample was collected at a depth of 0.5 feet below the ground surface and one sample was collected at 2 feet below the ground surface at each of the soil boring locations (Figure 2).

On October 25, 2013, 7 soil borings were advanced using a hand auger on the subject property. Each soil boring was advanced to a depth of 2 feet below the ground surface or until refusal. The deeper samples at each boring location ranged in depths from 1 to 2 feet below grade due to soil conditions on the subject property. The borings were located throughout the subject property, but focused on the areas historically associated with agricultural activity (Figure 2).
