Limited Phase II Soil Sampling

**Assessor's Parcel Numbers 395-250-08,
-09, -15, and -22, and 398-110-09, -10, and -75
14109, 14135, and 14173 Olde Highway 80,
and 14207 Rios Canyon Road
El Cajon, California**

November 7, 2014
Project Number: 01205547.04

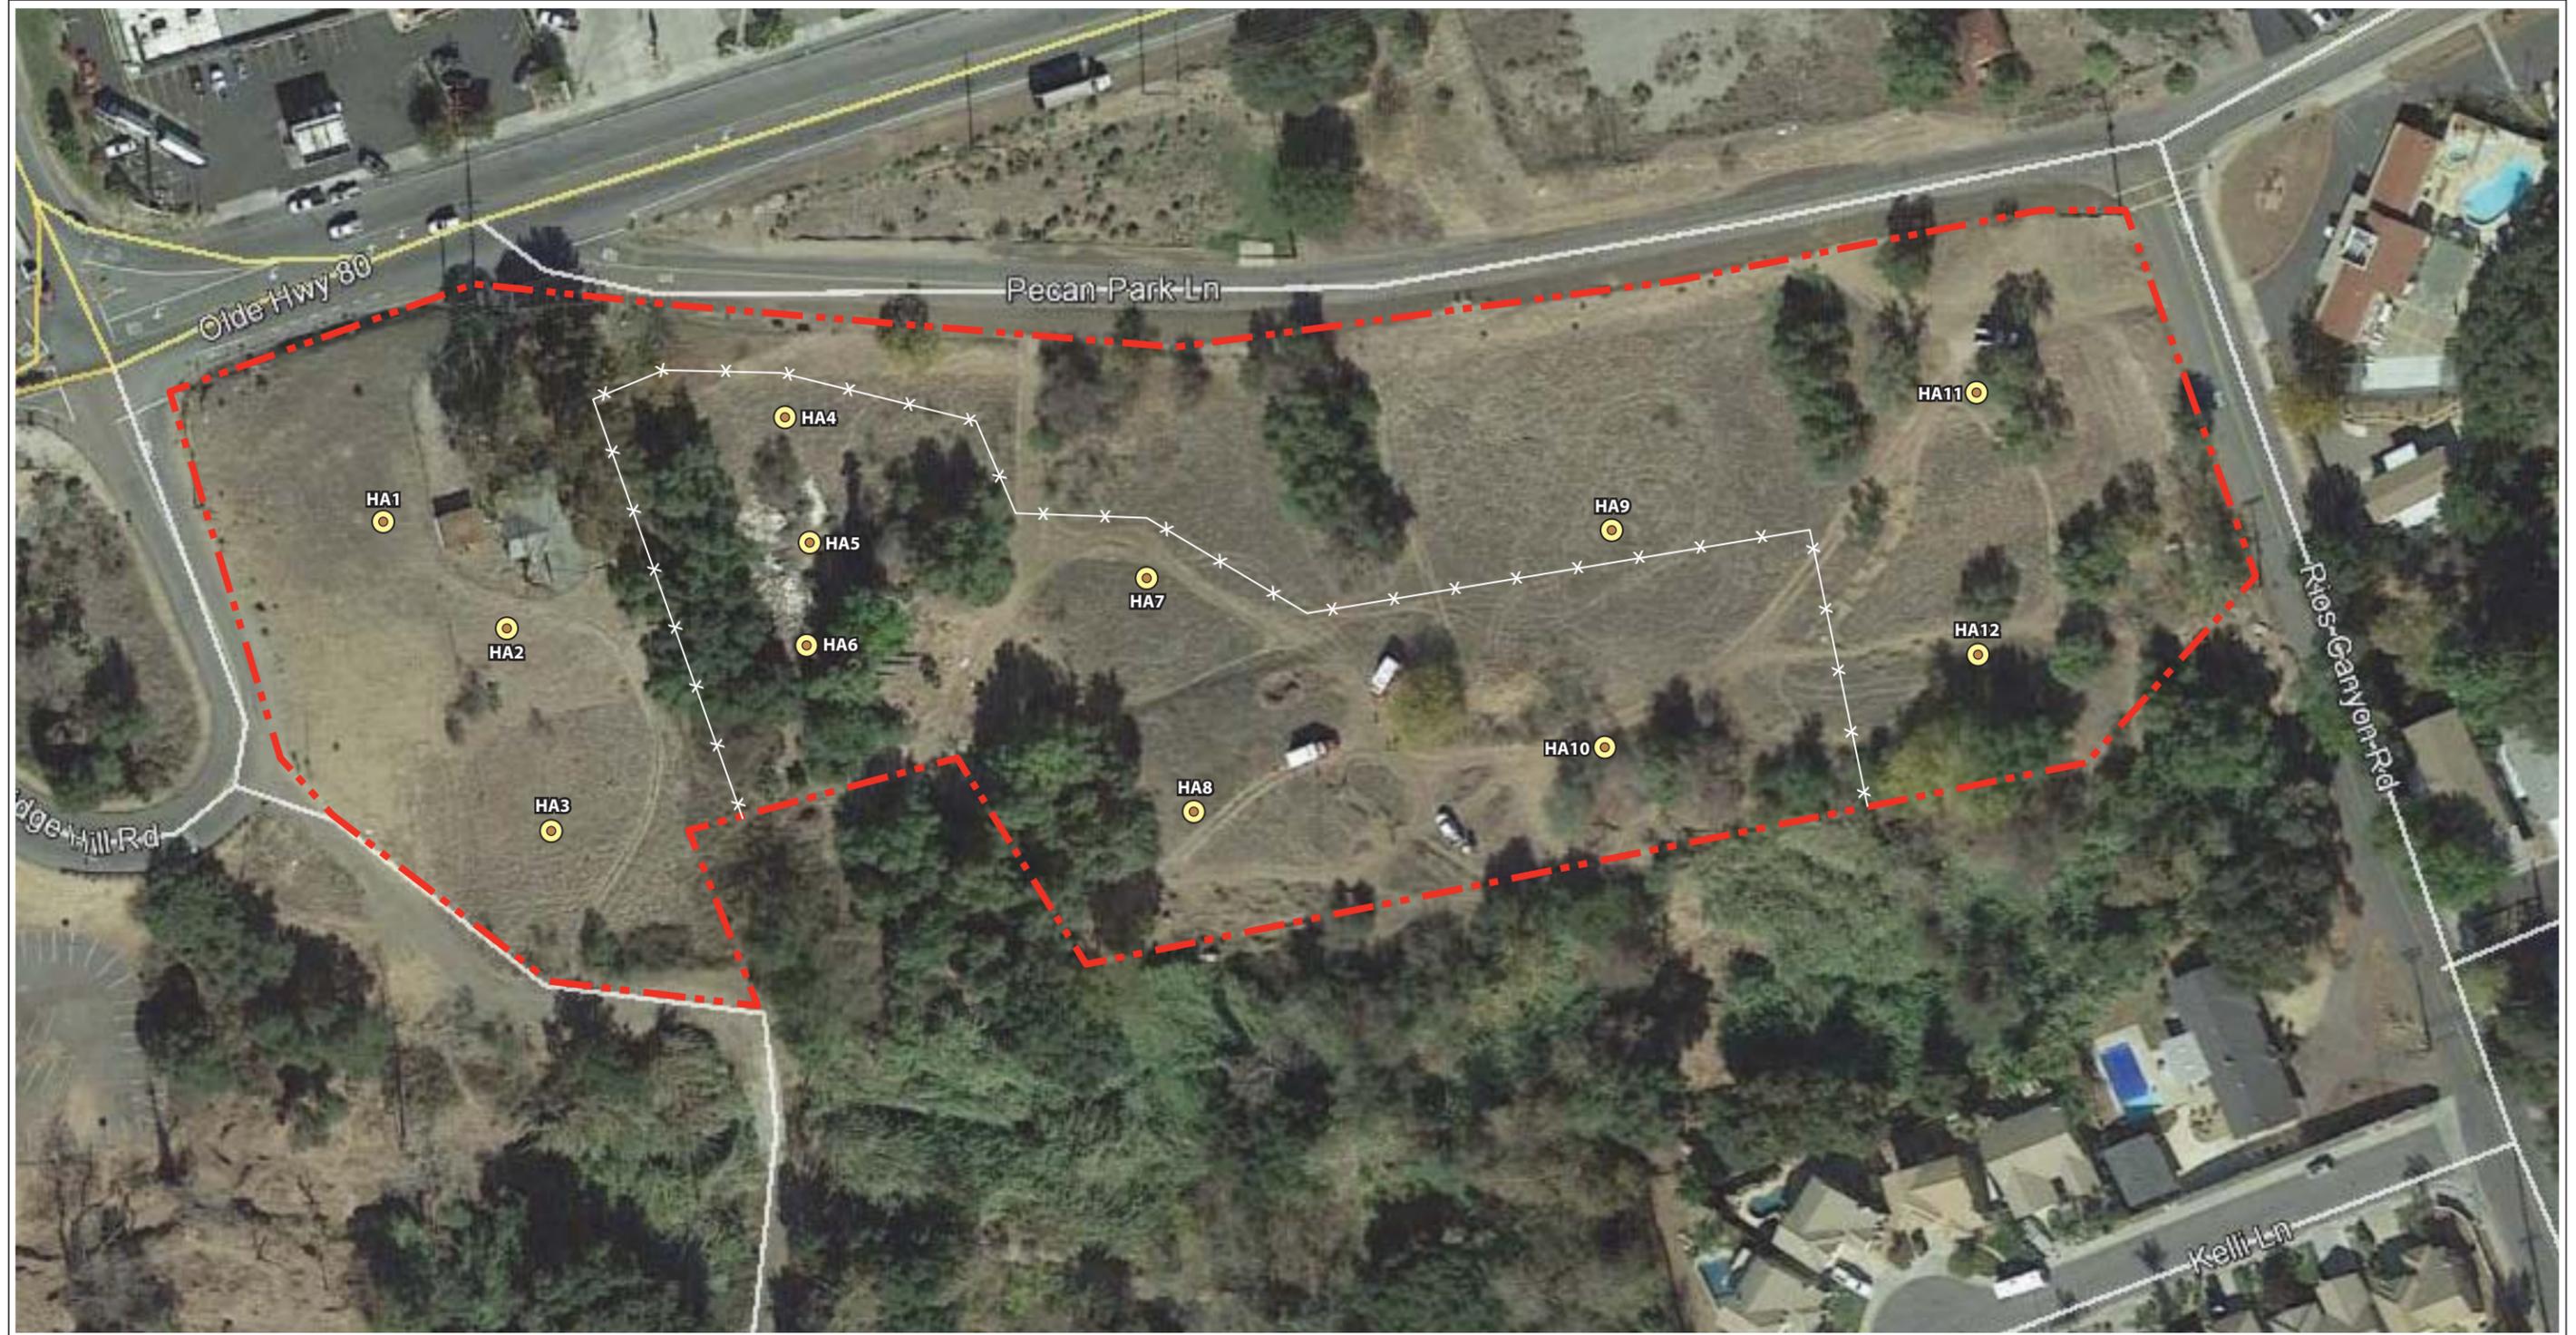
Figure 2

On October 13, 2014, SCS advanced 12 soil borings with the use of a hand auger, collecting samples at approximately 0.5 and 1.5 feet, to assess the extent of OCPs and arsenic in the shallow soil at the Site (Figure 2). The soil samples were placed directly from the hand auger into 4-ounce glass jars. The jars were closed, labeled, and placed in an ice-filled cooler for shipment to the laboratory. Chain-of-custody procedures were implemented for sample tracking.

- Approximate sampling area
- x x Fence
- Hand auger borings advanced by SCS on October 13, 2014

SITE PLAN WITH SOIL SAMPLING LOCATIONS

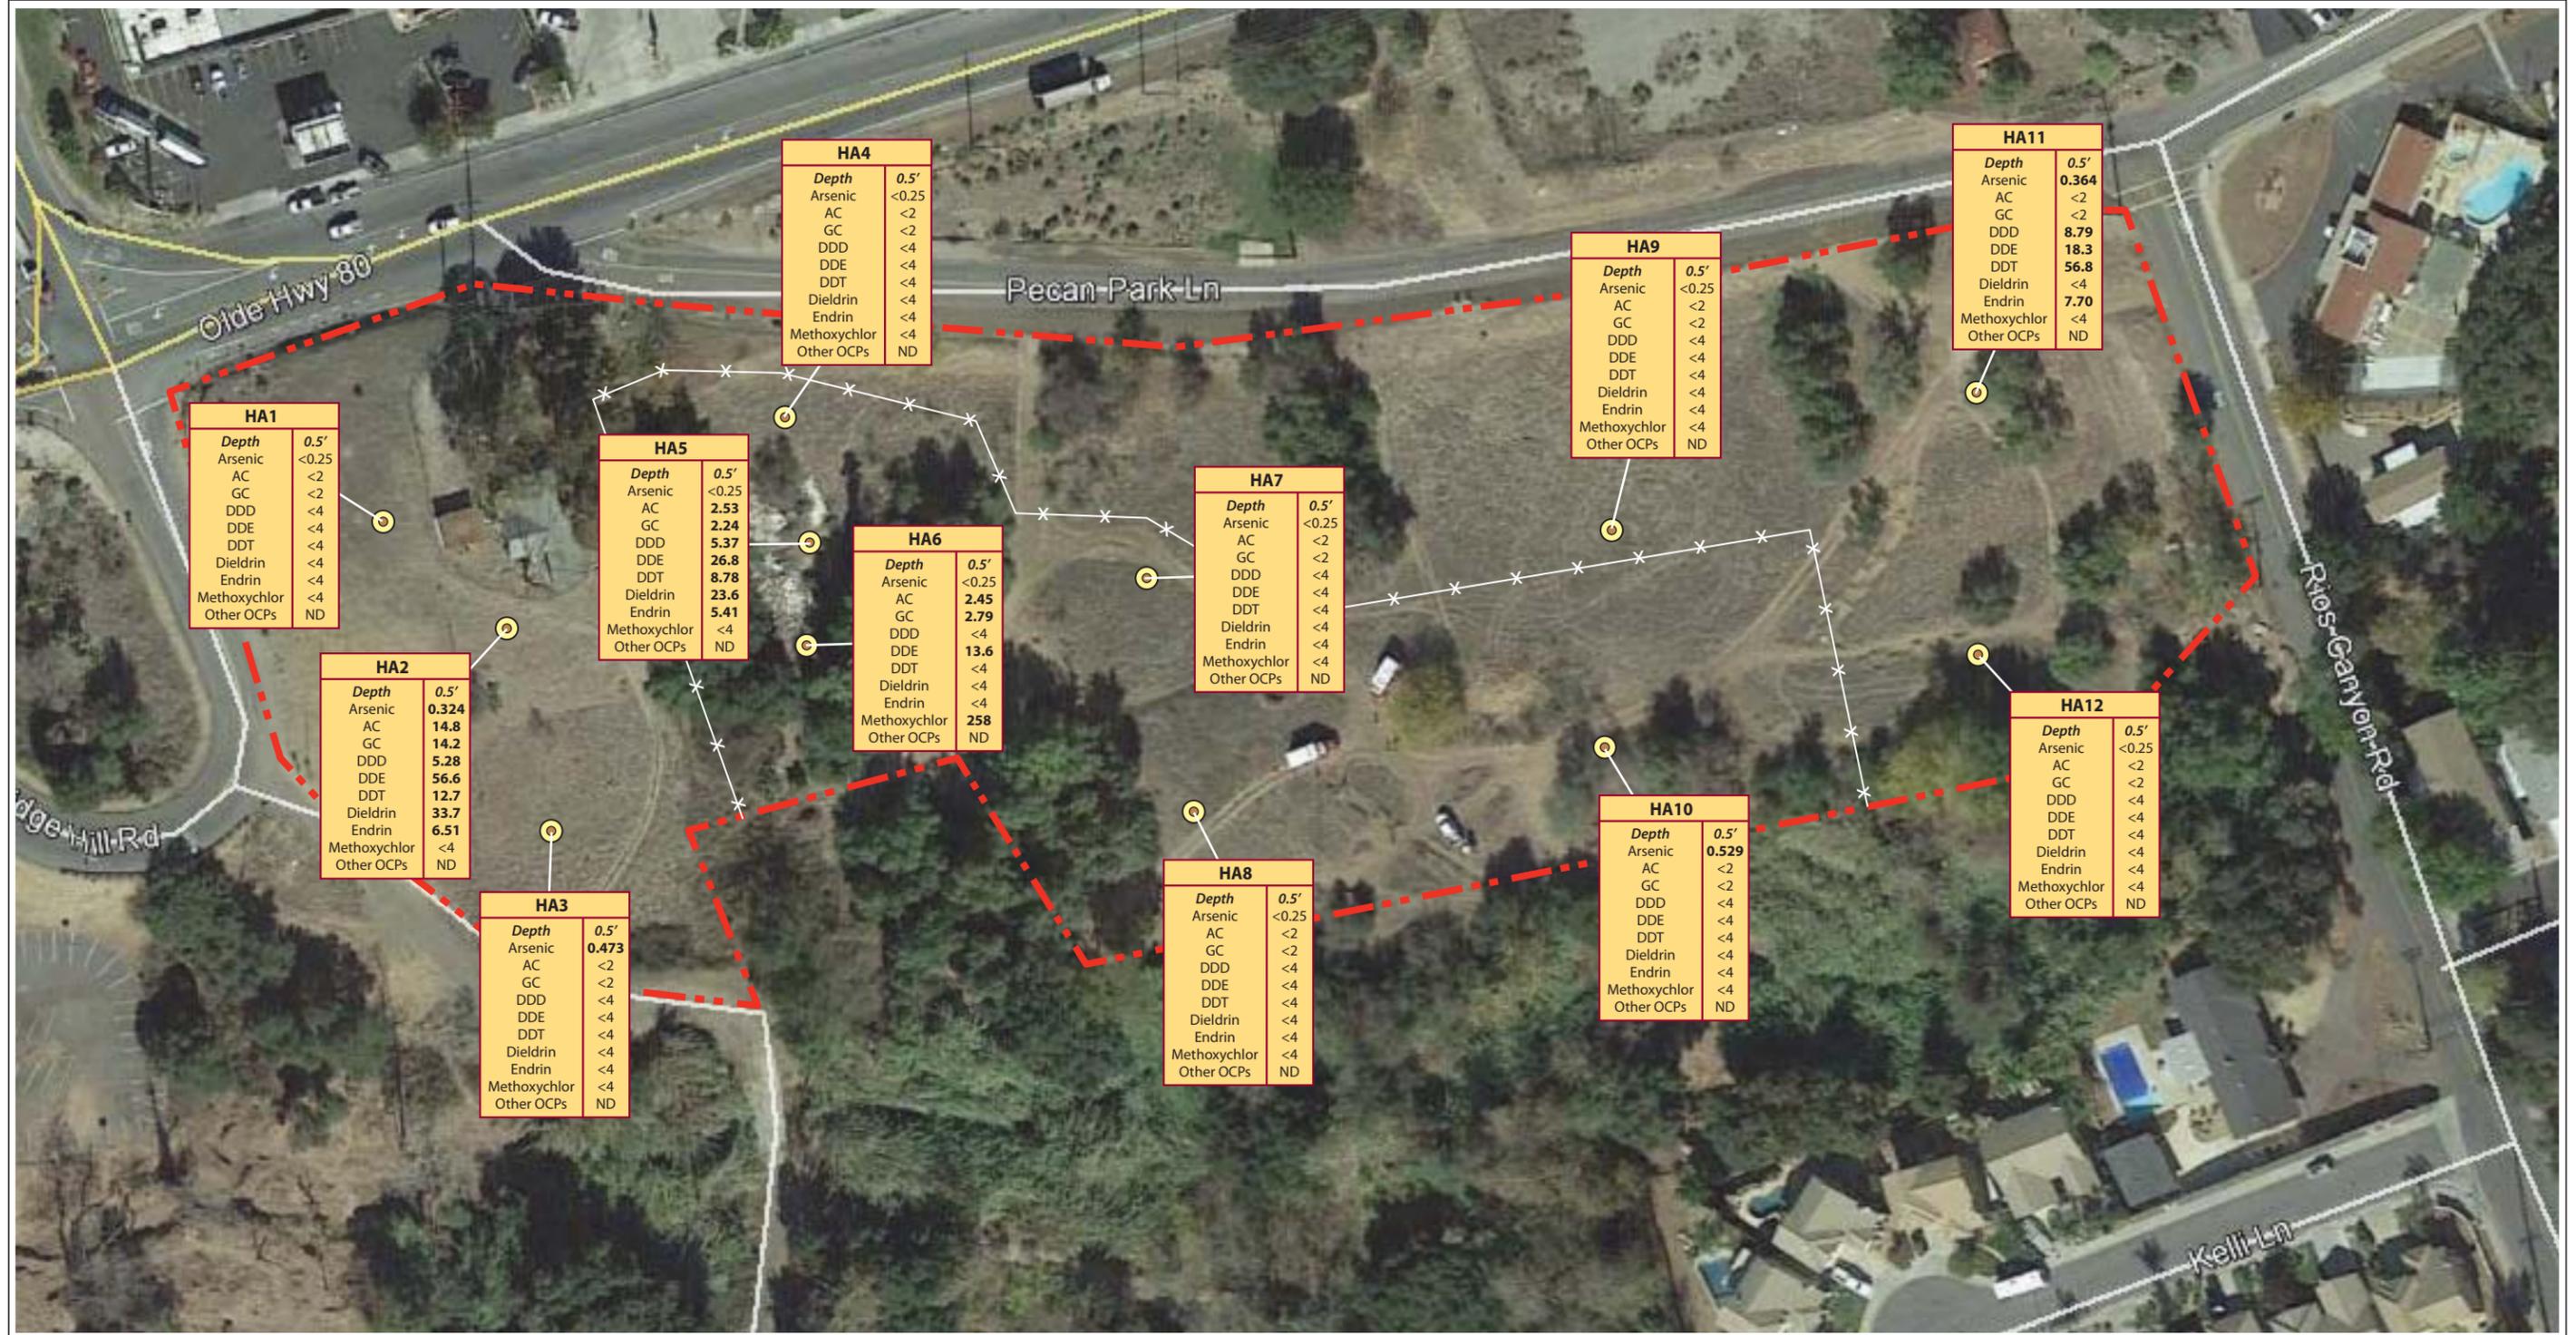
Figure 3

HA11	
Depth	0.5'
Arsenic	0.364
AC	<2
GC	<2
DDD	8.79
DDE	18.3
DDT	56.8
Dieldrin	<4
Endrin	7.70
Methoxychlor	<4
Other OCPs	ND

Soil samples, with depth in feet below grade, analyzed for arsenic by EPA Method 6010B with results reported in milligrams per kilogram (mg/kg); organochlorine pesticides (OCP) by EPA Method 8081A with results reported in micrograms per kilogram (µg/kg). **Bold** numbers indicate sample results above the laboratory reporting limit. < indicates results less than the laboratory reporting limit; number indicates individual analyte reporting limit.

AC = Alpha-chlordane
 GC = Gamma-chlordane
 DDD = 4,4-dichlorodiphenyldichloroethane
 DDE = 4,4-dichlorodiphenyldichloroethylene
 DDT = 4,4-dichlorodiphenyltrichloroethane

SITE PLAN WITH SOIL SAMPLE ANALYTICAL RESULTS
 South Coast Development, LLC
 14109, 14135, and 14173 Olde Highway 80
 and 14207 Rios Canyon Road
 El Cajon, California

A summary of the laboratory results for arsenic and select OCPs from the soil samples analyzed are presented in Table 1 and depicted on Figure 3. A complete listing of the results of arsenic and OCPs analyzed are presented in Appendix B.
