Groundwater Resources Investigation Report Rugged Solar Farm Project

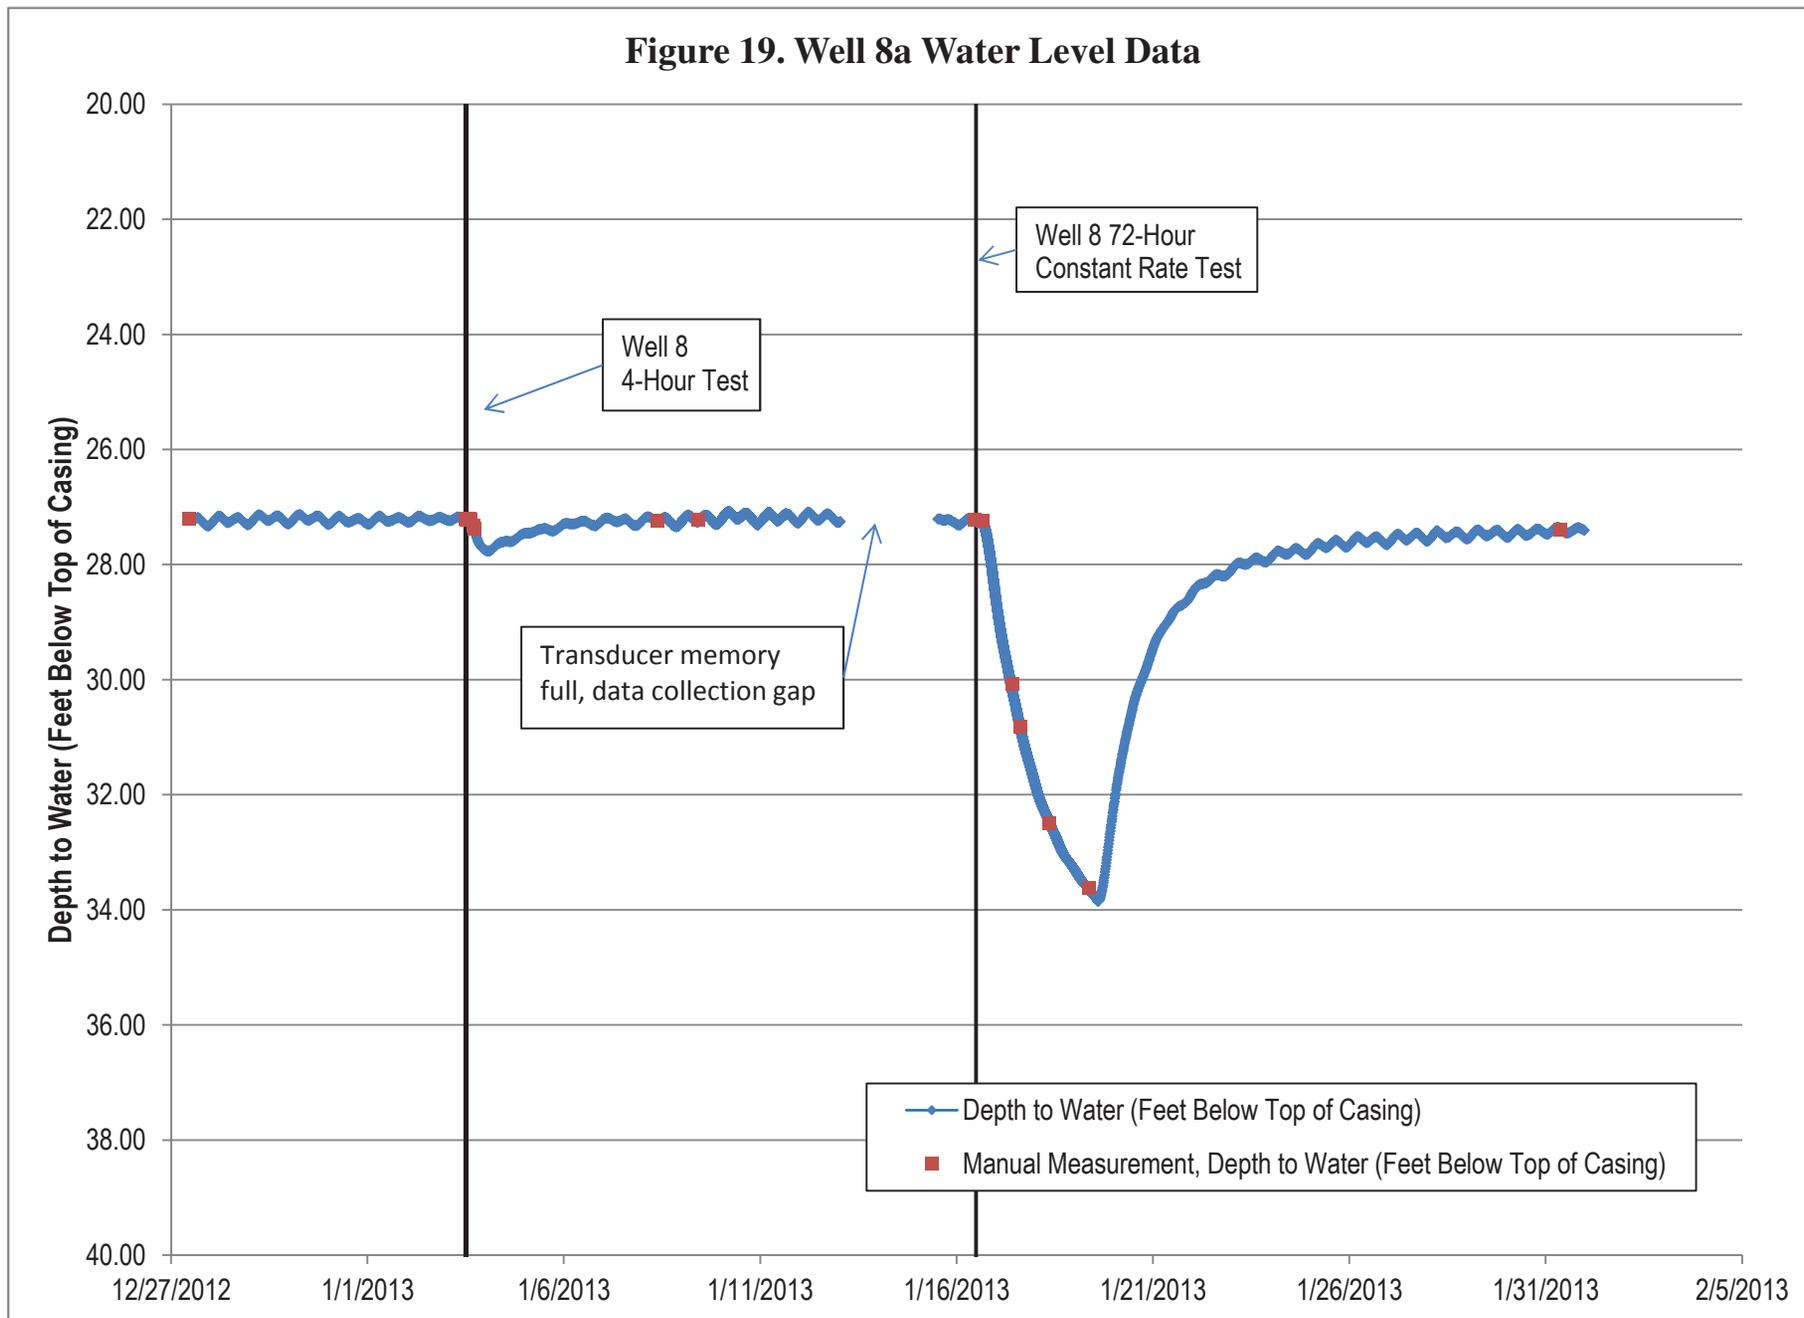
Figure 19. Well 8a Water Level Data

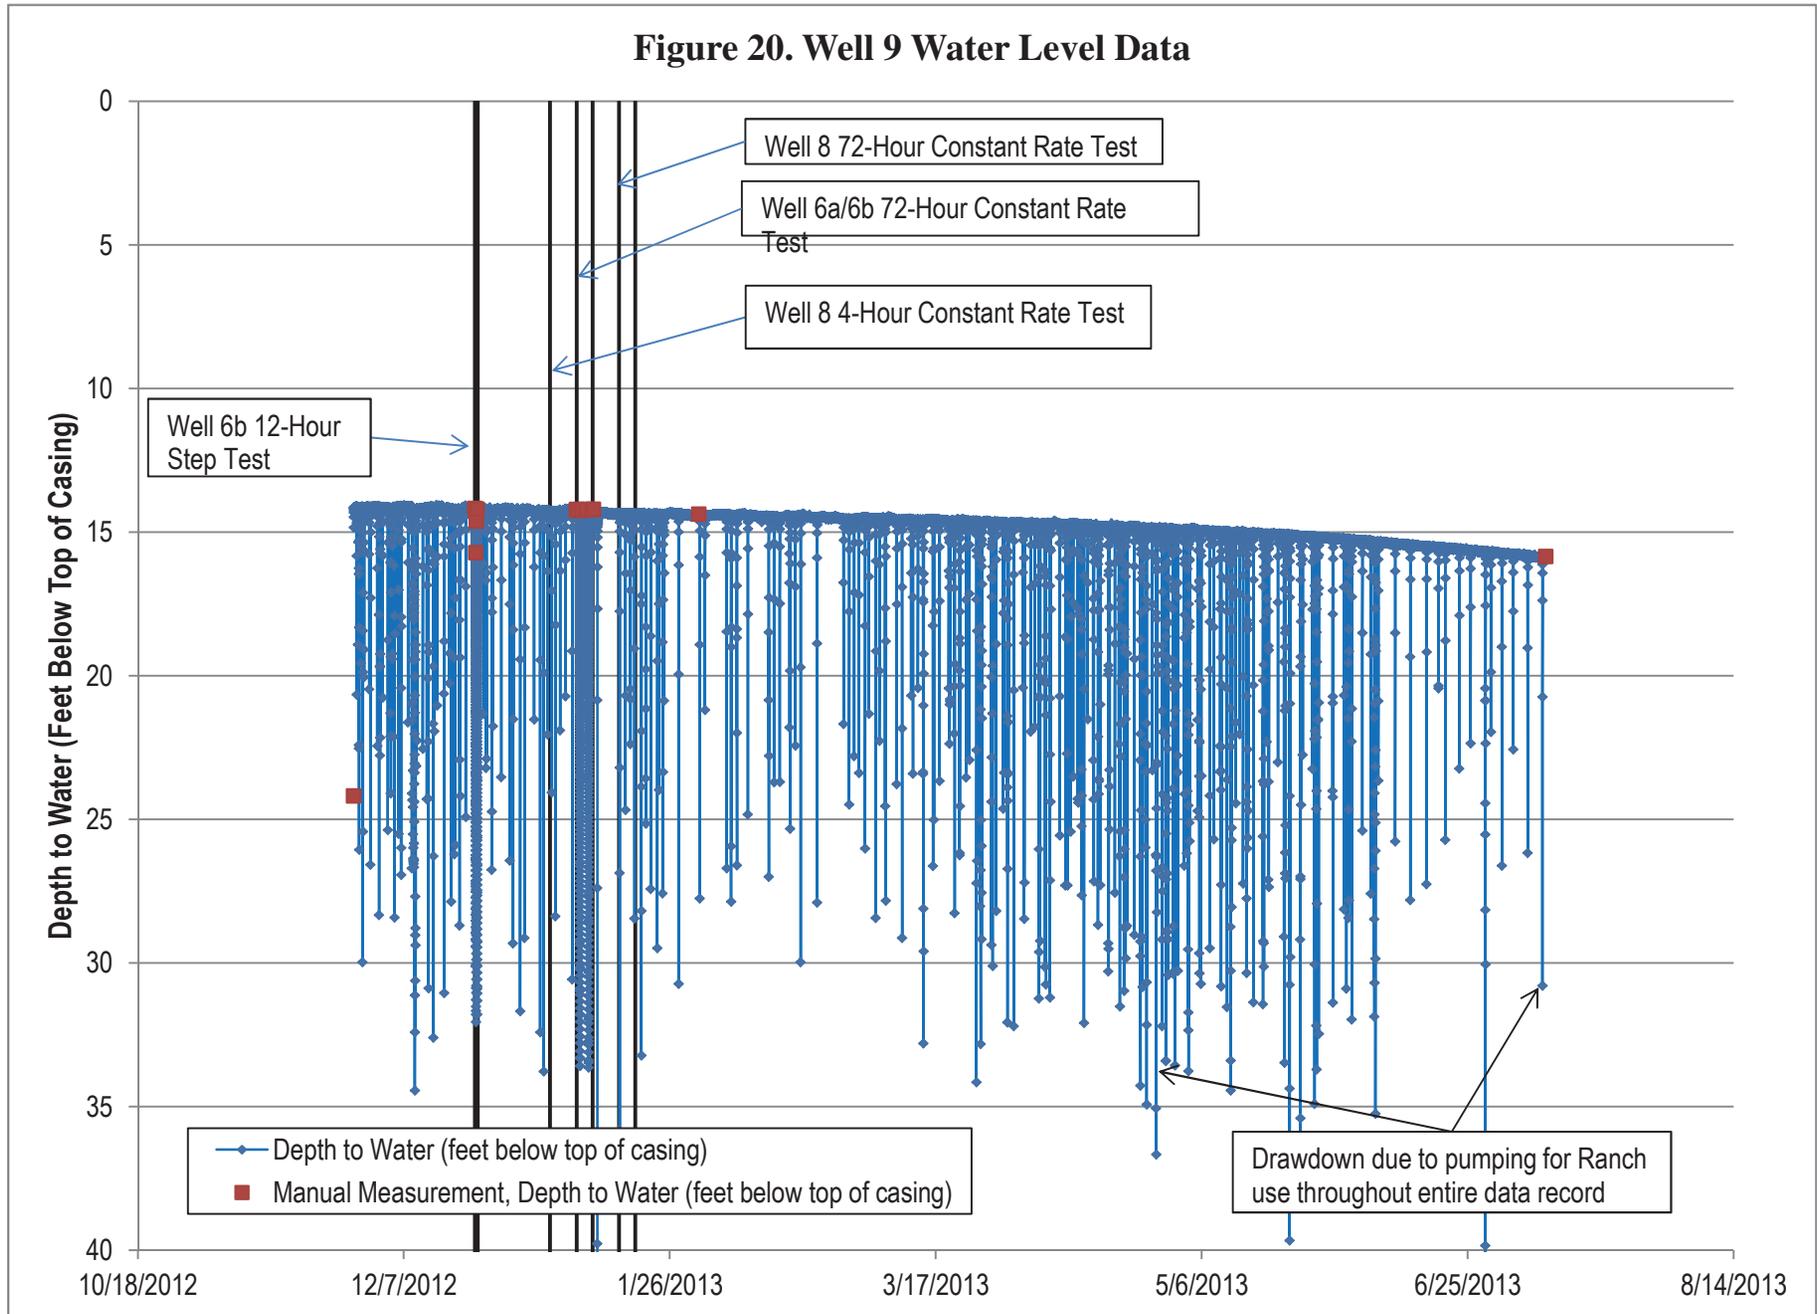
Figure 20. Well 9 Water Level Data

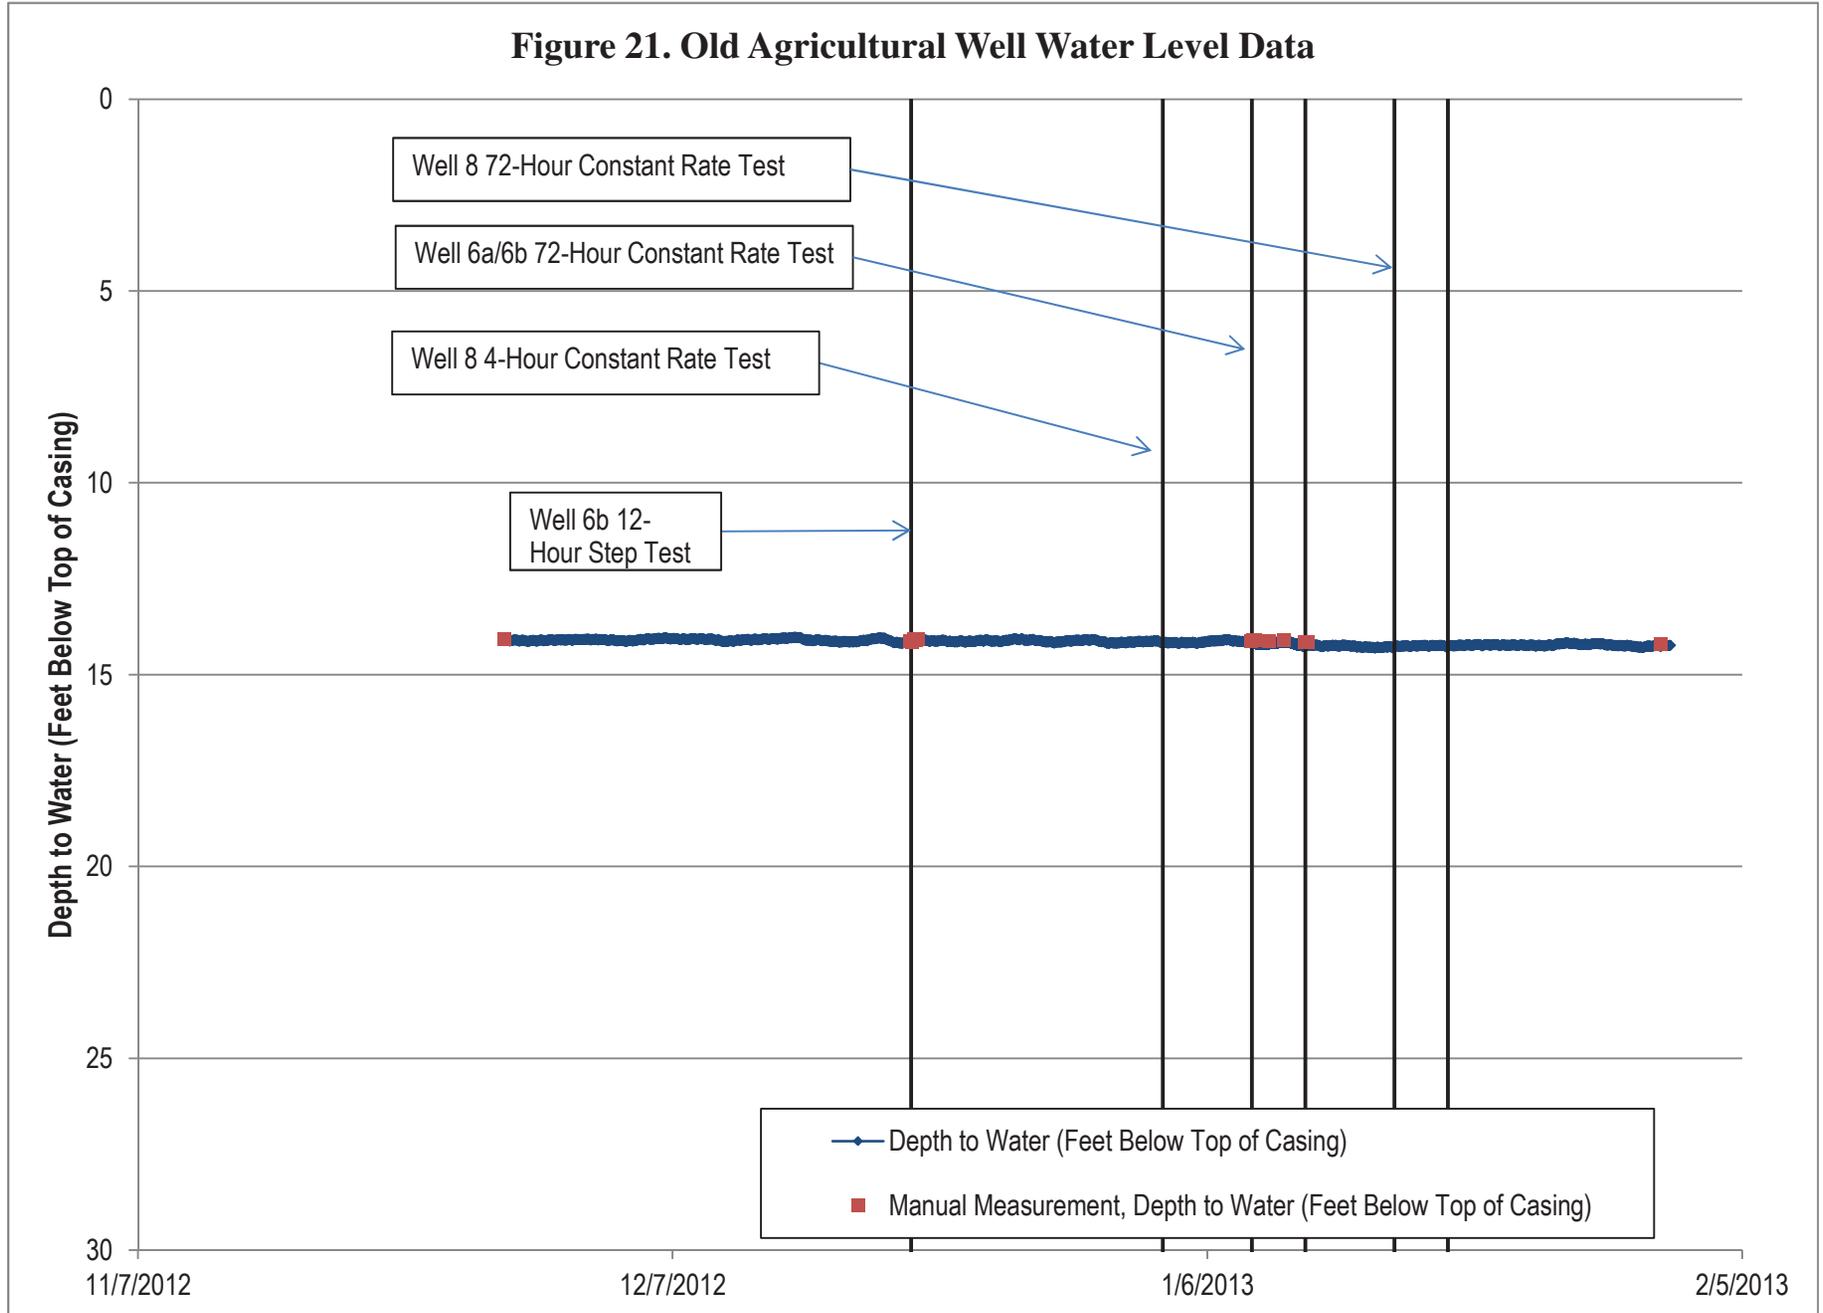
Figure 21. Old Agricultural Well Water Level Data

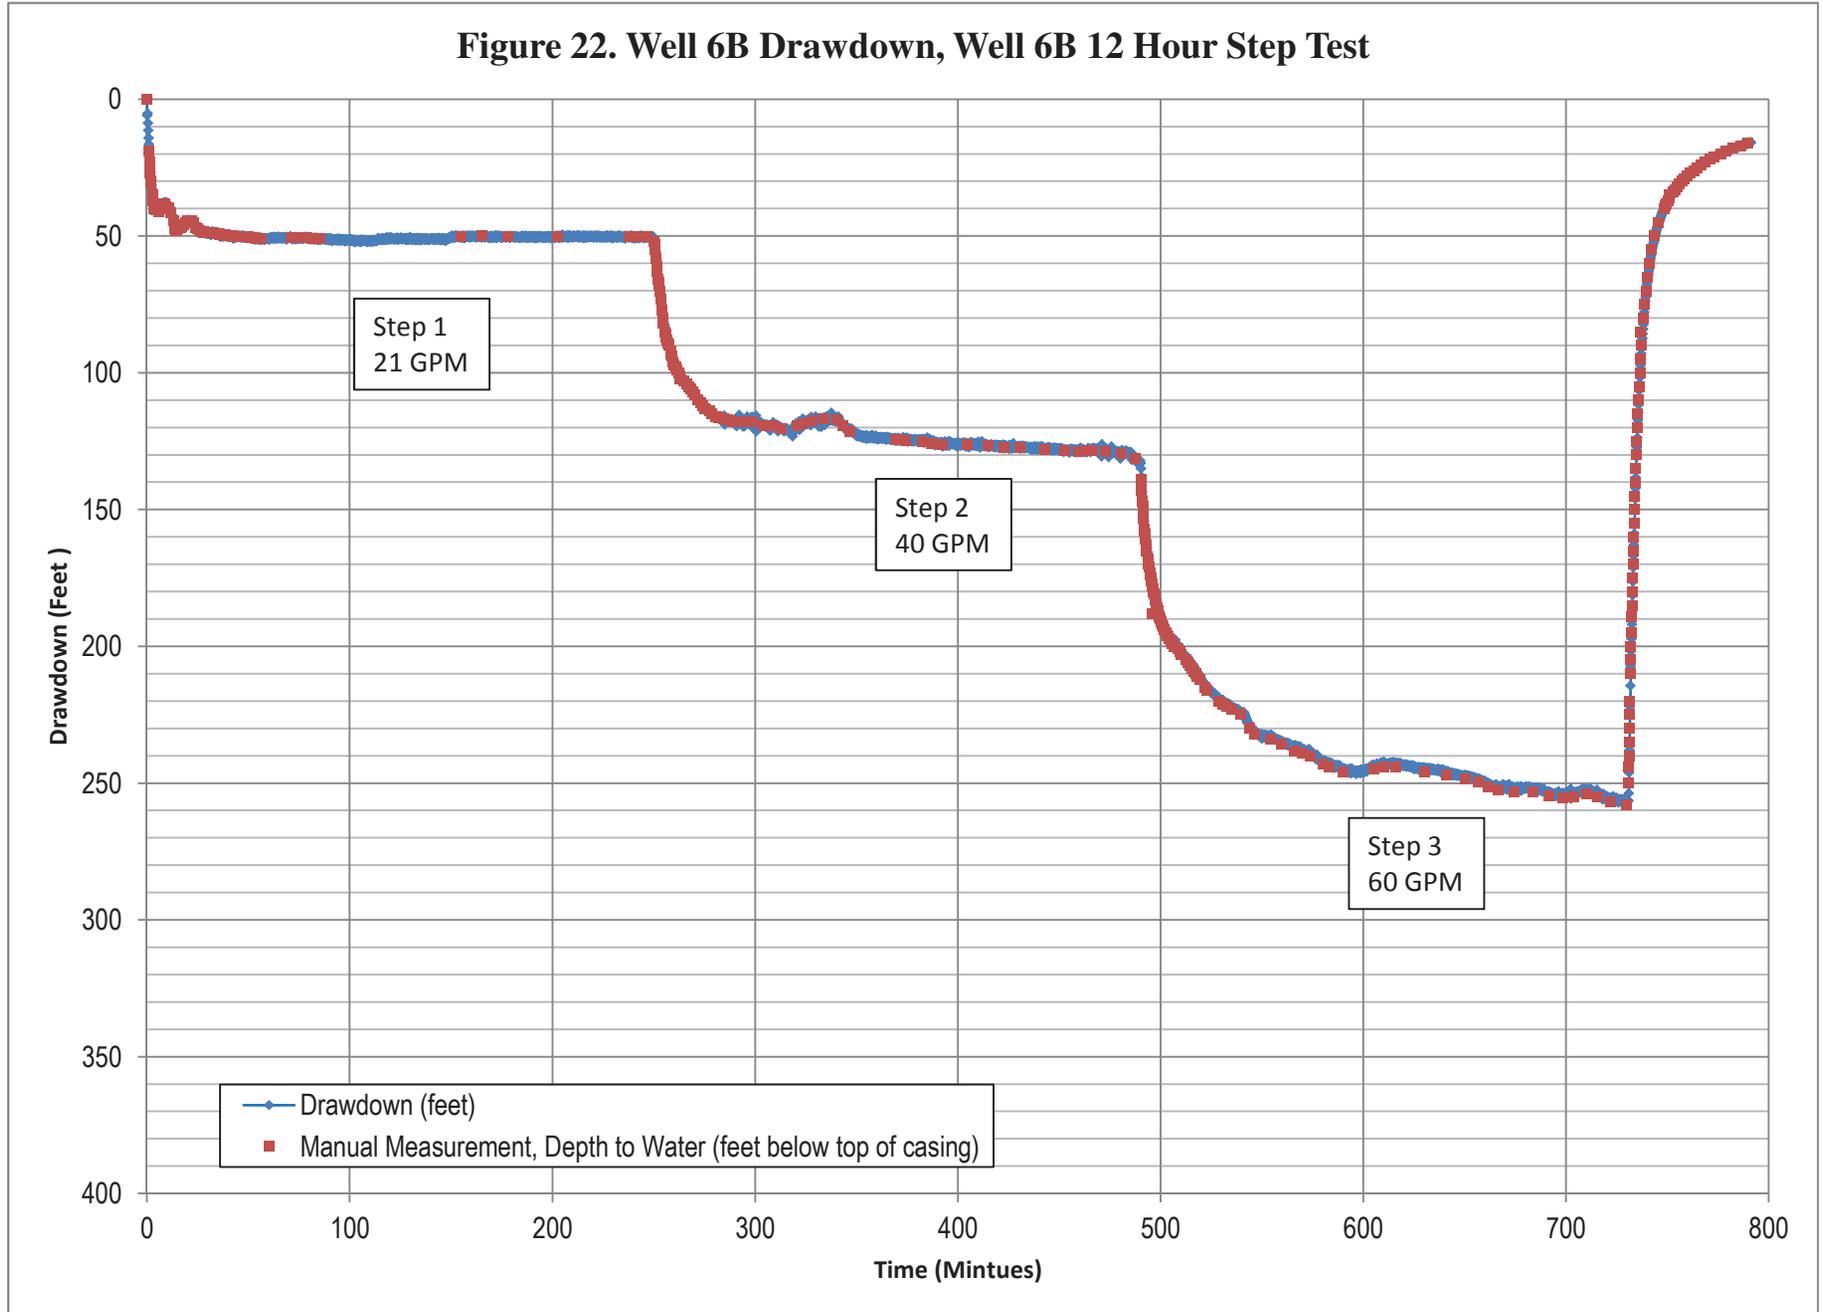
Figure 22. Well 6B Drawdown, Well 6B 12 Hour Step Test

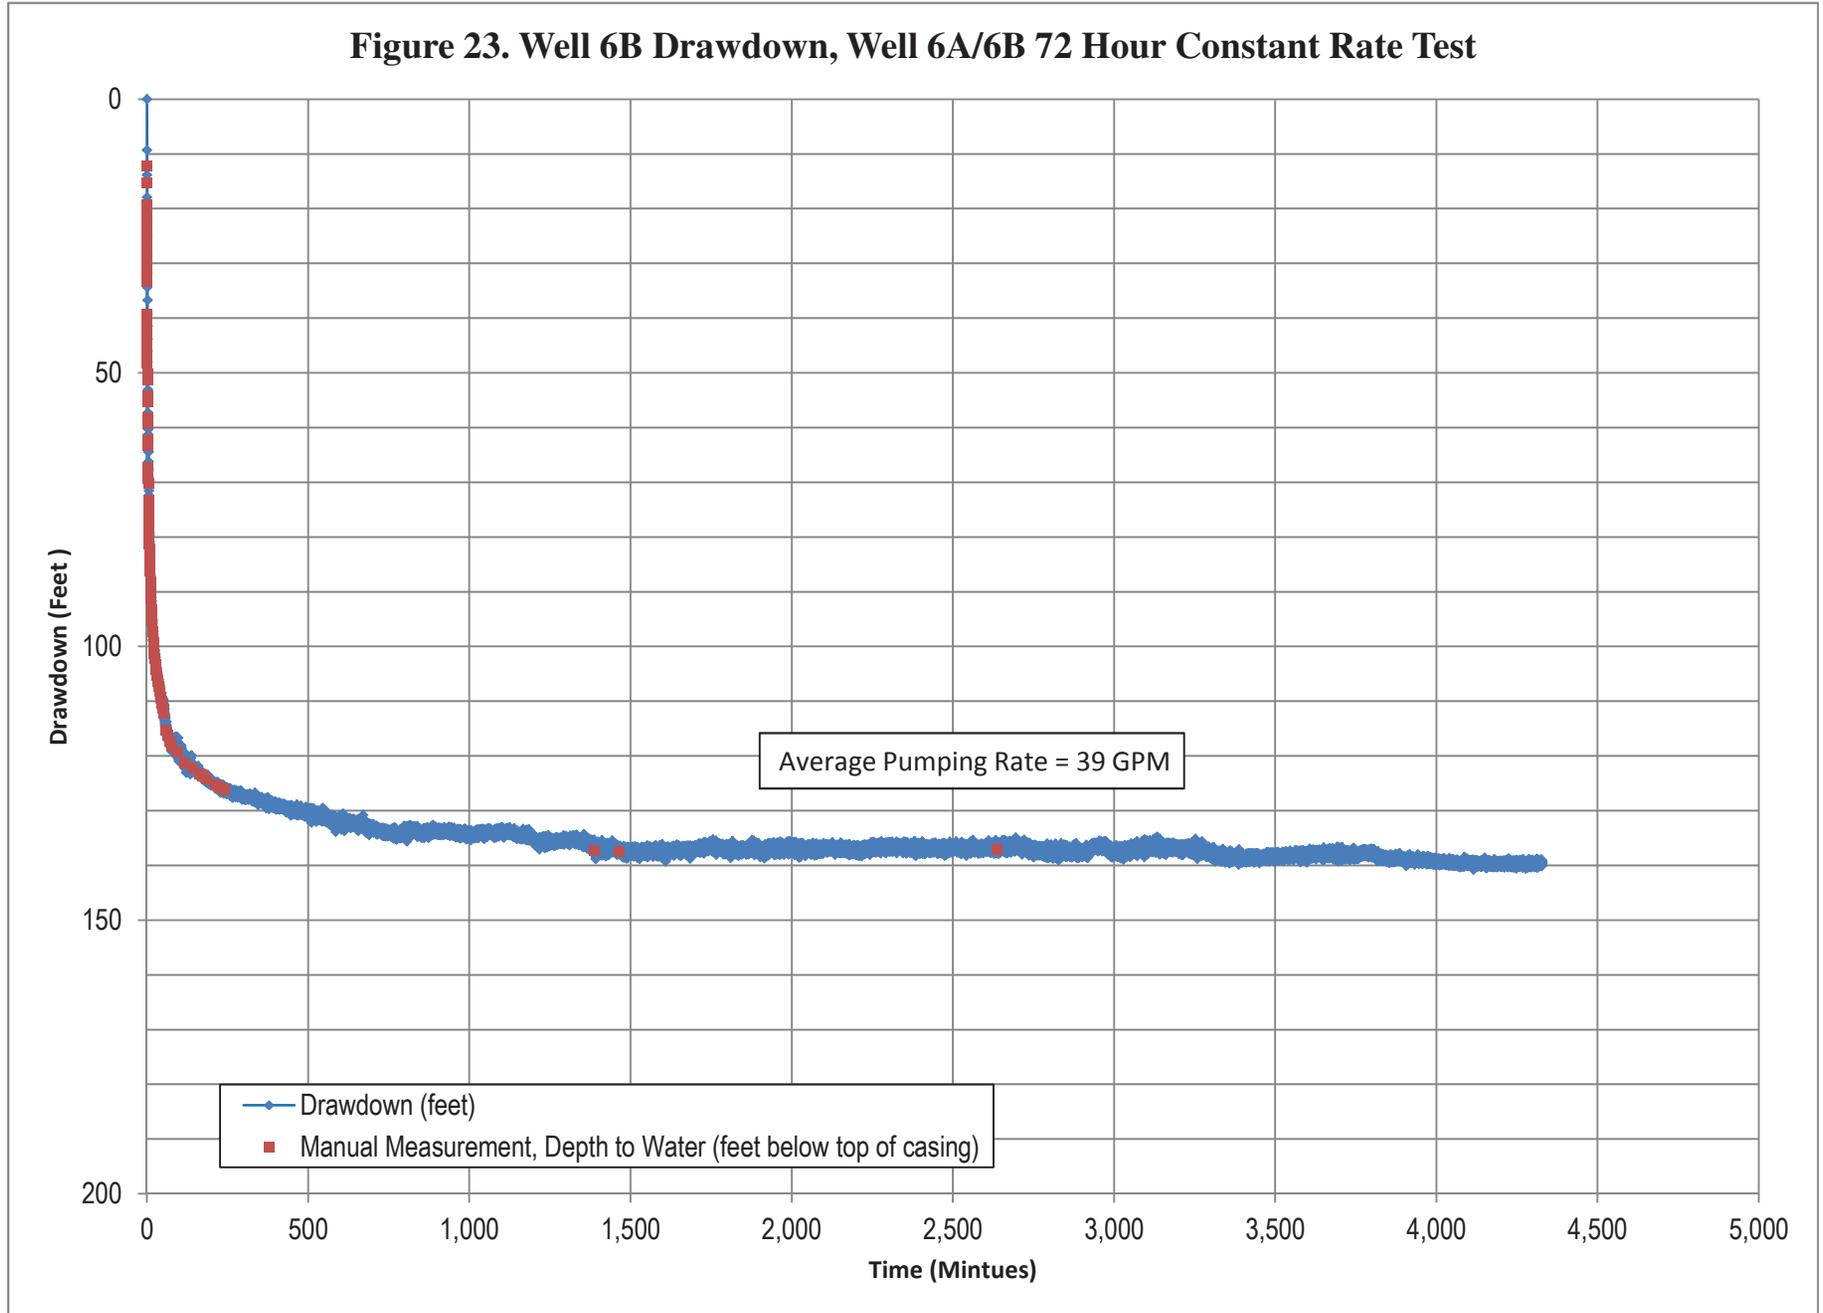
Figure 23. Well 6B Drawdown, Well 6A/6B 72 Hour Constant Rate Test

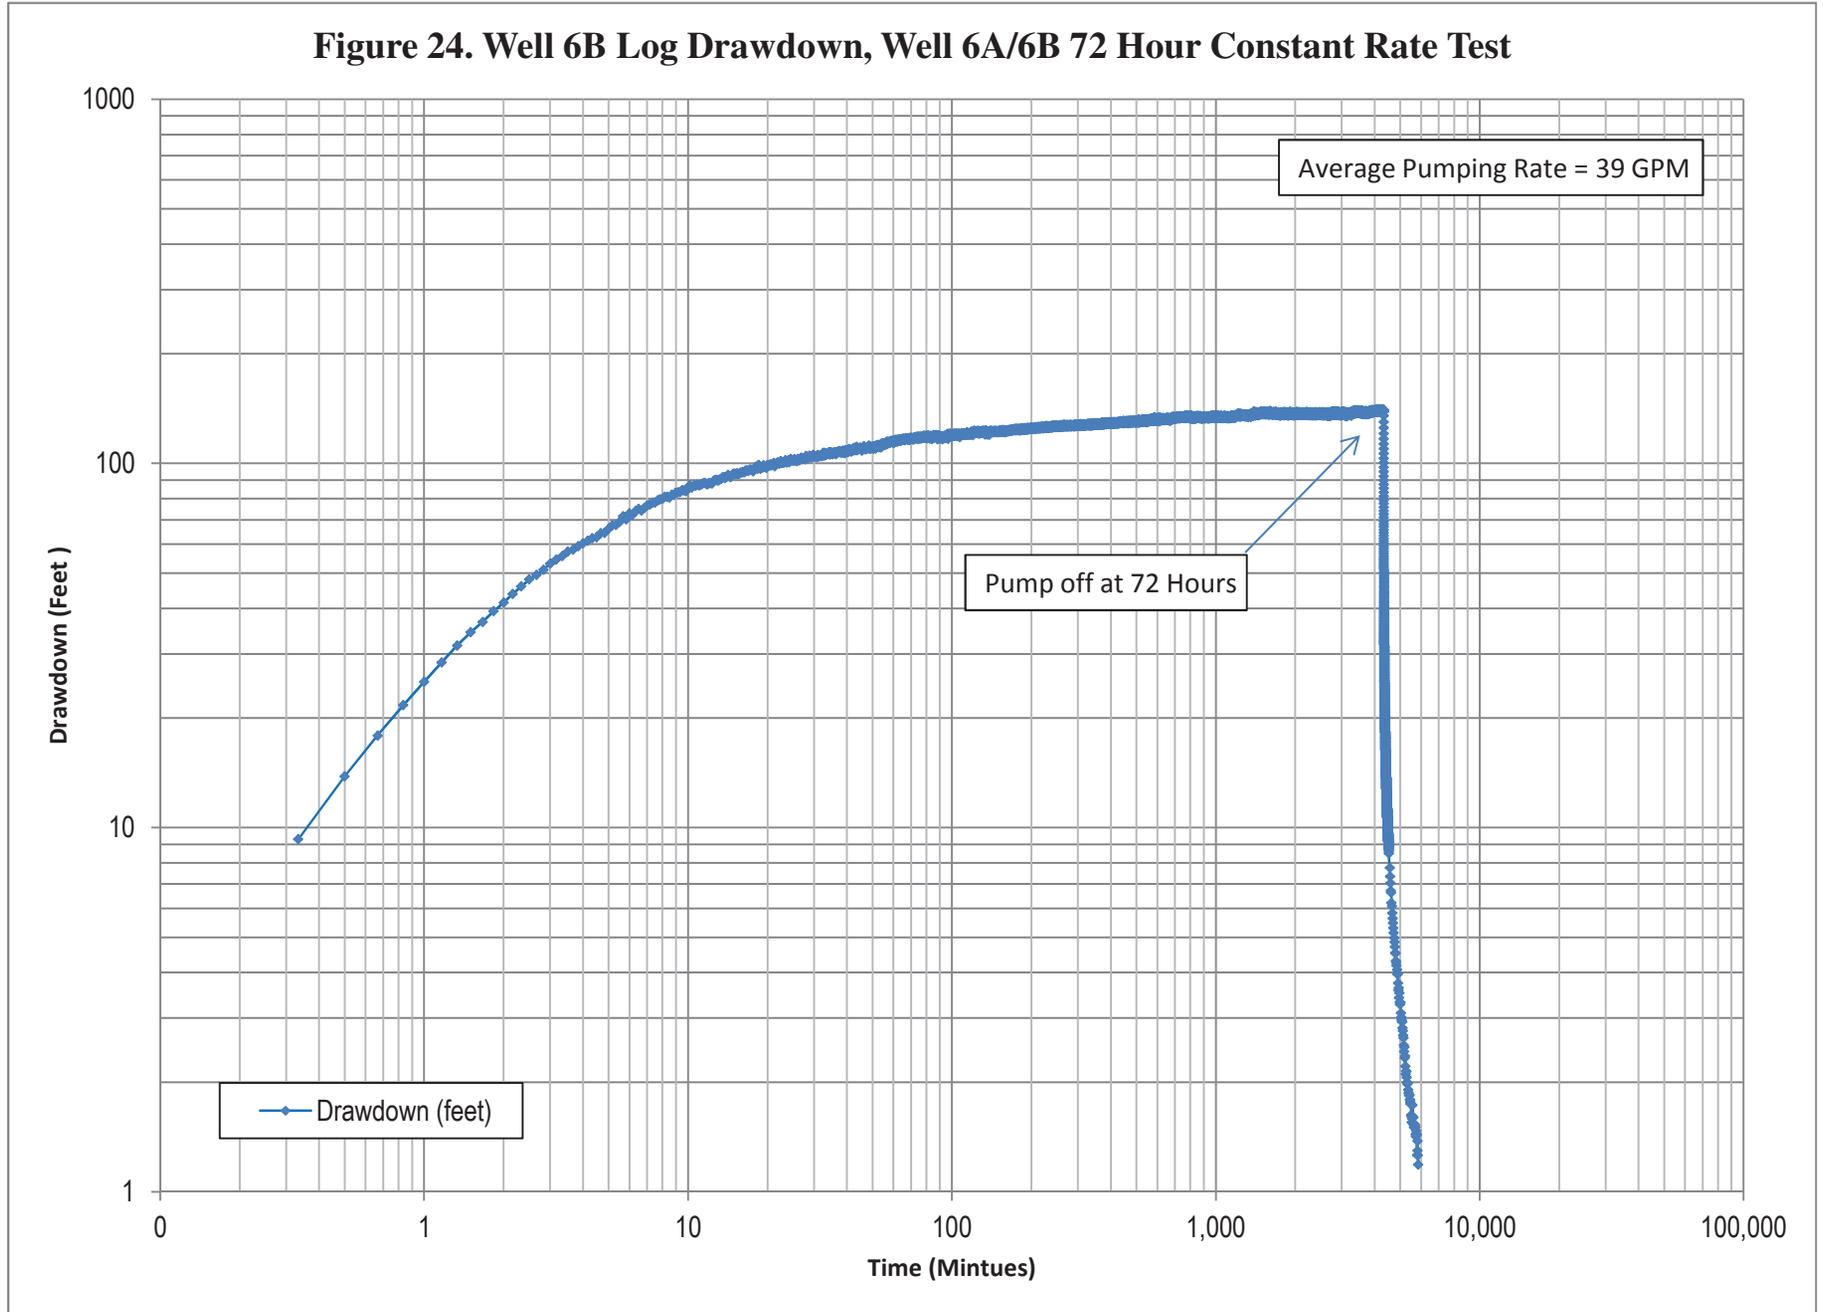
Figure 24. Well 6B Log Drawdown, Well 6A/6B 72 Hour Constant Rate Test

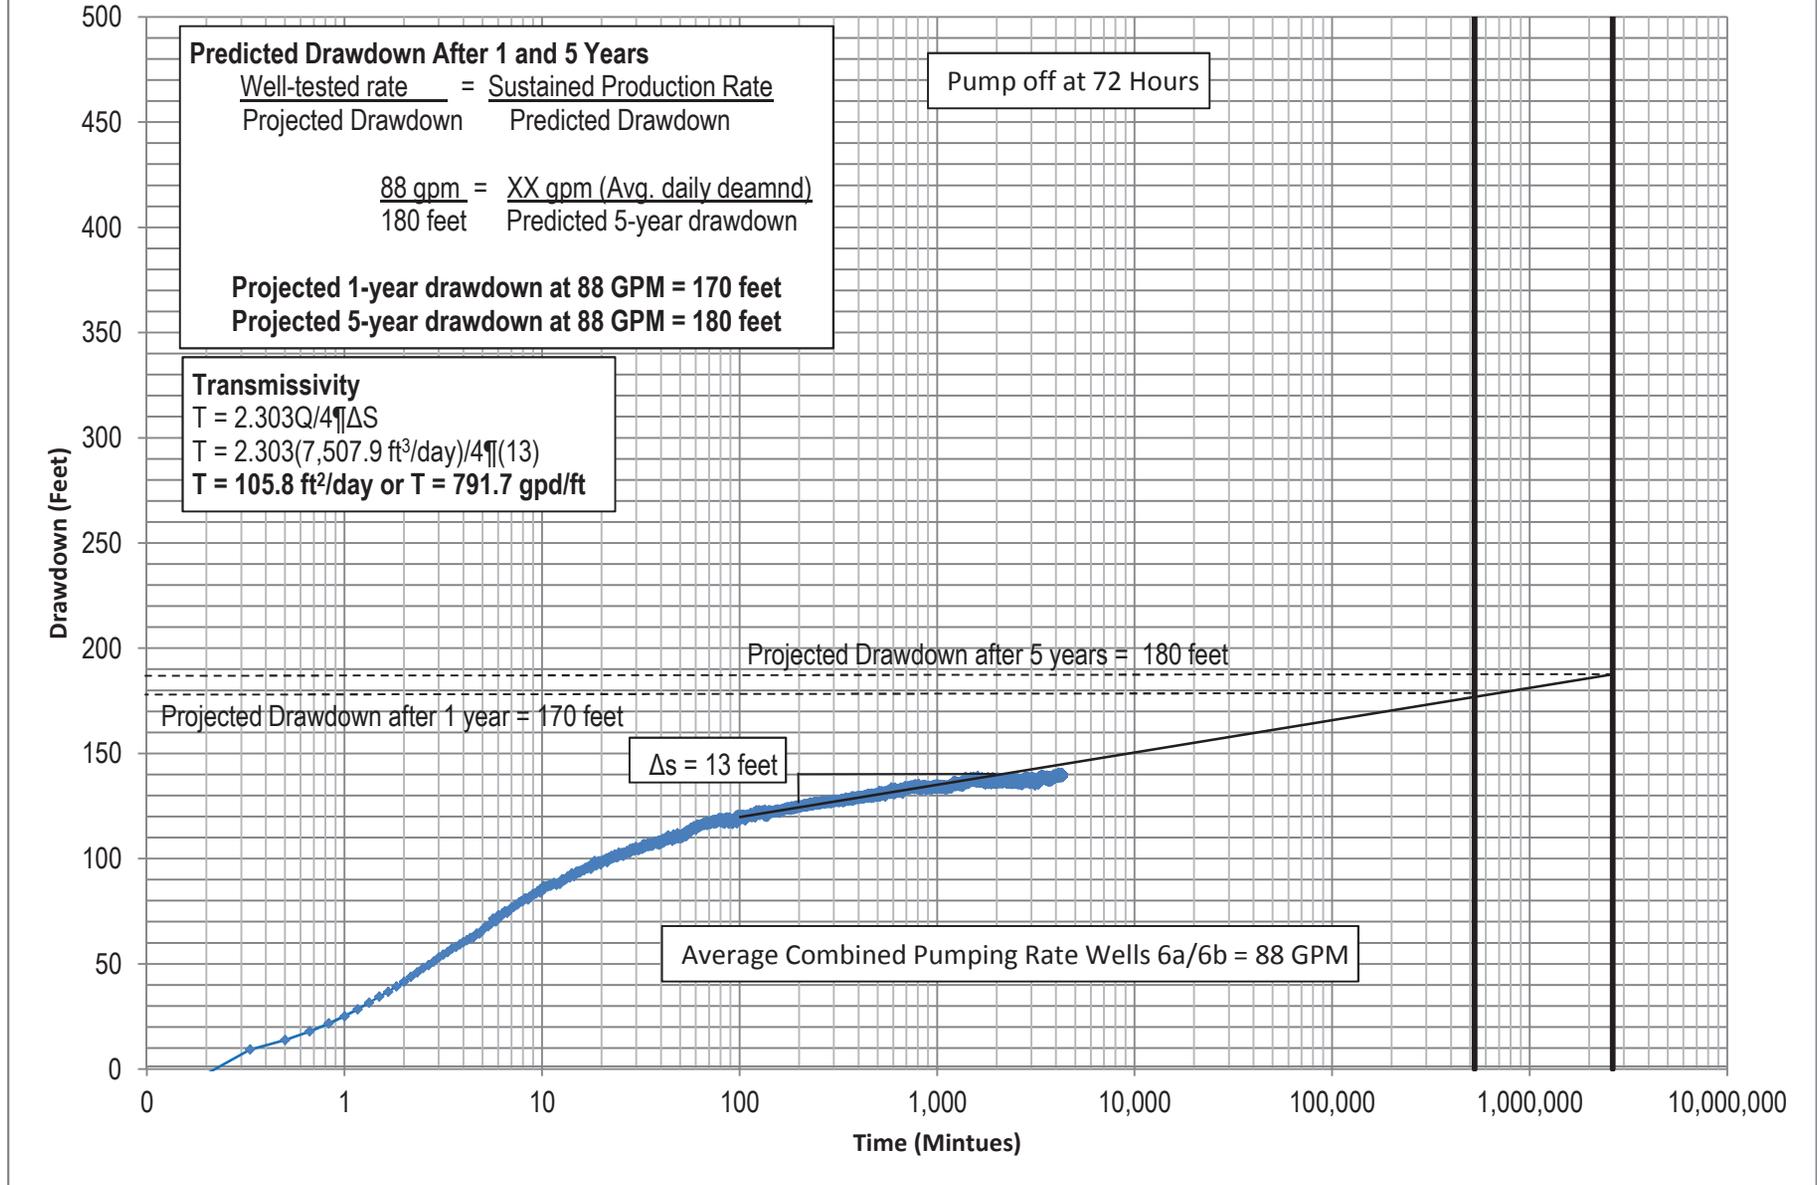
**Figure 25. Well 6B Cooper-Jacob Straight Line Test,
Well 6A/6B 72 Hour Constant Rate Test**

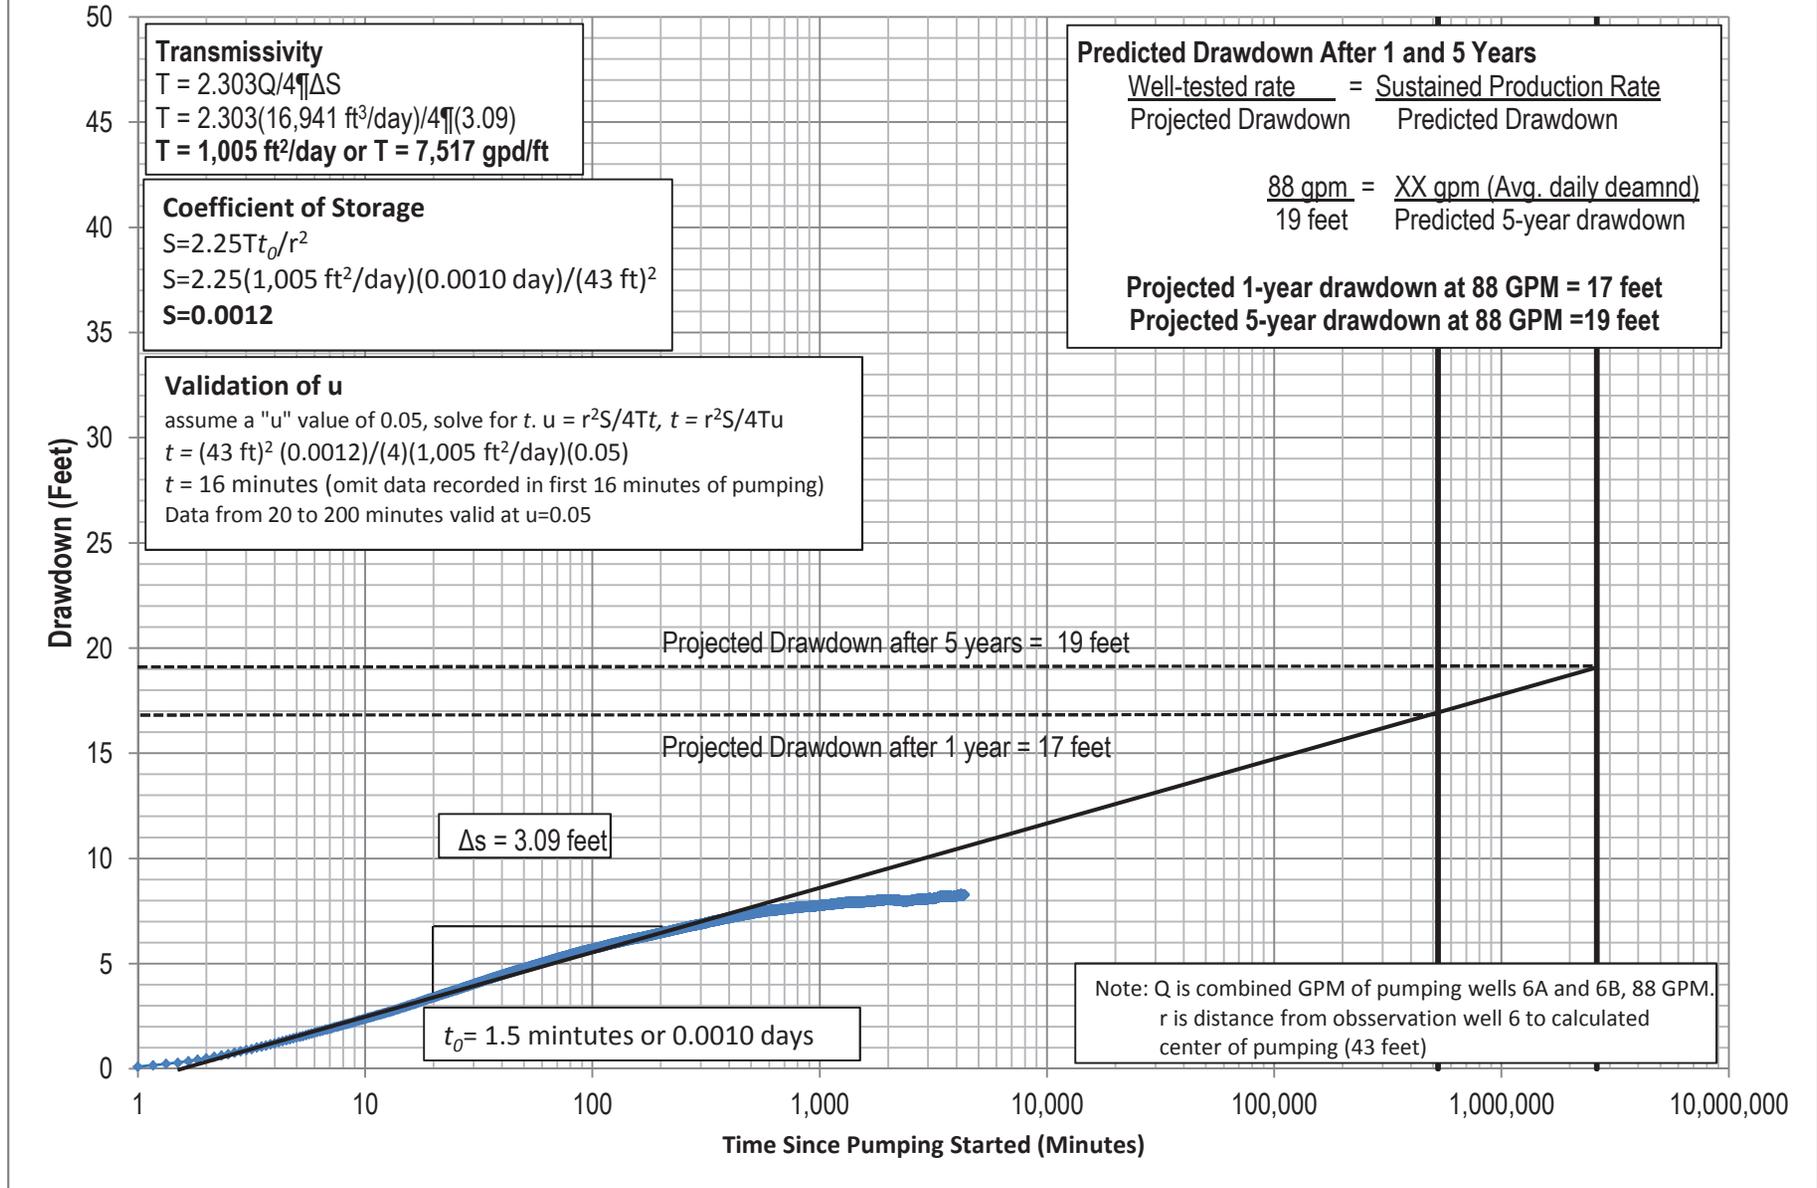
**Figure 26. Well 6 Cooper-Jacob Straight Line Test
Well 6A/6B 72 Hour Constant Rate Test**

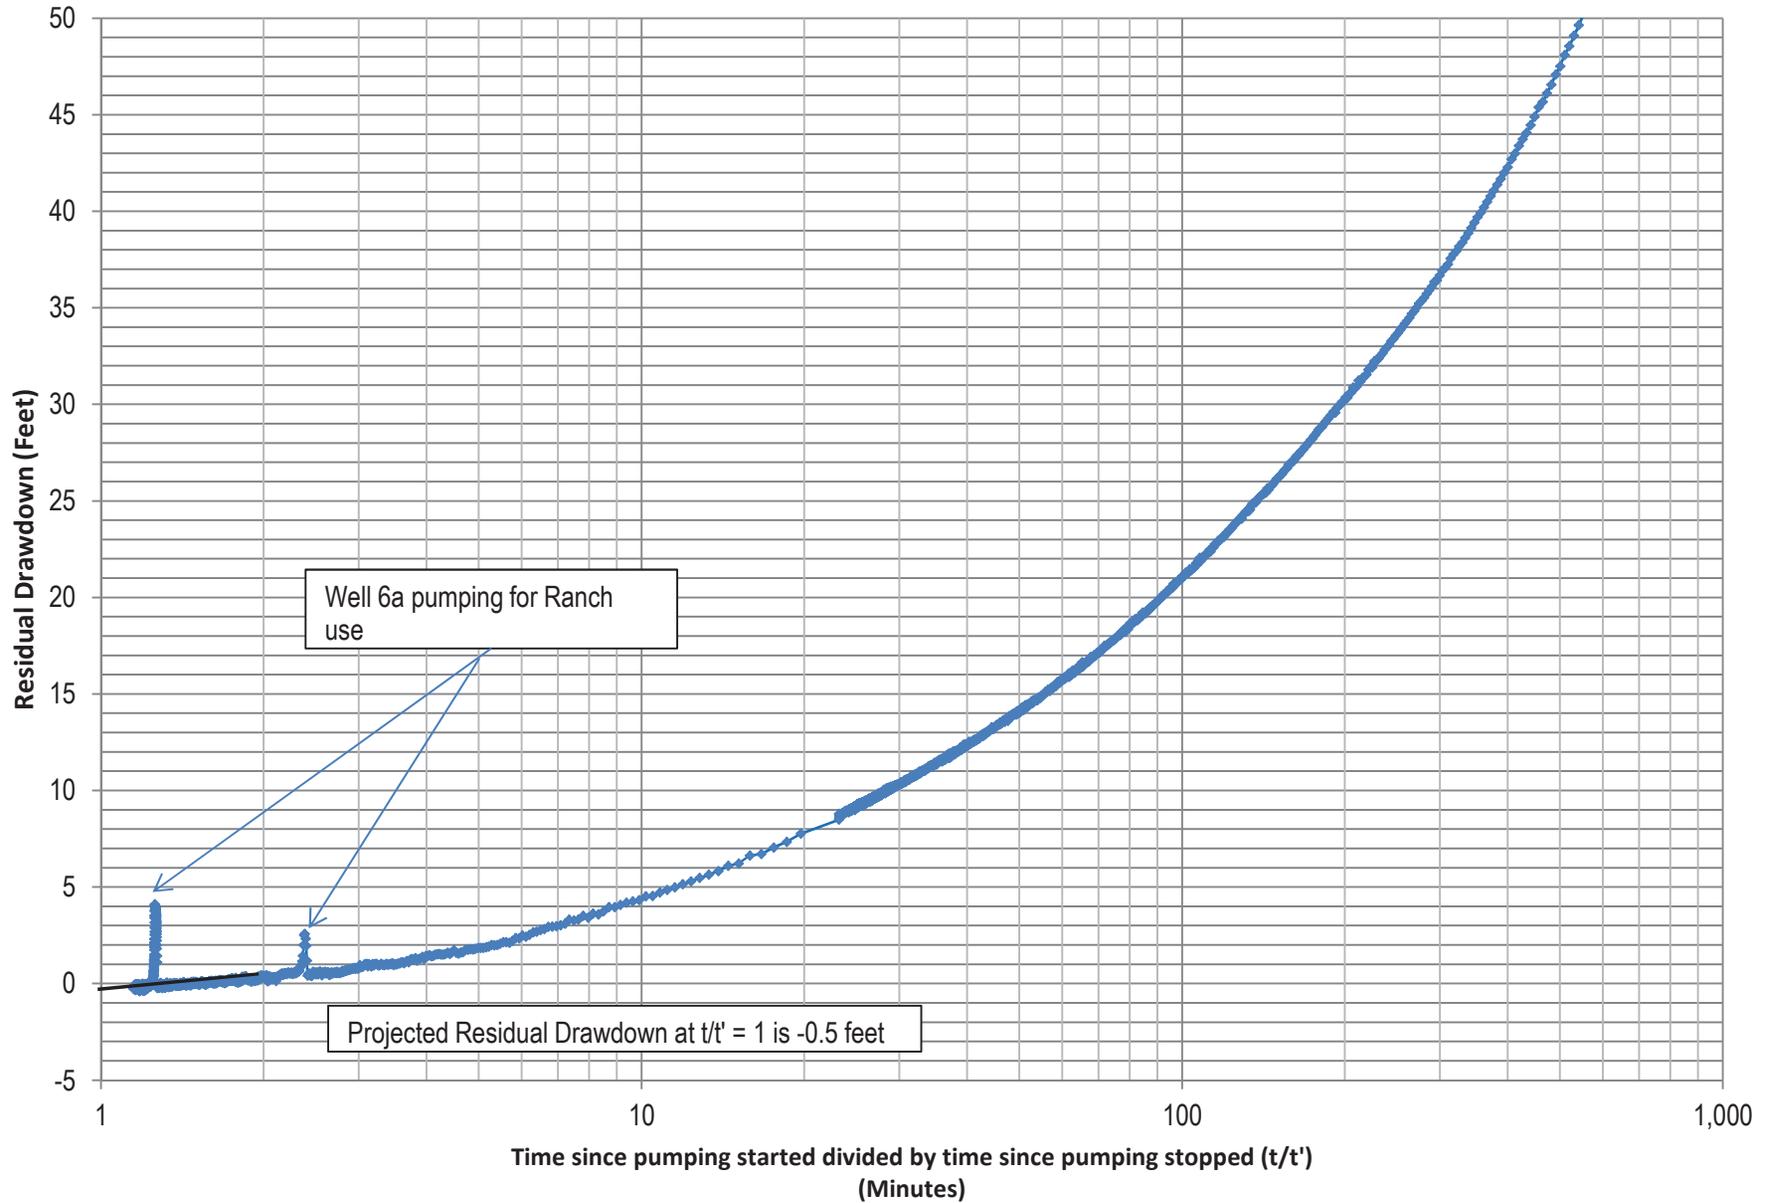
Figure 27. Well 6B Recovery Analysis, Well 6A/6B 72 Hour Constant Rate Test

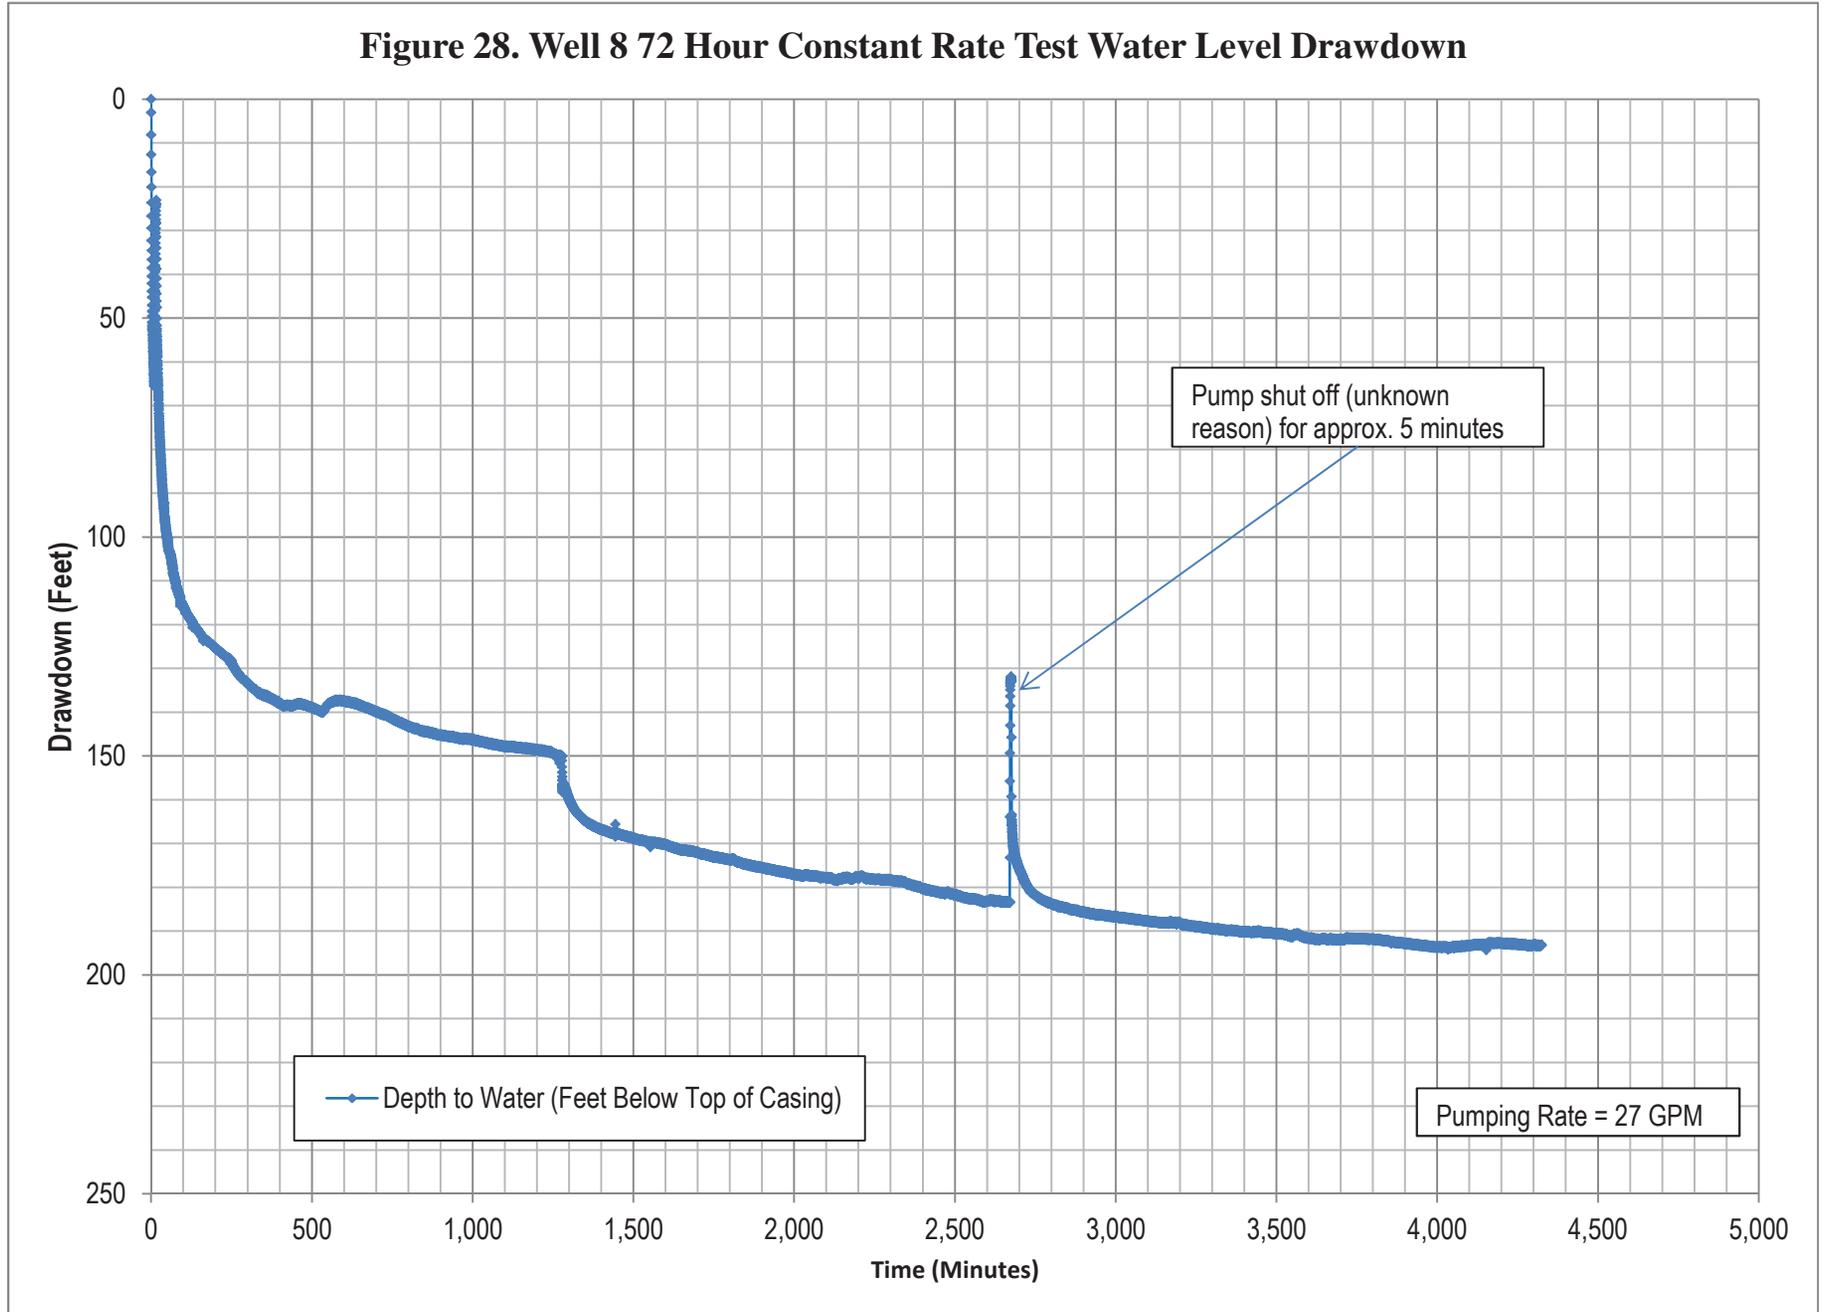
Figure 28. Well 8 72 Hour Constant Rate Test Water Level Drawdown
