We have performed a Phase I Environmental Site Assessment (ESA) in conformance with the scope and limitations of ASTM Designation E1527-05 for the proposed roadway expansion property including ramp segments at the intersection of Old Highway 395 and Interstate 15 (I-15), situated east and west of I-15, Escondido, California. Any exceptions to, or deletions from, this practice are described in Section 7.0 of this report. This Phase I ESA has revealed no evidence of *recognized environmental conditions* in connection with the property. Therefore, no further investigation appears to be warranted at this time.

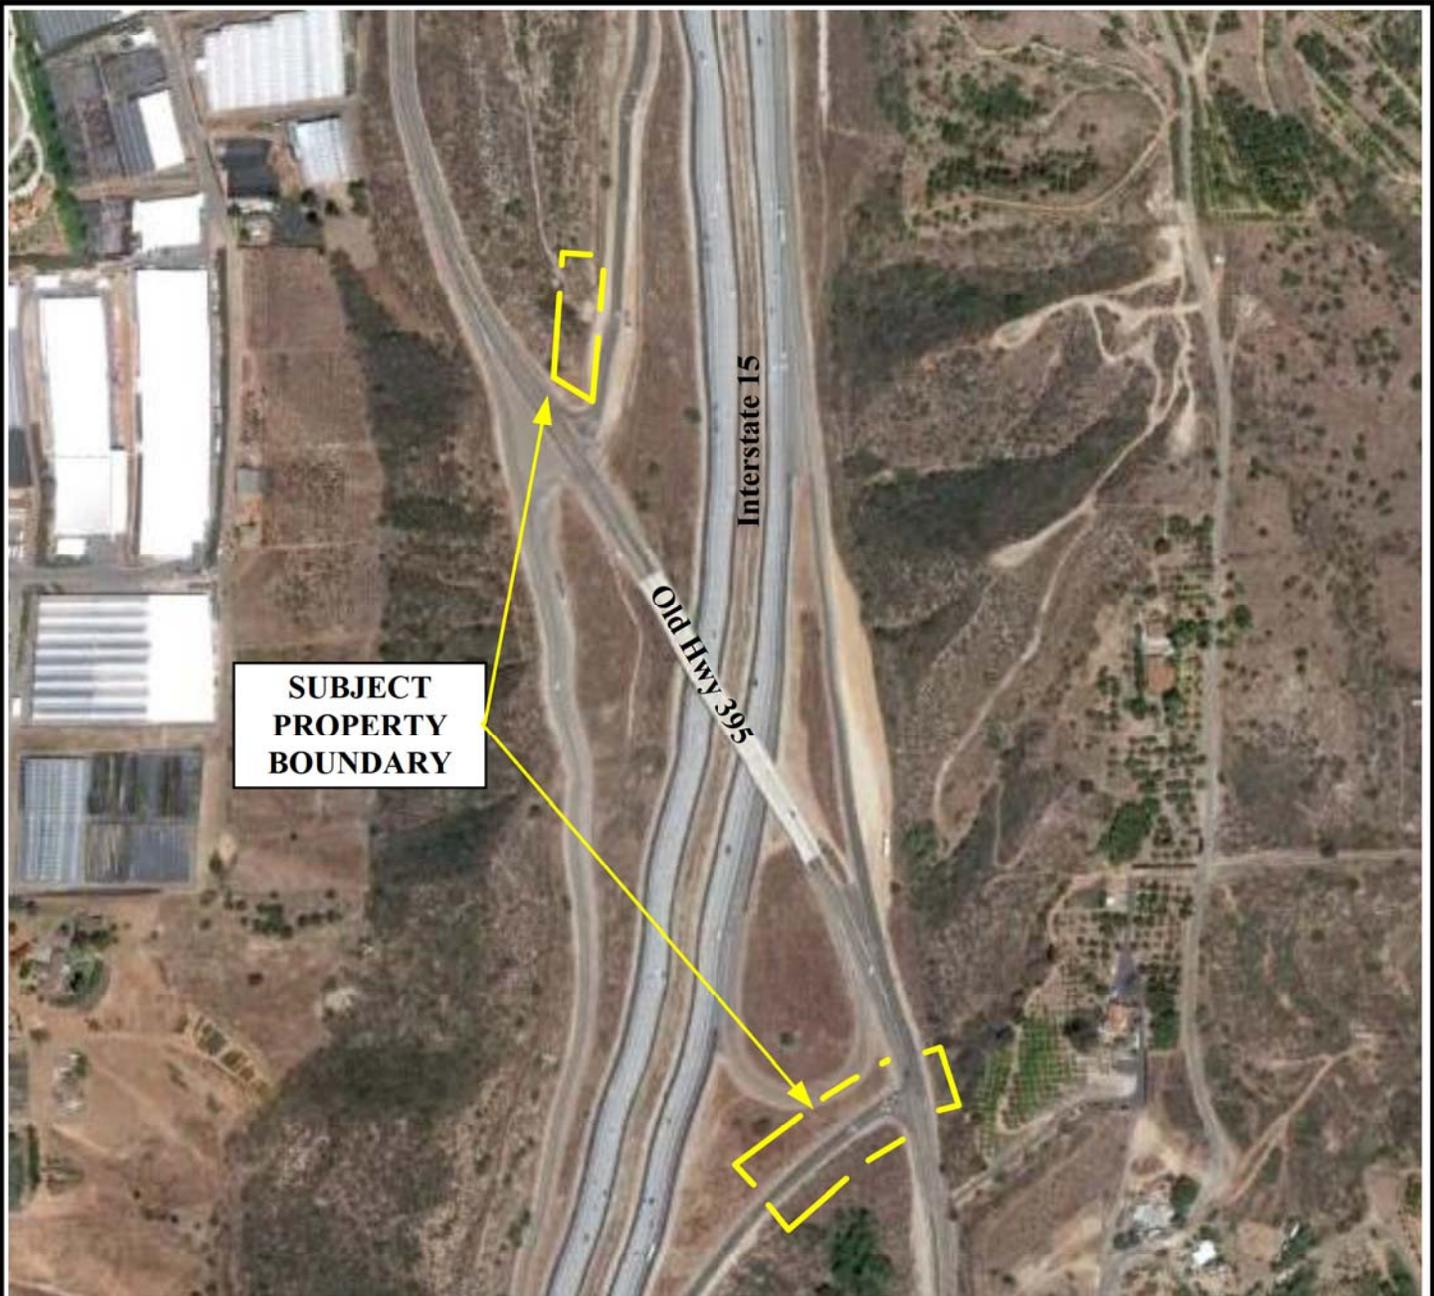
FIGURE 2

Aerial photographs and historical topographical maps were reviewed to identify historical land development and any surface conditions which may have impacted the subject property. Photographs and historical topographic maps dating 1939, 1946, 1948, 1951, 1953, 1963, 1968, 1974, 1975, 1980, 1990/91, 2002, 2008, and 2012 were obtained and reviewed from Track Info Services/FirstSearch®, an environmental information/database retrieval service. A 2010 aerial photograph was obtained from Google Earth® and reviewed, a copy of which is included herein (**Figure 2**).

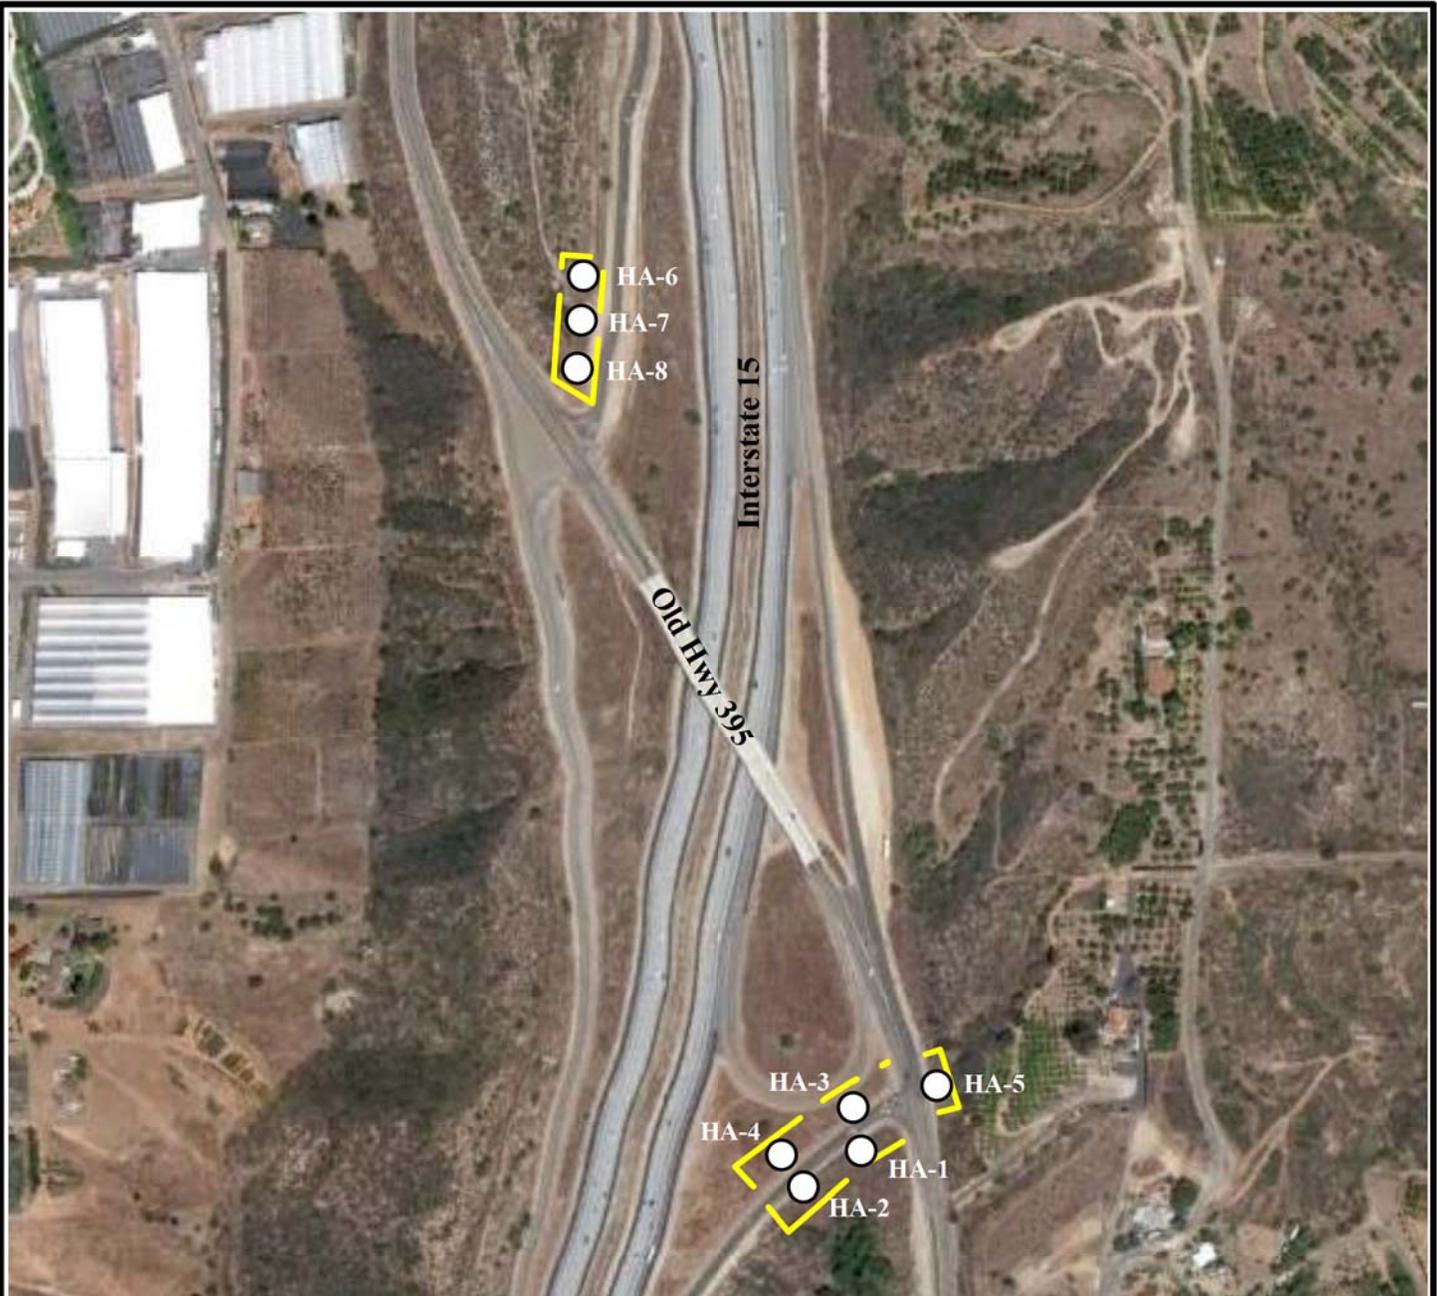
FIGURE 3

On August 2, 2012, EEI personnel mobilized to the subject areas to conduct soil sampling activities with a stainless steel hand auger. Soil sampling locations were selected with the goal of collecting representative soil samples from the subject property. A total of five (5) discrete locations (identified as HA-1 through HA-5, **Figure 3**) were chosen to provide representative coverage at the northbound I-15 off ramp to Old Highway 395. Three (3) soil samples were collected along the easement area on the westerly edge of the southbound off ramp of I-15 to Old Highway 395 (identified as HA-6 through HA-8, **Figure 3**).

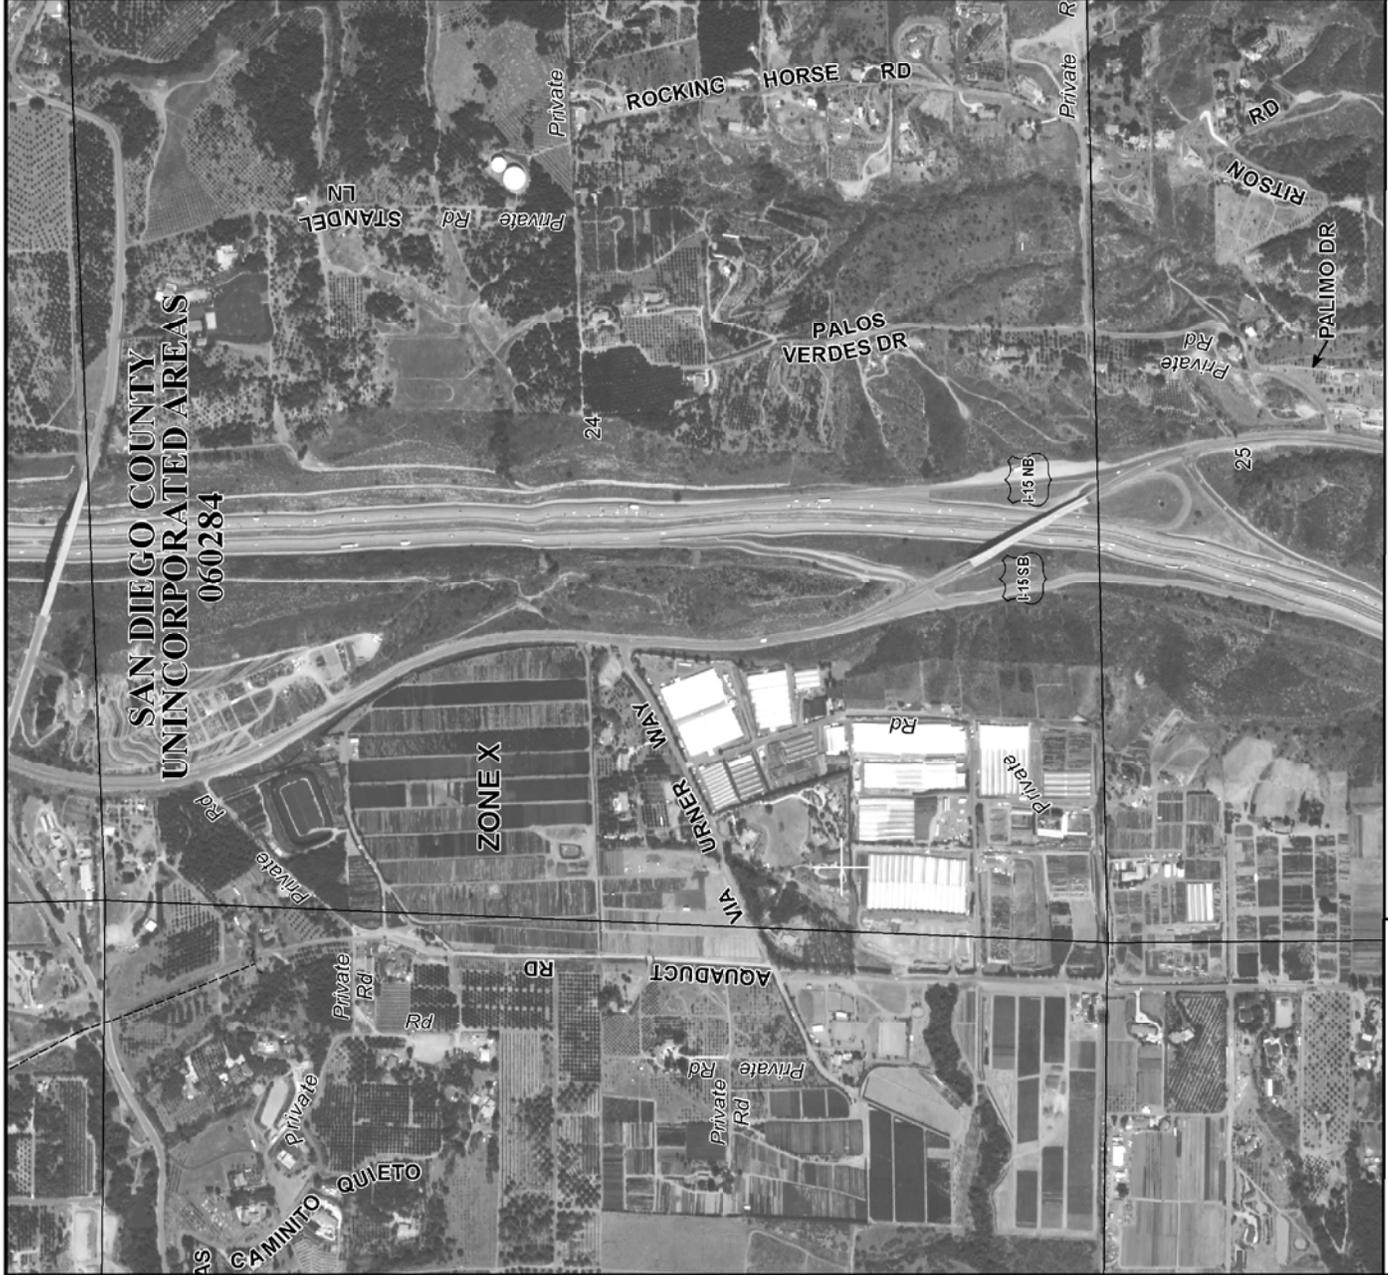
EEI reviewed the Federal Emergency Management Agency (FEMA, 2012) Flood Insurance Rate Map (FIRM) online database to determine if the subject property was in a flood zone. According to the information reviewed on FIRM 06073C0495G Panel 495 of 2375 (revised May 2012), the subject property is situated within Zone X. Zone X is designated as being areas of 500-year flood; areas of 100-year flood with average depths of less than one foot or with drainage areas less than one square mile, and areas protected by levees from 100-year flood. A copy of the FIRM is included in **Appendix B**.
