Project Number / Name: ACR-71497.2a / Roadway Expansion Property –Gopher Canyon Road

APPENDIX F
PHOTOGRAPHIC LOG

**PHASE I ENVIRONMENTAL
SITE ASSESSMENT
and
LIMITED SOIL INVESTIGATION**

**Accretive Investments, Inc.
Lilac Hills Ranch Development
Roadway Expansion Property
Portions of West Lilac Road, located West and East of Interstate 15,
and the intersection of West Lilac Road and Old Highway 395
Escondido, California 92026**

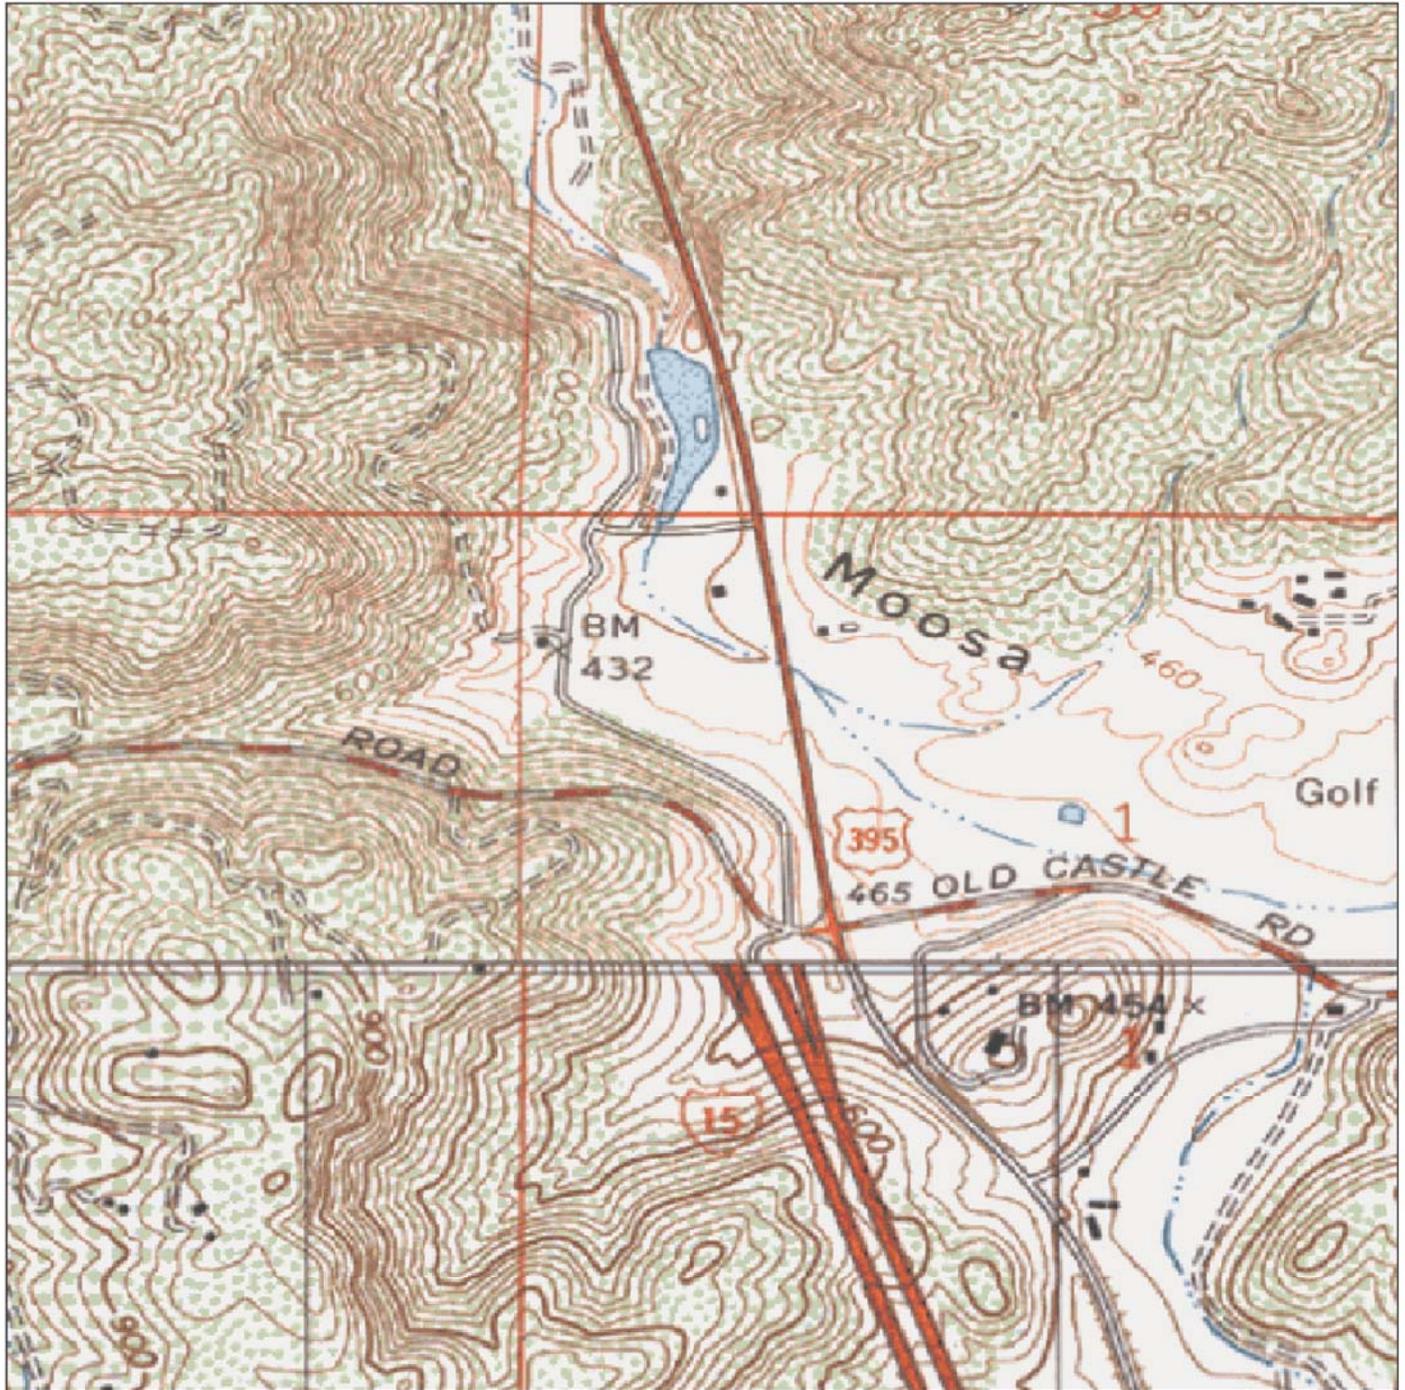
FIGURE NO.

Black Rings Represent 1/4 Mile Radii; Red Ring Represents 500 ft. Radius

Map Name: BONSALL
Map Reference Code: 33117-C2-TF-024

Date Created: 1968--
Contour Interval: 20 feet

Date Revised: 1975--
Elevation:

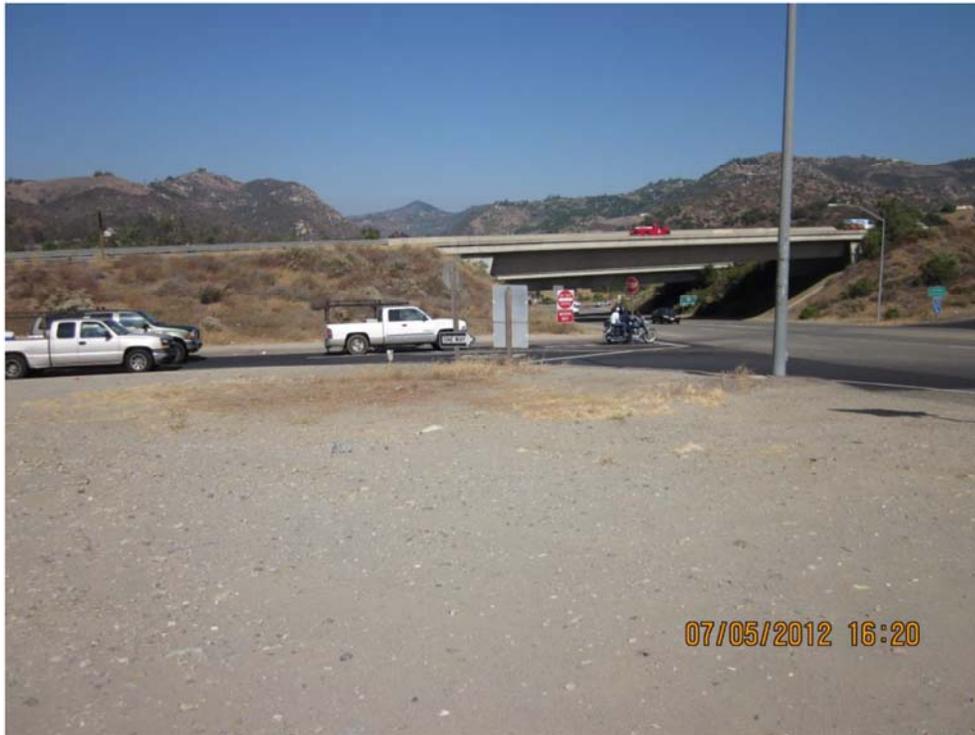
Photograph 1 – Easterly view of Gopher Canyon Road off ramp to southbound I-15.

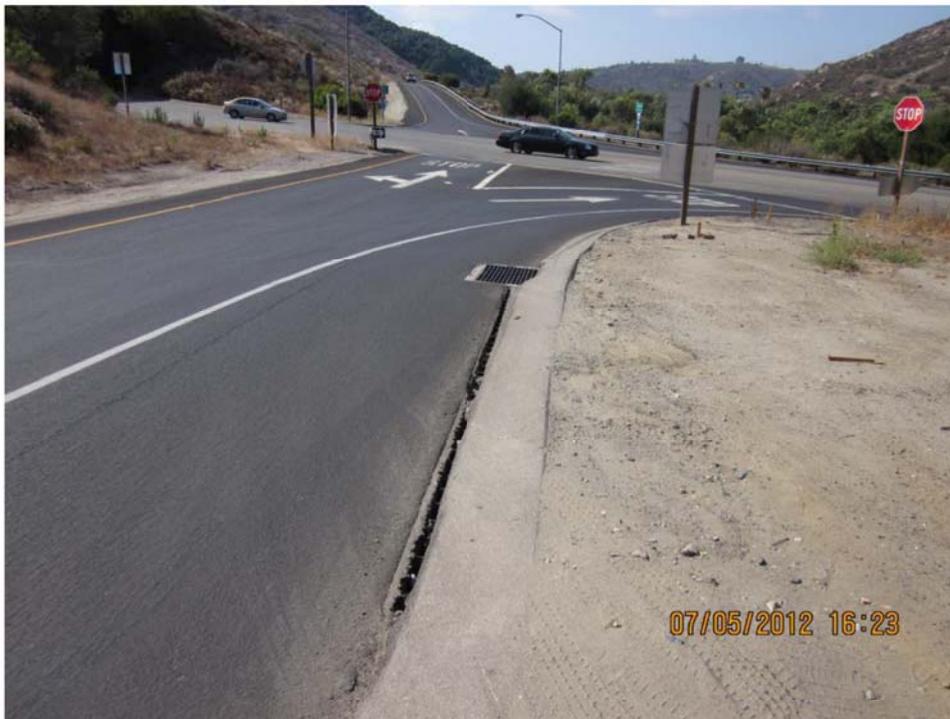
Photograph 2 – North view of Gopher Canyon Road off ramp to north bound I-15.

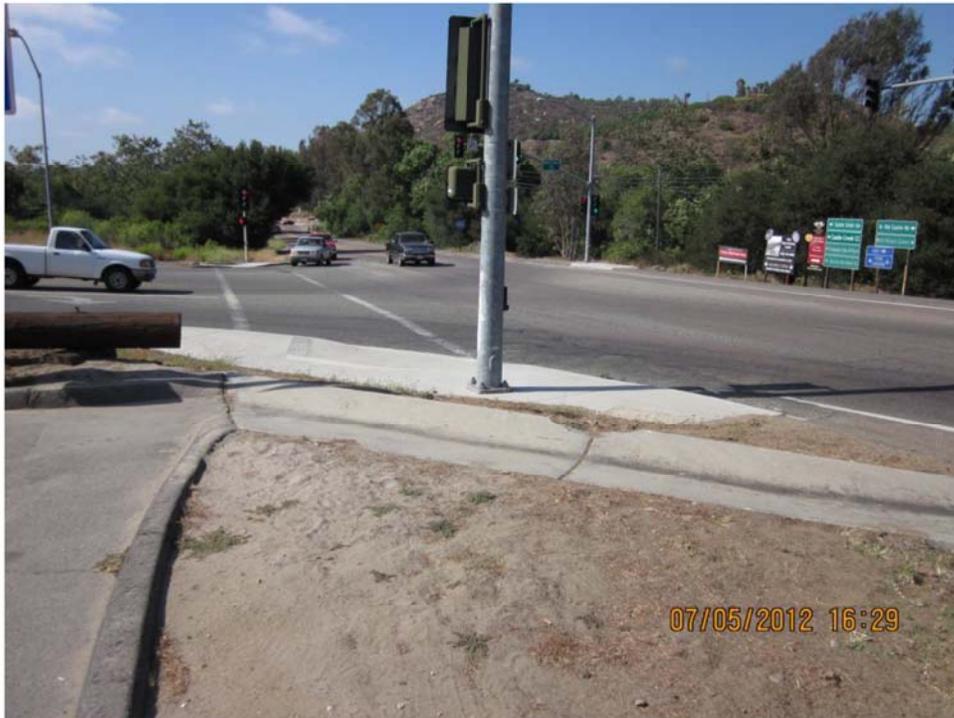
Photograph 3 – Northerly view of intersection of Gopher Canyon Road (left photo) and Old Highway 395. Photo taken from adjacent Car Pool parking lot.

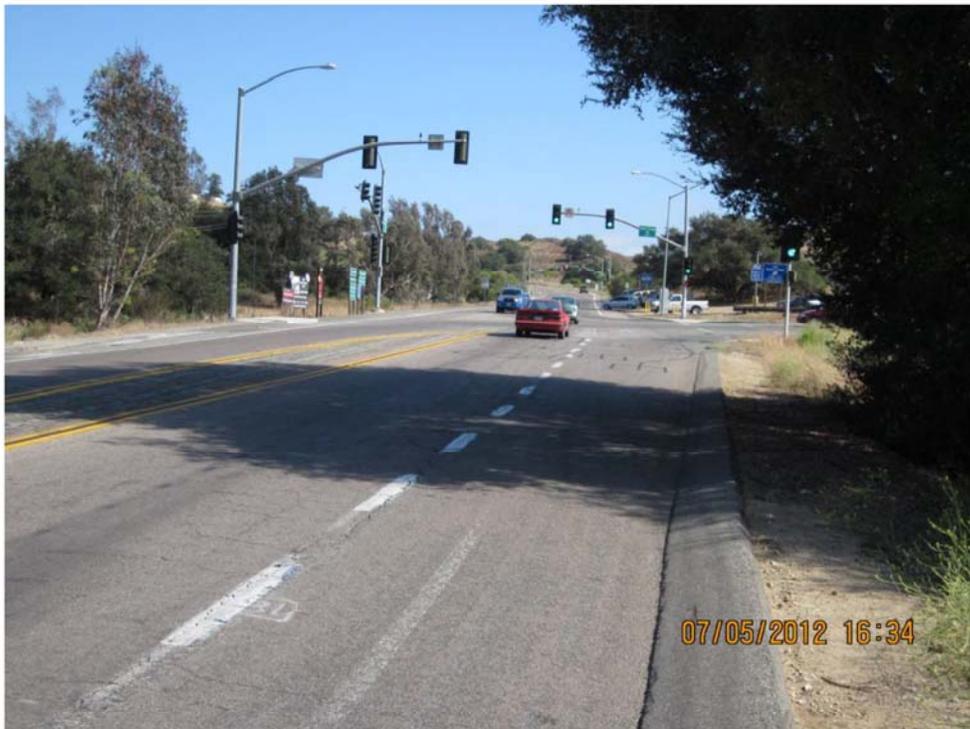
Photograph 4 – Southerly view along Old Highway 395 toward intersection with Gopher Canyon Road (right background).

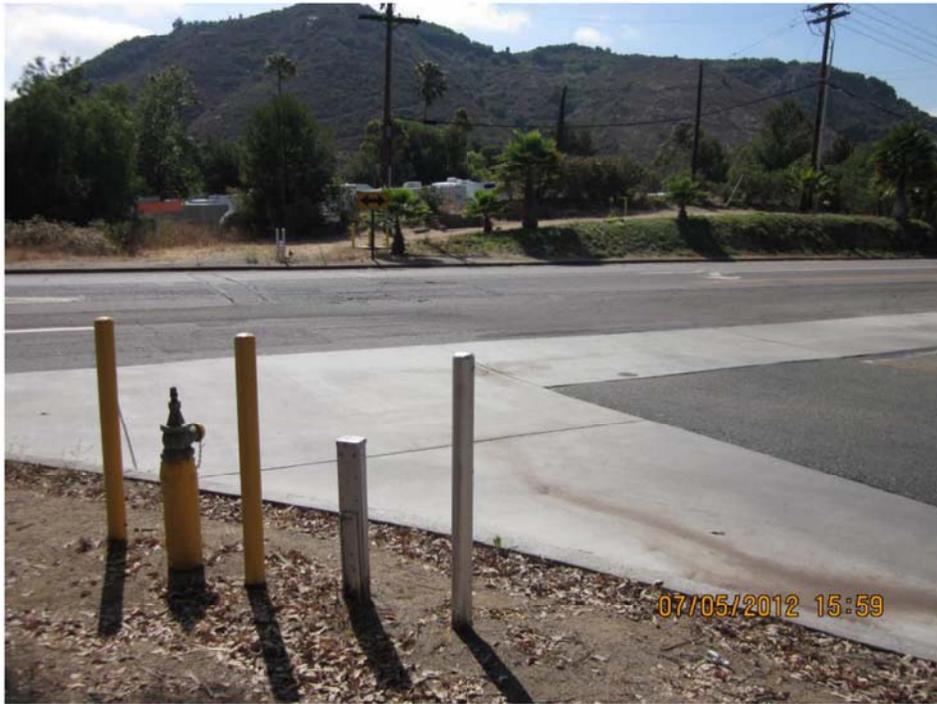
Photograph 5 – Northwesterly view of the intersection of Circle R Drive (right foreground) and Old Highway 395. Note water utilities on both edges of roadways.

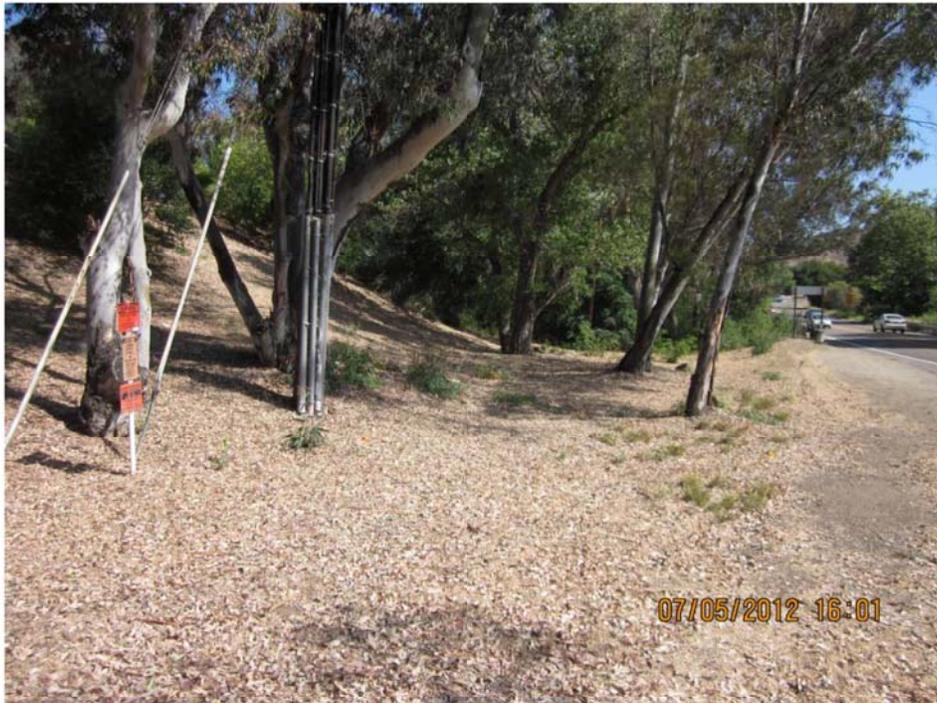
Photograph 6 – South view along northeast side of Old Highway 395 south of Circle R Drive. Note orange signage in left photo delineating buried fiber optic cable.

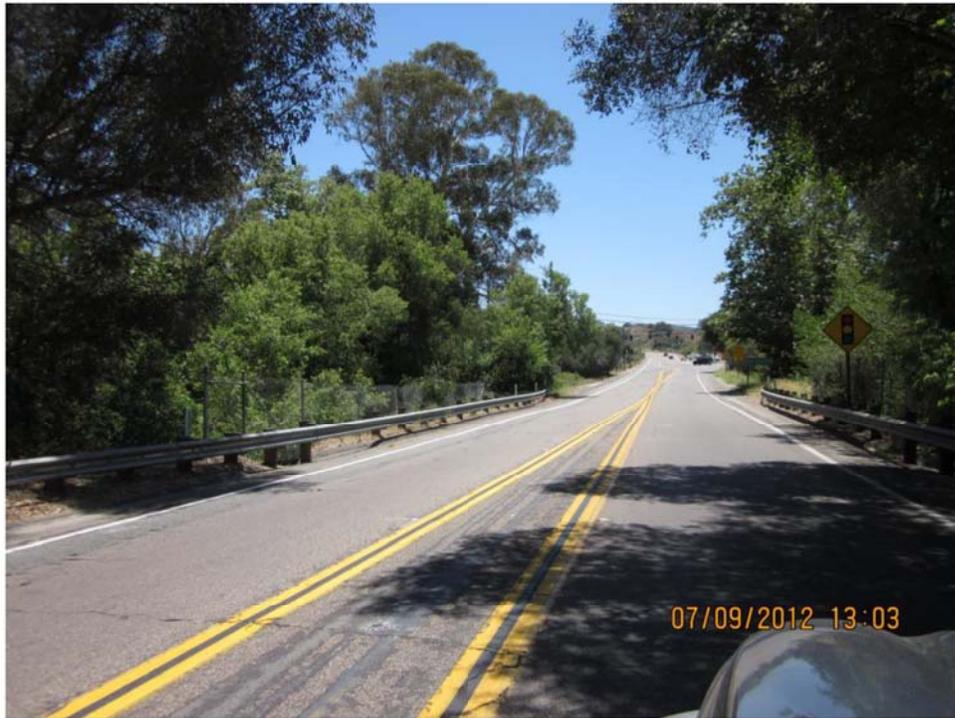
Photograph 7 – south view along central section of Old Highway 395 at culvert under-crossing, delineated by guard railing.

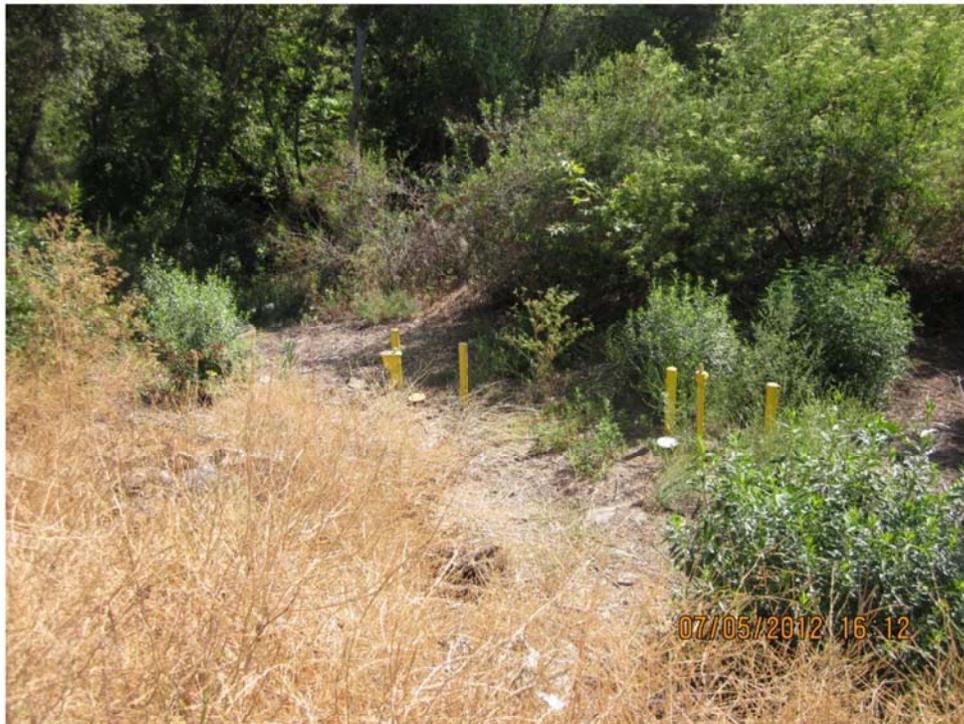
Photograph 8 – Southwesterly view of water utilities in drainage (easement?) area along west side of Old Highway 395, north of culvert under-crossing.
