SITE LOCATION MAP
 ACCRETIVE INVESTMENTS, INC.
 Lilac Hills Ranch
 Roadway Expansion Property
 Portions of West Lilac Road, located west and east of I-15, and the
 intersection of West Lilac Road and Old Highway 395
 Escondido, California 92026
 EEI Project Number ACR-71497.2b
 Created July 2012

AERIAL SITE MAP
 ACCRETIVE INVESTMENTS, INC.
 Lilac Hills Ranch
 Roadway Expansion Property
 Portions of West Lilac Road, located west and east of I-15, and the
 intersection of West Lilac Road and Old Highway 395
 Escondido, California 92026
 EEI Project Number ACR-71497.2b
 Created July 2012

SOIL BORING MAP
 ACCRETIVE INVESTMENTS, INC.
 Lilac Hills Ranch
 Roadway Expansion Property
 Portions of West Lilac Road, located west and east of I-15, and the
 intersection of West Lilac Road and Old Highway 395
 Escondido, California 92026
 EEI Project Number ACR-71497.2b
 Created July 2012

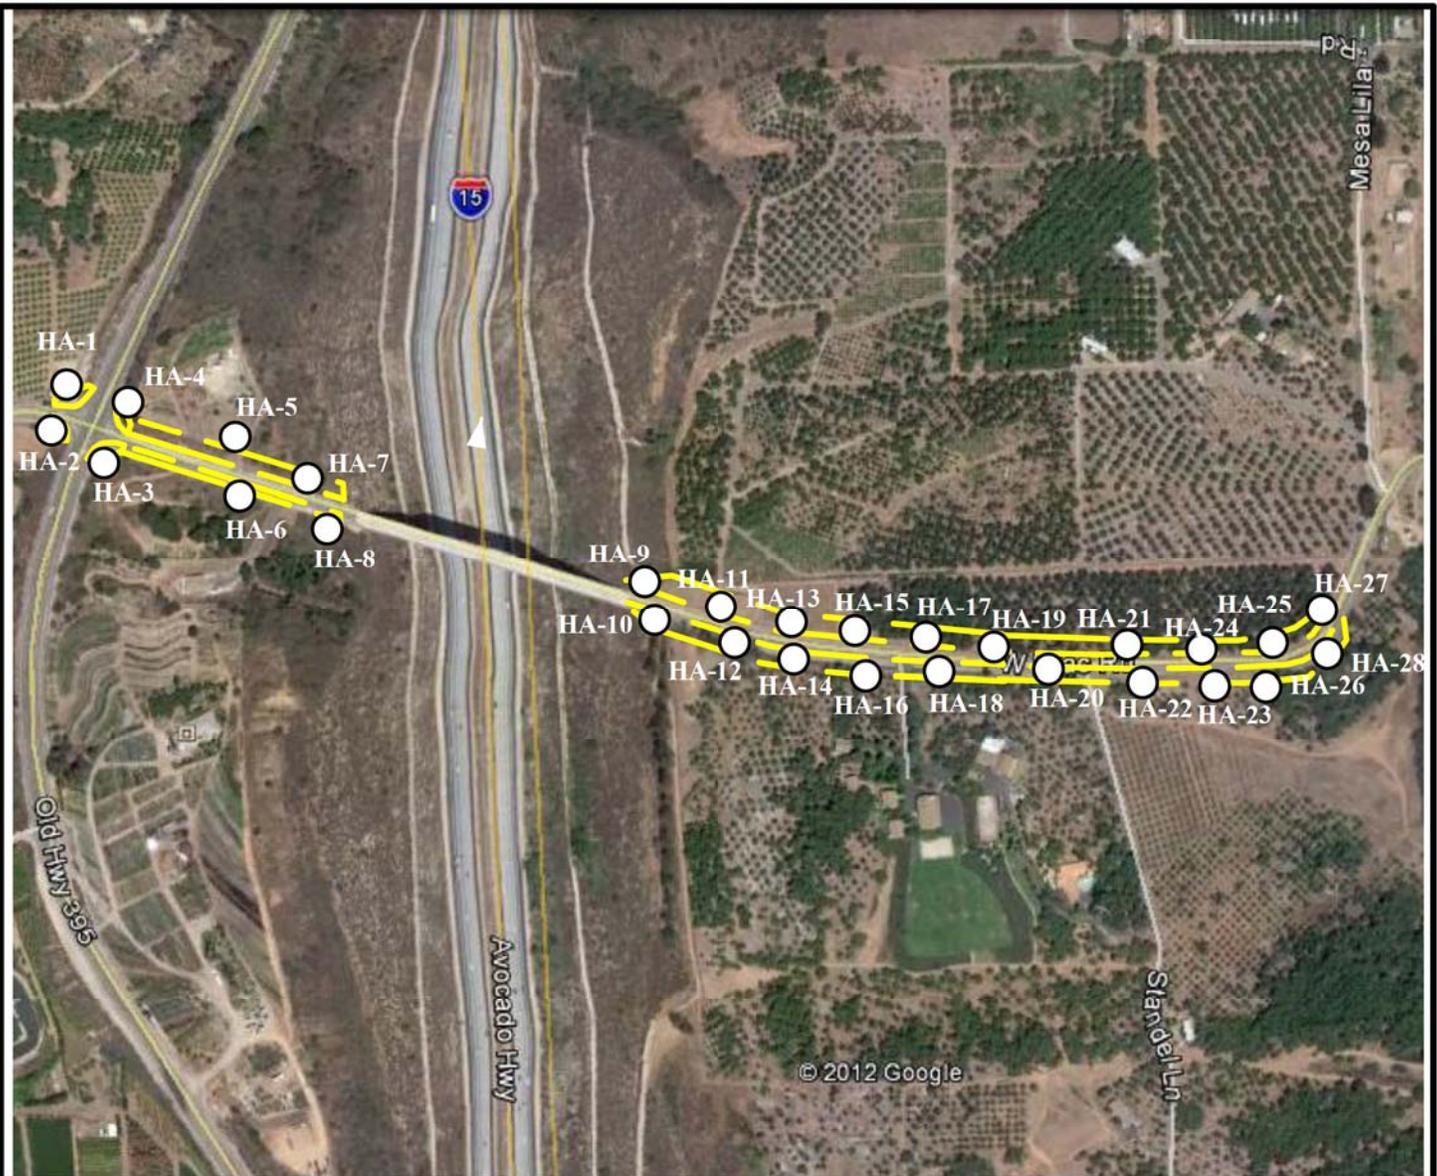
FIGURE 3

○ EEI Soil Boring Location
HA-1

No concentrations of arsenic were detected above the laboratory reporting limit (i.e., “non-detect”) in the samples analyzed during this investigation. Lead was detected above the laboratory detection limit in samples HA-1 through HA-4, HA-7, HA-9, HA-12 through HA, 14, HA-16, and HA-25 through HA-27. Concentrations of lead ranged from 7.1 milligrams per kilogram (mg/kg) (HA-25) to 160 mg/kg (HA-2). No other samples analyzed detected lead above the laboratory reporting limit (i.e., “non-detect”).
