ANALYTICAL REPORT FOR SAMPLES

At the request and authorization of the Client (Accretive Investments, Inc.), EEI conducted a Phase I Environmental Site Assessment (ESA) for the property located at 9383 West Lilac Road, Escondido, California. The purpose of this Phase I ESA was to assess the presence or likely presence of an existing, historical, or threatened release of any hazardous substances or petroleum products into structures, soil, and/or groundwater beneath the subject property, to the extent practical (i.e., *recognized environmental conditions* as delineated in ASTM E1527-05).

The purpose of this Phase I Environmental Site Assessment (ESA) was to assess the possible presence of *recognized environmental conditions* at the property located at 9383 West Lilac Road, Escondido, California (**Figure 1**). *Recognized environmental conditions* include those property uses that may indicate the presence or likely presence of an existing, historical, or threatened release of any hazardous substances or petroleum products into structures, soil, and/or groundwater beneath the property. The term *recognized environmental conditions* are not intended to include *de minimis* condition

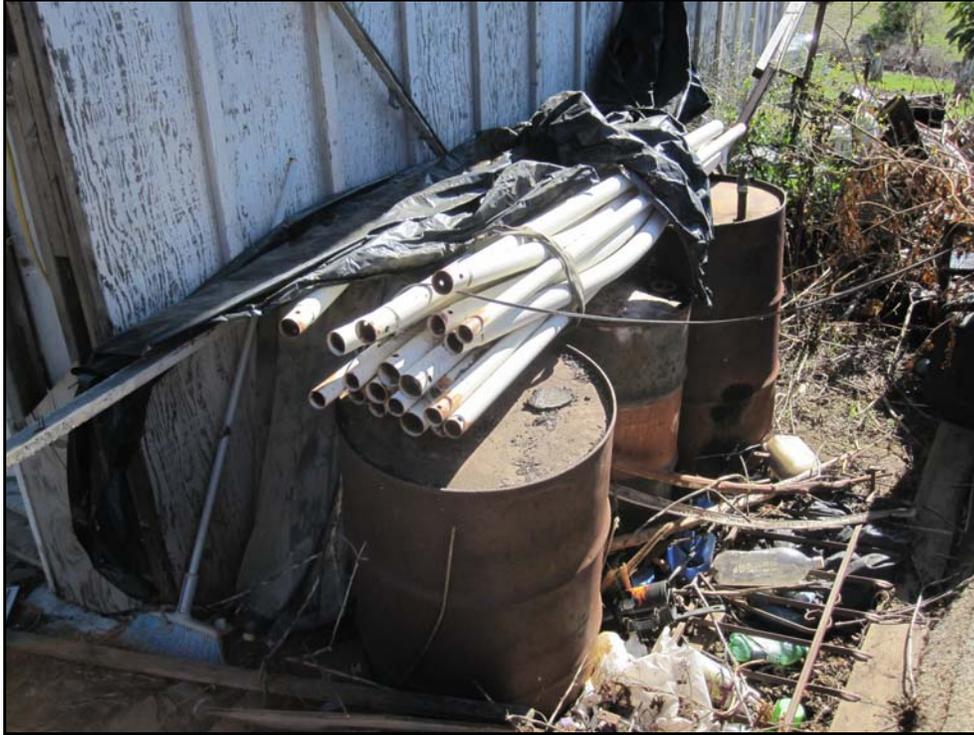
Photograph 7 – View of metal storage drums located along the west side of the detached garage.

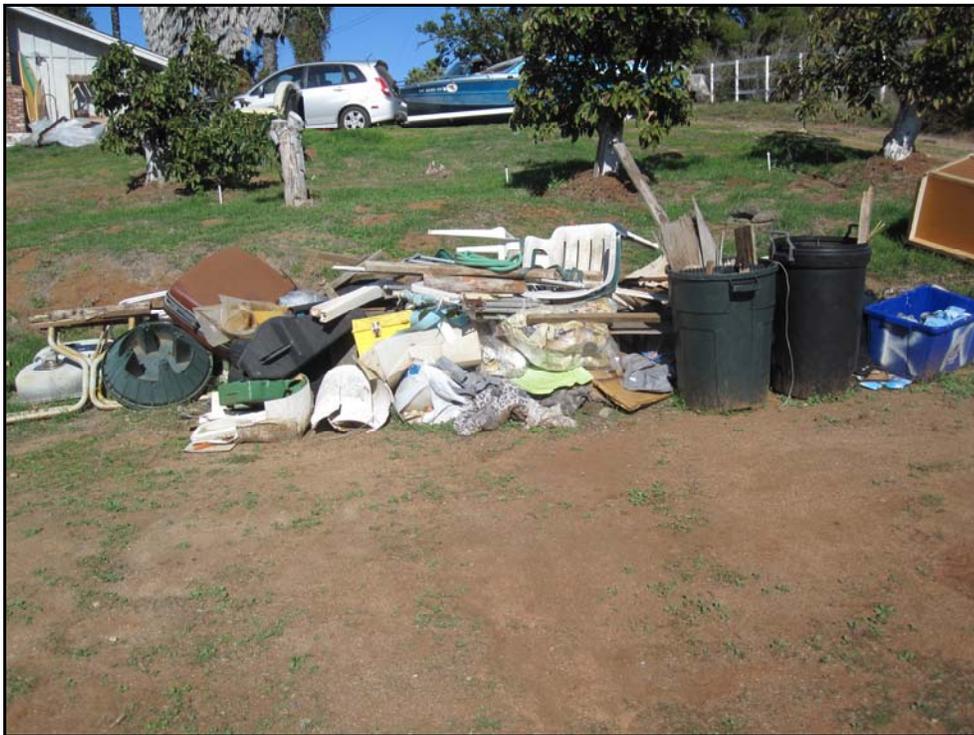
Photograph 8 – View of trash and debris located east of the detached garage.

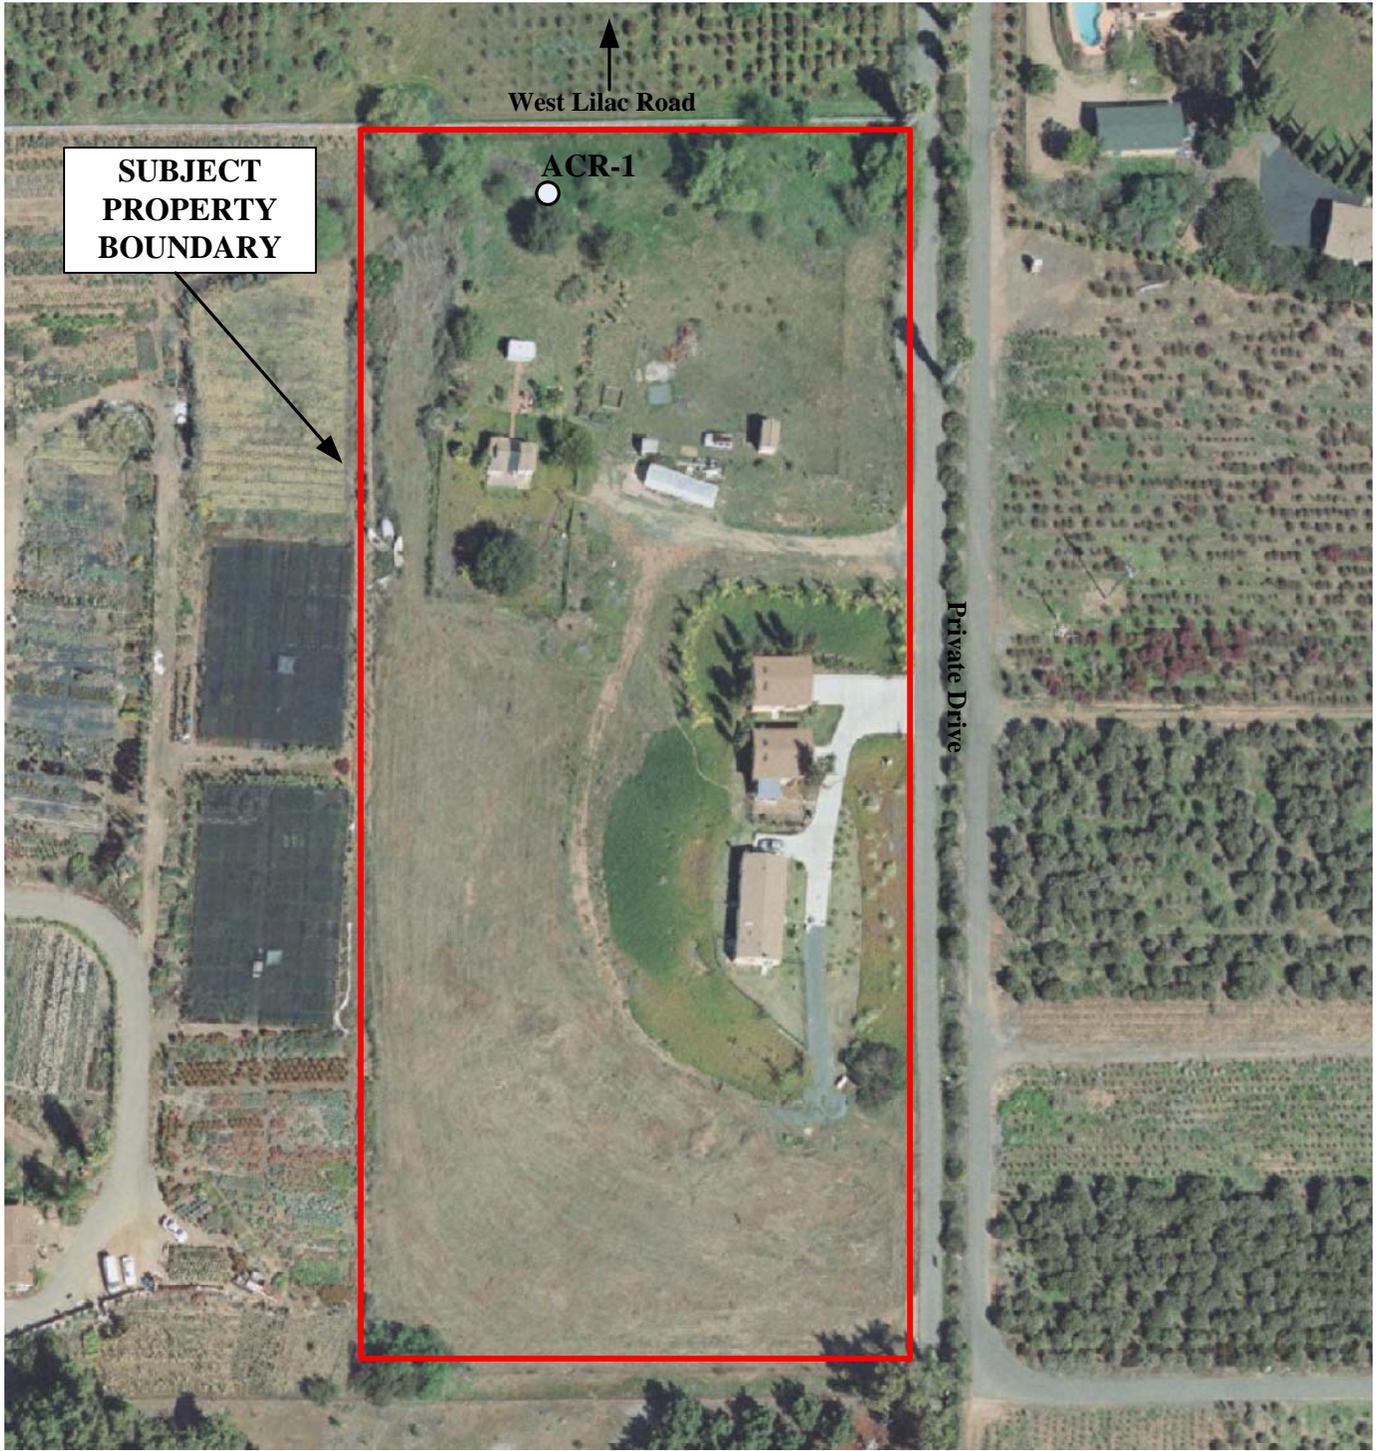
FIGURE 2

Aerial photographs and historical topographical maps were reviewed to identify historical land development and any surface conditions which may have impacted the subject property. Photographs and historical topographic maps dating 1942, 1946, 1948, 1953, 1963, 1968, 1975, 1976, 1980, 1991, and 2002 were obtained and reviewed from Track Info Services/FirstSearch®, an environmental information/database retrieval service. A 2012 aerial photograph was provided by Accretive Investments, Inc. and reviewed, a copy of which is included herein (**Figure 2**).

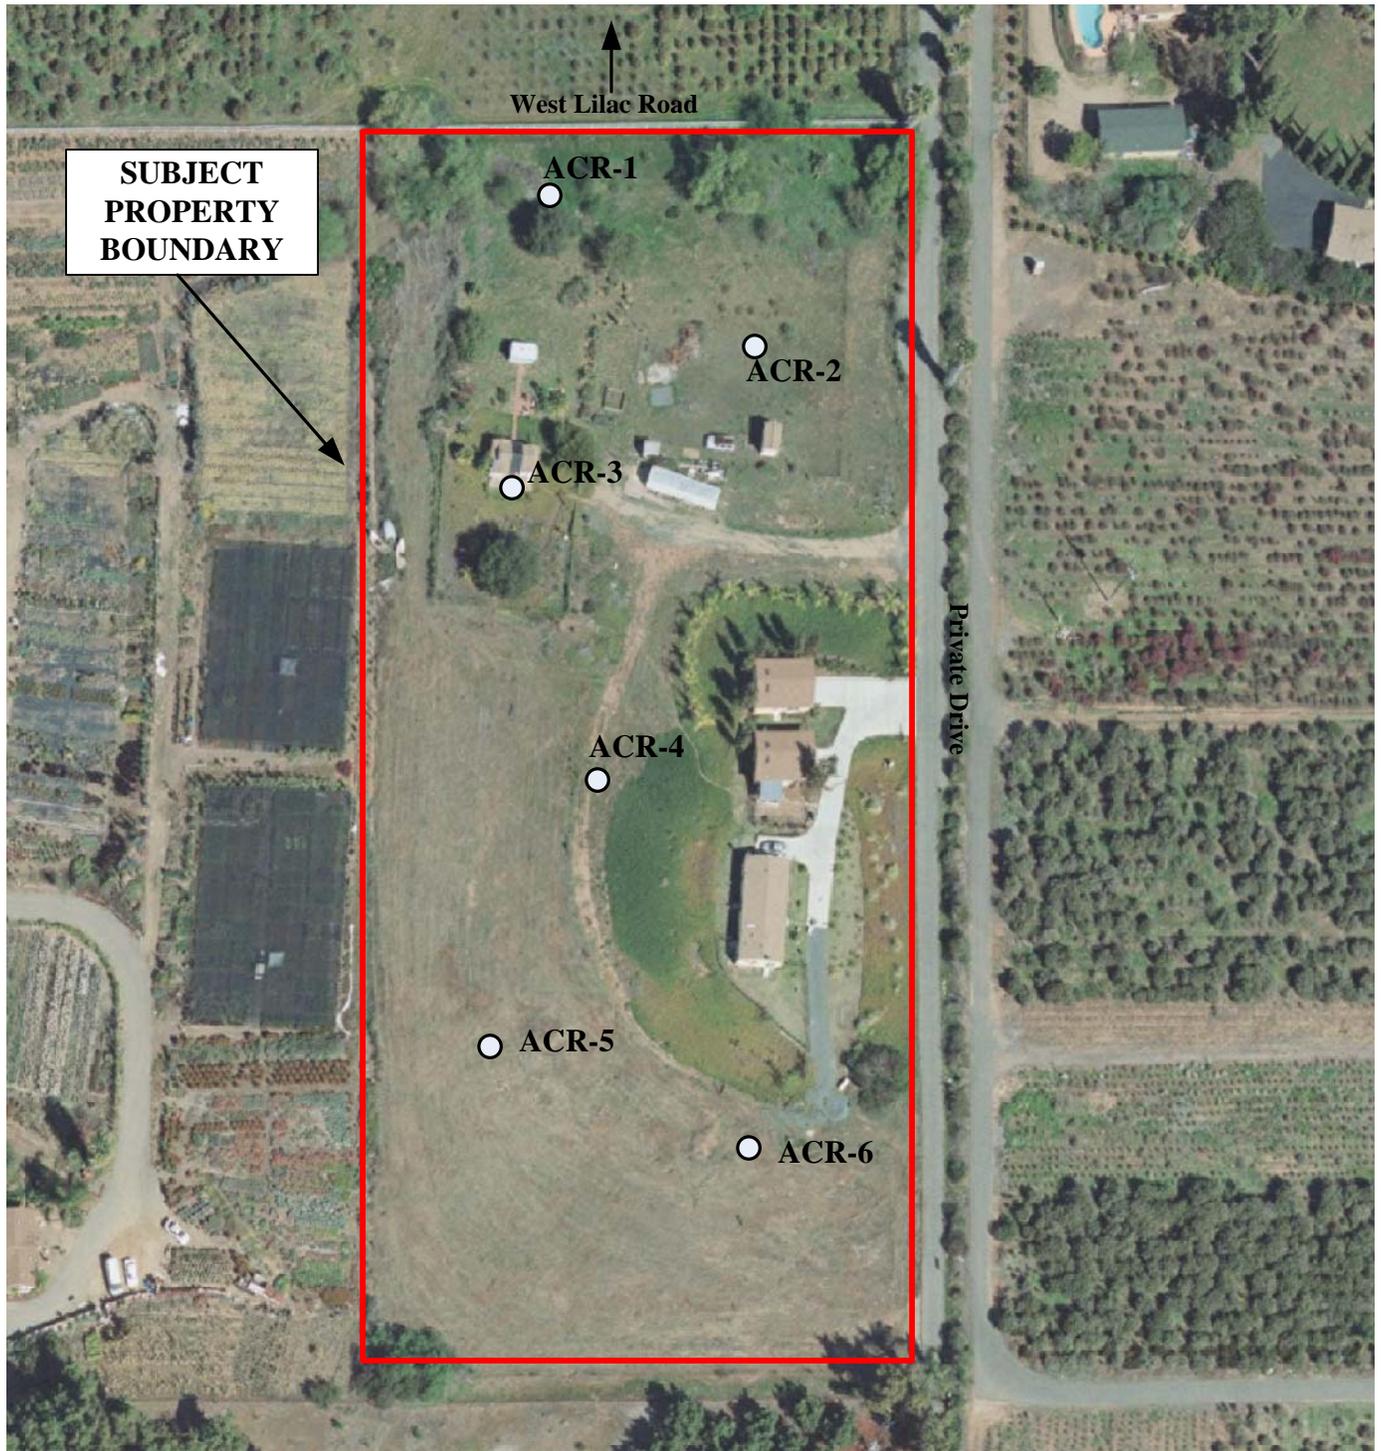
The rectangular-shaped subject property is located along private drive, south of West Lilac Road, Escondido, California (**Figure 2**). The subject property encompasses a total of 5.0-acres on one (1) contiguous parcel identified as Assessor’s Parcel Number (APN) 128-440-06 (**Appendix B**). The subject property is identified by the address: 9383 West Lilac Road.

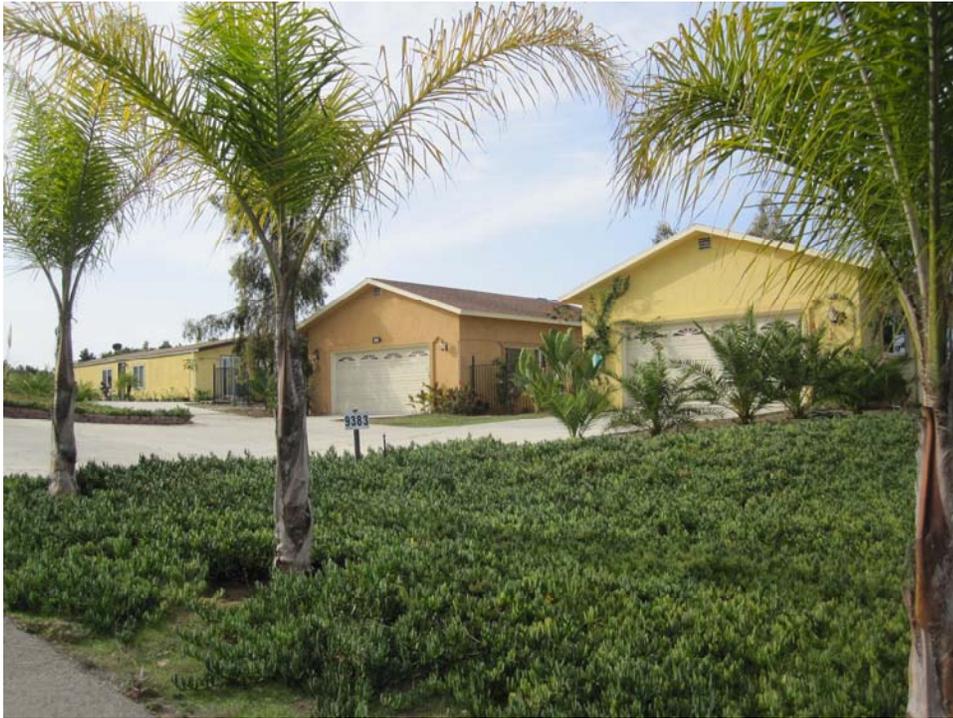
Photograph 1 – View of the subject property dwellings located on the east-central portion of the subject property. View is to the southwest.

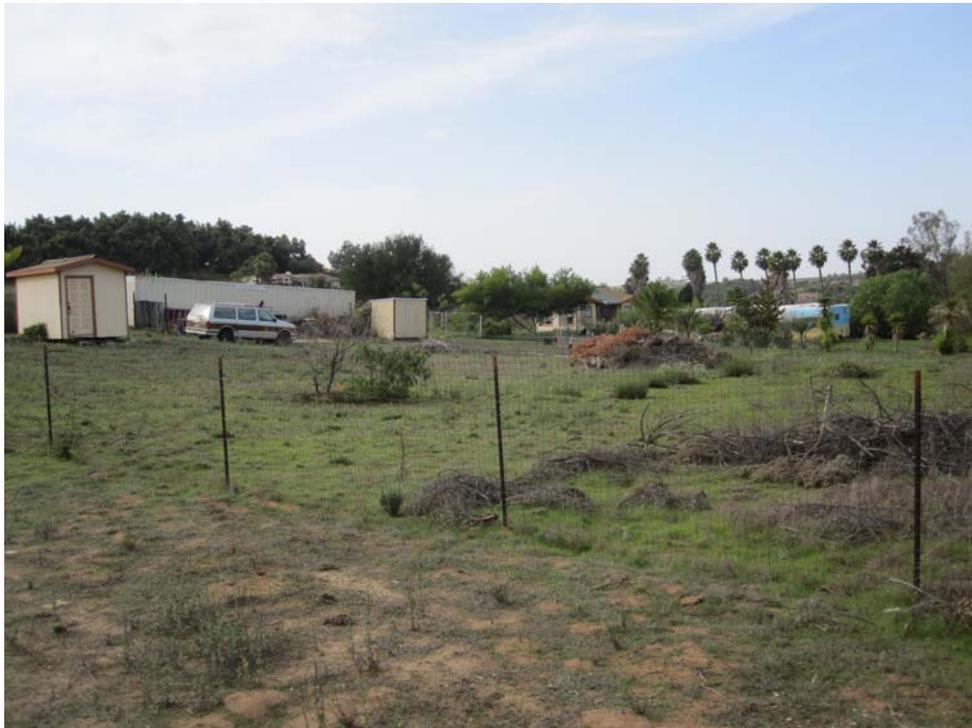
Photograph 2 – View of the subject property looking southwest. Photograph was taken from the northeast corner of the property.

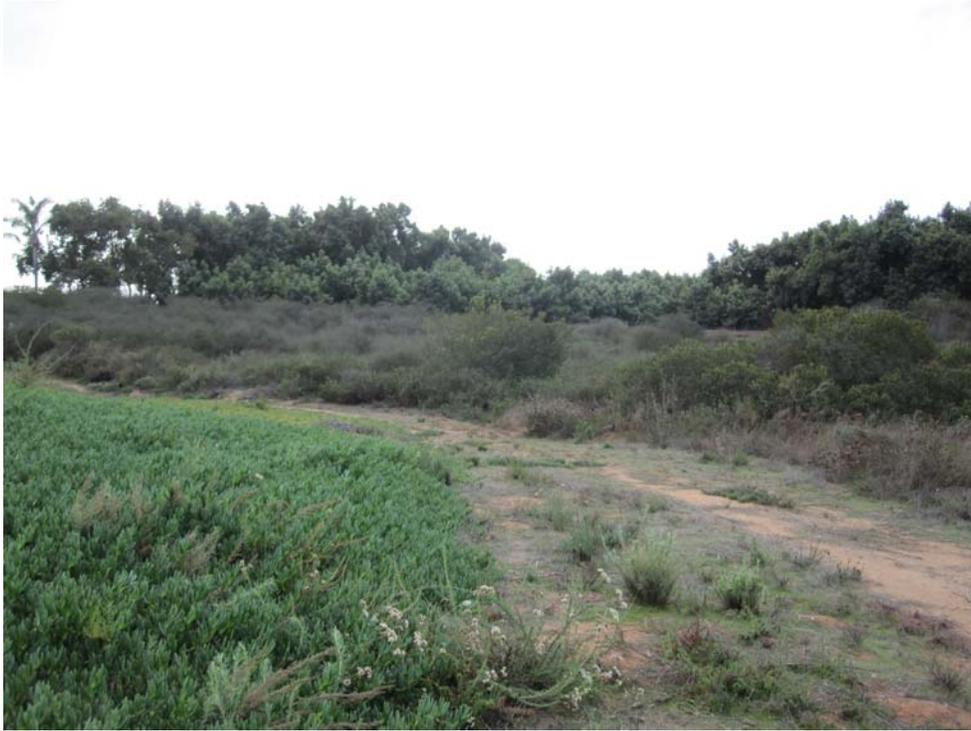
Photograph 3 – View of the southern portion of the subject property. View is to the south.

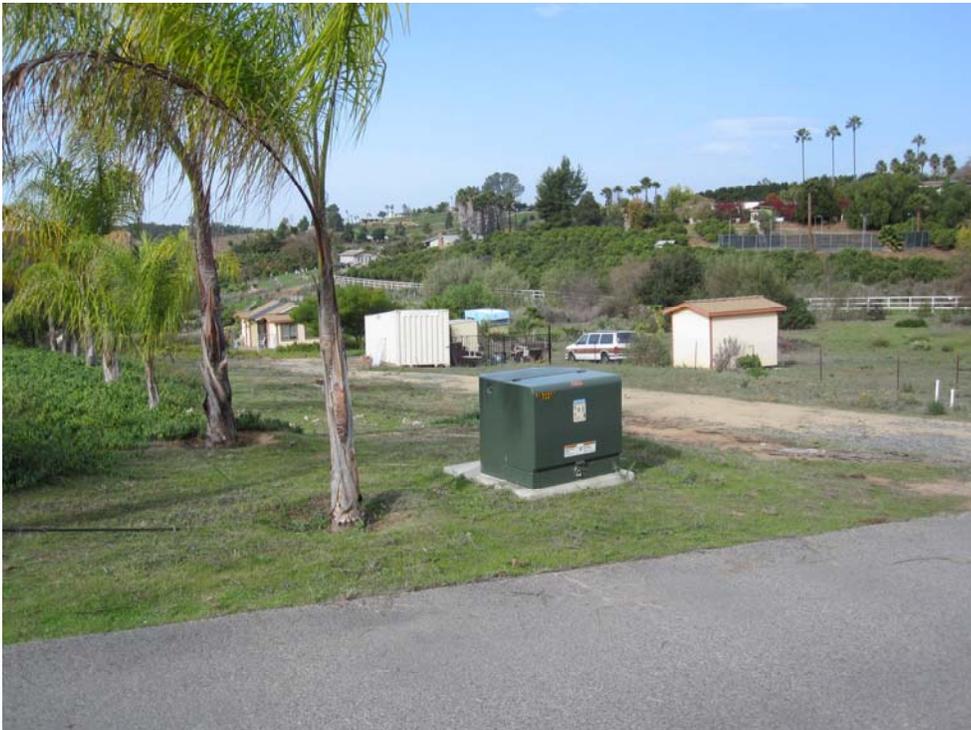
Photograph 4 – View of a pad-mounted transformer located along the east-central portion of the subject property.

One (1) pad-mounted transformer was observed along the east-central portion of the subject property. The transformer appeared to be in good operating condition and no signs of leaking were noted. Based on our experience with similar sites surrounding the subject property and San Diego County, the presence of PCB-containing transformers is unlikely; and is therefore not considered an environmental concern at this time.

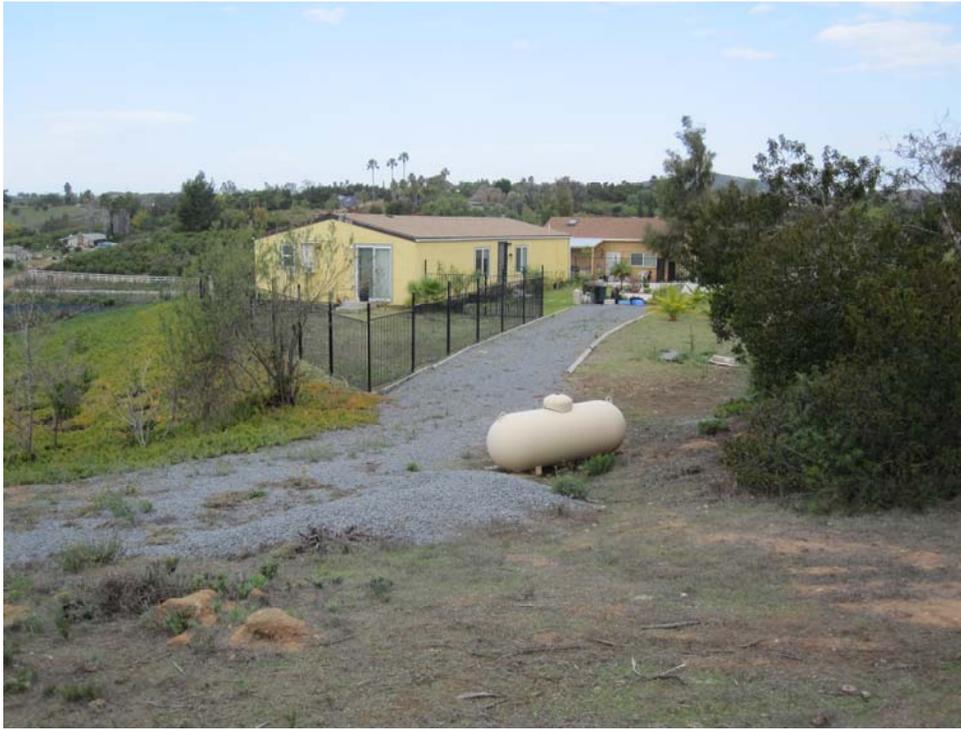
Photograph 5 – View of an above ground propane tank located along the southeast portion of the property. View is to the northwest.

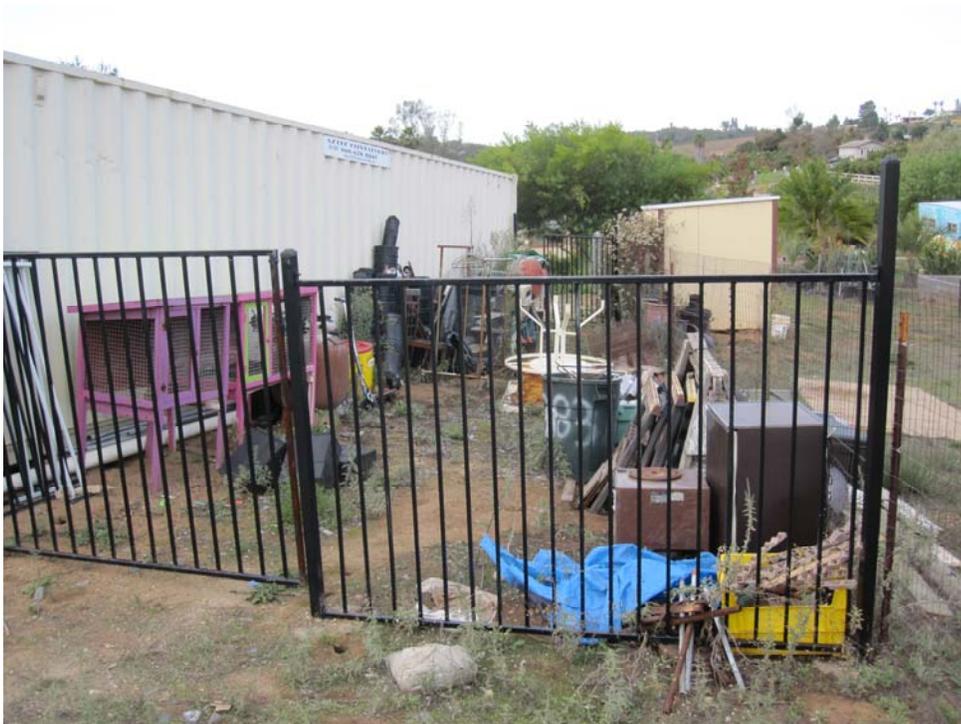
Photograph 6 – View of various household items located along the north-central portion of the subject property.

A small wooden storage shed and metal storage container were observed along the northern portion of the property. The shed and container contained various household items, gardening tools, small quantities of fuel and household cleaning products, and landscape materials. EEI observed below ground irrigation piping throughout the property and a pad-mounted transformer along the east-central portion of the property. The transformer appeared to be in good working condition and no signs of leakage or staining were observed. A above ground propane tank was observed along the southeast portion of the site. The tank appeared to be in good operating condition. The southern half of the subject property appeared to be undisturbed and covered with native vegetation.
