COUNTY OF SAN DIEGO DEPARTMENT OF PUBLIC HEALTH  
 SEPTIC TANK INSTALLATION REPORT  
 SOIL CONDITIONS OF TRENCH OR SEEPAGE PIT  
 PERCOLATION TEST

**APPENDIX G  
PHOTOGRAPHIC LOG**

At the request and authorization of the Accretive Investments, Inc. (“Client”), EEI conducted a Phase I Environmental Site Assessment (ESA) for the property located southwest of West Lilac Road and Shirey Road, Escondido, California. The purpose of this Phase I ESA was to assess the presence or likely presence of an existing, historical, or threatened release of any hazardous substances or petroleum products into structures, soil, and/or groundwater beneath the subject property, to the extent practical (i.e., *recognized environmental conditions* as delineated in ASTM E1527-05).

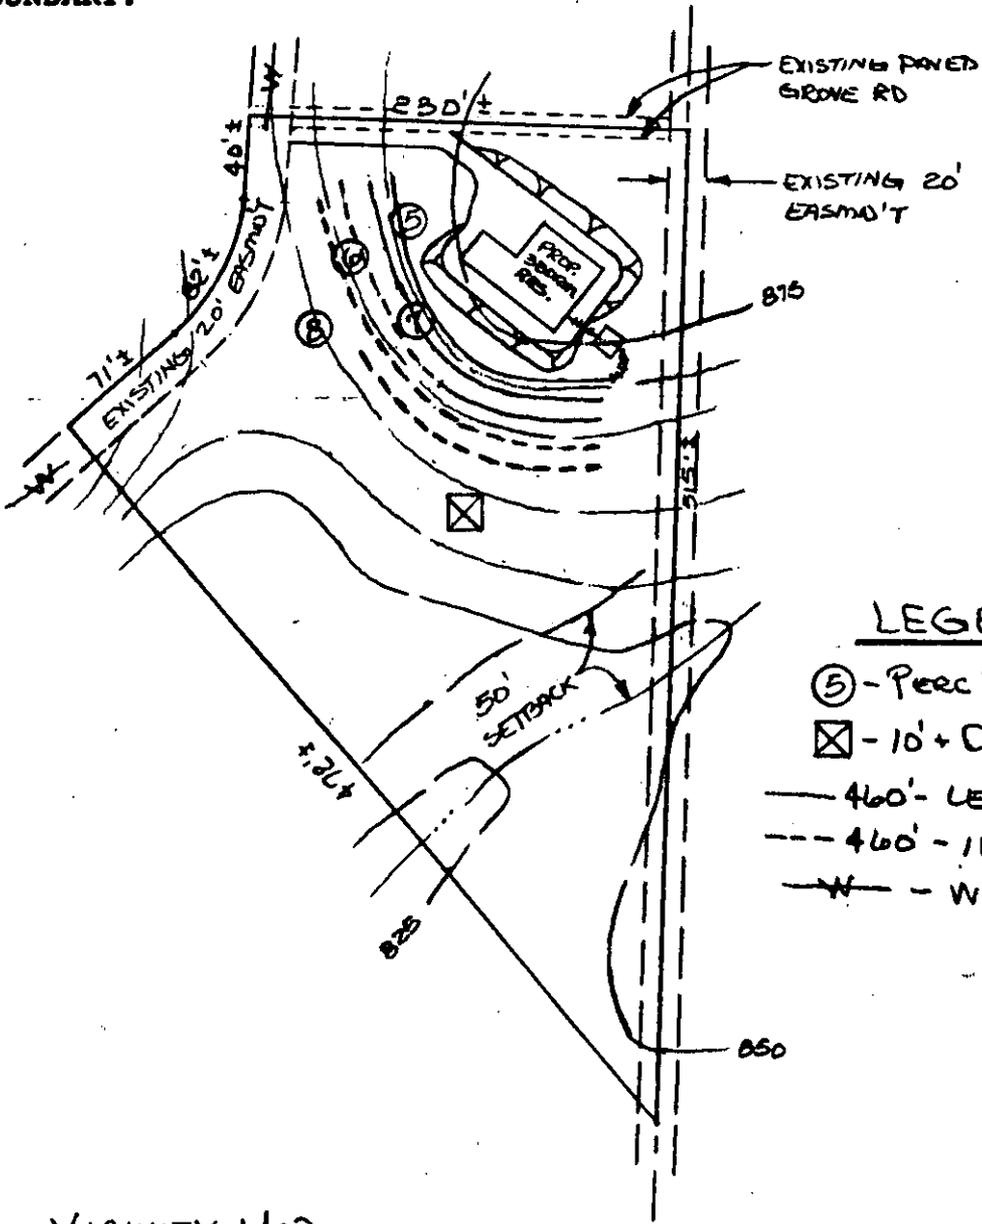
1040-83  
 PCL # 5  
 2.00 AC NET

- ⊙ - Perc TEST
- ⊗ - 10' + OBSERVATION HOLE
- 460' - LEACH LINE
- - - 460' - 100% RESERVE
- W — WATER LINE

SCALE: 1" = 100'

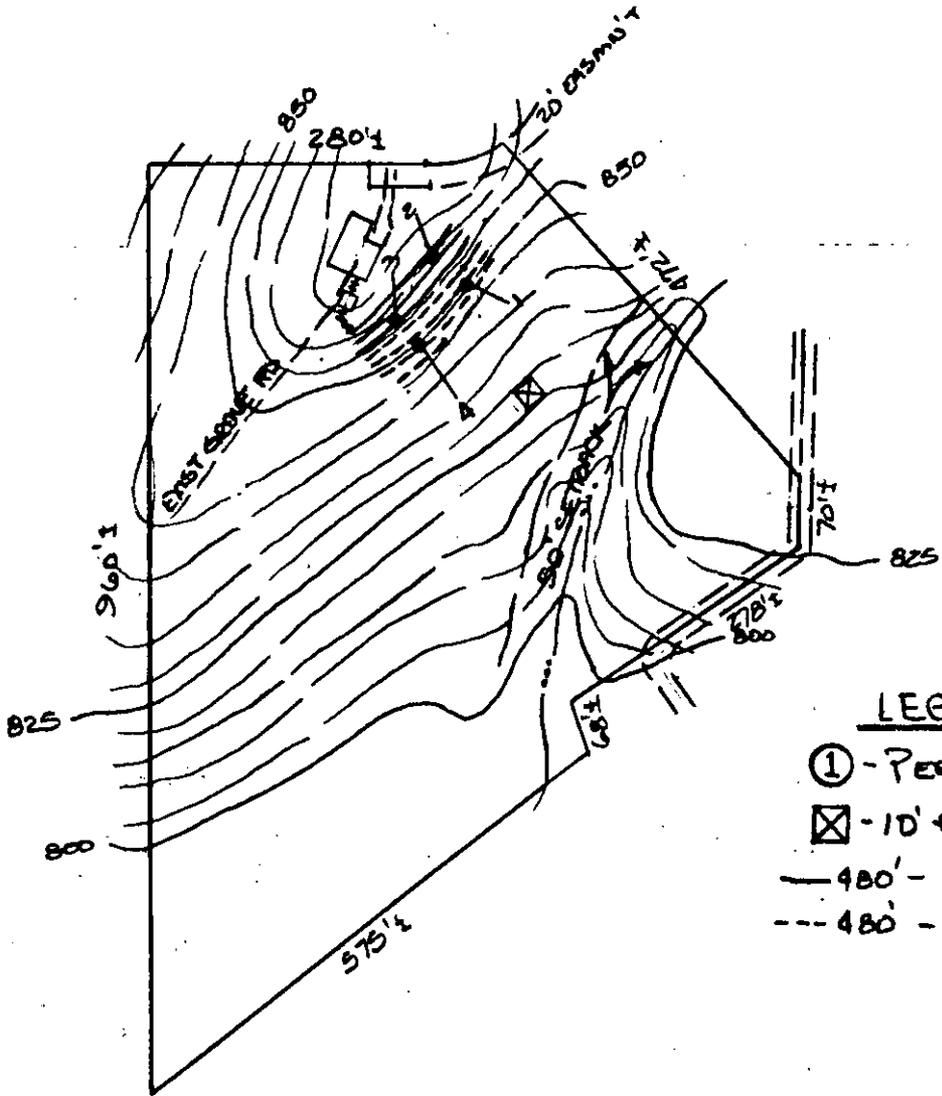
1040 B3  
 PCL. # 4  
 9.1/0 AC. NET.

SCALE: 1" = 200'

- ① - PERC TEST
- ⊠ - 10' + OBSERVATION HOLE
- 480' - LEACH LINE
- 480' - 100% RESERVE

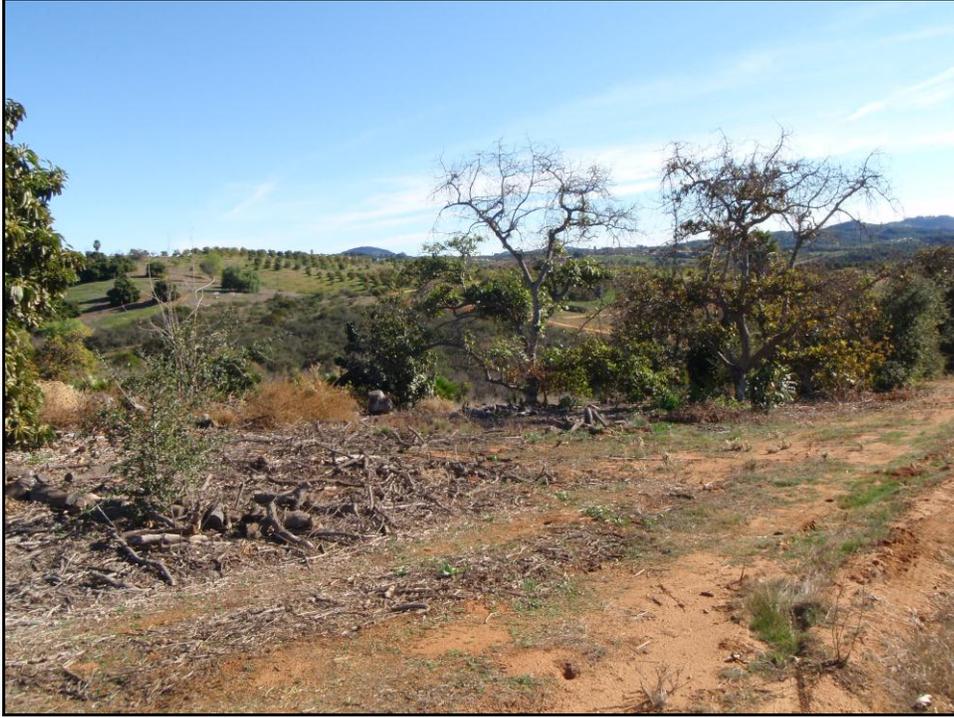
**Photograph 1** – View of the subject property looking southeast. View is from the western portion of the site.

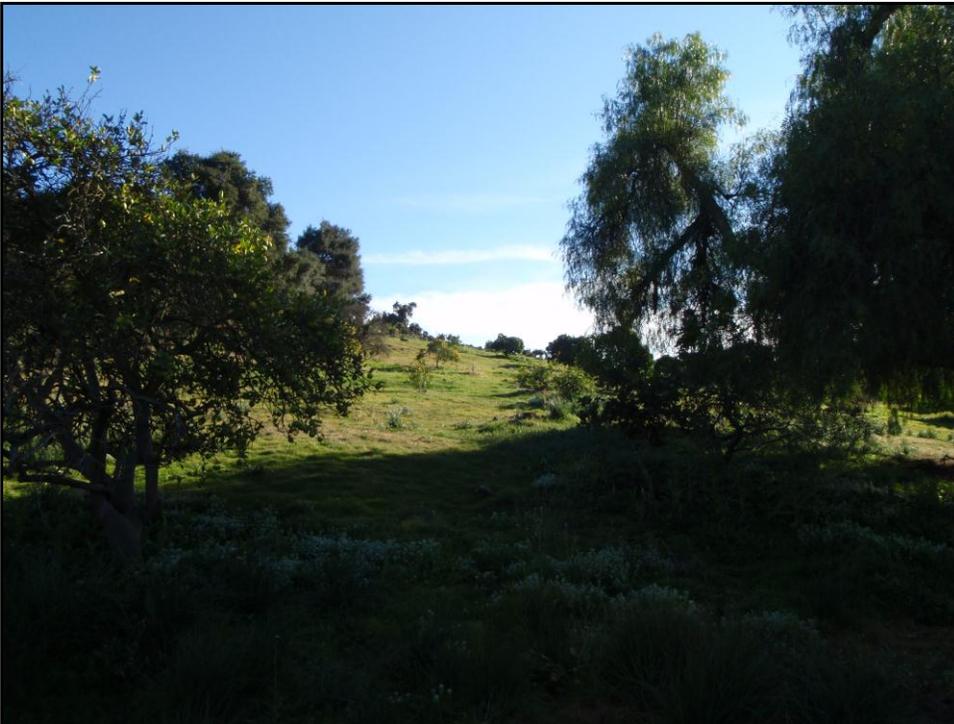
**Photograph 2** – View of the subject property looking south. View is from the northern portion of the site.

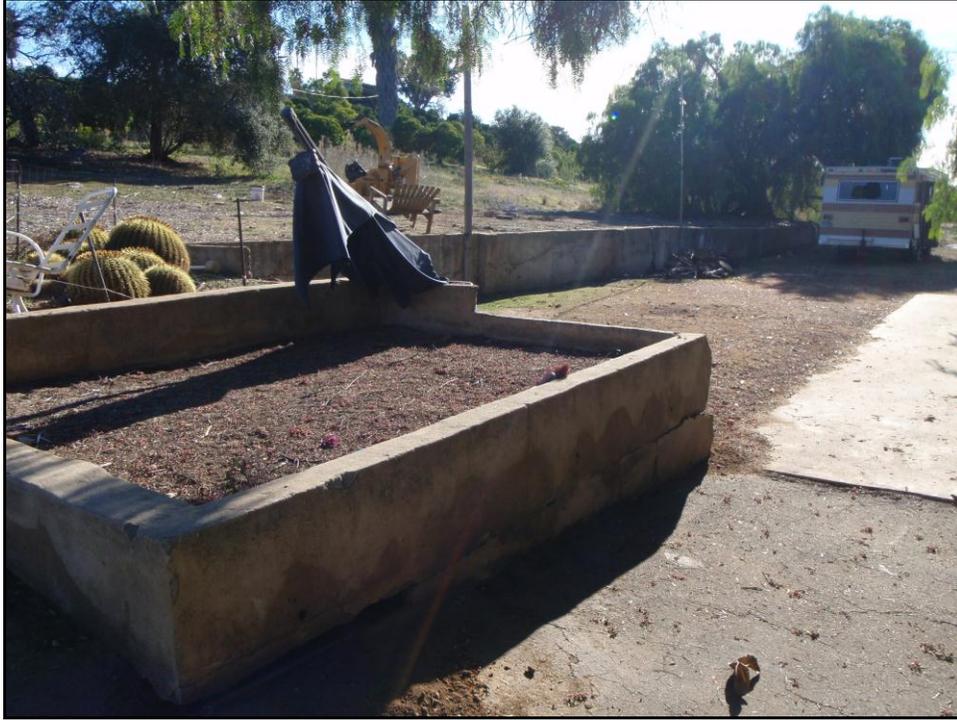
**Photograph 3** – View of concrete retaining wall, concrete pad, and RV, located in the northern portion of the subject property.

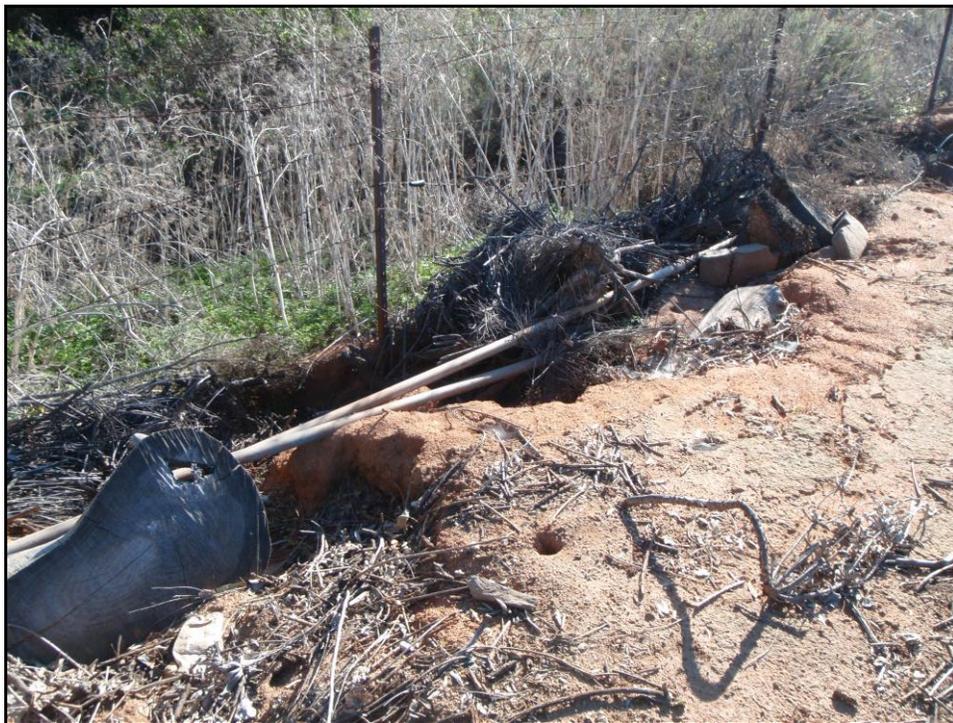
**Photograph 4** – View of piping located on the northwest portion of the site.

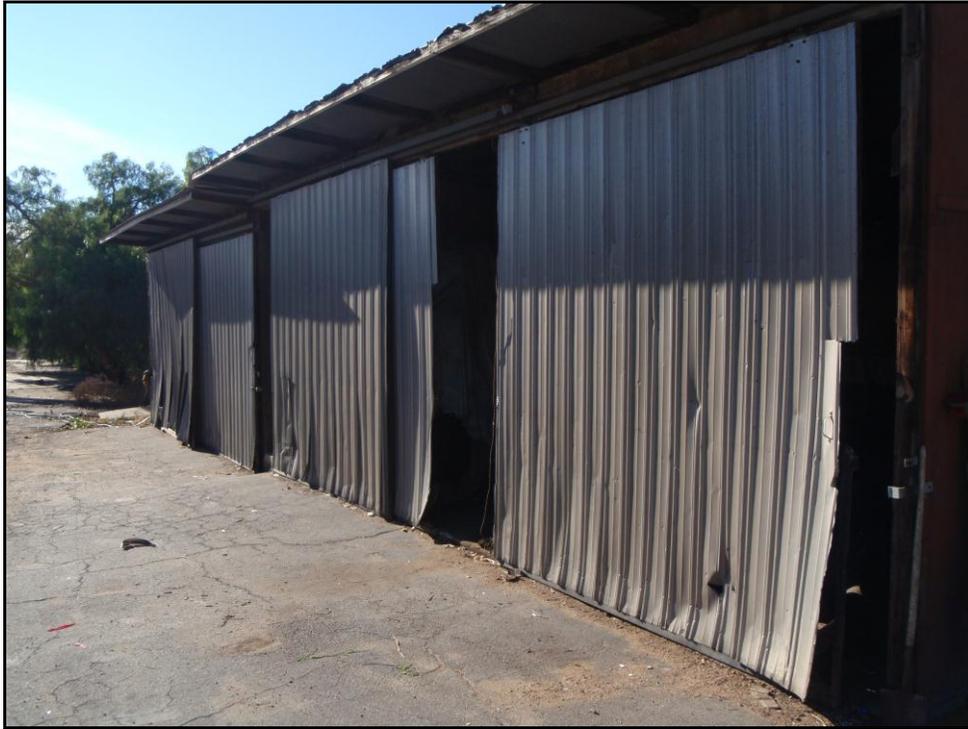
**Photograph 5** – View of a large storage shed located on the northeast portion of the subject property.

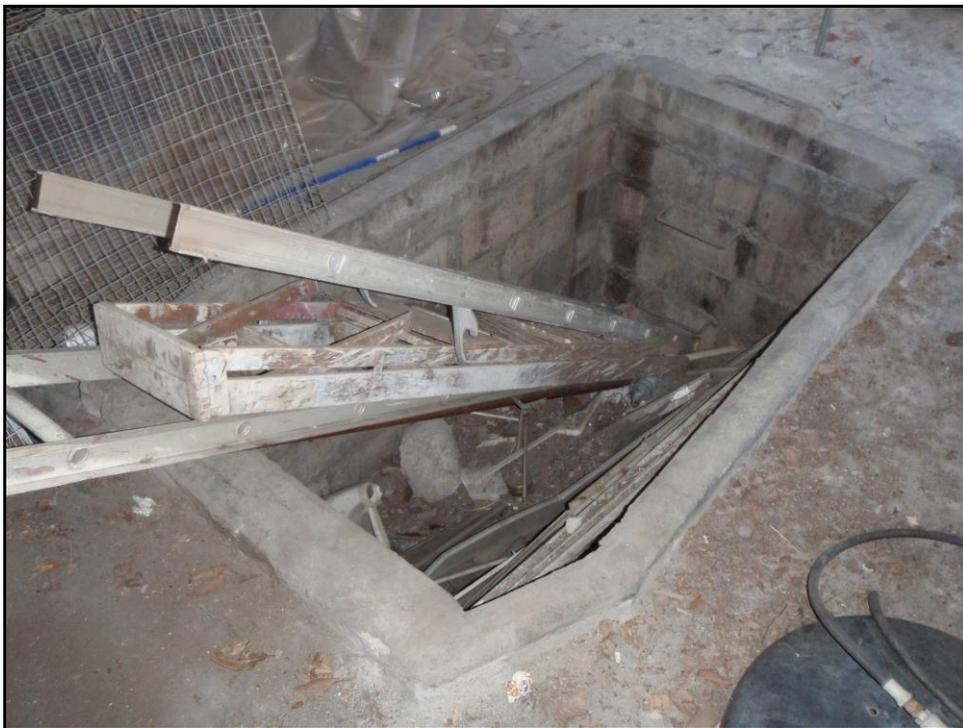
**Photograph 6** – View of ladders, construction materials and debris in a below ground vault located in the central area of the large storage shed in the northeast portion of the site.

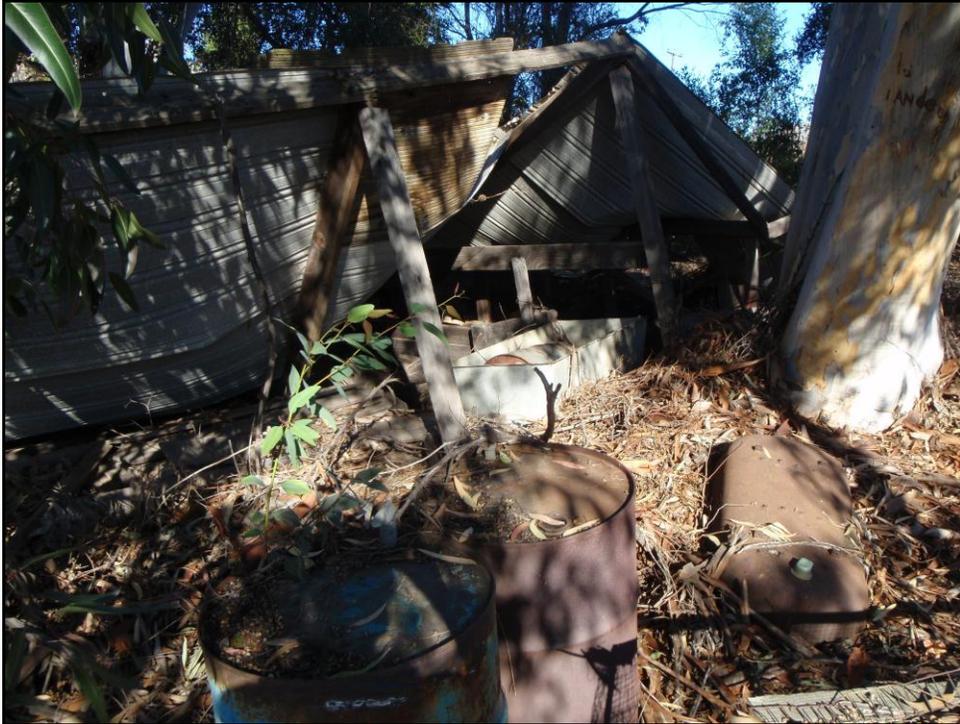
**Photograph 10** – View of steel storage drums located beneath a collapsed structure on the northeast portion of the site.

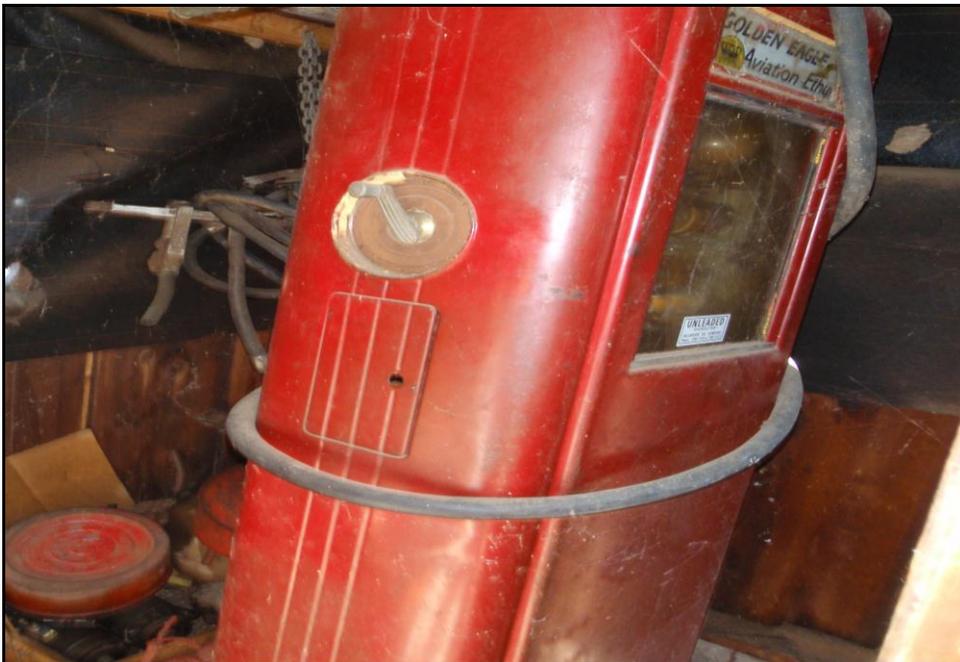
**Photograph 8** – View of a fuel pump located inside the small shed on the northeast portion of the site.

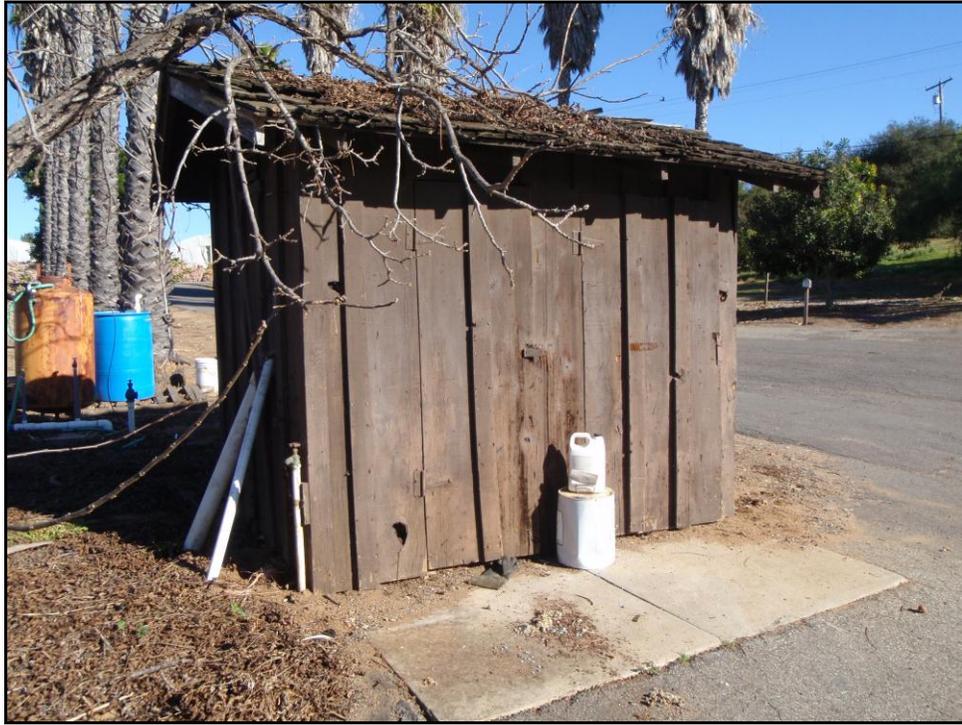
**Photograph 7** – Exterior view of small shed and piping located in the northeast portion of the site. An underground storage tank (UST) was formerly located beneath the shed.

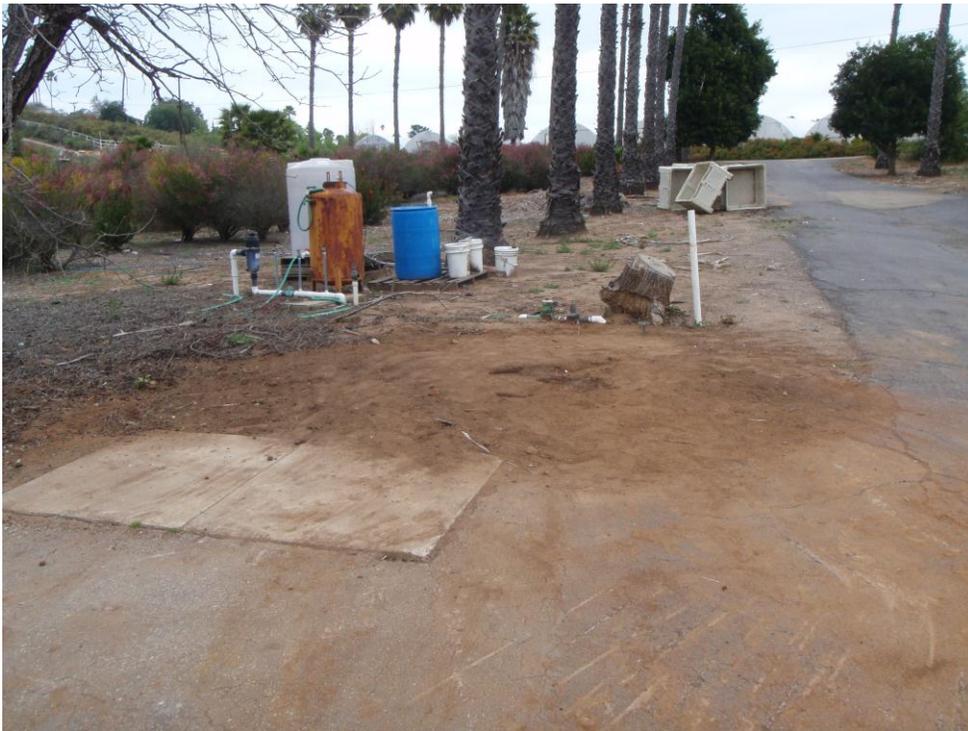
**Photograph 9** – View of the shed and former UST location after the shed was removed and subsurface soil sampling was conducted on March 6, 2012.

According to Accretive Investments, Inc., the AST and oil containers observed during our site reconnaissance were removed from the subject property sometime after our January 2012 site visit. EEI mobilized to the subject site on March 6, 2012 to collect subsurface samples in the area of the former AST and oil containers location to further evaluate site soils. At the AST location, stained soil and a strong petroleum odor were noted. It appeared that residual fuel in the tank had been spilled on to the ground. A hand auger was utilized to advance two (2) borings (ACR2 and ACR3) at the former AST location and stained soil, and one (1) boring (ACR1) at the former oil containers location. Samples were collected at 1-foot and 3 feet below grade in laboratory supplied glass jars, properly labeled, and stored in a chilled container.
