**APPENDIX G
PHOTOGRAPHIC LOG**

APPENDIX H
LIMITED AGRICULTURAL CHEMICAL SAMPLING
LABORATORY REPORT AND CHAIN OF CUSTODY

FIGURES

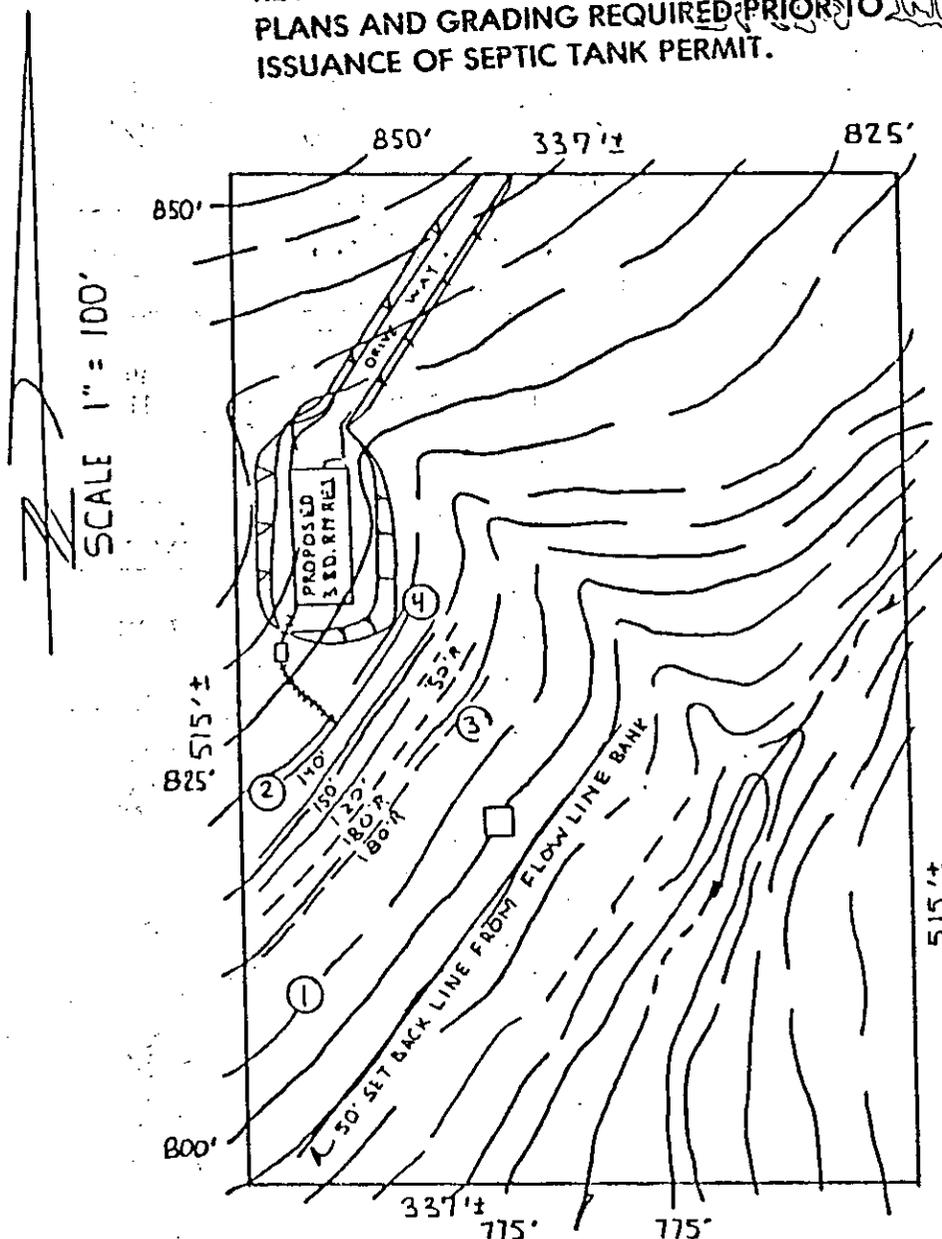
APN 128-440-9
4.01 ACRES

REVIEW OF STAMPED, APPROVED BUILDING PLANS AND GRADING REQUIRED PRIOR TO ISSUANCE OF SEPTIC TANK PERMIT.

Plot plan as shown by engineer is in substantial compliance with County Code.

Use Holes No. 1 through 4 for a rate average of 27 minutes per inch. For a three bedroom residence use 410 lineal feet of leach line with 100% reserve connected to a 1000 gallon septic tank.

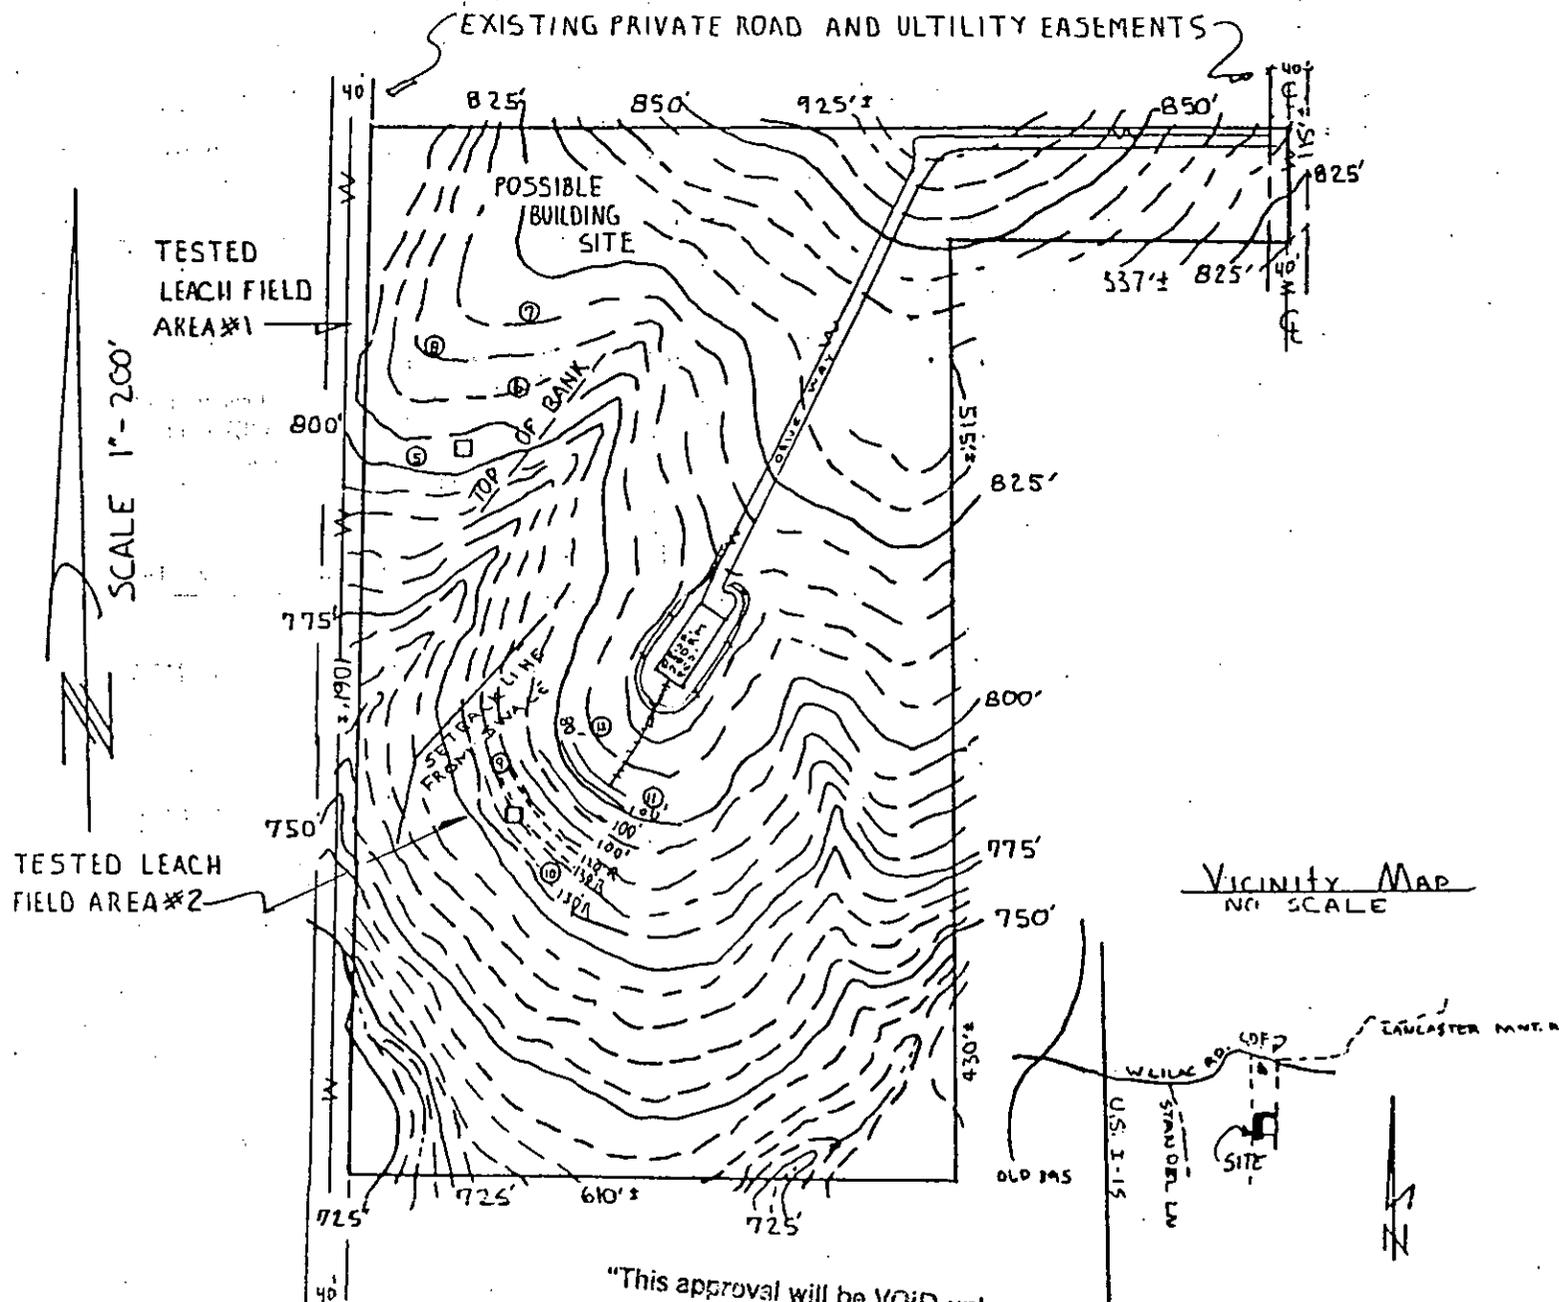
APN 128 440-10
 11.98 ACRES
 128-440-20

REVIEW OF STAMPED, APPROVED BUILDING
 PLANS AND GRADING REQUIRED PRIOR TO
 ISSUANCE OF SEPTIC TANK PERMIT.

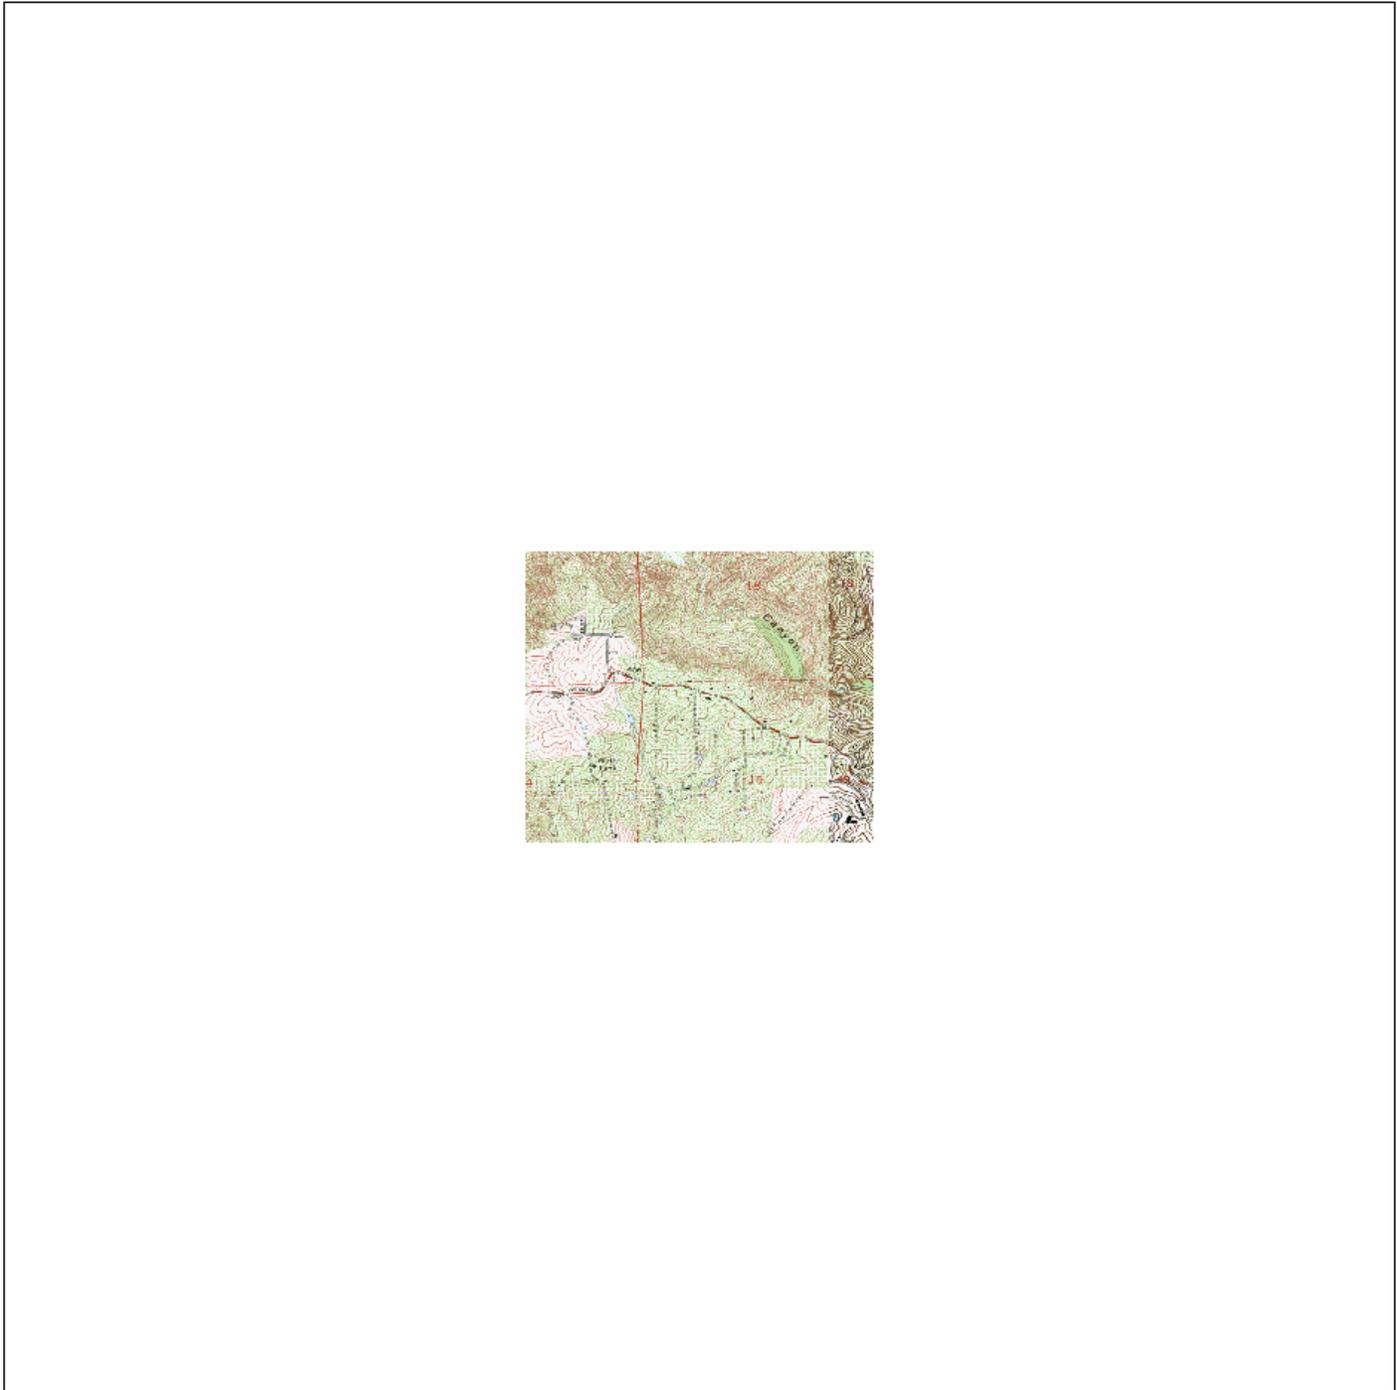
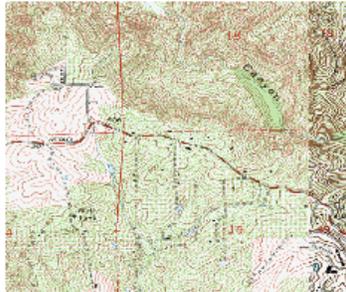
Topo : 0.75 Mile Radius from Area

SOURCE: SCANNED USGS TOPOGRAPHIC QUADRANGLES
SCANNED BY MAPTECH AND USGS
DISTRIBUTED AUGUST, 2005.

Black Rings Represent 1/4 Mile Radii; Red Ring Represents 500 ft. Radius

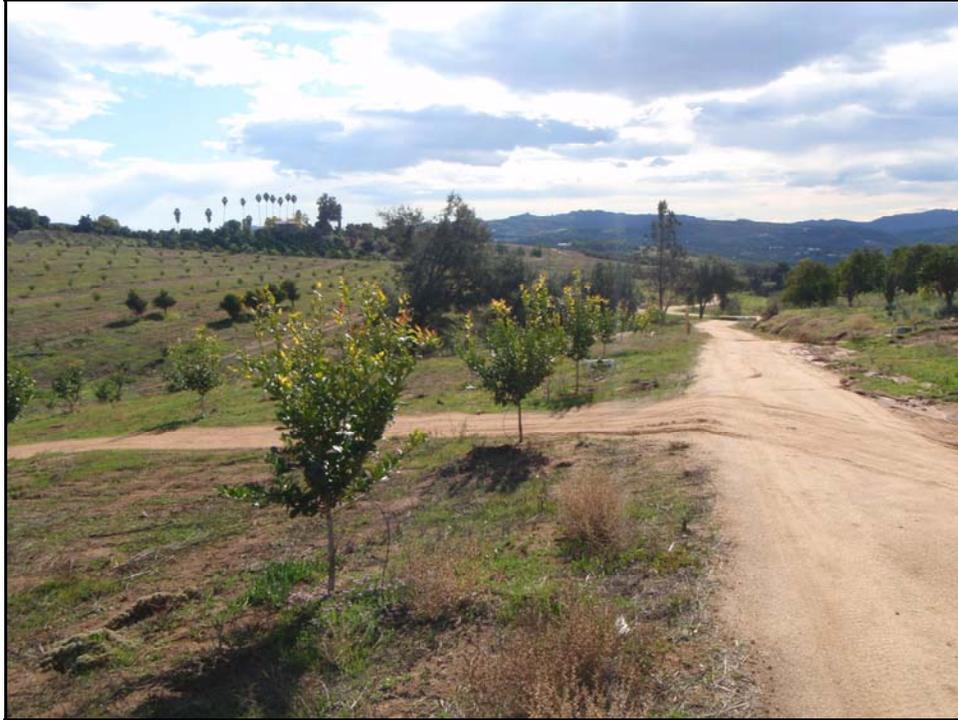
Photograph 1 – View of the subject property looking south along Birdsong Drive. View is from the northern portion of the subject property.

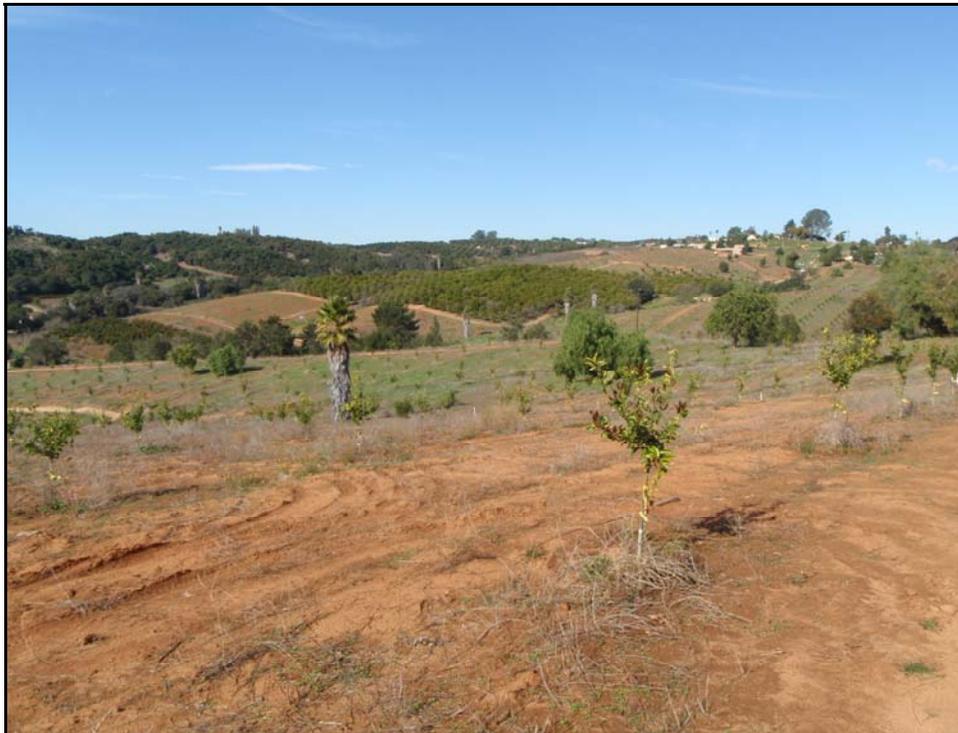
Photograph 2 – View of the subject property looking northwest. View is from the southeast corner of the subject property.

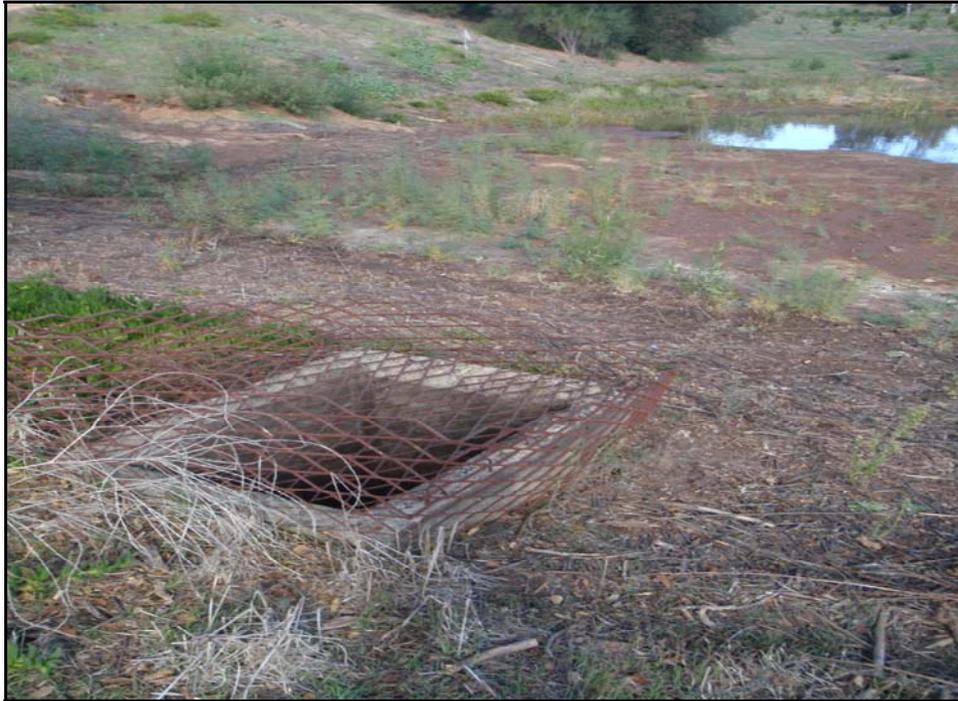
Photograph 3 – View of the concrete cistern near pond located in the central portion of the subject property. A man-made agricultural pond is also in view.

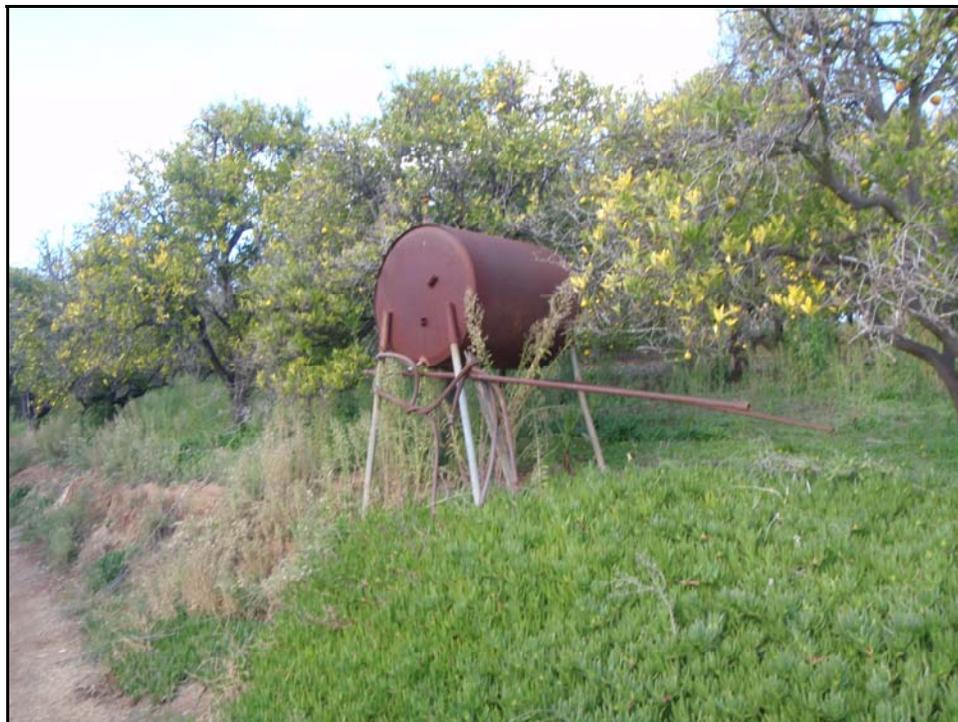
Photograph 4 – View of the above ground storage tank located in the central portion of the subject property.

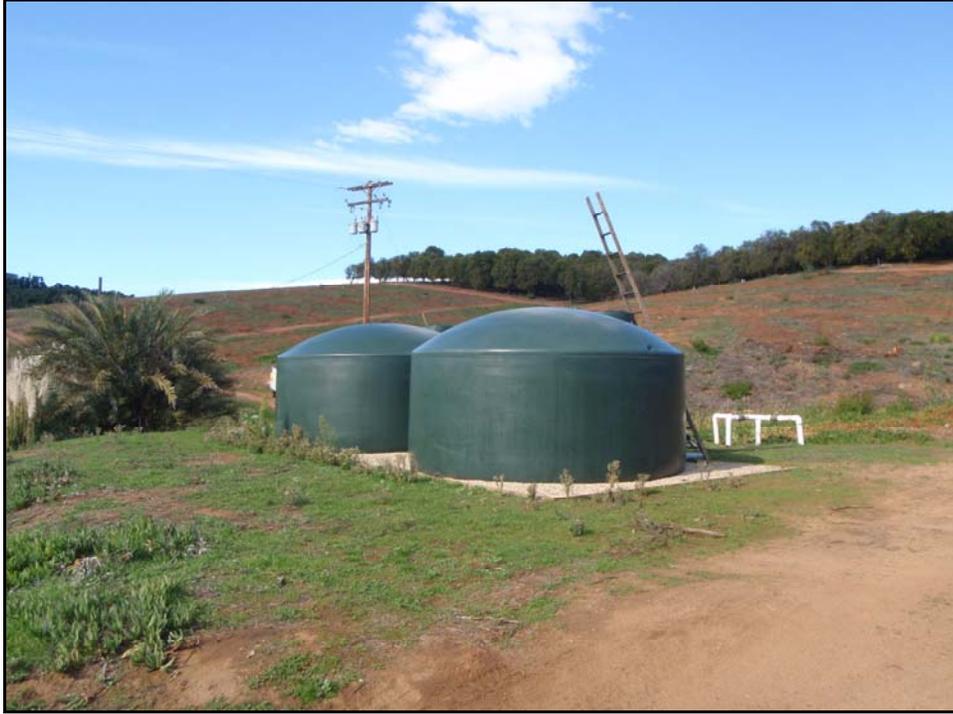
Photograph 5 – View of above ground water storage tanks in central portion of the subject property.

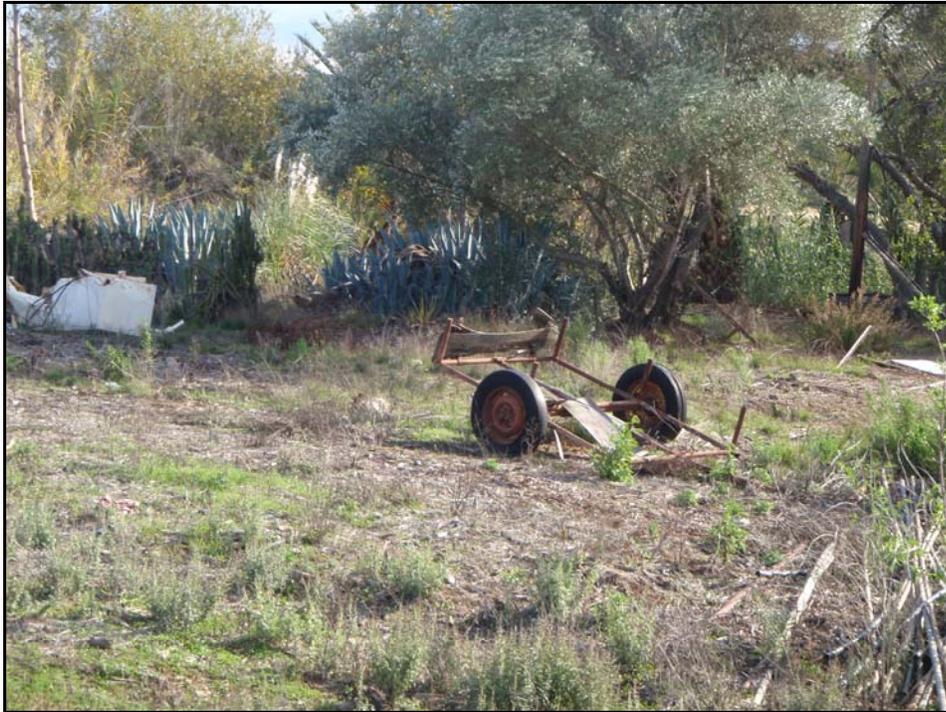
Photograph 6 – View of trash and debris in the central portion of the subject property.

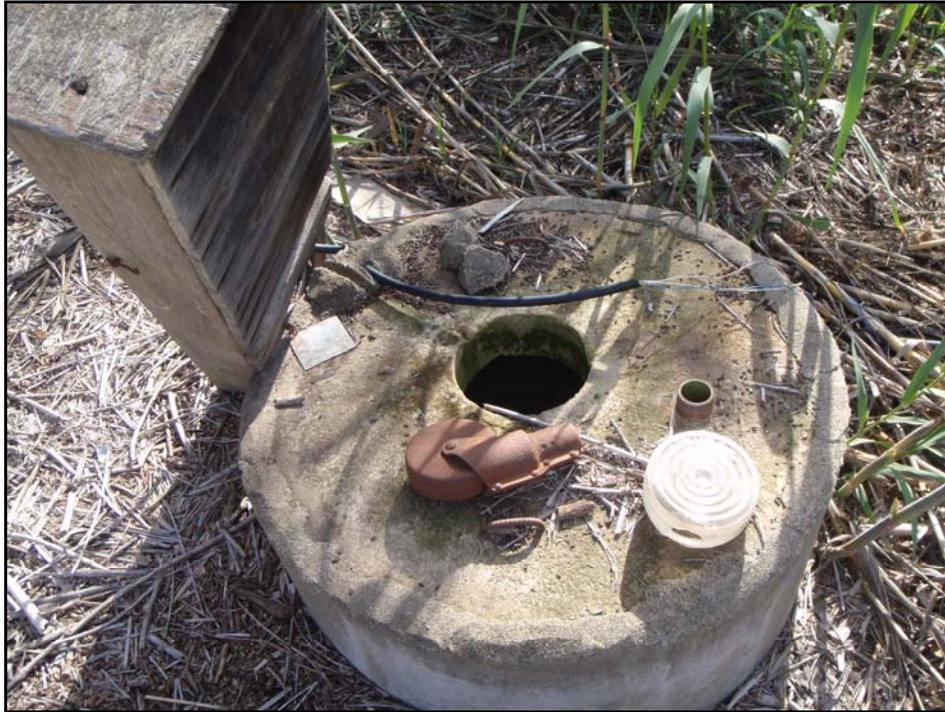
Photograph 7 – View of an uncovered concrete well with associated wiring (not in operating condition) located in south-central portion of subject property.

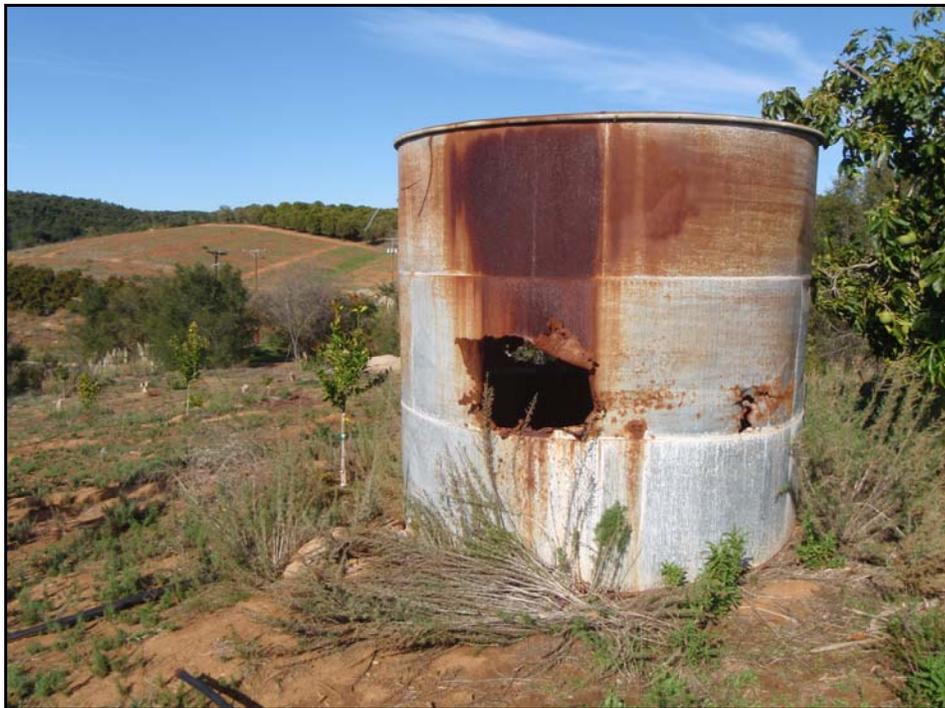
Photograph 8 – View of empty storage tank located in the south-central portion of the subject property.

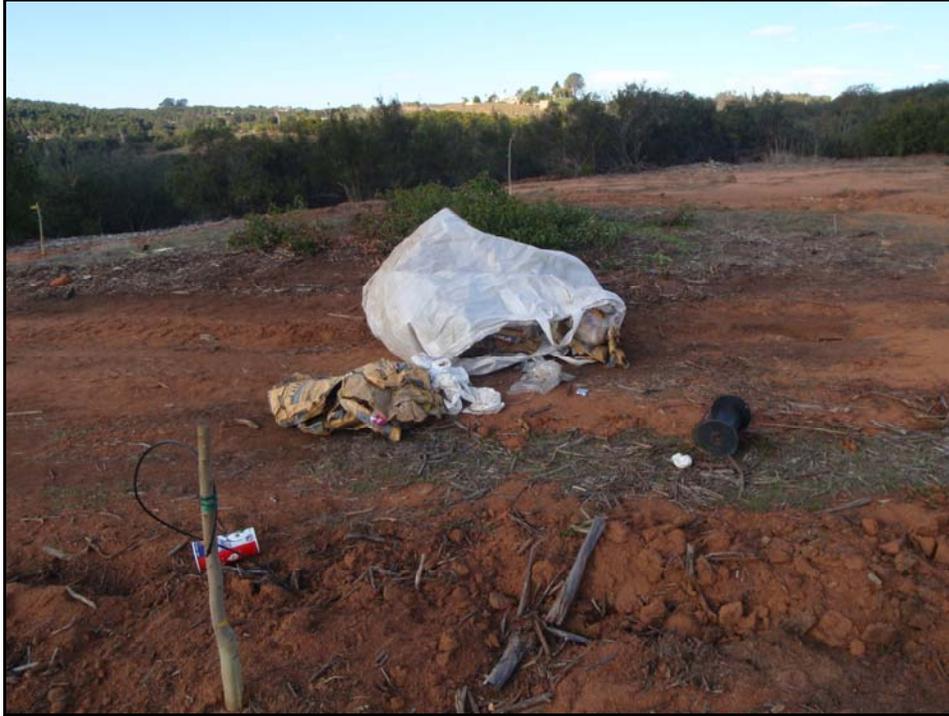
Photograph 9 – View of trash and debris in the south central portion of the subject property.

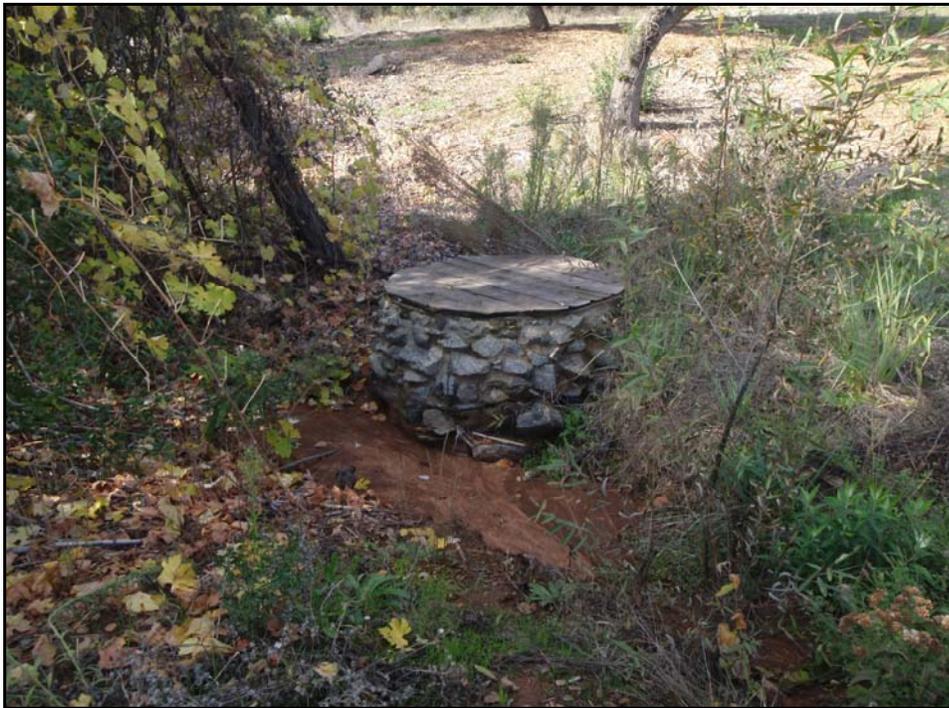
Photograph 10 – View of stone well located in southwest portion of subject property.

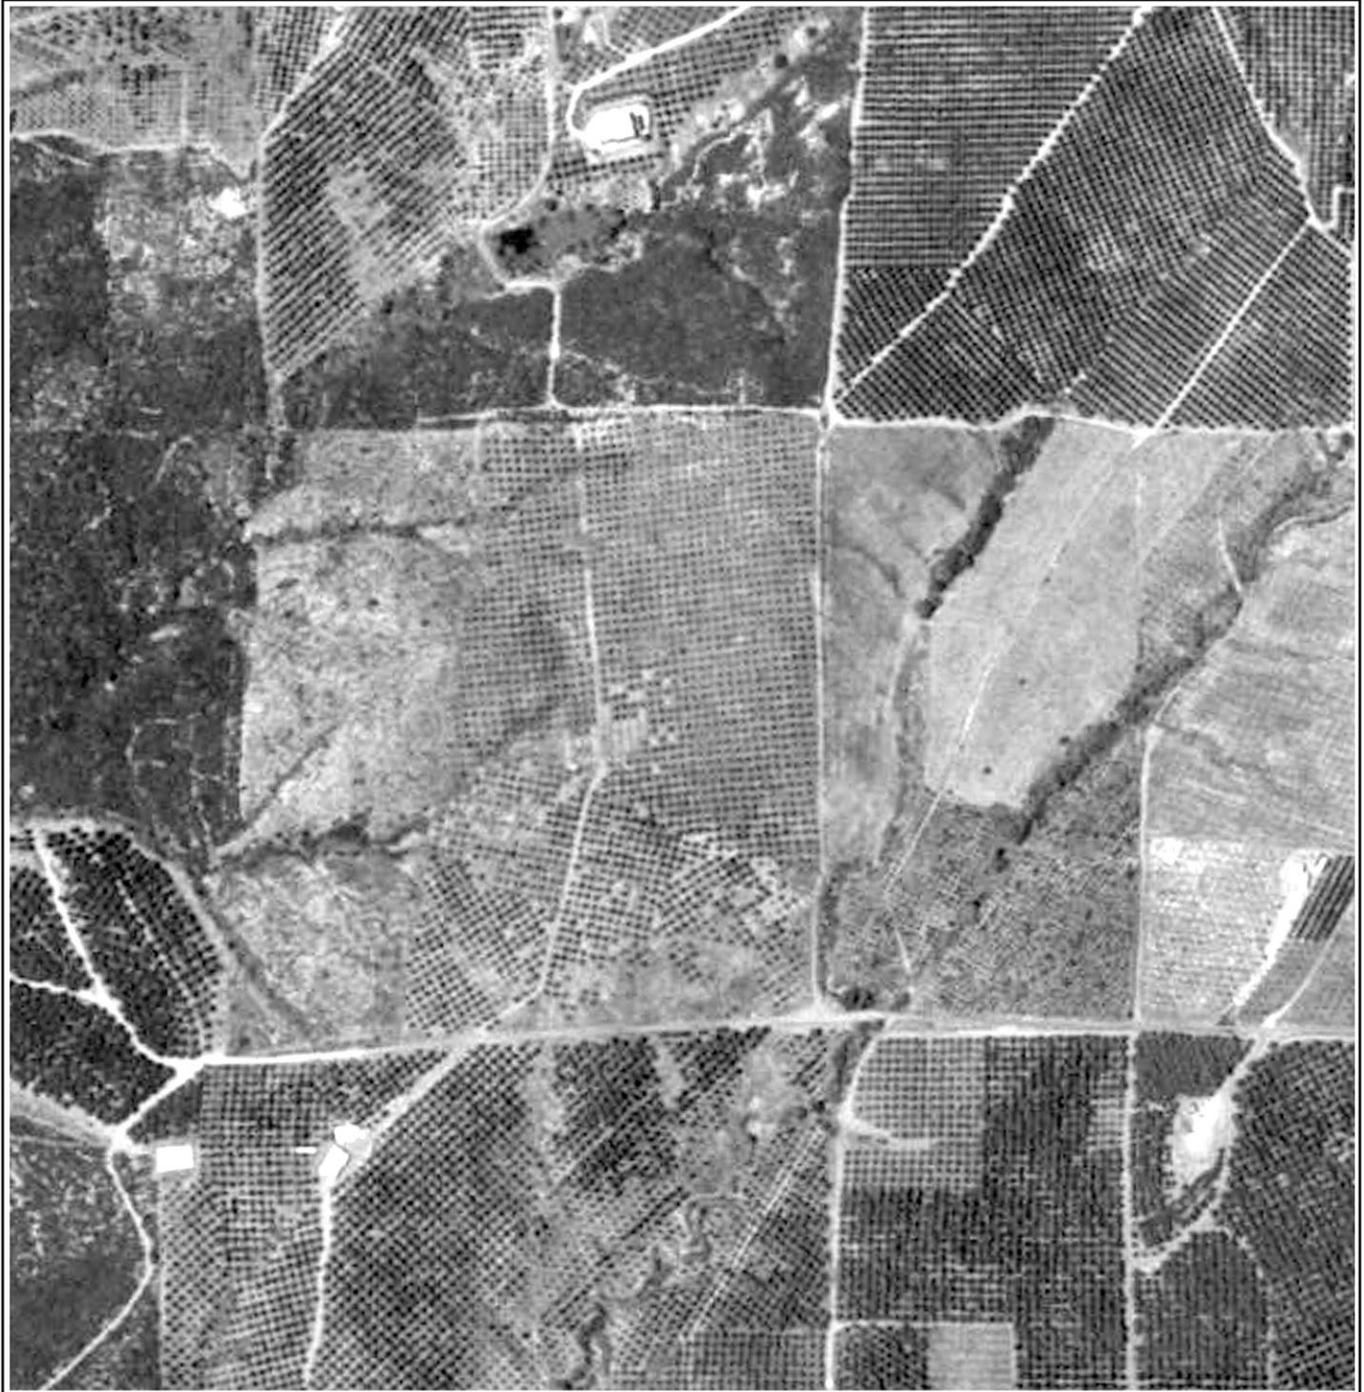
1980

Job Number: ACR71387.1b (AMI-SD-80_10235)
Target Site: 33.287844, -117.130786

Approximate Scale: 1 in equals 375 ft

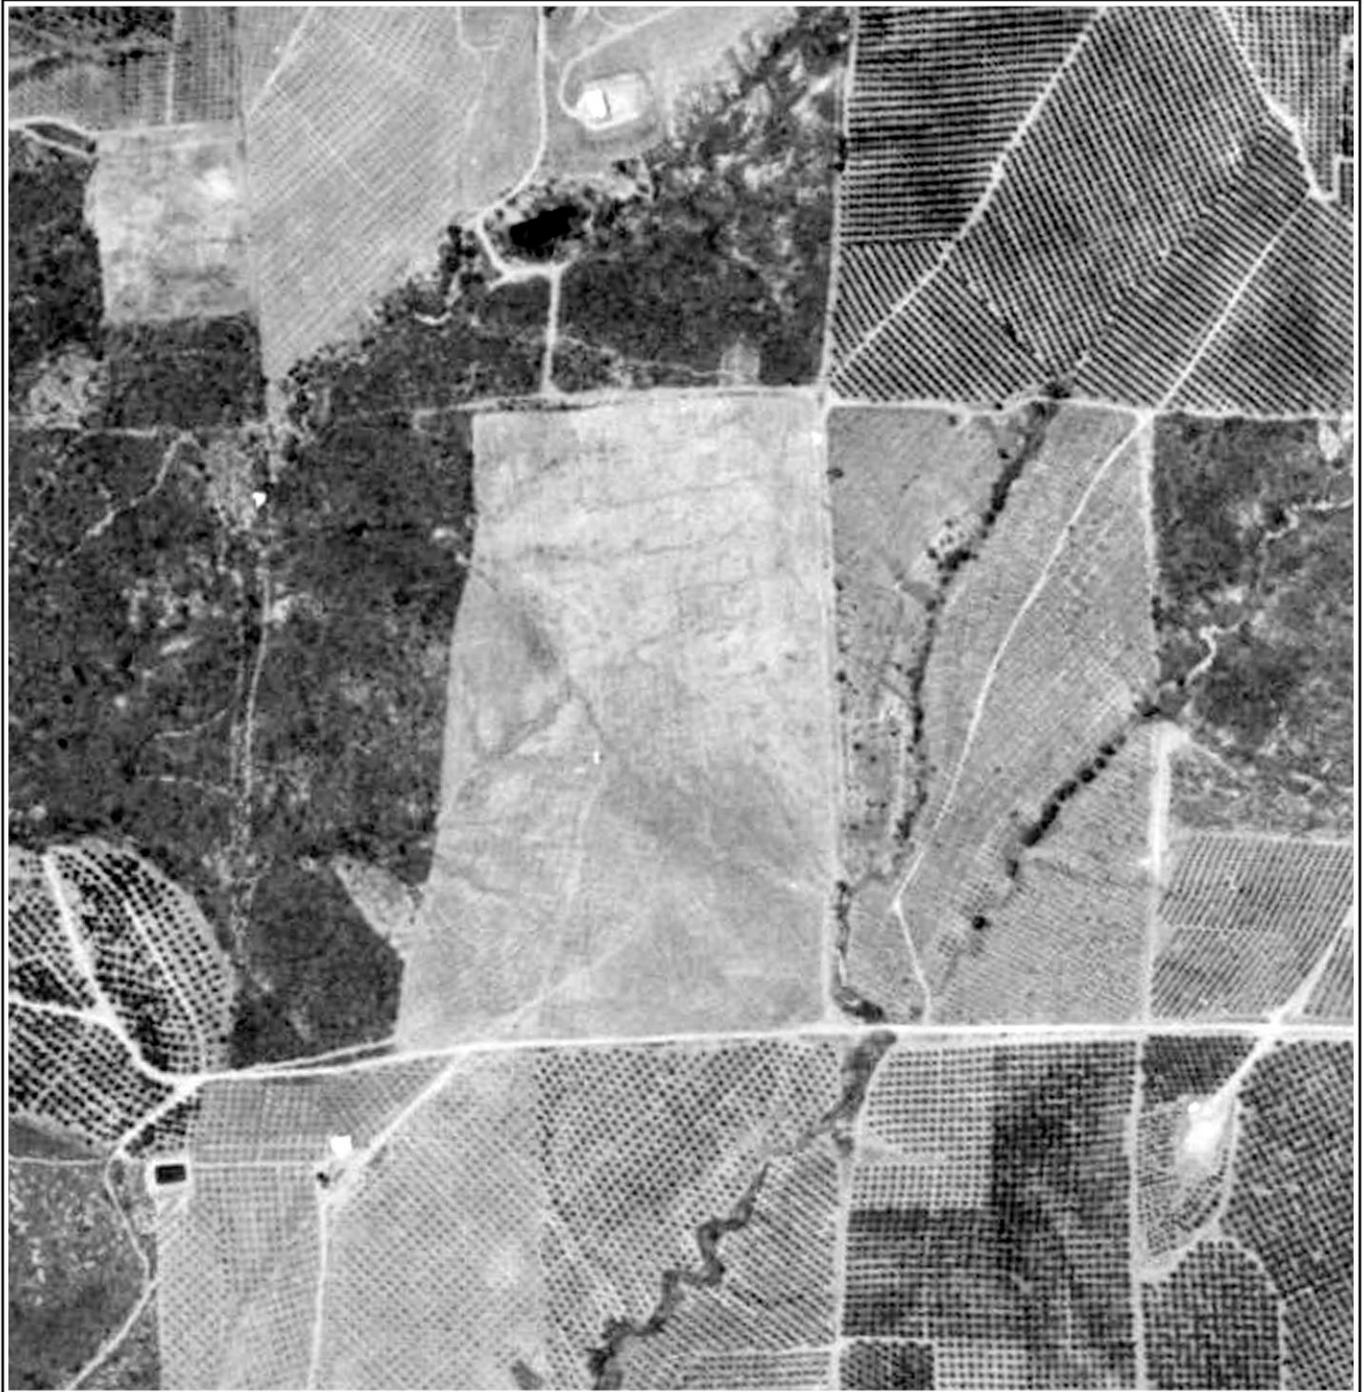
1975

Job Number: ACR71387.1b (AMI-SD-75_7649)
Target Site: 33.287844, -117.130786

Approximate Scale: 1 in equals 375 ft
