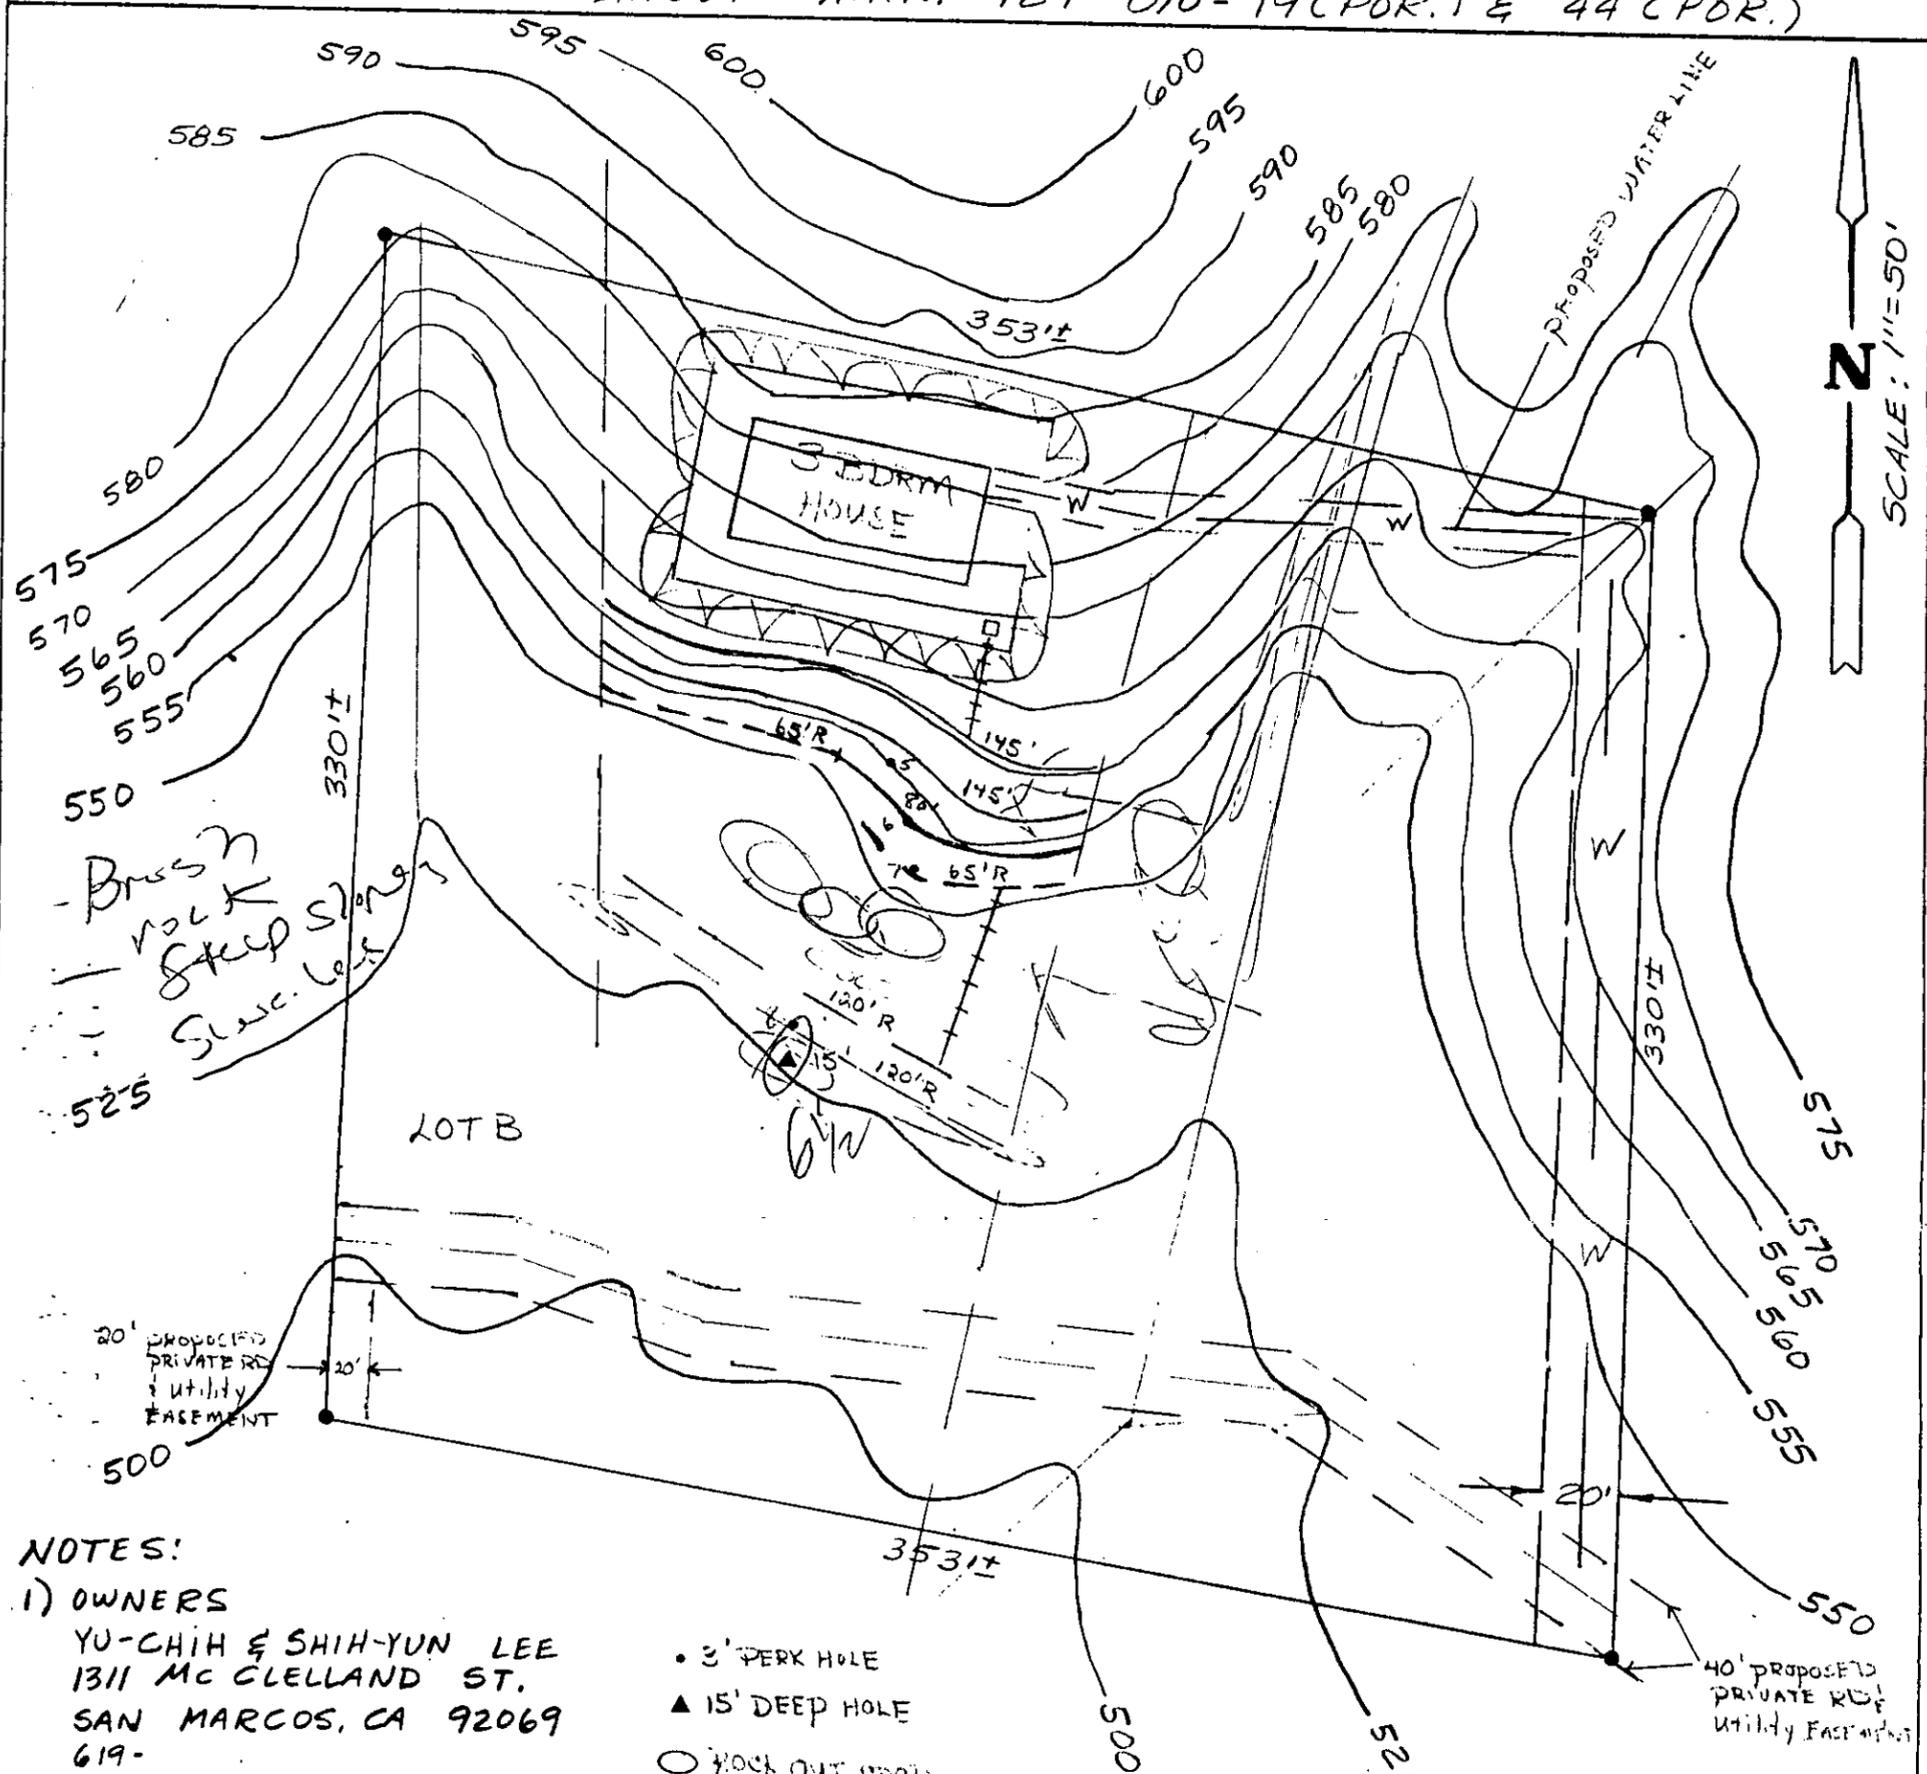
SEPTIC SYSTEM LAYOUT- A.P.N. 129-010-19(POR.) & 44(POR.)

- 1) OWNERS
 YU-CHIH & SHIH-YUN LEE
 1311 MC CLELLAND ST.
 SAN MARCOS, CA 92069
 619-
- 2) 370 TILE LINE REQ.
 FOR 3 - BDRM. HOUSE

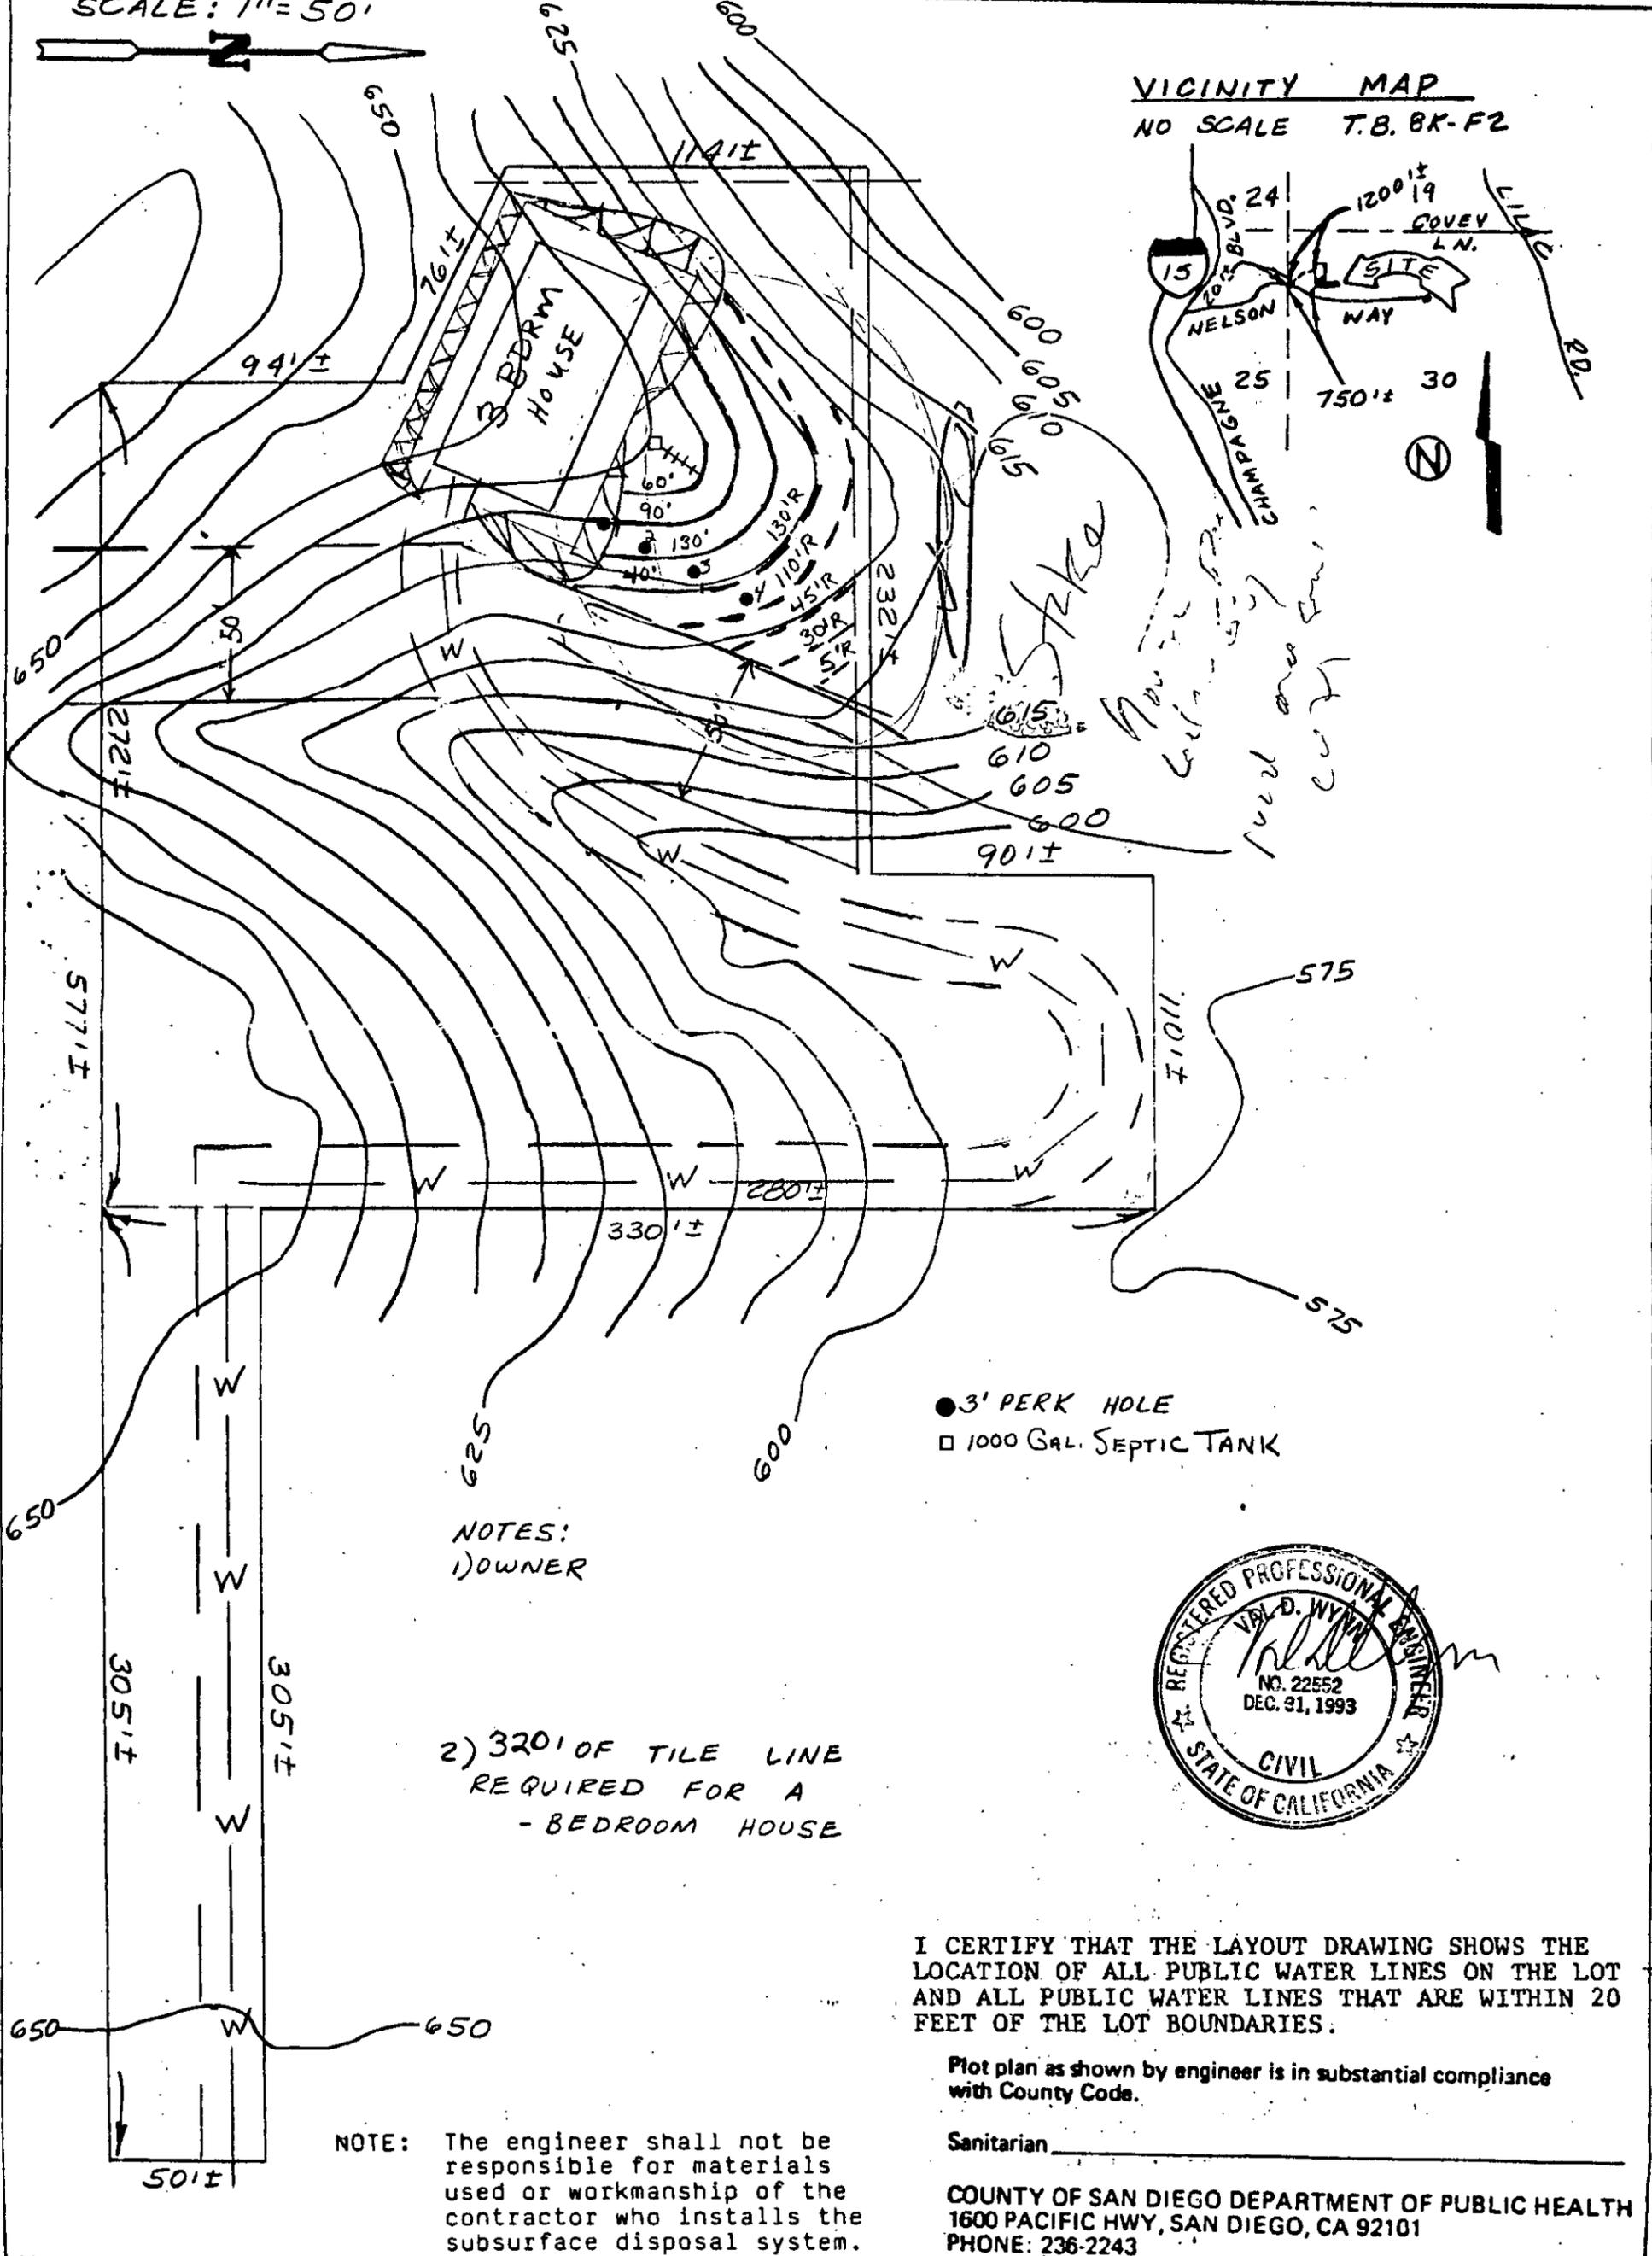
SEPTIC SYSTEM LAYOUT - A.P.N. 129-010-19,20,44 (PORTIONS)
 SCALE: 1"=50'

2) 320' OF TILE LINE
 REQUIRED FOR A
 - BEDROOM HOUSE

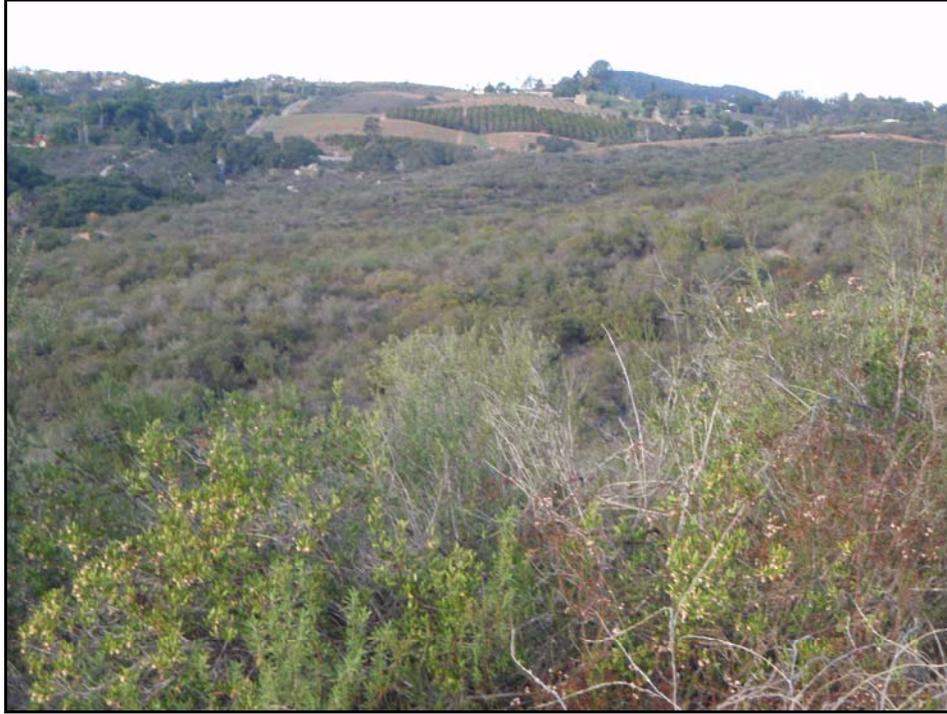
Photograph 1 – View of the subject property, looking north. View is from the southern portion of the property.

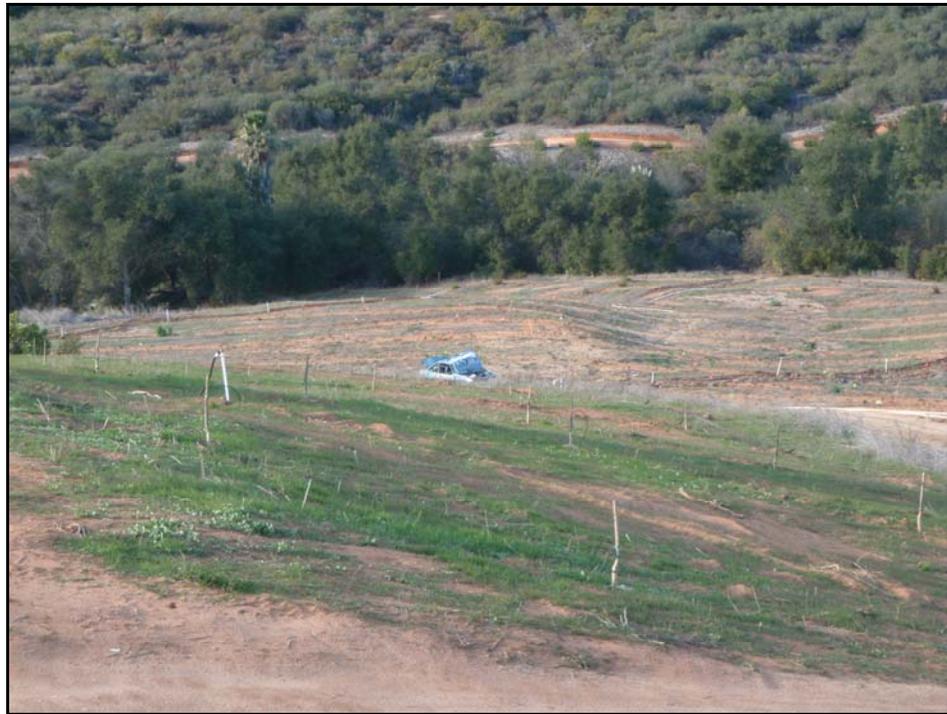
Photograph 2 – View of the central portion of subject property looking west. View is from the east edge of the property near Covey Lane. An abandoned vehicle is in view.

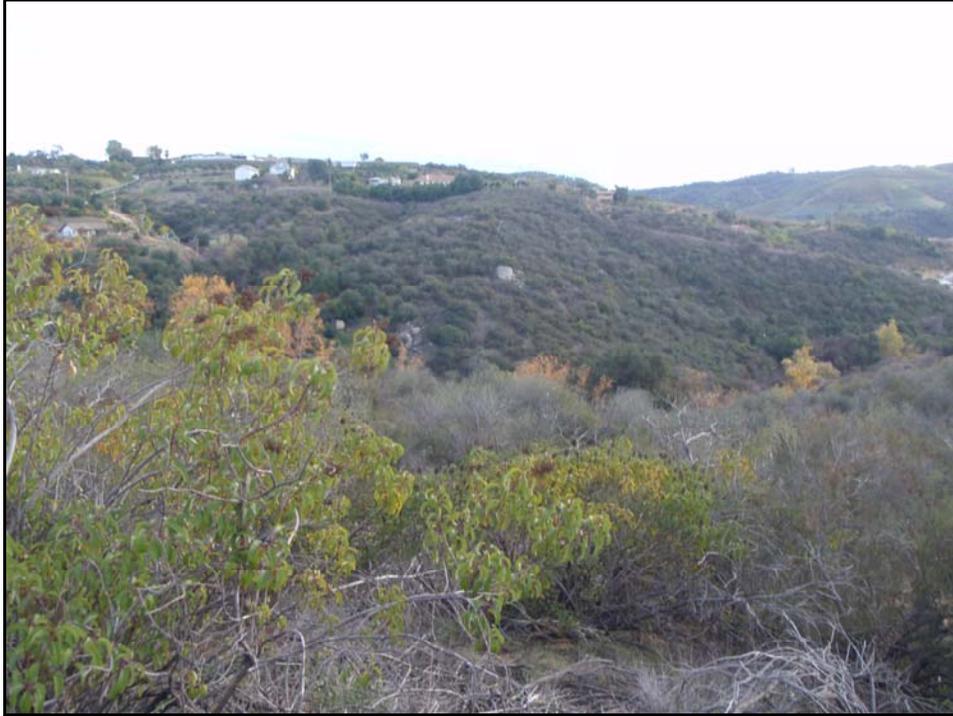
Photograph 3 – View of the southern portion of the subject property, looking south. View is from the road traversing the property.

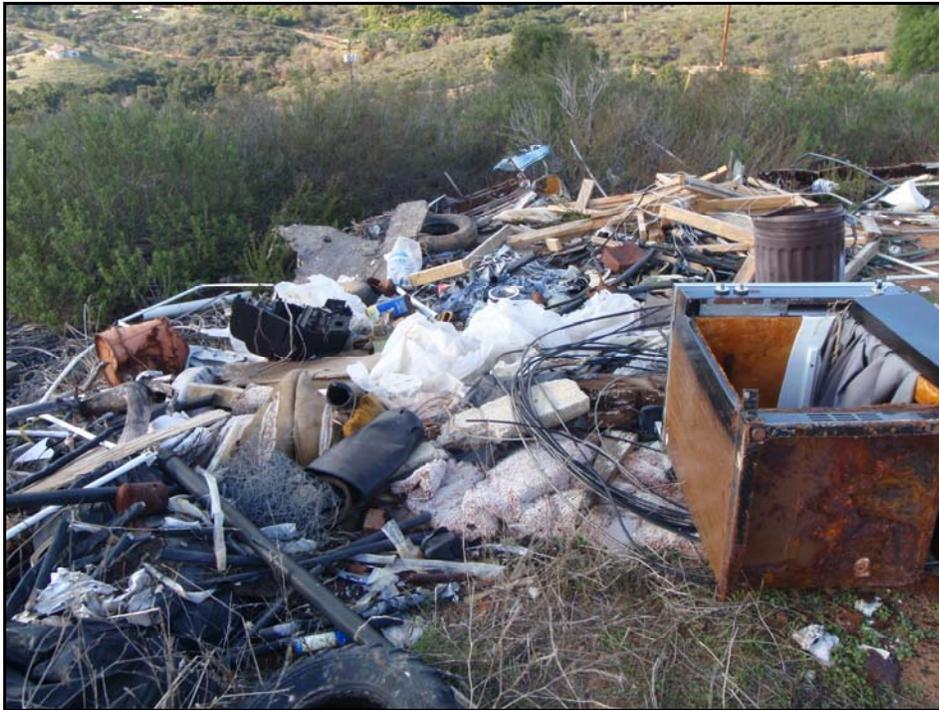
Photograph 4 – View of trash and debris located along the eastern property margin. Debris in the area includes steel buckets, empty propane tanks, empty motor oil containers, pipe, tires, cables, appliances, electronics, and other miscellaneous household and construction debris.

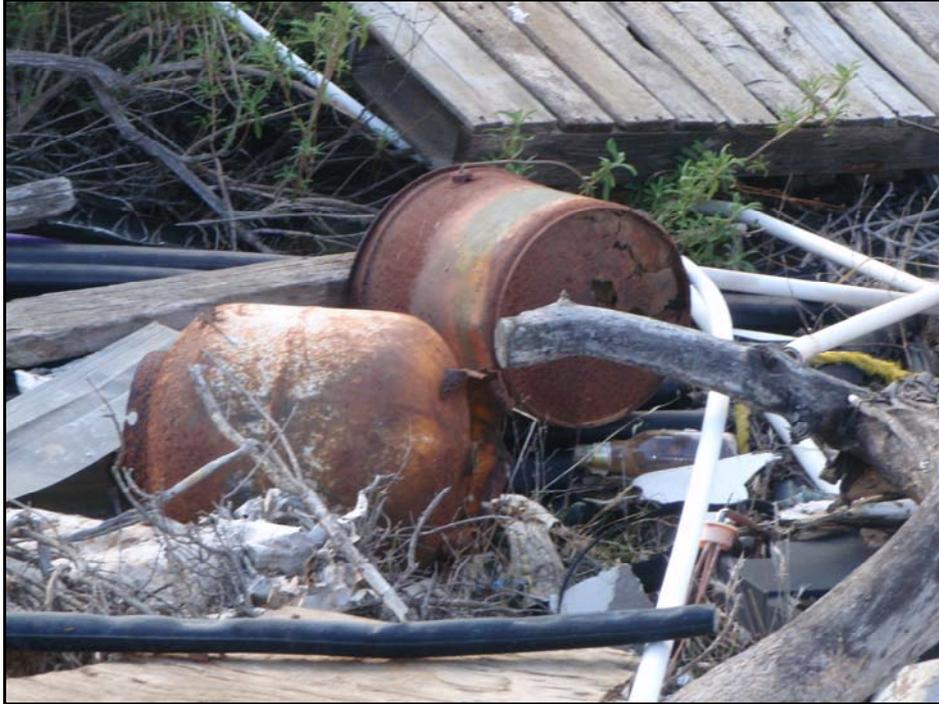
Photograph 5 – View of the empty propane tank and 5-gallon bucket in an area of debris located along the eastern property margin.

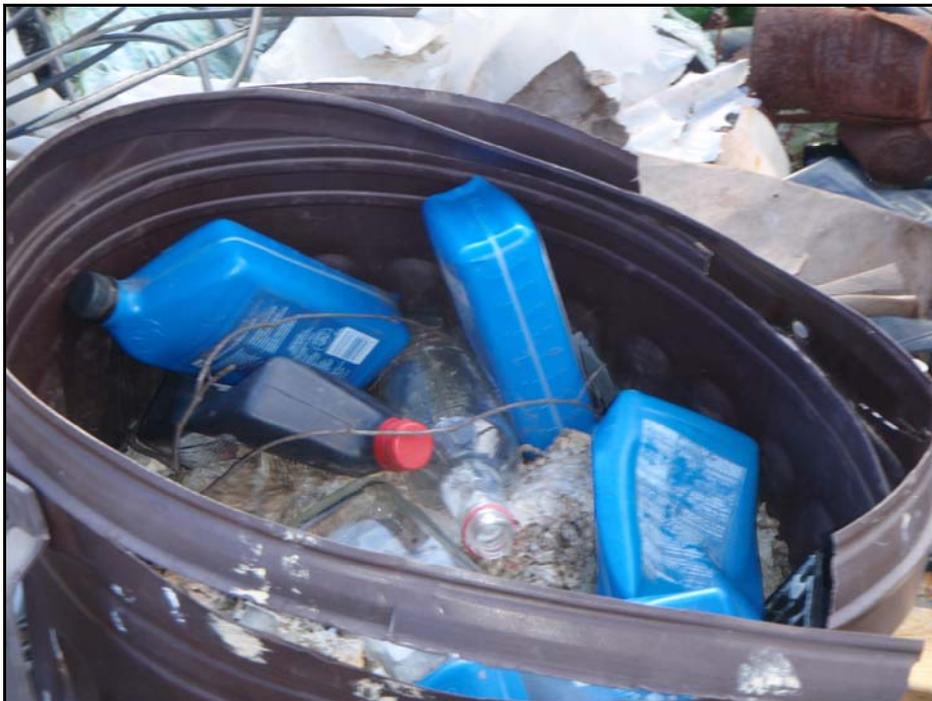
Photograph 6 – View of empty motor oil containers in an area of debris located along the eastern property margin.

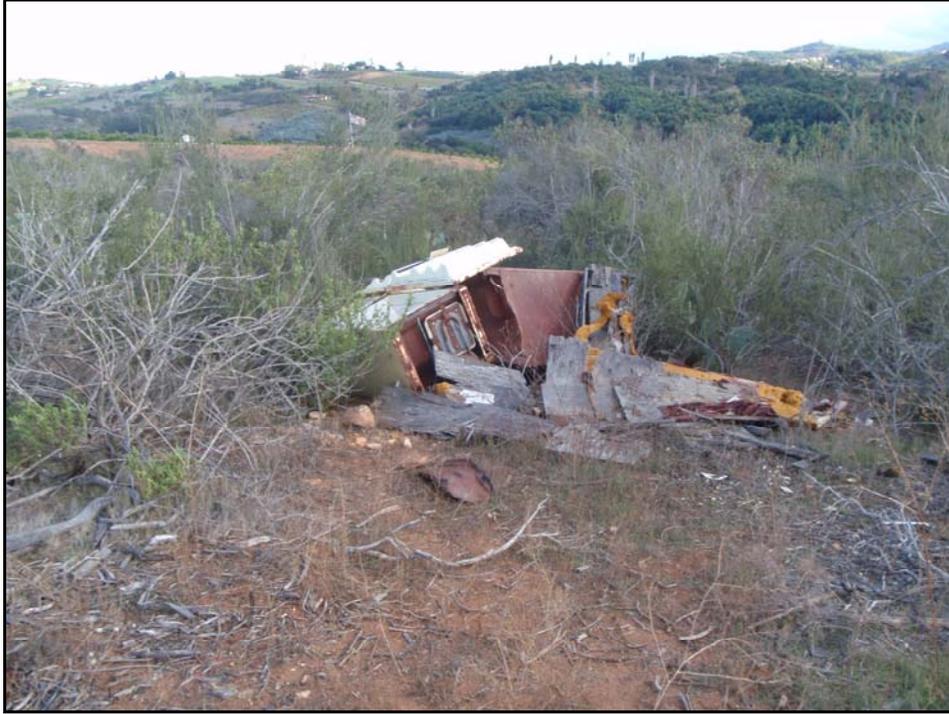
Photograph 7 – View of refrigerator and wood debris located along the eastern property margin.

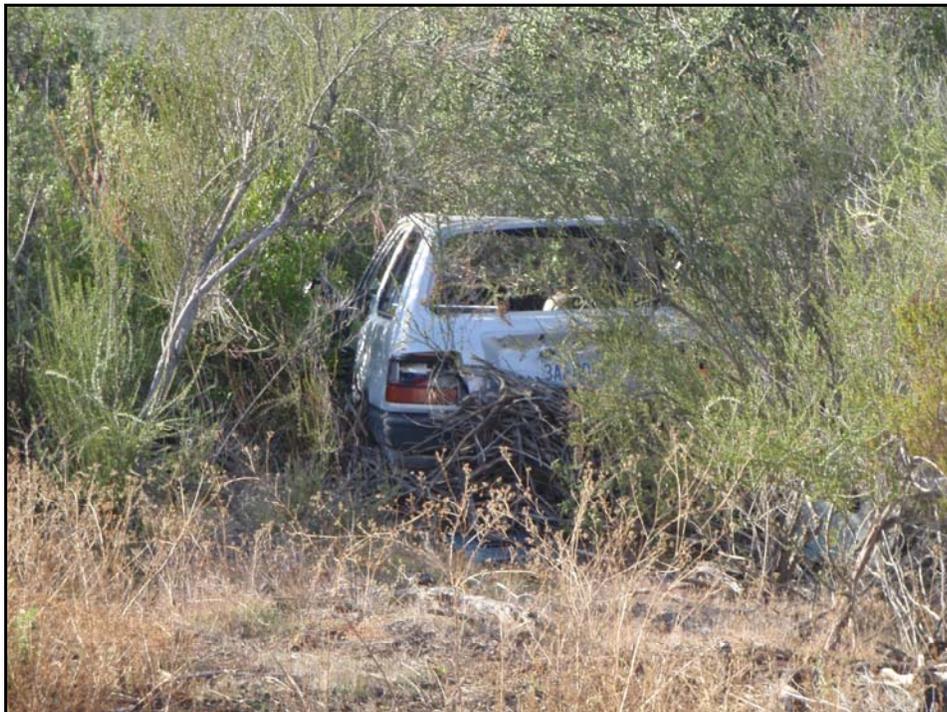
Photograph 8 – View of abandoned vehicle in the south-central portion of the subject property.

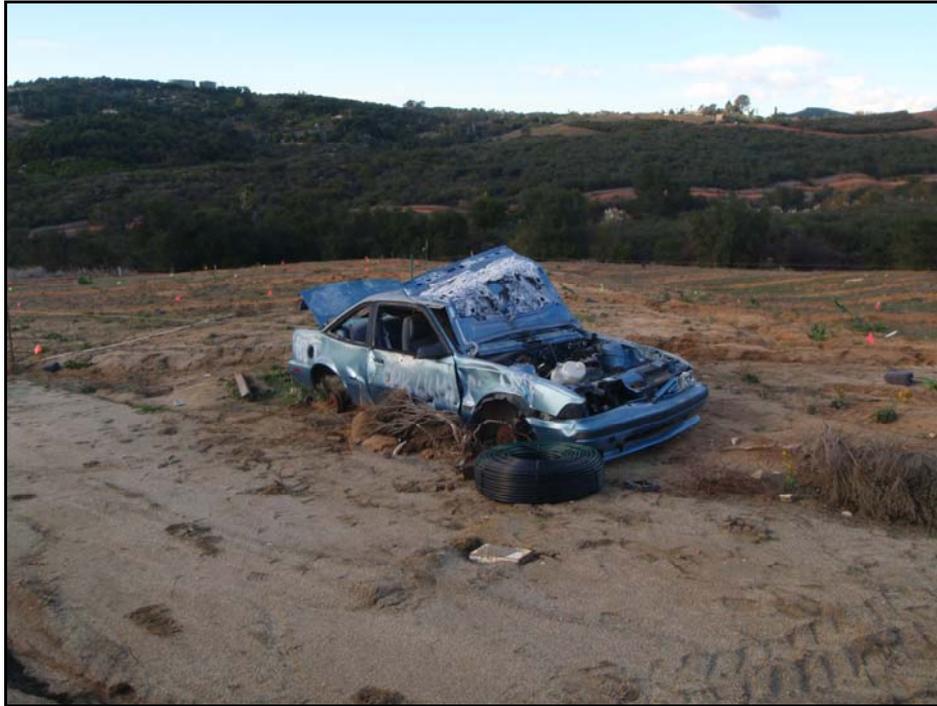
Photograph 9 – View of abandoned vehicle in central portion of the subject property.

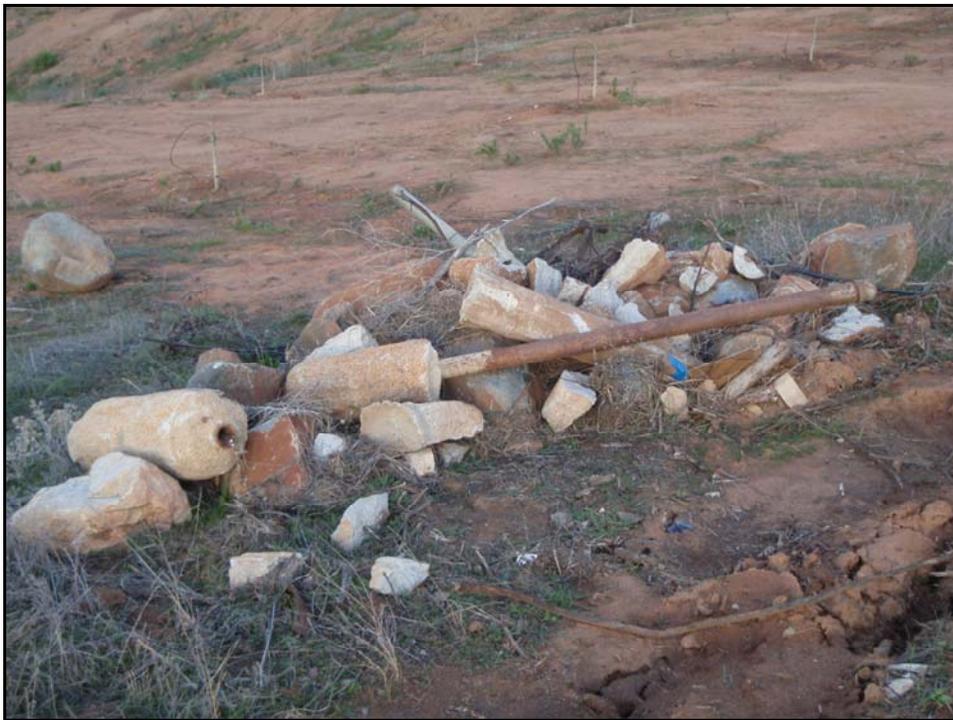
Photograph 10 – View of concrete and pipe debris in the central portion of the subject property.

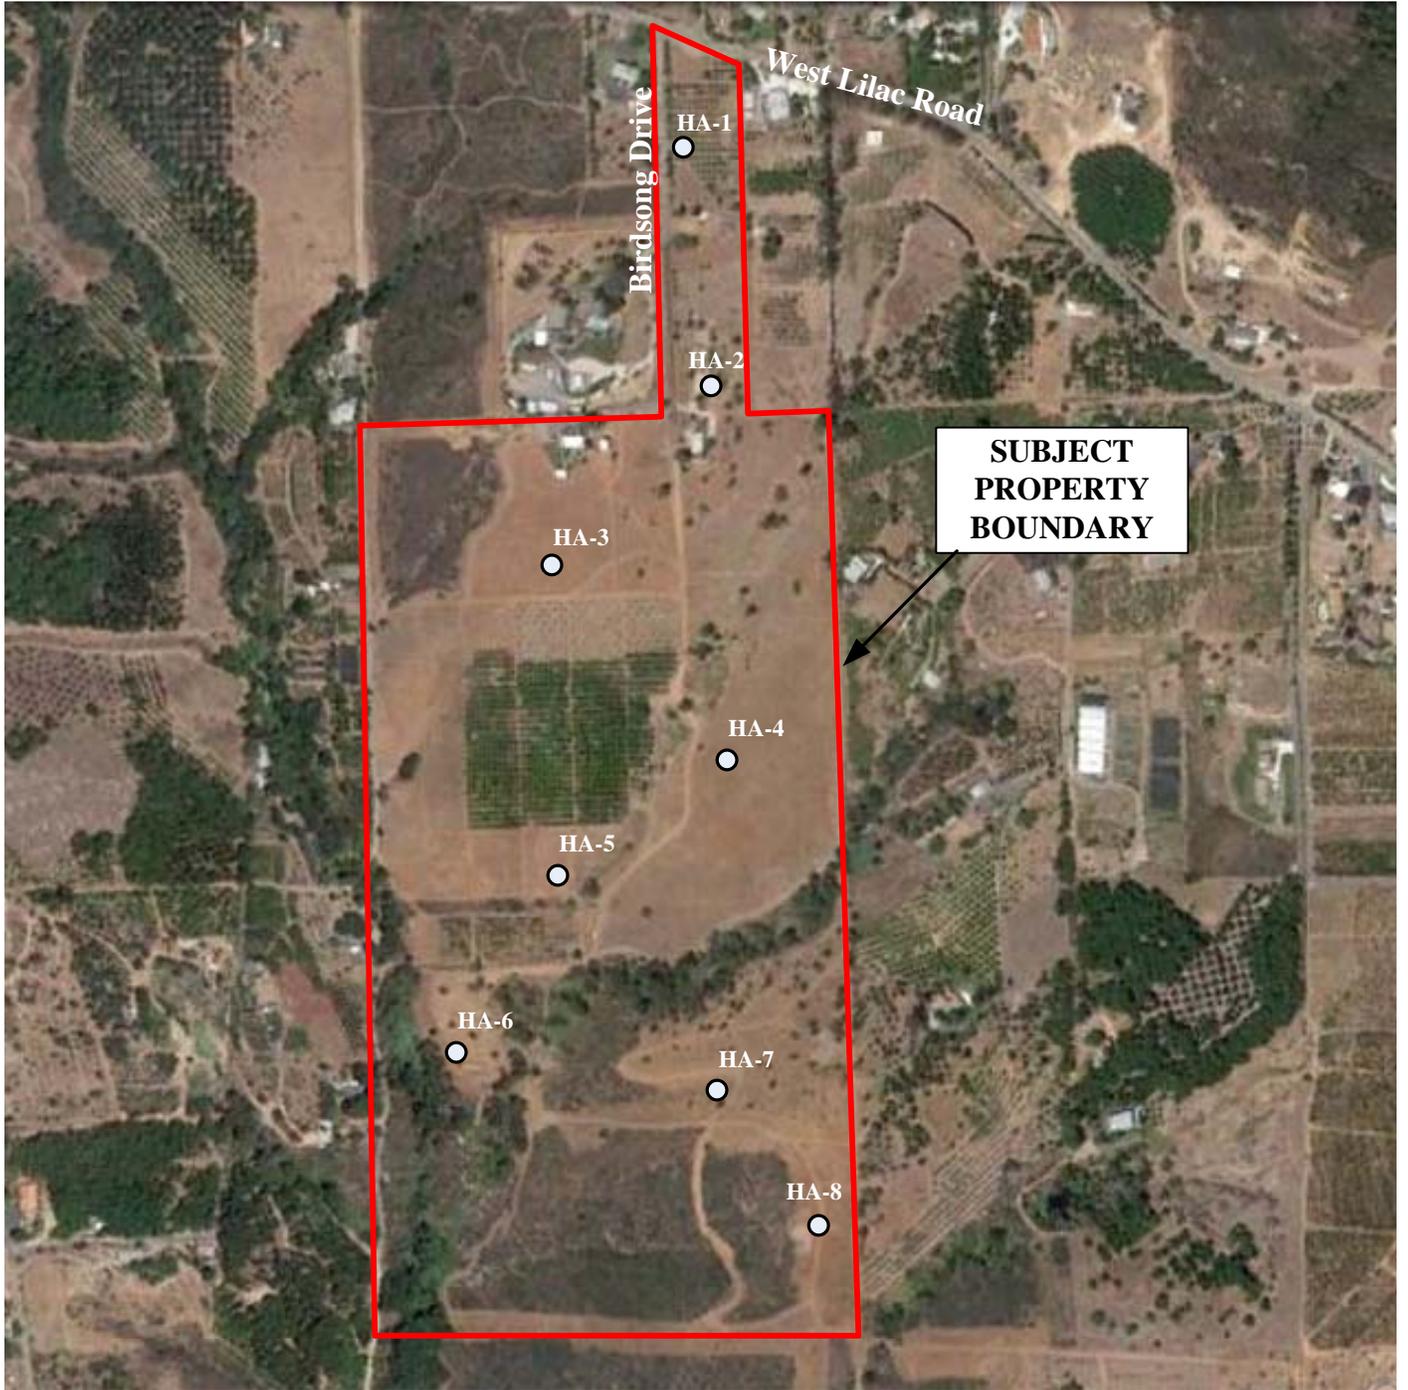
FIGURE 1

This report documents additional limited soil sampling activities performed at the subject property (**Figure 1**). This work was completed on July 20, 2012.

Figure 1- Site Location Map

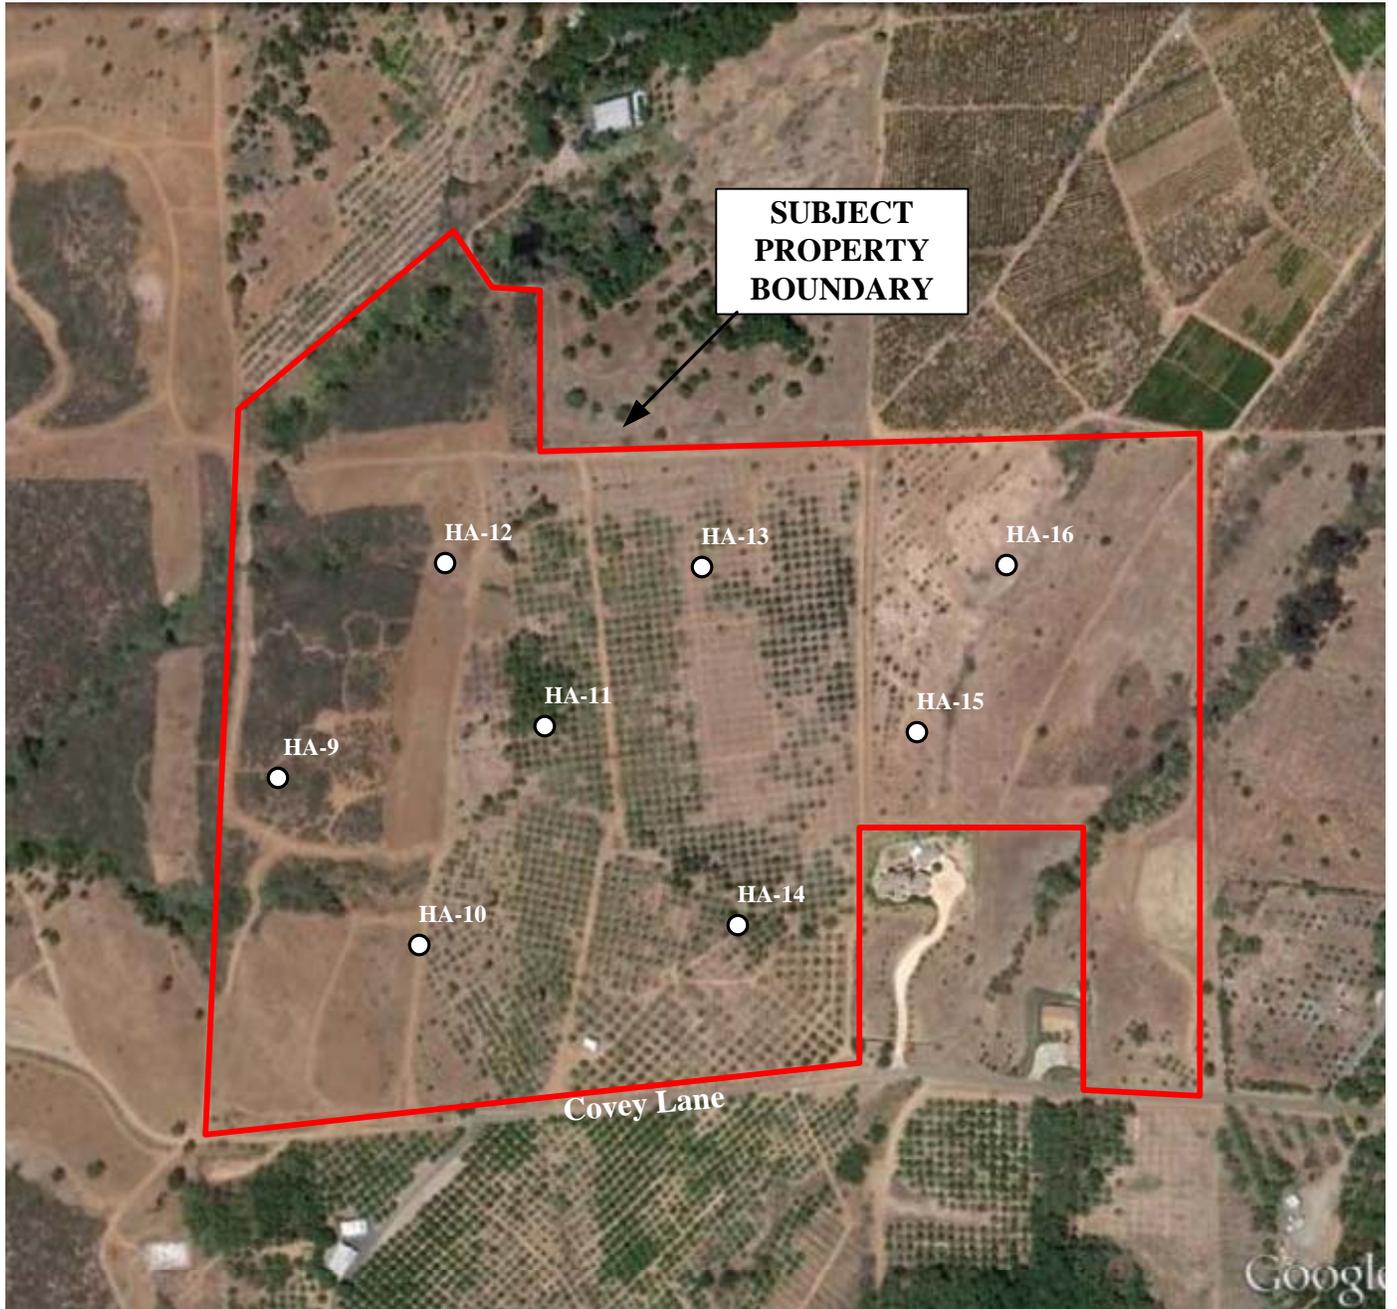
FIGURE 3

HA-9
 ○ Soil boring location

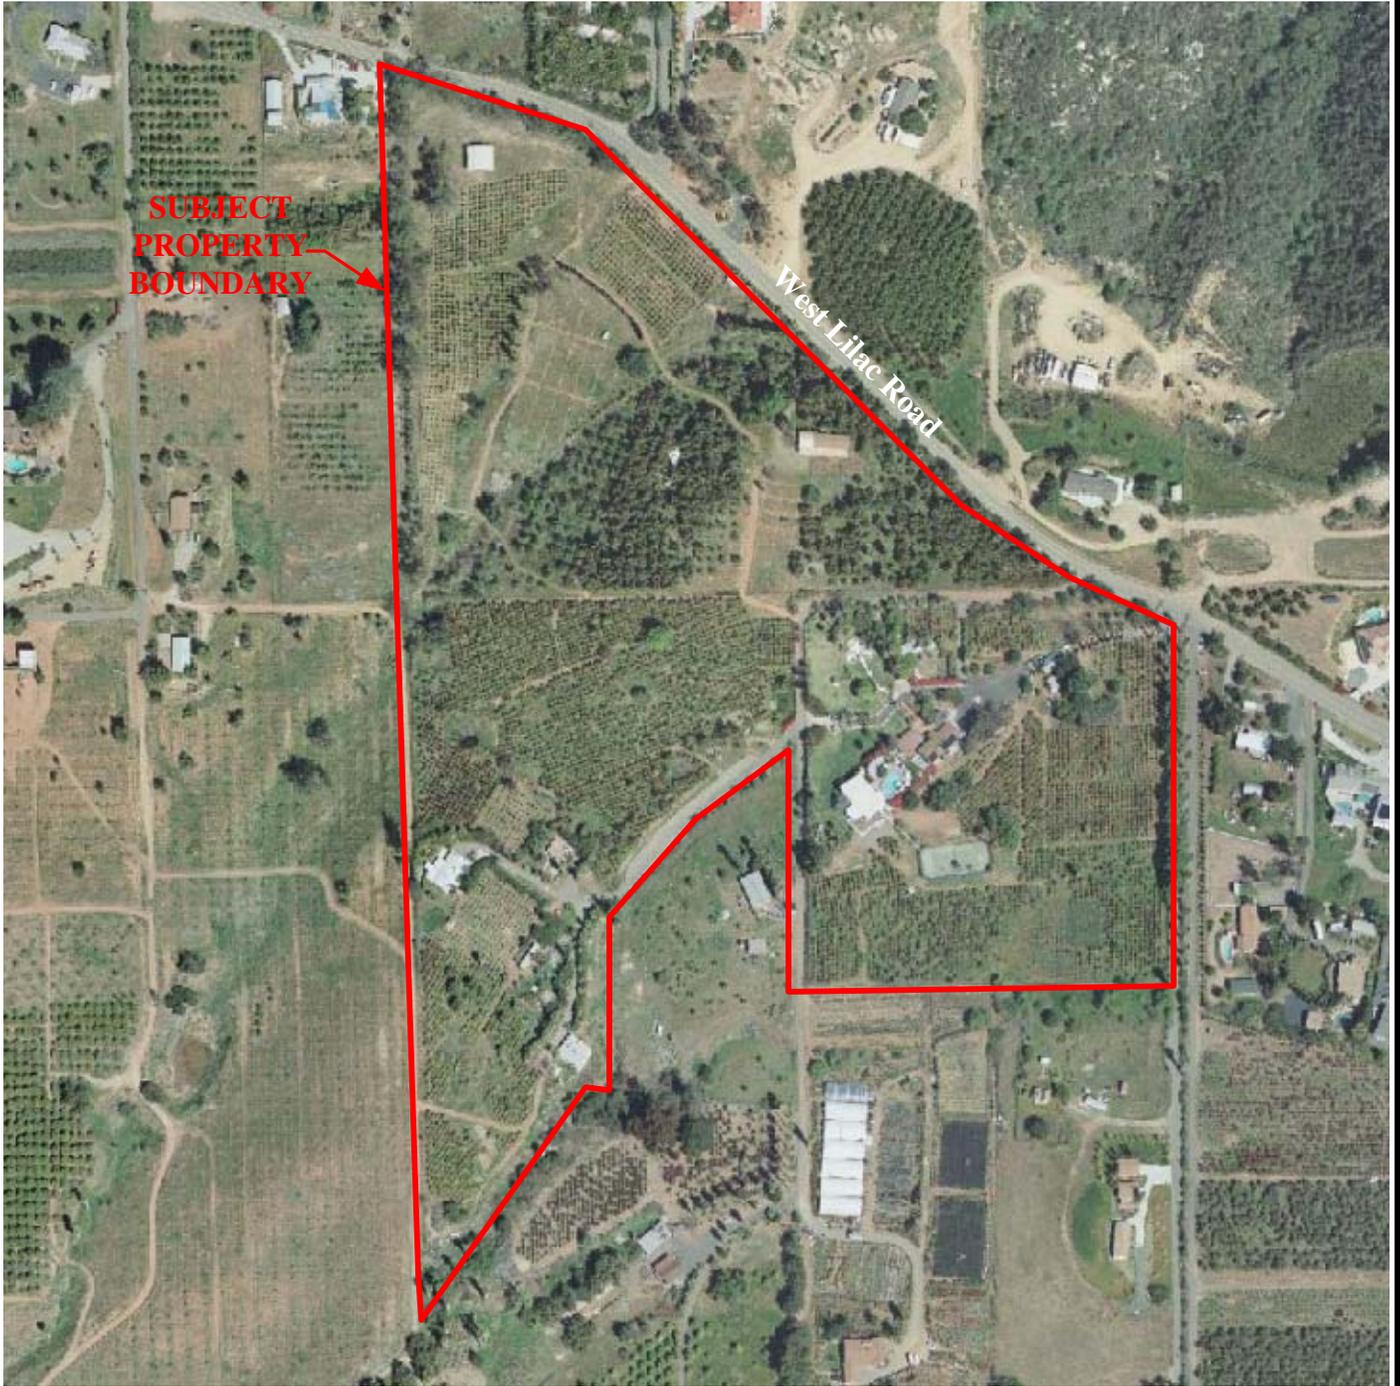
FIGURE 1

The purpose of this Phase I Environmental Site Assessment (ESA) was to assess the possible presence of *recognized environmental conditions* at the property located 9435 West Lilac Walk, Escondido, California (**Figure 1**). *Recognized environmental conditions* include those property uses that may indicate the presence or likely presence of an existing, historical, or threatened release of any hazardous substances or petroleum products into structures, soil, and/or groundwater beneath the property. The term *recognized environmental conditions* are not intended to include *de minimis* conditions that generally do not present a material risk of harm to public health or the environment and that would not be subject to enforcement actions by a regulatory agency.

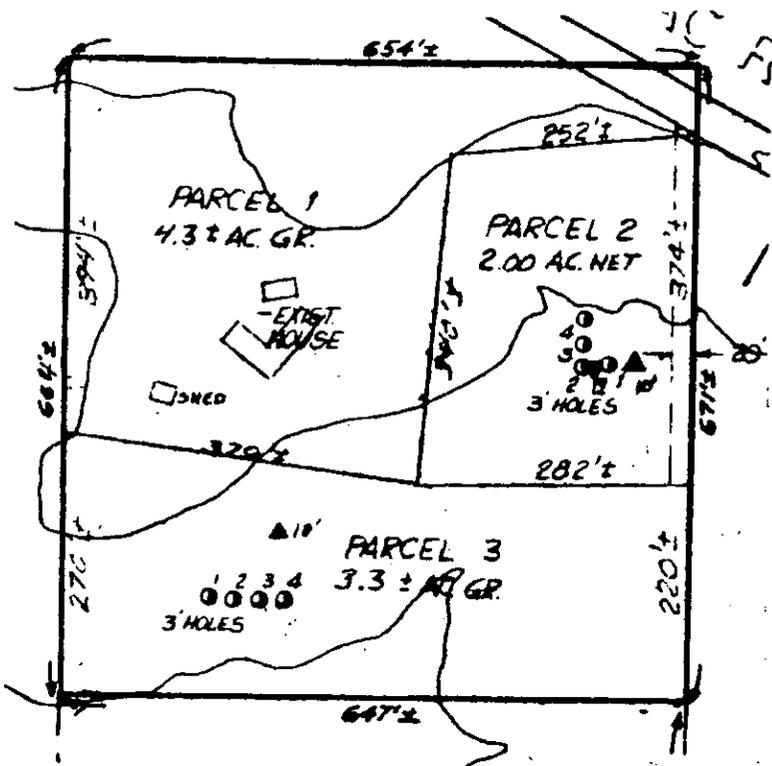
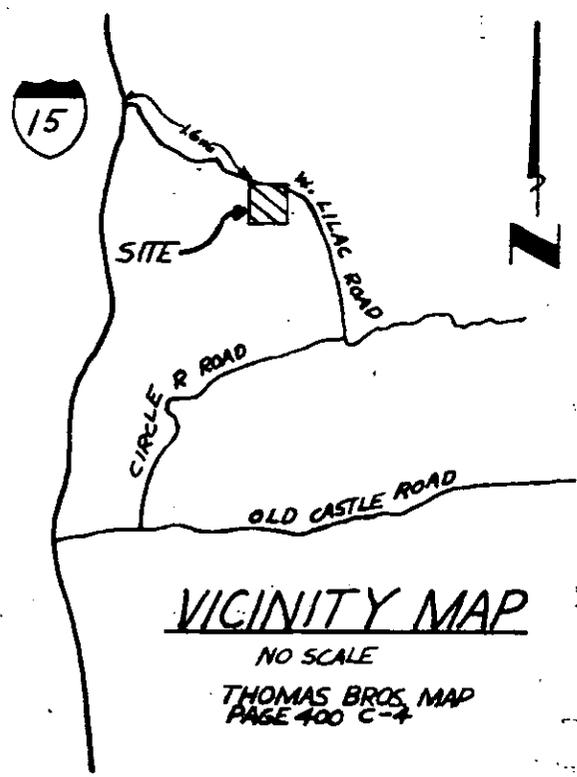
P.L. 2

PERCOLATION TEST		
TEST LOC.	TEST NO	PERC. RATE MIN/IN.
PCL 2	1	48
	2	60
	3	80
	4	40
		AU = 57 min/in. 530 LF DRAIN TILE
PCL 3	1	30
	2	40
	3	60
	4	34
		AU = 41 min/in. 460 LF DRAIN TILE

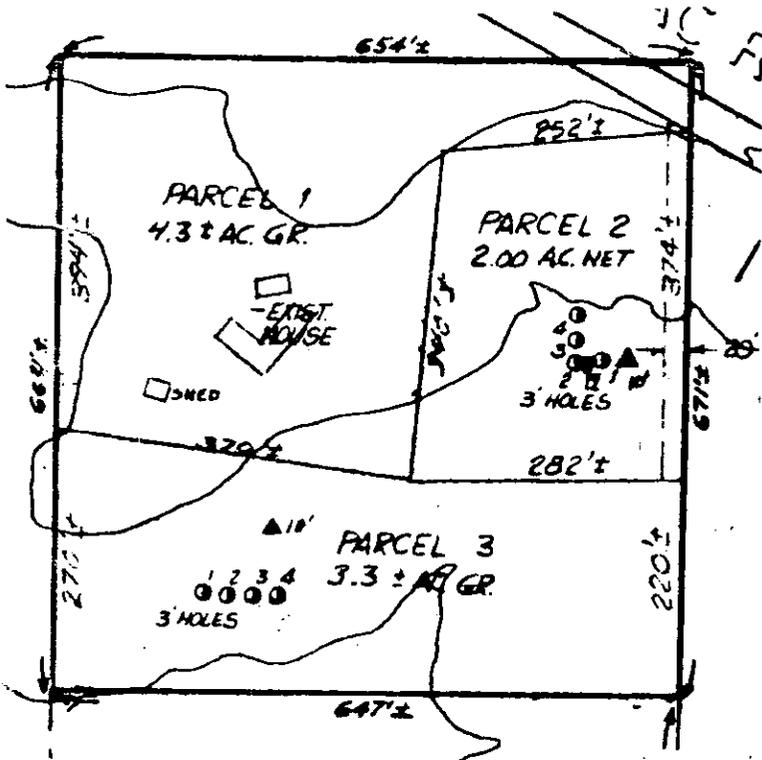
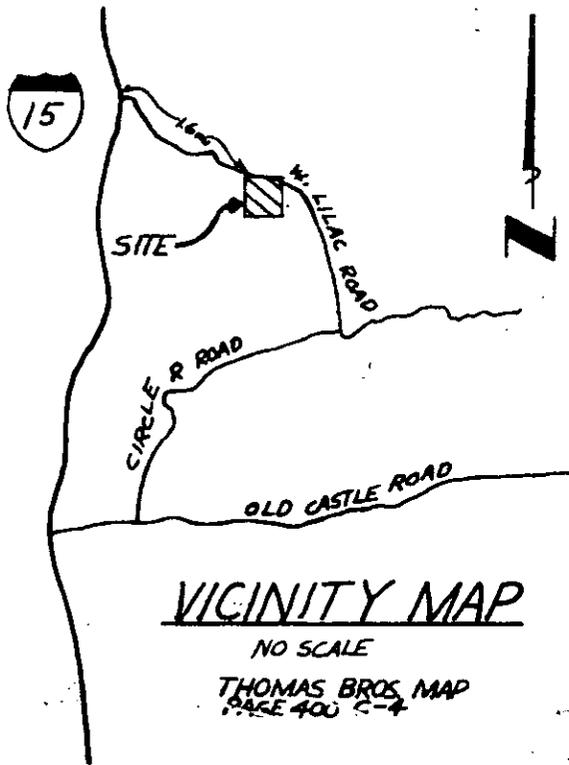
P.L. 3

PERCOLATION TEST		
TEST LOC.	TEST NO.	PERC. RATE MIN/IN.
PCL 2	1	48
	2	60
	3	80
	4	40
		AU = 57 min/in. 530 LF DRAIN TILE
PCL 3	1	30
	2	40
	3	60
	4	34
		AU = 41 min/in. 460 LF DRAIN TILE
