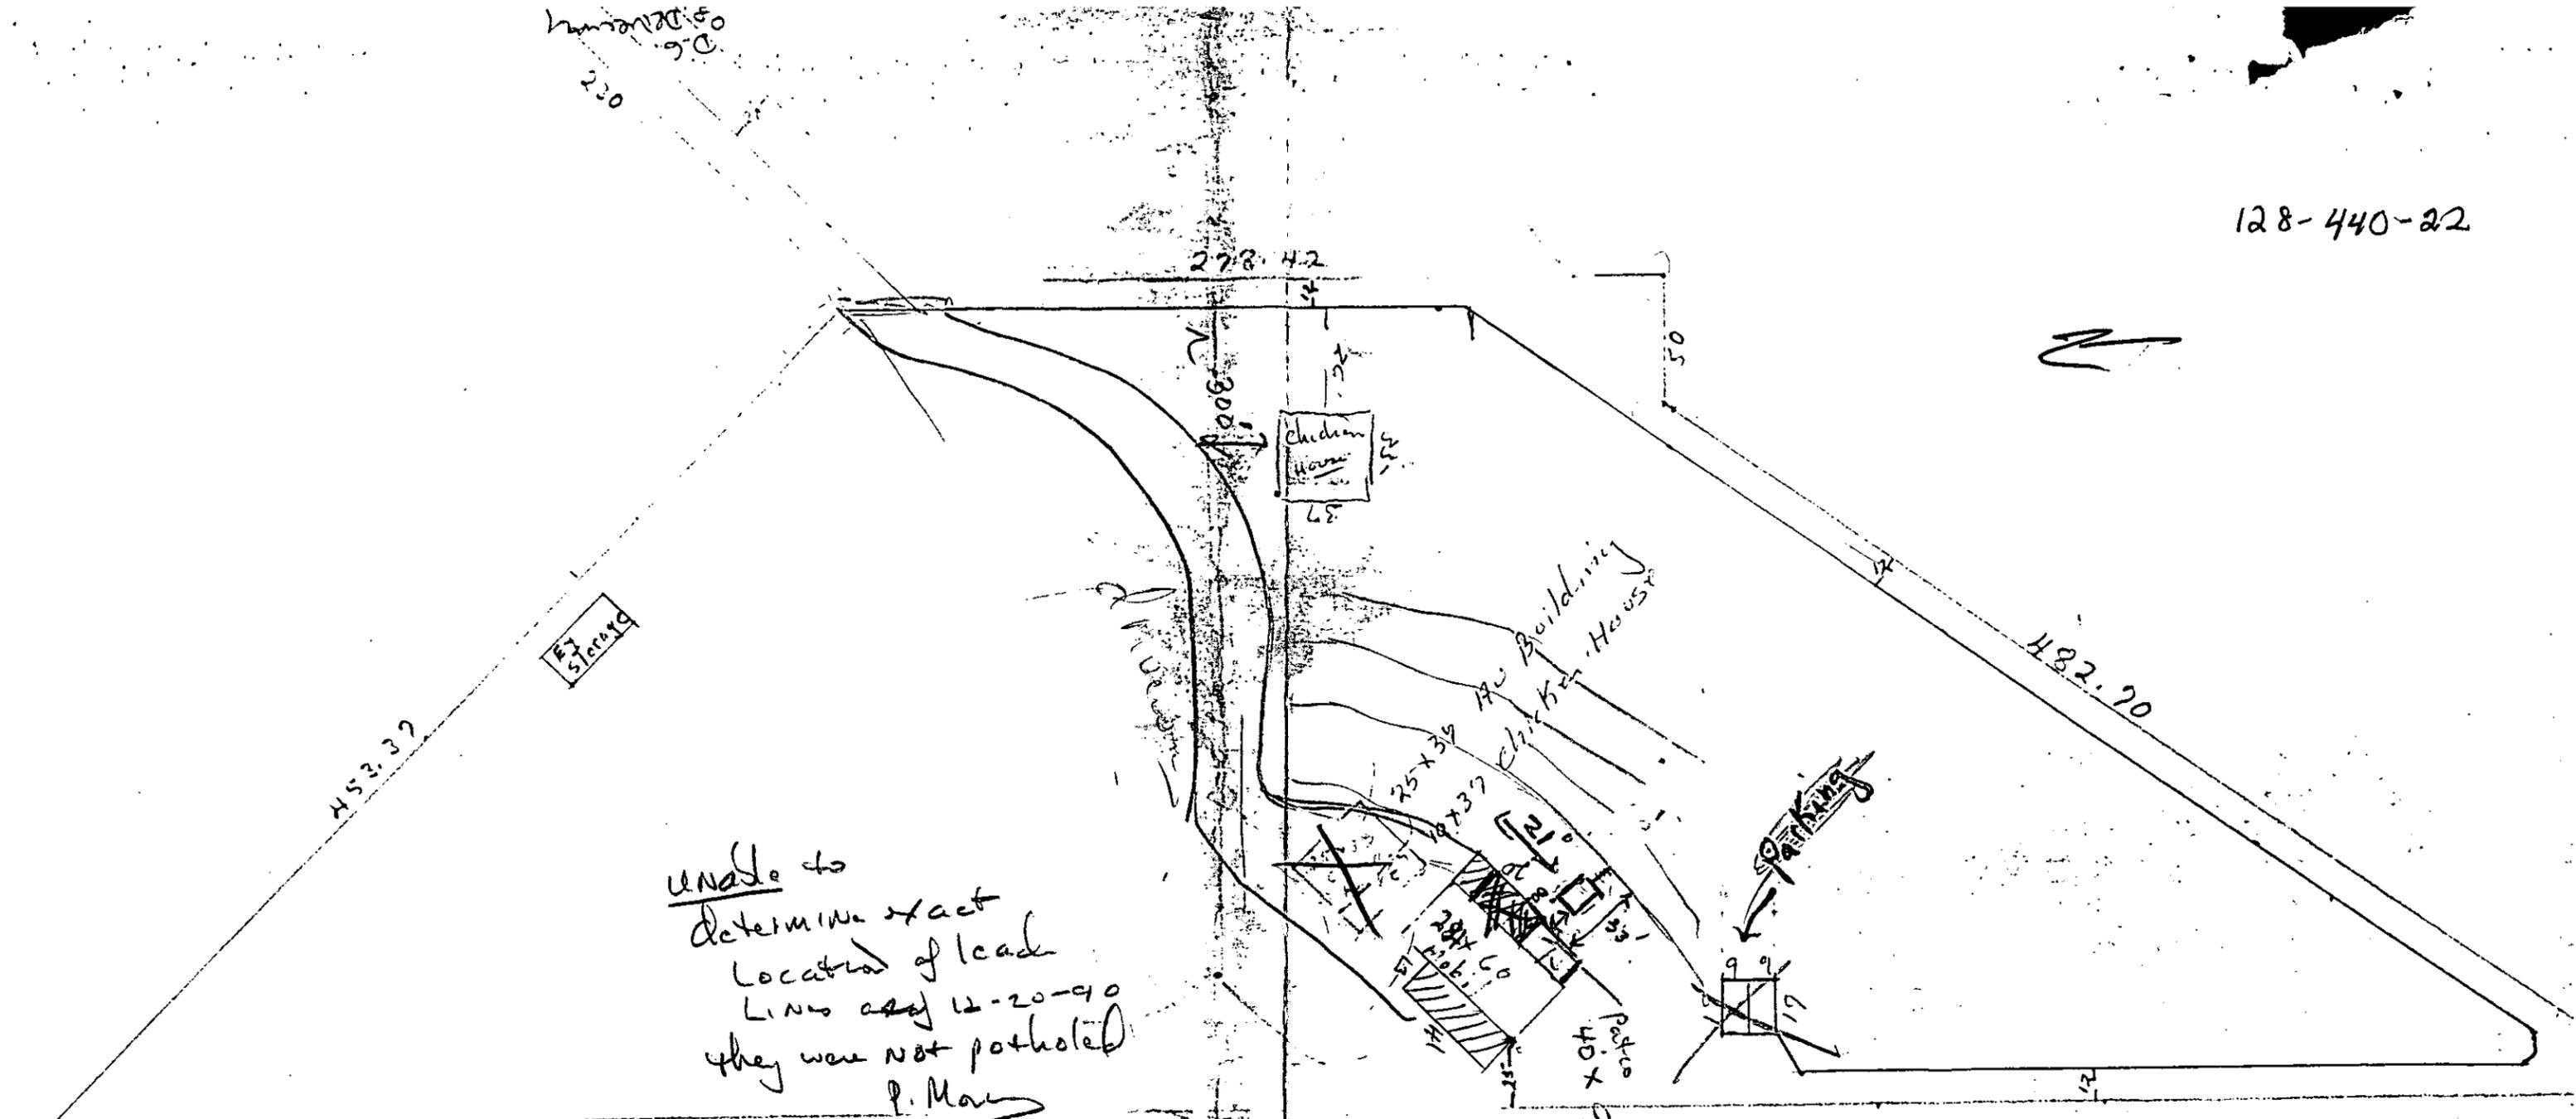
unable to
 determine exact
 location of lead
 lines as of 12-20-90
 they were not potholed
 P. Mon
