**PHASE I ENVIRONMENTAL
SITE ASSESSMENT
and
LIMITED SOIL INVESTIGATION**

**Accretive Investments, Inc.
Lilac Hills Ranch Development
Roadway Expansion Property**

**Gopher Canyon Road and Interstate 15 Intersections;
Old Highway 395 from Gopher Canyon Road
North to Circle R Drive, Escondido, California 92026**

EEI Project Number ACR-71497.2a

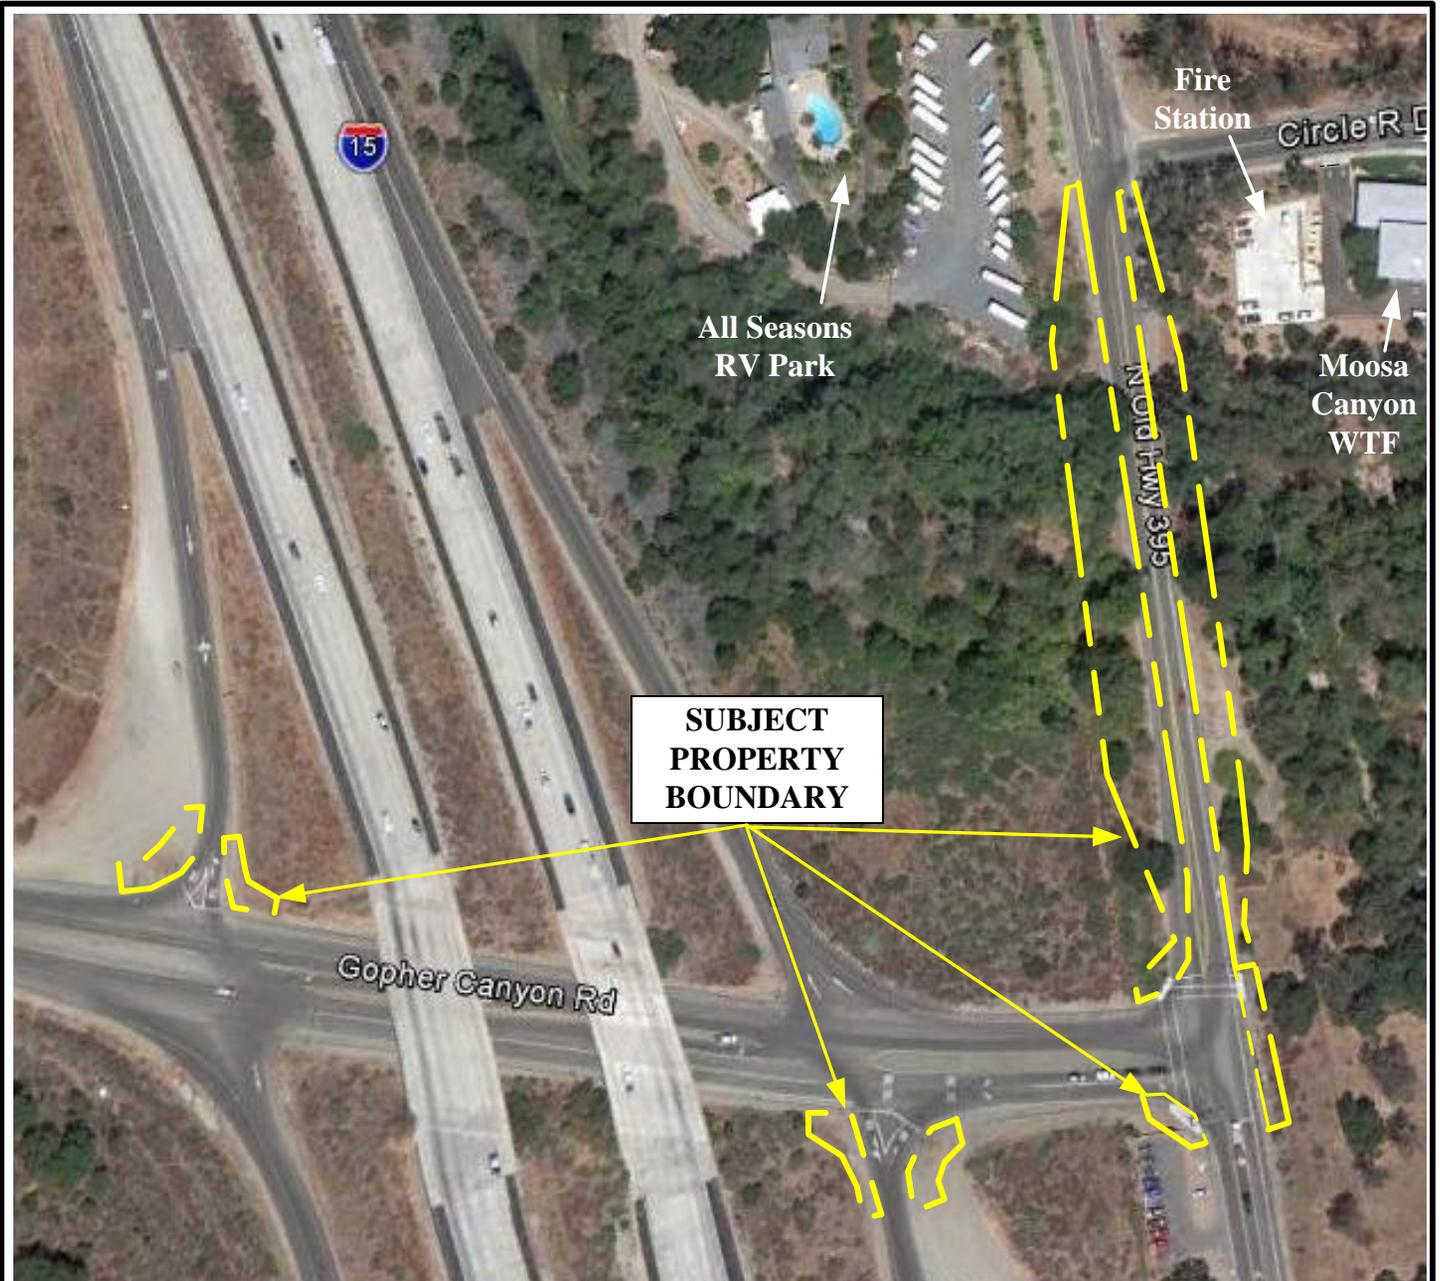
FIGURE 2

AERIAL SITE MAP
 ACCRETIVE INVESTMENTS, INC.
 Lilac Hills Ranch
 Roadway Expansion Property
 Gopher Canyon Rd and Interstate 15 Intersections. and Old Hwy. 395
 from Gopher Canyon Rd. North to Circle R Dr.
 Escondido, California 92026
 EEI Project Number ACR-71497.2a
 Created July 2012

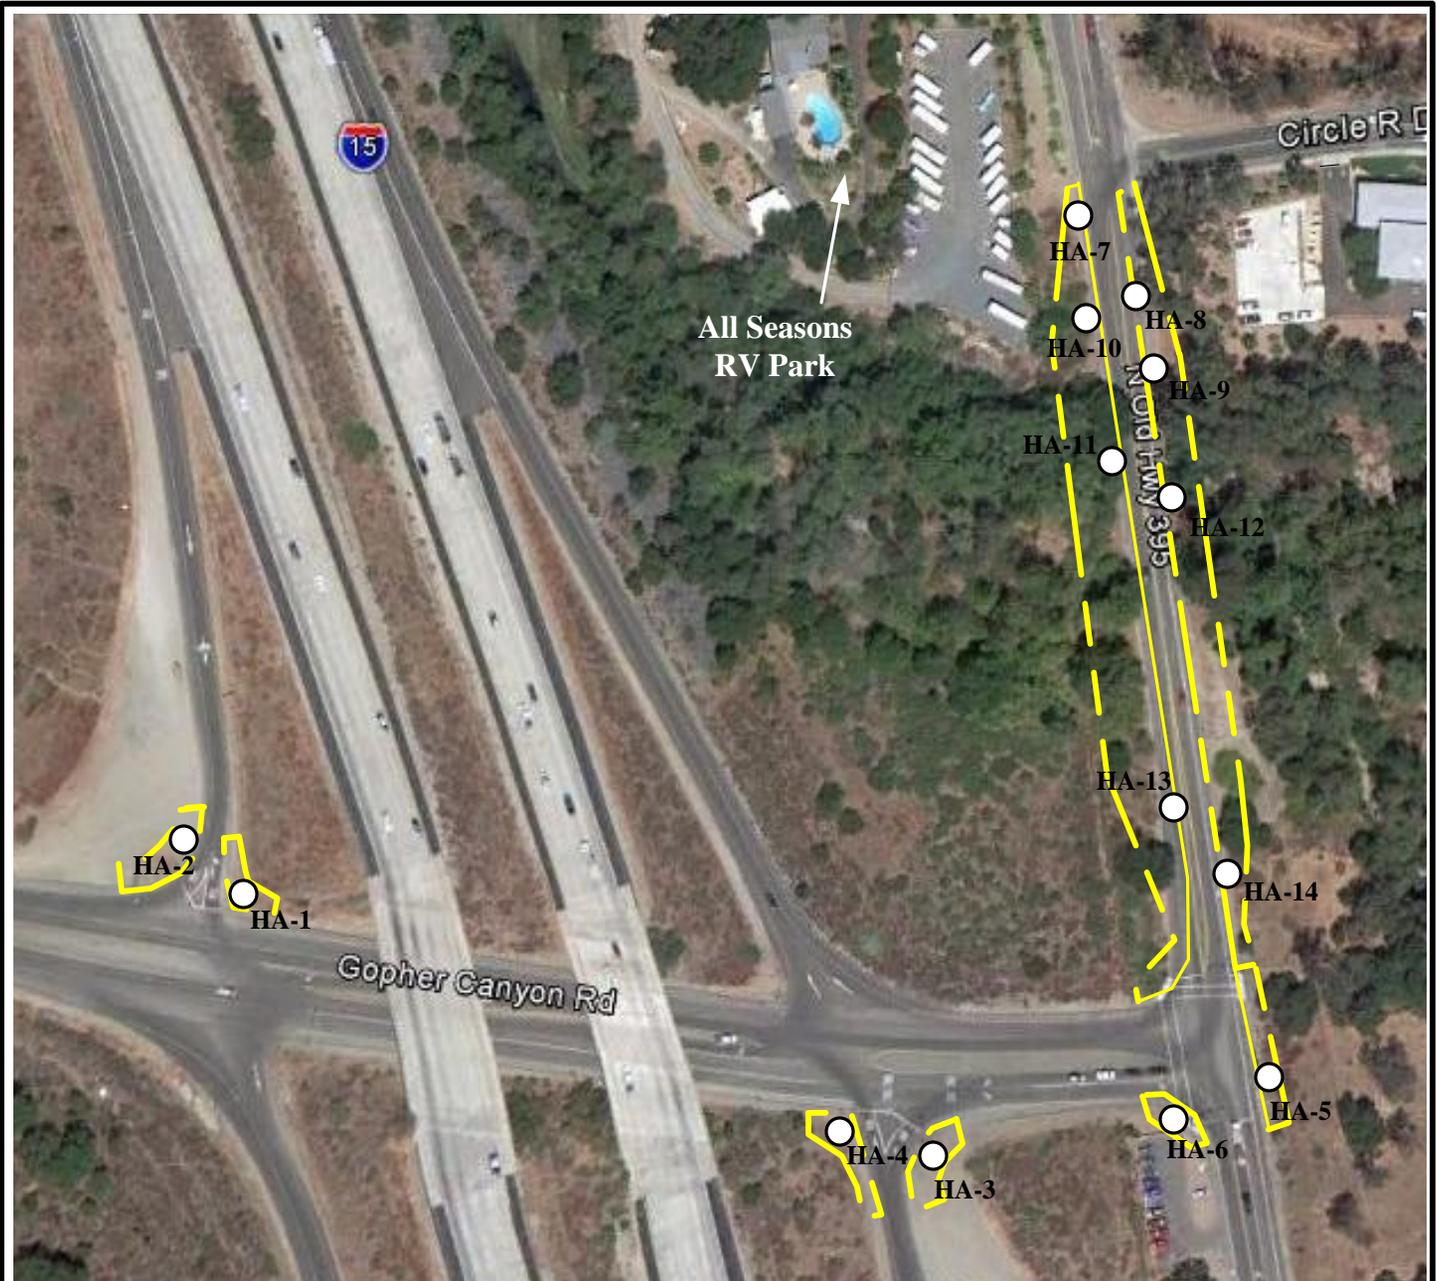
FIGURE 3

On July 3, 2012, EEI personnel mobilized to the subject property to conduct soil sampling activities with a stainless steel hand auger. Soil sampling locations were selected with the goal of collecting representative soil samples from the subject property. A total of six (6) discrete locations (identified as HA-1 through HA-6, **Figure 3**) were chosen to provide representative coverage at the two I-15 off ramps and the intersection of Gopher Canyon Road and Old Highway 395. Eight (8) soil samples were collected along the shoulders of Old Highway 395 (identified as HA-7 through HA-14, **Figure 3**).
