**PHASE I ENVIRONMENTAL  
SITE ASSESSMENT  
and  
LIMITED SOIL INVESTIGATION**

**Accretive Investments, Inc.  
Lilac Hills Ranch Development  
Roadway Expansion Property  
Portions of West Lilac Road, located West and East of Interstate 15,  
and the intersection of West Lilac Road and Old Highway 395  
Escondido, California 92026**

At the request and authorization of Accretive Investments, Inc. (“Client”), EEI conducted a Phase I Environmental Site Assessment (ESA) for the proposed roadway expansion property including: portions of West Lilac Road, located west and east of Interstate 15 (I-15), and the intersection of West Lilac Road and Old Highway 395 situated west of I-15, Escondido, California. The purpose of this Phase I ESA was to assess the presence or likely presence of an existing, historical, or threatened release of any hazardous substances or petroleum products into structures, soil, and/or groundwater beneath the subject property, to the extent practical (i.e., *recognized environmental conditions* as delineated in ASTM E1527-05).

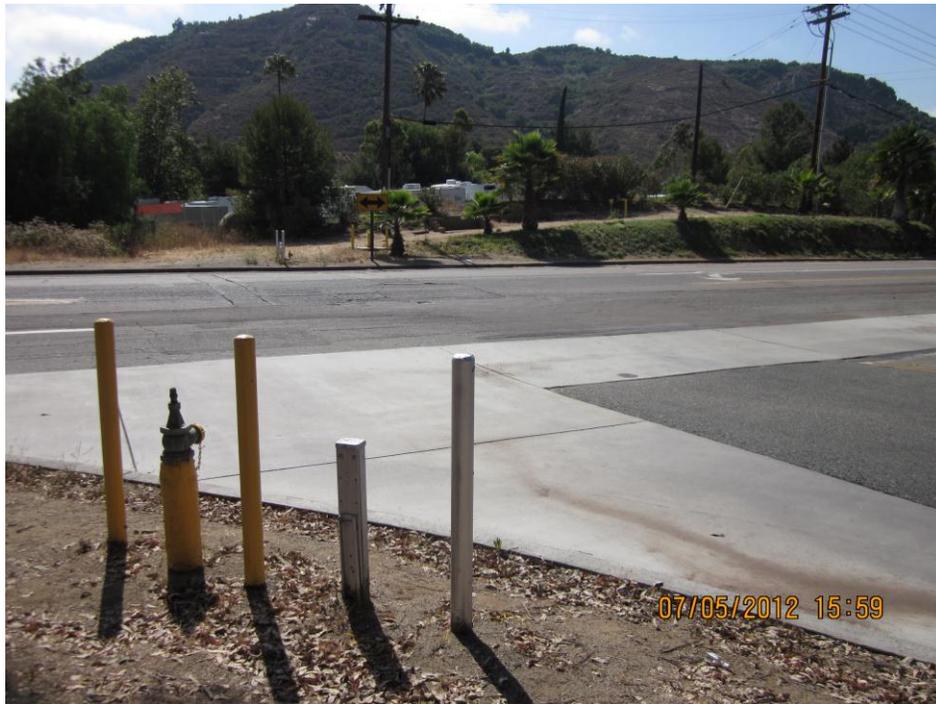
**Photograph 5** – Northwesterly view of the intersection of Circle R Drive (right foreground) and Old Highway 395. Note water utilities on both edges of roadways.

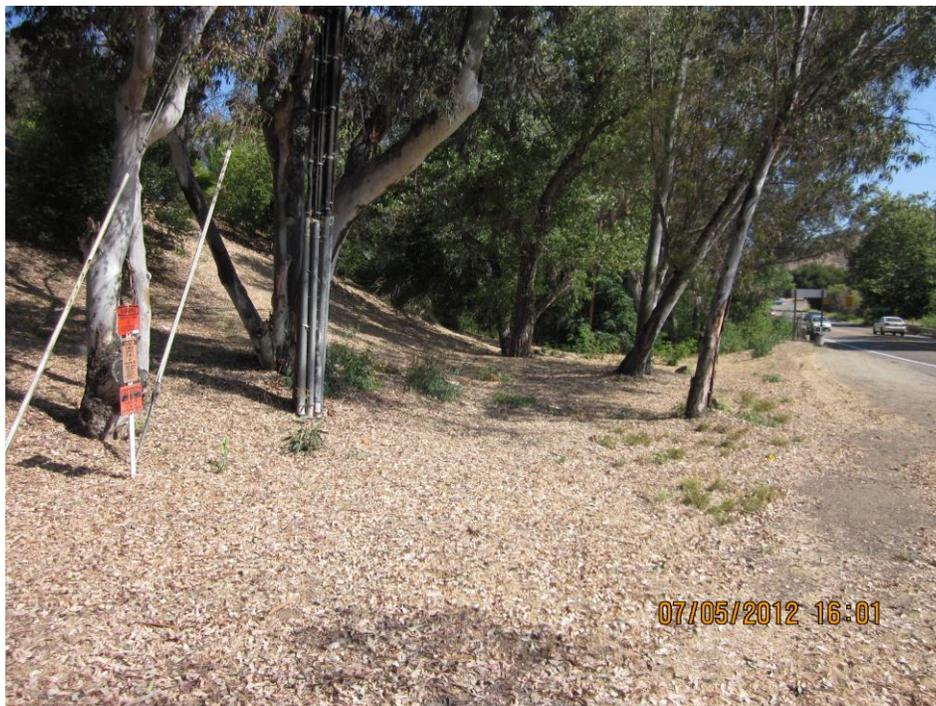
**Photograph 6** – South view along northeast side of Old Highway 395 south of Circle R Drive. Note orange signage in left photo delineating buried fiber optic cable.

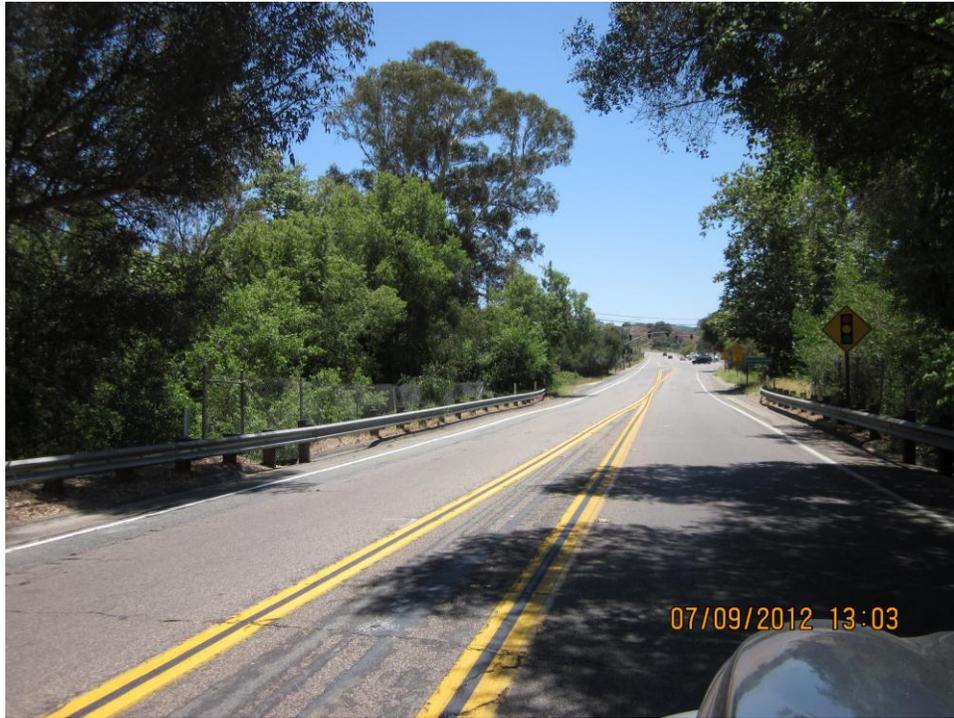
**Photograph 7** – south view along central section of Old Highway 395 at culvert under-crossing, delineated by guard railing.

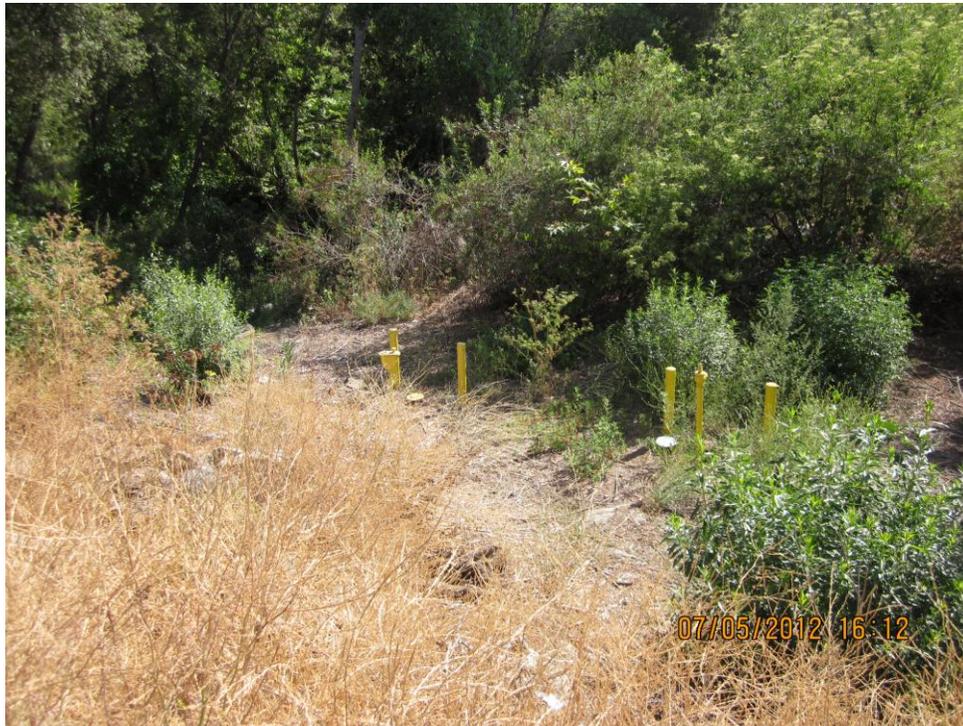
**Photograph 8** – Southwesterly view of water utilities in drainage (easement?) area along west side of Old Highway 395, north of culvert under-crossing.

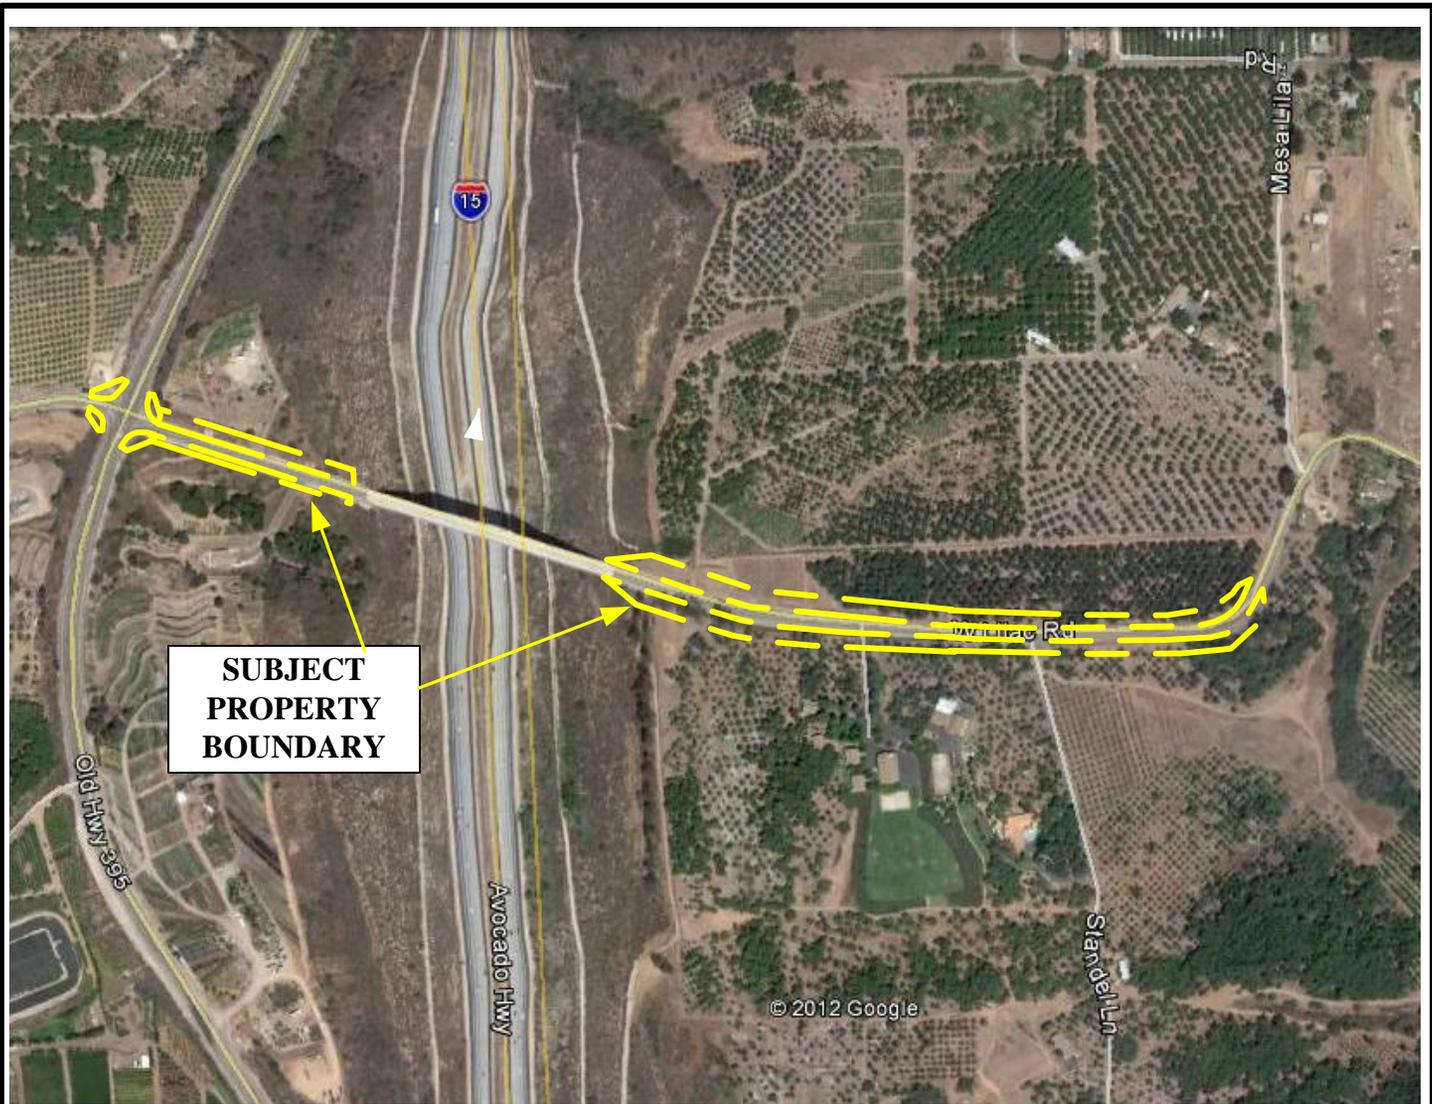
**FIGURE 2**

**AERIAL SITE MAP**  
 ACCRETIVE INVESTMENTS, INC.  
 Lilac Hills Ranch  
 Roadway Expansion Property  
 Portions of West Lilac Road, located west and east of I-15, and the  
 intersection of West Lilac Road and Old Highway 395  
 Escondido, California 92026  
 EEI Project Number ACR-71497.2b  
 Created July 2012

Aerial photographs and historical topographical maps were reviewed to identify historical land development and any surface conditions which may have impacted the subject property. Photographs and historical topographic maps dating 1939, 1947, 1948, 1951, 1953, 1964, 1968, 1974, 1975, 1980, 1994, 2002, and 2012 were obtained and reviewed from Track Info Services/FirstSearch®, an environmental information/database retrieval service. A 2010 aerial photograph was obtained from Google Earth® and reviewed, a copy of which is included herein (**Figure 2**).
