**APPENDIX F  
PHOTOGRAPHIC LOG**

**PHASE I ENVIRONMENTAL  
SITE ASSESSMENT  
and  
LIMITED SOIL INVESTIGATION**

**Accretive Investments, Inc.  
Lilac Hills Master Planned Community Development  
Roadway Expansion Property  
Covey Lane  
Escondido, California 92026**

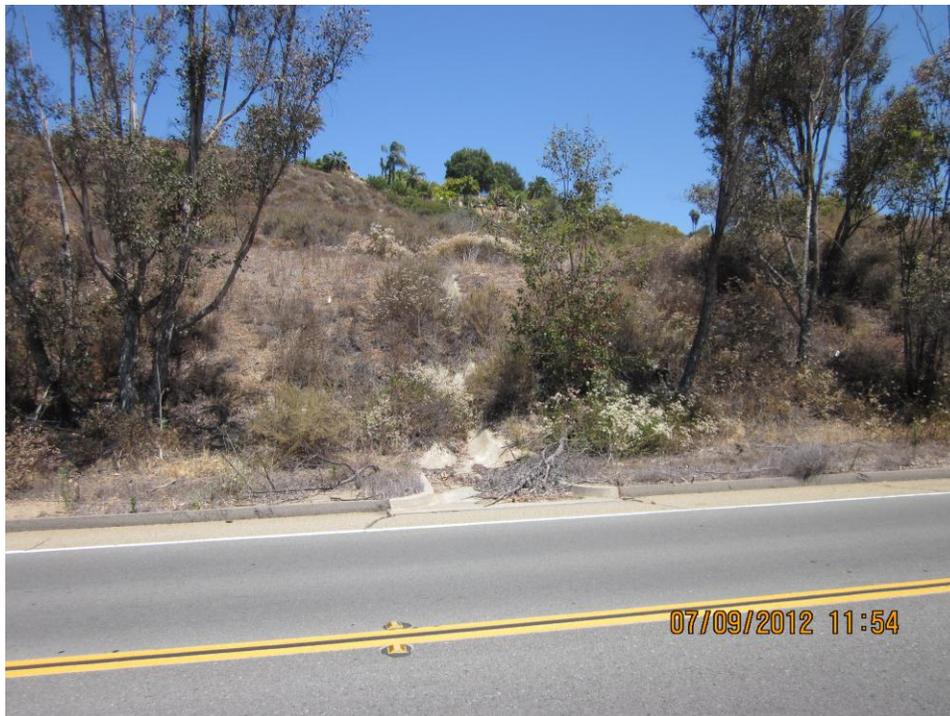
**Photograph 4** – Northeasterly view of typical concrete drainage swale along the northern edge of Circle R Drive. Photo is taken north of the Circle R Ranch residential development.

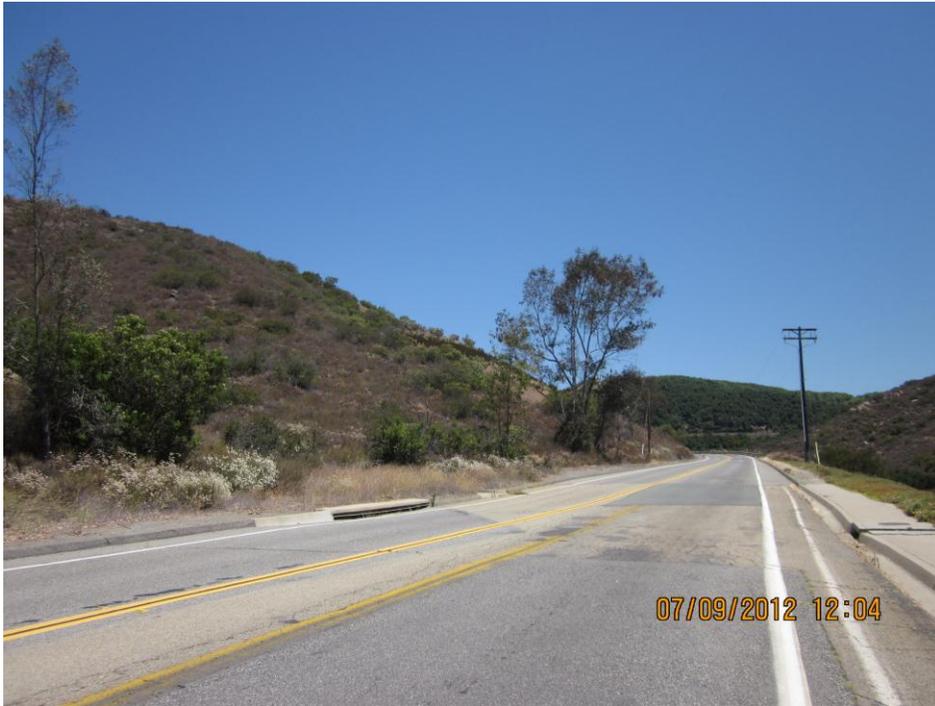
**Photograph 5** – Easterly view of Circle R Drive showing storm drain curb inlets situated east of Circle R Court.

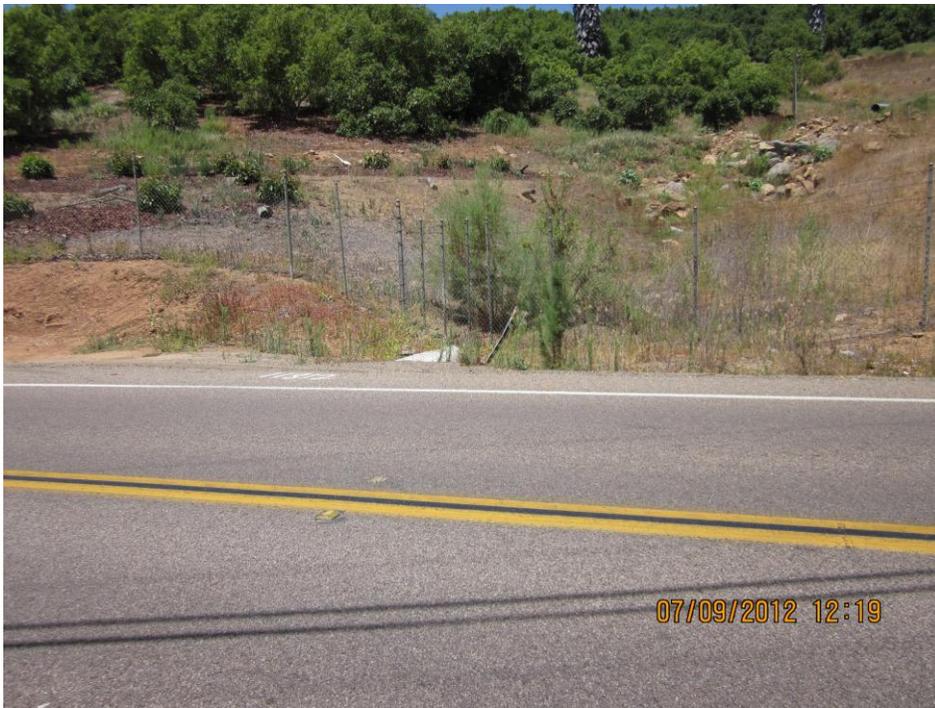
**Photograph 6** – Westerly view of CMP inlet to west edge of Circle R Drive under-crossing located south of northern intersection with El Camino De Pinos.

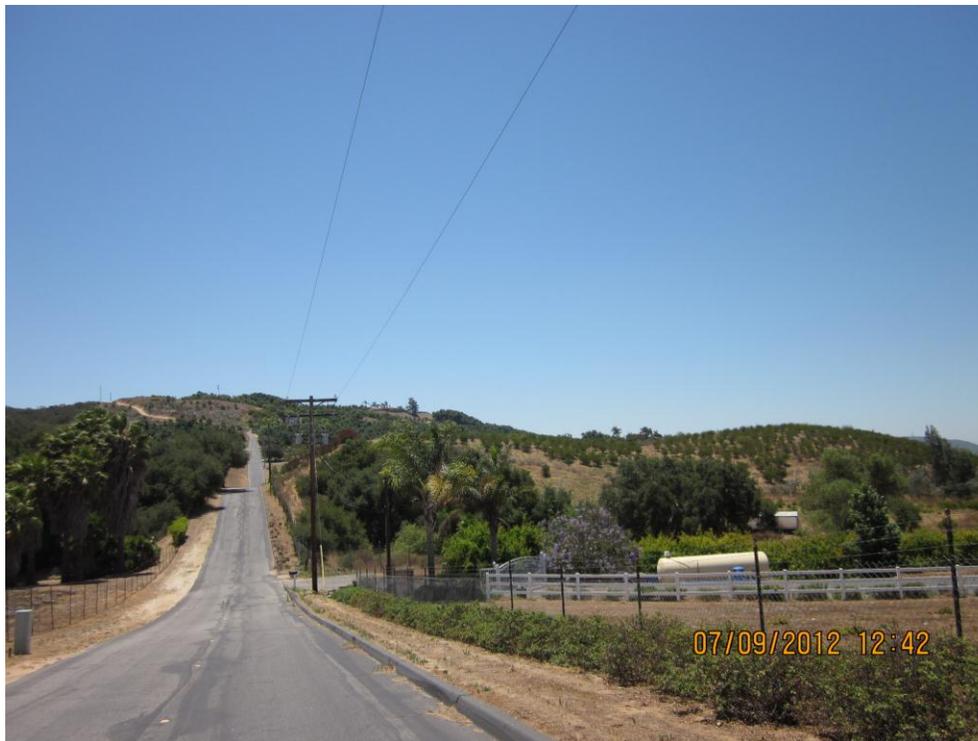
**Photograph 8** – South view of central portion of Mountain Ridge Road, south of Megan Terrace. Note pole-mounted transformers, propane AST in right photo (30911 Mountain Ridge Rd.), and cable box along east (i.e., left) edge of roadway.

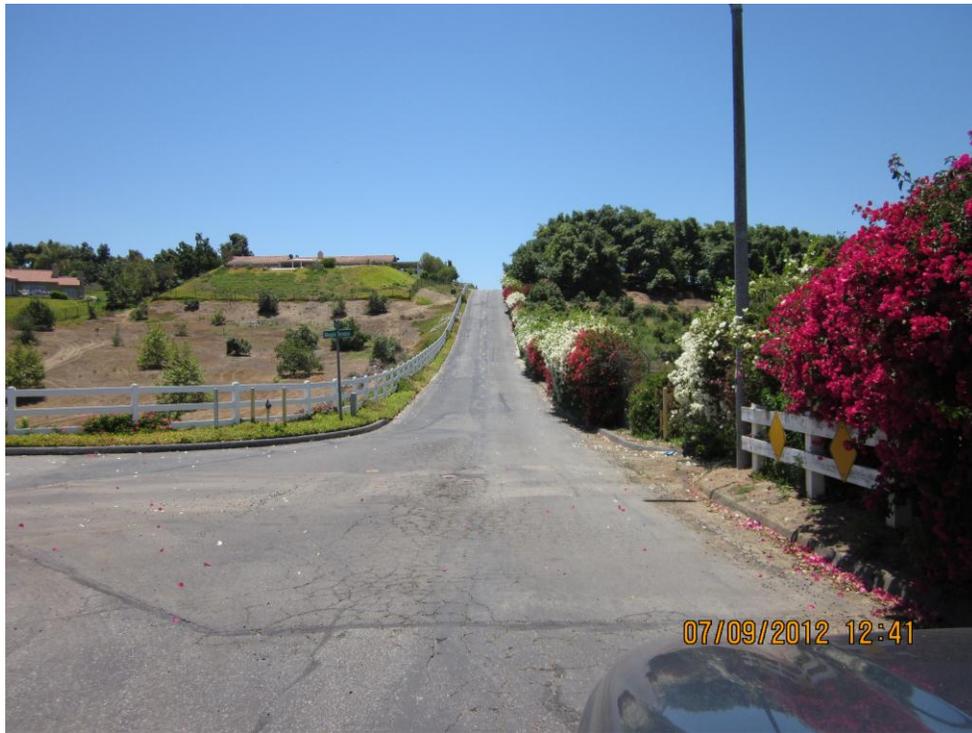
**Photograph 9** – South view of intersection of Mountain Ridge Road and Megan Terrace (left photo). Note hydrant at southern corners and storm drain inlet south of light post in right photo.

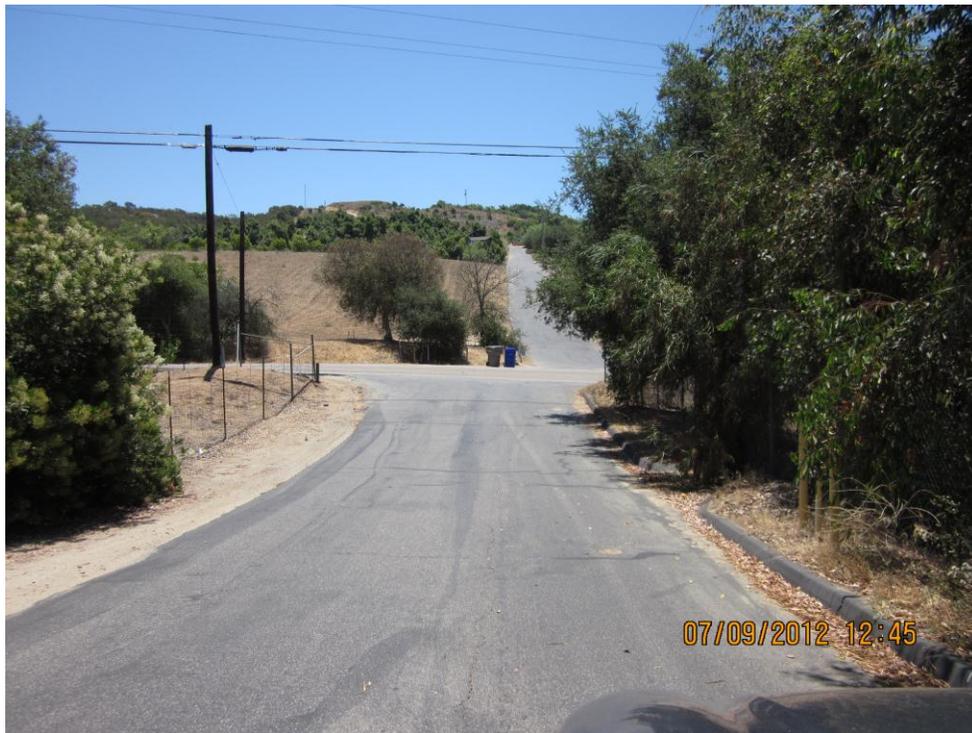
**Photograph 10** – South view of intersection of Mountain Ridge Road (foreground) And Circle R Drive. Note hydrant and asphalt-paved drainage swale in right photo.
