**PHASE I ENVIRONMENTAL
SITE ASSESSMENT
and
LIMITED SOIL INVESTIGATION**

**Accretive Investments, Inc.
Lilac Hills Ranch Development
Roadway Expansion Property
Old Highway 395 and Interstate 15 Ramp Segments
Escondido, California 92026**

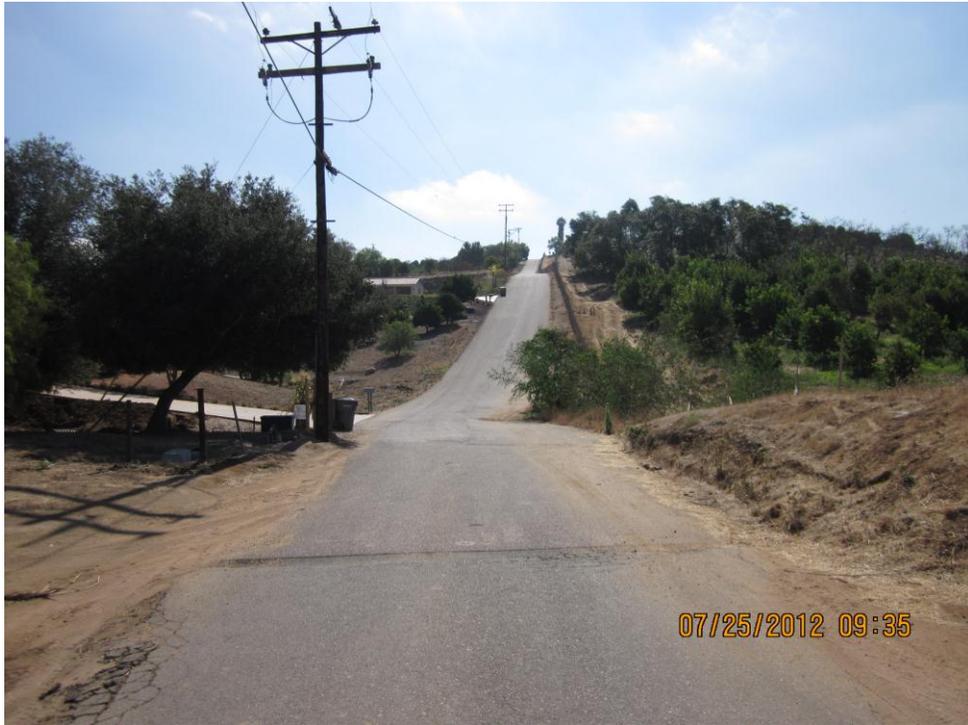
Photograph 1 – East view along Covey Lane showing the western limits of the subject property. Concrete driveway to 9542 Covey Lane visible in left photo.

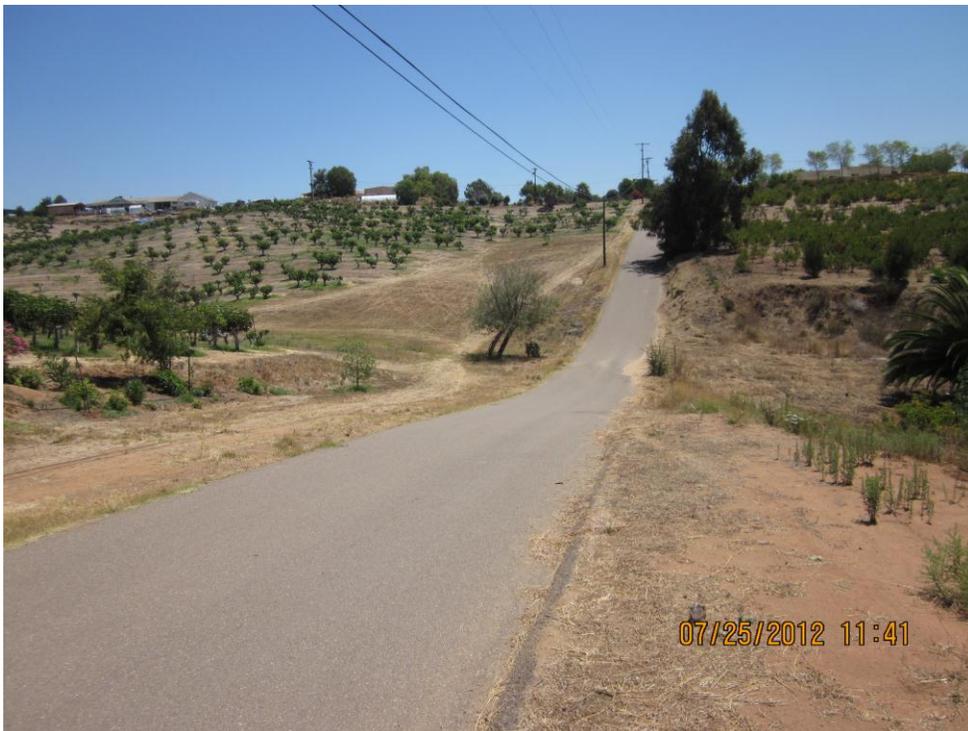
Photograph 2 – Northeasterly view of the east central canyon area on Covey Lane.

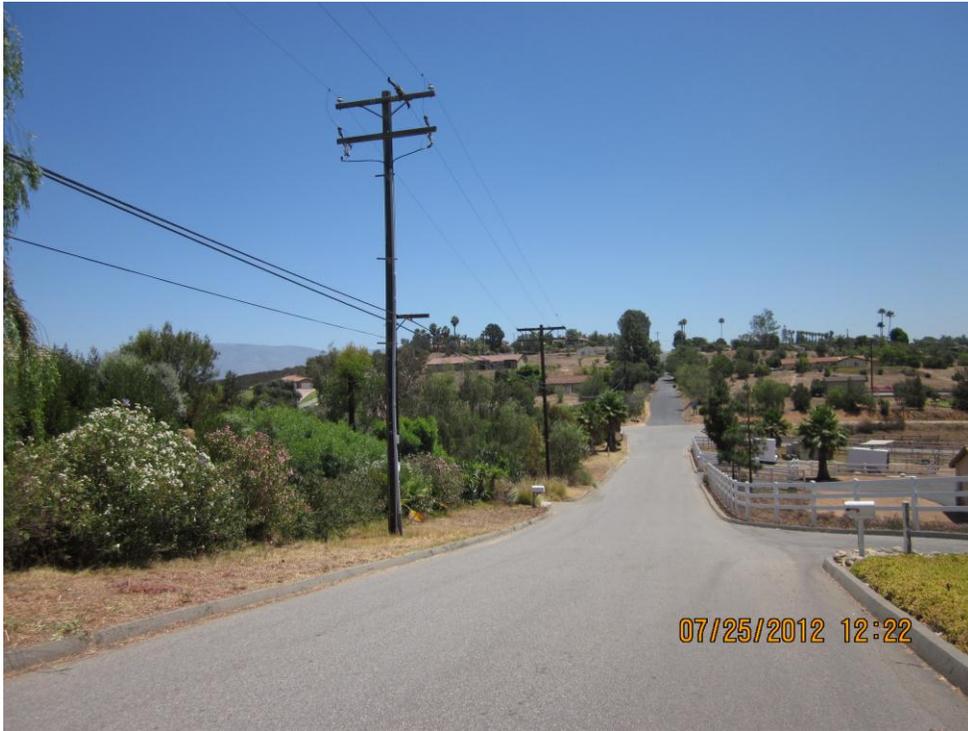
Photograph 3 – East view of the eastern portion of Covey Lane. Driveway to 9825 Covey Lane visible in right photo. Intersection with Lilac Road visible in background.

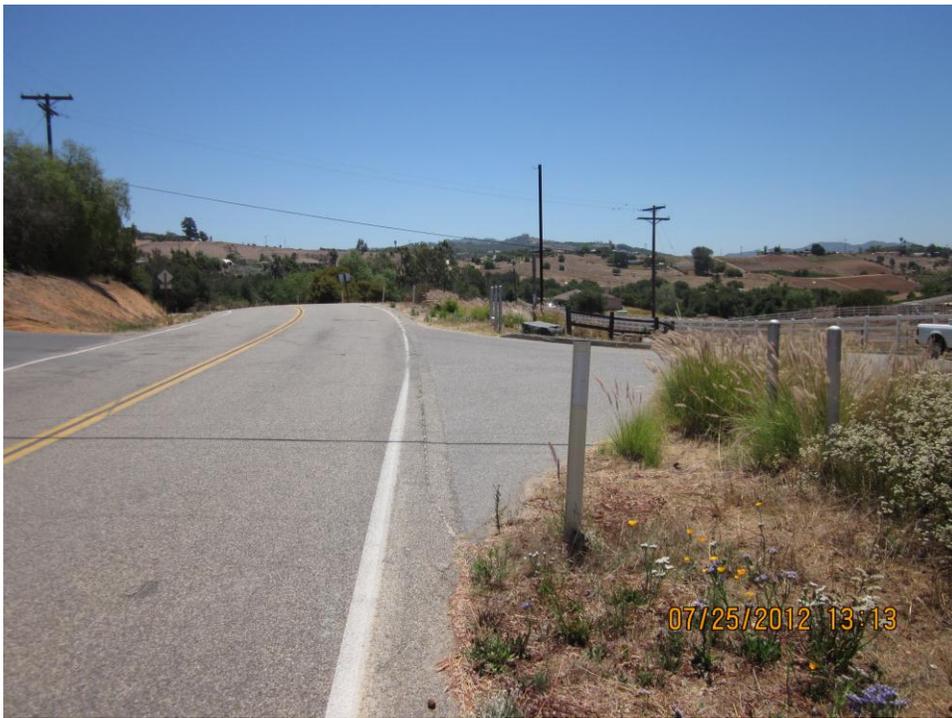
Photograph 4 – South view along west edge of Lilac Road showing Covey Lane in right photo.

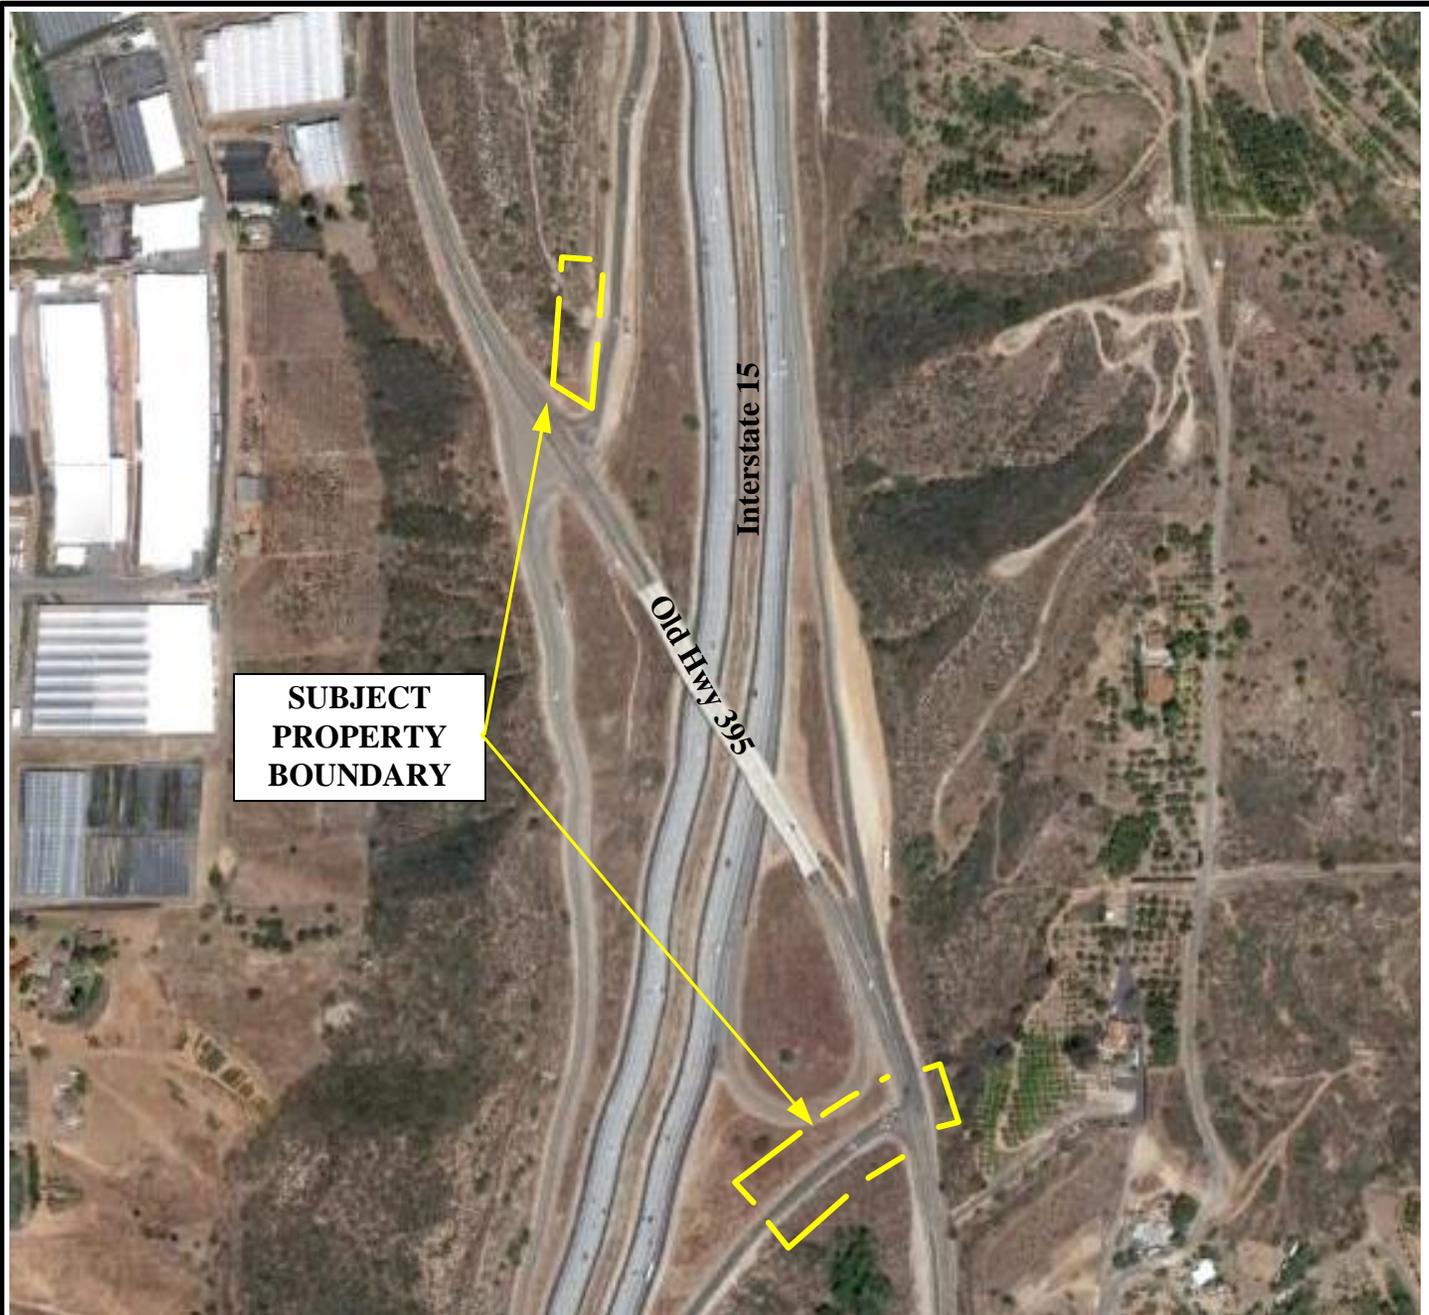
FIGURE 2

**SUBJECT
PROPERTY
BOUNDARY**

Aerial photographs and historical topographical maps were reviewed to identify historical land development and any surface conditions which may have impacted the subject property. Photographs and historical topographic maps dating 1939, 1946, 1948, 1951, 1953, 1963, 1968, 1974, 1975, 1980, 1990/91, 2002, 2008, and 2012 were obtained and reviewed from Track Info Services/FirstSearch®, an environmental information/database retrieval service. A 2010 aerial photograph was obtained from Google Earth® and reviewed, a copy of which is included herein (**Figure 2**).
