# Groundwater Resources Investigation Report Rugged Solar Farm Project

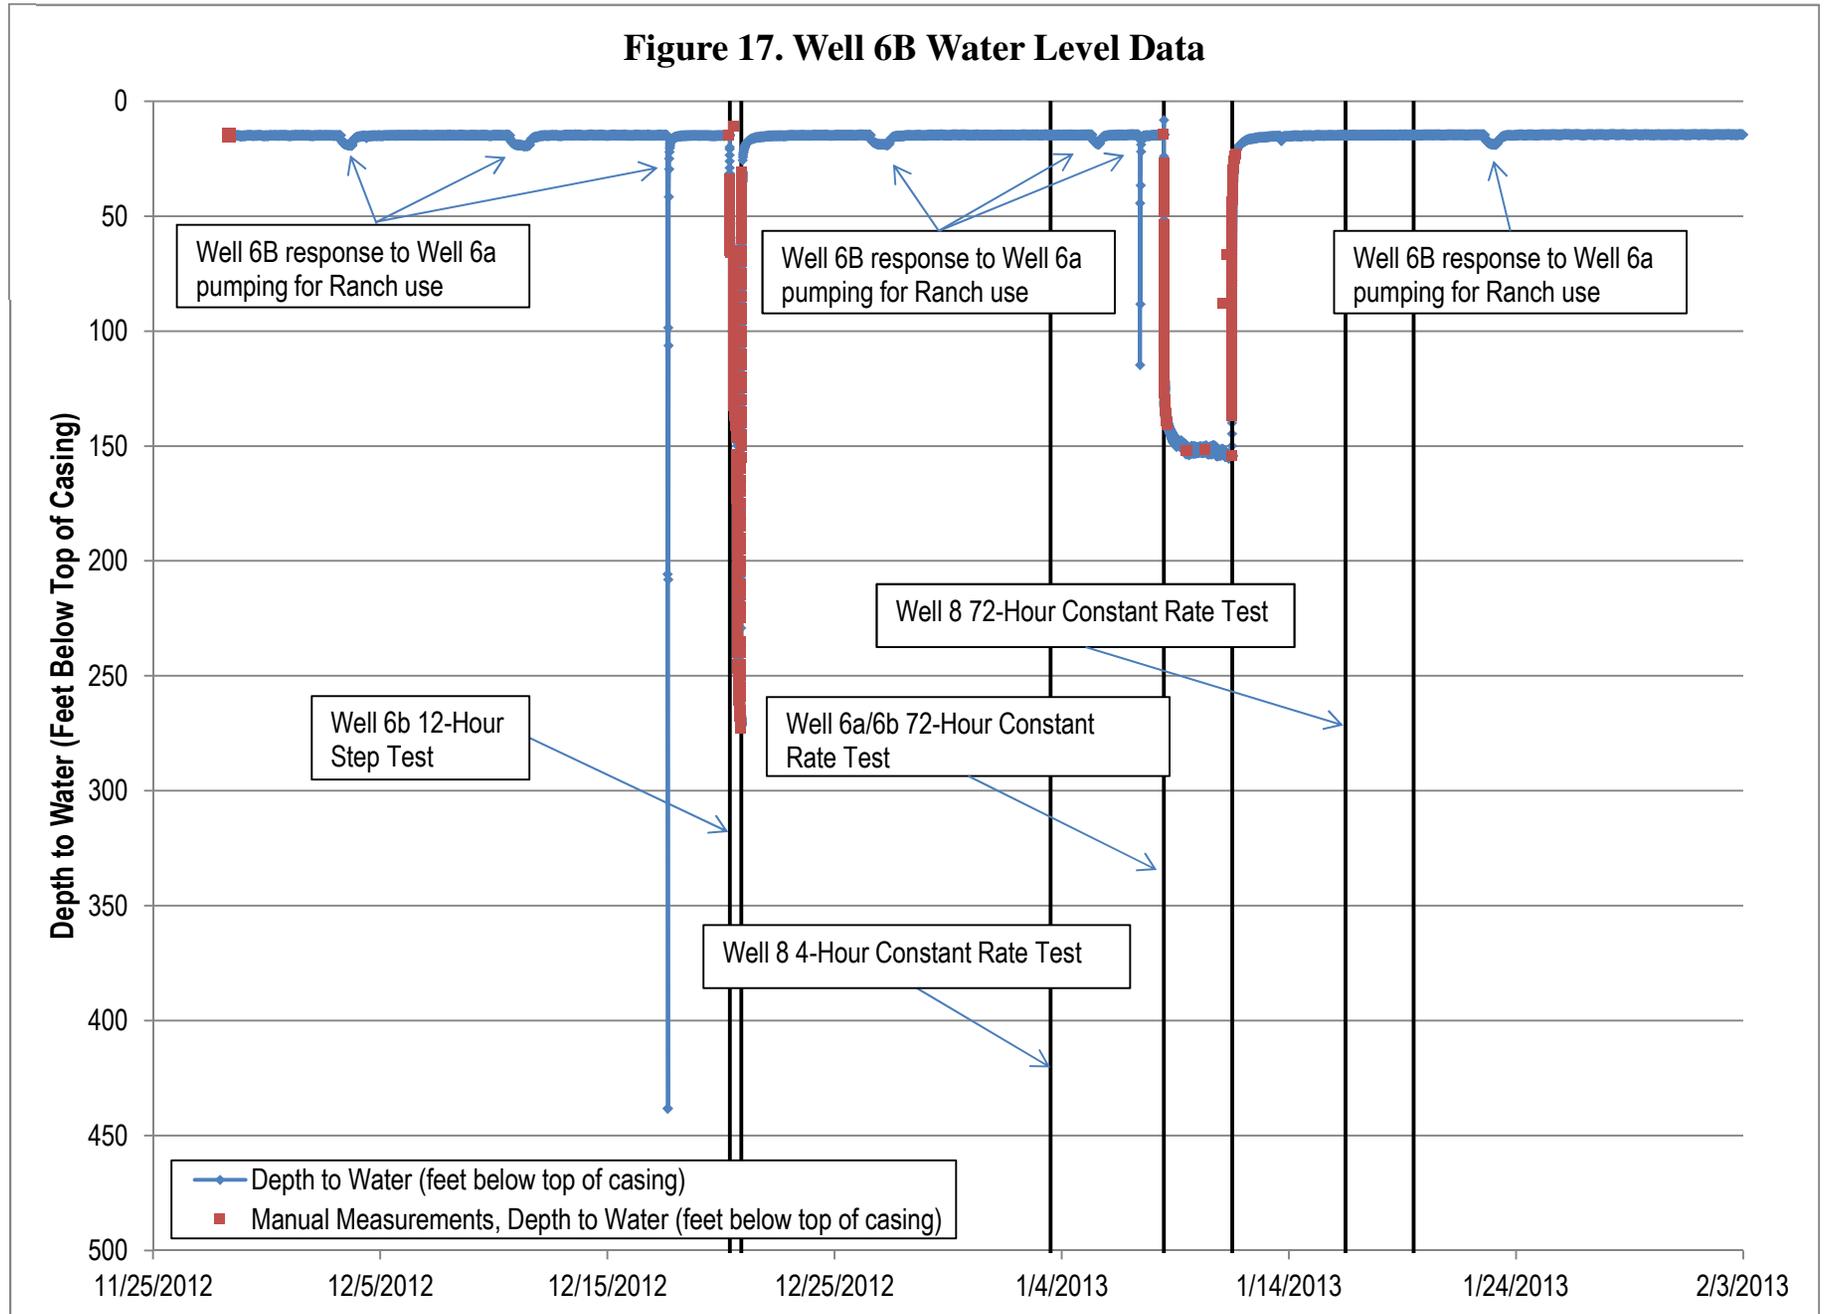
## Figure 17. Well 6B Water Level Data

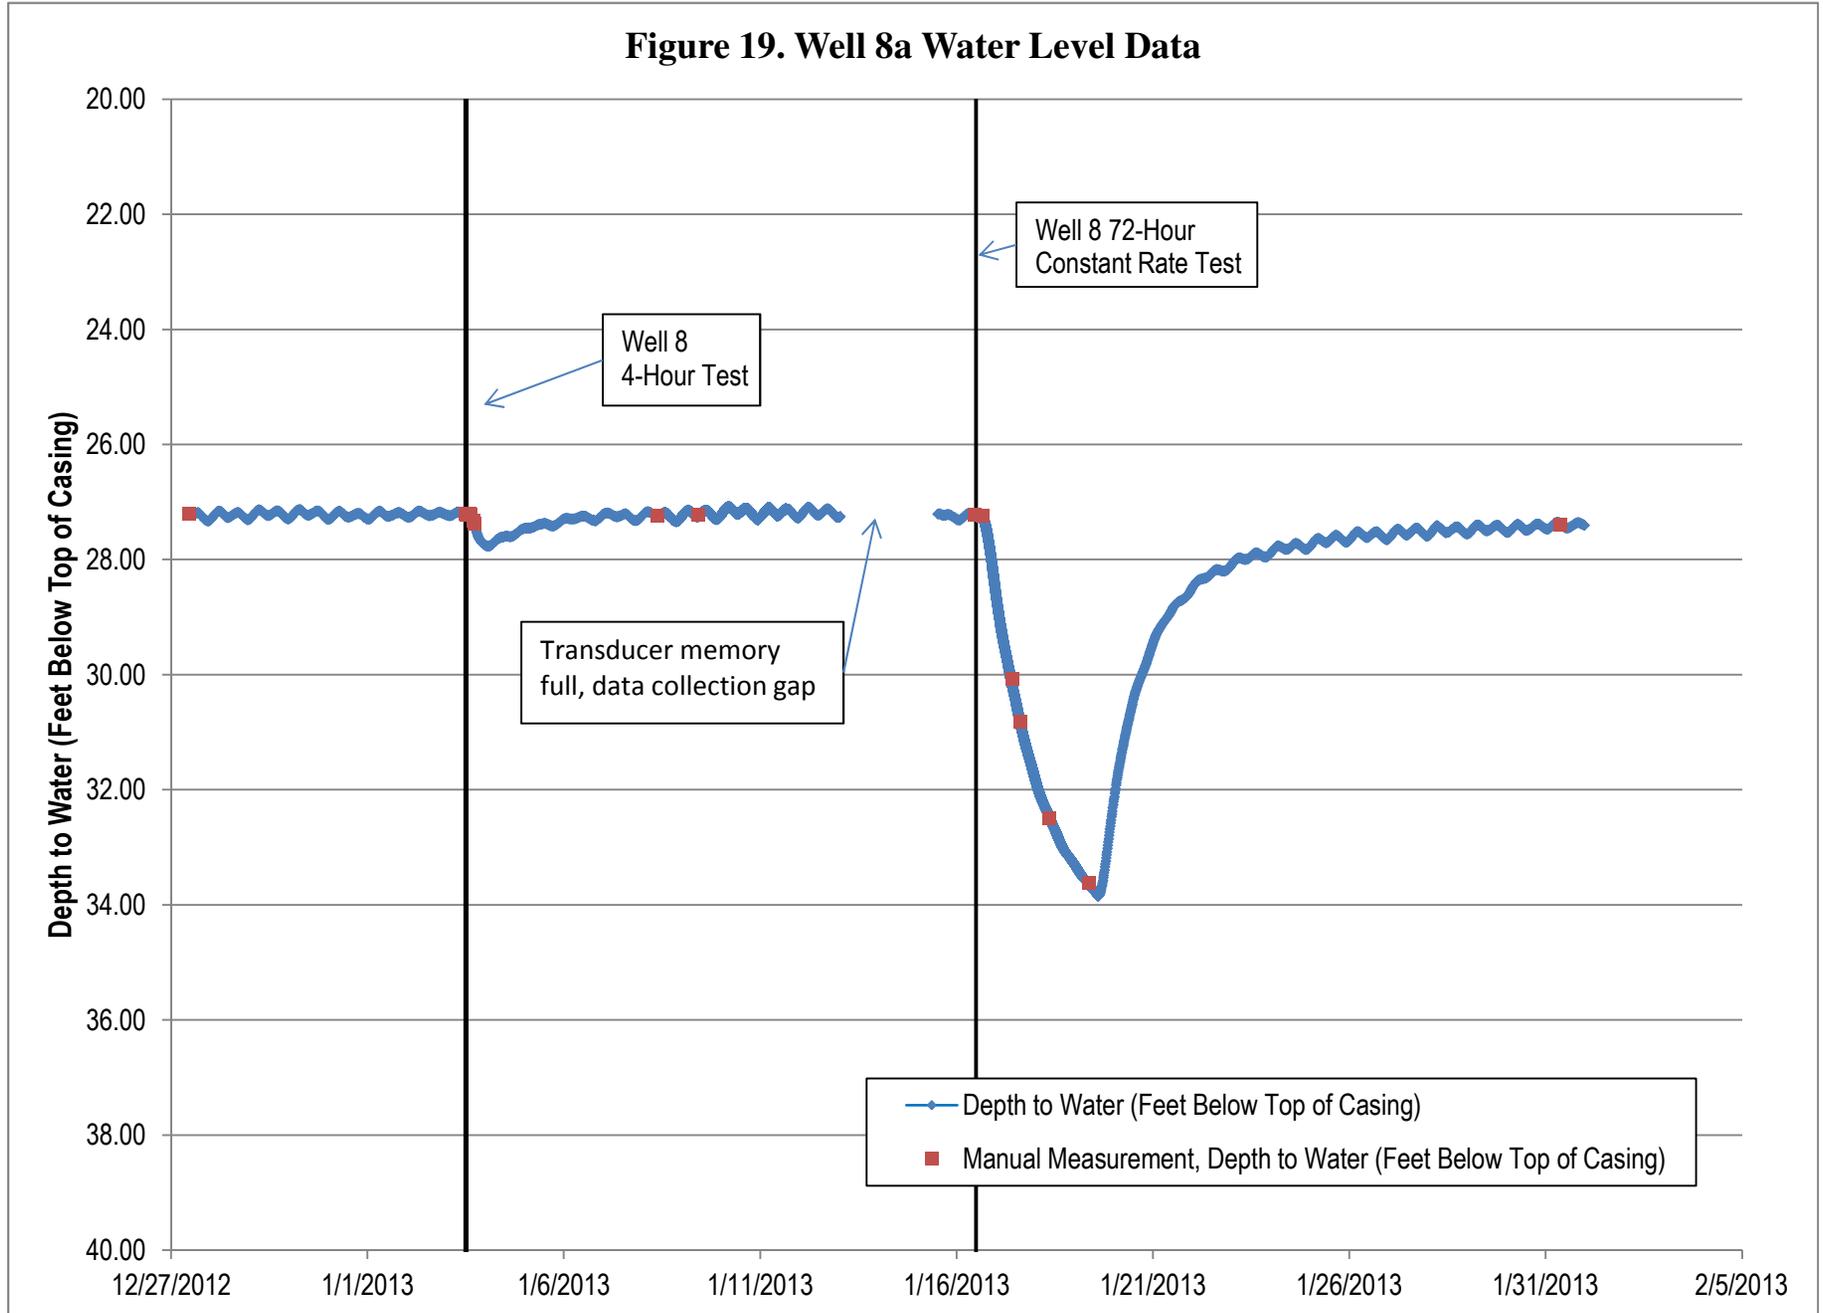
## Figure 19. Well 8a Water Level Data

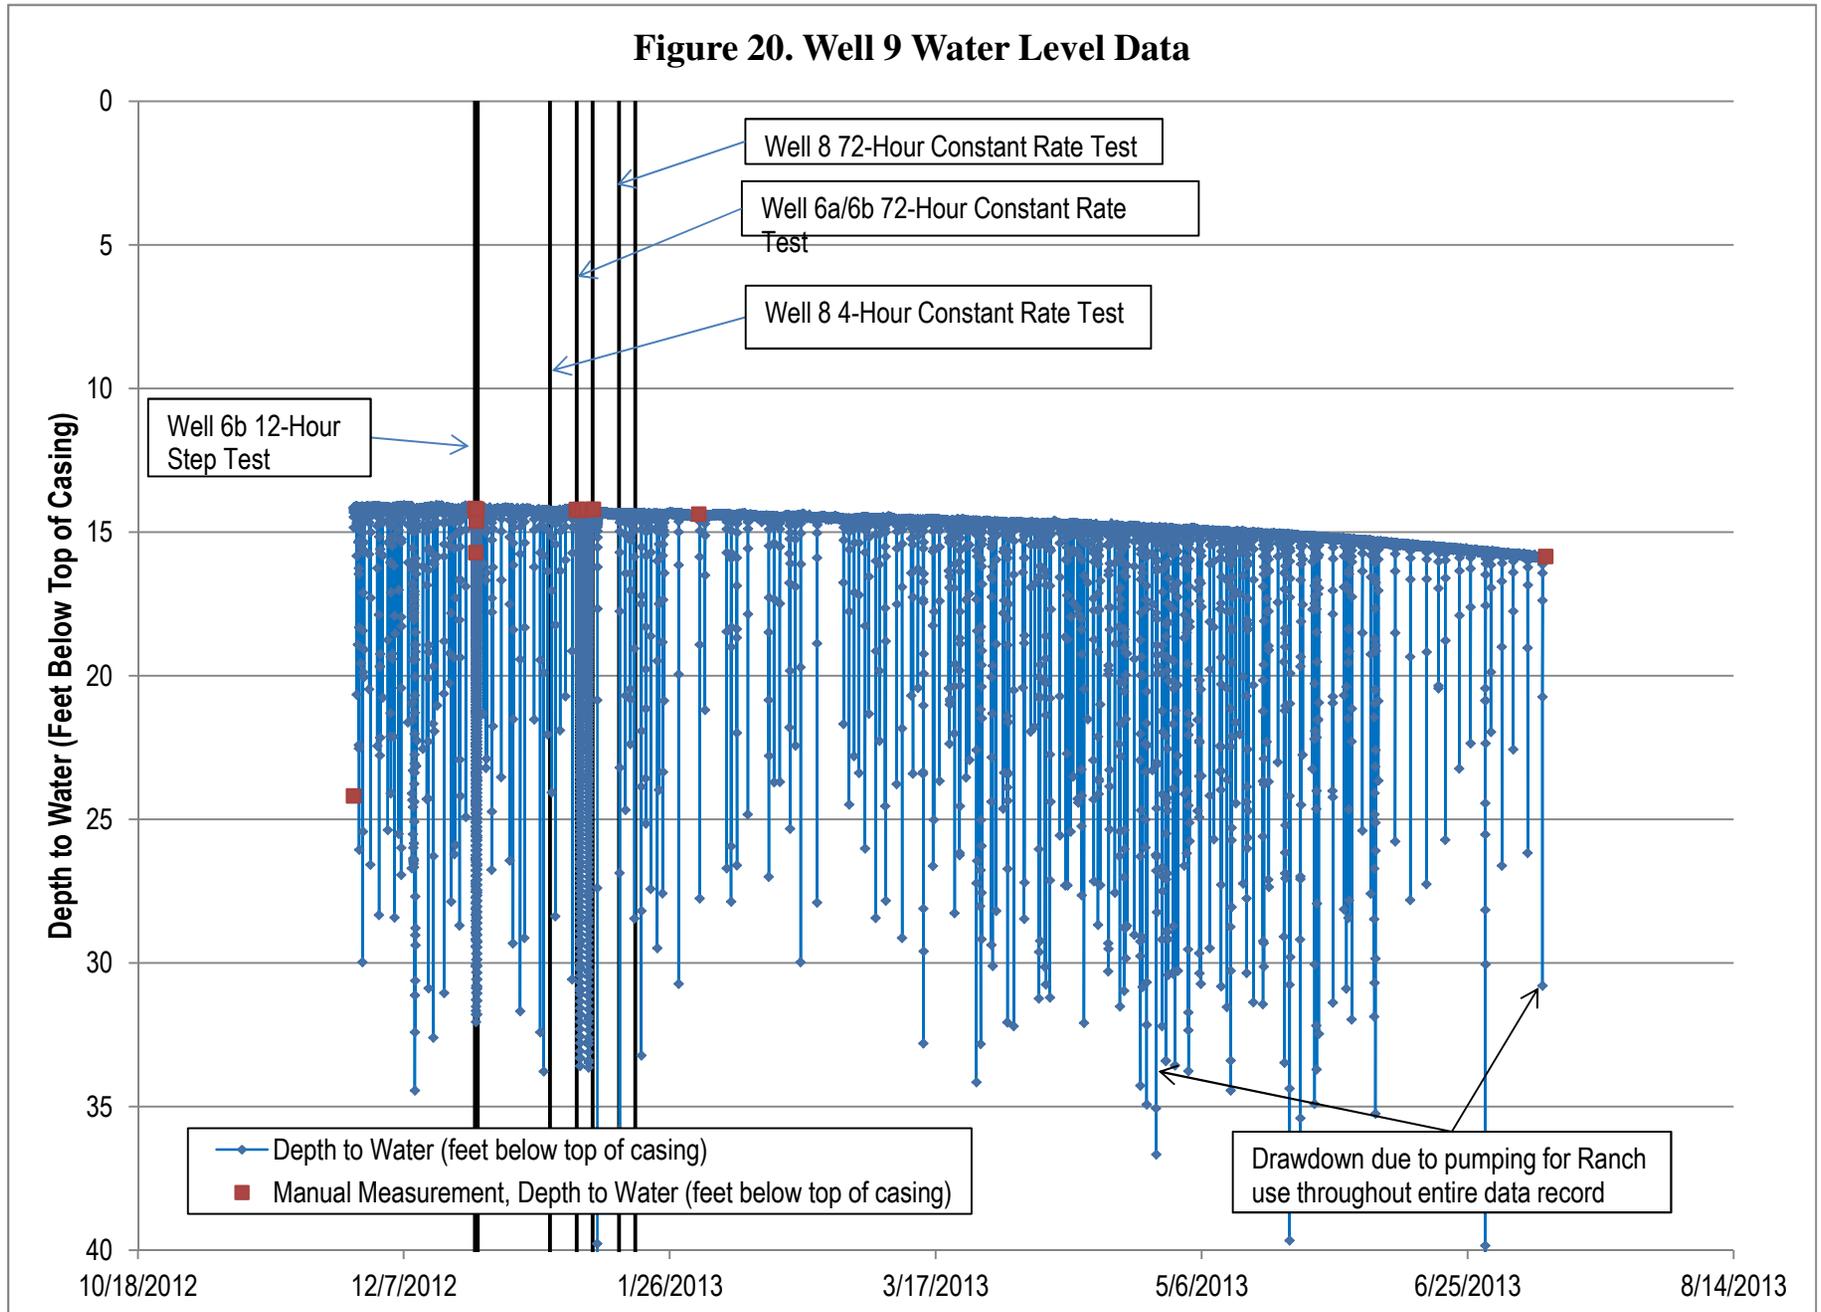
## Figure 20. Well 9 Water Level Data

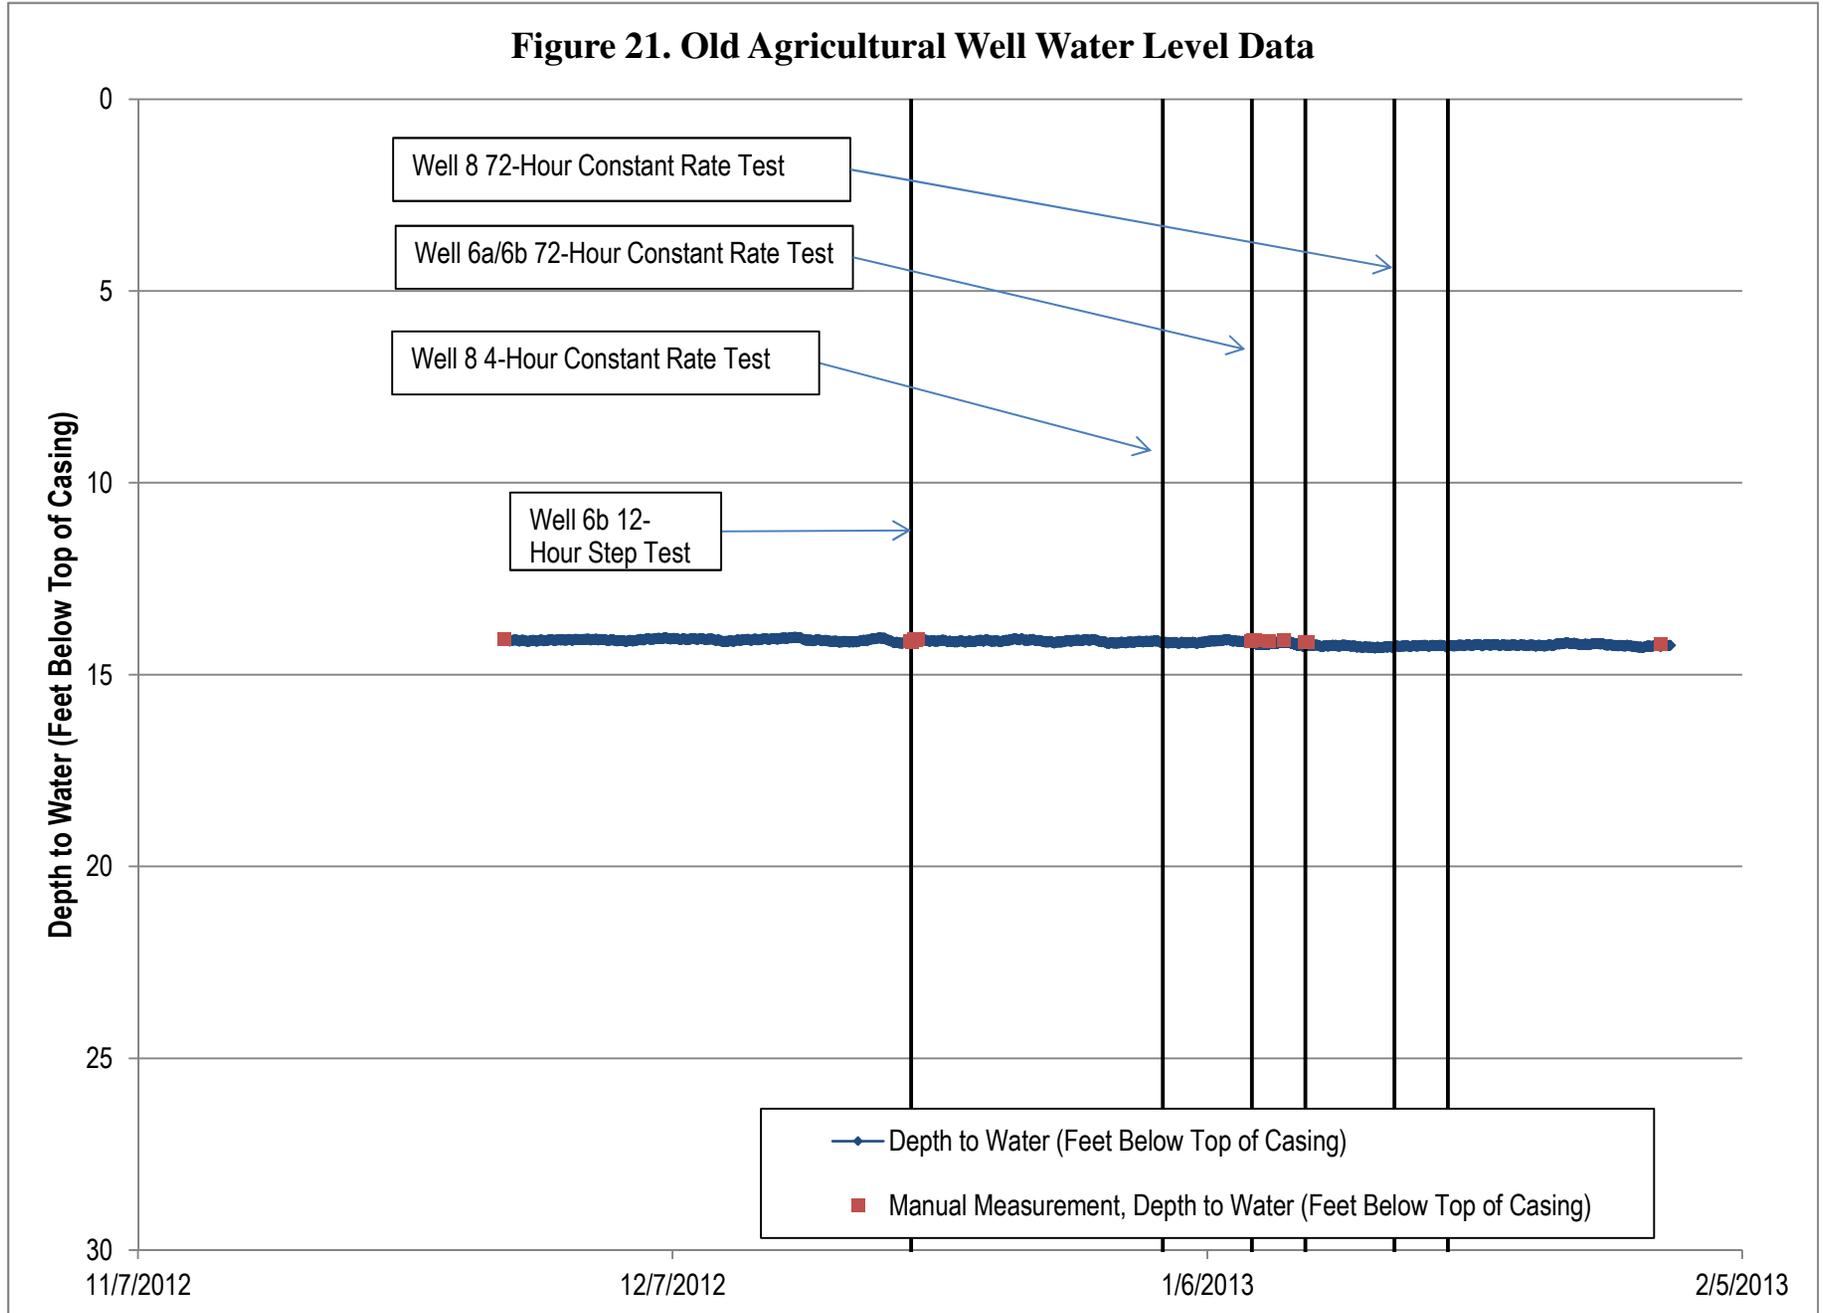
## Figure 21. Old Agricultural Well Water Level Data

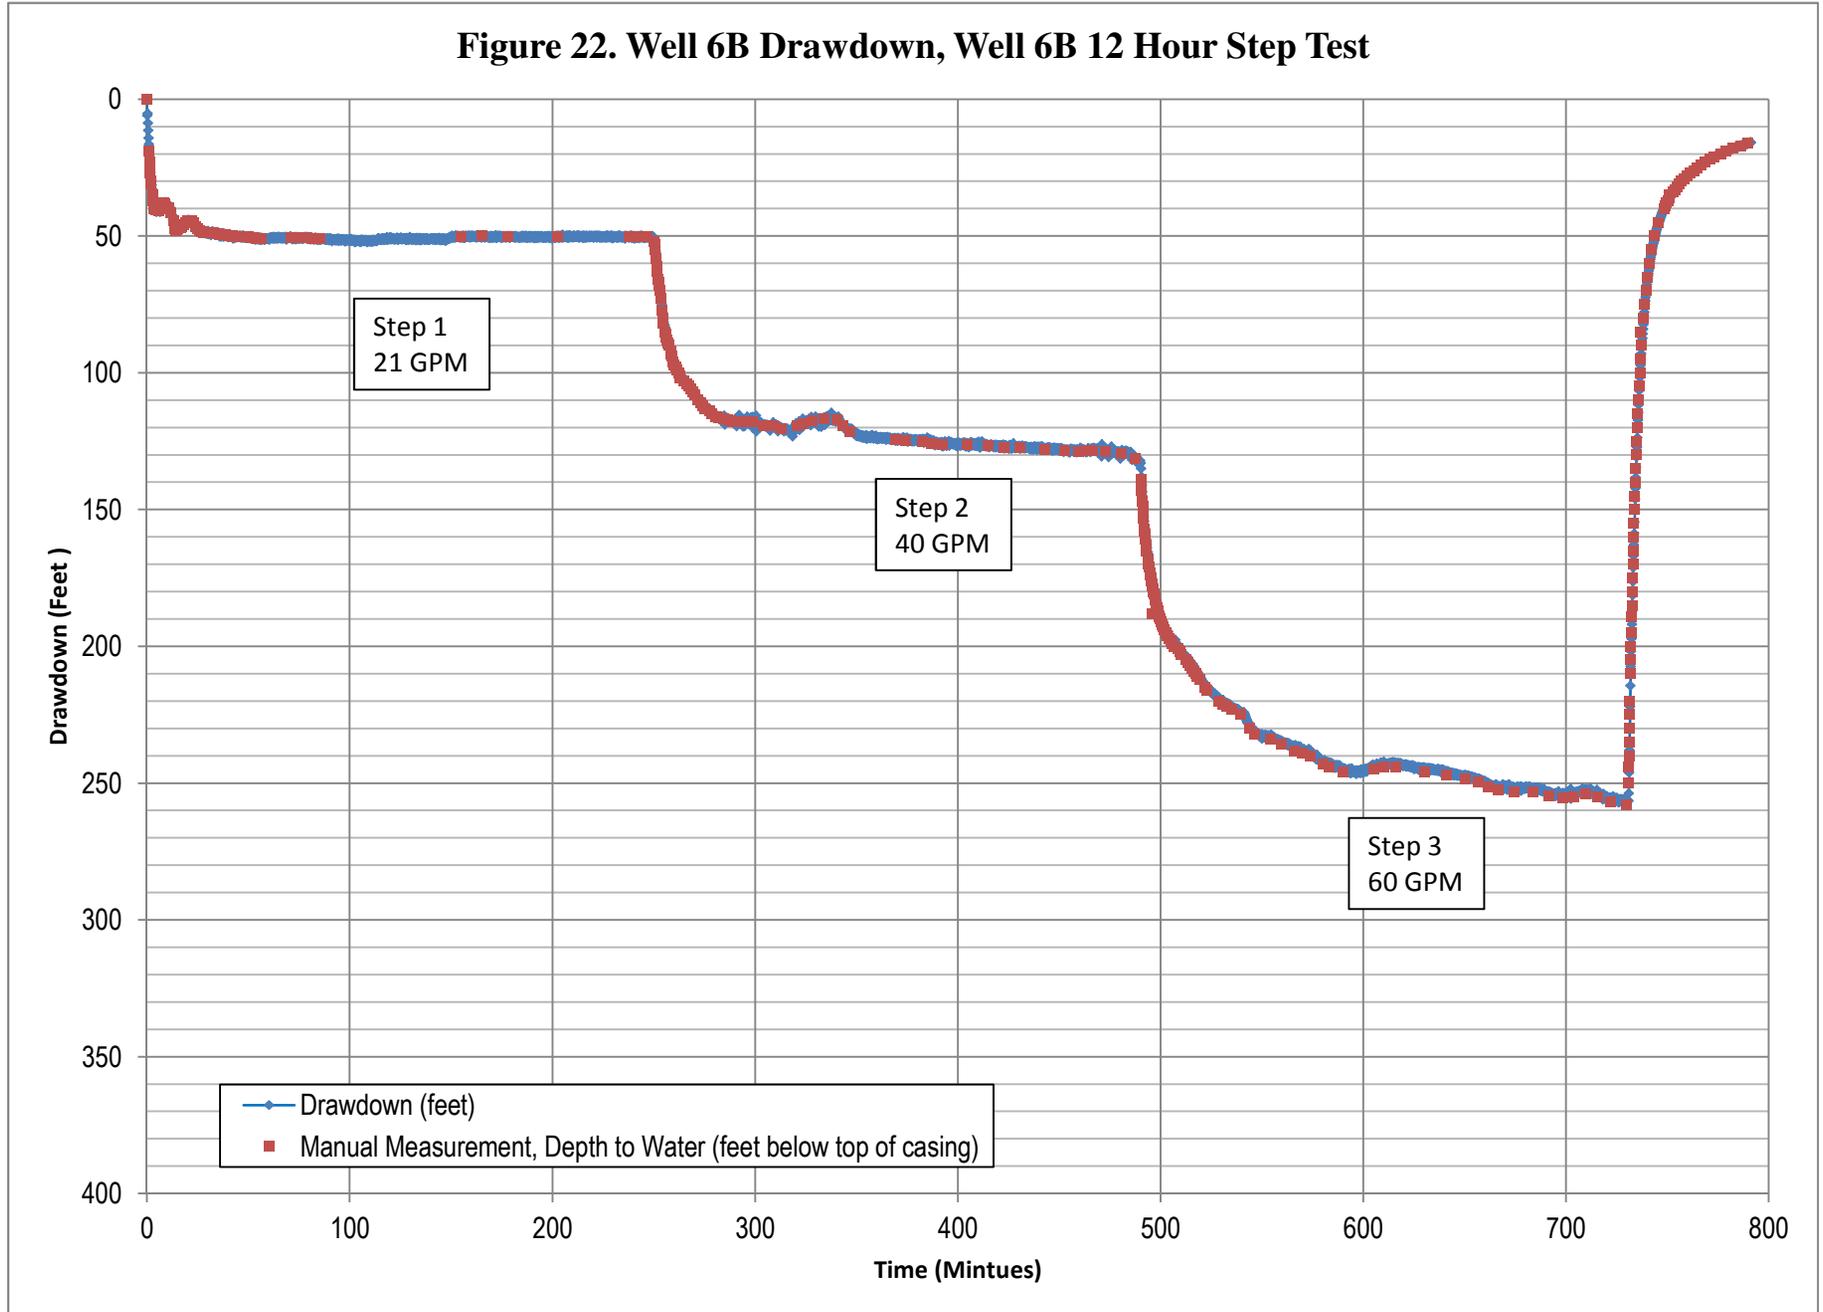
## Figure 22. Well 6B Drawdown, Well 6B 12 Hour Step Test

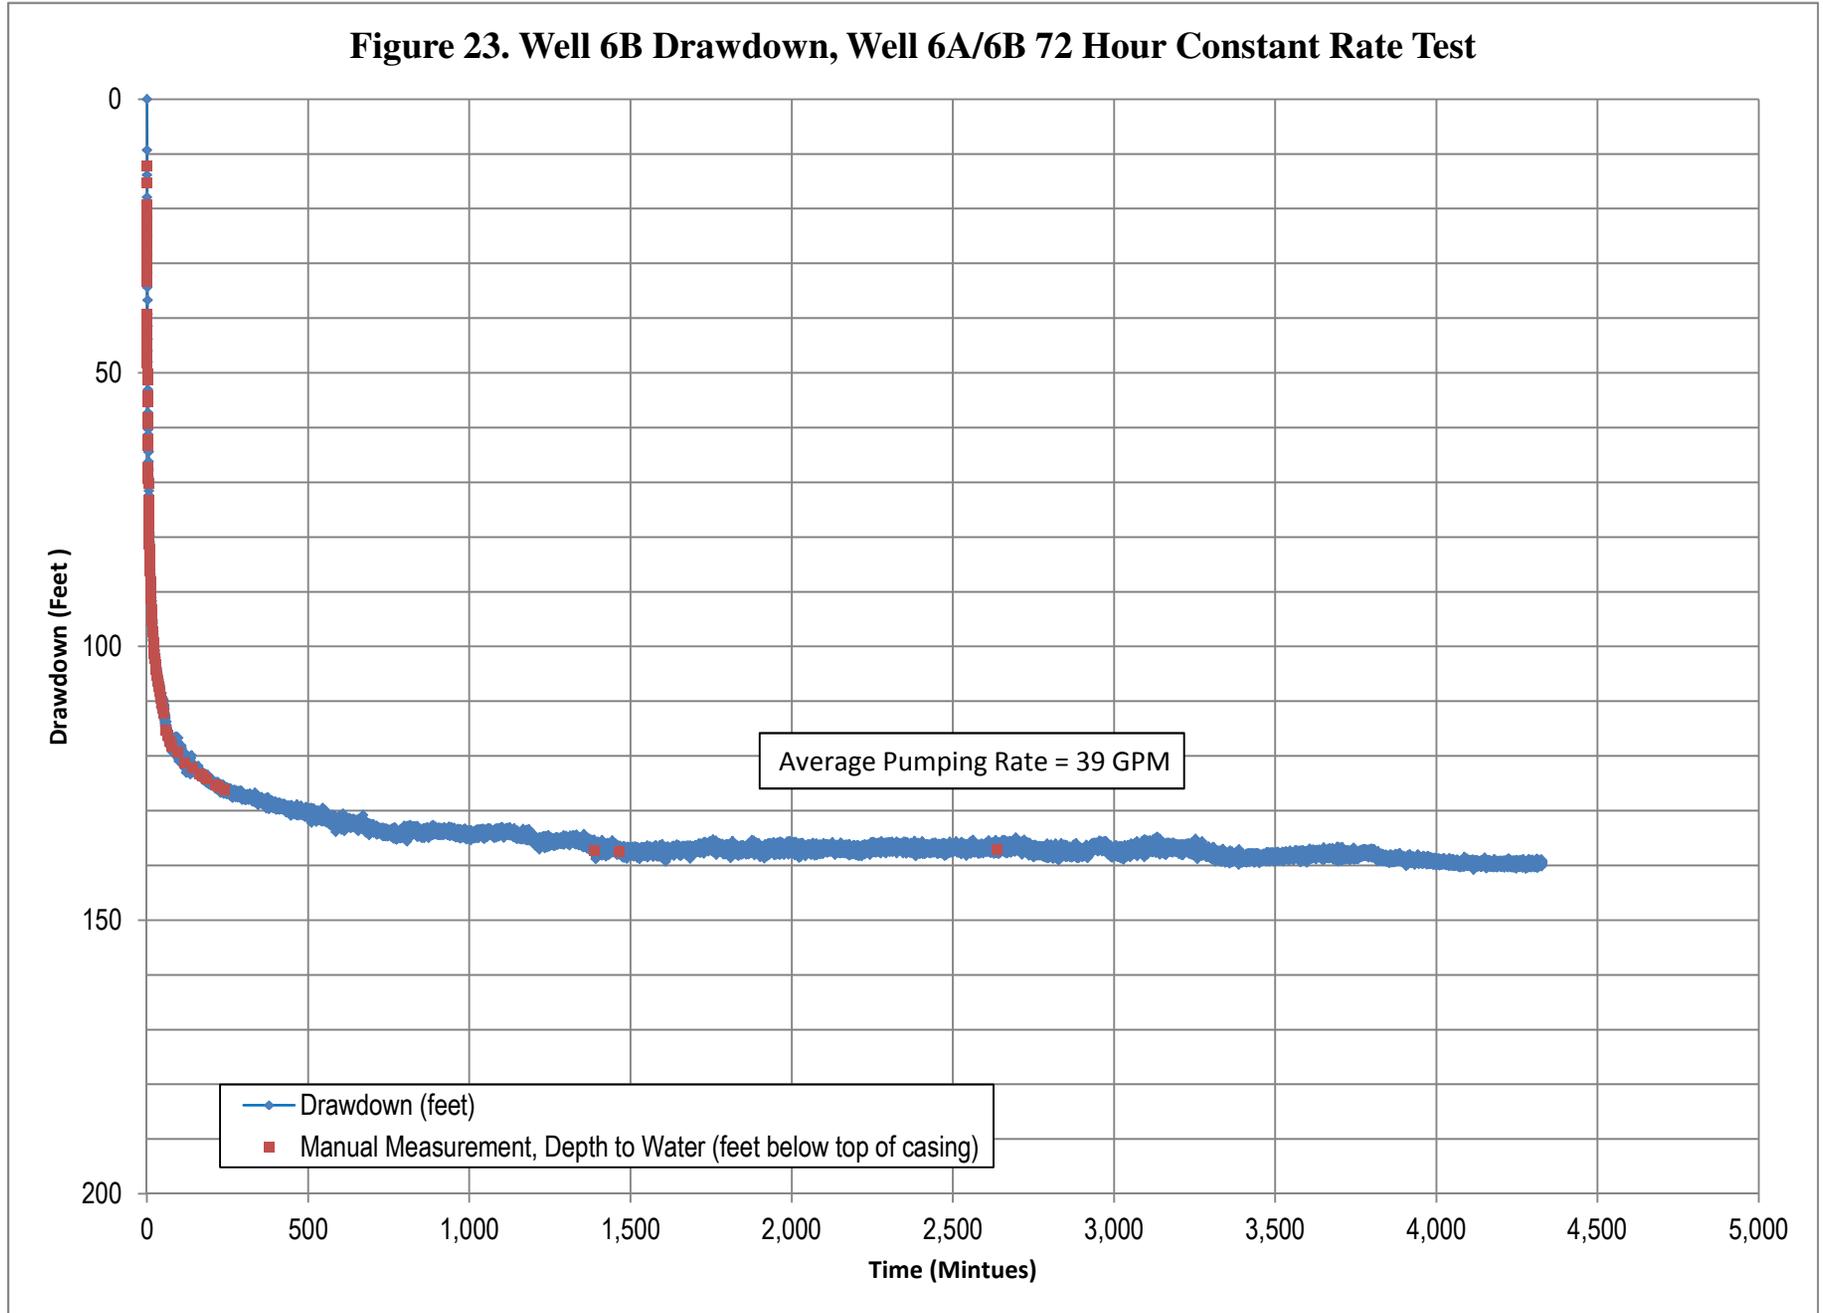
## Figure 23. Well 6B Drawdown, Well 6A/6B 72 Hour Constant Rate Test

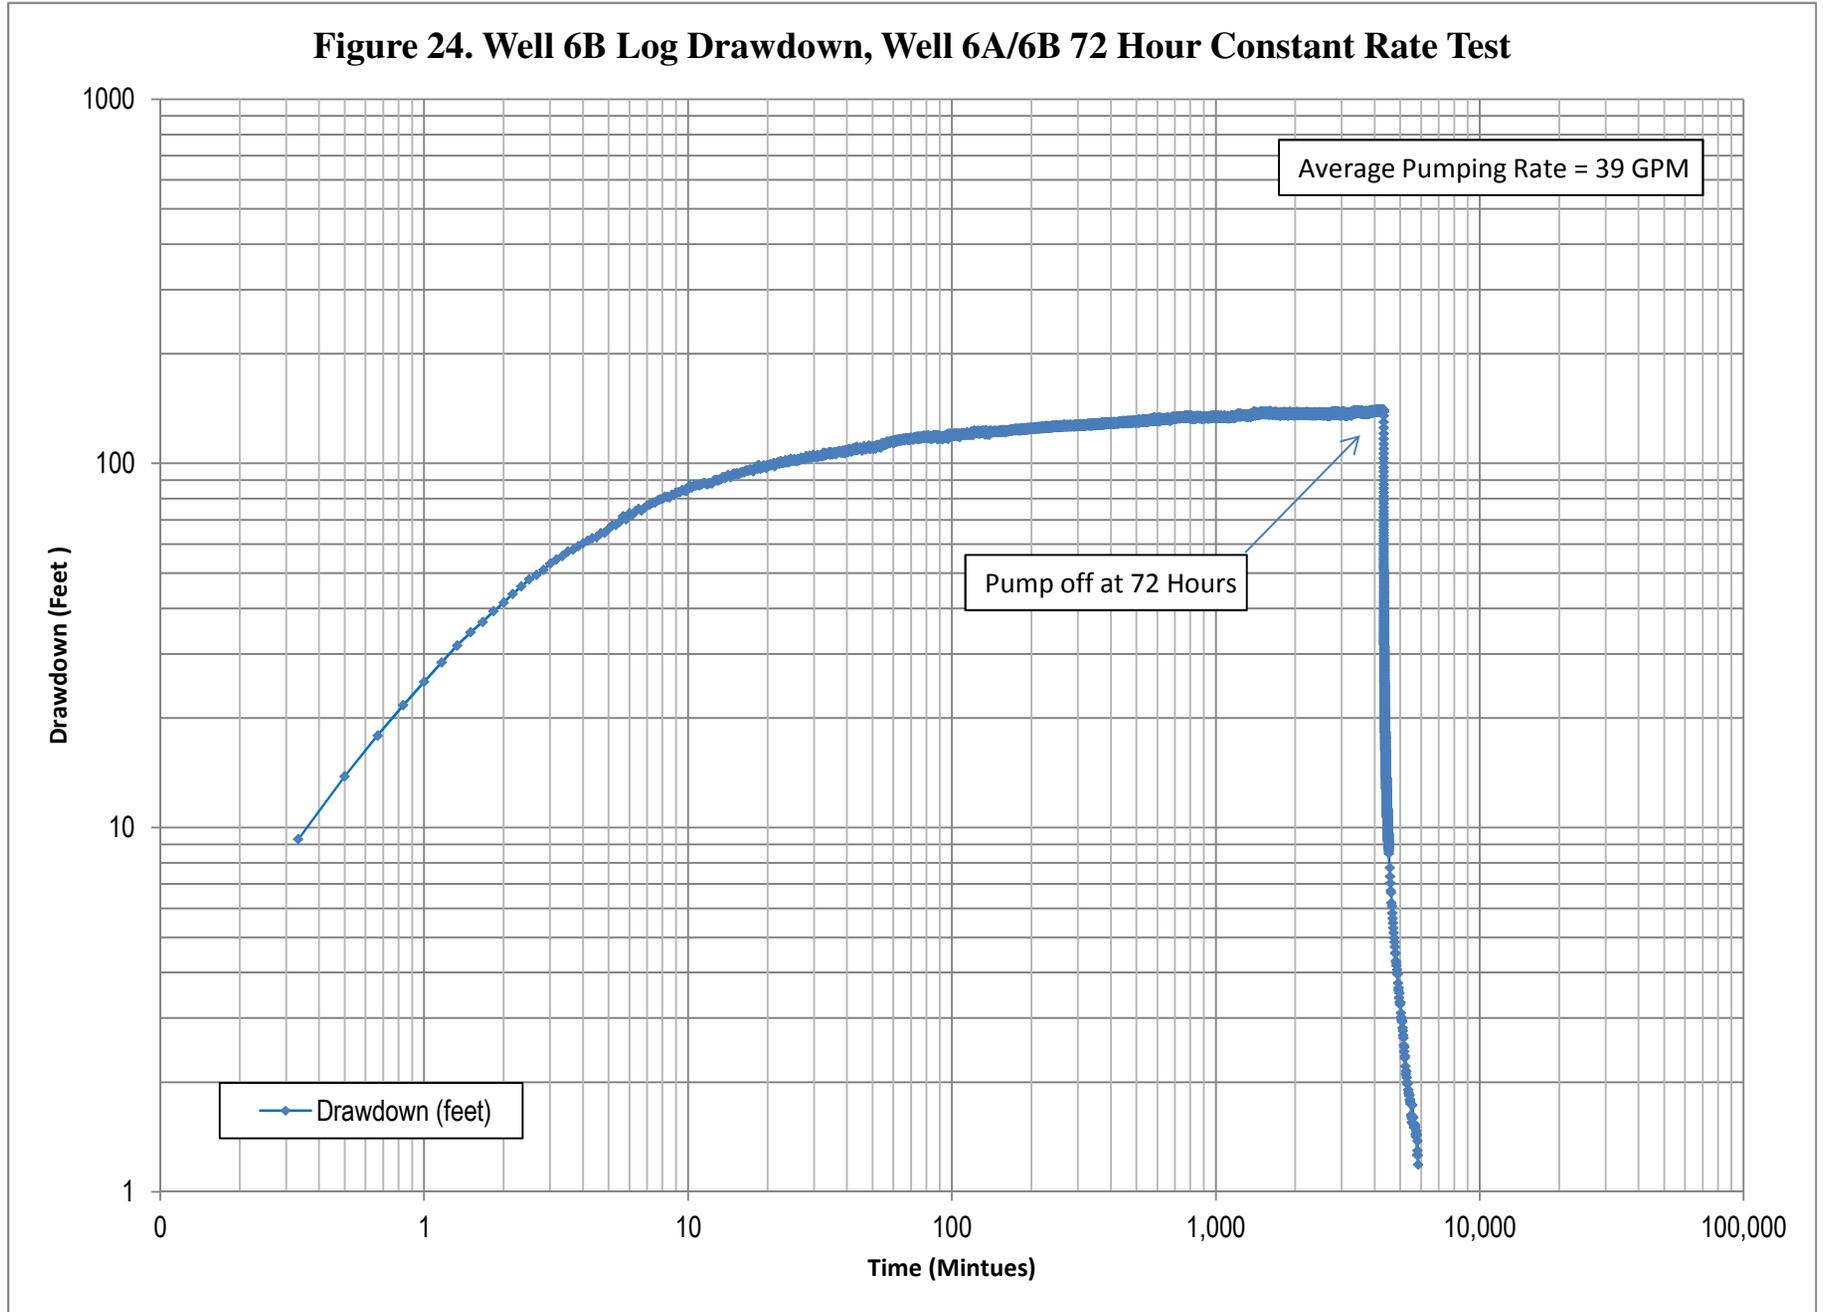
## Figure 24. Well 6B Log Drawdown, Well 6A/6B 72 Hour Constant Rate Test

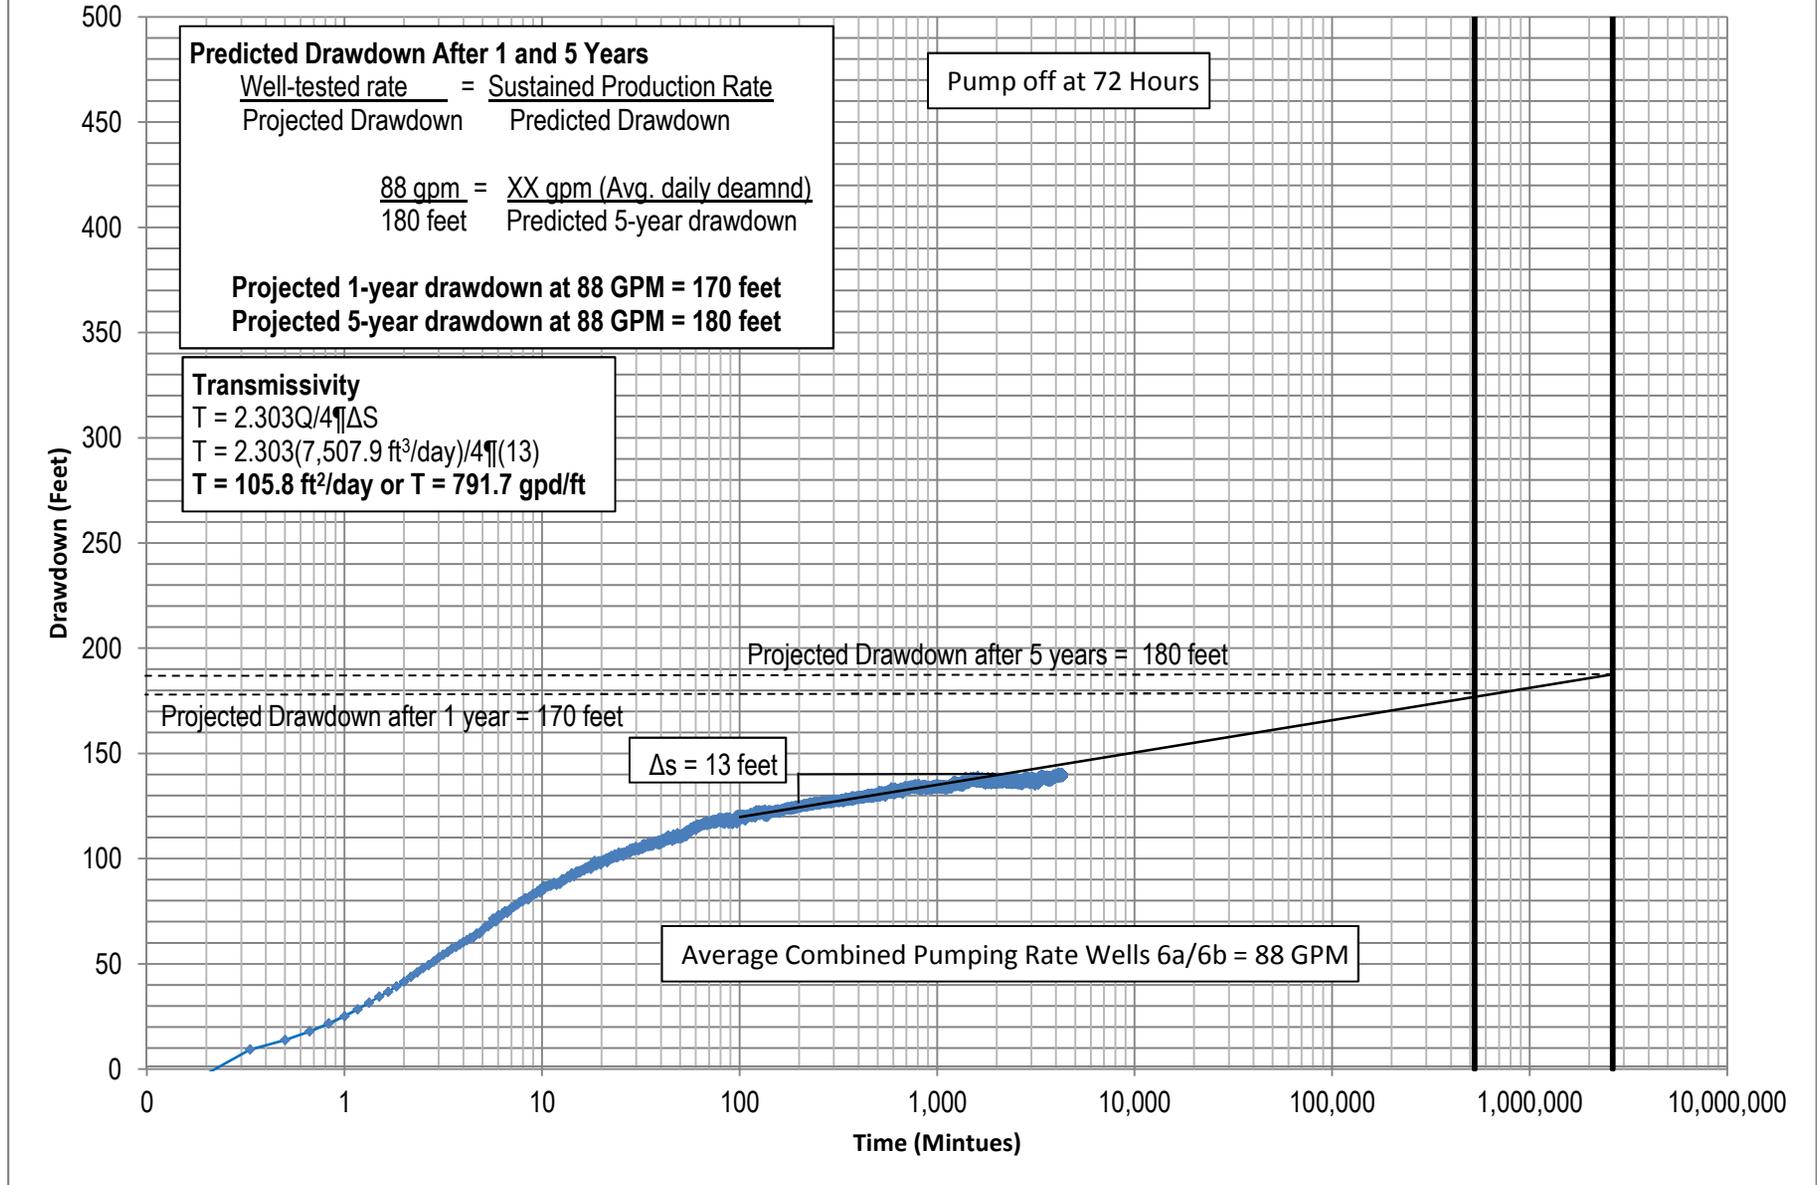
**Figure 25. Well 6B Cooper-Jacob Straight Line Test,  
Well 6A/6B 72 Hour Constant Rate Test**

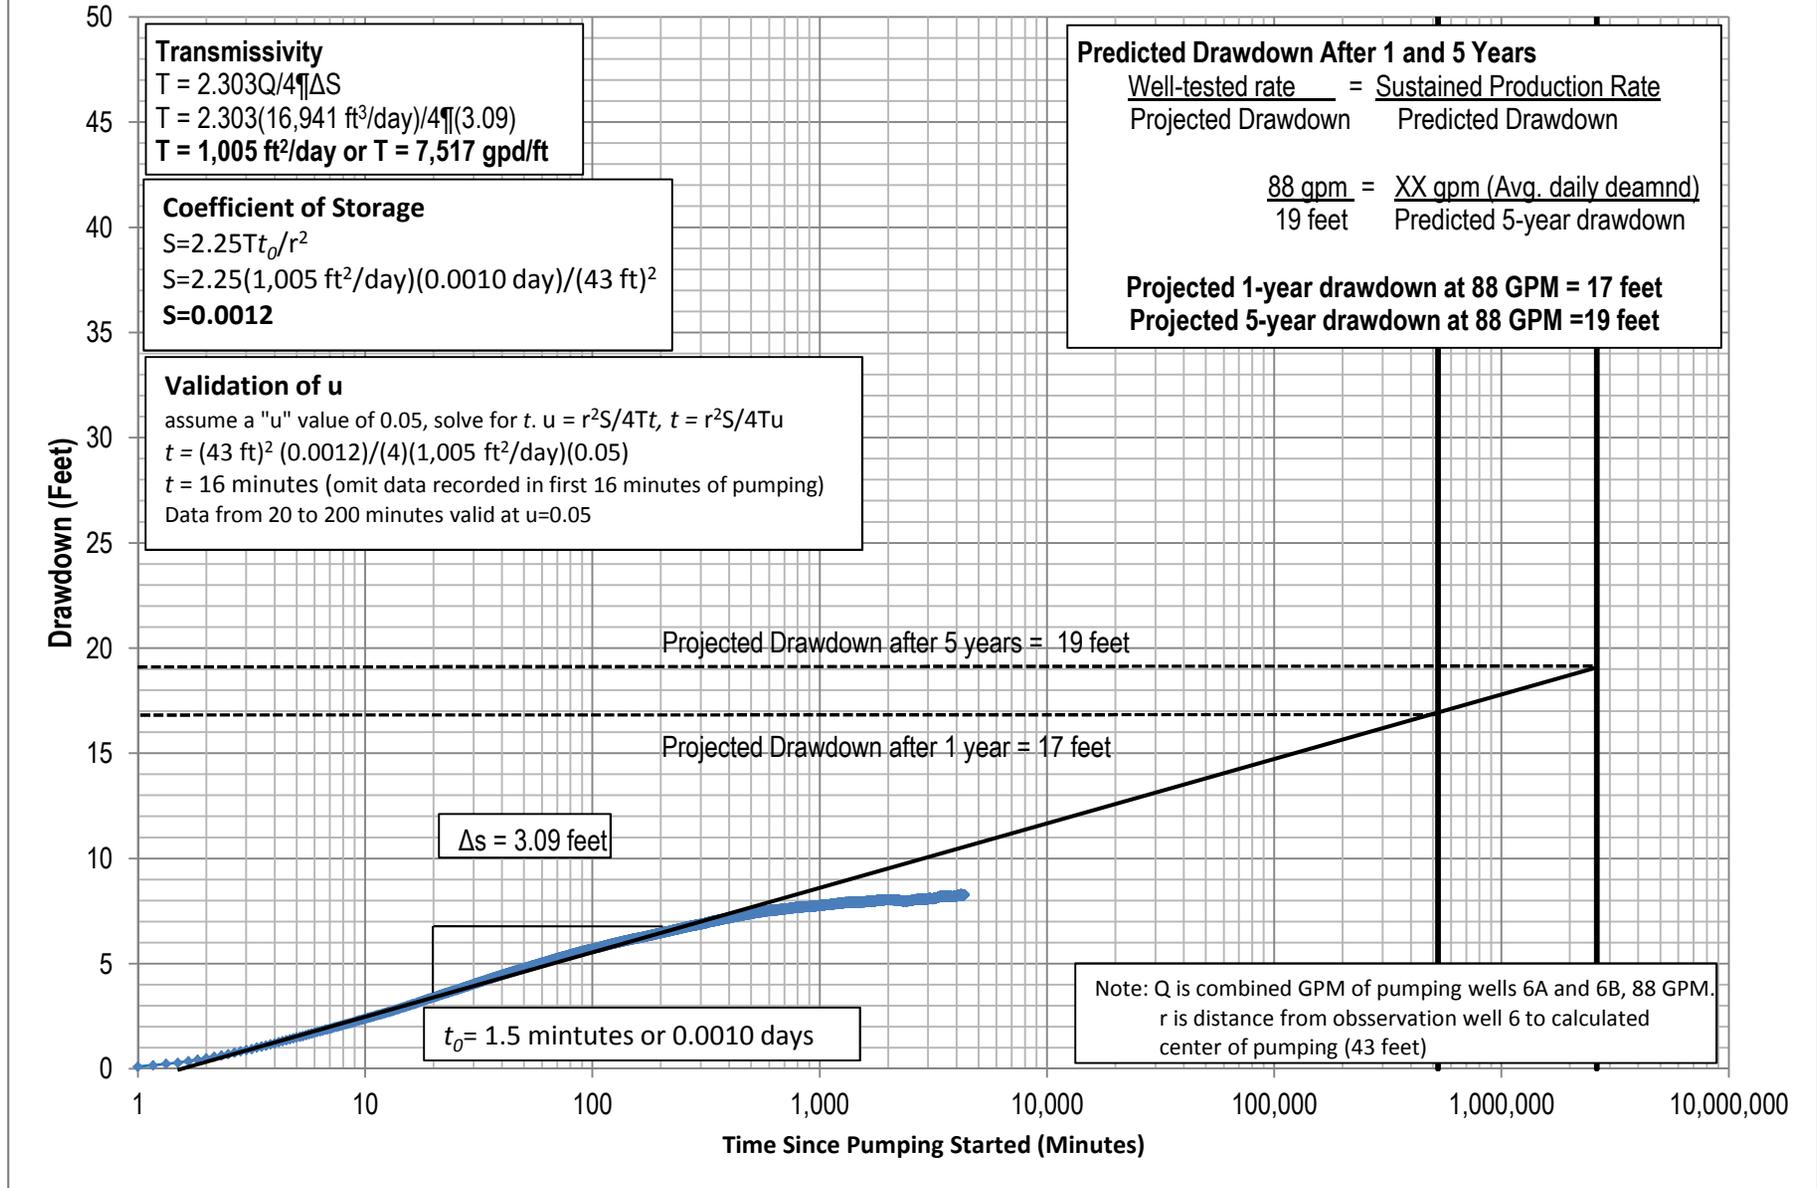
**Figure 26. Well 6 Cooper-Jacob Straight Line Test  
Well 6A/6B 72 Hour Constant Rate Test**
