### **III. ERAS AND ARCHITECTURAL STYLES**

**B. Architectural Styles**

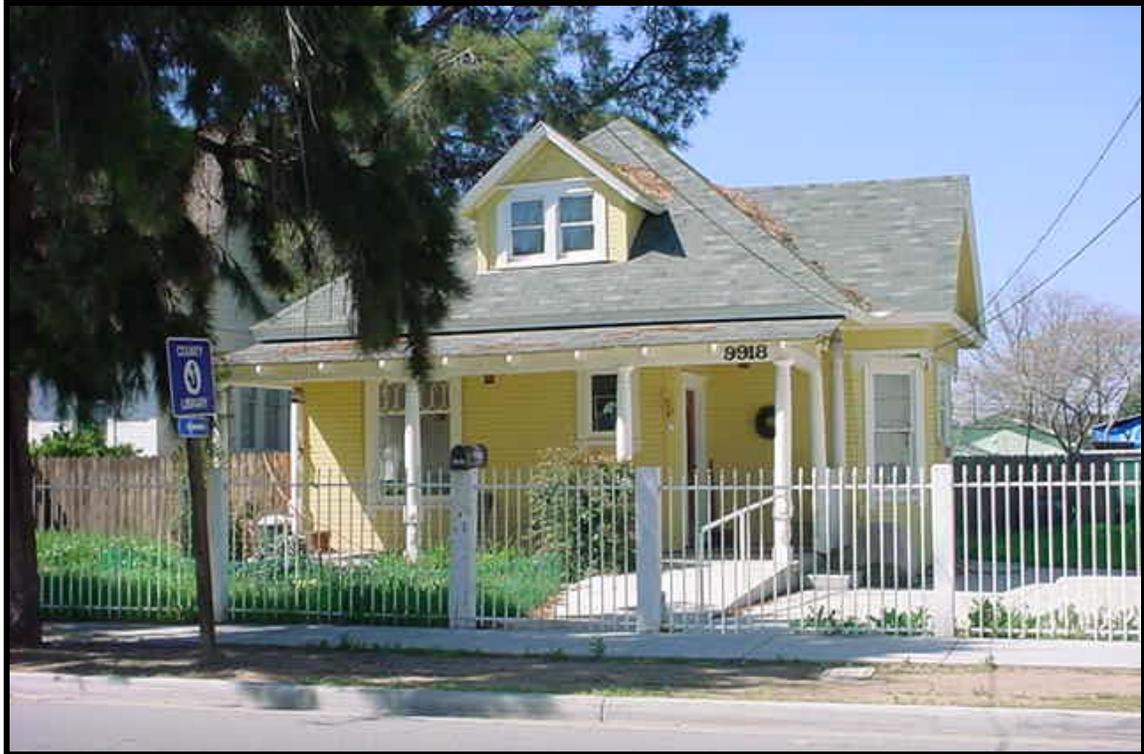
**Photo Plate 10**

**J.H. Neale House**

***Folk Victorian 1870-1910***

Identifying Features: Porches with spindle work detailing (turned spindles and lace-like spandrels) or flat, jigsaw cut trim appended to National Folk house forms; symmetrical facade; cornice-line brackets are common.

Some terms have been added to the National Park Service (NPS) nomenclature in an attempt to directly describe certain prevalent architectural styles frequently seen in the Lakeside Town Center and the potential historic district. Affinis Inc. has identified specific architectural styles for several potential historic resources in Lakeside. Examples of the architectural styles identified are as follows: Folk Victorian, Queen Anne, Colonial Revival, Craftsman, California Bungalow and Spanish Eclectic are shown in **Photo Plates 10 through 15**.

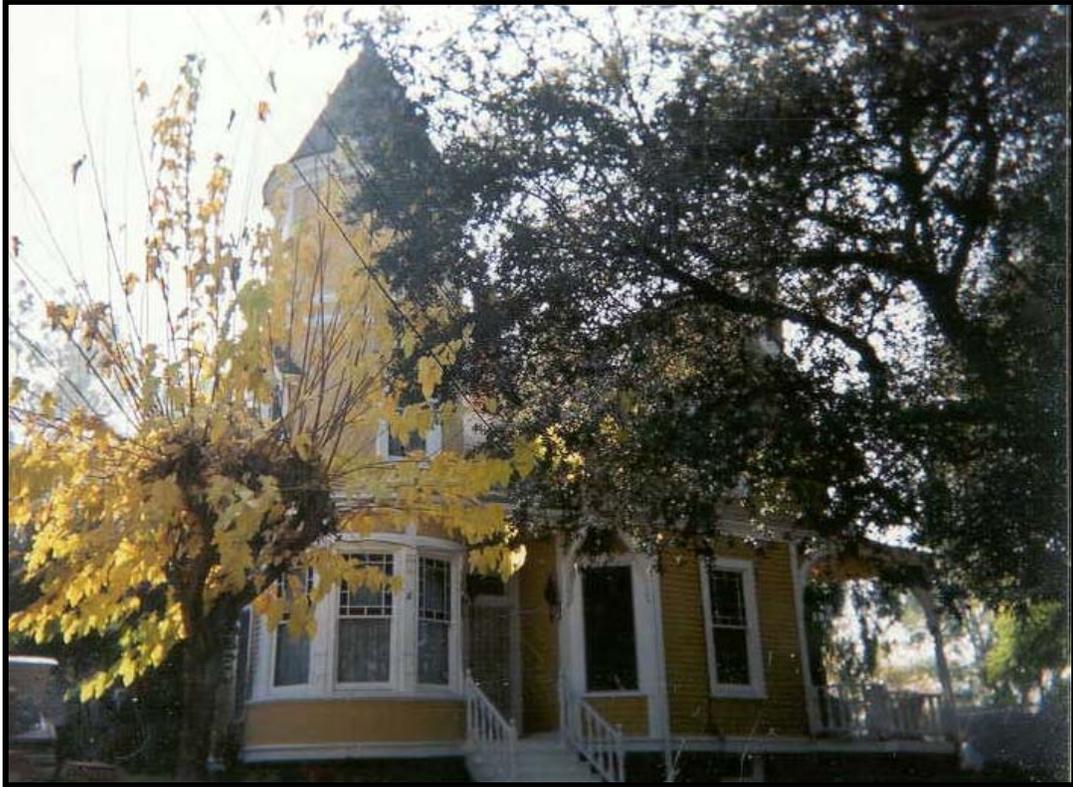
**Photo Plate 11**

**Mansfield House**

***Queen Anne 1880-1910***

Identifying Features: Steeply pitched roof of irregular shape, usually with a dominant front-facing gable; decorative patterned shingles, cutaway bay windows, and other devices used to avoid a smooth-walled appearance; asymmetrical façade with partial or full-width porch which is usually one story and extended along one or both side walls.

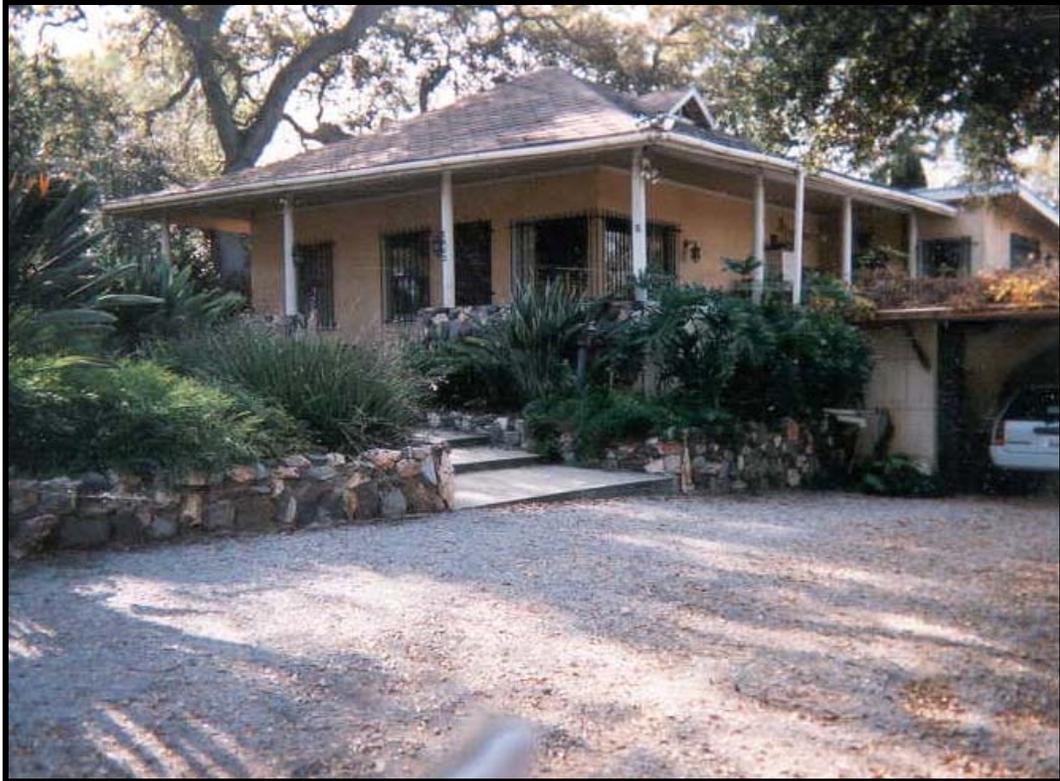
**Photo Plate 12**

**W.R. Rogers Cottage**

***Colonial Revival 1880-1955***

Identifying Features: Accentuated front door, normally with decorative crown supported by pilasters, or extended forward and supported by slender columns to form entry porch; doors commonly have overhead fanlights or sidelights; façade normally shows symmetrically balanced windows and center door; windows with double-hung sashes, usually with multi-pane glazing in one or both sashes; windows frequently in adjacent pairs.

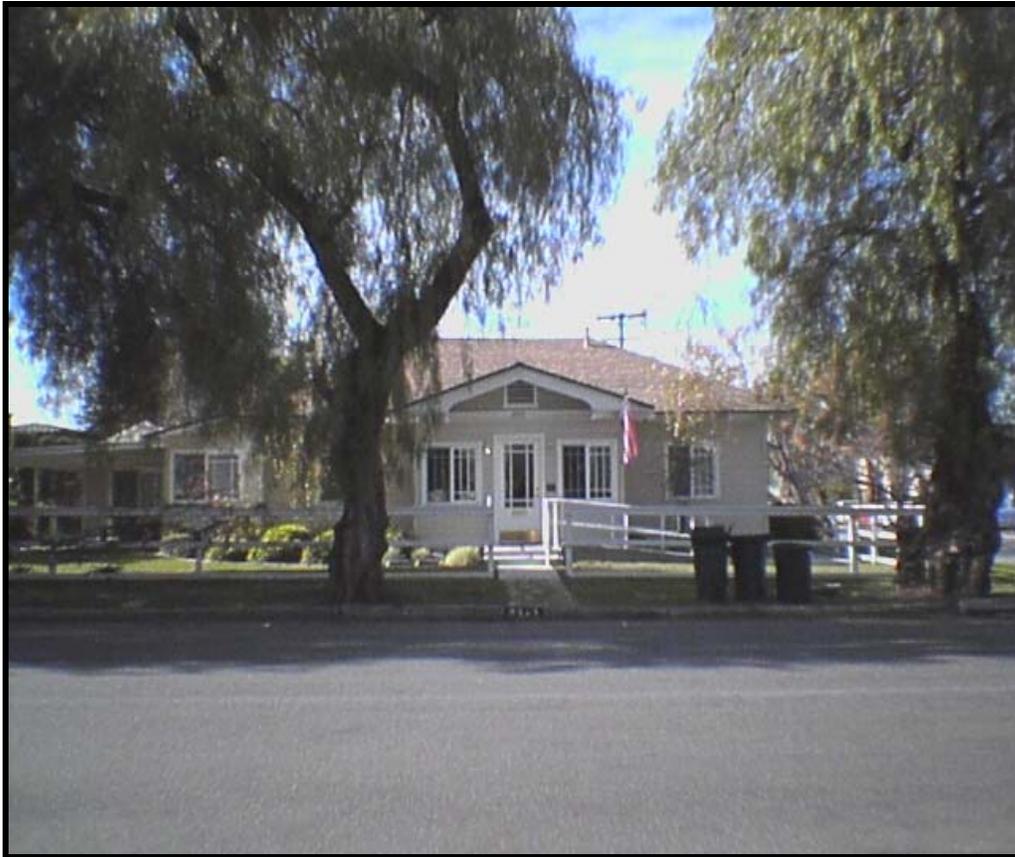
**Photo Plate 13**

**Culbertson House**

***Craftsman 1900-1930***

Identifying features: Low-pitched, gabled roof with unenclosed eave overhang; roof rafters usually exposed; decorative beams or braces commonly added under gables; porches, either full- or partial-width, with roof supported by tapered square columns; columns or pedestals frequently extend to ground level.

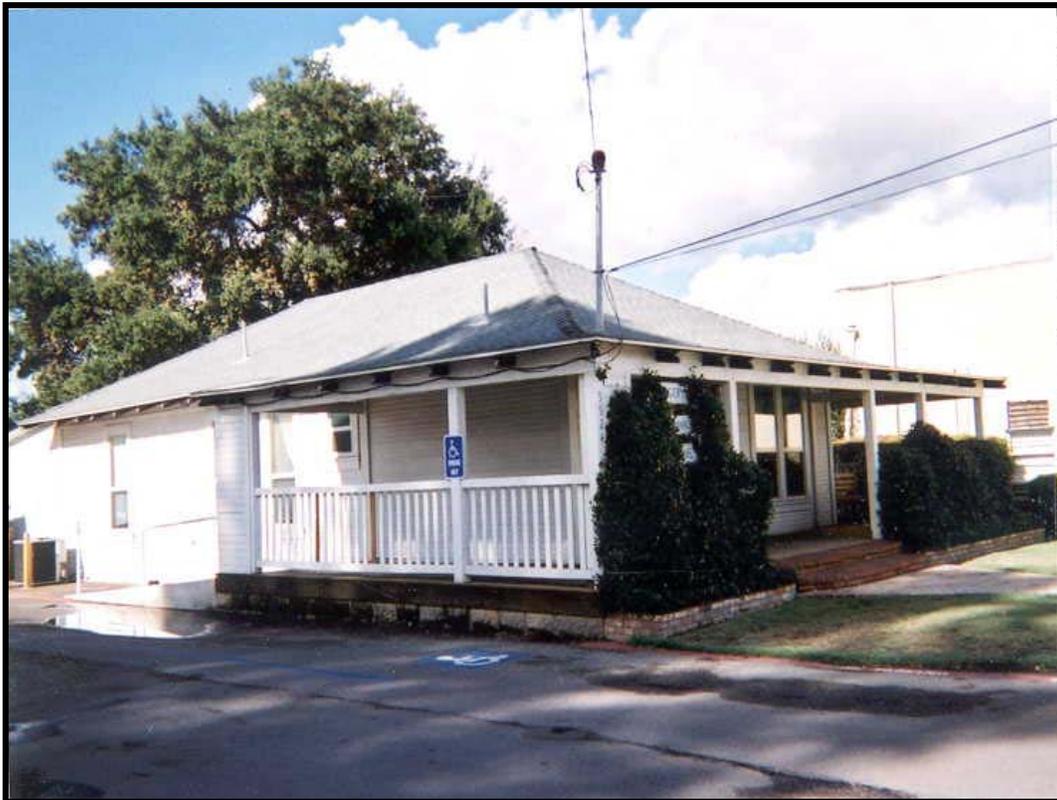
**Photo Plate 14**

**Ross House**

***California Bungalow 1900-1930***

Identifying Features: Typically a single-story house with one or more broadly pitched, overhanging gable or gables; a small gable entry porch set to one side of the gabled roof behind; the front window is divided into three parts with the center portion being the largest.

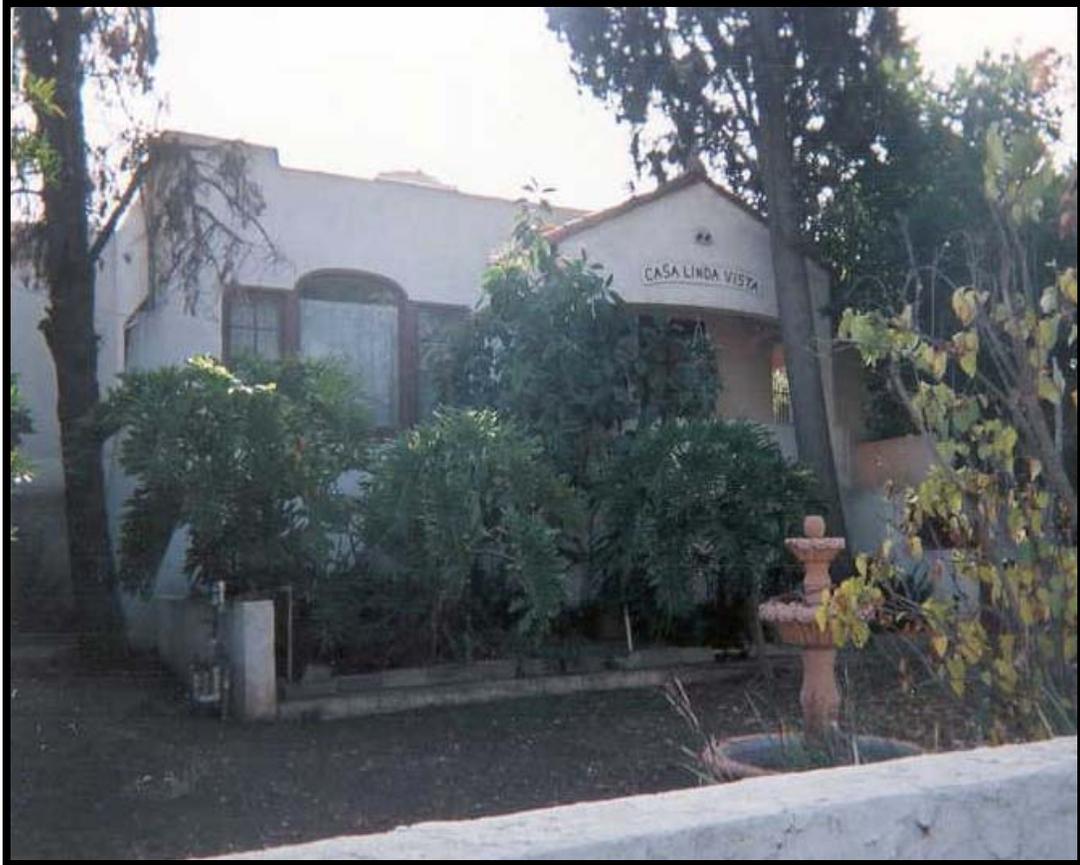
**Photo Plate 15**

**Einer House**

***Spanish Eclectic 1915-1940***

Identifying Features: Low-pitched roof, usually with little or no eave overhang; red tile roof covering; typically with one or more prominent arches placed above door or principal window or beneath porch roof; wall surface usually stucco; facade normally asymmetrical.
