Final Report for the
Cottonwood Creek Exotic
Plant Species Removal
and Revegetation Project
Grant Agreement
#04-065-559-0

RECON Environmental, Inc.
1927 Fifth Avenue
San Diego, CA 92101-2358
P 619.308.9333 F 619.308.9334
RECON Number 4437B
March 26, 2008

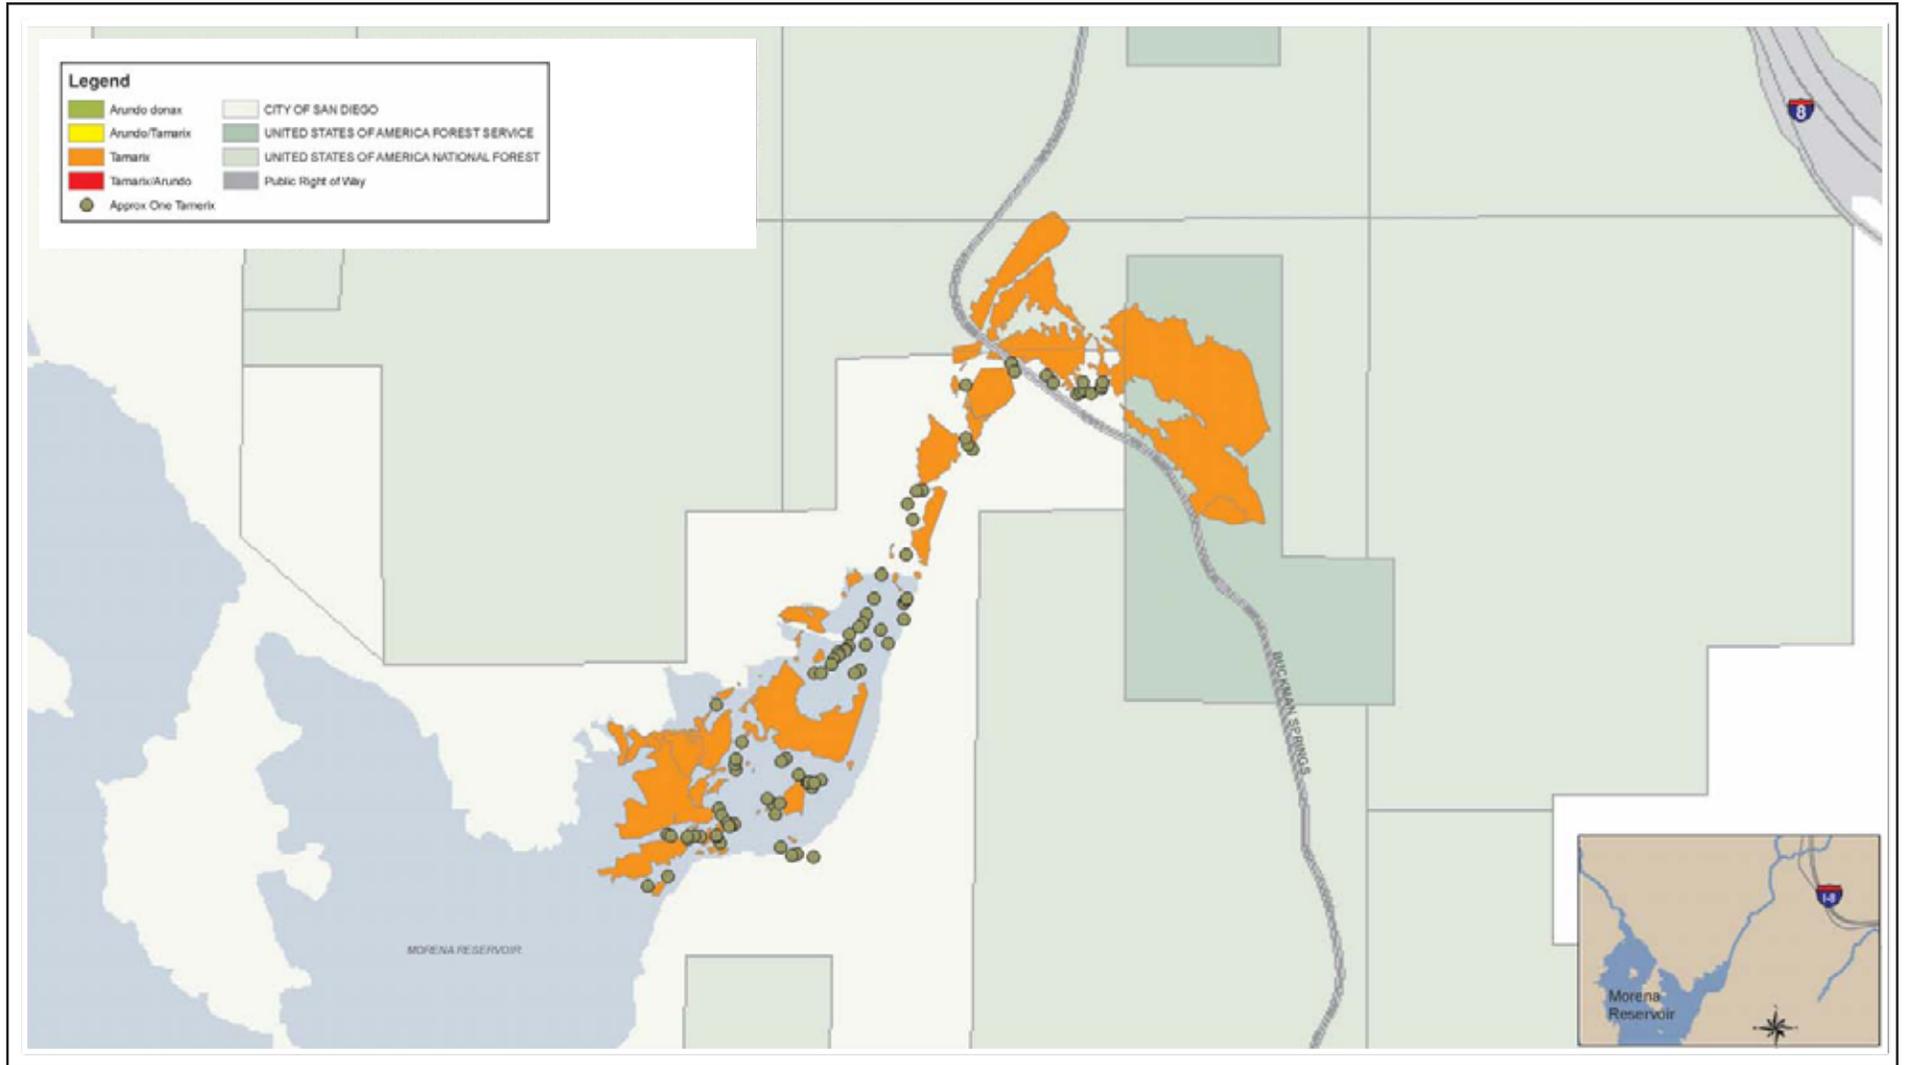
FIGURE 3
Invasive Species at Morena Reservoir Project Area

The County of San Diego identified two areas of salt cedar and giant reed infestation within the upper Cottonwood Creek watershed, and populations of each target species throughout the project area were recorded using a Global Positioning System (GPS). These surveys found that target invasive plant populations at the Morena Reservoir site consisted solely of salt cedar (approximately 95 total acres; Figure 3). In contrast, the Barrett Reservoir site was dominated by salt cedar, but also included large stands of giant reed in the lower portions of the project area near SR-94 (approximately 64 total acres). Due to time and budgeting constraints, work was only conducted in the Morena Reservoir project area.

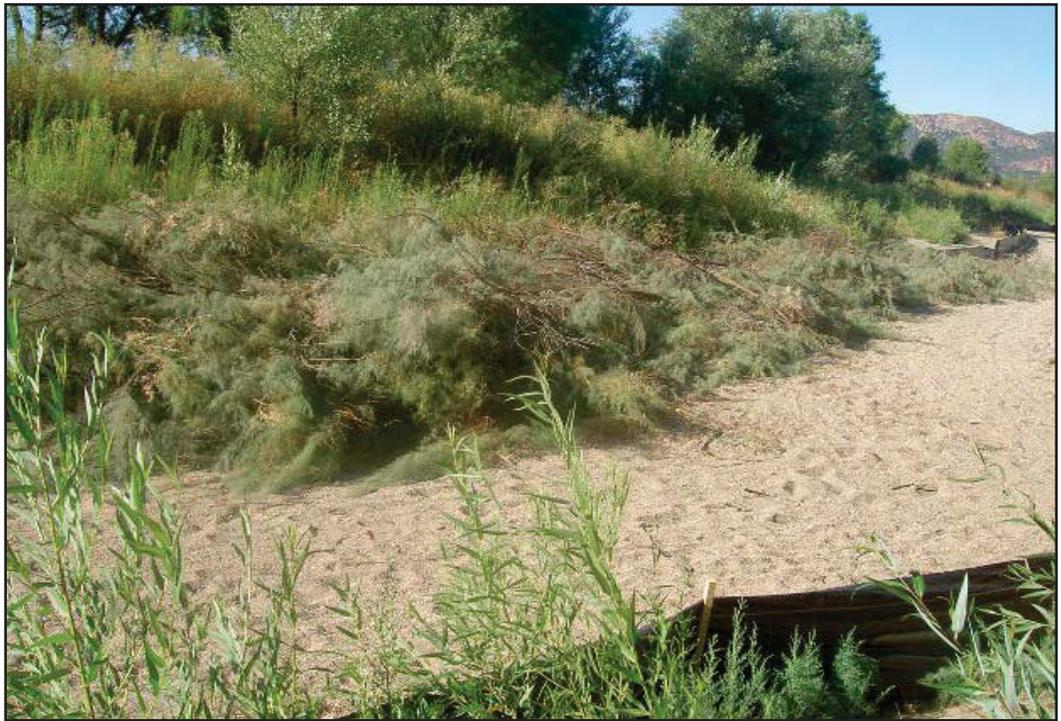
PHOTOGRAPH 1
Arroyo Toad Exclusion Fencing Surrounded High-traffic Areas During
Salt Cedar Removal, Cut Salt Cedar Biomass Was Piled in
Predetermined Locations

Consultation regarding arroyo toad fencing was provided by Chris Otahal (USFWS) and John Konecny (EDAW, Inc.). After reviewing the Morena Reservoir site, it was decided that the density of vegetation in some locations limited toad habitat and restricted the installation of toad fencing. The original project plans instructed that fencing be installed around work areas as work occurred. However, this proposal was deemed unfeasible because installation of the fence would cause greater disturbance to native habitat than would localized removal of target plants. Therefore, the USFWS and EDAW suggested the installation of toad exclusion fencing only surrounding high activity corridors leading

to and from the major areas of salt cedar removal. This revised method would both limit the amount of soil disturbance in valuable habitat, while also concentrating foot and vehicular traffic to existing established ranch roads, trails, and the dry streambed.

The majority of all fencing was situated in the dry streambed where sandy substrate could be used to bury and secure the bottom edge of the fabric. However, in limited portions of uplands, adjacent to previously mentioned ranch roads, the bottom of the fence fabric had to be secured with sandbags.

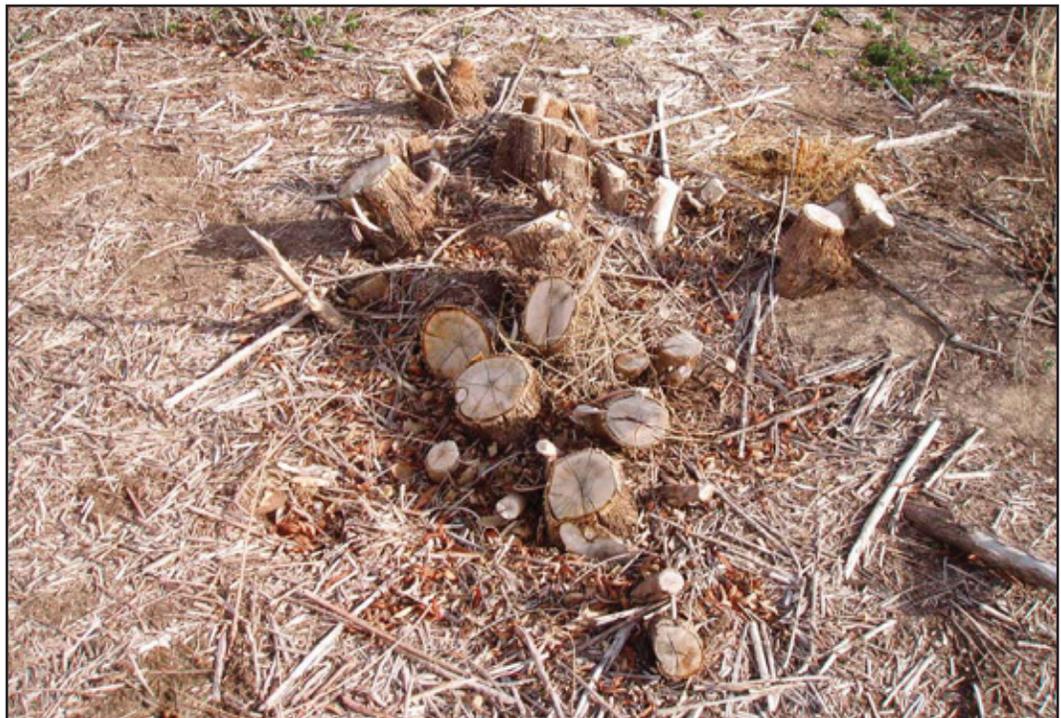
PHOTOGRAPH 2
Cut Salt Cedar Stumps Were Treated With
Herbicide to Prevent Resprouting

Salt cedar removal was accomplished using chainsaws. Each plant was cut to a stump height of approximately 8 to 15 inches using a chainsaw, and biomass was removed (Photograph 2). Pathfinder II™, a triclopyr-based herbicide, was then immediately applied to the cut stump using a backpack sprayer held no further than 8 inches from the target plant. Pathfinder II was chosen because it is effective on woody plants such as salt cedar but does not harm native grasses and sedges. Use of this product was approved by a certified Pest Control Advisor. Herbicide application occurred between 7:30 A.M. and 2:00 P.M. during calm conditions of no more than 5 mph wind to minimize chemical particle drift. No foliar or broadcast spraying occurred in this project.

Herbicide application was conducted by Mr. Rogelio Ramos, a state licensed and County-registered herbicide applicator provided by the CCC. In some instances, Mr. Ramos was not immediately available or was not present on-site. In this case, plants were “pre-cut” to approximately three feet in height, and most of the biomass was removed. When the herbicide applicator became available, the stem was re-cut and herbicide was applied to the freshly cut stump.

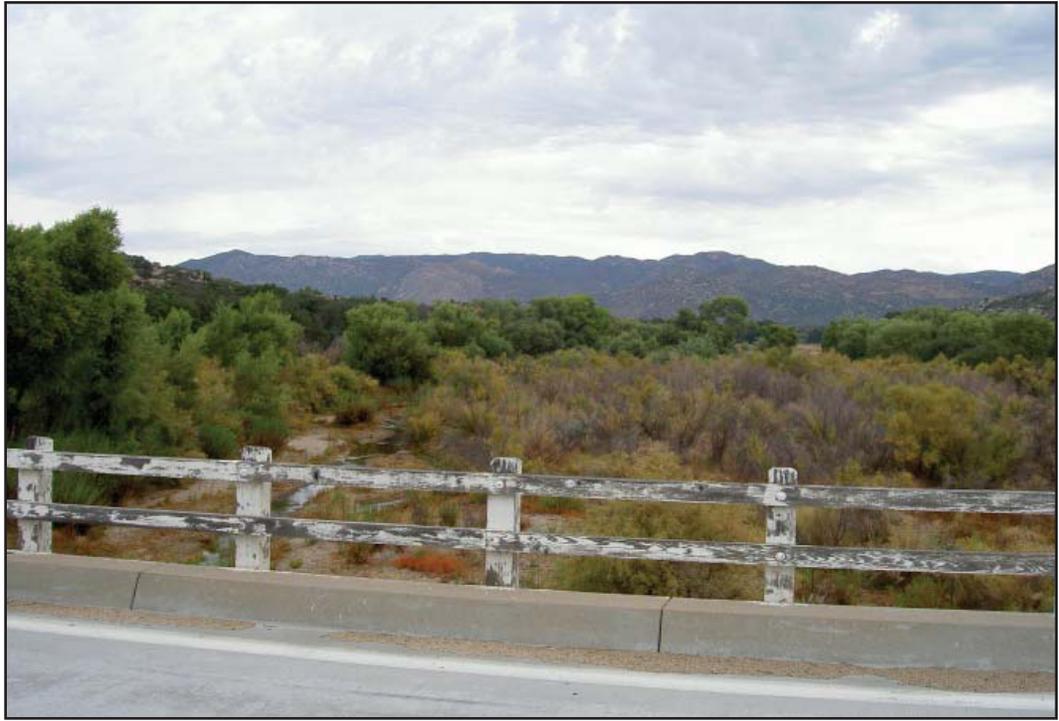
PHOTOGRAPH 3
Project Area in September 2005, Prior to Salt Cedar Removal and Revegetation, Looking Upstream from Buckman Springs Road Bridge

The herbicide treatment of salt cedar in the Morena Reservoir area was highly effective (Photographs 3-6). The vast majority (estimated greater than 90 percent) of individuals that were cut and painted with herbicide demonstrated no evidence of regrowth 16 months following treatment. The remaining individuals (approximately 10 percent) had small resprouts and would benefit from re-treatment with herbicide.

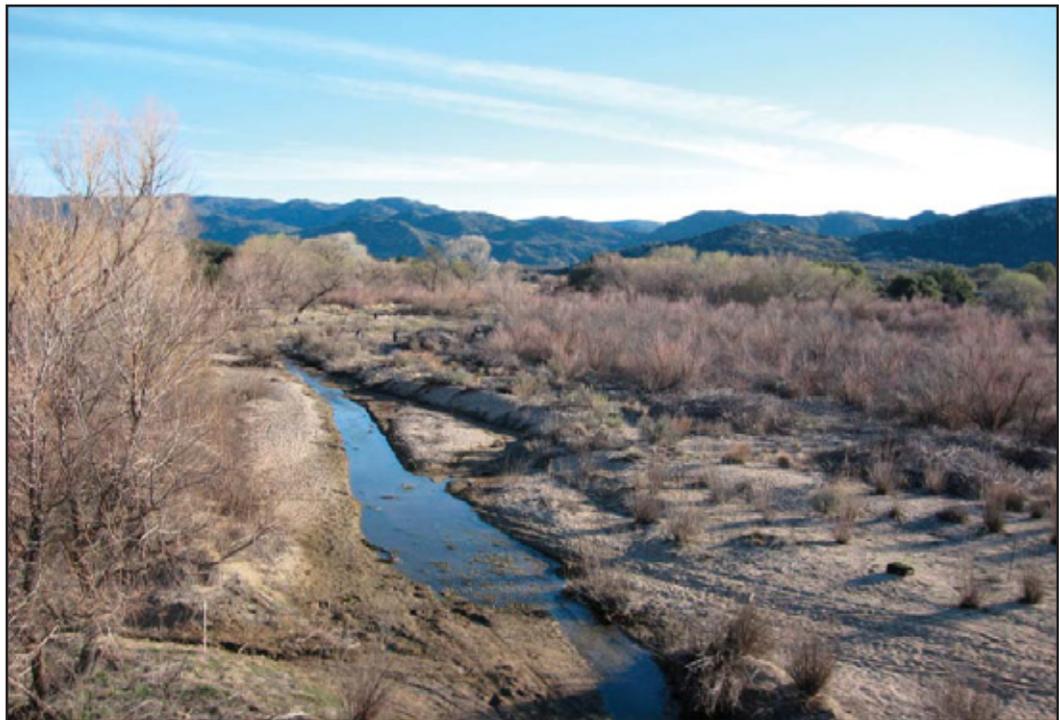
PHOTOGRAPH 4
Project Area in March 2008, Following Salt Cedar Removal and Revegetation, Looking Upstream from Buckman Springs Road Bridge

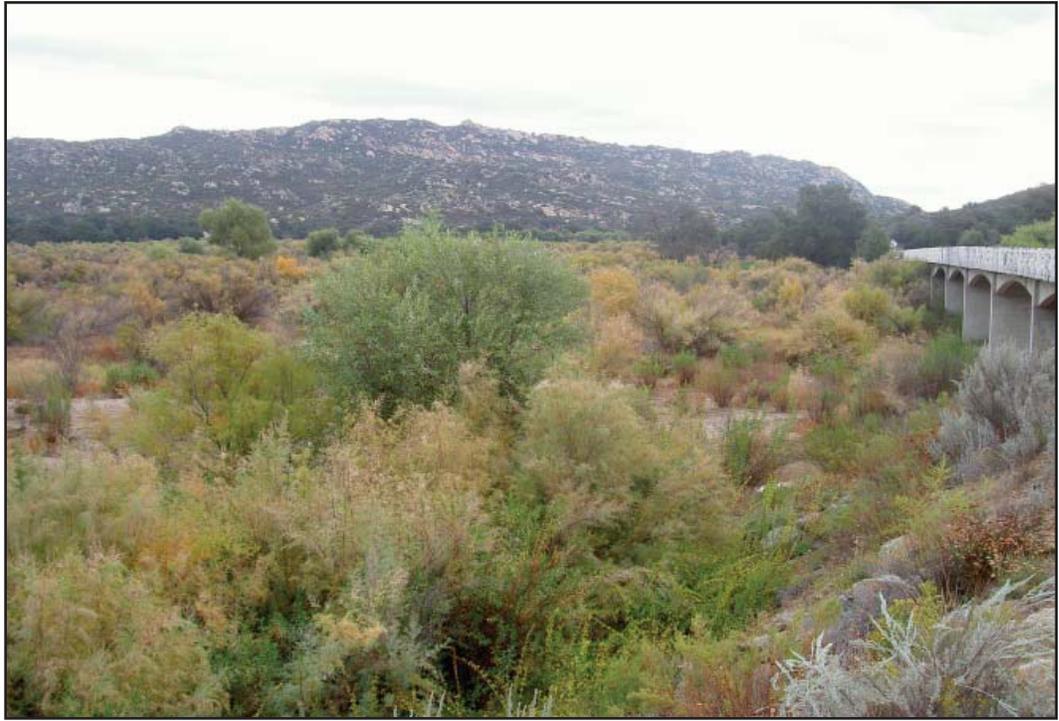
PHOTOGRAPH 5
Project Area in September 2005, Prior to Salt Cedar Removal and
Revegetation, Looking South from Staging Area on
Buckman Springs Road

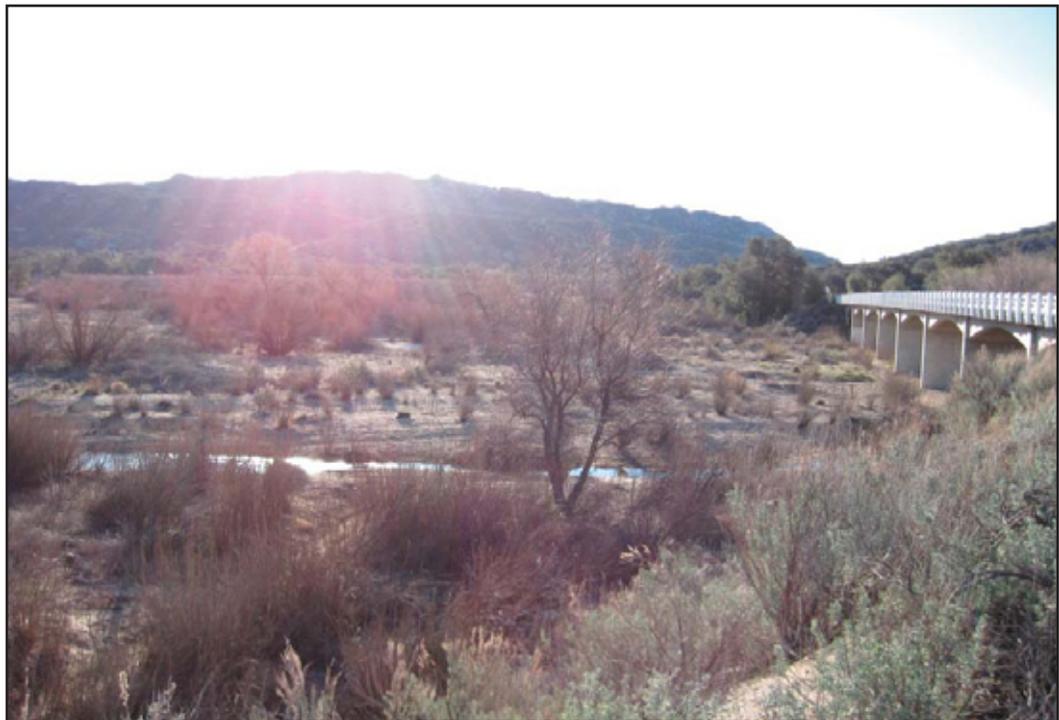
PHOTOGRAPH 6
Project Area in March 2008, Following Salt Cedar Removal and
Revegetation, Looking South from Staging Area on
Buckman Springs Road

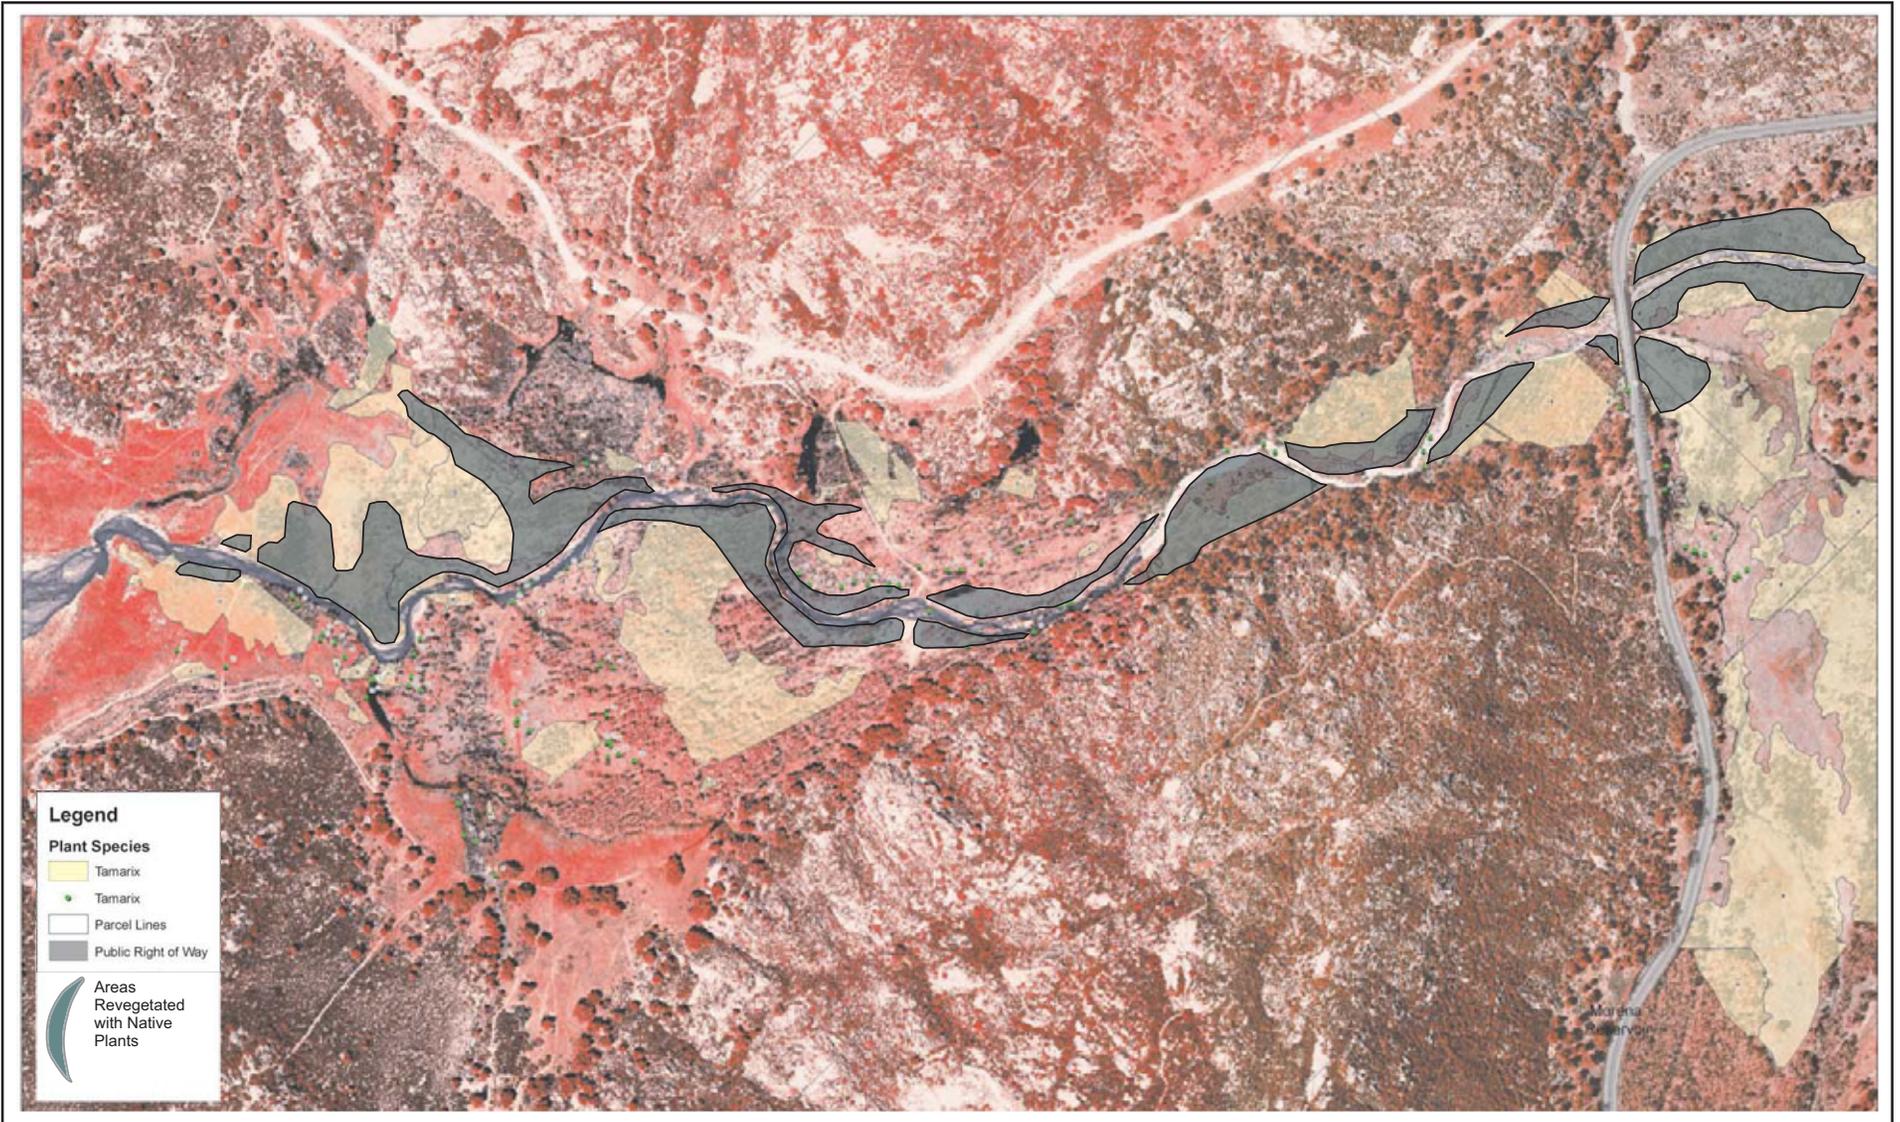
FIGURE 4
Revegetated Areas at Morena Reservoir Project Area

The initial planting effort commenced on February 5, 2007 and was completed on February 16, 2007. Approximately 18 acres of floodplain at the Morena Reservoir site were revegetated during this phase of work (Figure 4).

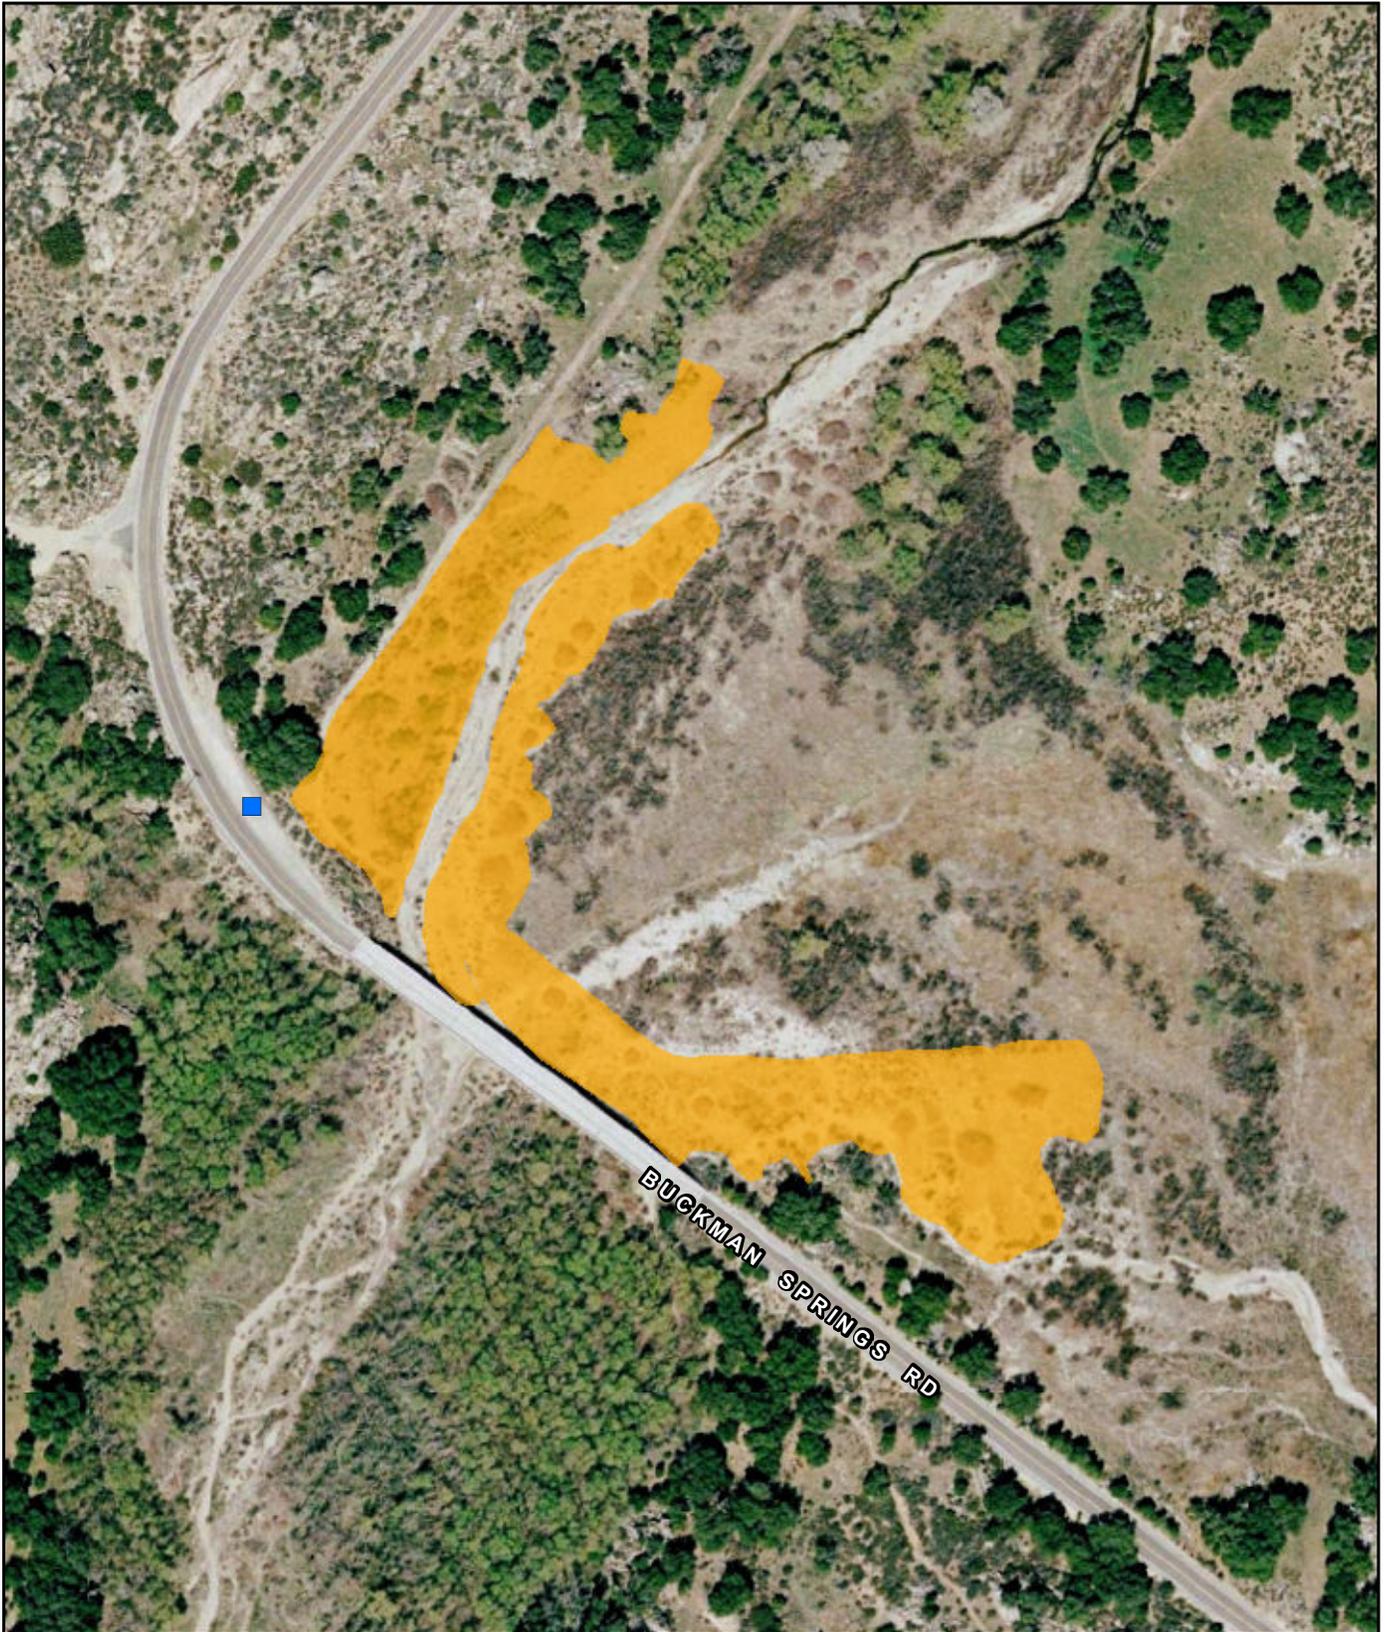
FIGURE 5
Supplemental Planting Areas (March 2008)

A second planting effort concentrated in the area upstream of the Buckman Springs Bridge (Figure 5). This area, comprising approximately four acres, was determined to have a higher probability of plant survivorship because it was accessible by a water truck parked along Buckman Springs Road for supplemental watering. In addition, the upstream location is beneficial, as it will likely result in the distribution of native seeds to other, downstream parts of the project area.

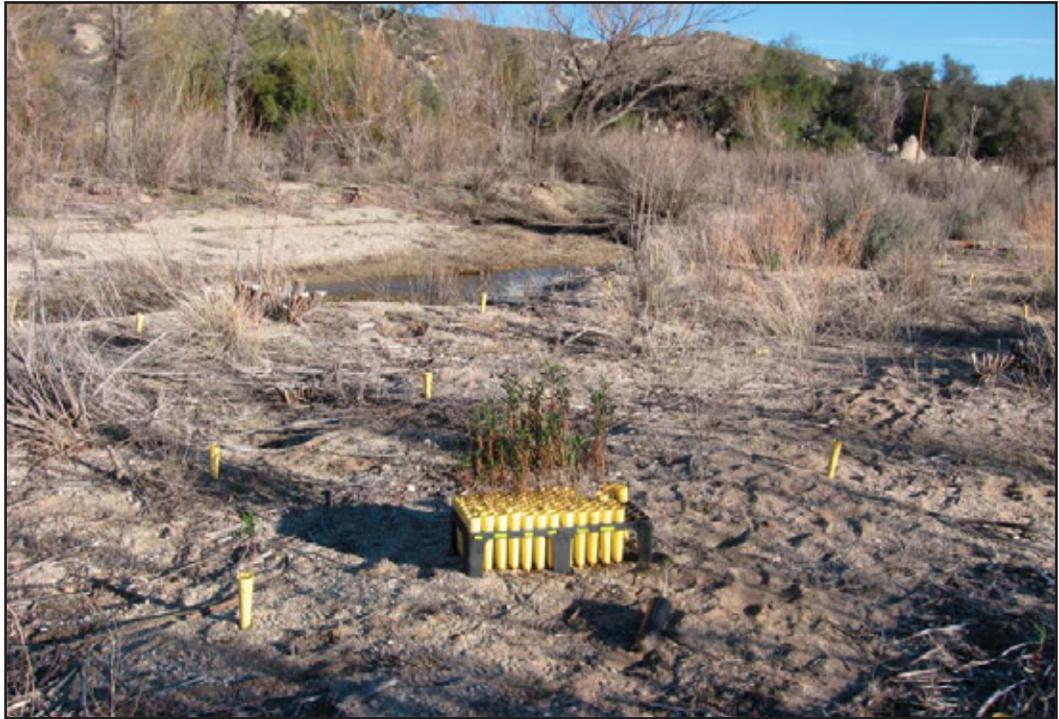
PHOTOGRAPH 7
RECON Crews Installed 4,233 Additional Container Plants in March 2008
in a 4-acre Area Upstream from Buckman Springs Road

Planting commenced on March 10, 2008, and was completed on March 12, 2008. RECON field crews installed 4,233 container plants (Table 4; Photographs 7-9).

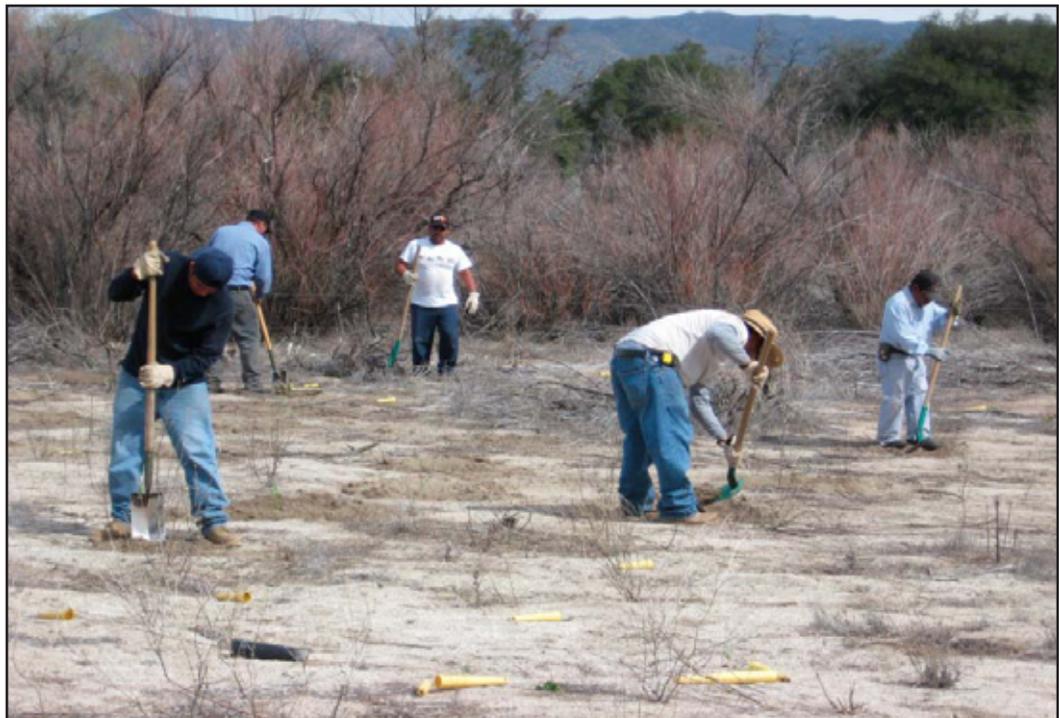
PHOTOGRAPH 8
RECON Crews Installed 4,233 Additional Container Plants in March 2008
in a 4-acre Area Upstream from Buckman Springs Road

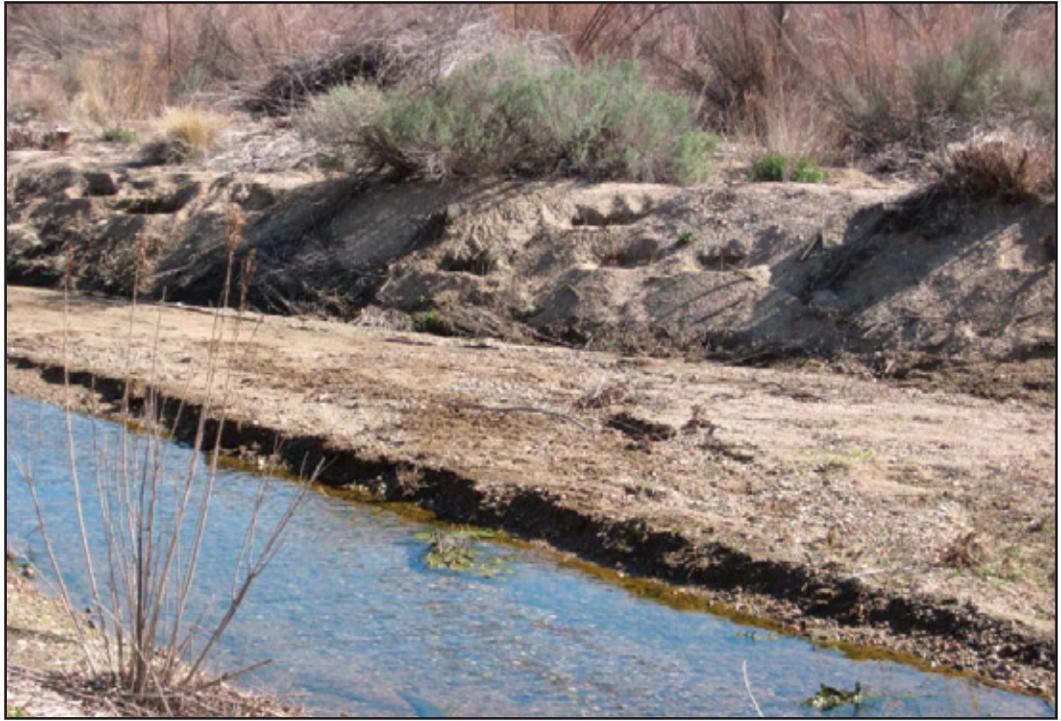
PHOTOGRAPH 9
Area South of Cottonwood Creek Following Planting in March 2008

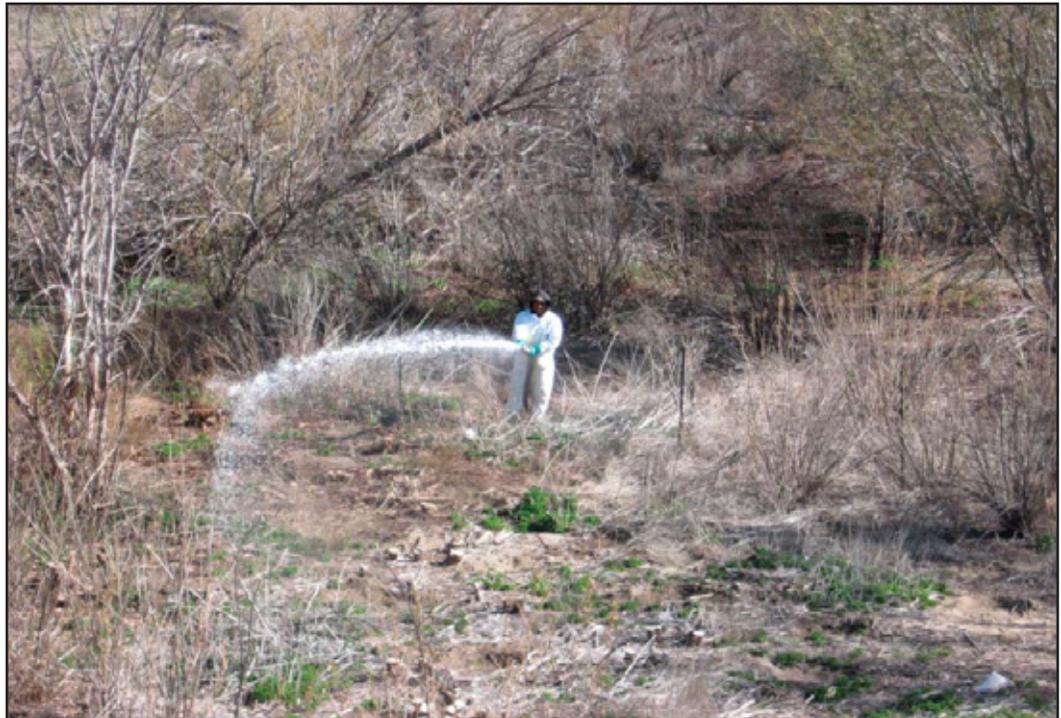
PHOTOGRAPH 10
Areas Planted in March 2008 Were Hand-watered Using Hose
Connected to a Water Truck

Supplemental watering by water truck occurred on four occasions following planting in order to aid plant establishment (Photograph 10).
