ARCHAEOLOGICAL RESOURCES REPORT CROSBY ENCLAVE PROJECT

Project No. 3813 11-001, 3600 11-001, 3100 5569, 3500 11-014
DPLU Environmental Log No. 95-08-007K

Report Title: Archaeological Resources Letter Report, Crosby Enclave Project

Type of Study: Archaeological Assessment

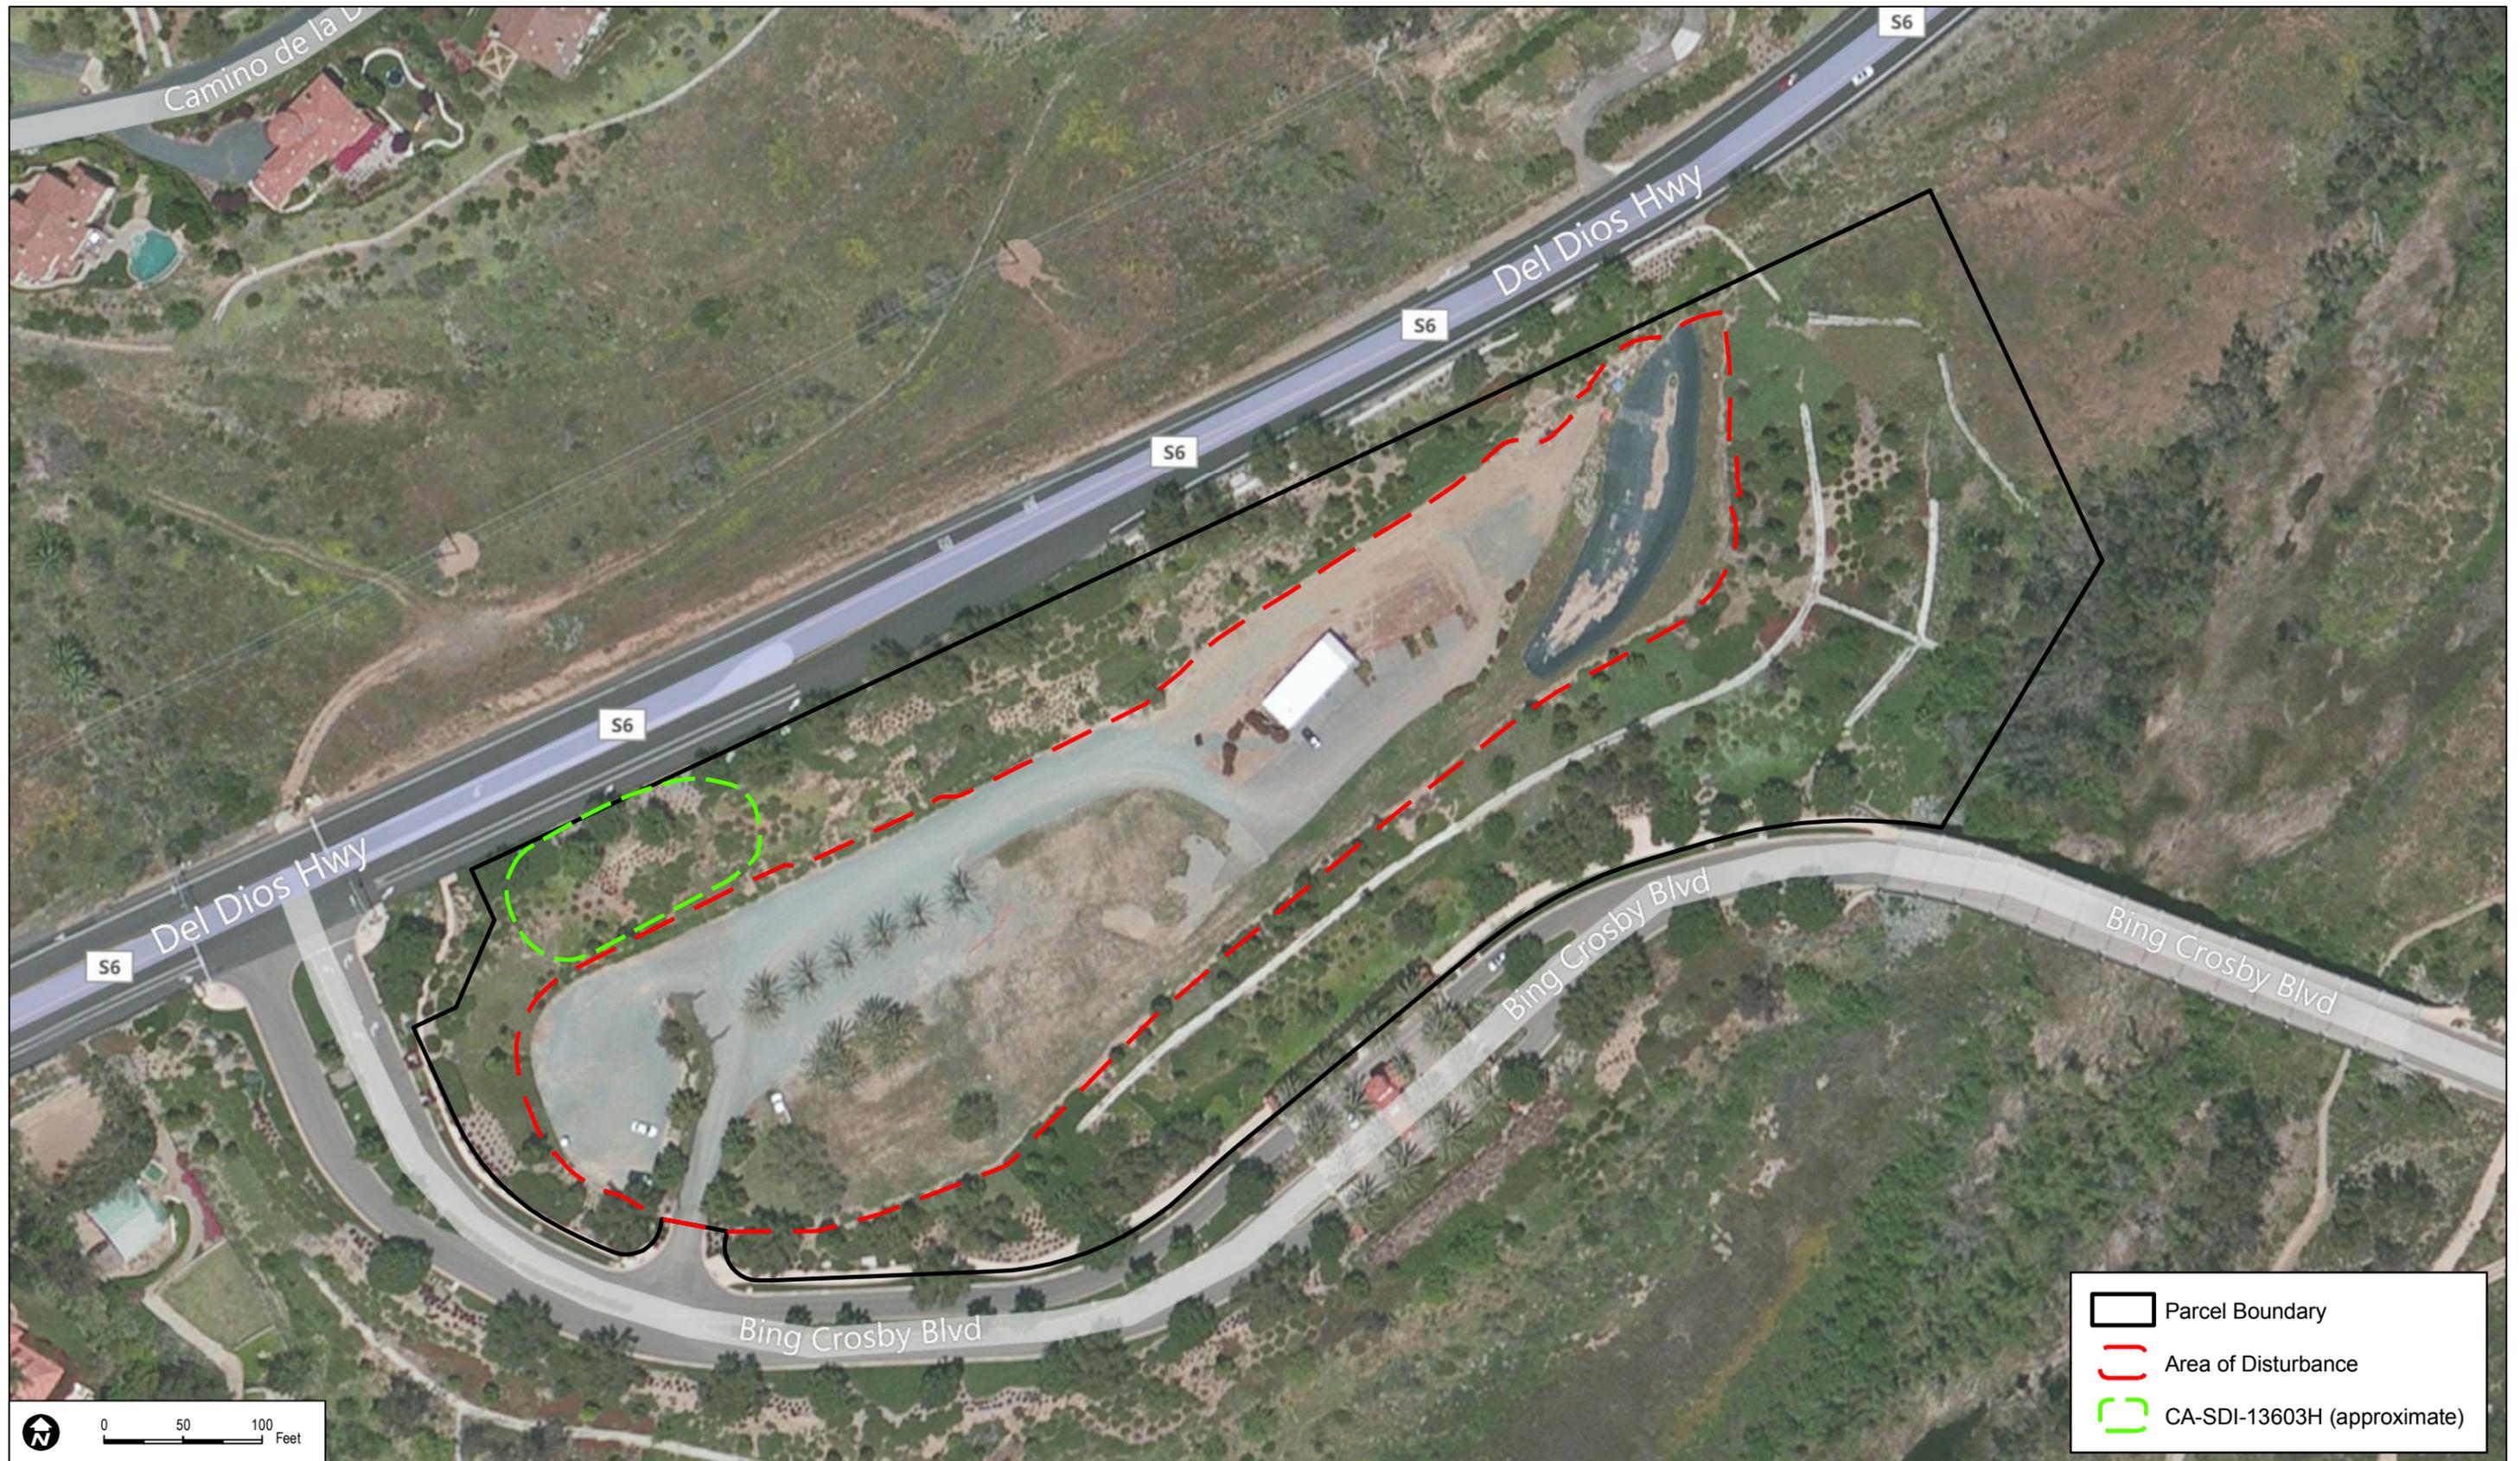
The resulting topography within the project site includes 3.48 acres that is a leveled residential development footprint, surrounded by 4.58 acres of slopes, sidewalks, and roads including Bing Crosby Boulevard (see Figure 3, attached). This peripheral area on the northern project boundary has been landscaped and surface PVC irrigation piping system has been established.

Dios Highway, but north of the previously graded and leveled residential development footprint. The location of CA-SDI-13603H is identified on Figure 3.

CA-SDI-13603H (approximate)

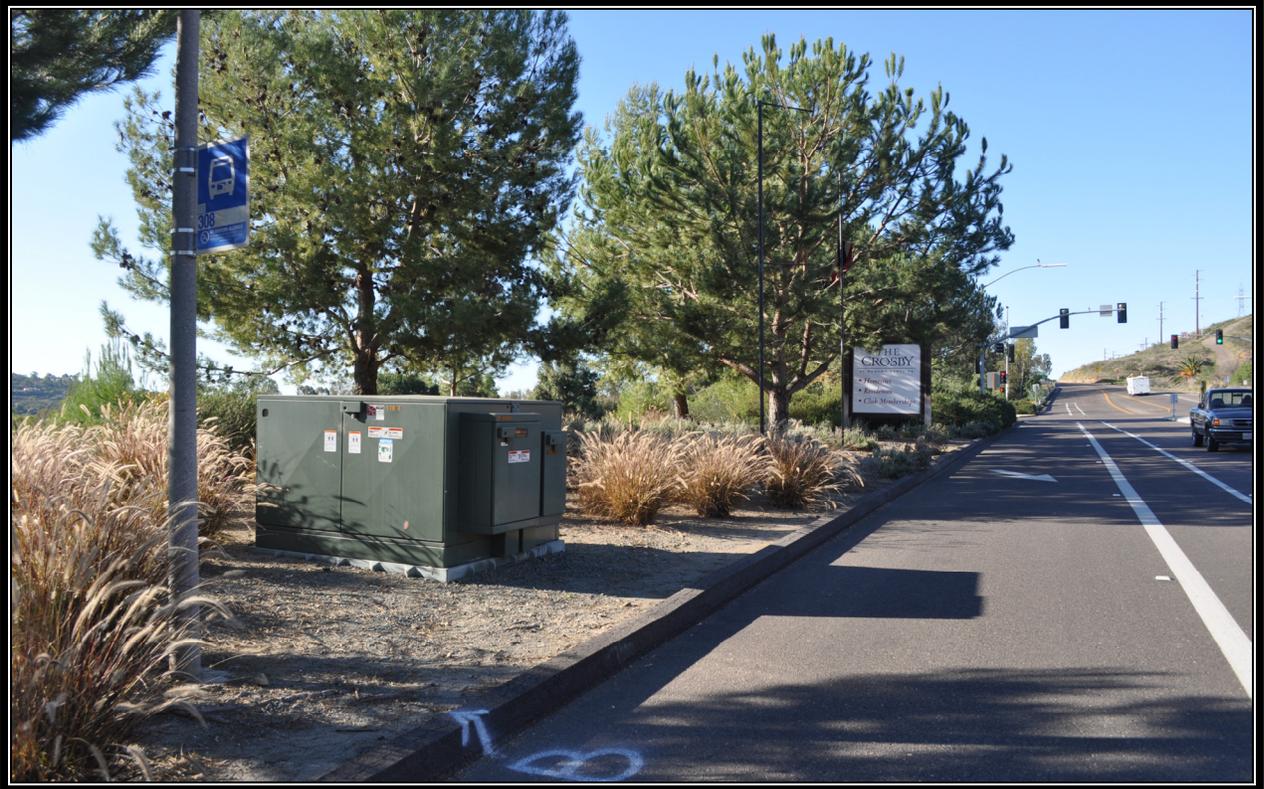
Results. The roughly 10-meter (33-foot) wide road shoulder south of Del Dios Highway is

level (see Figures 4 and 5, attached). Ground surface visibility was good to excellent (50 to 100 percent). Evidence of previous ground disturbances associated with underground utilities (electrical, irrigation, traffic signal) and landscaping was observed.

Figure 4: Del Dios Highway Southern Road Shoulder, Looking West

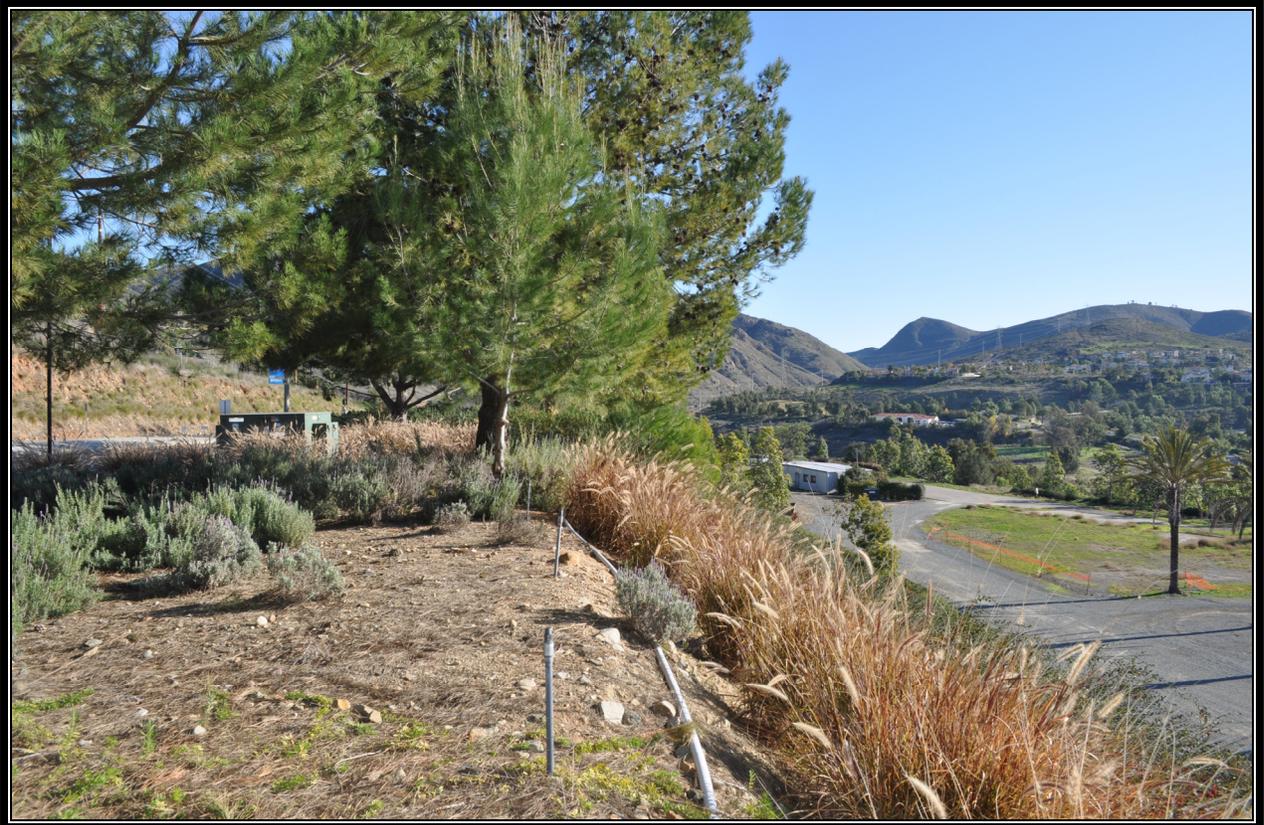
Beyond the level road shoulder was an extremely steep, south-facing slope (see Figures 5, 6, and 7, attached). Ground surface visibility was fair to good (10 to 90 percent). Evidence of previous ground disturbances associated with extensive landscaping was observed.

Figure 5: Del Dios Highway Southern Road Shoulder and Cut Slope, Looking East

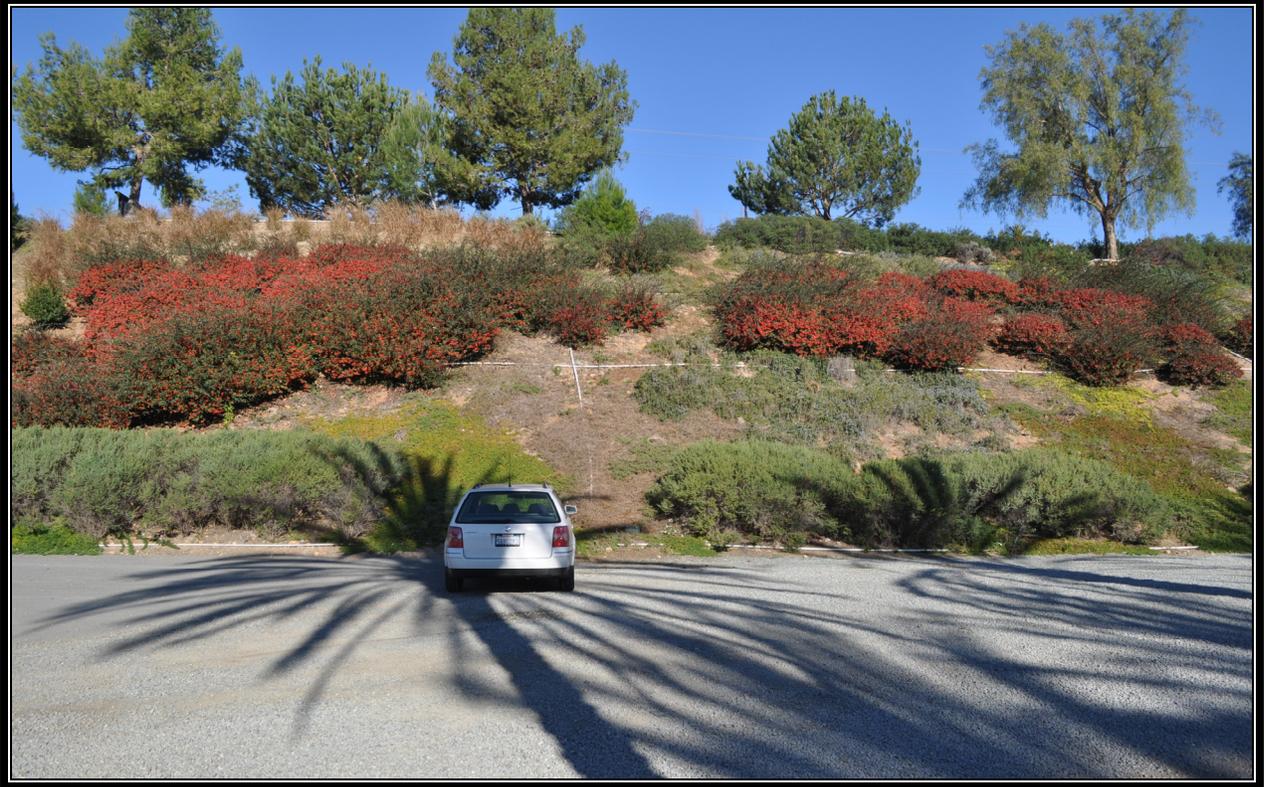
No historic-period artifacts described in the 1993 CA-SDI-13603H site record form including glass bottle fragments, white ware ceramic fragments, metal cans, or lumber, were observed on the level road shoulder south of Del Dios Highway, or on the extremely steep slope below and south of the road shoulder. An update to the CA-SDI-13603H archaeological site record form is included in Appendix B.

Figure 6: Cut Slope below Del Dios Highway, Looking North

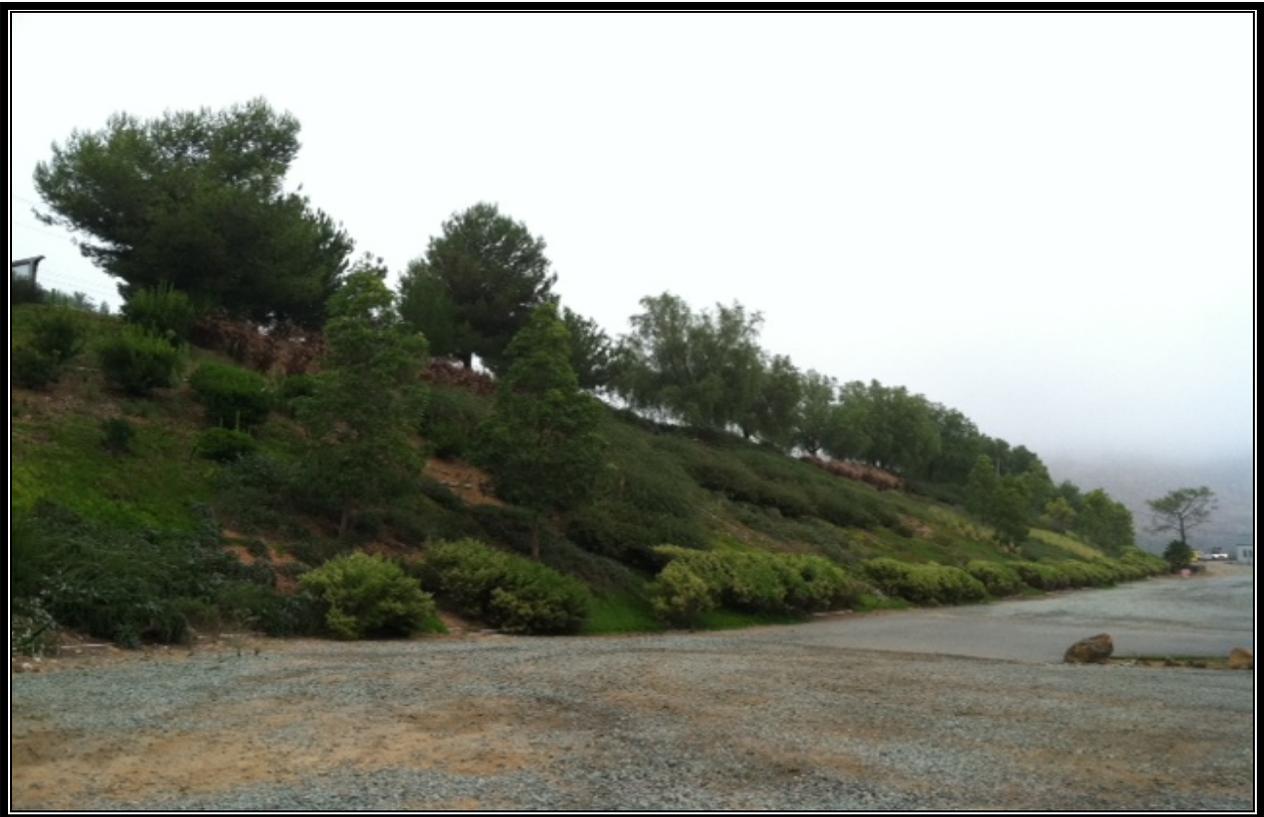
Figure 7: Cut Slope below Del Dios Highway, Looking Northeast
