June 25, 2013

RE: Lilac Hills Ranch (TM 5571) - Sight Distance Analysis at Circle R Drive and Mtn Ridge Rd

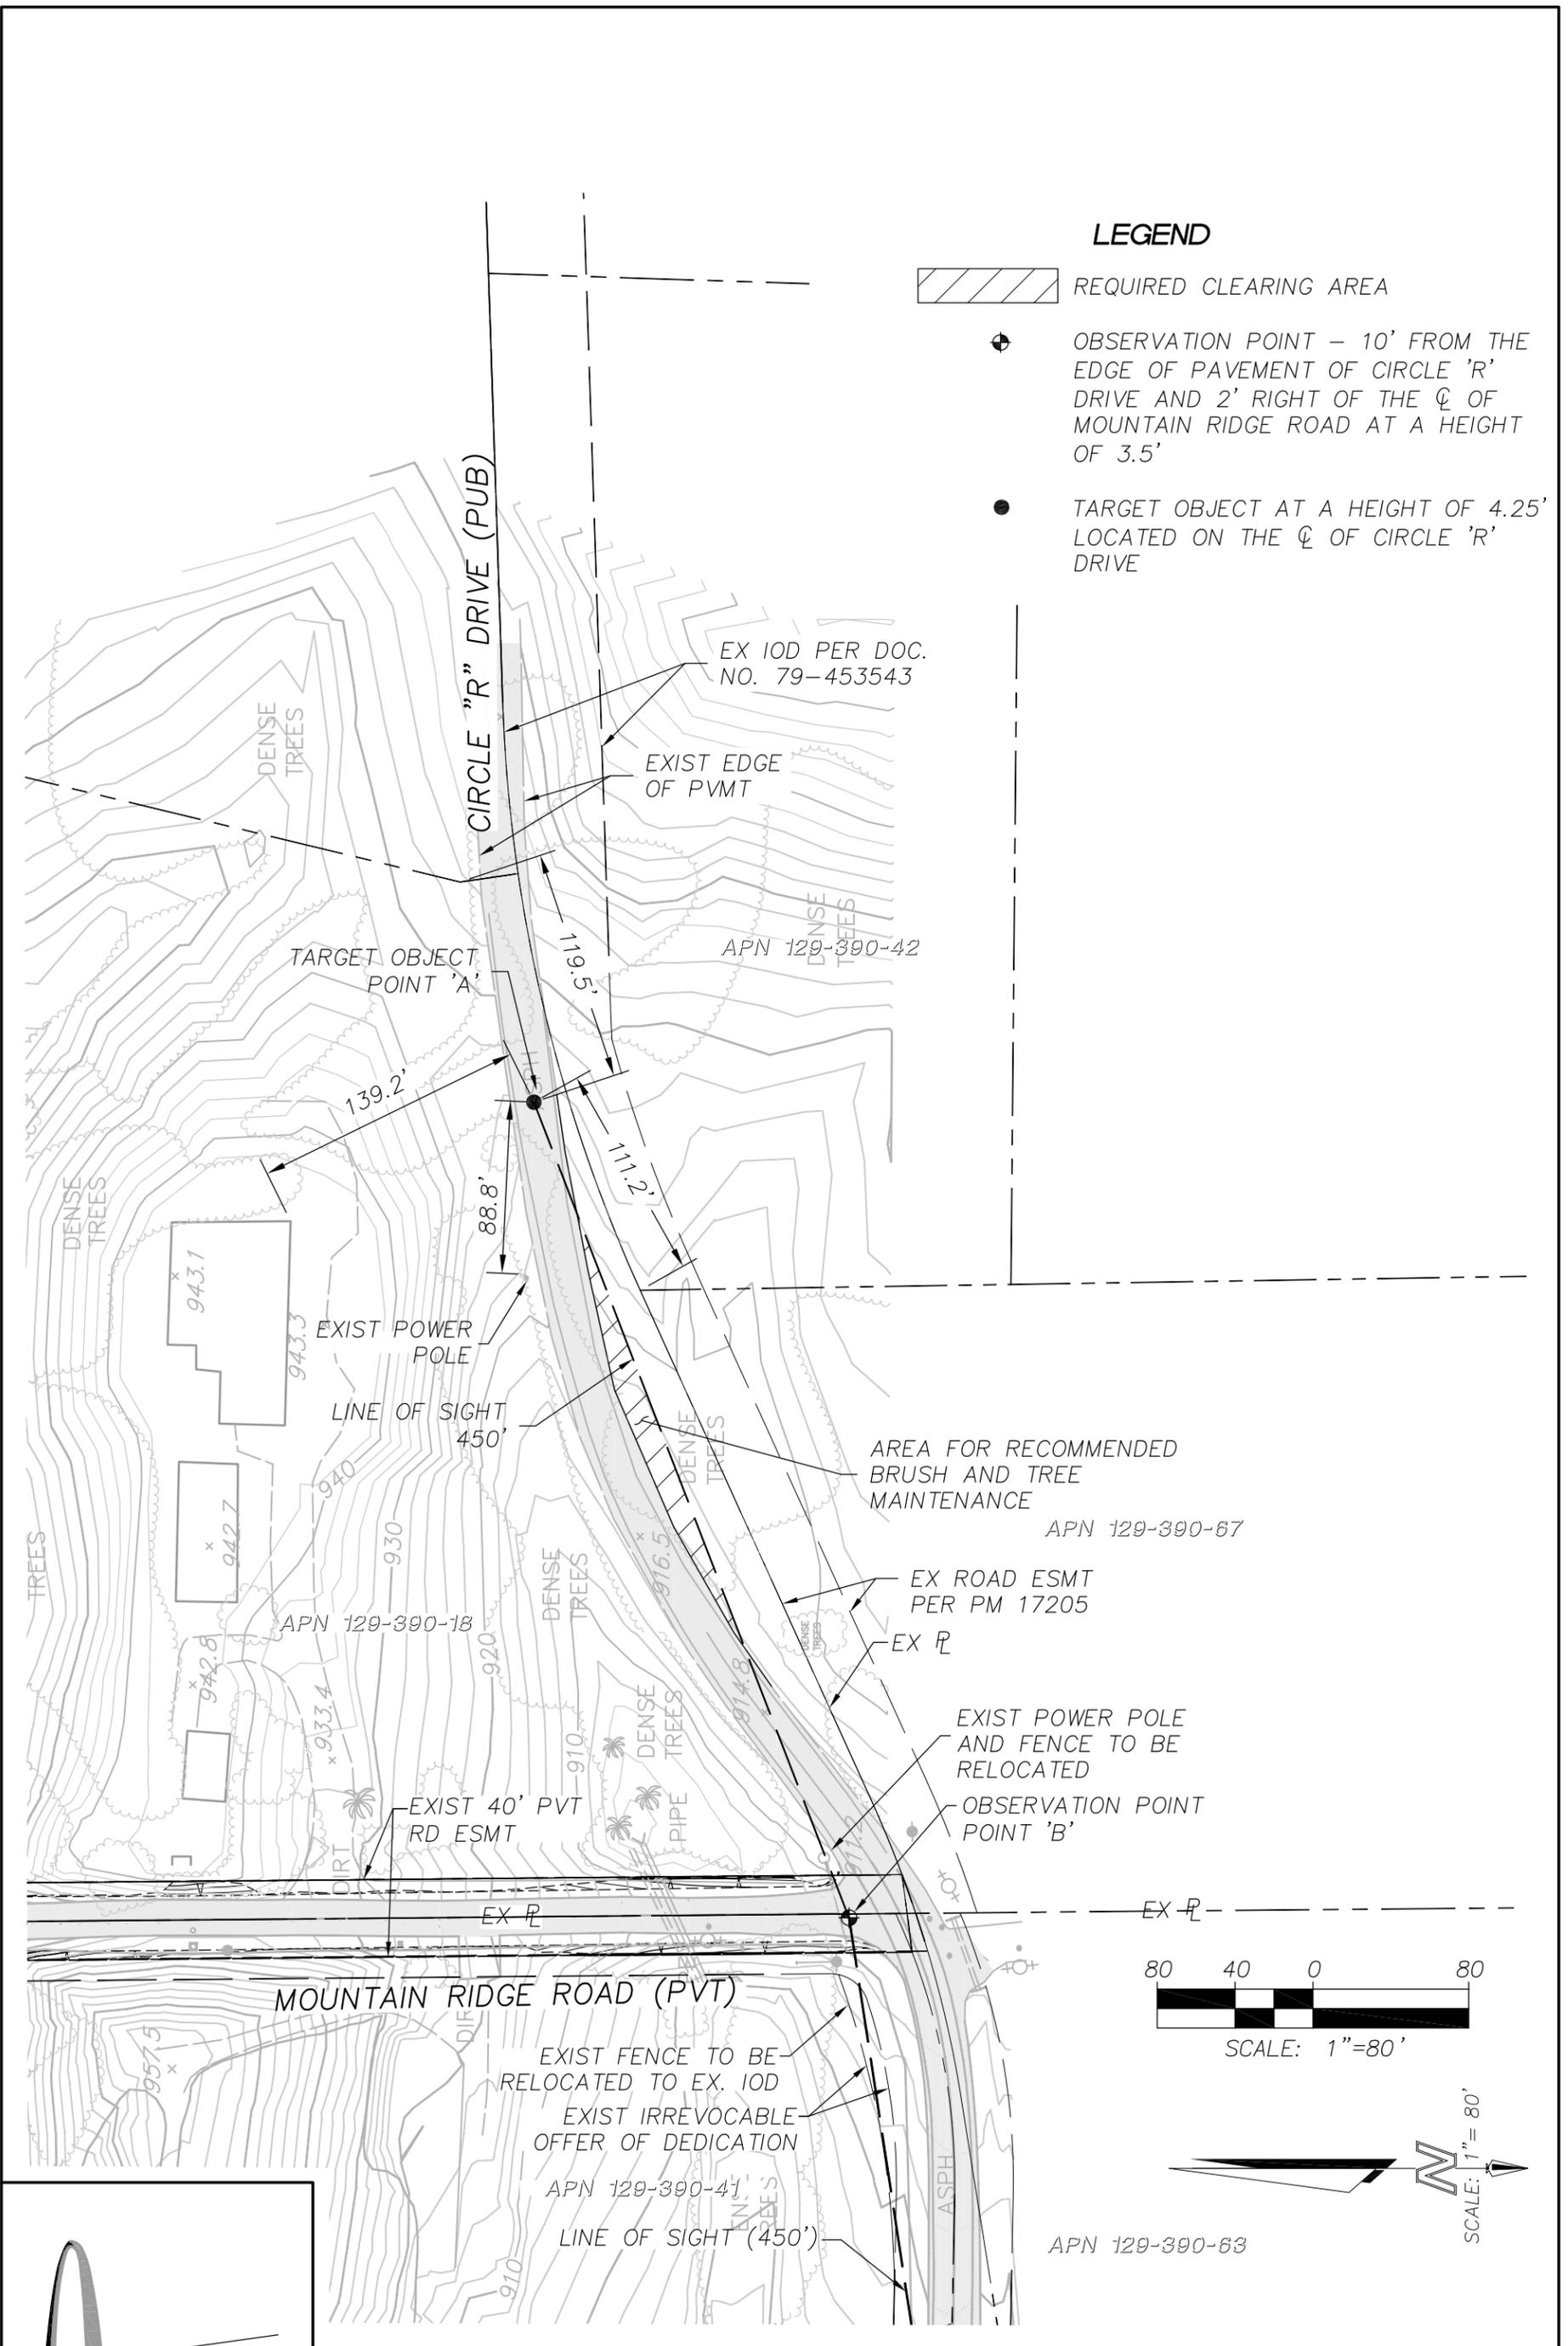
FIGURE 2
SIGHT DISTANCE ANALYSIS
CIRCLE R DRIVE AND MOUNTAIN RIDGE RD

Per your request, we have conducted the Sight Distance Analysis at the intersection of Circle R Drive and Mountain Ridge Road in Valley Center (see Figure 1 - Vicinity Map) to determine adequate sight distance per the San Diego County Public Road Standards requirements. For this analysis, it was assumed the existing alignment of Mountain Ridge Road would remain the same as it approaches Circle R Drive from the north.

The line of sight from Observation Point 'B' looking east is of 450' has been achieved due to recent clearing performed in April 2013 along the existing public road within APN 129-390-18 between the existing pavement of Circle R Drive and an existing public road easement granted per PM 17205. It is recommended that this area be kept clear by means of preventative maintenance to maintain adequate sight distance at this Intersection. The County has prescriptive easement rights to this portion of Circle R Drive, a public road. Since the required clearing area is between the existing pavement to the north and an existing public road easement to the south, the County should have the right to clear this area to establish the required line of sight to assure public safety for the use of this existing public road as part of their normal maintenance responsibilities. However, a clear space easement should be obtained over this area (as illustrated on Figure 2) from the offsite property owner (APN 129-390-18) to ensure maintenance rights in perpetuity. Additionally, this clearing area falls within the 50' fire buffer area required by the Deer Springs Fire Protection District along all existing property lines.

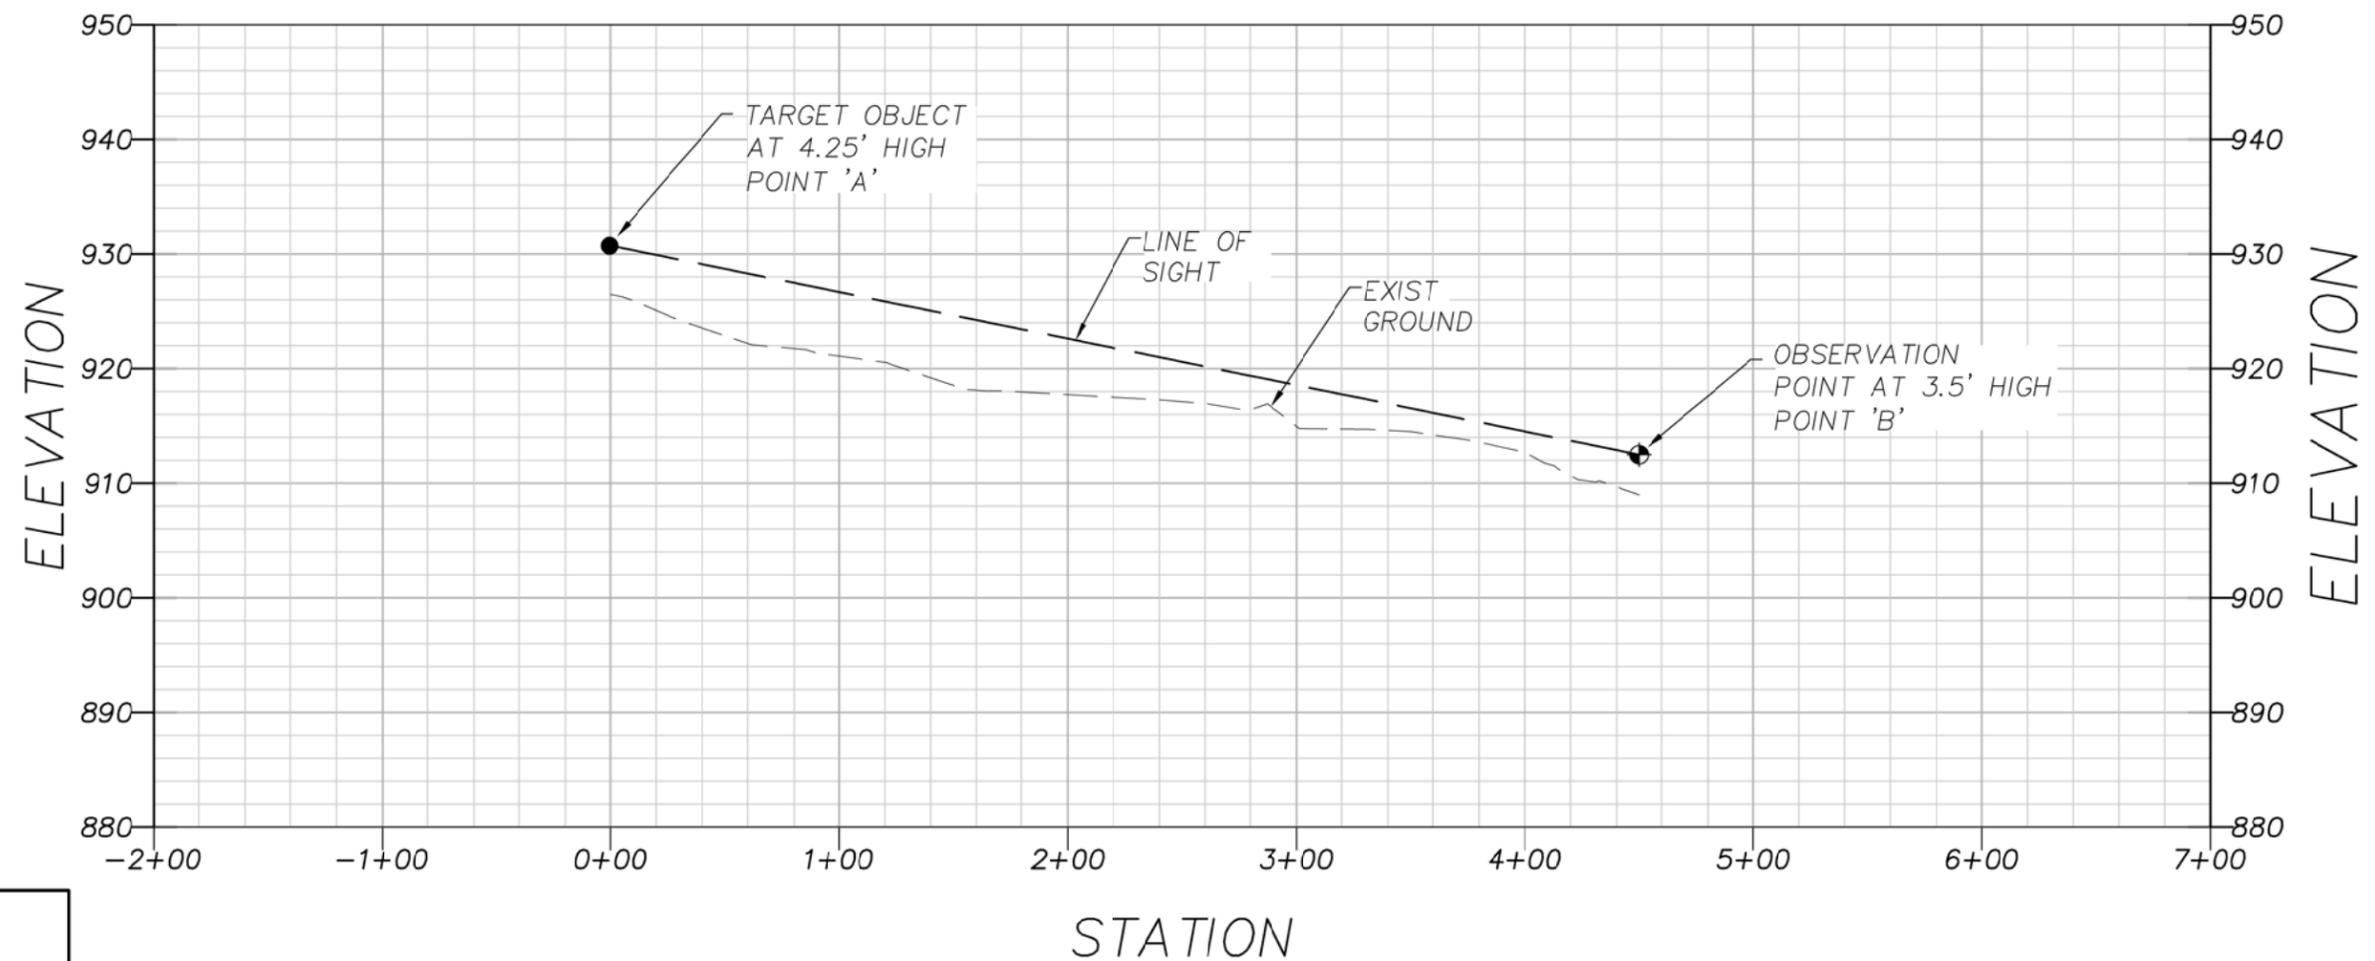
FIGURE 3
LINE OF SIGHT PROFILE FOR MTN RIDGE RD AND CIRCLE R DR (WESTBOUND TRAFFIC)

PROFILE: CIRCLE R EAST

Profiles through both lines of sight and photos are provided for clarity (Figures 3-6).

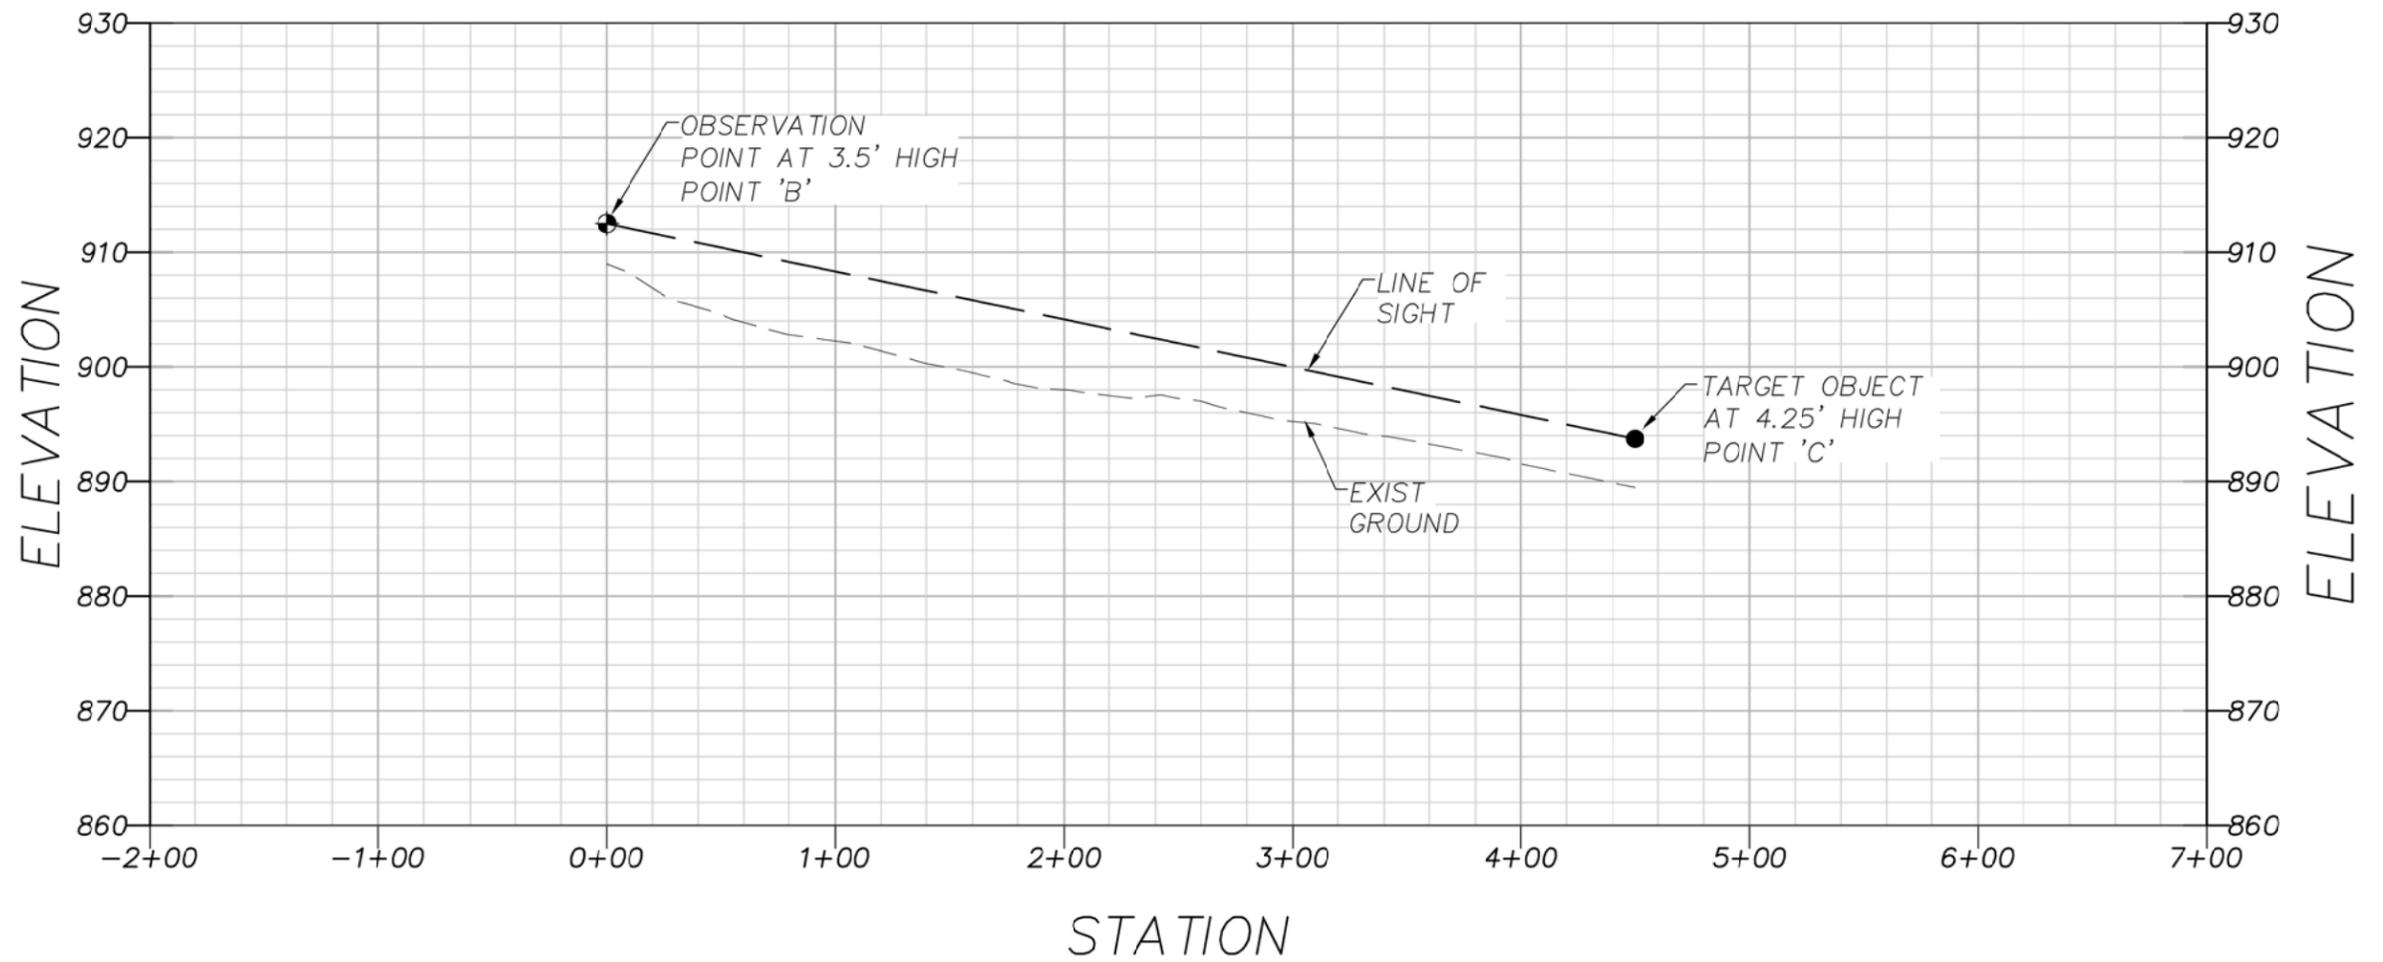
FIGURE 4
LINE OF SIGHT PROFILE FOR MTN RIDGE RD AND CIRCLE R DR (EASTBOUND TRAFFIC)

The current line of sight for the eastbound traffic as seen from Observation Point 'B' on Mountain Ridge Road looking west toward Object Target 'C' on Circle R Drive is also adequate and neither maintenance nor clearing is recommended at this time.

PROFILE: CIRCLE R WEST

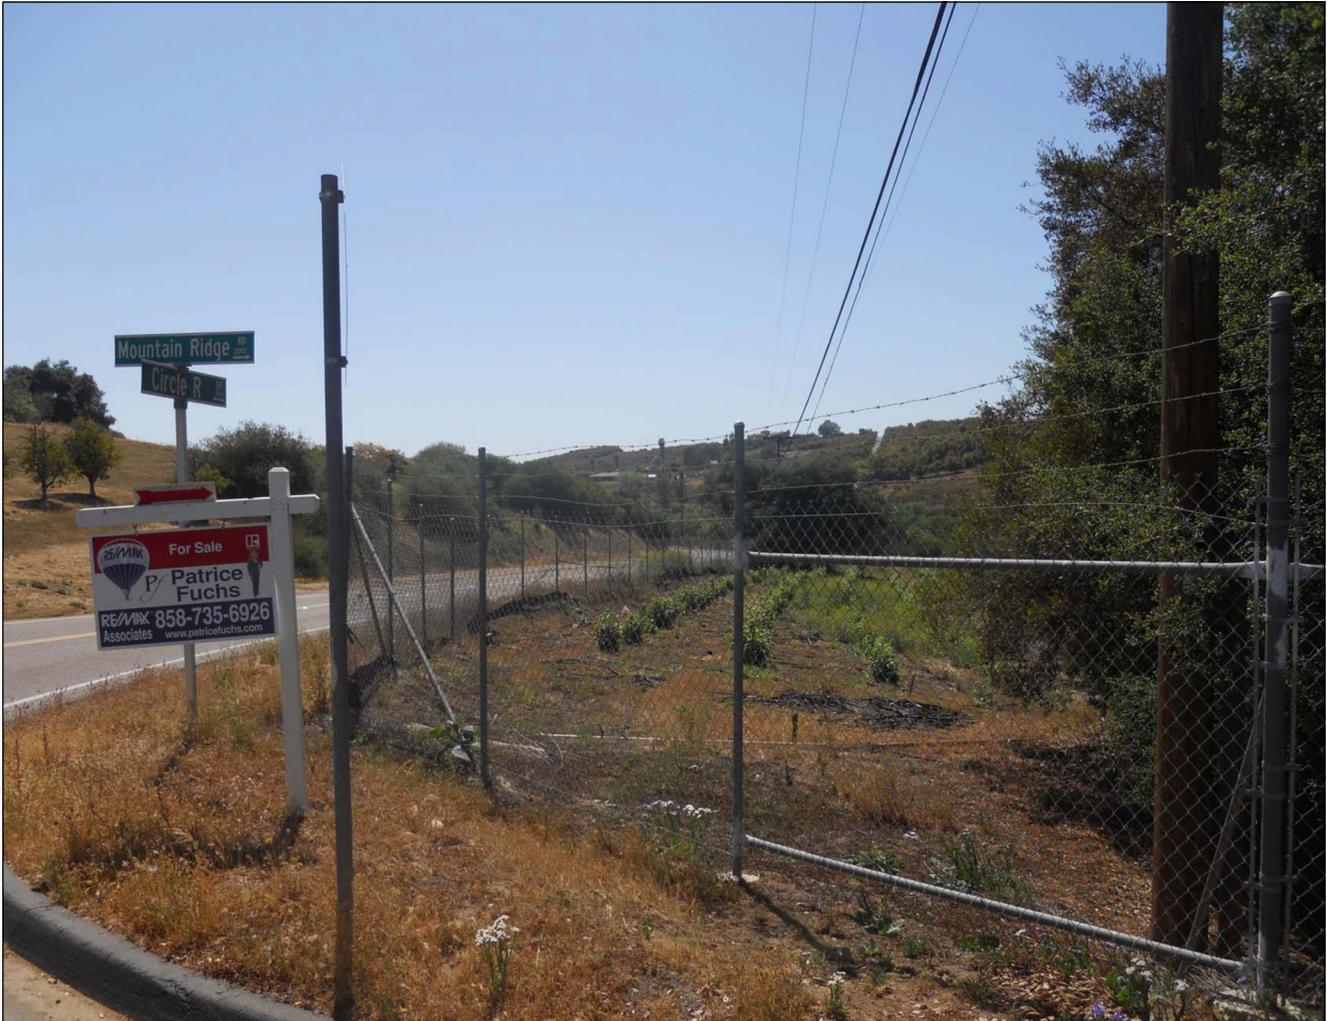
FROM MOUNTAIN RIDGE ROAD LOOKING WEST ONTO
CIRCLE "R" DRIVE

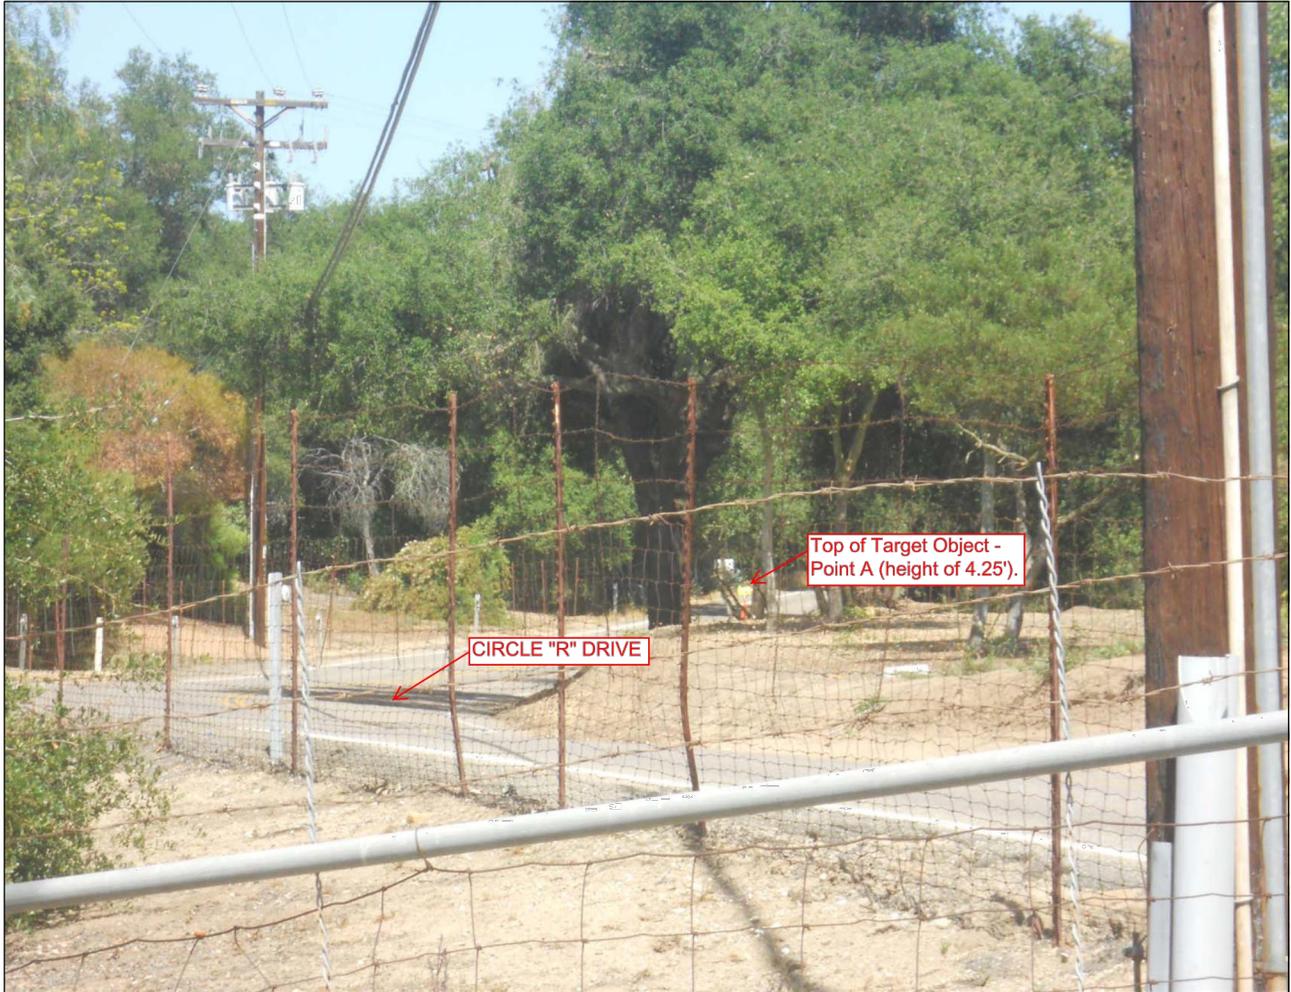
FROM MOUNTAIN RIDGE ROAD LOOKING EAST ONTO
CIRCLE "R" DRIVE
