COUNTY OF SAN DIEGO MODEL MUNICIPAL OPERATIONS CENTER

Final Report *Phase II Porous Paving and Treatment Train* *Water Quality Monitoring Program*

KINNETIC
LABORATORIES
INCORPORATED

SEPTEMBER 2008

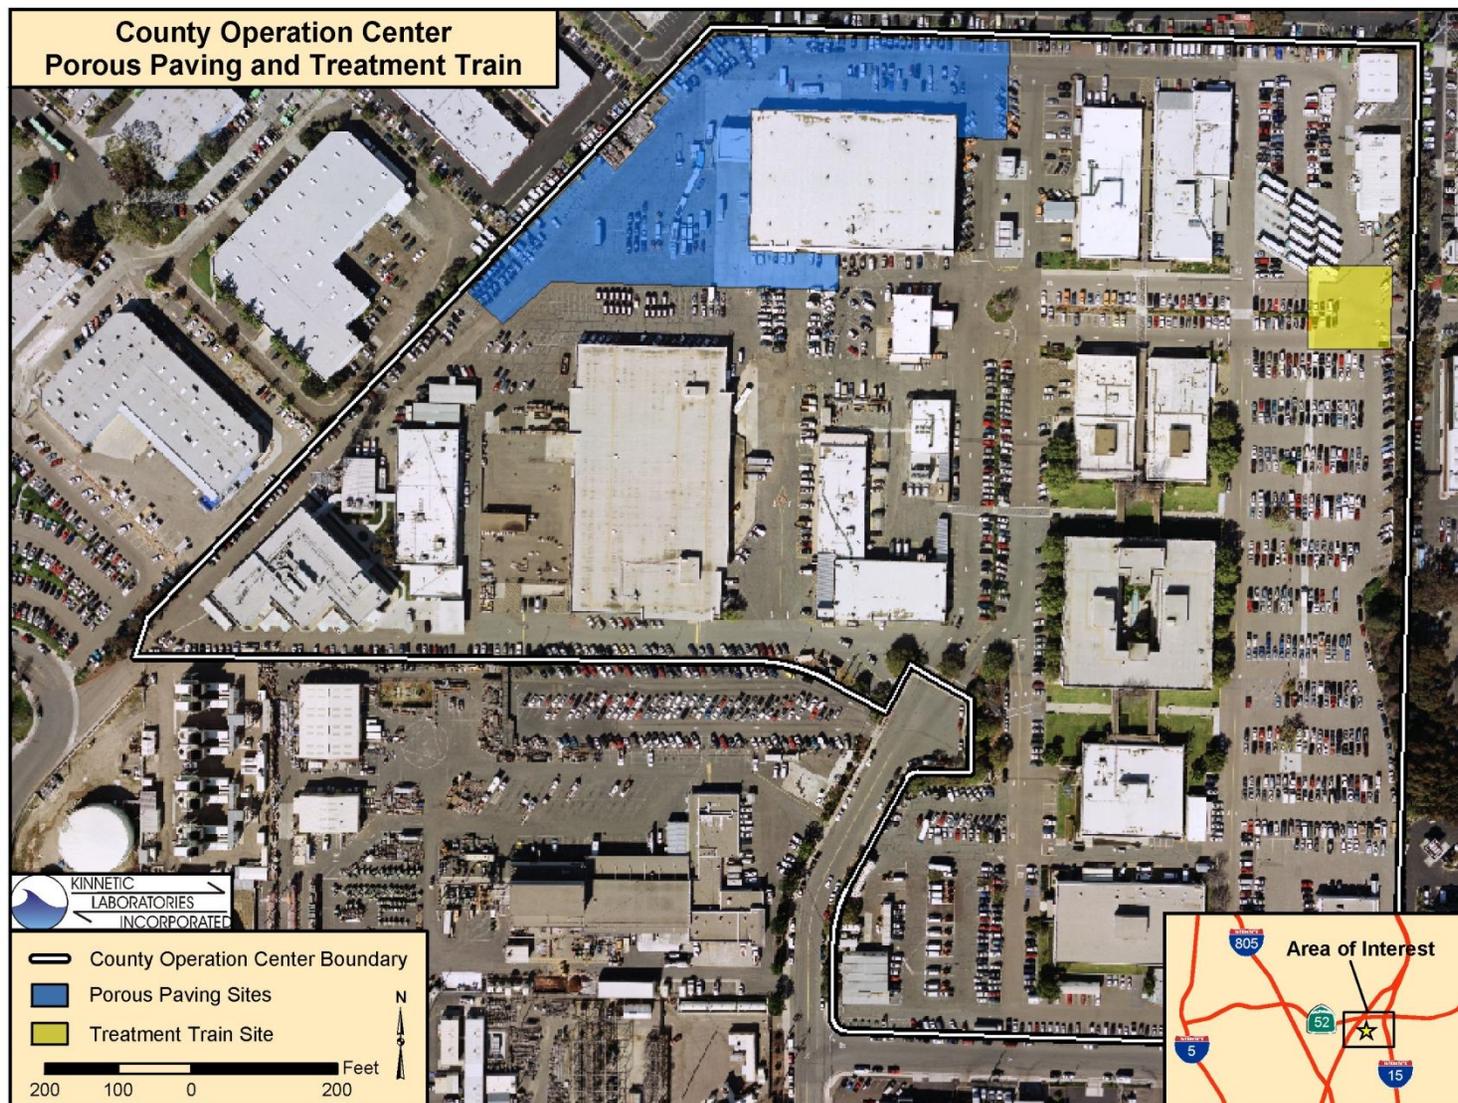
Figure 1. General Location of the Porous Paving and Treatment Train Demonstration Sites at the County Operations Center.

This project was comprised of two major elements. The first element was designed to examine the effects of reducing overall discharges by incorporation of infiltration BMPs. The second element was designed to assess the ability of a treatment train to remove contaminants of concern that tend to be associated with the particulate fraction before they leave the site. The general locations of the porous paving and treatment train demonstration sites are shown in Figure 1.

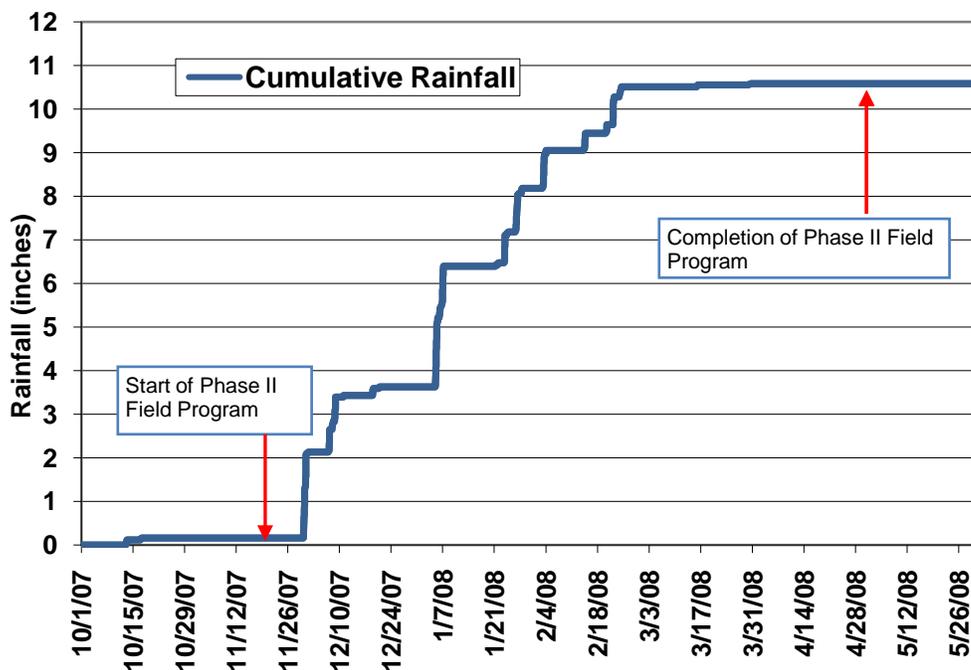
Figure 4. Cumulative Rainfall and Key Milestones at the COC during the 2007/2008 Wet Season (data from KEA Rain Gauge)

Figure 2 through Figure 4 provide a summary of rainfall and key milestones during both Phase I and II of the project. Initiation of sampling efforts at the Phase I porous paving and treatment sites during the 2005/2006 storm season is noted on Figure 2. Phase I equipment installations at the porous paving sites were fully operational in time for the first event of the season in 2005. Some delays were experienced in implementing monitoring at the Treatment Train site due to a need to redesign the monitoring system to facilitate improvements in measuring stormwater flow entering the MFS unit, treated stormwater exiting the system and flow over the internal bypass weir. In addition, the system needed to be altered to assure that the effluent monitoring system collected only treated water. All required Phase I monitoring was completed during the 2005/2006 season but equipment was reinstalled at the start of the 2006/2007 season to assure that rainfall and runoff data was recorded. Phase II sampling started in January 2007 at the reference site, three porous paving sites and treatment train facilities that were previously developed during Phase I of the project. Construction of the two Phase II porous paving sites and the expanded treatment train began in the summer of 2007. Construction was complete and monitoring equipment installed at all the new sites by mid-November 2007. Phase II monitoring then continued through April 30, 2008.

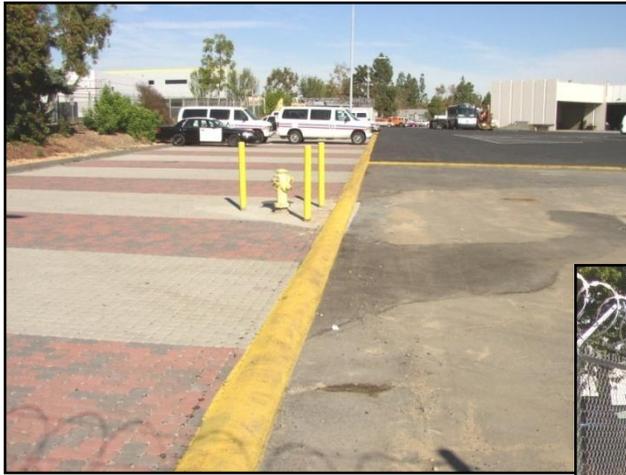
Figure 5. EcoStone Paver Installation

EcoStone concrete pavers were installed as part of the Phase I work. The pavers were laid in a rectangular form along the northwestern edge of the property line (Figure 5 and Figure 7). As with all sites, including the reference site, the EcoStone pavers were isolated by berms to assure that the test sites were not subject to runoff or runoff. Since some runoff was expected from the pavers, a catch basin was installed at the southwestern end to redirect any runoff from intense events back into the infiltration bed. A filtration system was installed in the catch basin to prevent introduction of coarser sediment and trash into the infiltration bed. The

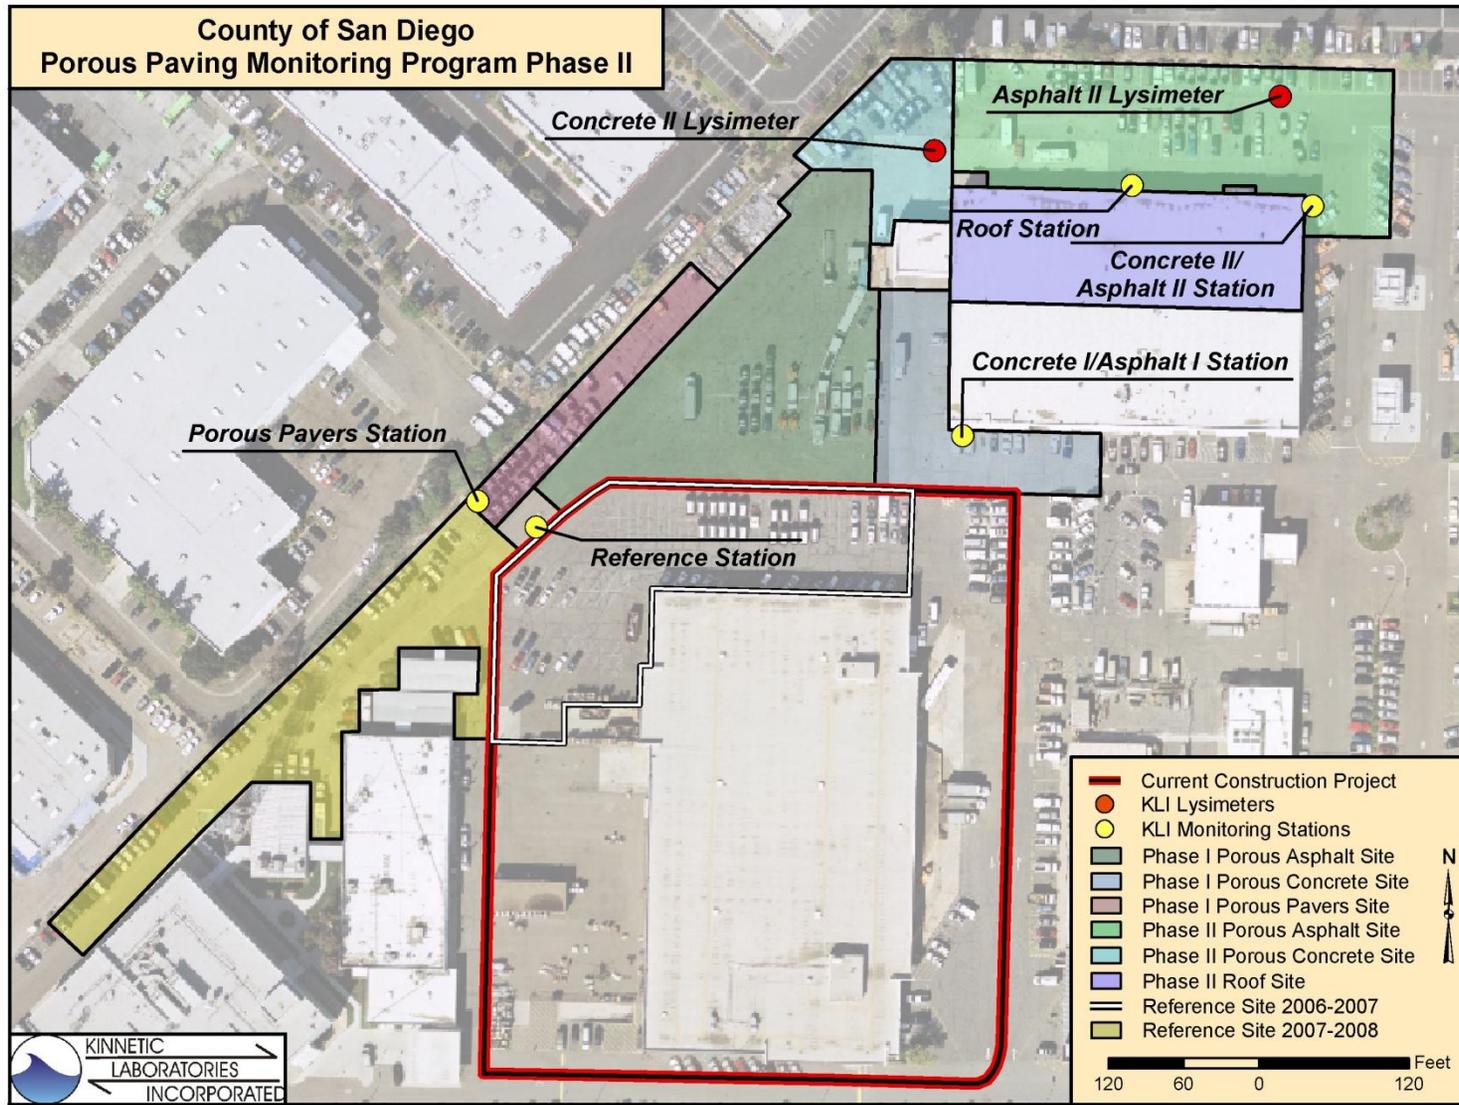
Figure 7. Porous Pavement/Infiltration System Layout

During Phase I the County replaced approximately 64,000 square feet of traditional imperious pavement with three different types of porous paving materials at the COC; EcoStone concrete pavers, porous asphalt and porous concrete. Another 54,000 square feet of impervious asphalt was replaced with porous asphalt and porous concrete during construction of the Phase II improvements (Figure 7).

The Phase II Porous Concrete is located in the northwestern corner of the COC (Figure 7). The process of installing the porous concrete is shown in Figure 13. Black plastic necessary to maintain moisture is visible on alternating swaths of poured concrete in the background. The overflow structure (control basin) for the Phase II concrete (Figure 14) can be seen closest to the antiseep collar that was installed to prevent flow between the Phase II asphalt and concrete infiltration basins. The 8-foot inlet pipe that provides a conduit to the infiltration basin can be seen coming out of the concrete box on the left side of the photograph. This was later wrapped in geotextiles to prevent large particles from passing into the overflow system. Similar to all other porous paving sites, holes were drilled along the inlet pipe to allow water from the infiltration basin to enter. The inlet pipe was located at the bottom of the scarified layer which was about six inches deep.

The Phase II porous asphalt was largest test site covering 41,900 square feet of the parking lot (Figure 7, Table 2). Runoff from 25,000 square feet of the roof at Building 7 was also directed into the underlying infiltration bed. Although a single infiltration bed was used for the asphalt, two different asphalt formulations were used and a geogrid was used with half of each type of formulation to assess how the formulations and geogrid impact durability. That evaluation was

Suction lysimeters were installed at both of the Phase II porous paving sites (Figure 7) for use in collection of infiltrating water for water quality testing. Lysimeters were installed near each of the basin control structures, at a depth of 1.7' to 2.3' below the bottom of the scarified layer of the infiltration basins. Sampling ports for the lysimeters were located inside a utility box and were accessible by removal of a square cover.

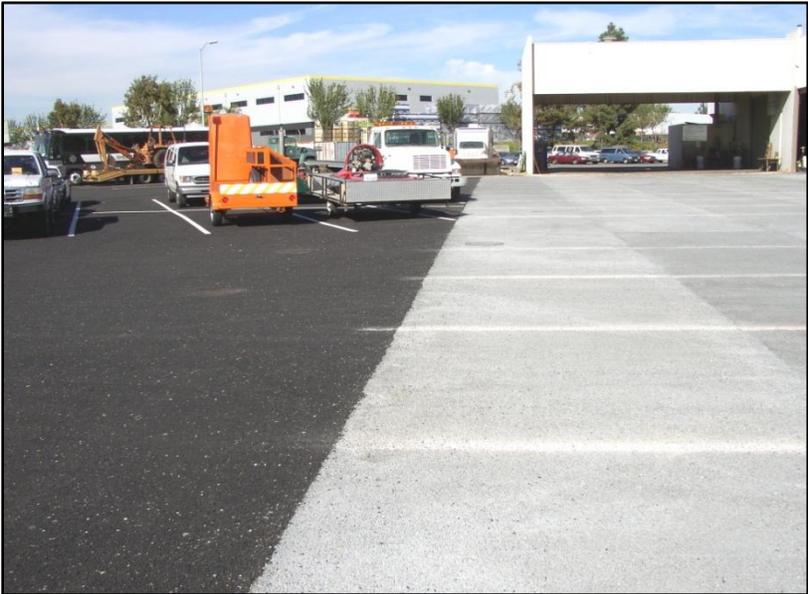
Figure 8. Transition between Phase I Porous Concrete and Asphalt.

Porous concrete (14,936 square feet) was installed adjacent to Building 7 as part of the Phase I construction effort (Figure 7 through Figure 9, Table 2). The test site largely replaced an existing impervious concrete apron in this region. Figure 8 is a view looking north showing the transition from porous concrete to porous asphalt. The canopy of the Building 7 washdown area is visible in the upper right portion of the photograph. Figure 9 is a view looking to the west with the porous asphalt in the background. A portion of the Phase 1 reference area can be seen in the upper left portion of the photograph inside the yellow berm that was installed to assure isolation of the reference area and to prevent runoff from entering the porous concrete and porous asphalt sites.

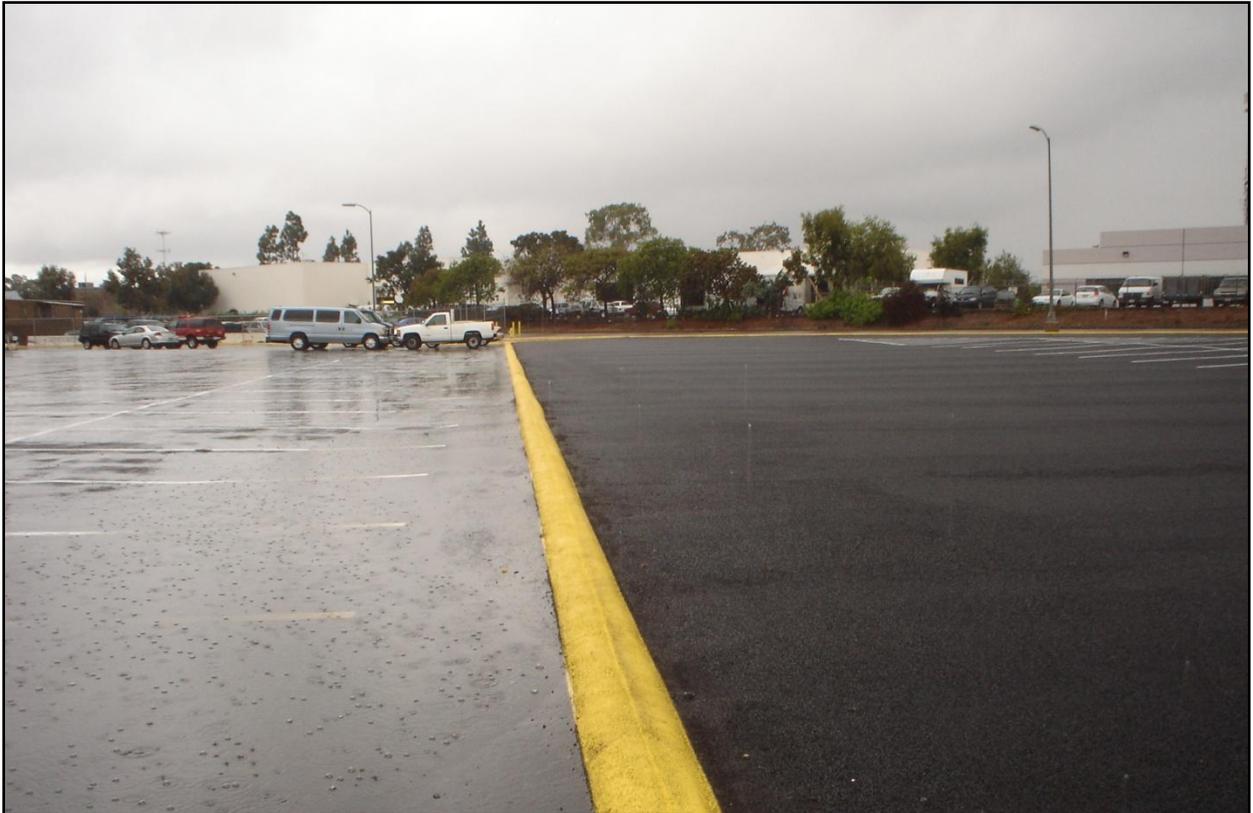
Figure 12. View of Phase I Porous Asphalt and Reference Areas during a Storm Event in 2005.

Porous asphalt formed the largest Phase I test site with over an area of 41,092 square feet (Figure 7). As previously noted, the Phase I porous asphalt and concrete sites shared a common monitoring location (Figure 10, Figure 11). Figure 12 provides a view towards the west during a storm event showing the Phase I parking lot reference site to the left of the yellow berm and the porous asphalt to the right.

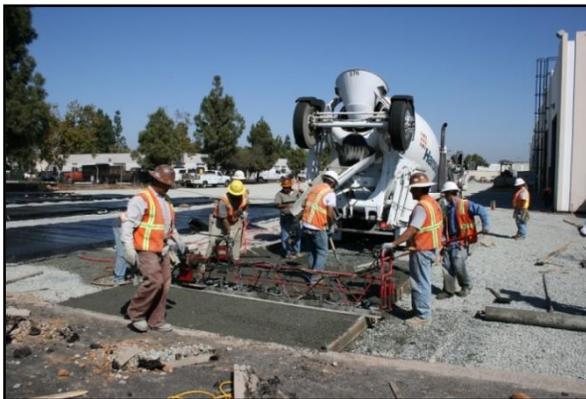
Figure 13. Installation of Phase II Concrete

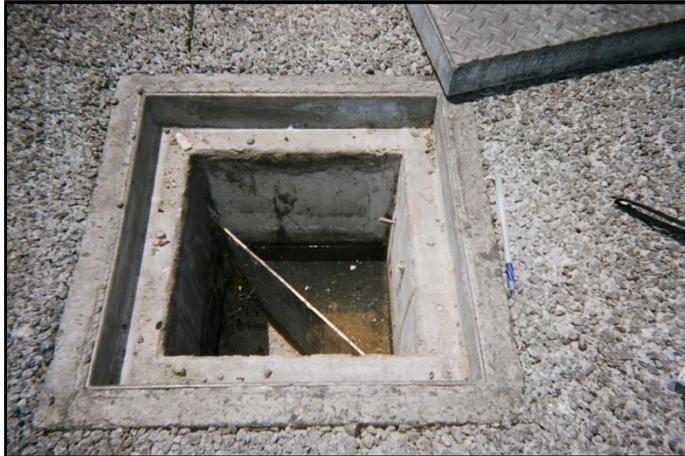
Figure 15. Phase II Concrete Control Basin showing the Weir.

Figure 15 shows the Phase II porous concrete weir used to control water levels in the infiltration basin. When water levels in the infiltration basin exceed the height of the weir, water is discharged through a pipe which goes to the sampling point located at the northeast corner of Building 7. The sampling points for both the Phase II concrete and asphalt were located at this site. The Phase II concrete discharge pipe ran to the east under the

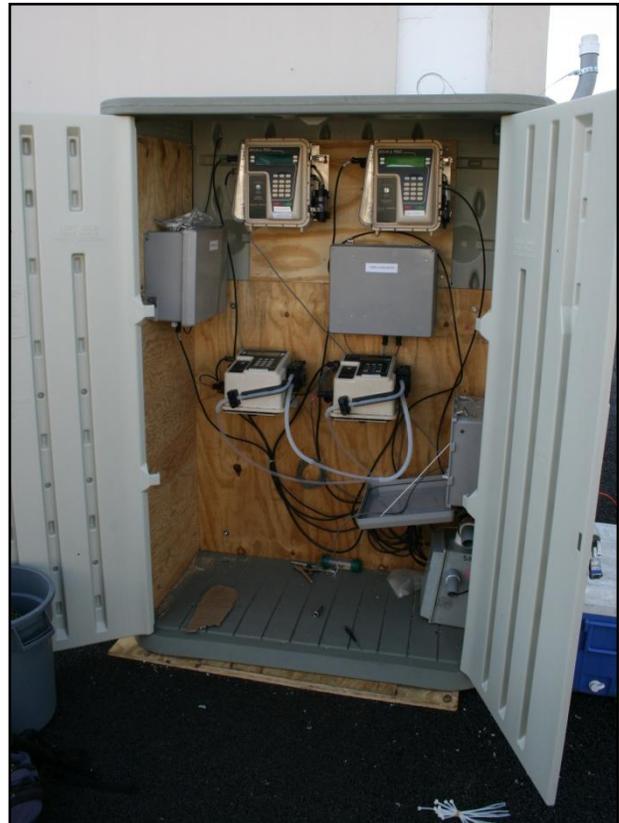
Figure 17. Phase II Porous Concrete and Asphalt Monitoring Enclosure and Equipment.

As noted in the previous section, the Phase II concrete and asphalt monitoring sites were located together at the northeastern corner of Building 7 (Figure 17). A hard-wire telephone line was installed to provide remote control and communication with this site. This site also provided communications with the roof reference site using a spread-spectrum radio link.

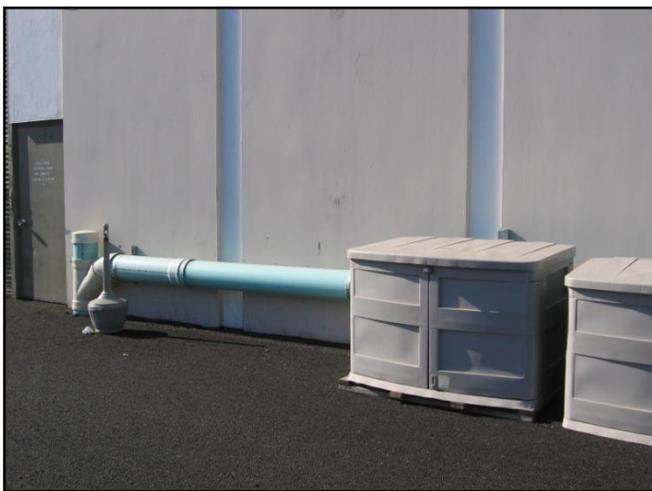
Figure 20. Roof Reference Monitoring Site and Discharge Point into the Phase II Porous Asphalt Infiltration Basin.

The roof runoff reference site was located on the north side of Building 7 (Figure 7). This system drained roughly half of the roof or 25,000 square feet. This site used a manifold system to aggregate all downspouts from the north side of the Building into a single pipe. Runoff from the roof was directed through the manifold and down the side of the building (Figure 21). Approximately 18 inches before reaching ground level the pipe made a 90 degree angle and ran 45 feet along the wall at a 1% slope before turning down and being directed into the infiltration bed (Figure 20). An access port was cut in the top of the pipe at a distance of 30 feet past the downspout and 15 feet before entering the infiltration basin. This location was considered the optimal spot to measure flow. A Doppler flow meter was installed in the pipe to monitor flow. The autosampler intake hose was installed downstream of the flow sensor using a special low flow, intake strainer to allow effective sampling with relatively low water levels.

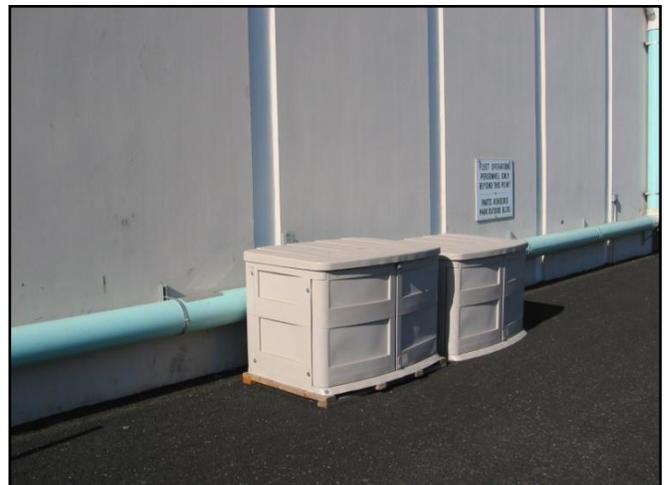
Figure 21. Roof Reference Monitoring Site Showing Approach Section and Manifold Downspout.

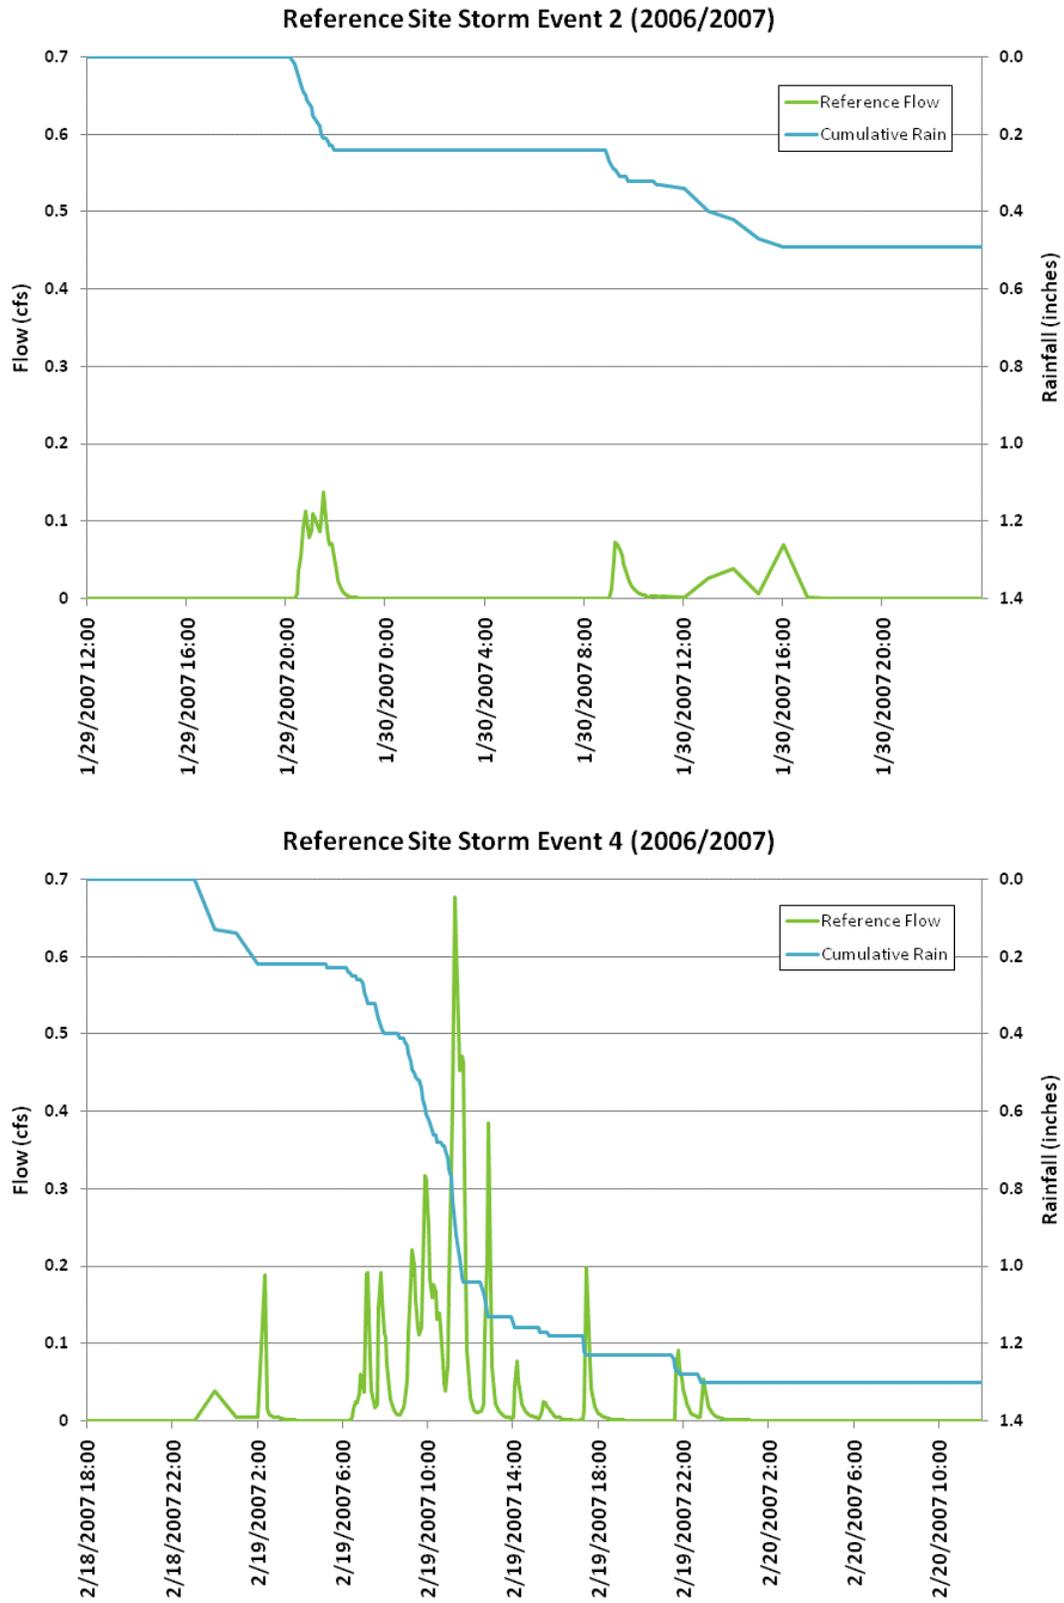
Figure 22. Hydrographs for Events 2 and 4 at the Parking Lot Reference Site, 2006/2007.

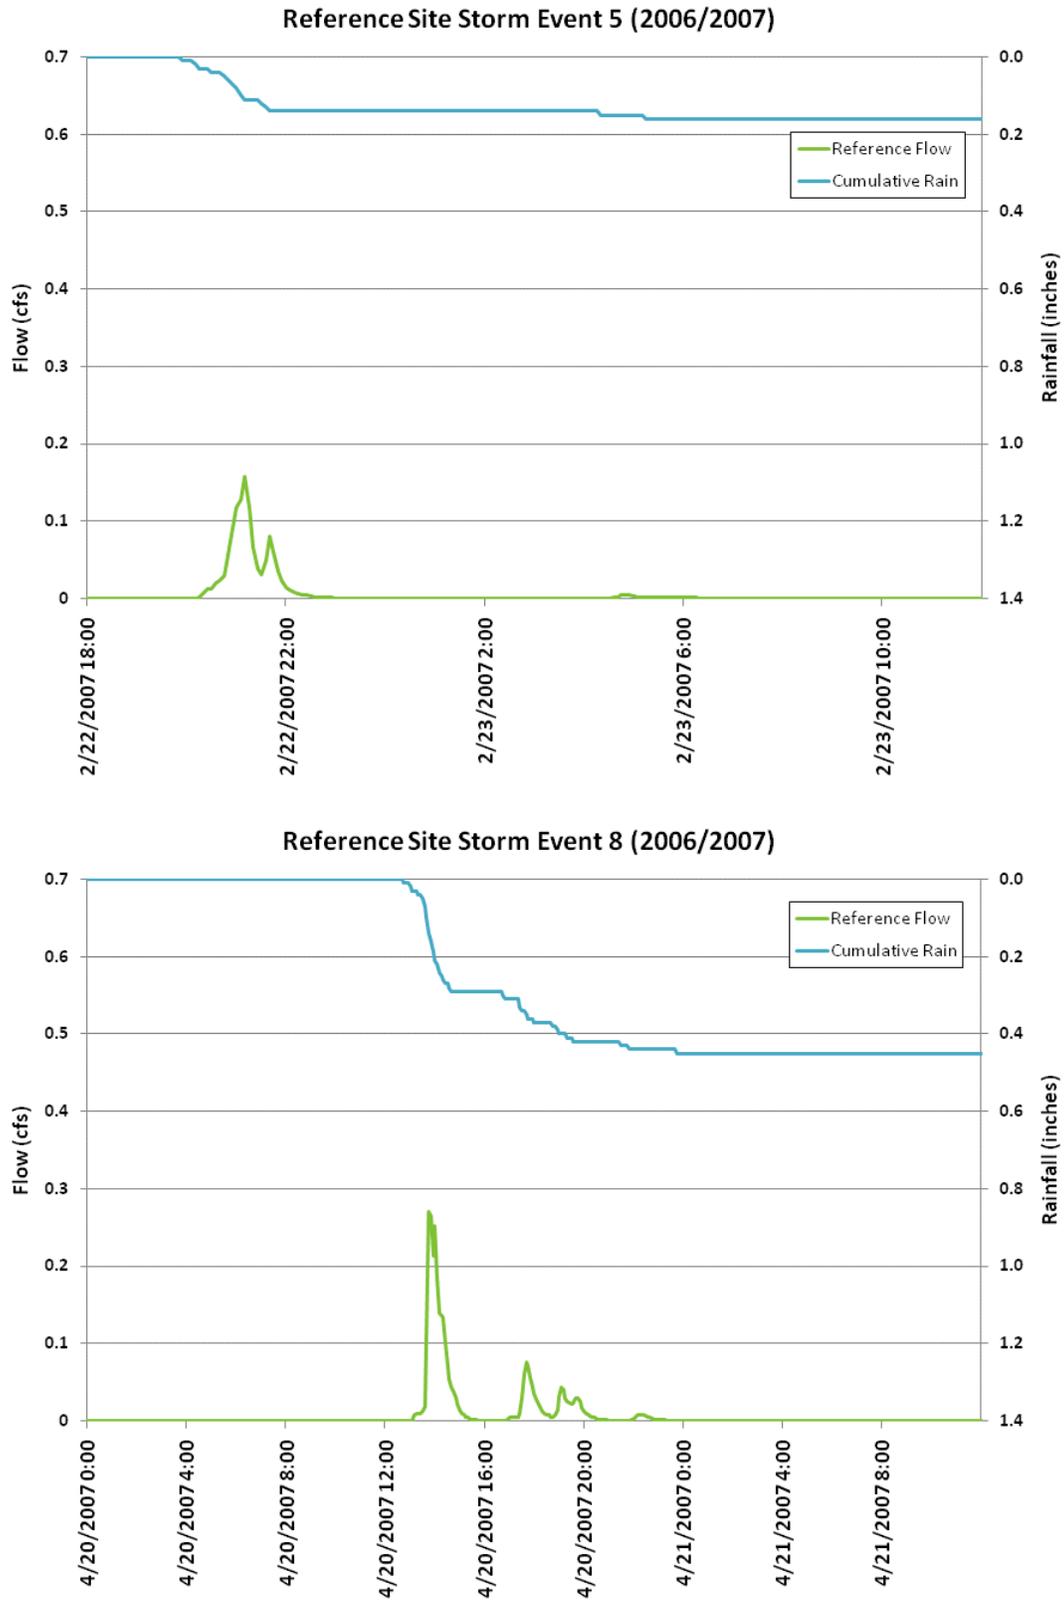
Figure 23. Hydrographs for Events 5 and 8 at the Parking Lot Reference Site, 2006/2007.

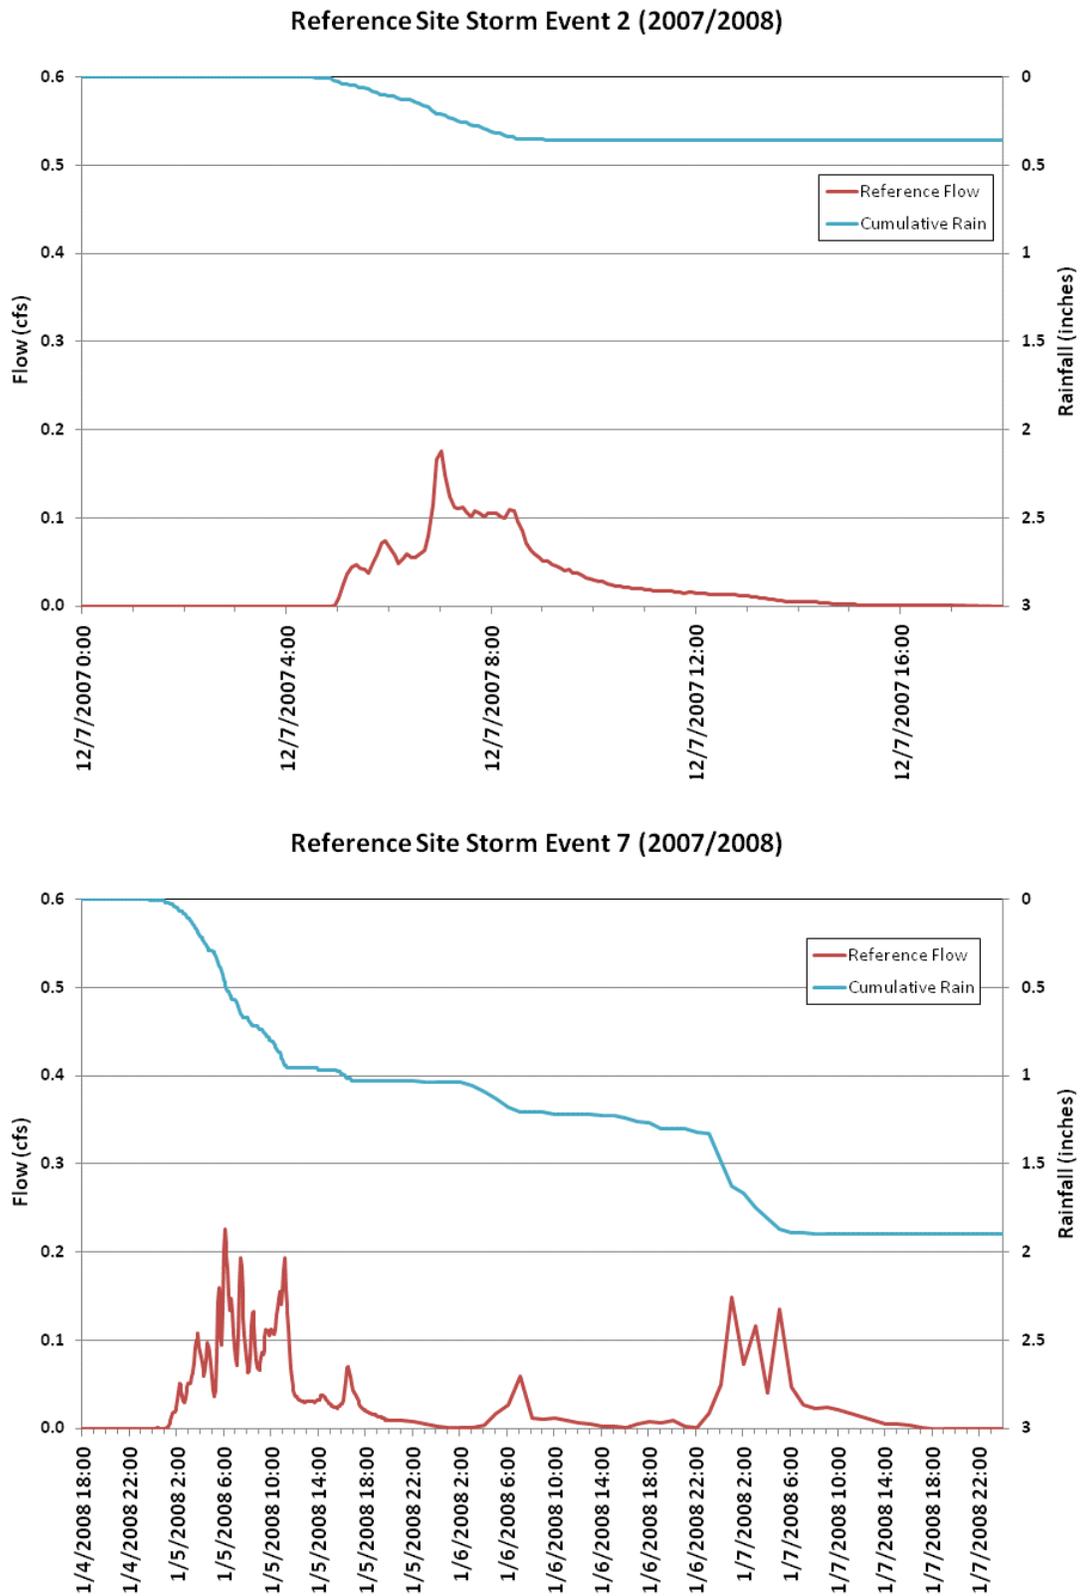
Figure 24. Hydrographs for Events 2 and 7 at the Parking Lot Reference Site, 2007/2008.

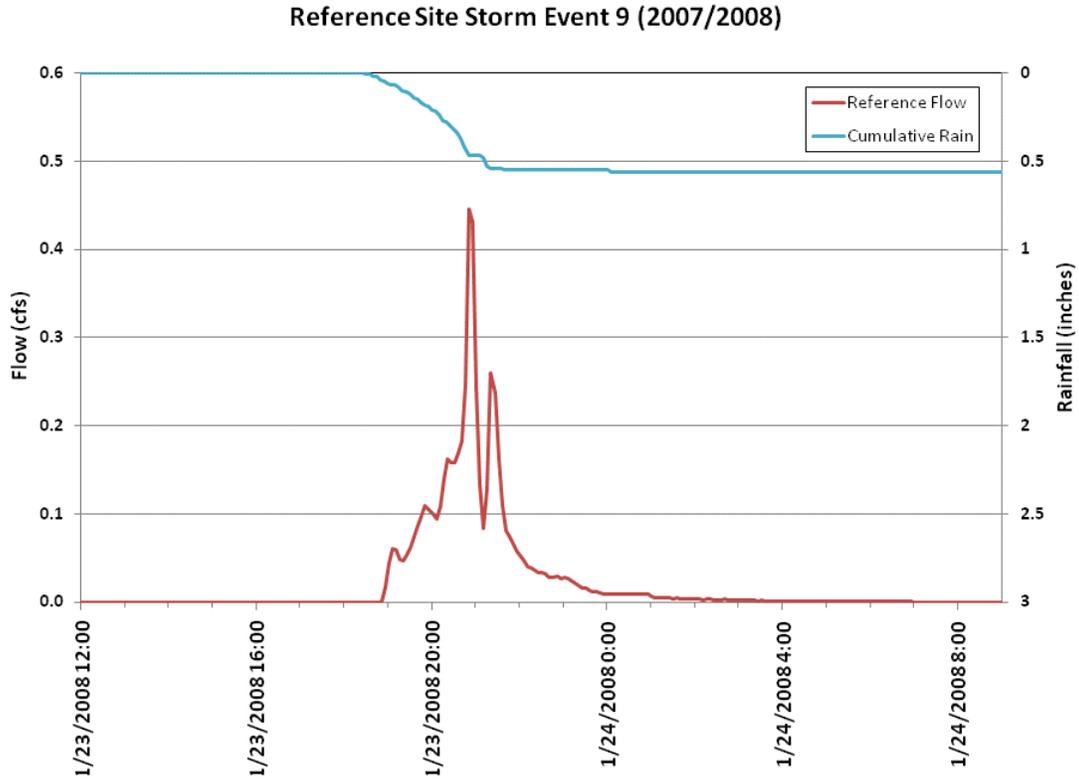
Figure 25. Hydrographs for Event 9 at the Parking Lot Reference Site, 2007/2008.

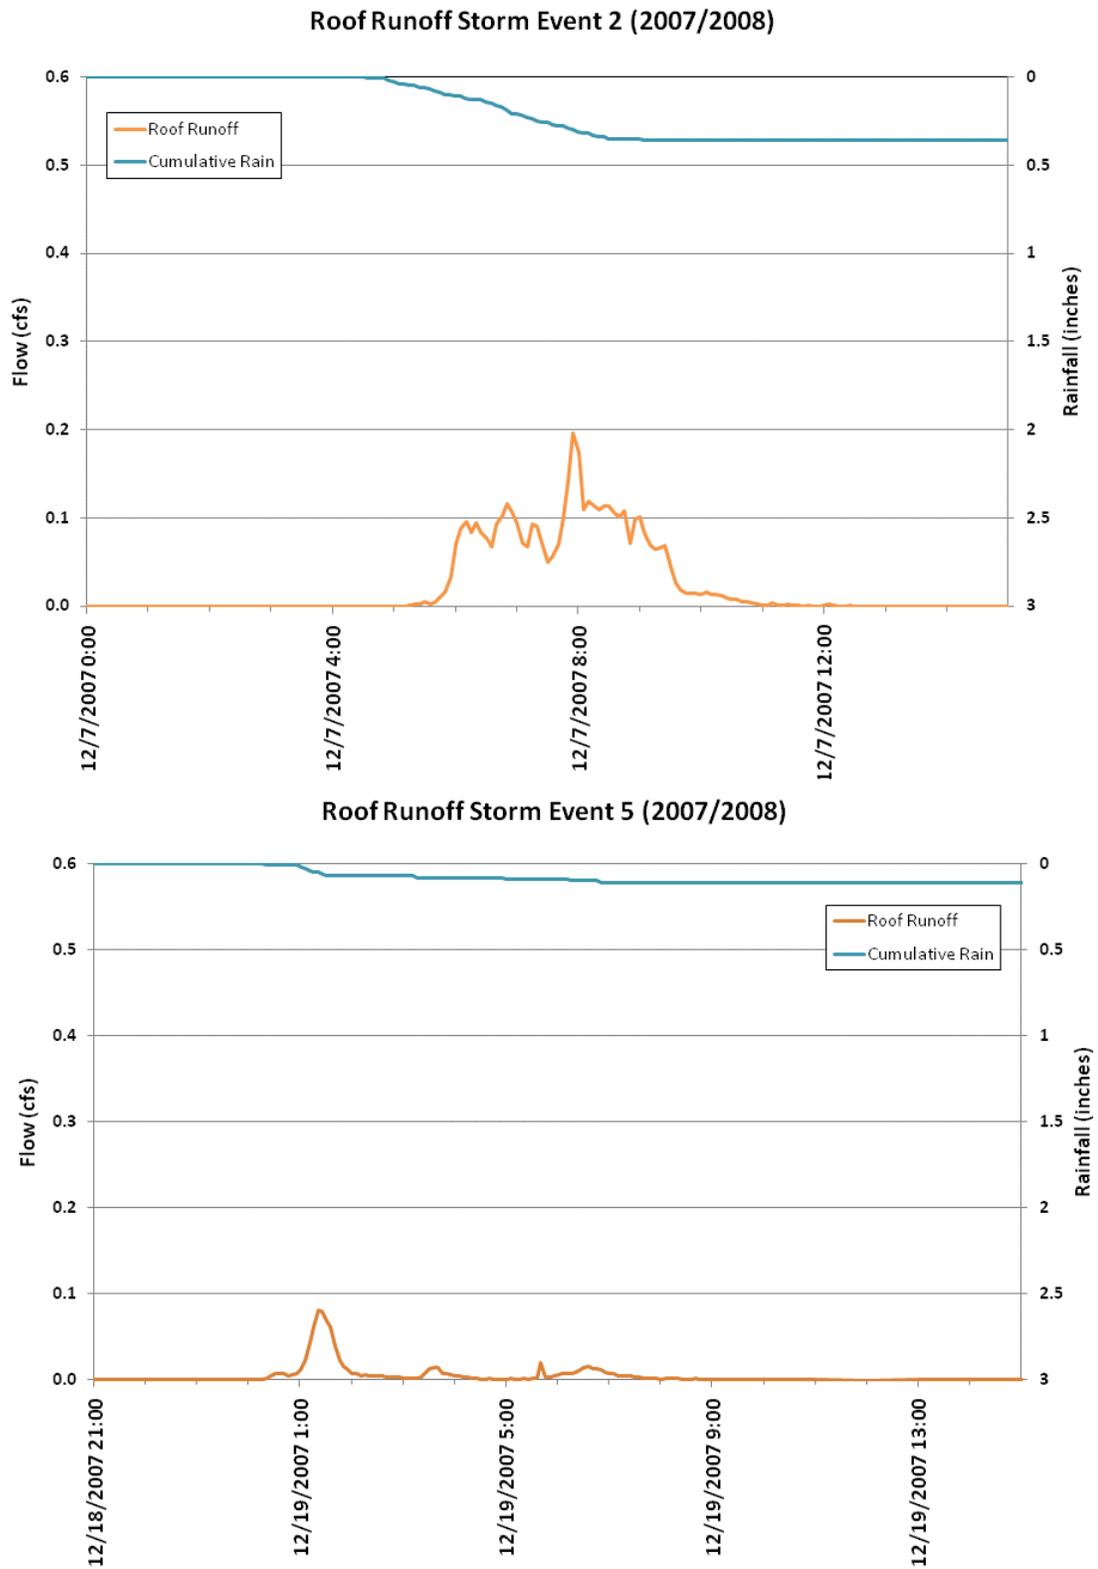
Figure 26. Hydrographs for Events 2 and 5 at the Roof Reference Site, 2007/2008.

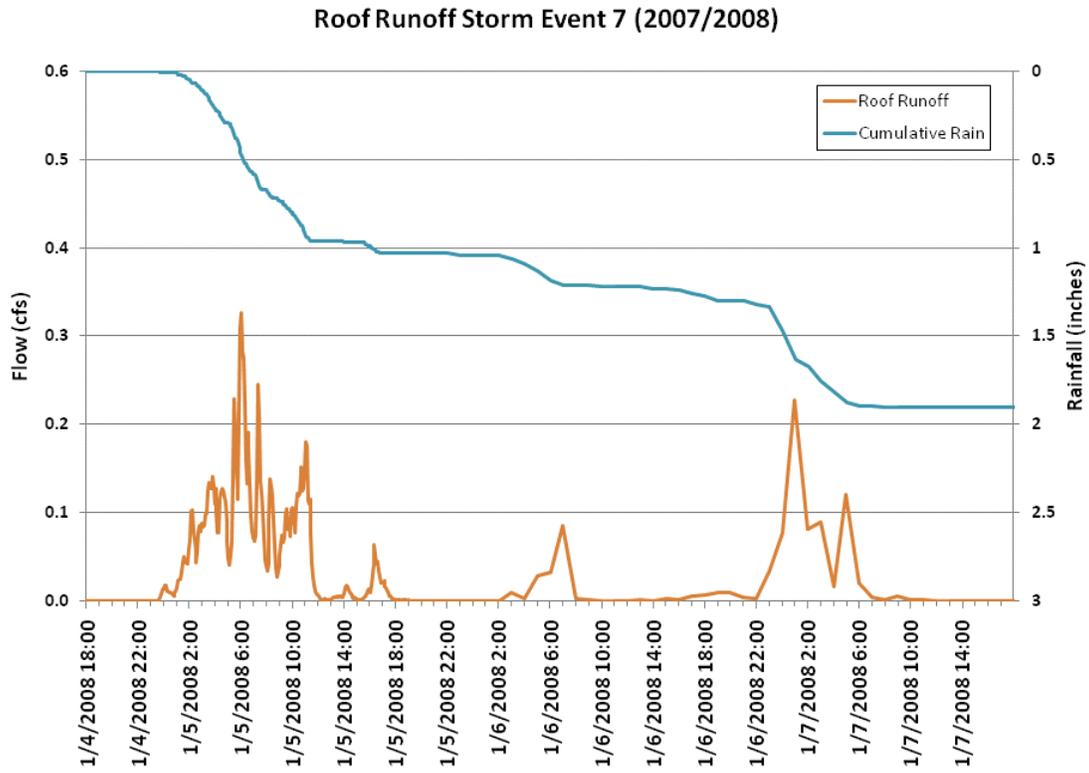
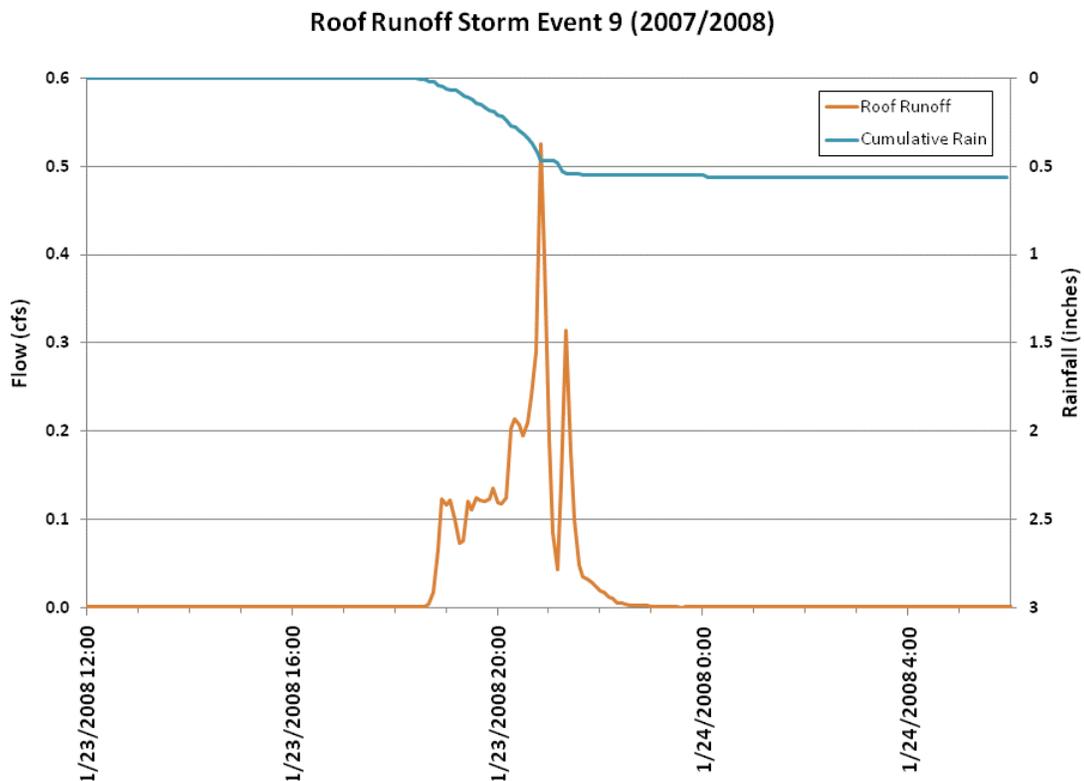
Figure 27. Hydrographs for Events 7 and 9 at the Roof Reference Site, 2007/2008.

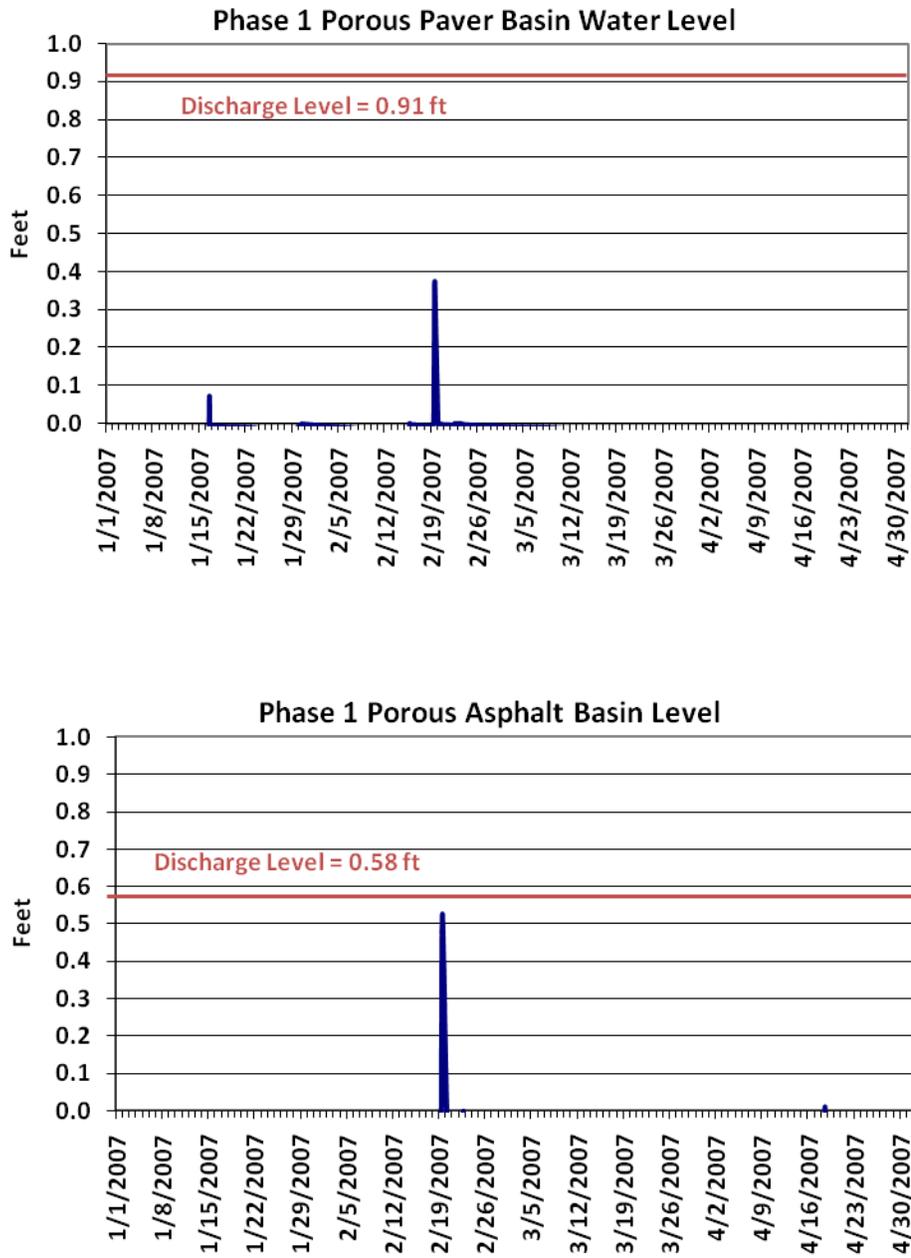
Figure 28. Water Levels in the Phase I Porous Paver and Asphalt Infiltration Basins, 2006/2007 Season.

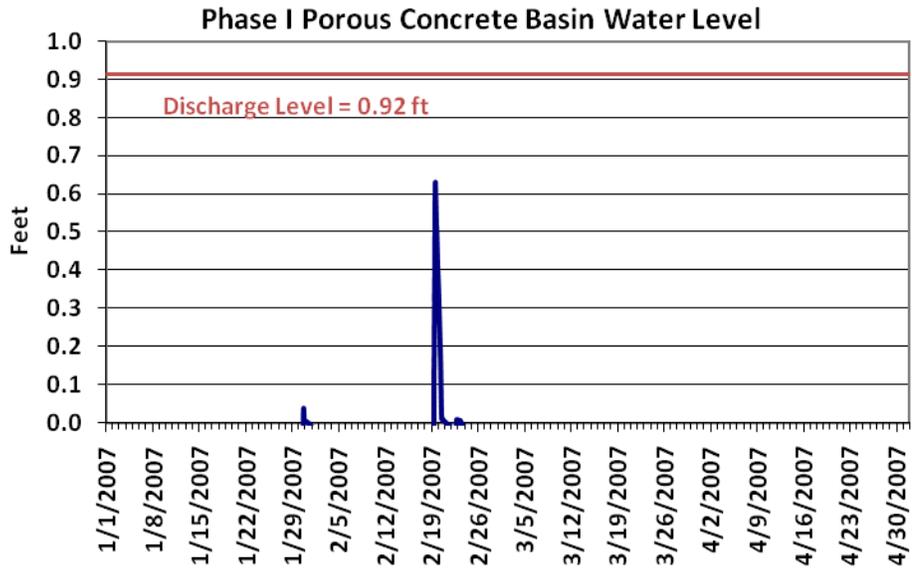
Figure 29. Water Levels in the Phase I Porous Concrete Infiltration Basins, 2006/2007 Season.

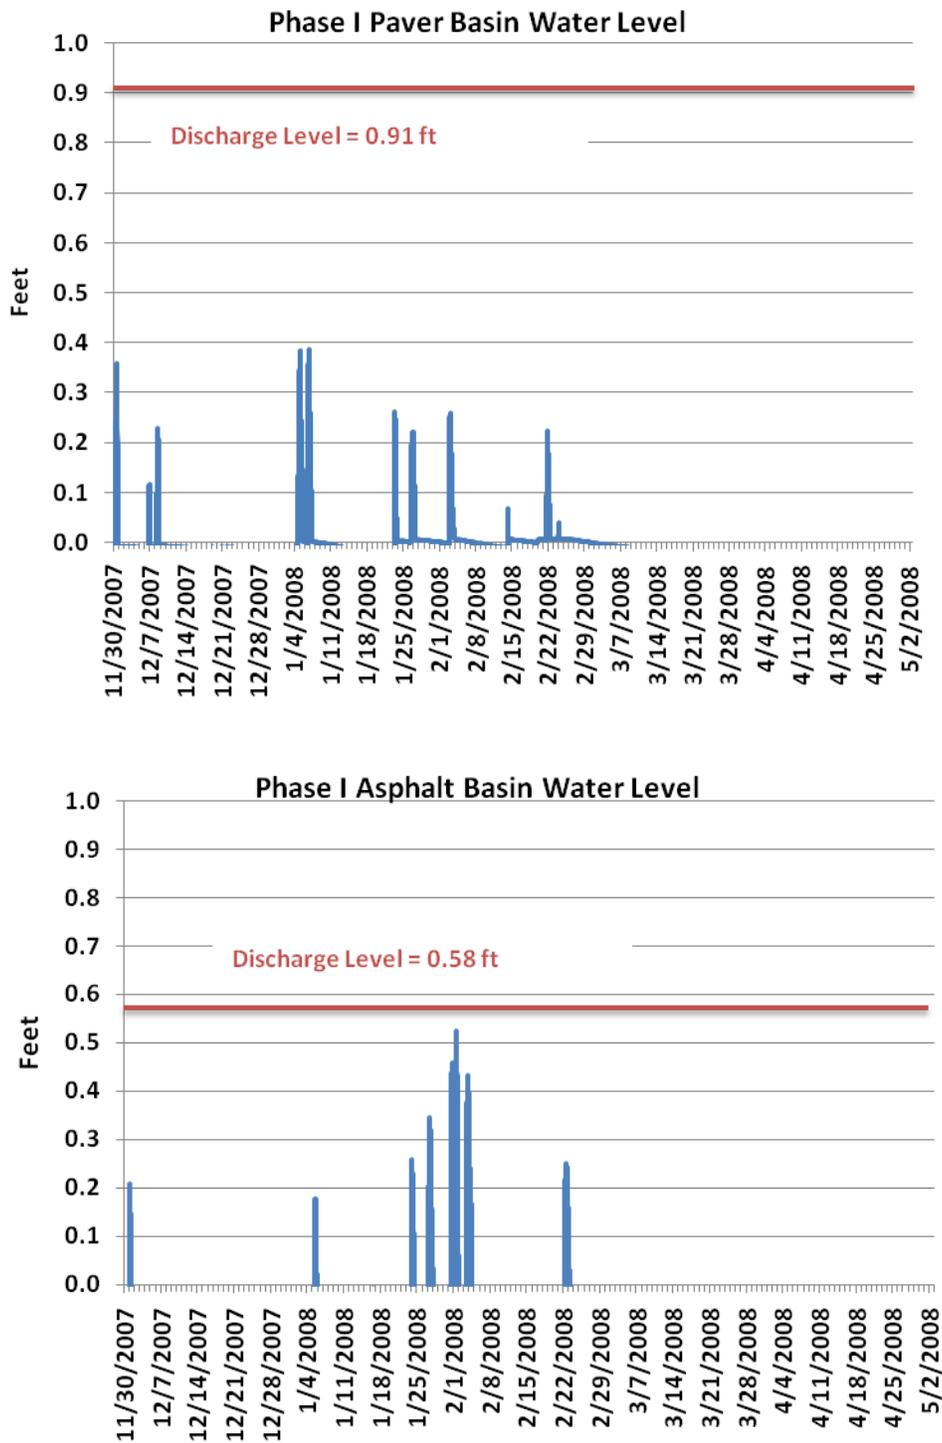
Figure 30. Water Levels in the Phase I Porous Paver and Asphalt Infiltration Basins, 2007/2008 Season.
