COUNTY OF SAN DIEGO MODEL MUNICIPAL OPERATIONS CENTER

Final Report *Phase II Porous Paving and Treatment Train* *Water Quality Monitoring Program*

KINNETIC
LABORATORIES
INCORPORATED

SEPTEMBER 2008

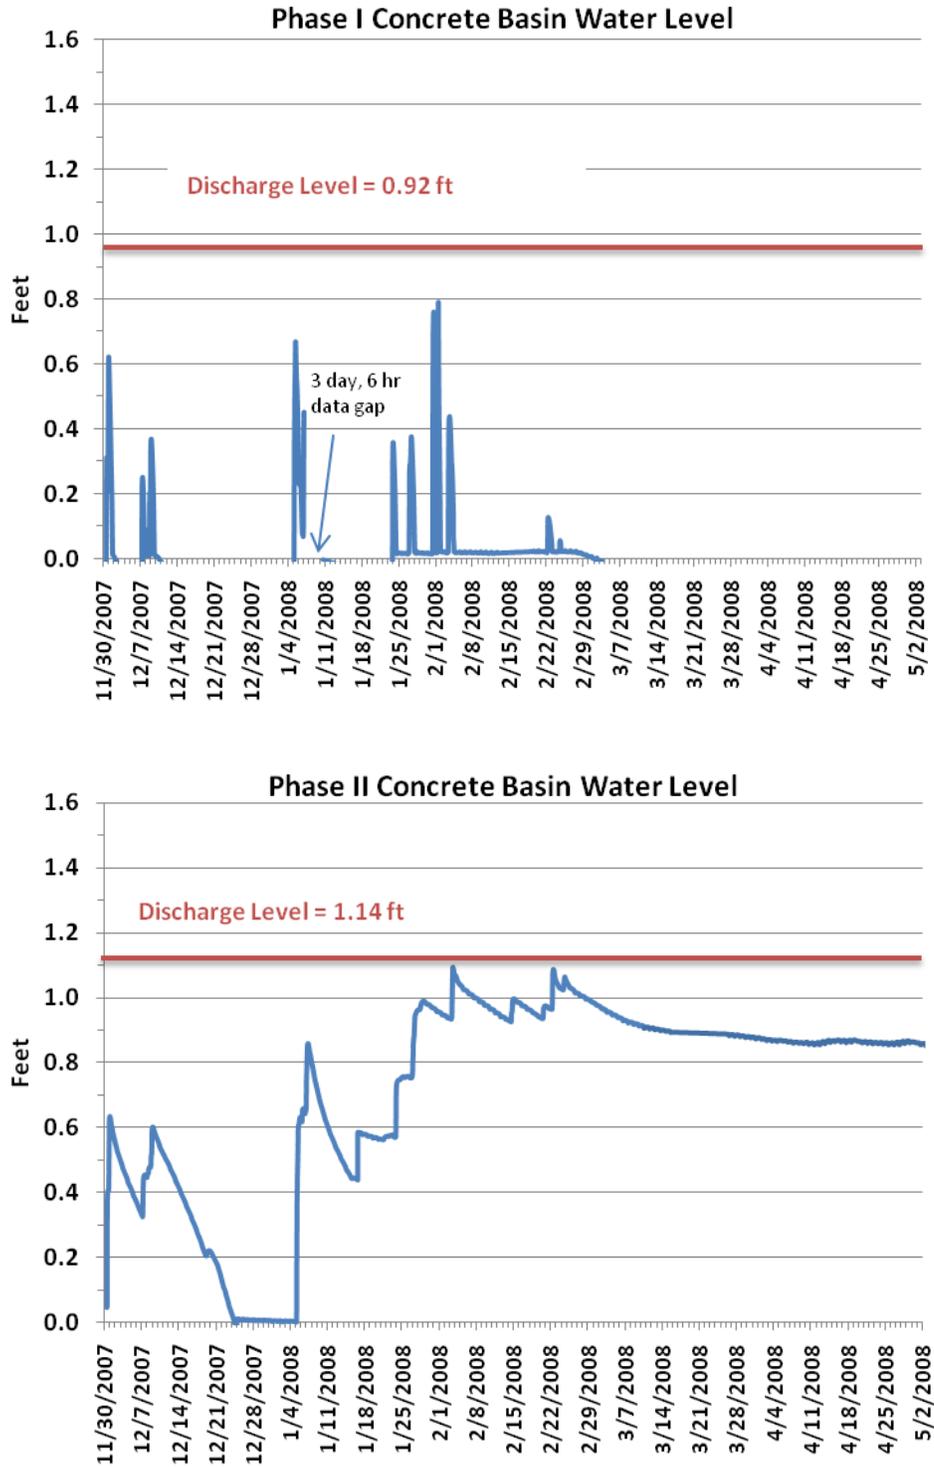
Figure 31. Water Levels in the Phase I and Phase II Porous Concrete Infiltration Basins, 2007/2008 Season.

Once repaired in mid January 2008, water levels progressively increased in the Phase II concrete (Figure 31) nearly reaching the top of the weir during two storm events. After the last rainfall, water levels slowly dropped and stabilized at a depth of 0.86 feet. In early May, water in the basin was crystal clear. By June, the visual appearance of water in the basin had changed substantially. Water samples were taken and analyzed to evaluate both the general water quality for reuse or disposal. The results of the analysis are summarized in the following section.

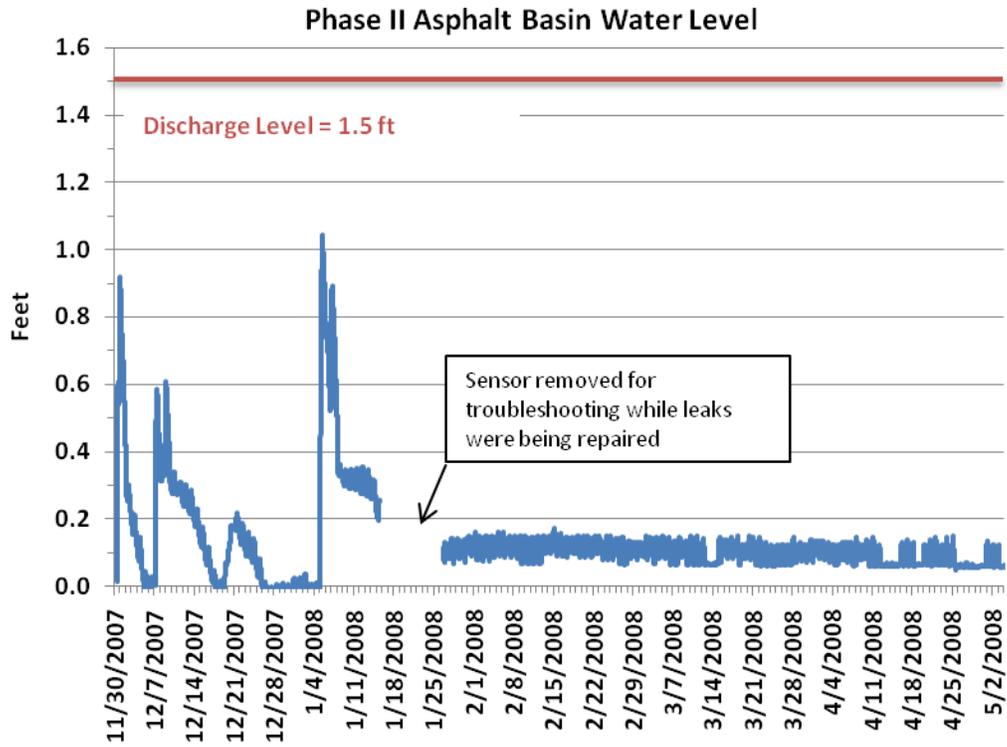
Figure 32. Water Levels in the Phase II Asphalt Infiltration Basin, 2007/2008 Season.

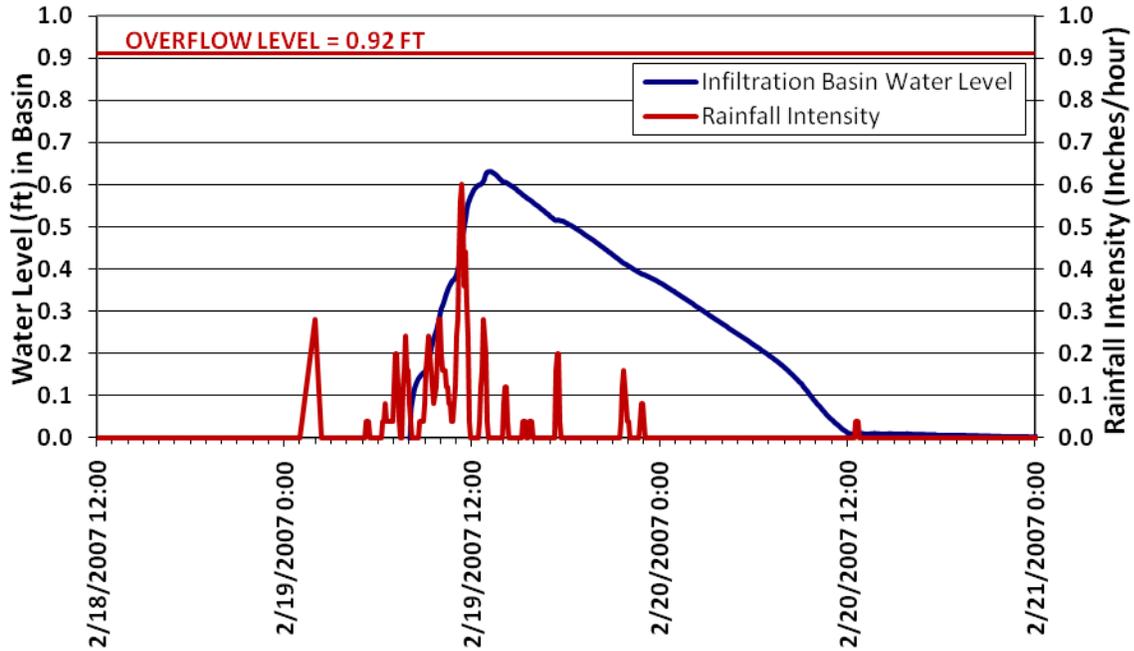
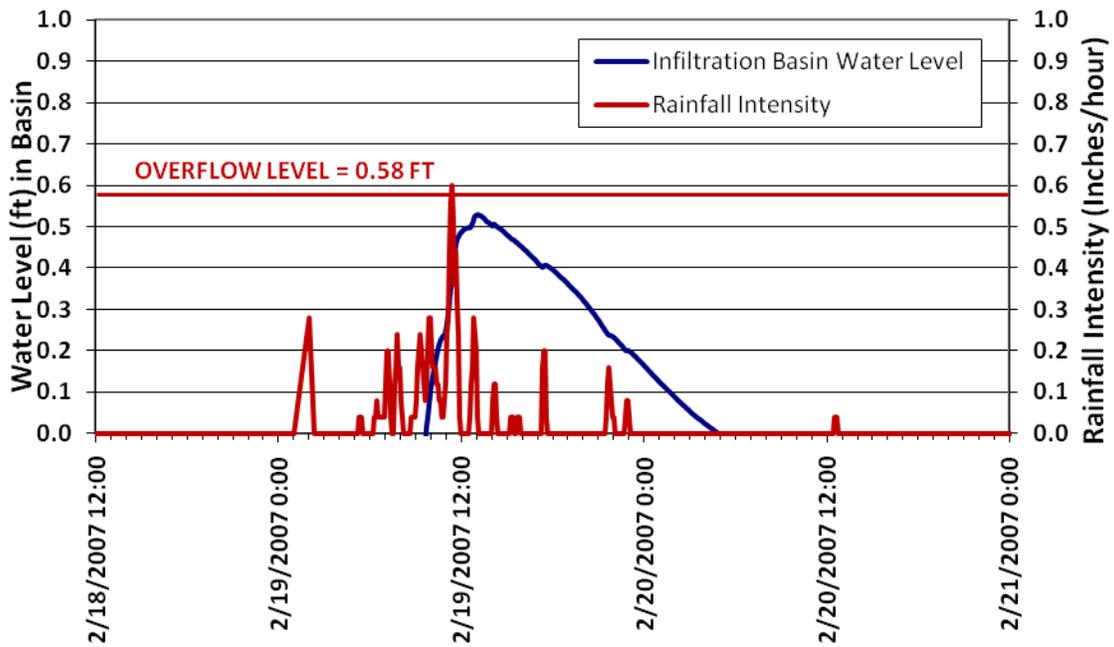
Phase I Porous Concrete - Event (02/18 - 02/20/2007)

Phase 1 Porous Asphalt - (02/18 - 02/20/2007)

Figure 33. Comparison of Infiltration Rates at Phase I Asphalt and Concrete during a February 2007 Event.

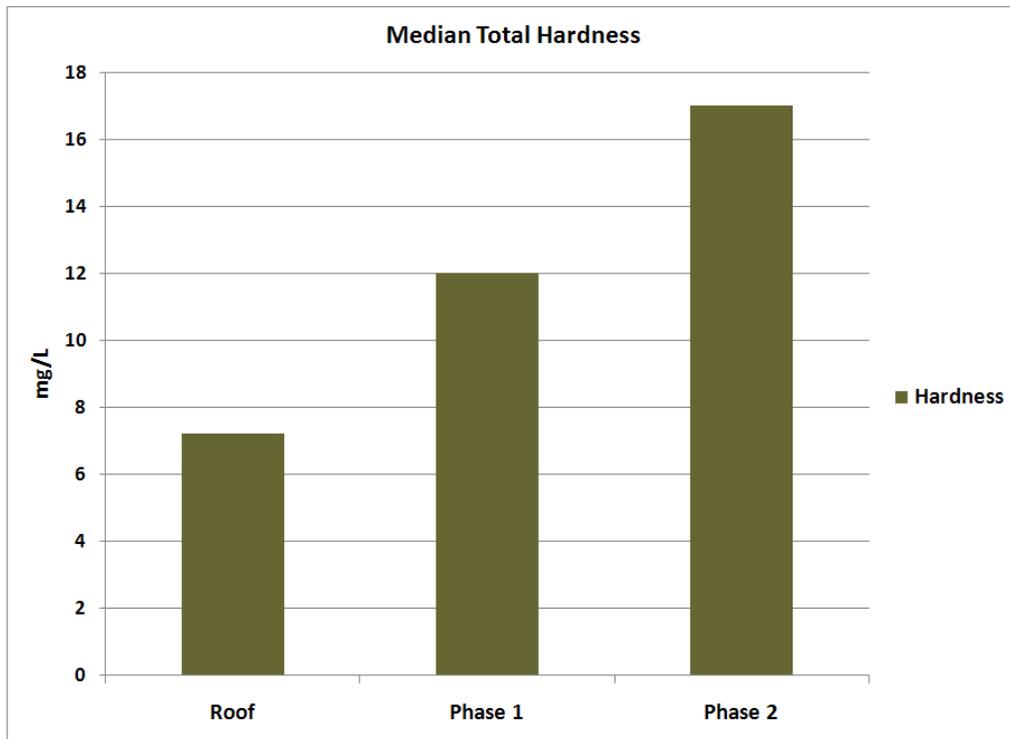
Figure 34. Comparison of Hardness as CaCO₃ measured in Runoff from the Three Reference Sites.

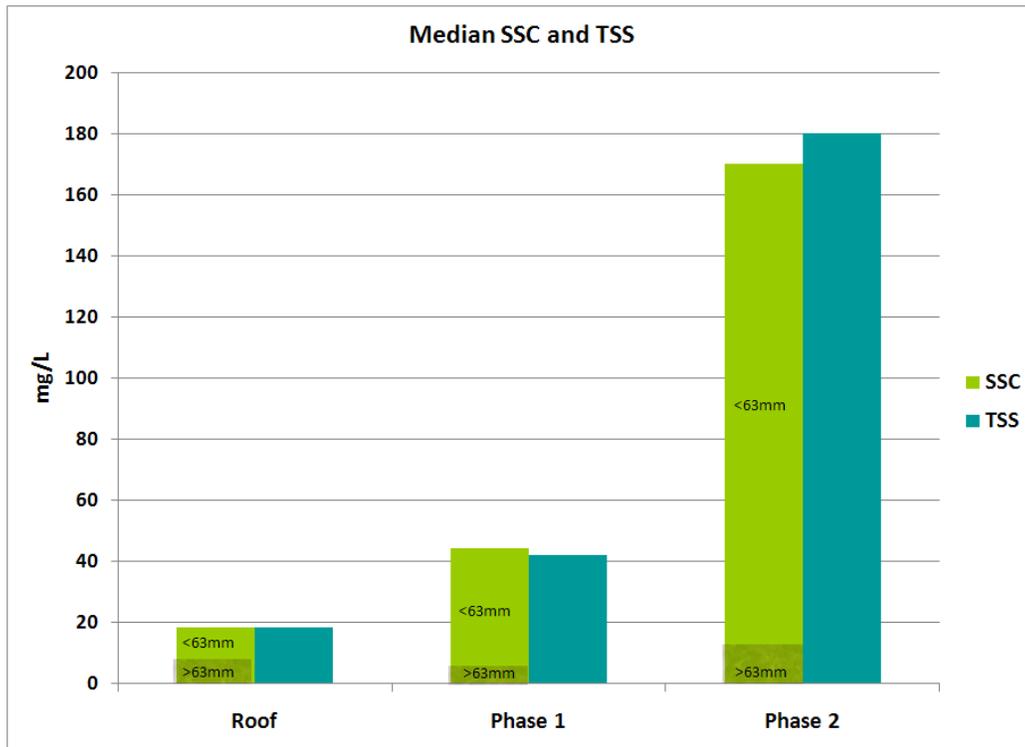
Figure 35. Comparison of Concentrations of Suspended Sediment measured in Runoff from the Three Reference Sites.

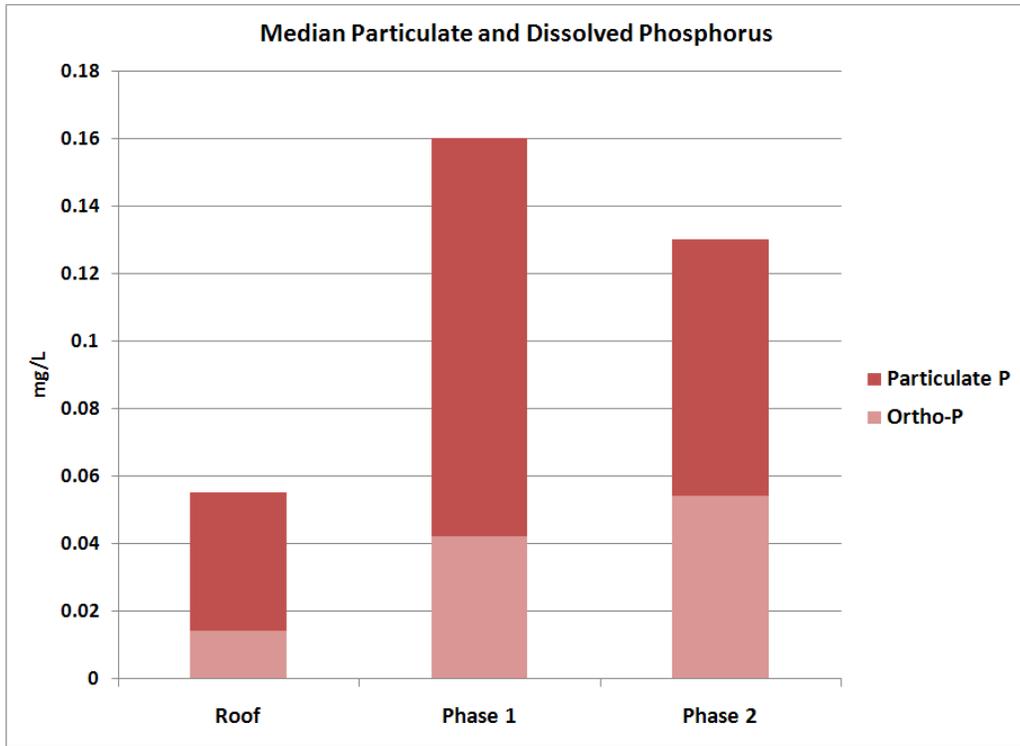
Figure 36. Comparison of Particulate-P and Ortho-P measured in Runoff from the Three Reference Sites.

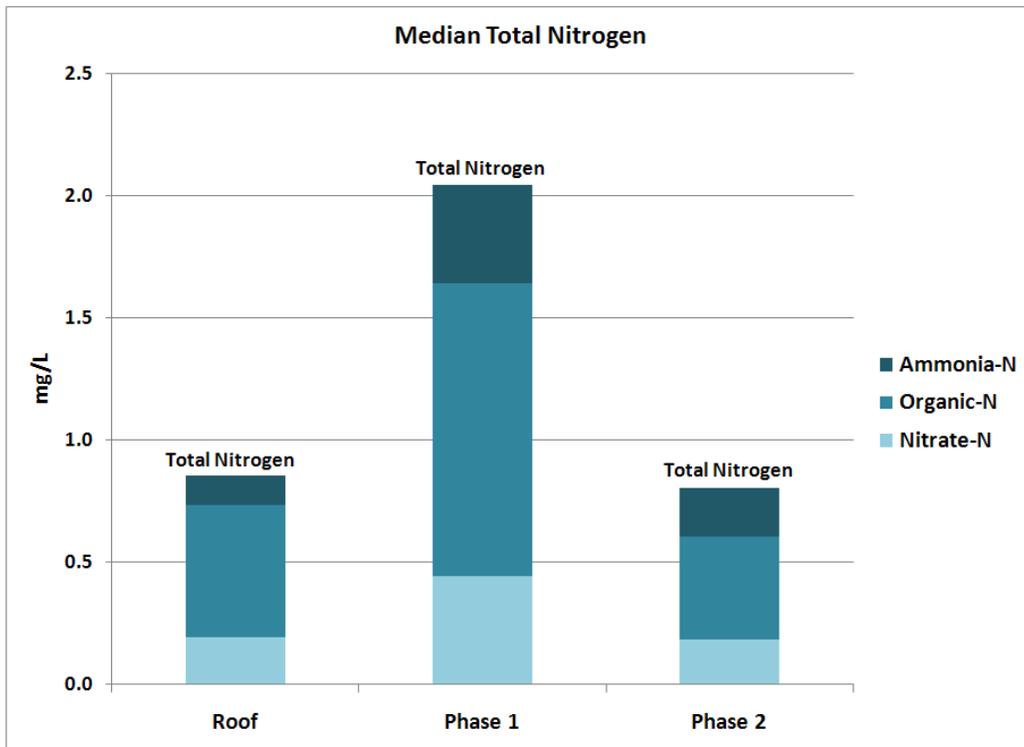
Figure 37. Comparison of Total Nitrogen measured in Runoff from the Three Reference Sites.

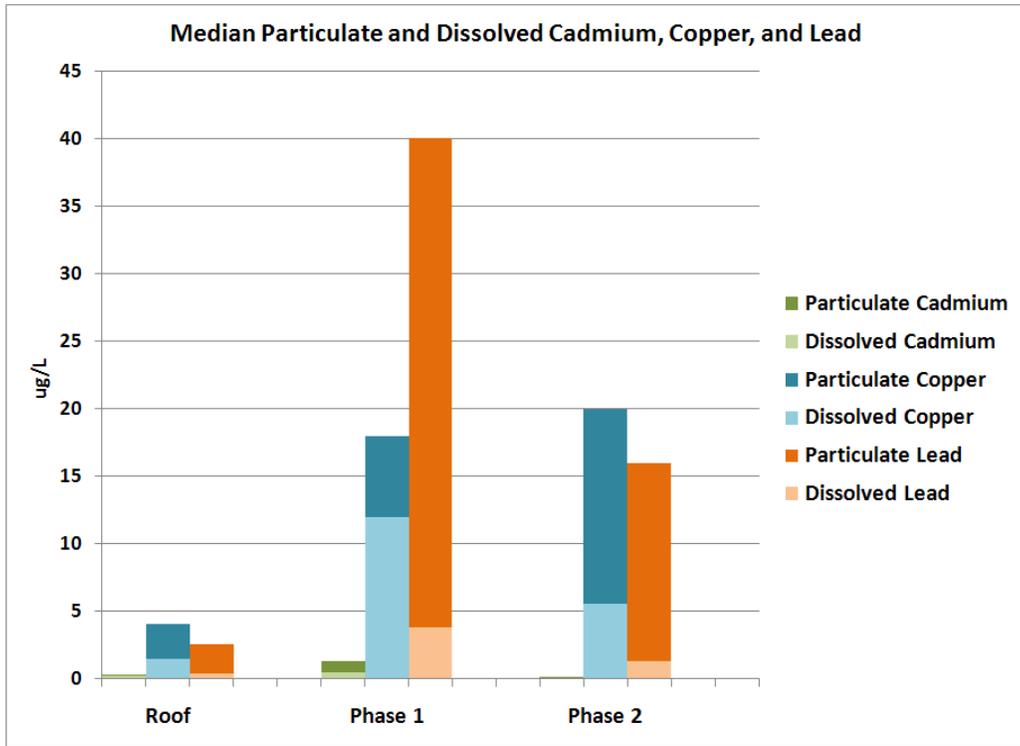
Figure 38. Comparison of Particulate and Dissolved Cadmium, Copper, and Lead measured in Runoff from the Three Reference Sites.

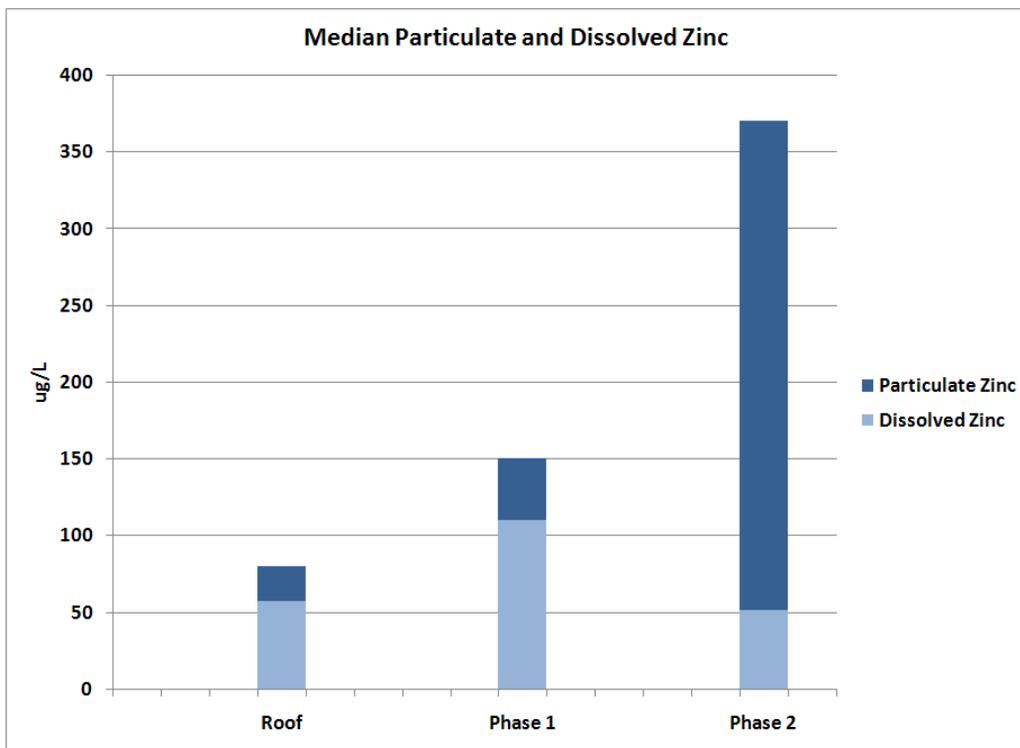
Figure 39. Comparison of Particulate and Dissolved Zinc measured in Runoff from the Three Reference Sites.

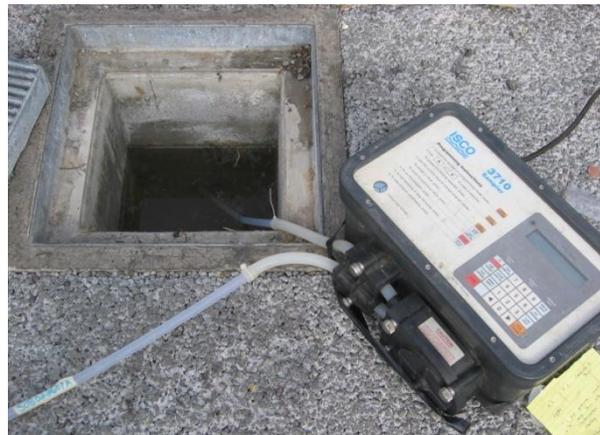
Figure 40. Sampling of Water from the Phase II Porous Concrete Infiltration Bed, 2 June 2008.

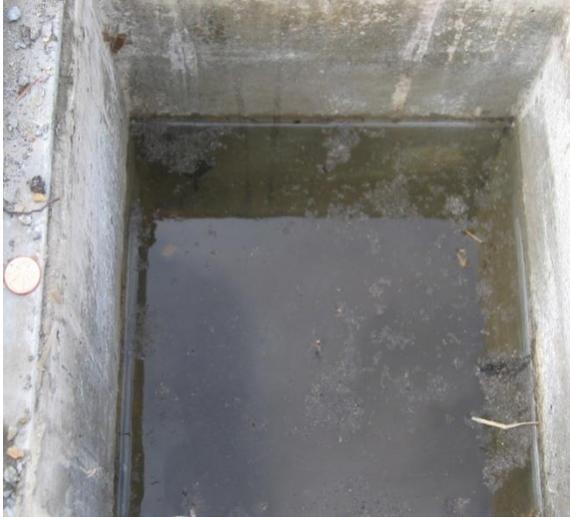
Figure 41. Catch Basin and Standing Water in Phase II Porous Concrete Infiltration Basin during 2 June 2008 Sampling.

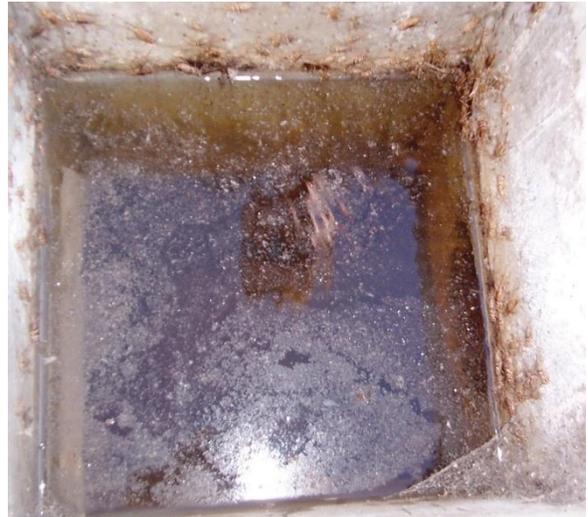
Figure 42. Catch Basin and Standing Water in Phase II Infiltration Basin during Revisit on 21 July 2008.

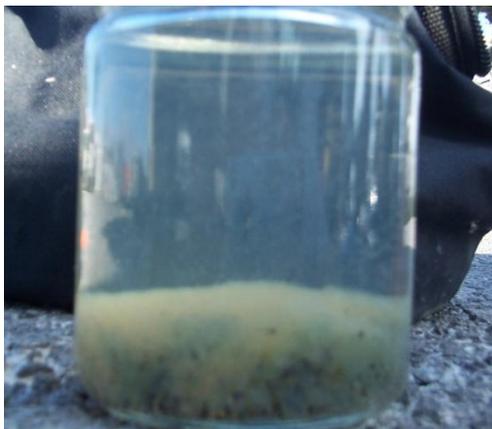
Figure 43. Water from Perforated Pipe connecting to the Porous Concrete Infiltration after Settling.

Water sampled from the perforated pipe was radically different than water undisturbed water within the catch basin (Figure 43 and Figure 44). Prior to allowing the sample to settle, turbidity was measured at 200 NTU. After allowing the sample to settle for just a few minutes, the supernatant water had a measured turbidity of 18.8 NTU.

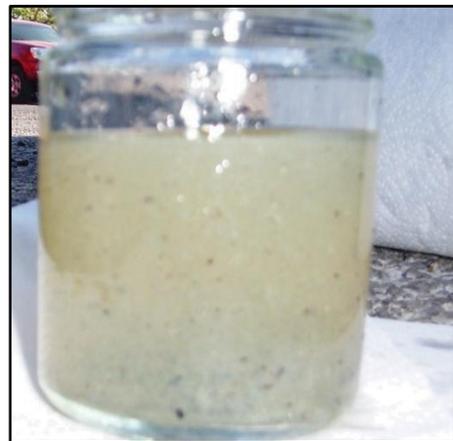
Figure 44. Water from Perforated Pipe connecting to the Porous Concrete Infiltration Basin prior to Settling.

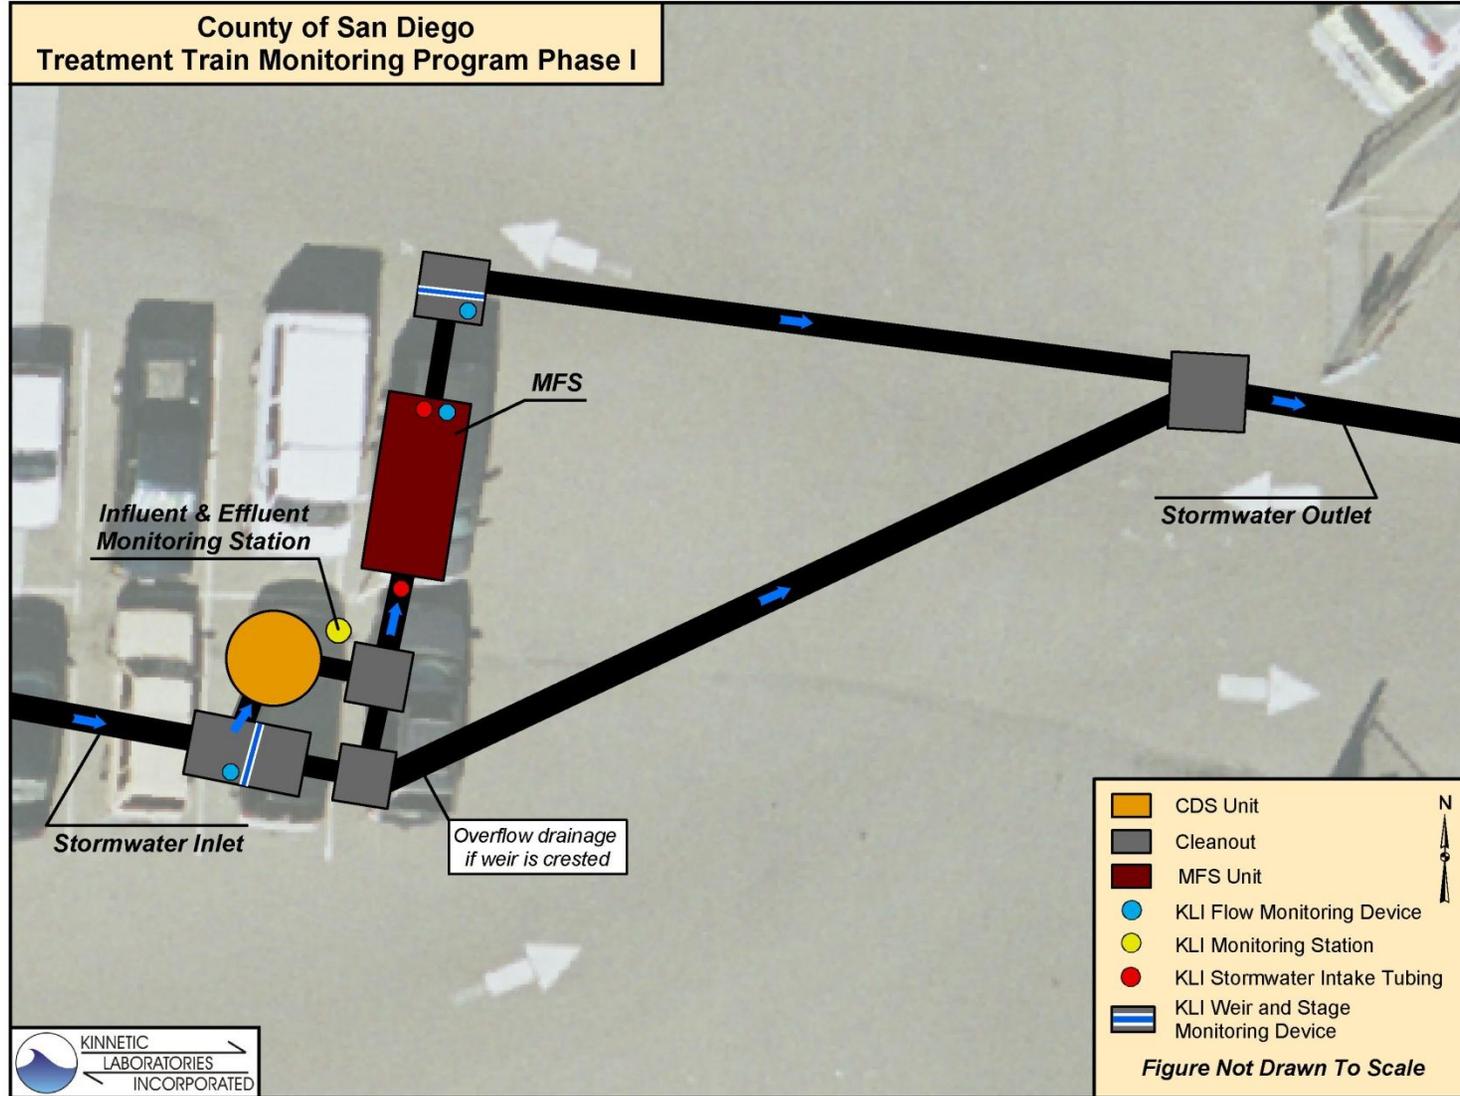
Figure 45. Generalized Plan View of Phase I CDS Treatment Train and Monitoring System.

Improvements in the accuracy of total flow measurements was achieved by installation of a 60 degree V-notch weir in the junction box located immediately downstream of the MFS unit. Flow at this location was monitored with a pressure sensor encased in a stilling well.

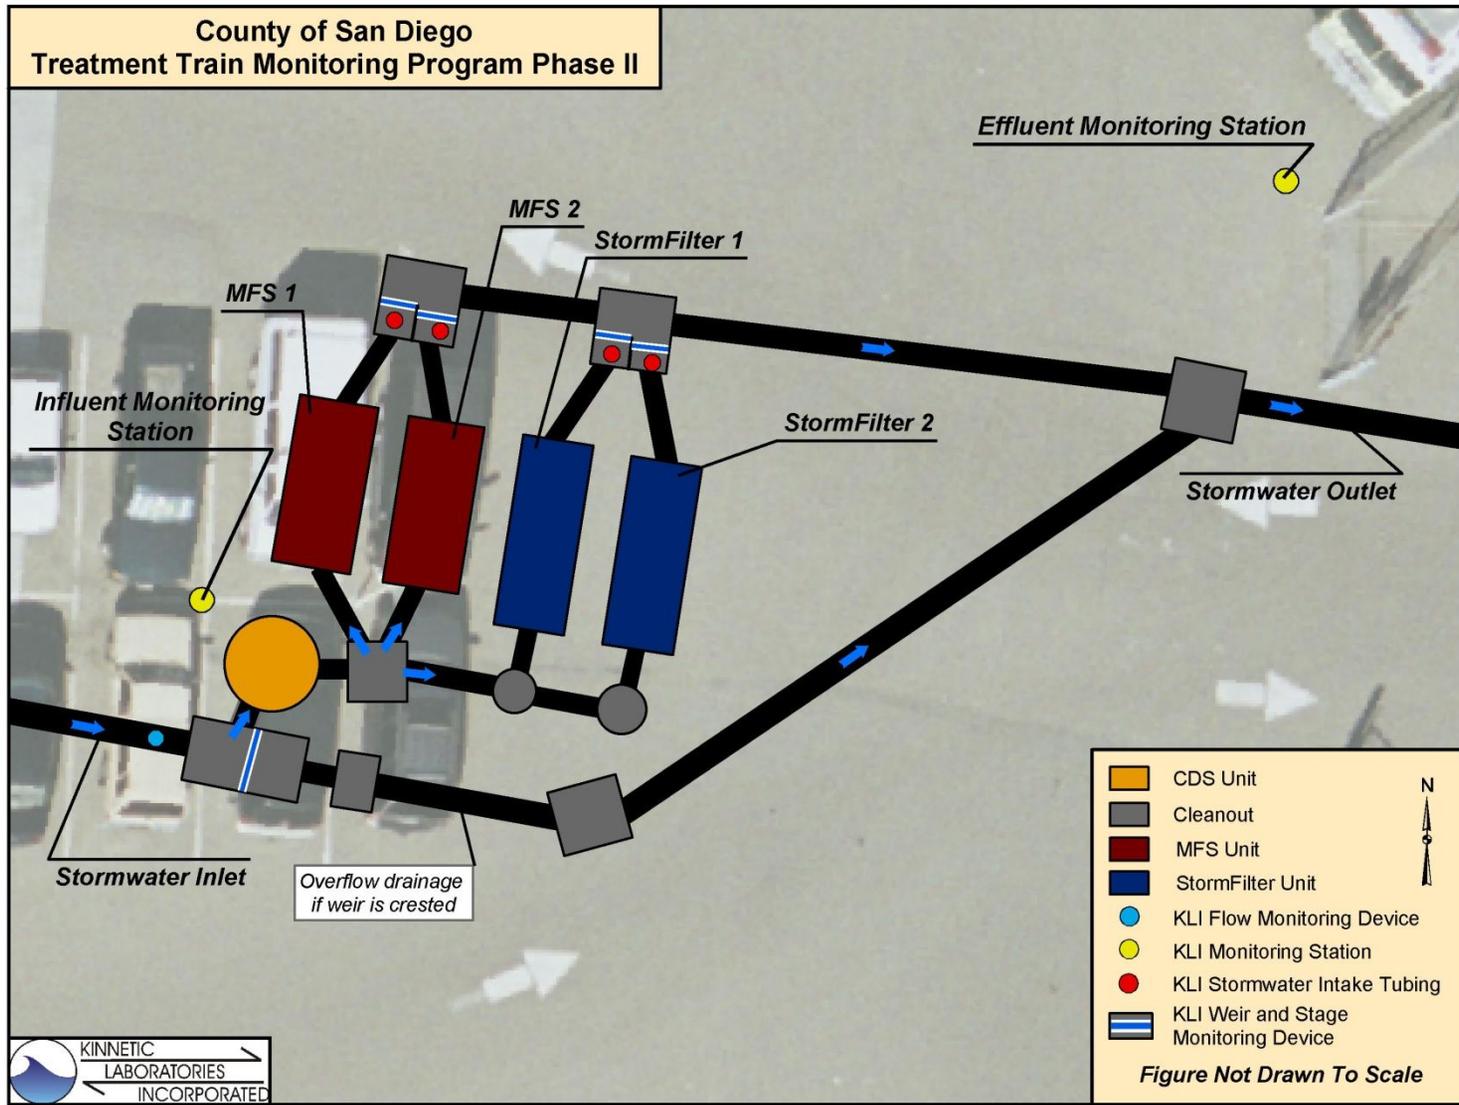
Figure 47. Treatment Train Configuration and Sampling Points for Phase II Monitoring, 2007/2008.

With the expanded filtration capacity none of the systems had internal bypasses. The weir preceding the CDS unit was designed to limit flows passing through the treatment train to 7.0 cfs to avoid exceeding the combined capacity of the four filtration units. Flows exceeding capacity were directed through the bypass.

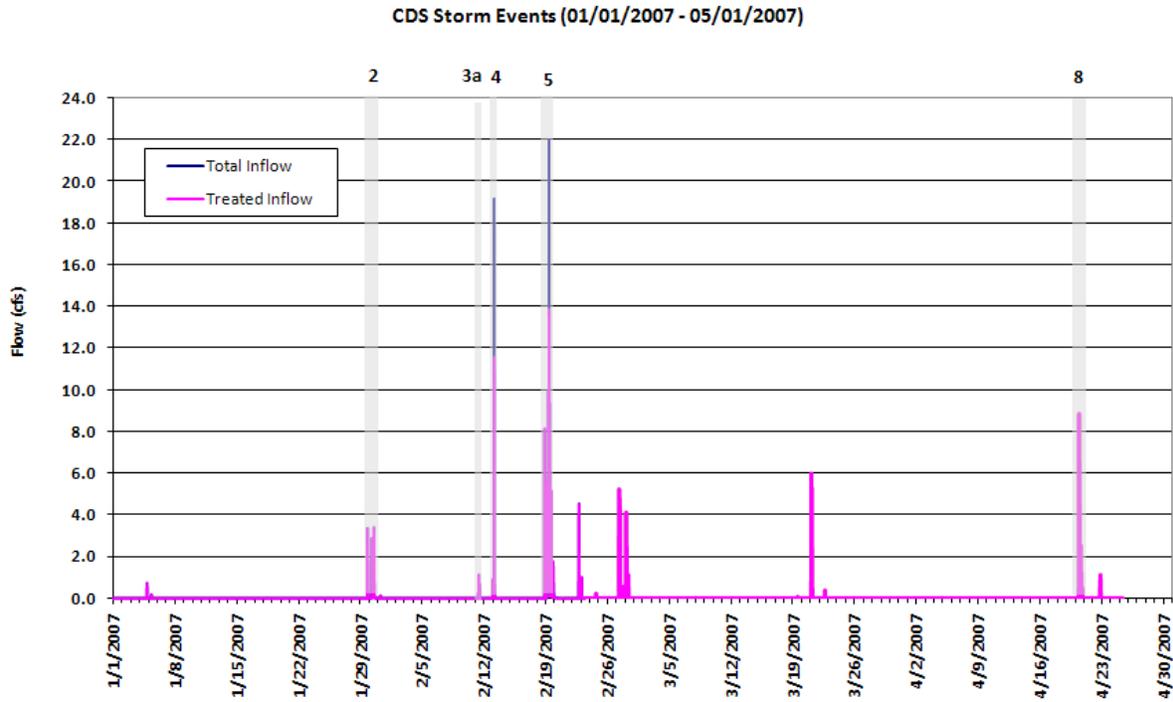
Figure 48. Total and Treated Flow through the CDS unit, January through May 2007.

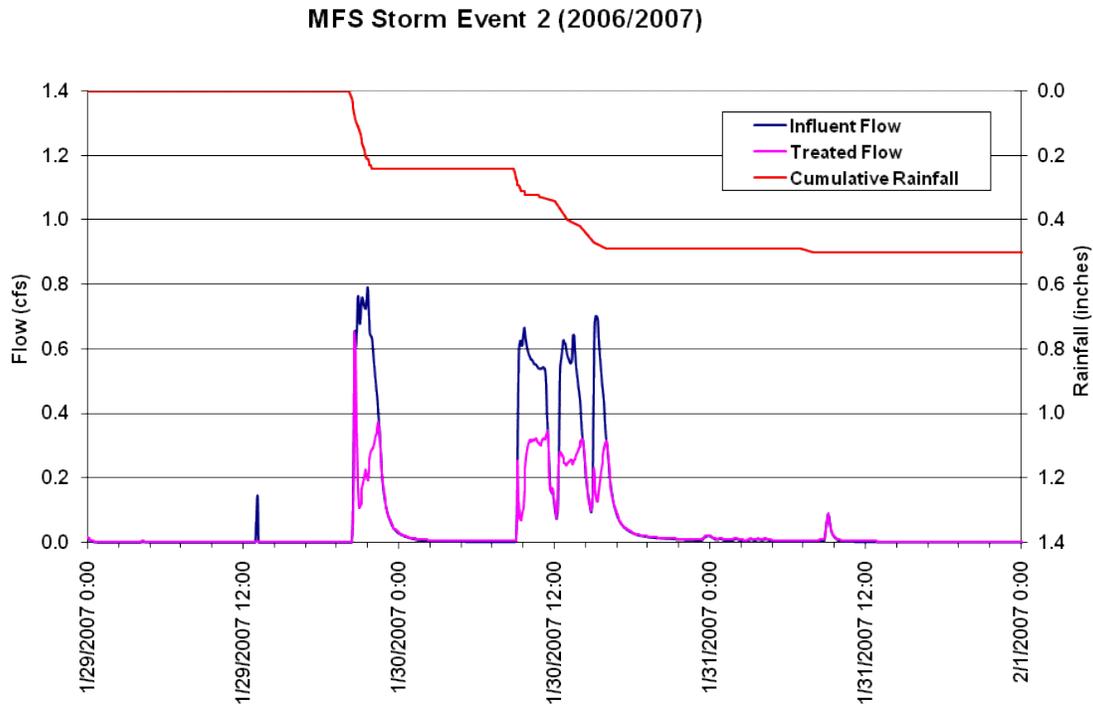
Figure 50. Cumulative Rainfall and Flow Response at Phase I MFS2 Unit during the 1/29-30/07 Storm Event.

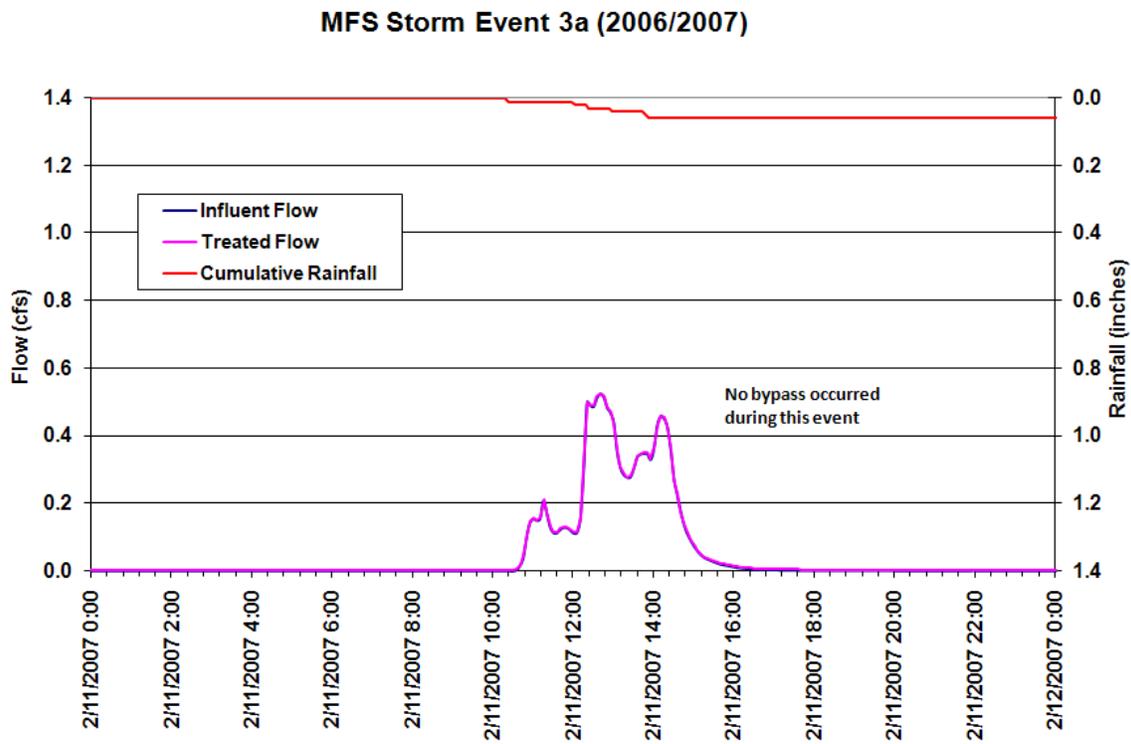
Figure 51. Cumulative Rainfall and Flow Response at Phase I MFS2 Unit during the 2/11/07 Storm Event.

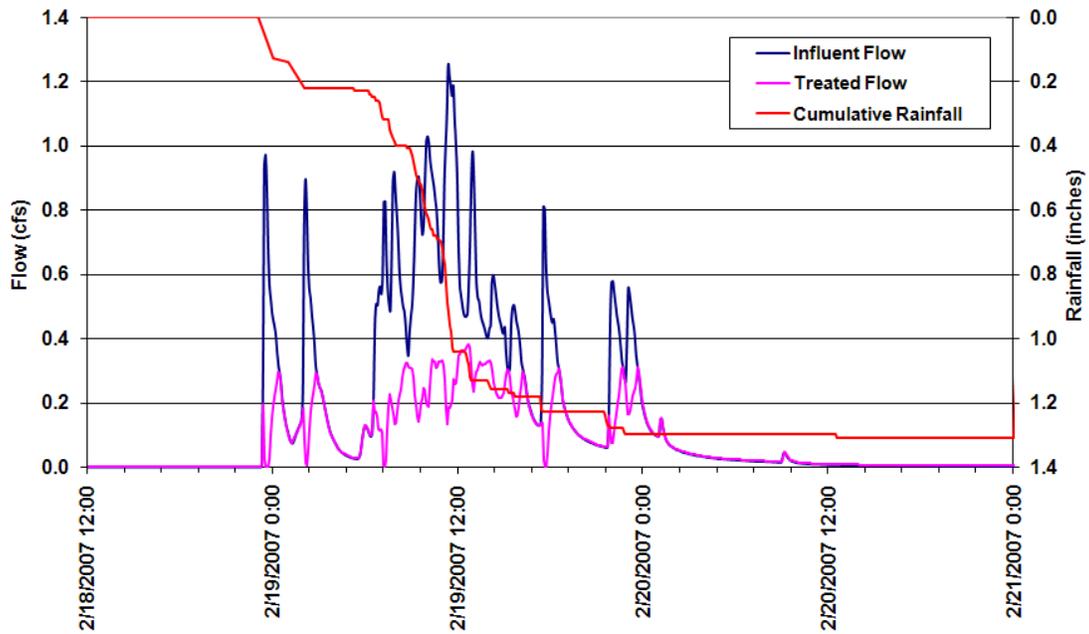
Figure 52. Cumulative Rainfall and Flow Response at Phase I MFS2 Unit during the 2/19-20/07 Storm Event.

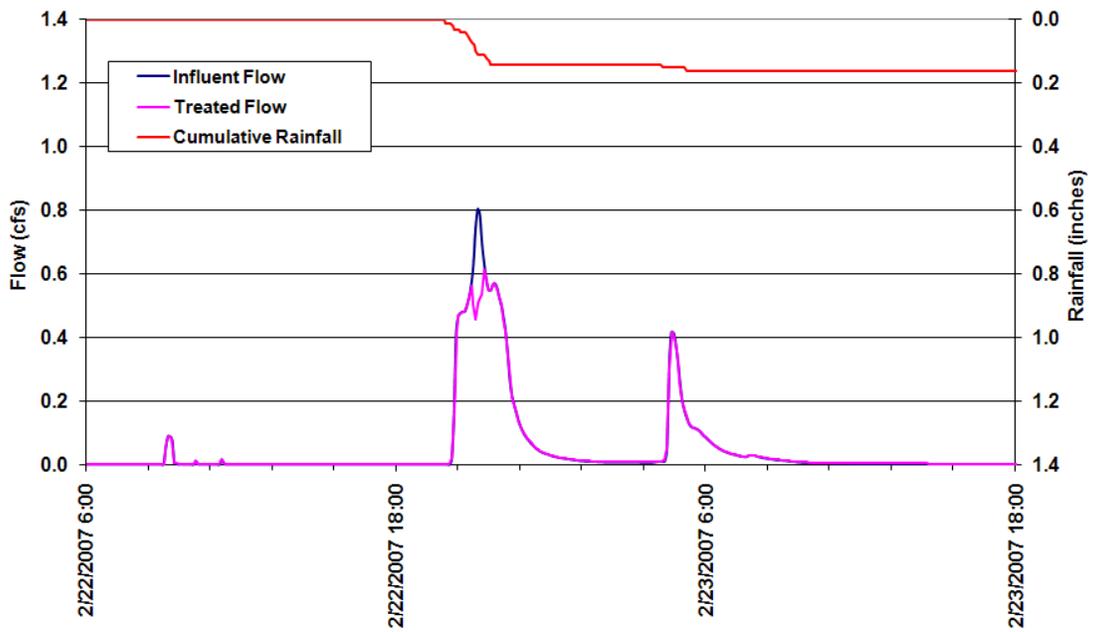
Figure 53. Cumulative Rainfall and Flow Response at Phase I MFS2 Unit during the 2/22-23/07 Storm Event.

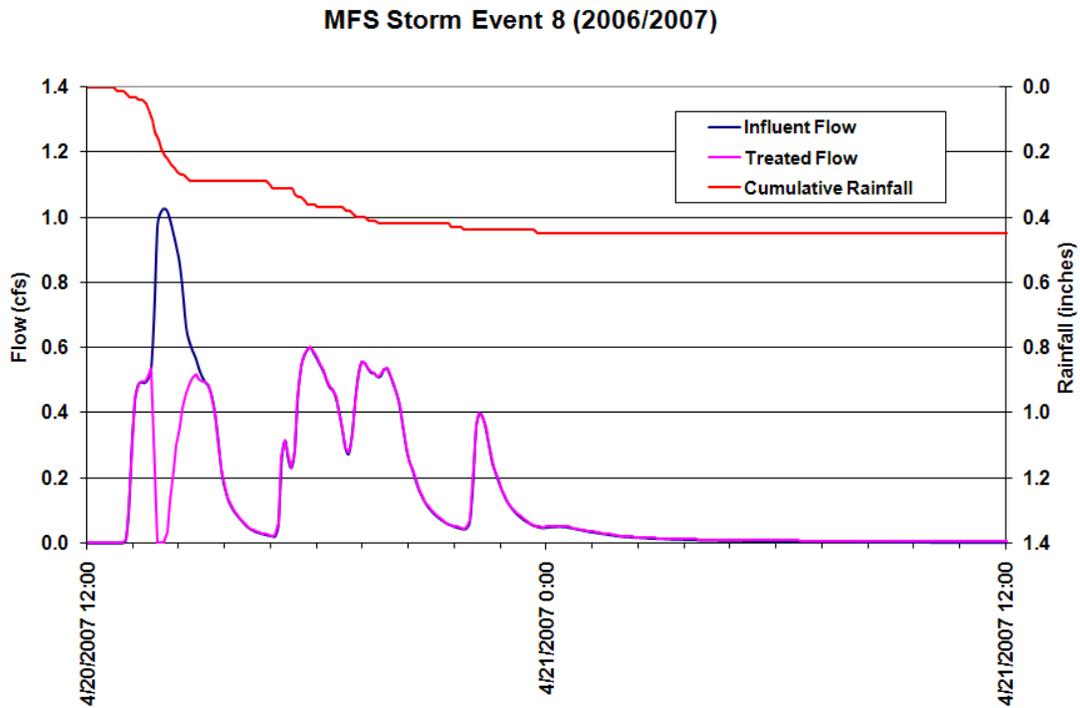
Figure 54. Cumulative Rainfall and Flow Response at Phase I MFS2 Unit during the 4/21/07 Storm Event.

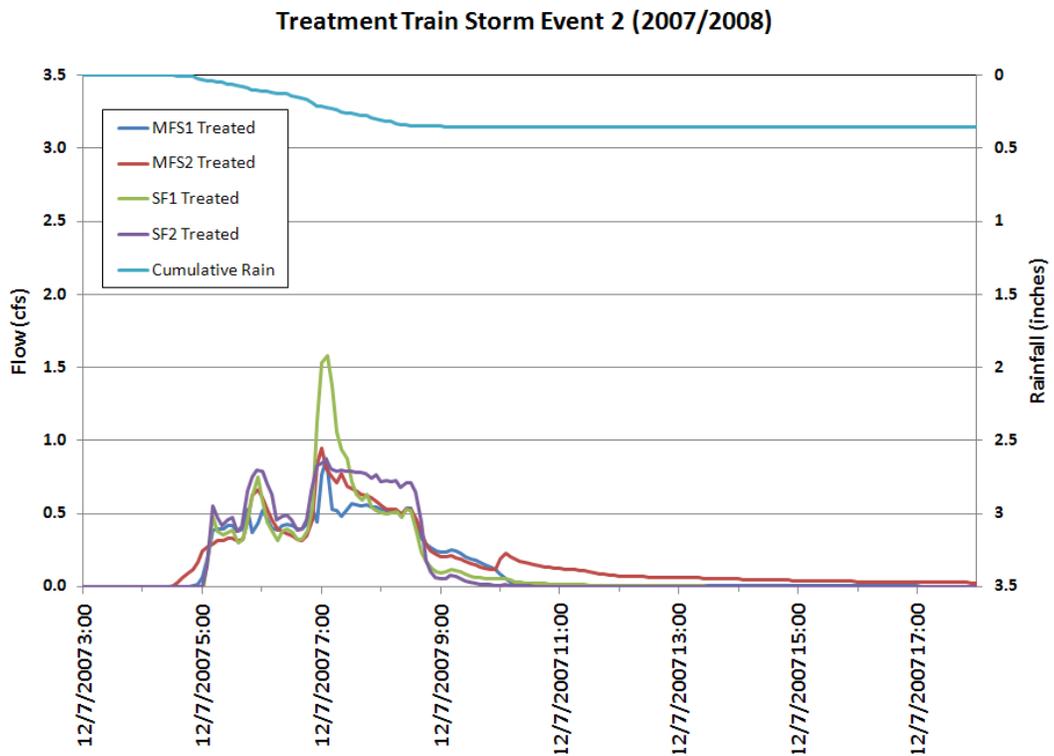
Figure 55. Cumulative Rainfall and Flow Response through the Four Filtration Systems during the 12/7/2007 Storm Event.

In the Phase II treatment train configuration (Figure 55 through Figure 57; Appendix B) all filtration units were rated at a maximum of 1.5 cfs per unit. During the more intense rain events, flows through the MFS1, MFS2 and SF1 units well exceeded the design capacity. Peak flows through MFS1 reached over 3 cfs during the final storm event. MFS2 flows also peaked over 3 cfs but this was not unexpected with disconnected cartridges. Flow through the SF1 unit reached a maximum of 2.0 cfs. The SF2 unit with CSF media was the only system that never exceeded the design capacity. This was reflected in the overall lower flows through this unit (Table 17).

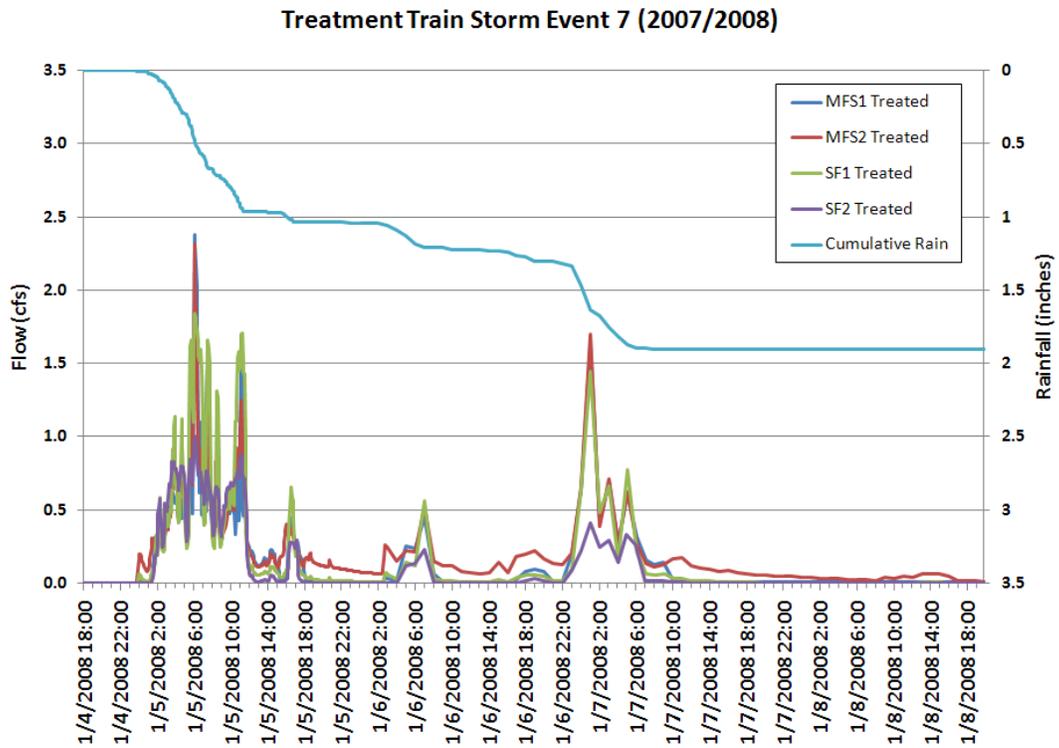
Figure 56. Cumulative Rainfall and Flow Response through the Four Filtration Systems during the 1/4-7/2007 Storm Event.

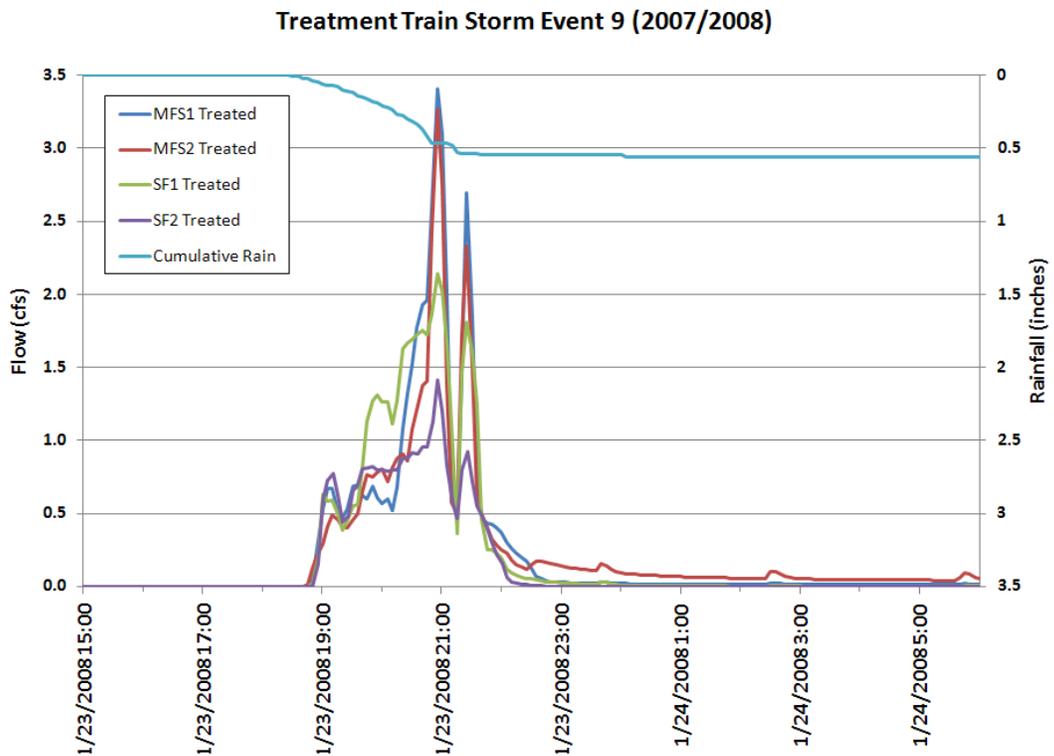
Figure 57. Cumulative Rainfall and Flow Response through the Four Filtration Systems during the 1/23-24/2008 Storm Event.

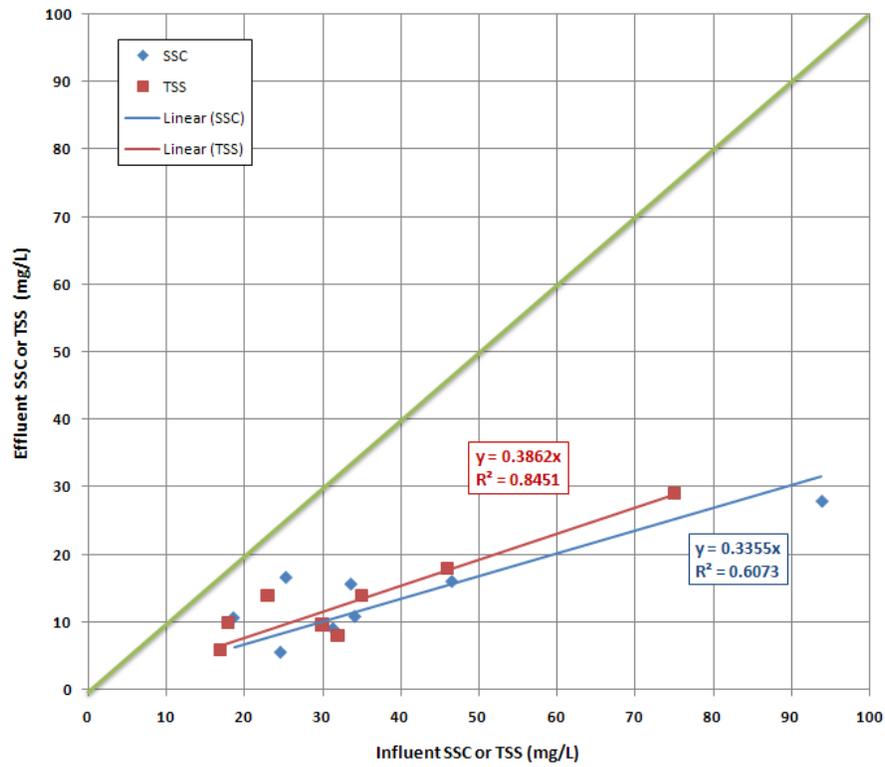
Figure 58. Efficiency of Phase I MFS Configuration in Treatment of Suspended Sediment.

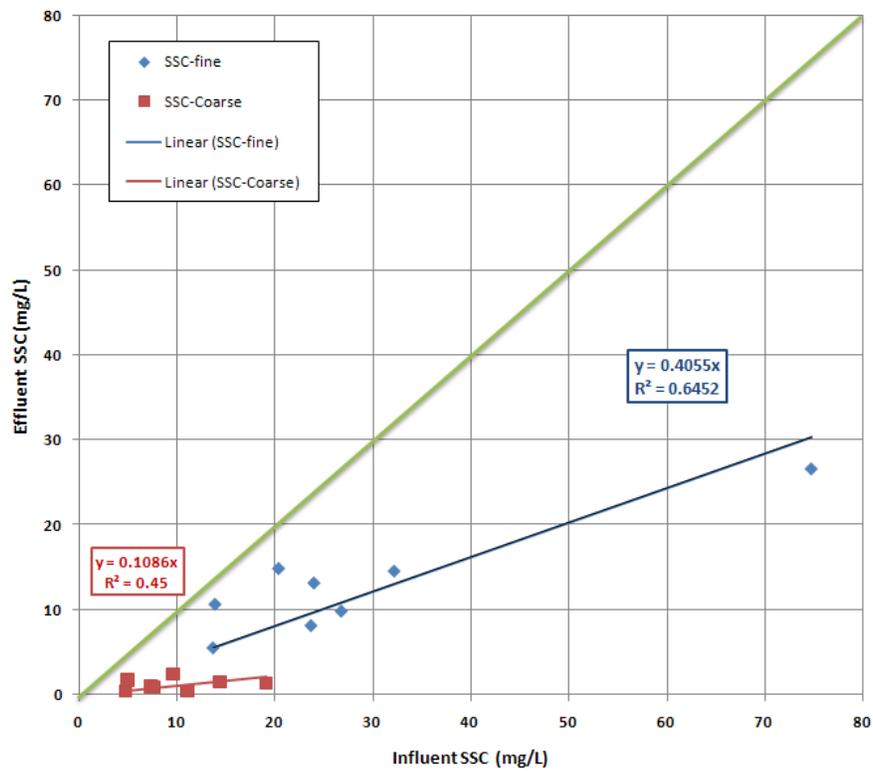
Figure 59. Efficiency of Phase I MFS Configuration in Treatment of Fine and Coarse Suspended Sediment Concentrations (SSC).

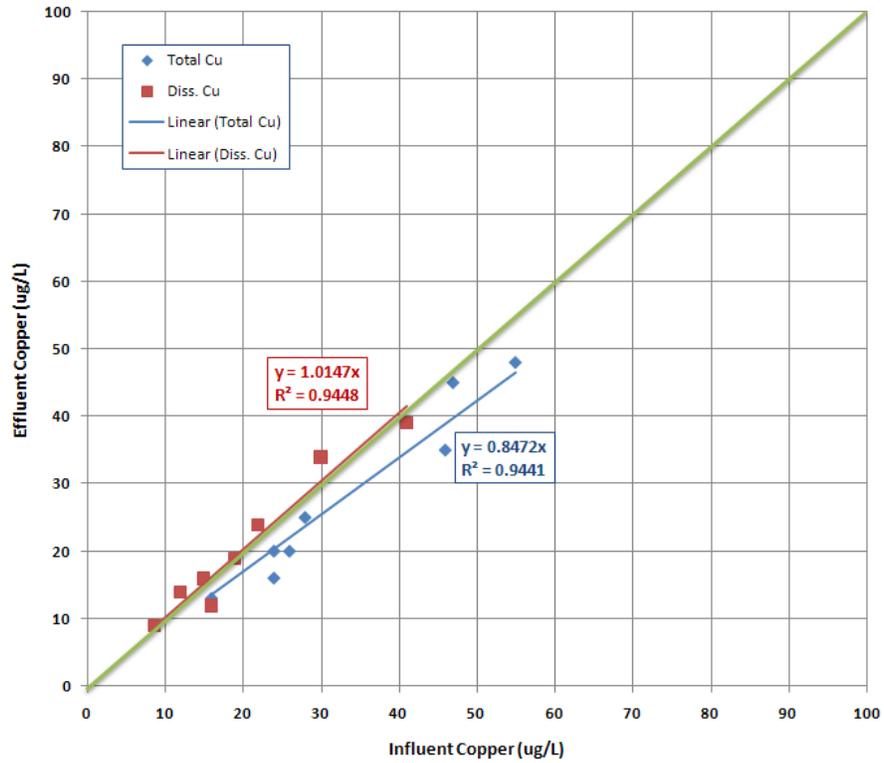
Figure 62. Efficiency of Phase I MFS Configuration in Treatment of Total and Dissolved Copper.
