COUNTY OF SAN DIEGO MODEL MUNICIPAL OPERATIONS CENTER

Final Report *Phase II Porous Paving and Treatment Train* *Water Quality Monitoring Program*

KINNETIC
LABORATORIES
INCORPORATED

SEPTEMBER 2008

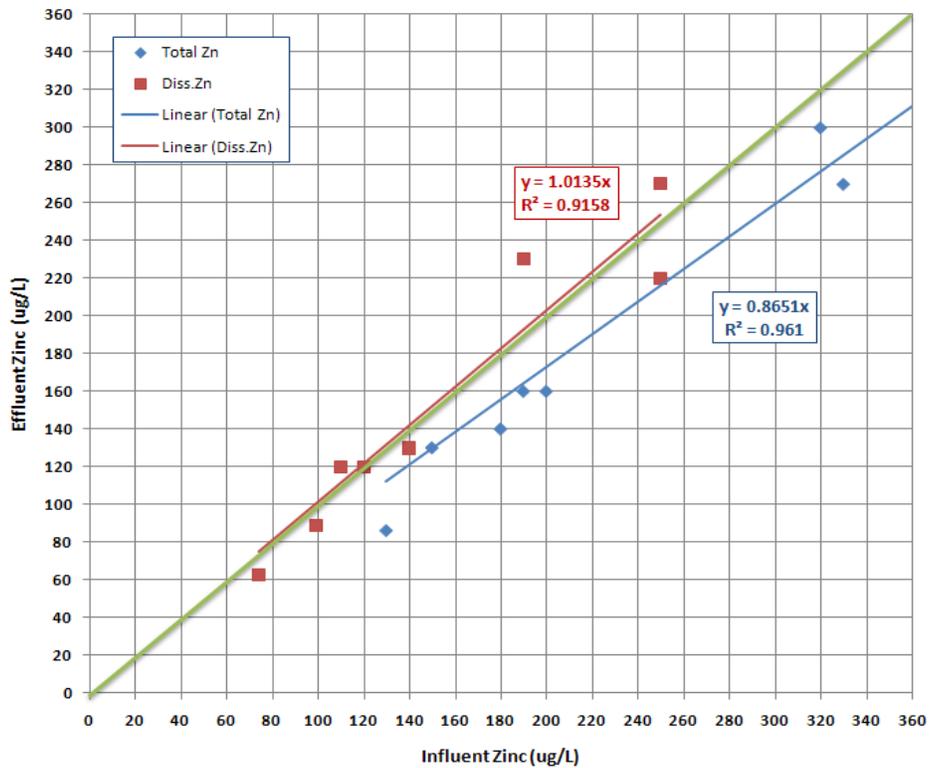
Figure 63. Efficiency of Phase I MFS2 Configuration in Treatment of Total and Dissolved Zinc.

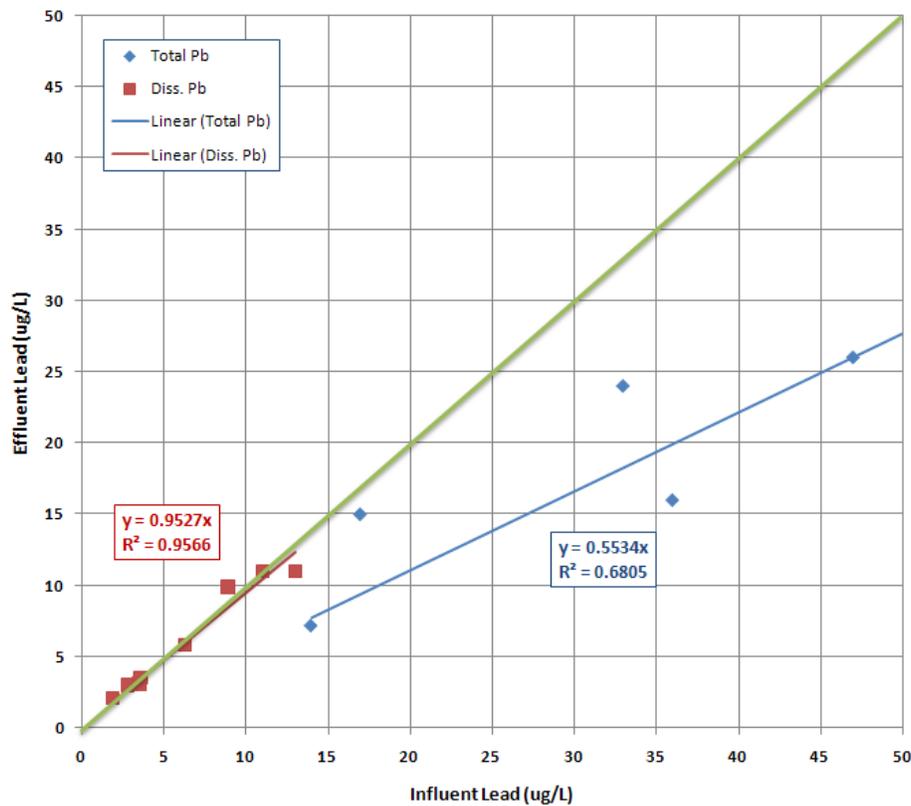
Figure 64. Efficiency of Phase I MFS2 Configuration in Treatment of Total and Dissolved Lead.

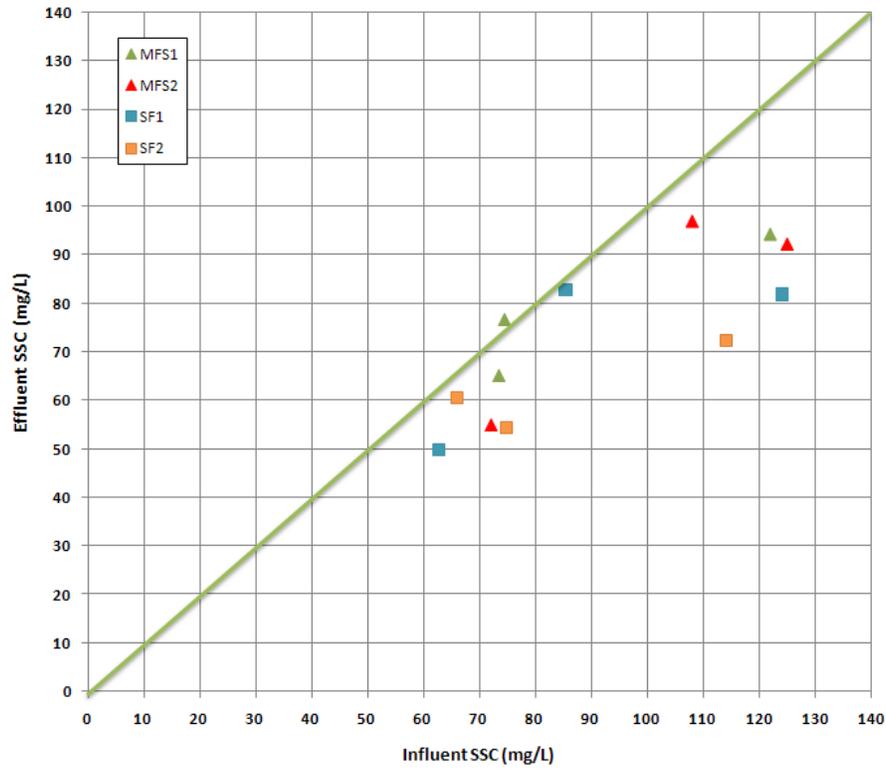
Figure 65. Efficiency of Phase II Filtration BMP in the Treatment of Suspended Solids Concentrations (SSC).

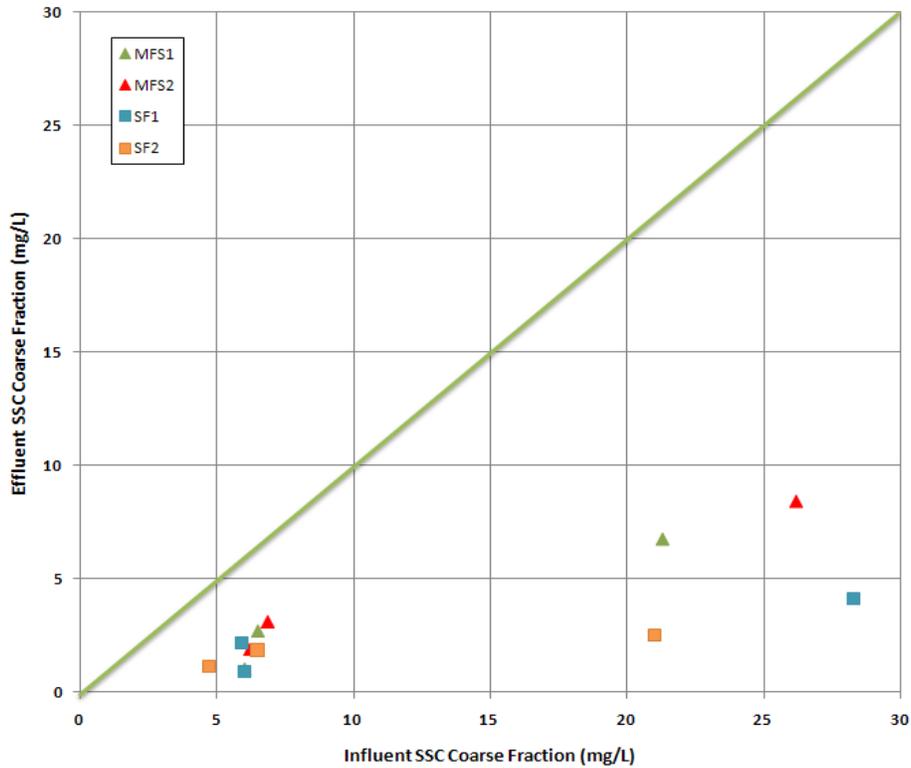
Figure 66. Efficiency of Phase II Filtration BMP in the Treatment of the Coarse Fraction of Suspended Solids Concentrations (SSC-Coarse).

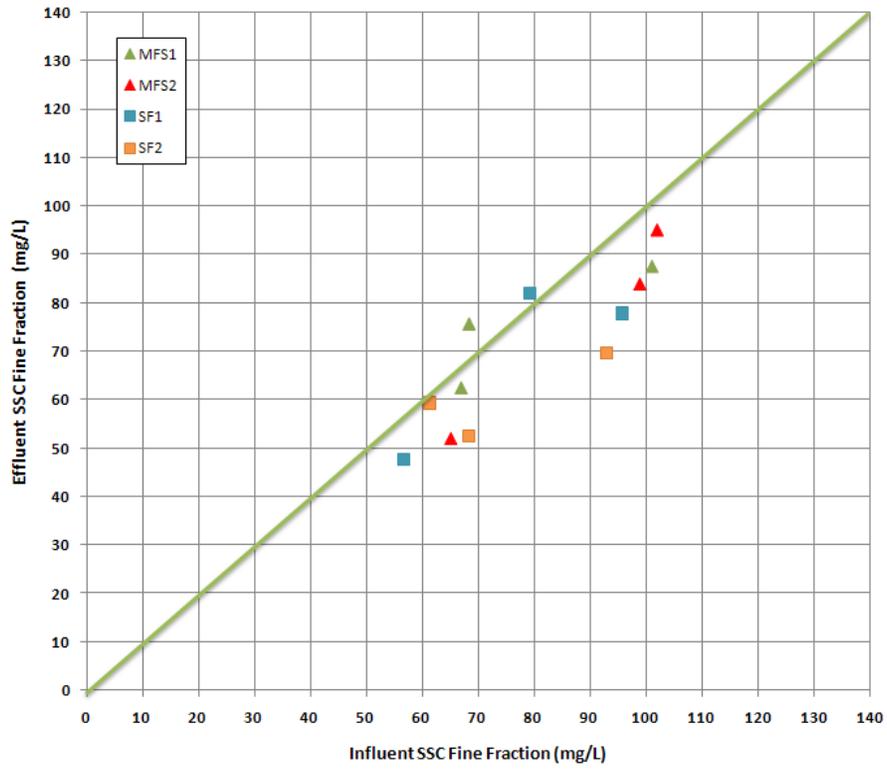
Figure 67. Efficiency of Phase II Filtration BMP in the Treatment of the Fine Fraction of Suspended Solids Concentrations (SSC-Fine).

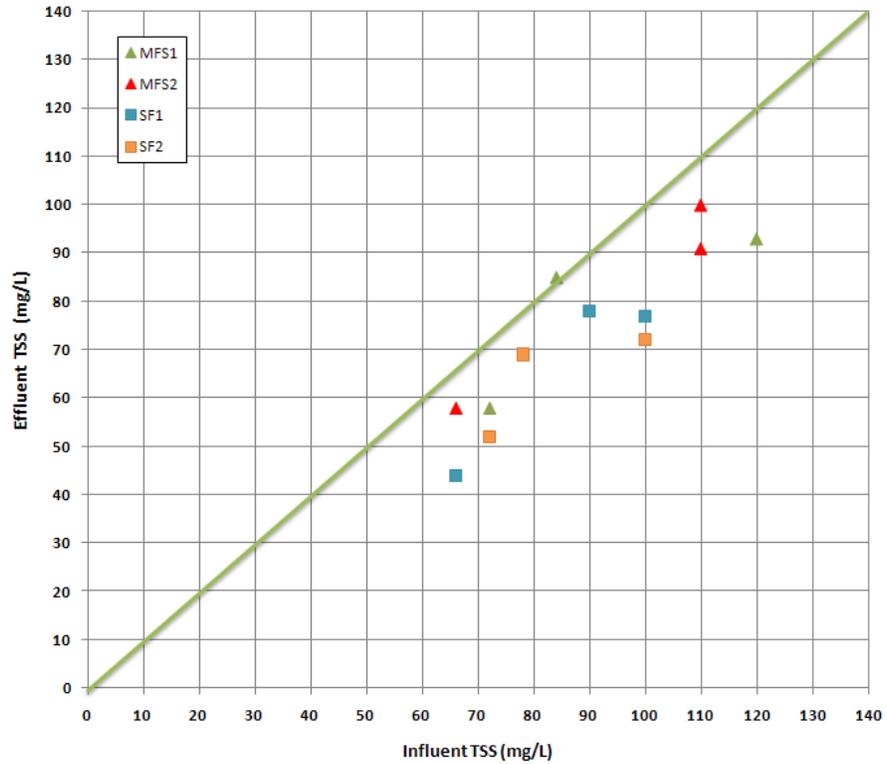
Figure 68. Efficiency of Phase II Filtration BMP in the Treatment of Total Suspended Solids (TSS).

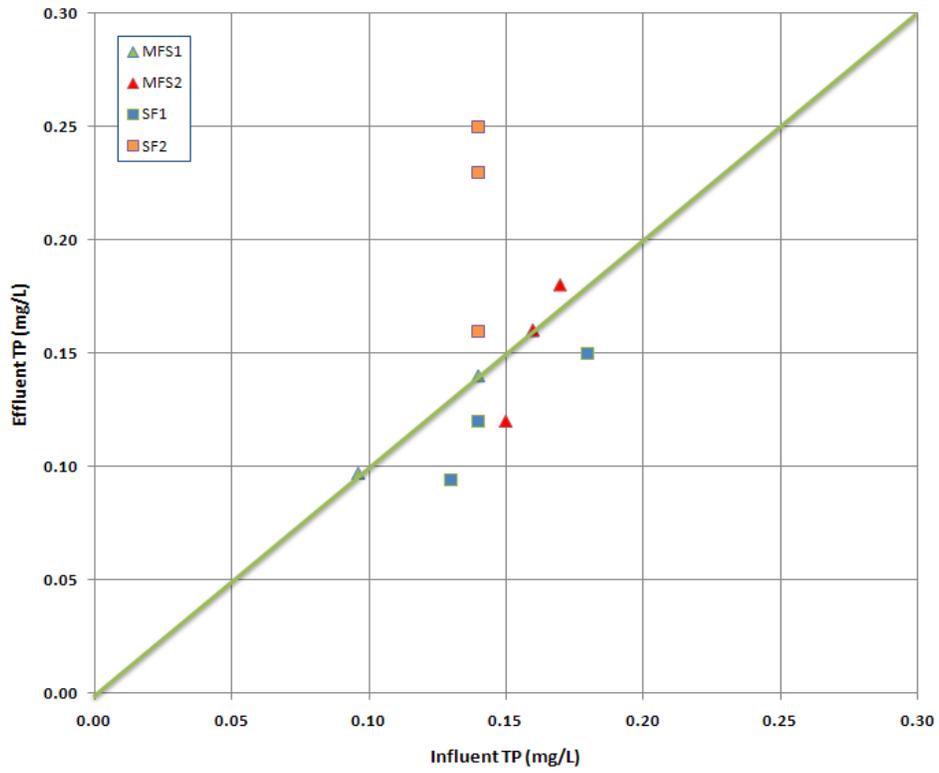
Figure 69. Efficiency of Phase II Filtration BMP in the Treatment of Total Phosphorous (TP).

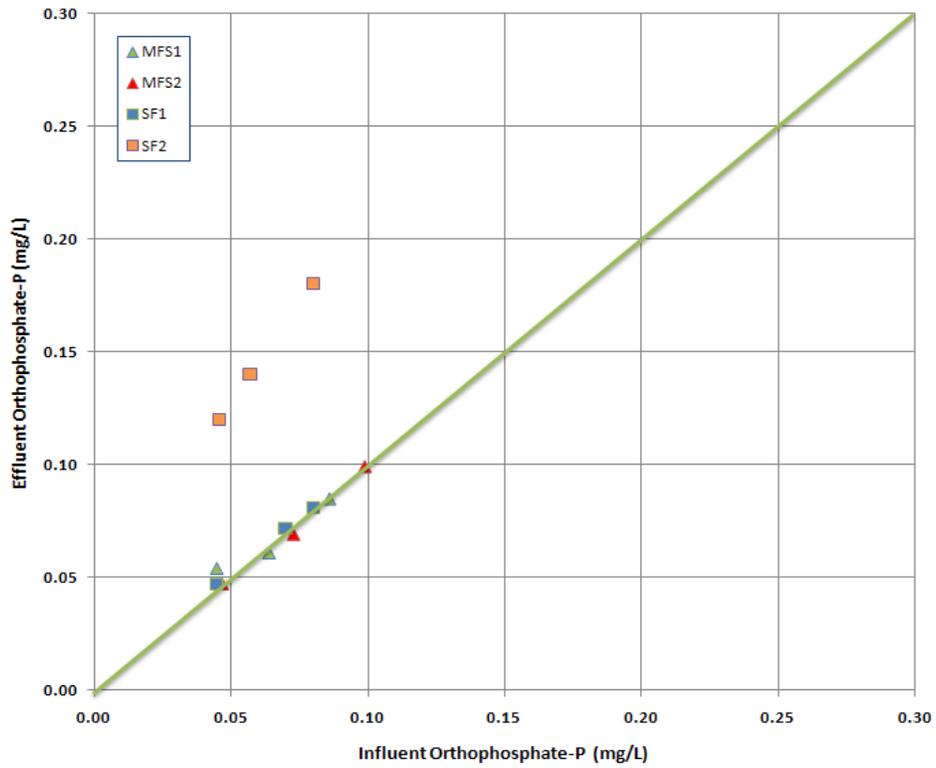
Figure 70. Efficiency of Phase II Filtration BMP in the Treatment of Orthophosphate-P (Ortho-P).

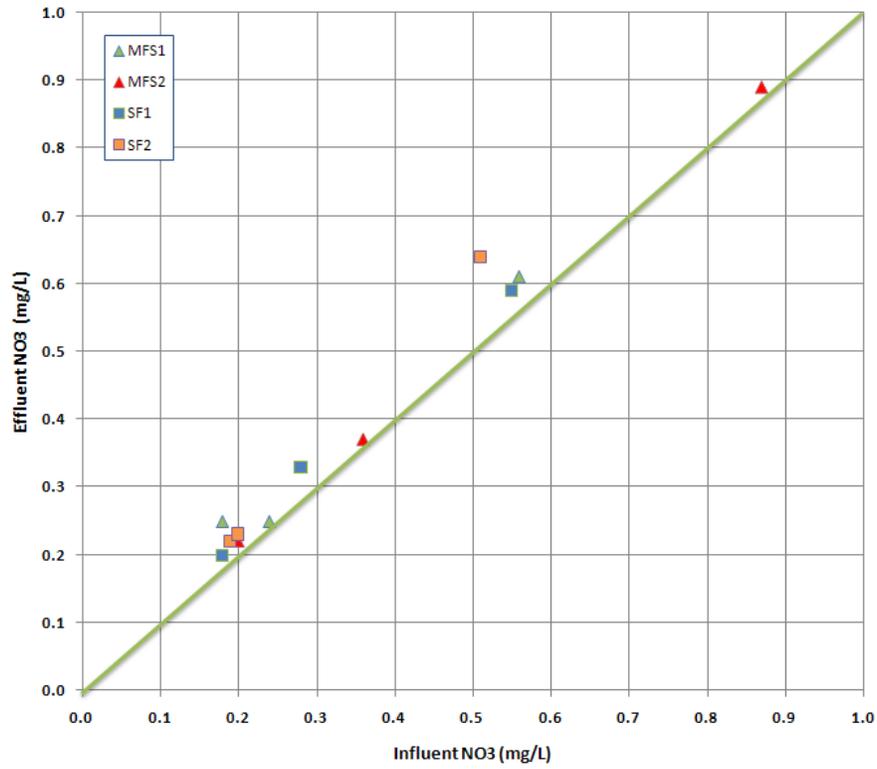
Figure 73. Efficiency of Phase II Filtration BMP in the Treatment of Nitrate-Nitrogen (NO₃-N)

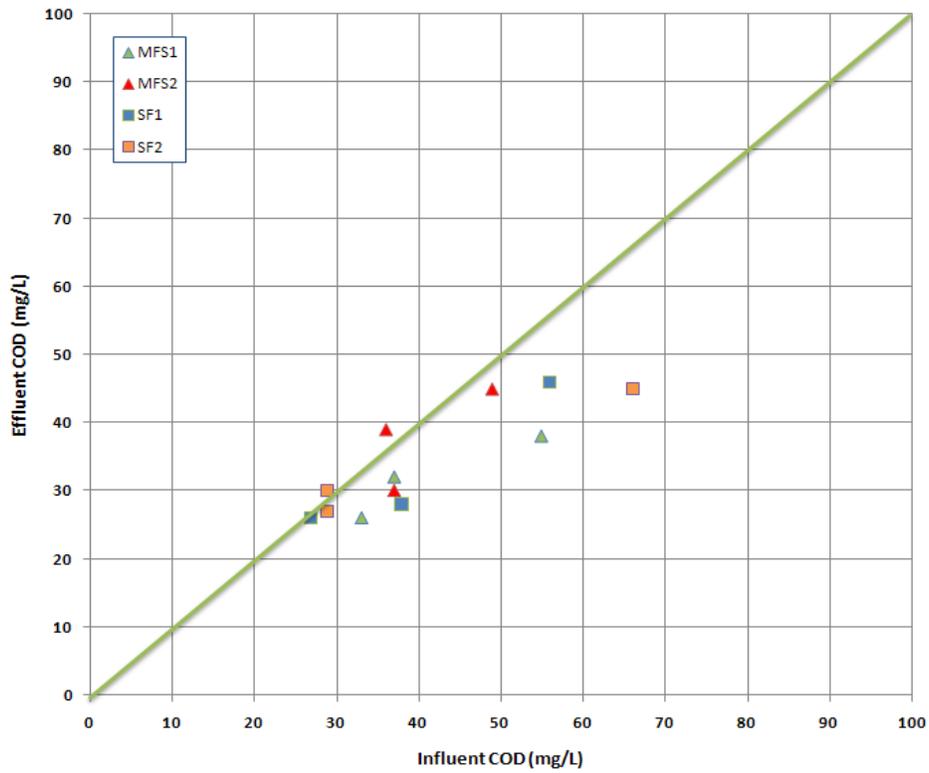
Figure 74. Efficiency of Phase II Filtration BMP in the Treatment of Chemical Oxygen Demand (COD)

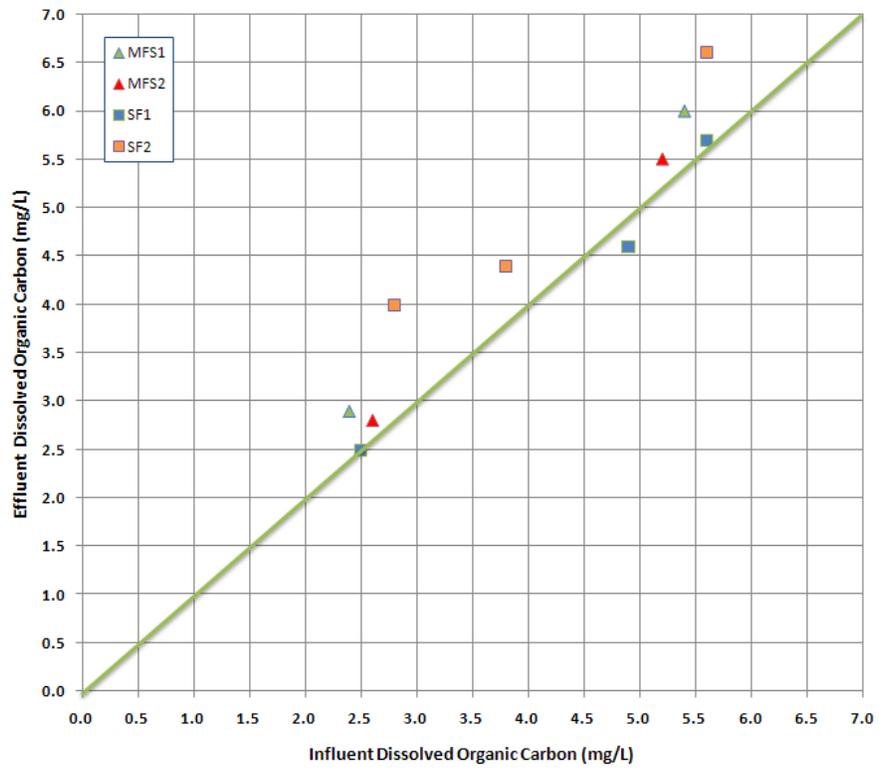
Figure 75. Efficiency of Phase II Filtration BMP in the Treatment of Dissolved Organic Carbon (DOC).

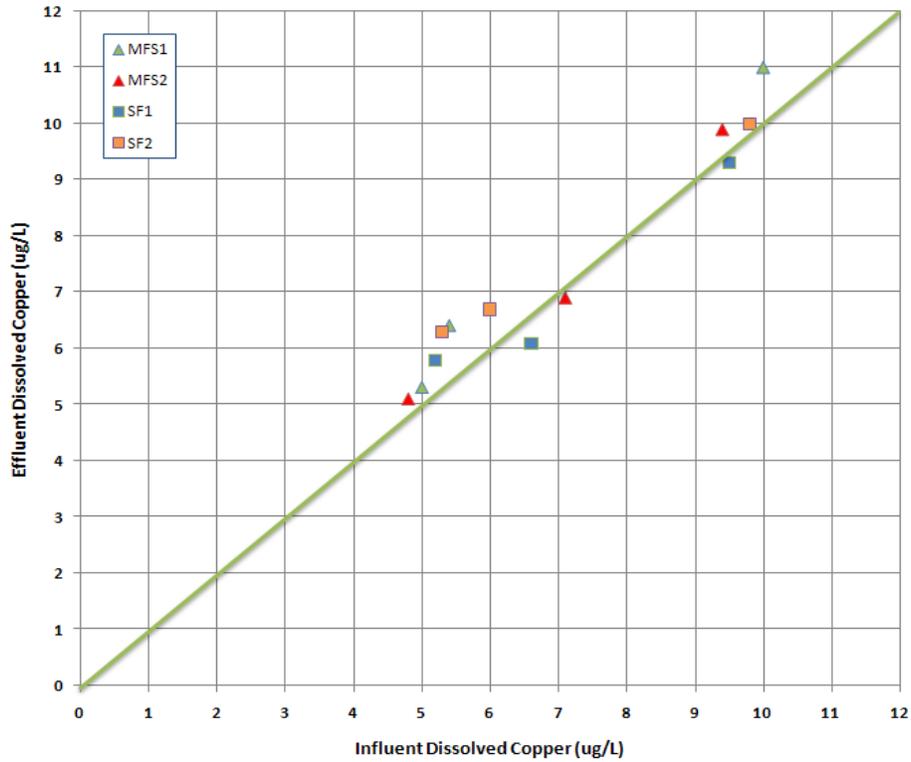
Figure 77. Efficiency of Phase II Filtration BMP in the Treatment of Dissolved Copper.

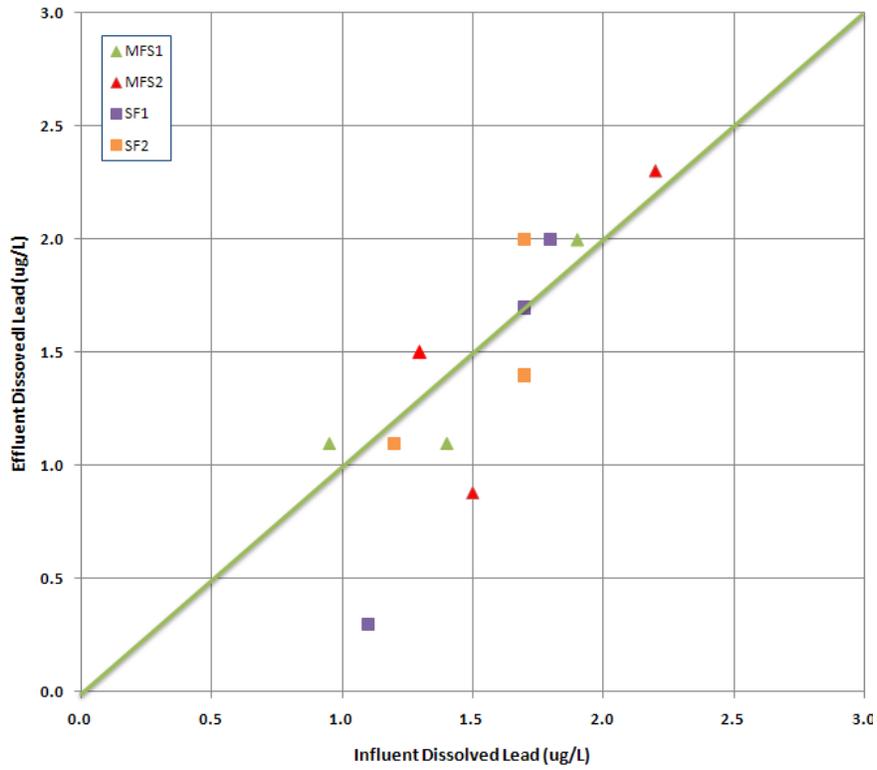
Figure 79. Efficiency of Phase II Filtration BMP in the Treatment of Dissolved Lead.

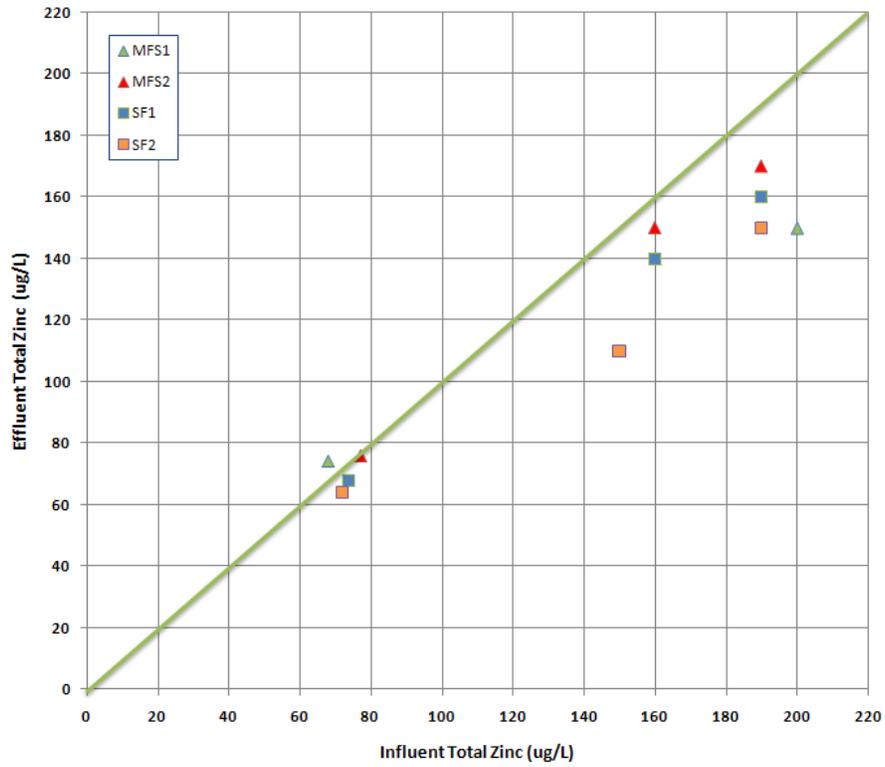
Figure 80. Efficiency of Phase II Filtration BMP in the Treatment of Total Zinc.

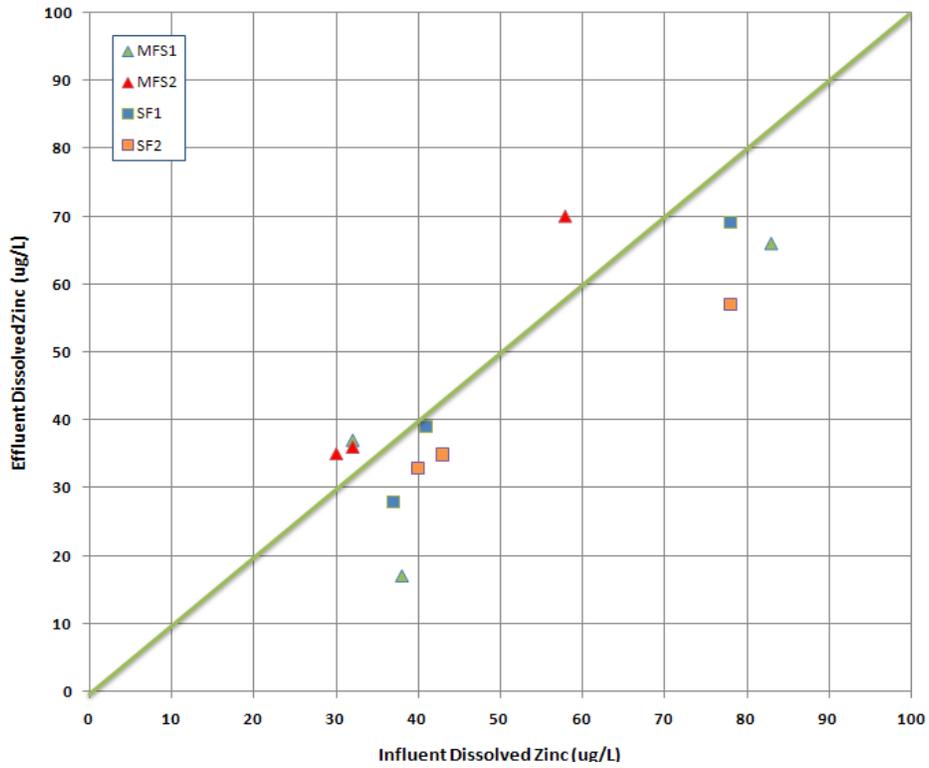
Figure 81. Efficiency of Phase II Filtration BMP in the Treatment of Dissolved Zinc.

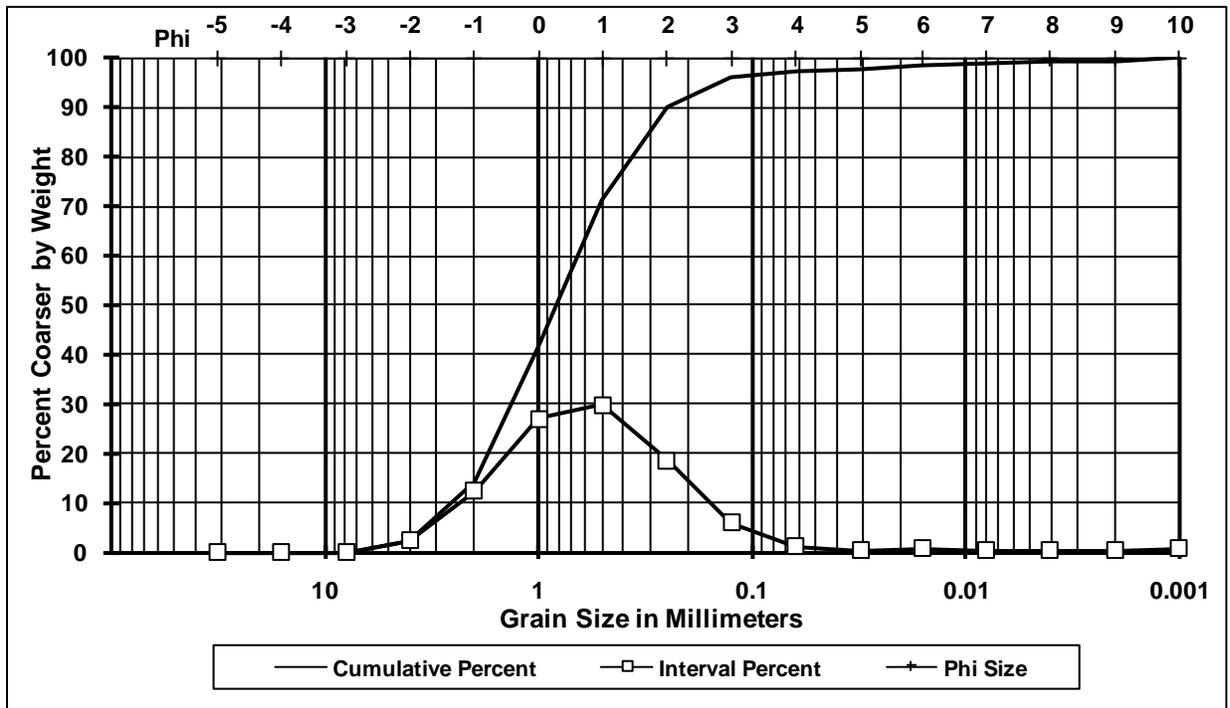
Figure 82. Particle Size Analysis of the Sediment Fraction (<4.75 mm) of Gross Pollutants collected from the CDS Sump - 2006.

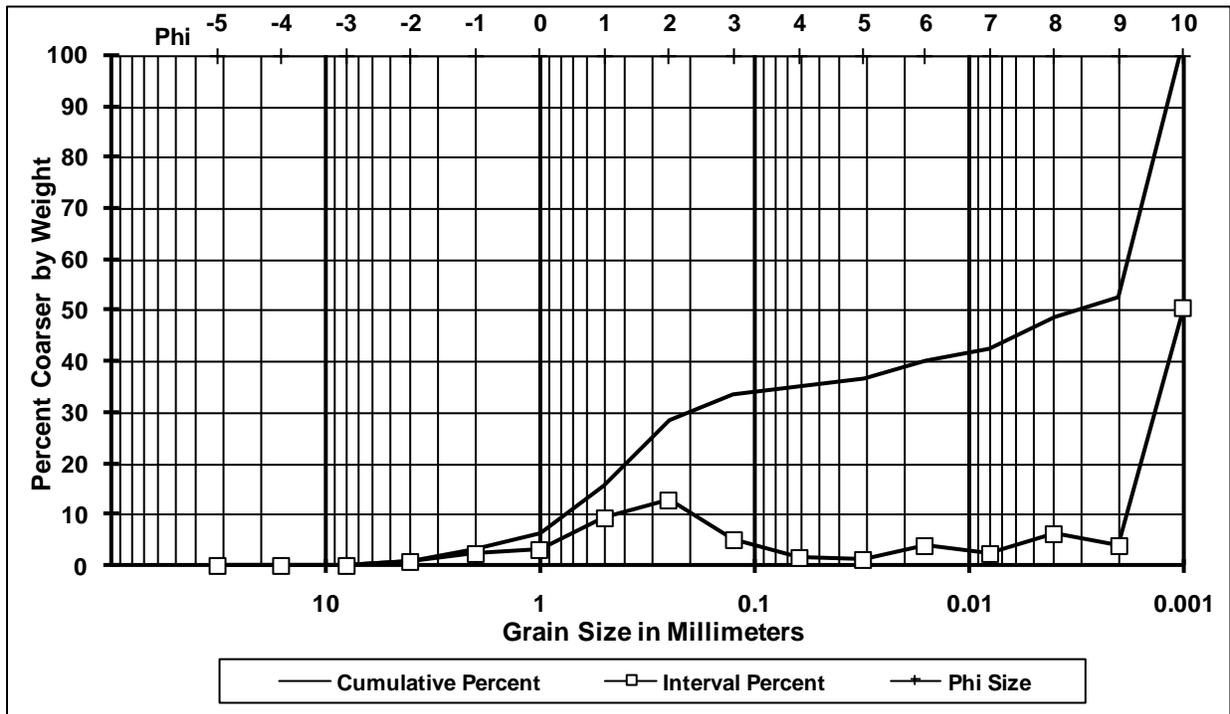
Figure 83. Particle Size Analysis of the Sediment Fraction (<4.75 mm) of Gross Pollutants collected from the CDS Sump - 2008.
