## Pine Valley Trailer Park A Tale of Two (fractured rock) Aquifers

Charles E. Houser, CHg  
Project Manager  
SCS Engineers

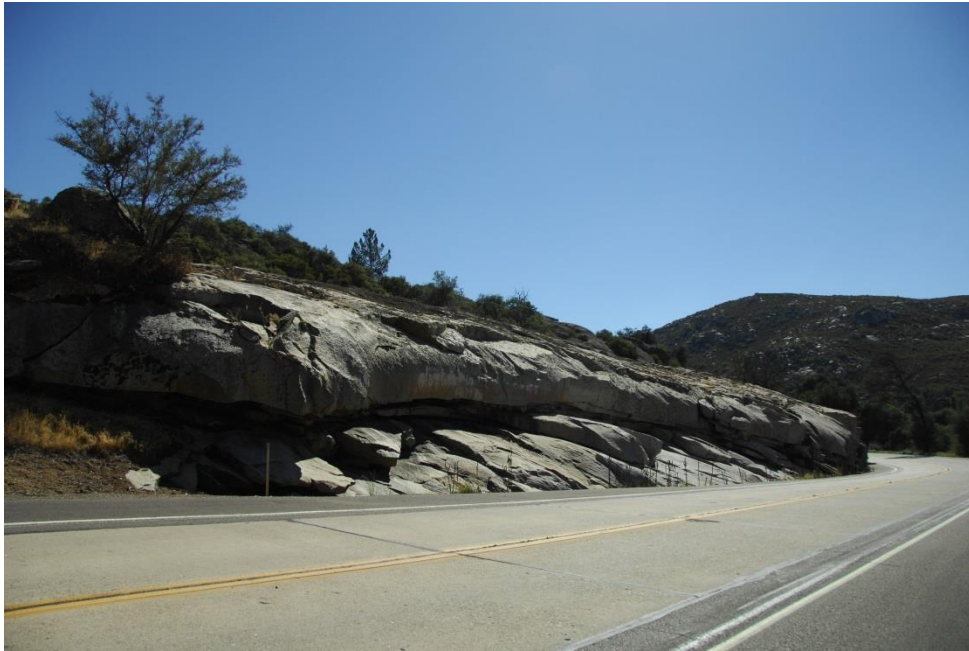
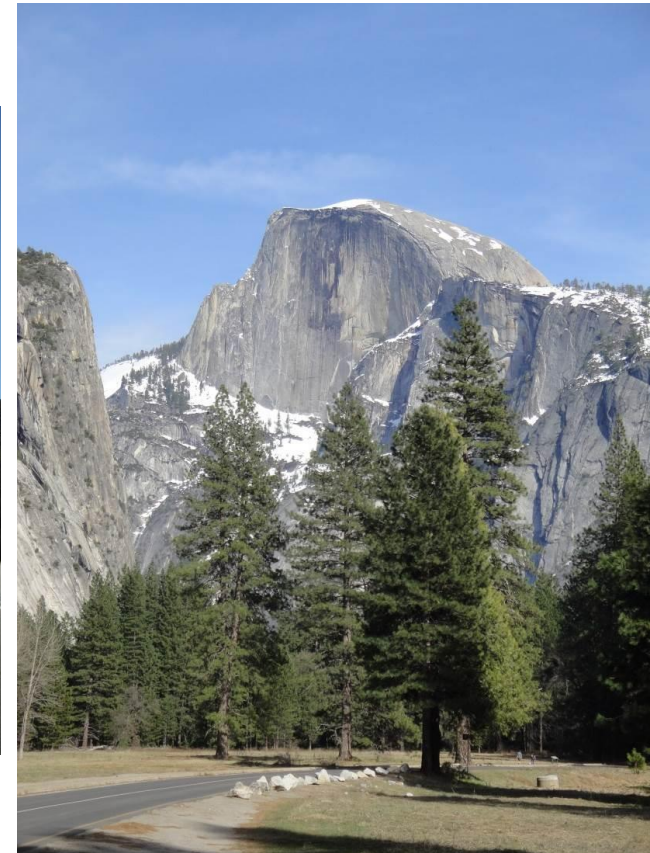
- Residuum to 15 feet
- Fractured granitic rock below that
  - Plutonic emplacement
  - Stress-release

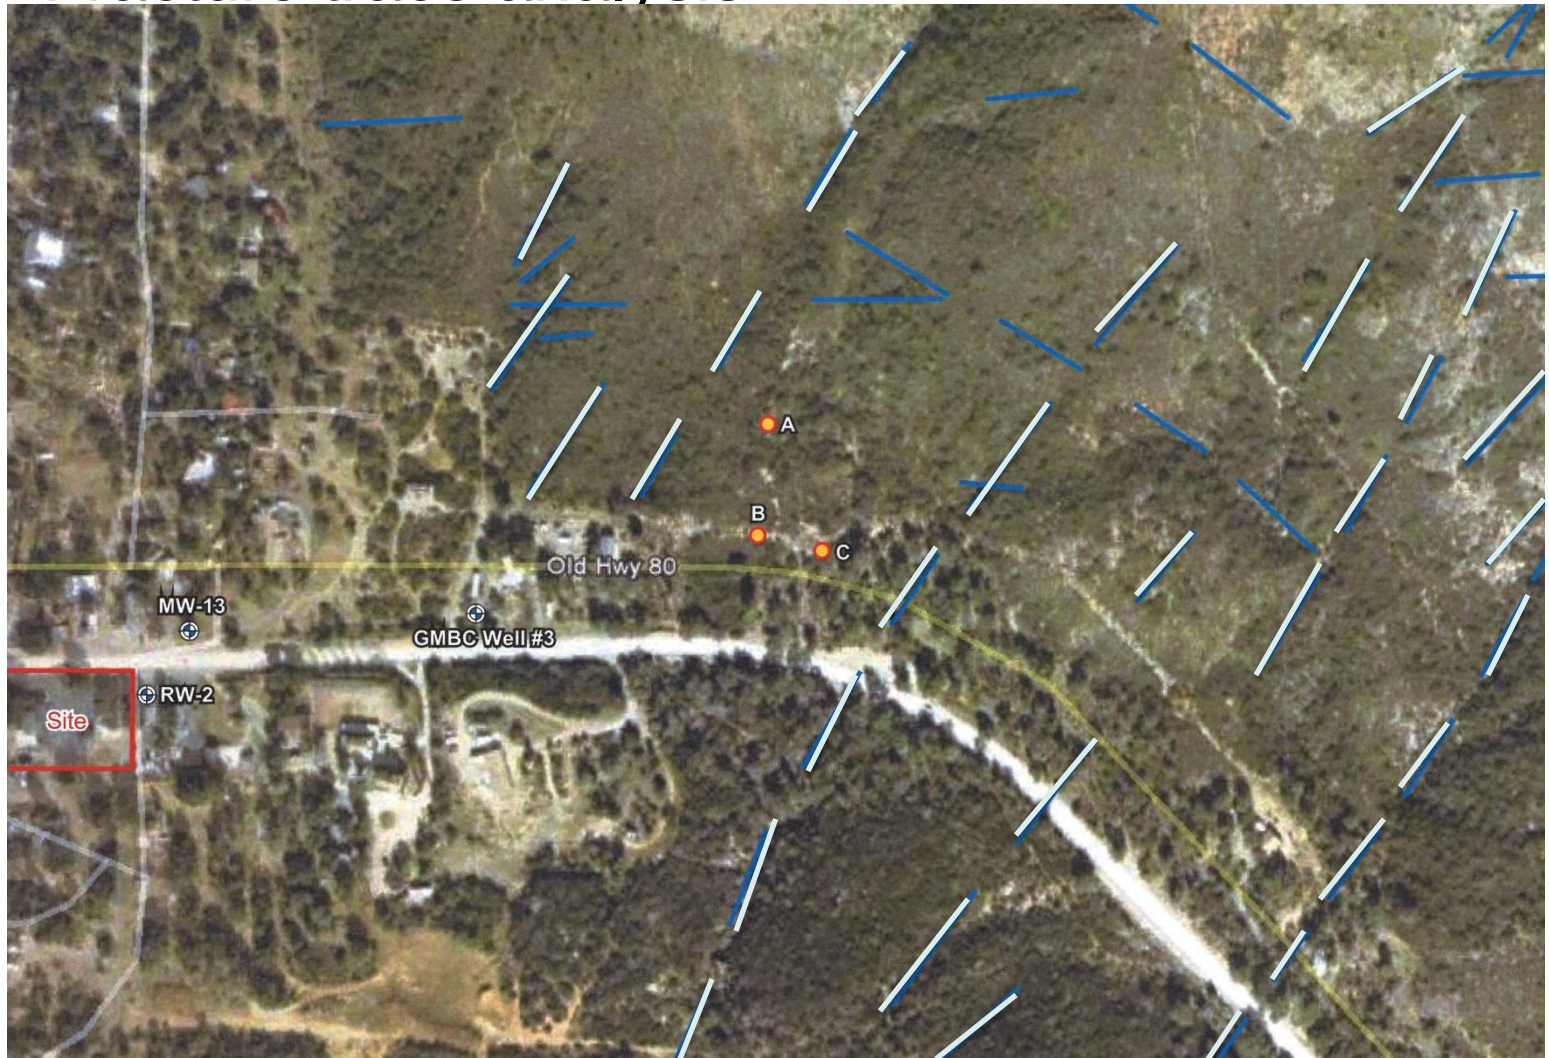
- Fracture trace analysis

- Approximately 650 feet east-northeast of the Site
- Low Toluene (about 15 ug/l)
- ***DEH requested evaluation of connectivity between PVTP and GMBC Well #3***
  - Fracture Trace Analysis

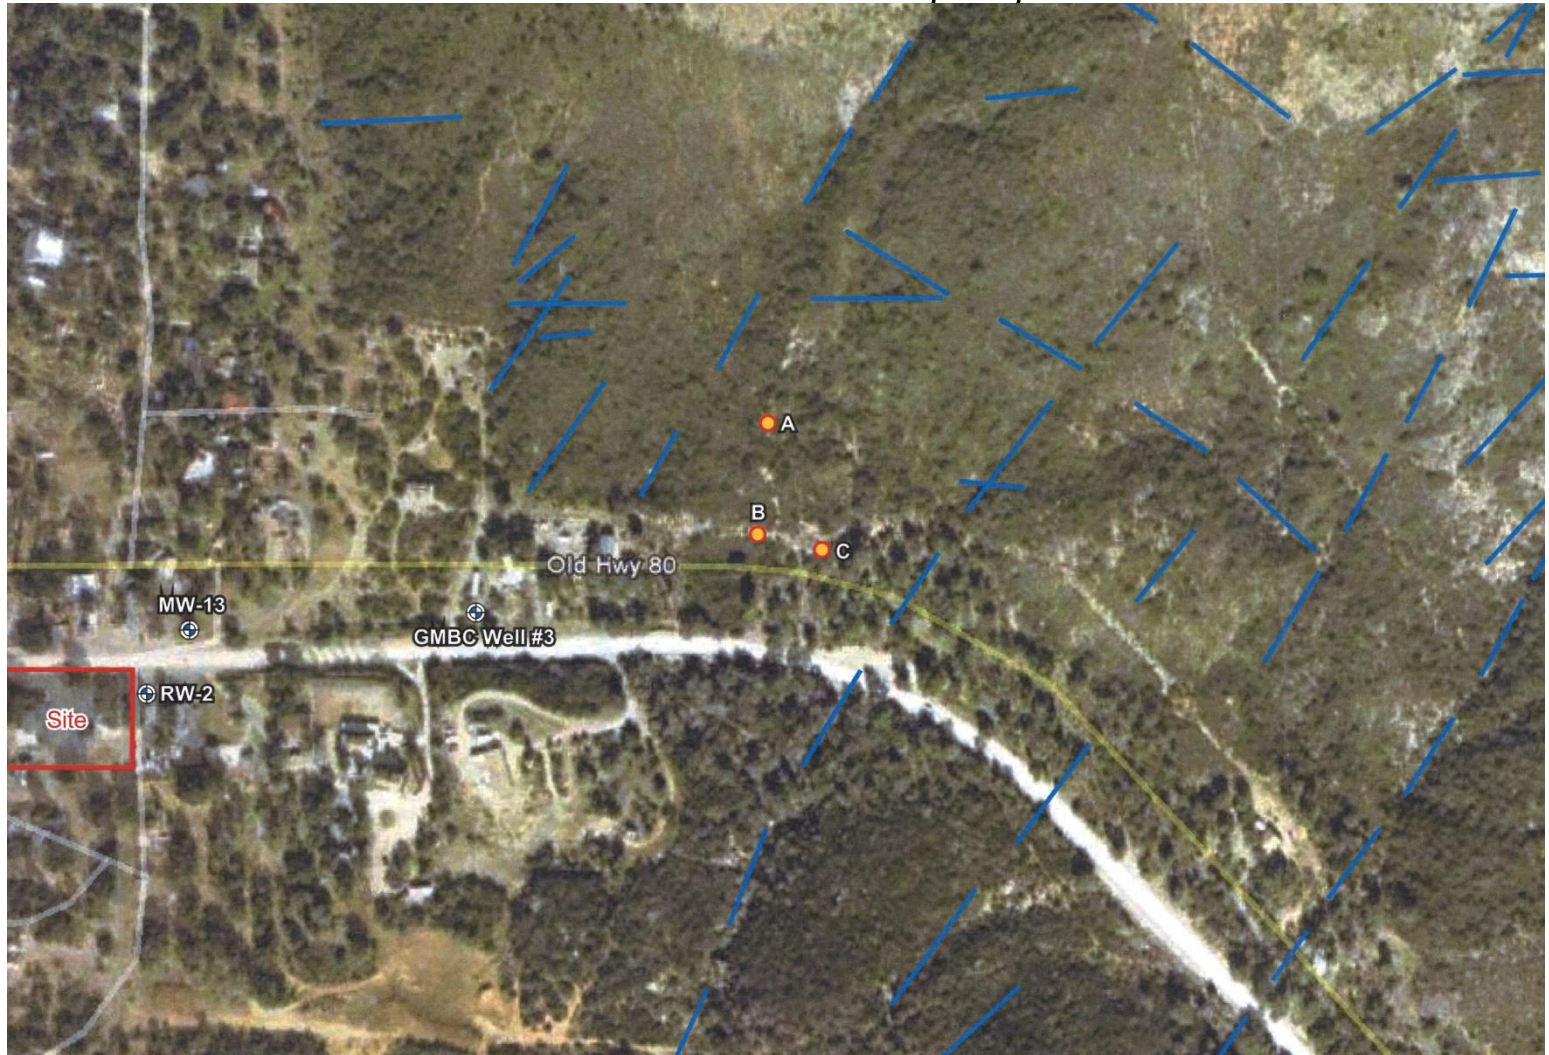
- Fracture measurements at A, B, and C

- Fracture measurements at A, B, and C

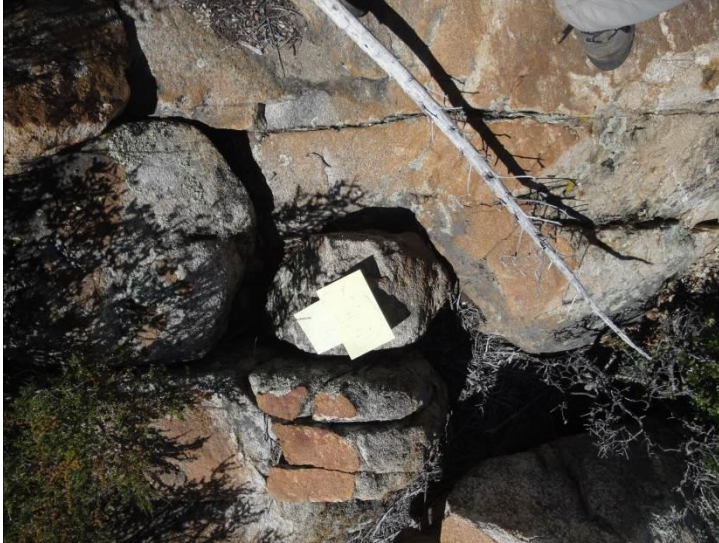
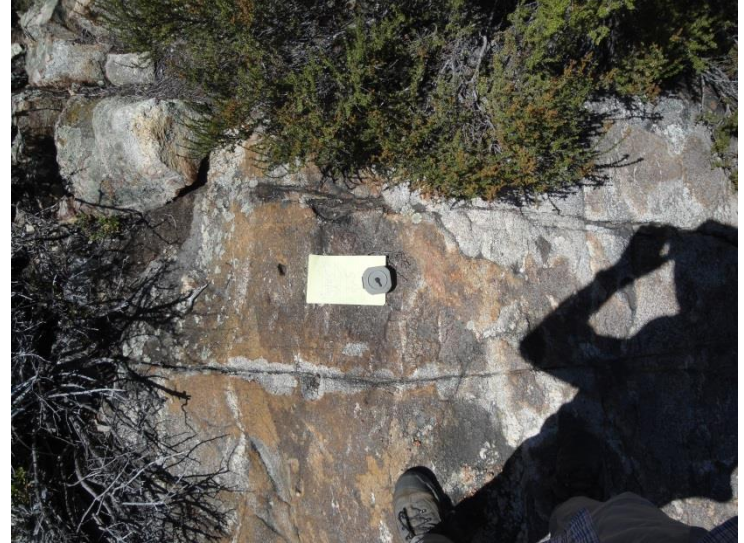
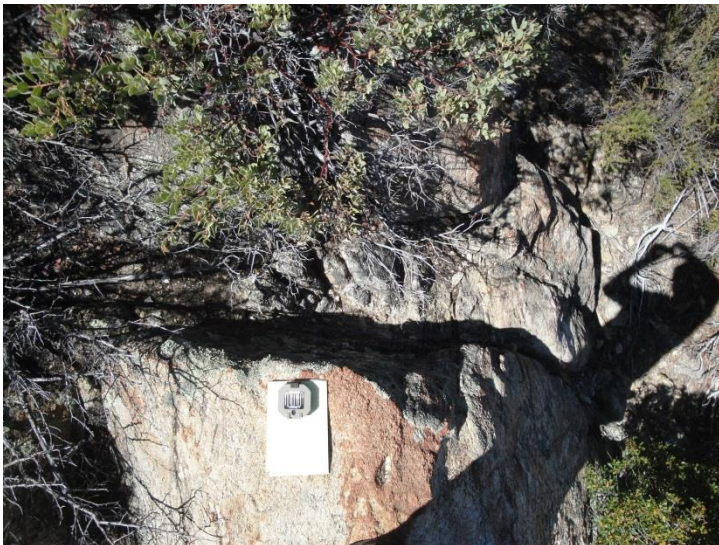
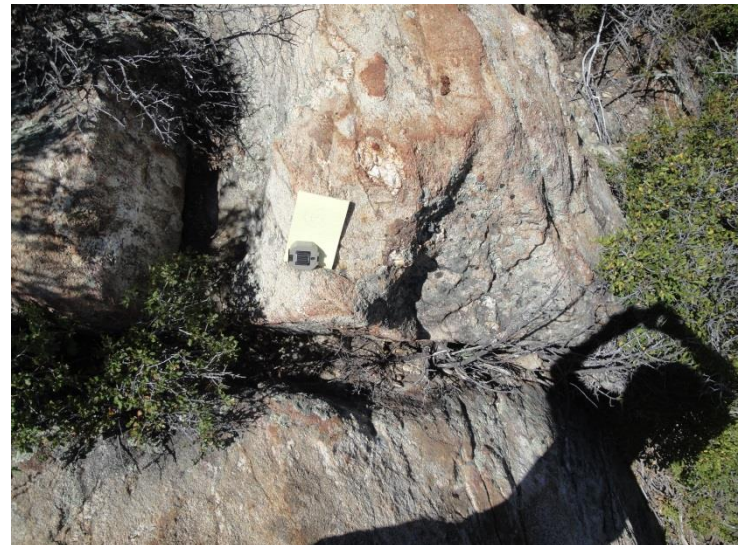
- Field fracture measurements

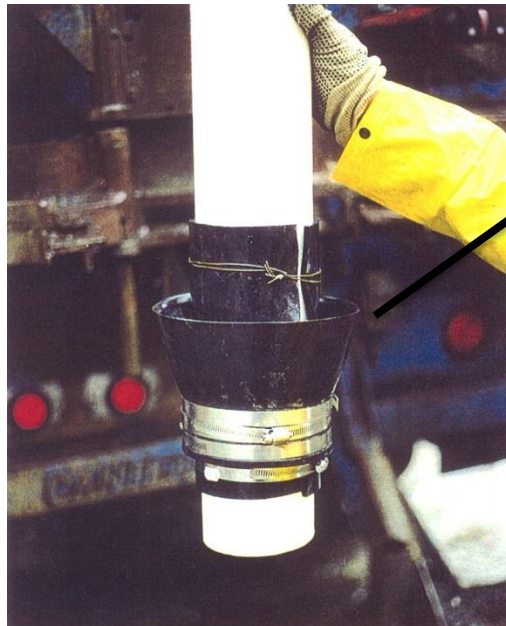
- MW-11
  - Cored to 75 feet, observed fractures closed or mineral-filled
  - Installed steel conductor to 75 feet
  - Drilled to 200 feet
  - Installed PVC casing with formation packer to 80 feet
  - Got rid of well as soon as possible!

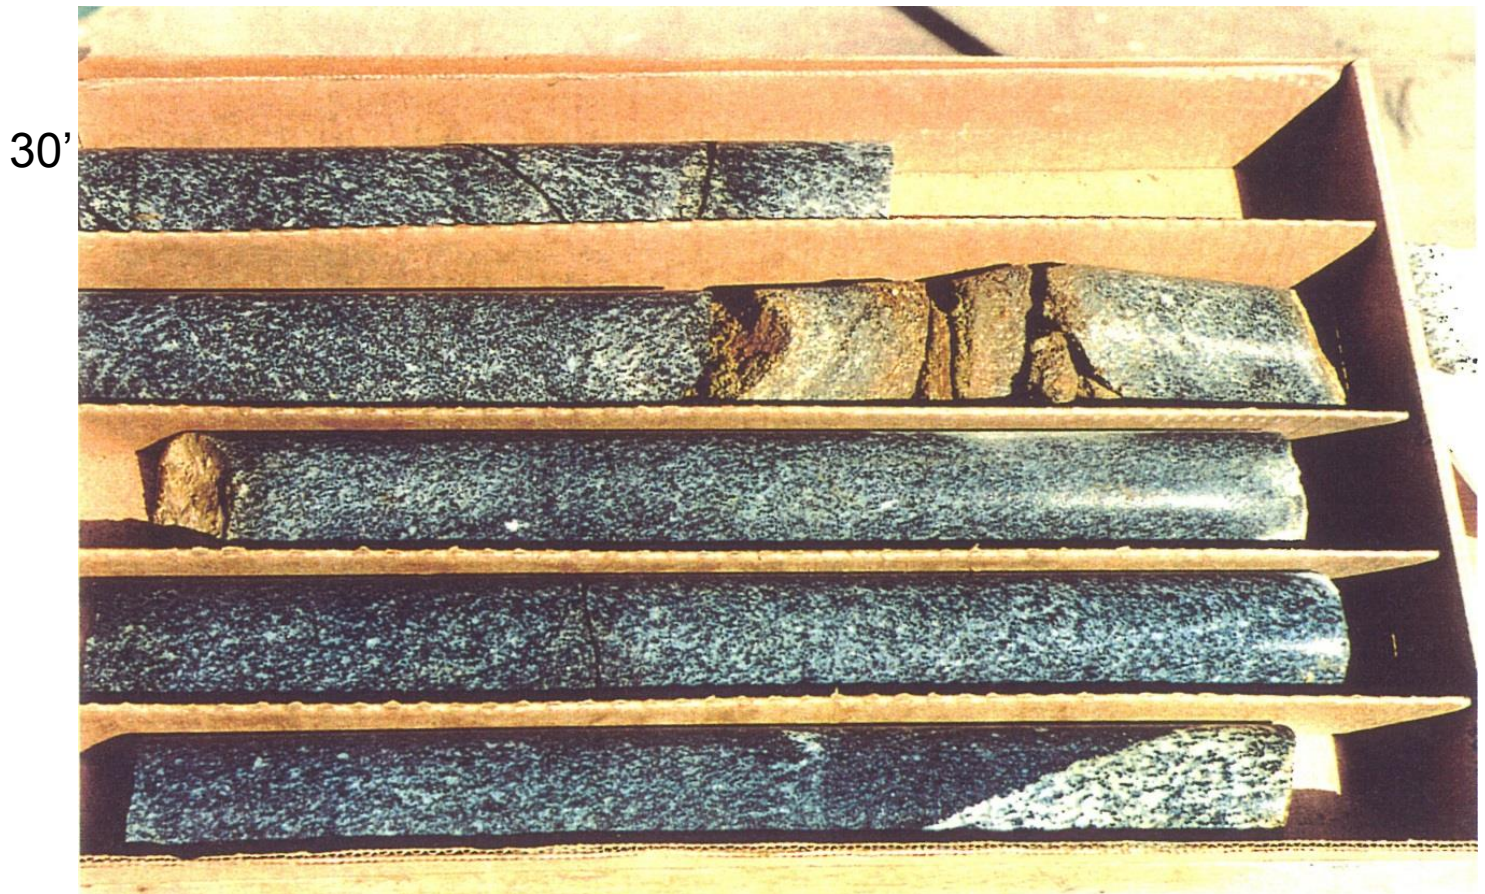
- Fractured granitic rock

30'

38'

- Residuum to 15 feet
- Fractured granitic rock to 15 kilometers+:
  - Cuyamaca gabbro
  - Quartz monzonite and granodiorite
  - Granite pegmatites
- Groundwater-***Two Aquifers:***
  - Shallow groundwater at 25 to 30 feet
  - Deeper (regional) groundwater at ~160 feet
  - Subhorizontal (stress relief) fracture at about 30 - location of impacted groundwater

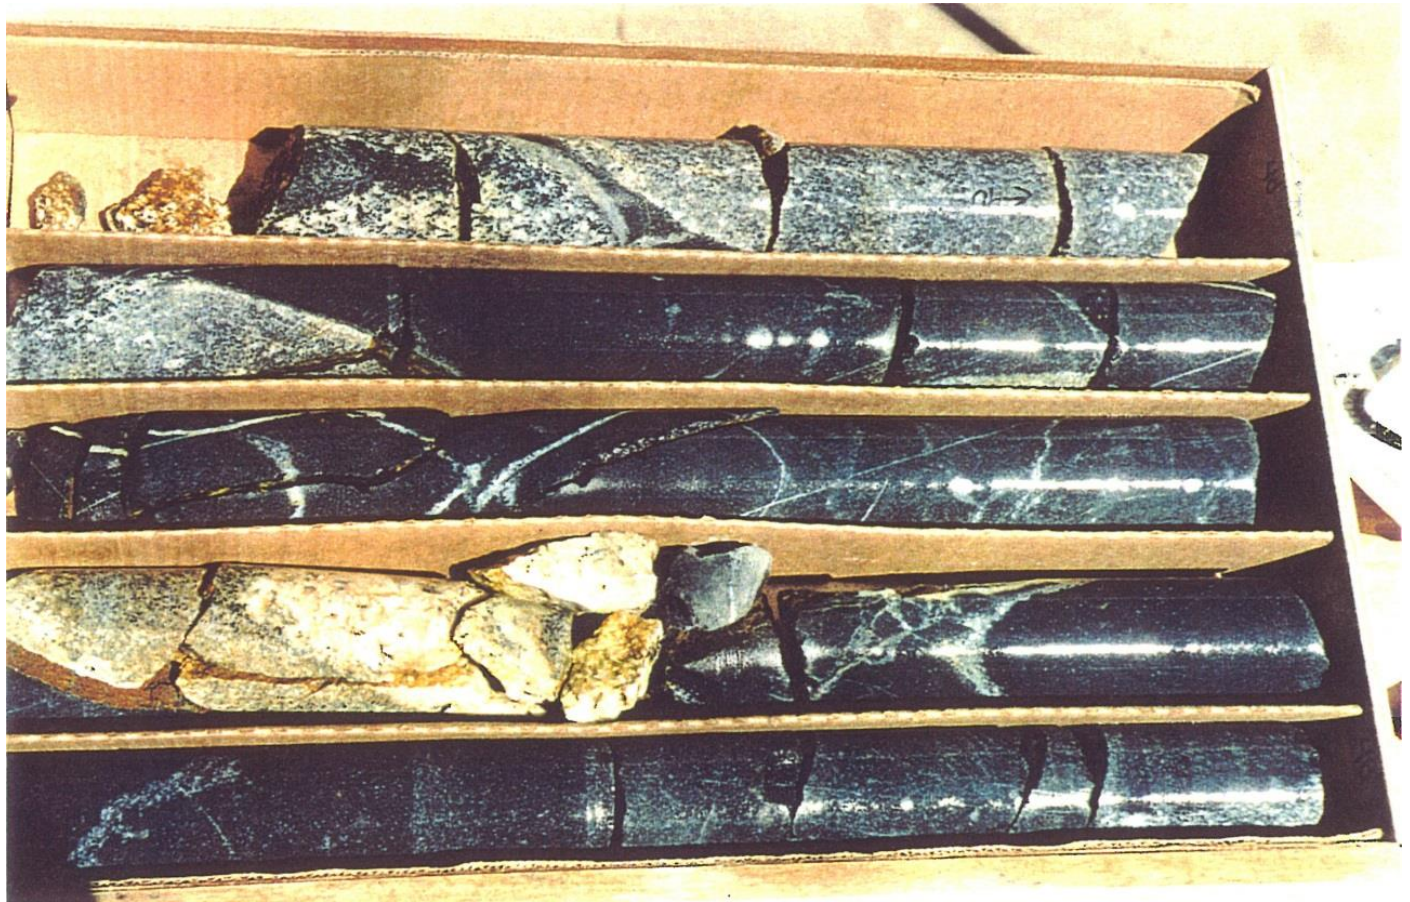
- Fractured granitic rock

38'

48'

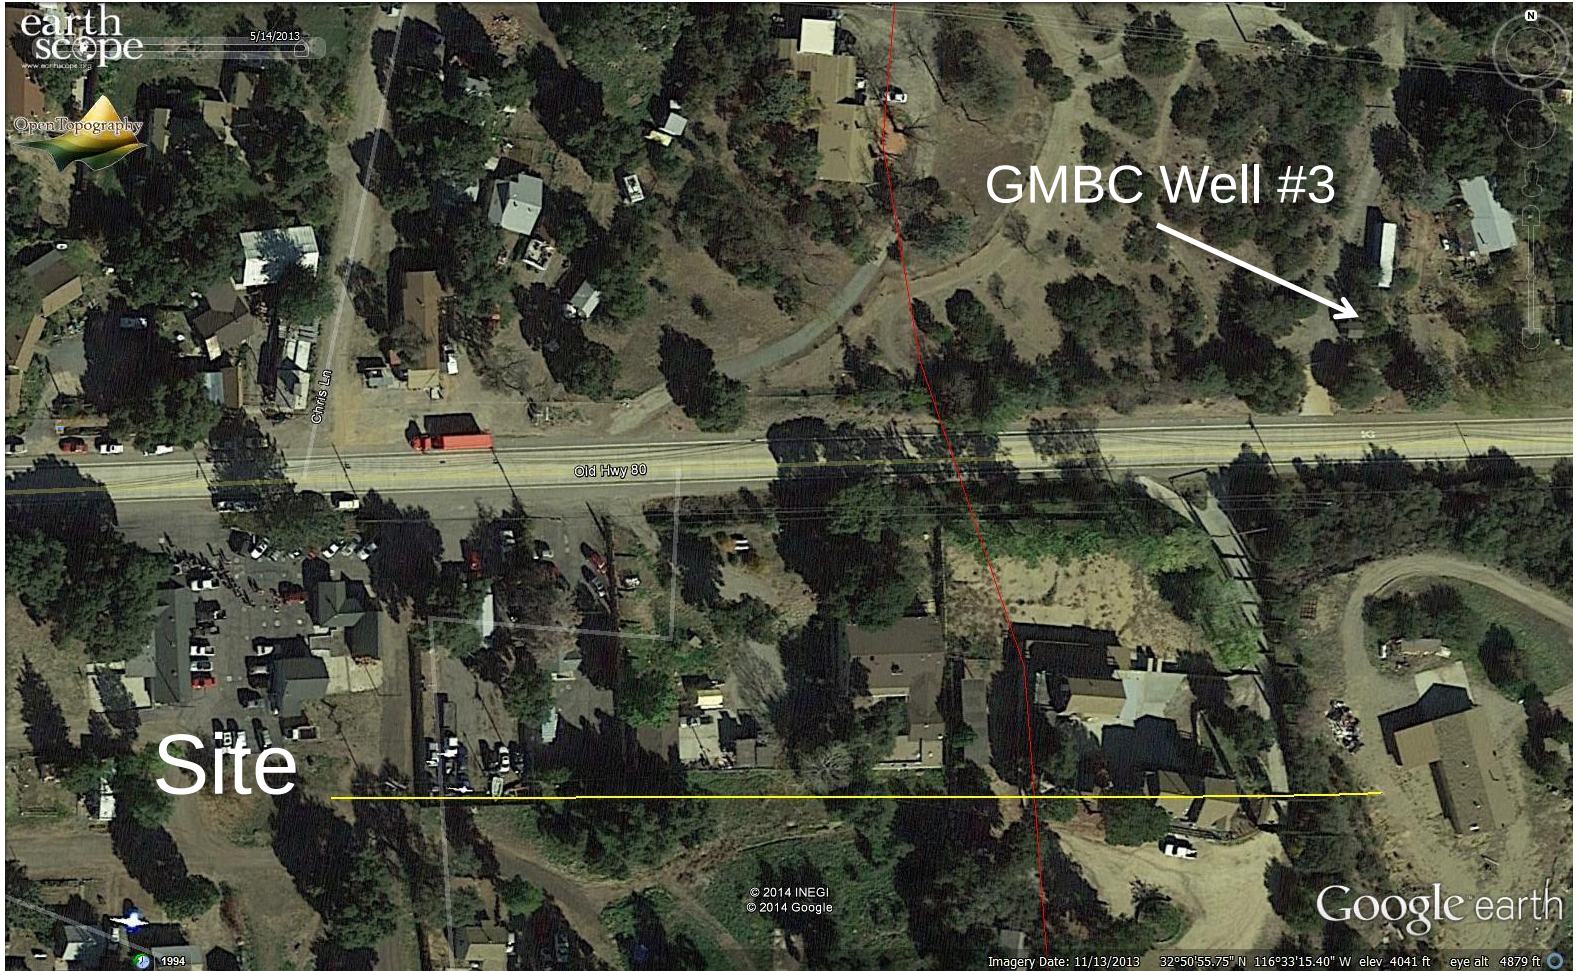
- Approximately 650 feet east-northeast of the Site

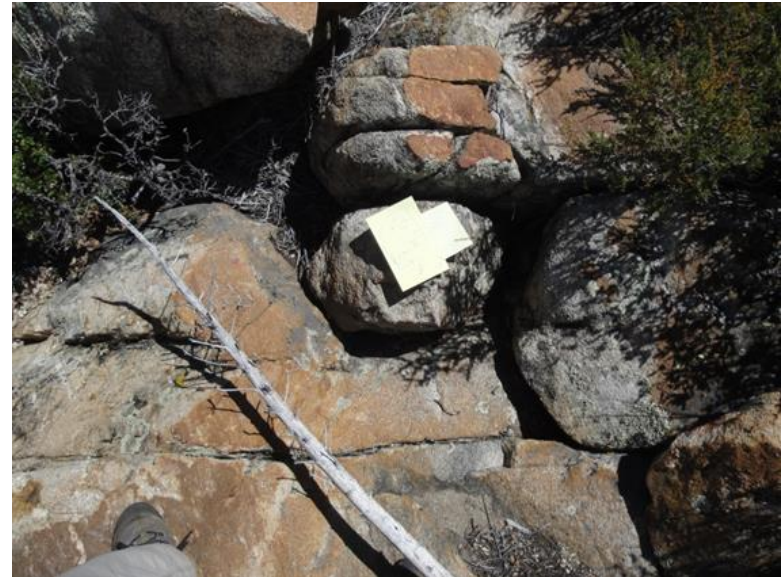
- Approximately 650 feet east-northeast of the Site
- Low Toluene (about 15 ug/l)
- ***DEH requested evaluation of connectivity between PVTP and GMBC Well #3***
  - Fracture Trace Analysis
  - Fracture Mapping
