**JURISDICTIONAL DELINEATION
FOR THE FORRESTER CREEK INDUSTRIAL PARK
PBS&J, February 19, 2009**

Draft Jurisdictional Delineation
for the Proposed
Forrester Creek Industrial Park Project

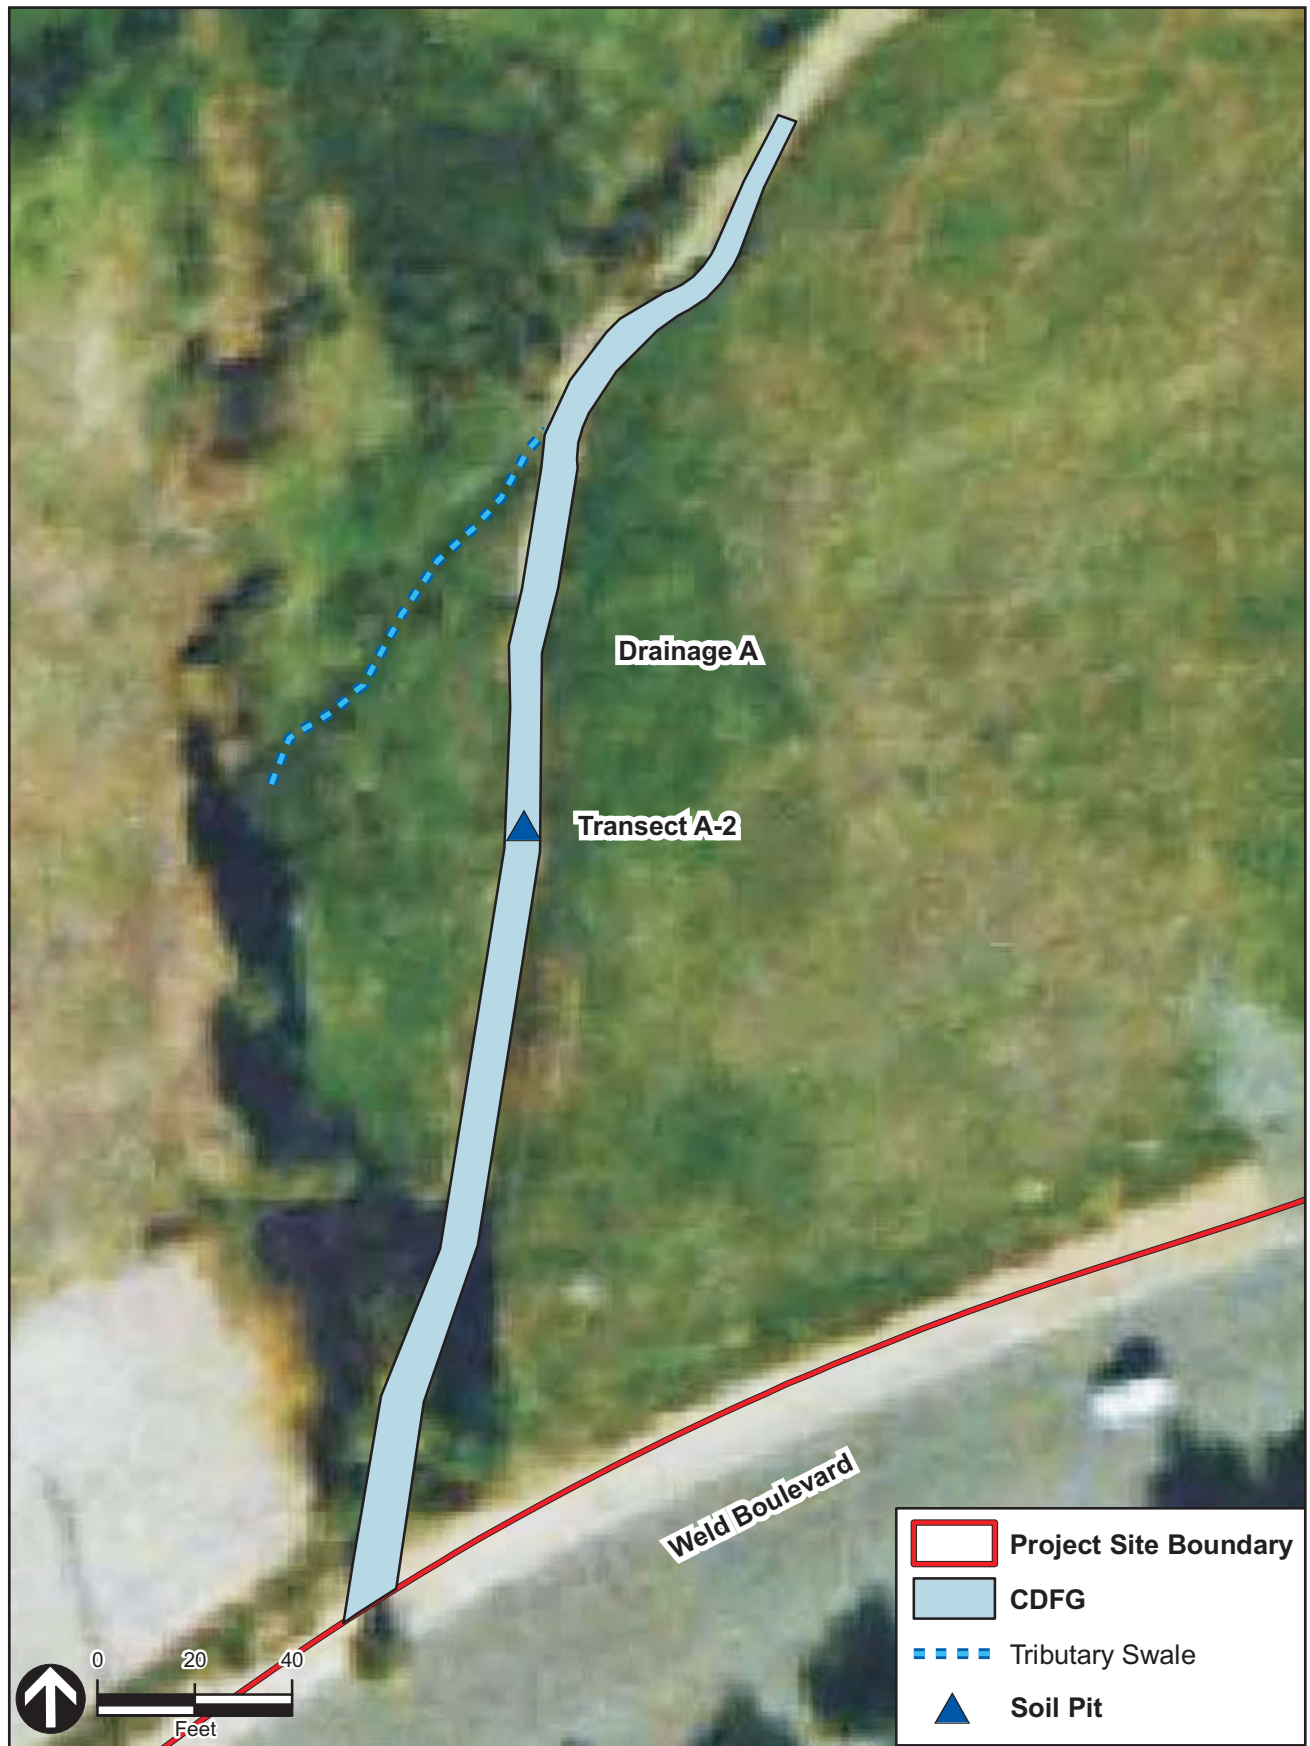
FIGURE 5

DRAINAGE A JURISDICTIONAL AREA

Approximately 35 feet downstream of the culvert at the downstream limit of a small grove of salt cedar (*Tamarix* sp.), a soil pit (Transect A-2) was dug (Figure 5 and Photo A-5). The data sheet for this soil pit, available in Appendix A, concluded that hydrophytic vegetation, hydric soils, and wetland hydrology were present.

In summary, Drainage A is a non-jurisdictional feature under ACOE or RWCQB because it is an isolated feature that has no downstream connectivity to a navigable waterway. This feature may be jurisdictional under CDFG due to the presence of a marginal streambed and riparian vegetation. Figure 5 depicts the area under potential CDFG jurisdiction.

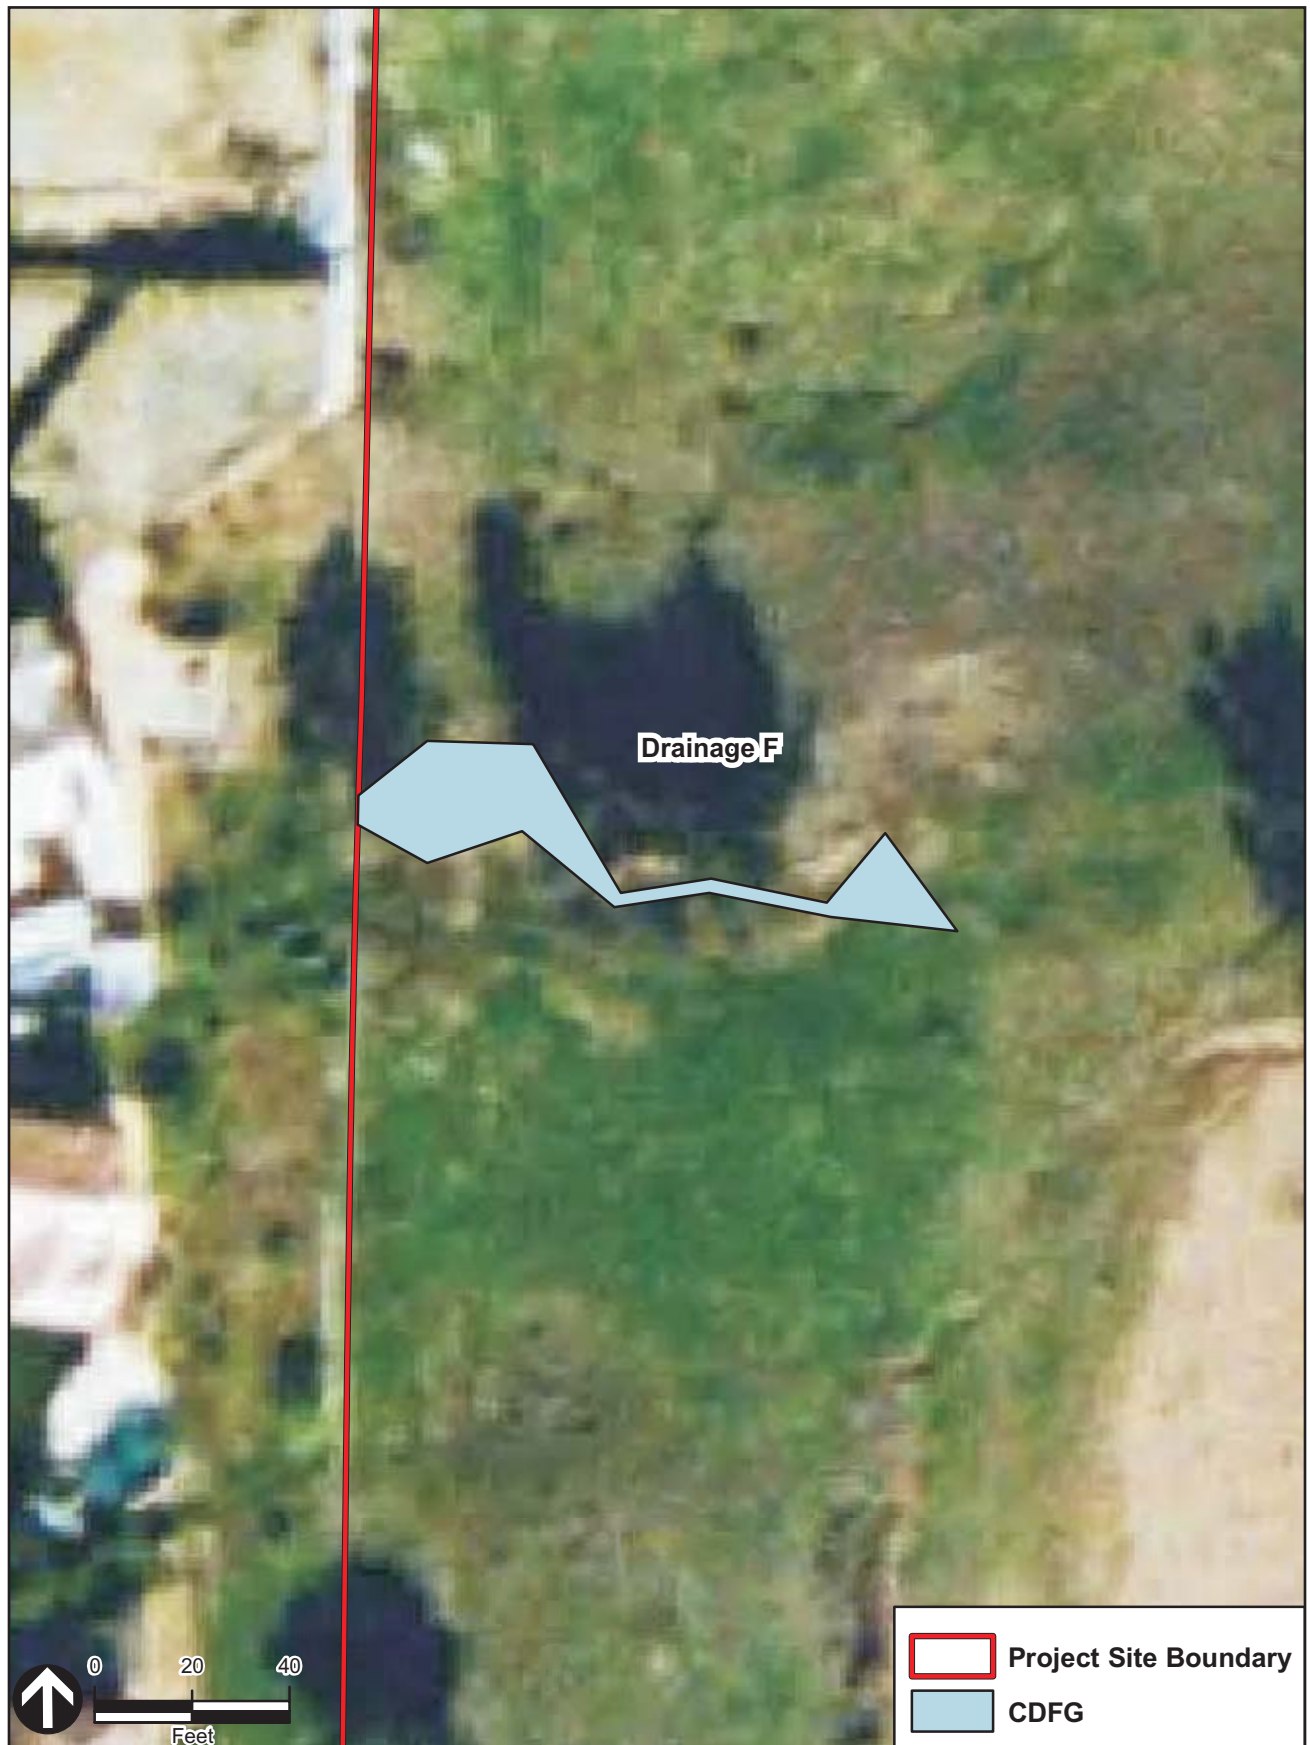
FIGURE 8

DRAINAGE F JURISDICTIONAL AREA

In the middle reach of the drainage, there is a eucalyptus overstory with an understory of disturbed habitat dominated by rabbitfoot, curly dock, and bristly ox-tongue (*Picris echioides*). Water was also present during the field visit in this area. In the lower reaches, from outside of the eucalyptus overstory to the terminus, broadleaf cattails are again the dominant vegetation. Other plant species include jimson weed (*Datura wrightii*) and small palms. The drainage transitions into a swale-like feature into non-native grassland vegetation (Figure 8 and Photos F-4 through F-6).

In summary, Drainage F is a non-jurisdictional feature under ACOE or RWCQB because it is an isolated feature that has no downstream connectivity to a navigable waterway. This feature may be jurisdictional under CDFG due to the presence of a streambed and riparian vegetation. Figure 8 depicts the area under potential CDFG jurisdiction.

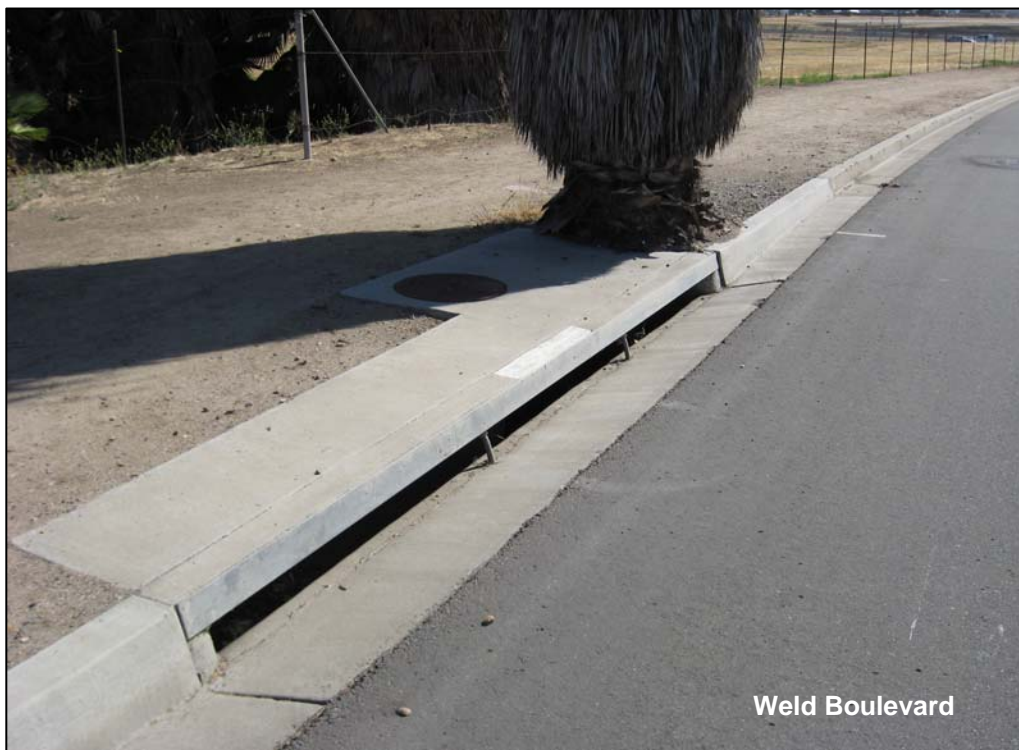
Photo A-1: Catch basin on Weld Boulevard that conveys off-site flows to Drainage A.

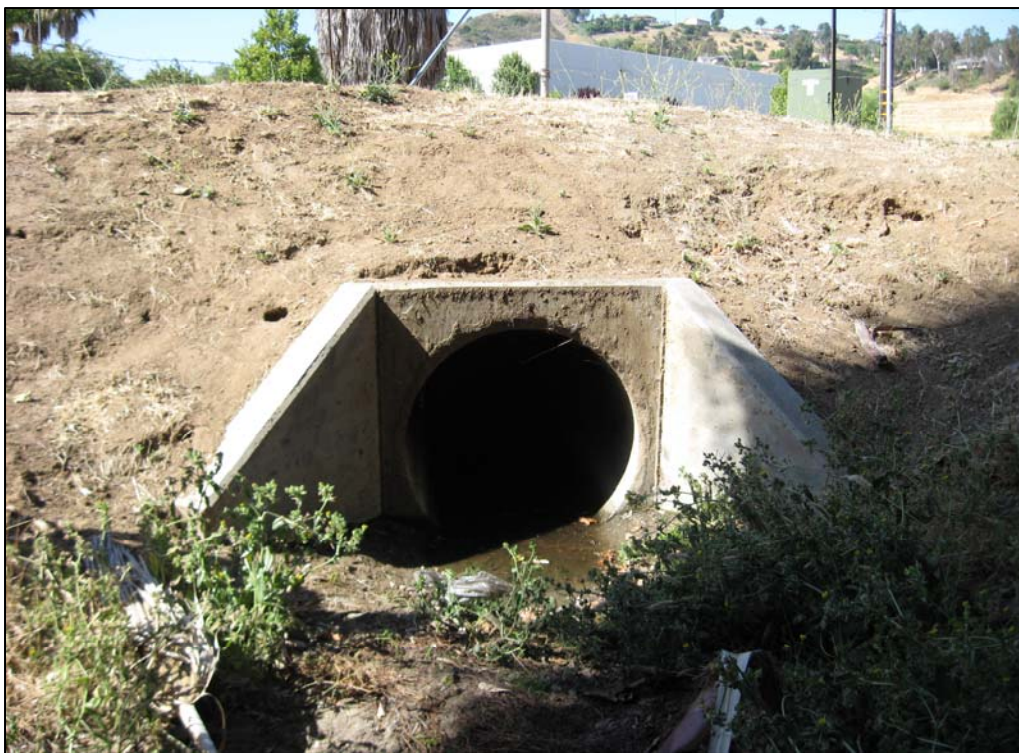
Photo A-2: Thirty-six inch concrete pipe culvert that conveys off-site flows to Drainage A.

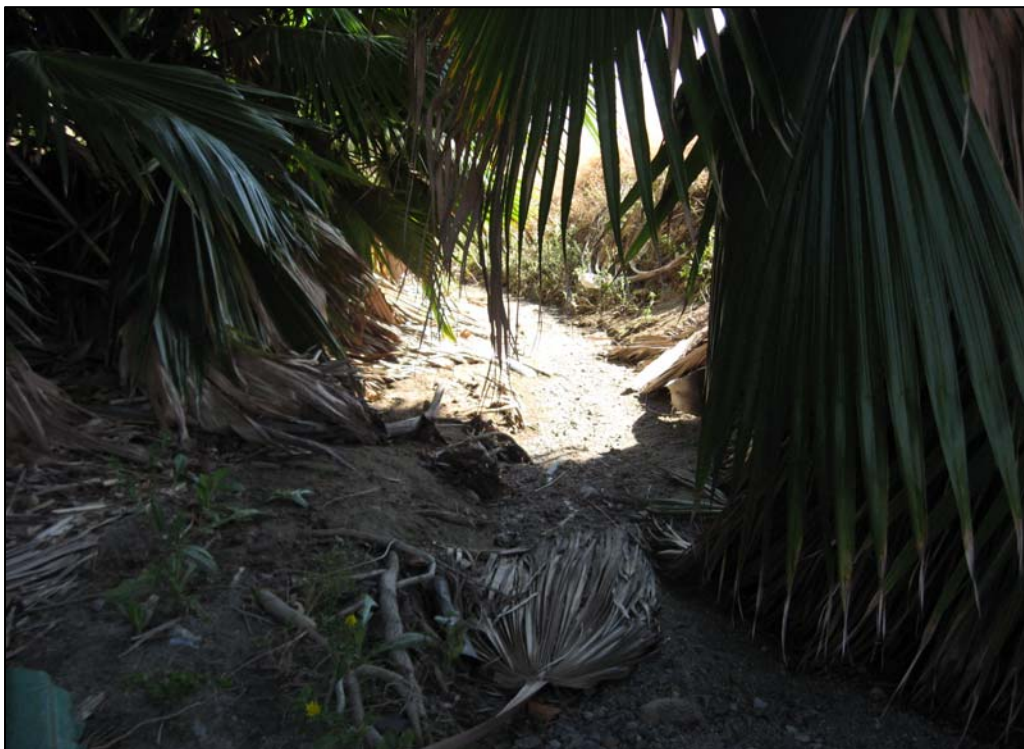
Drainage A is located in the south-central portion of the site. The source of water into Drainage A is from off-site nuisance flows which flow from off-site areas to the south of the project site, through a catch basin on Weld Boulevard, and through a 36-inch concrete pipe culvert (Photos A-1 and A-2). The origin of the drainage, near the culvert, is an isolated, incised drainage caused by erosion from the off-site nuisance flows. The bottom of the drainage is coarse alluvial sand with pebbles. The dominant vegetation along bank in this area is sow-thistle (*Sonchus oleraceus*) and Mexican fan palm (*Washingtonia robusta*). Rabbitfoot is restricted to the active channel and adjacent to the channel and non-native grasses are located on the banks (Photo A-3).

Photo A-3: Downstream view of Drainage A immediately downstream of 36-inch concrete pipe culvert (see Photo A-2).

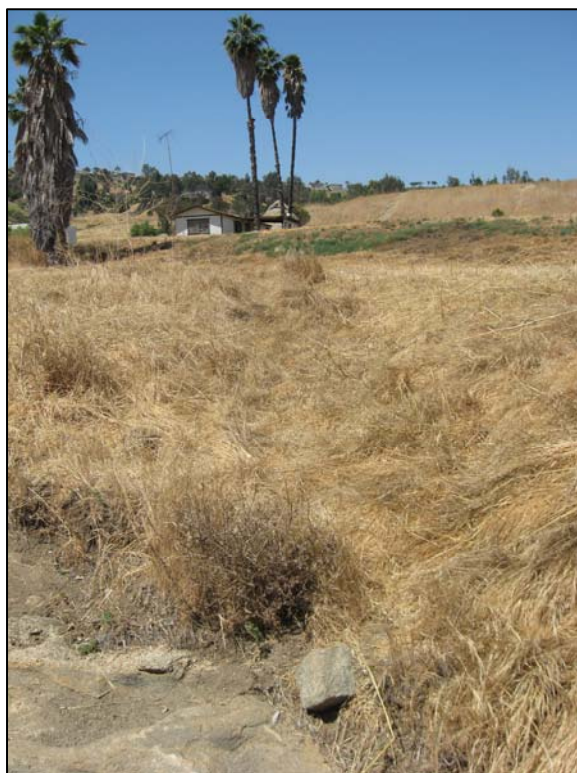
In the upper reach of the drainage, pools of standing water were located within the grove of salt cedar. A tributary swale connects in the middle reach of Drainage A. This swale does not have a defined bed and bank or OHWM. No functional wetland or riparian vegetation is present and the tributary is surrounded by non-native grassland (Photo A-4).

Photo A-4: Tributary swale at middle reach of Drainage A. There is no defined bed and bank or OHWM. No functional riparian or wetland vegetation is present.

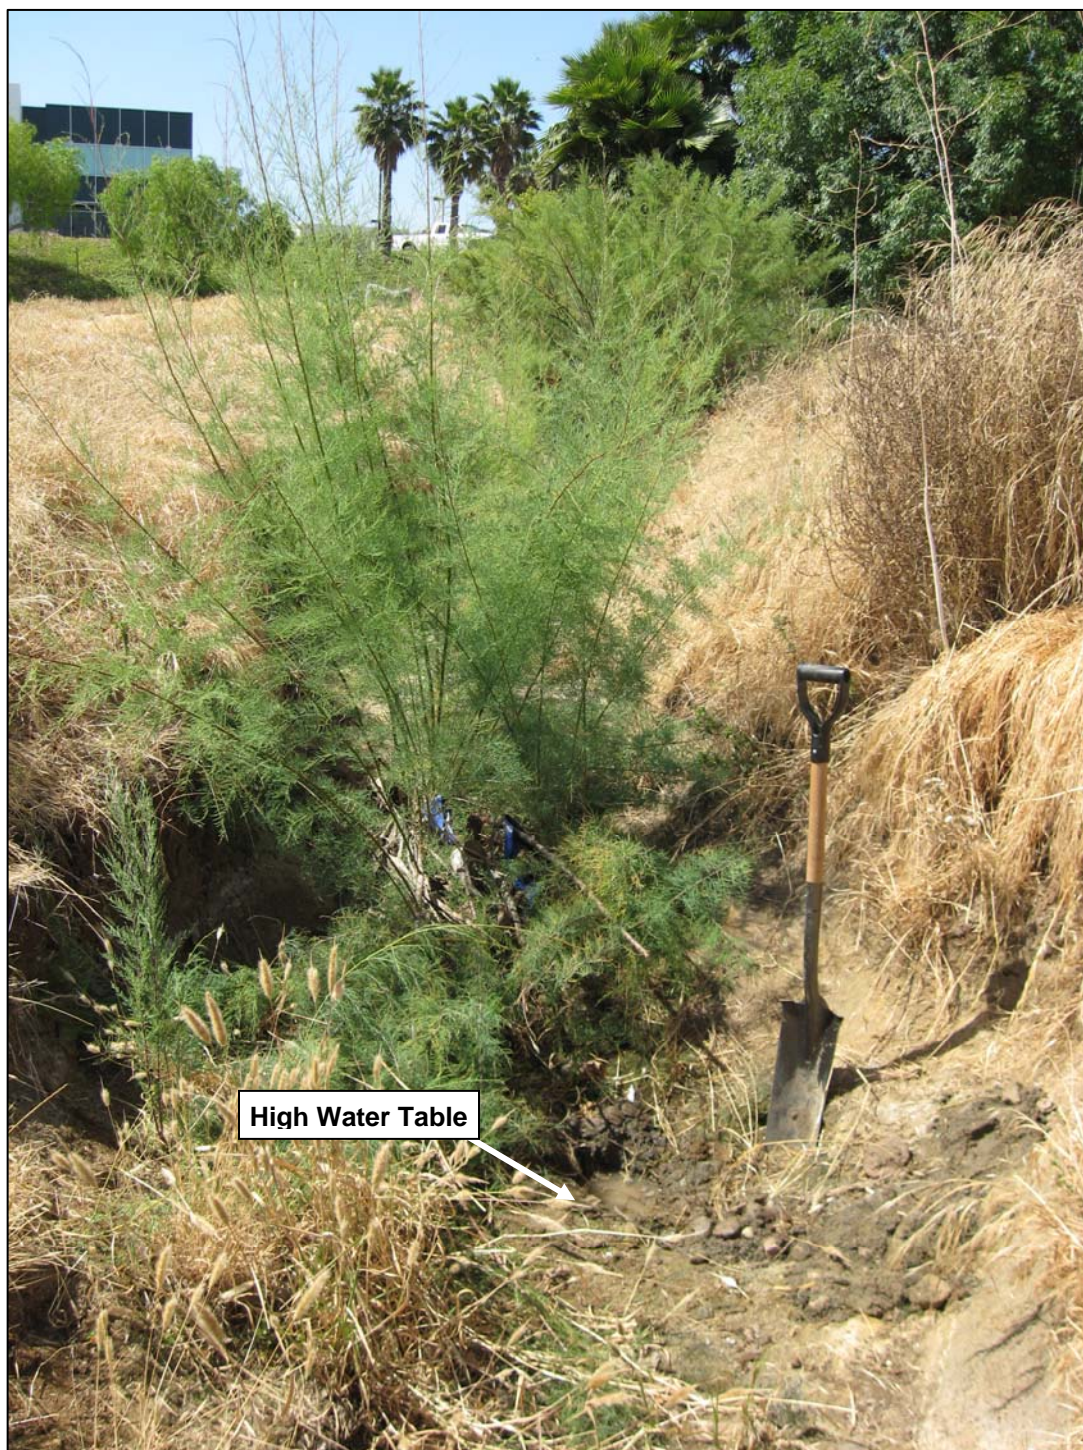
Photo A-5: Soil pit at Transect A-2 located downstream of salt cedar grove (*Tamarix* sp.). High water table can be seen.

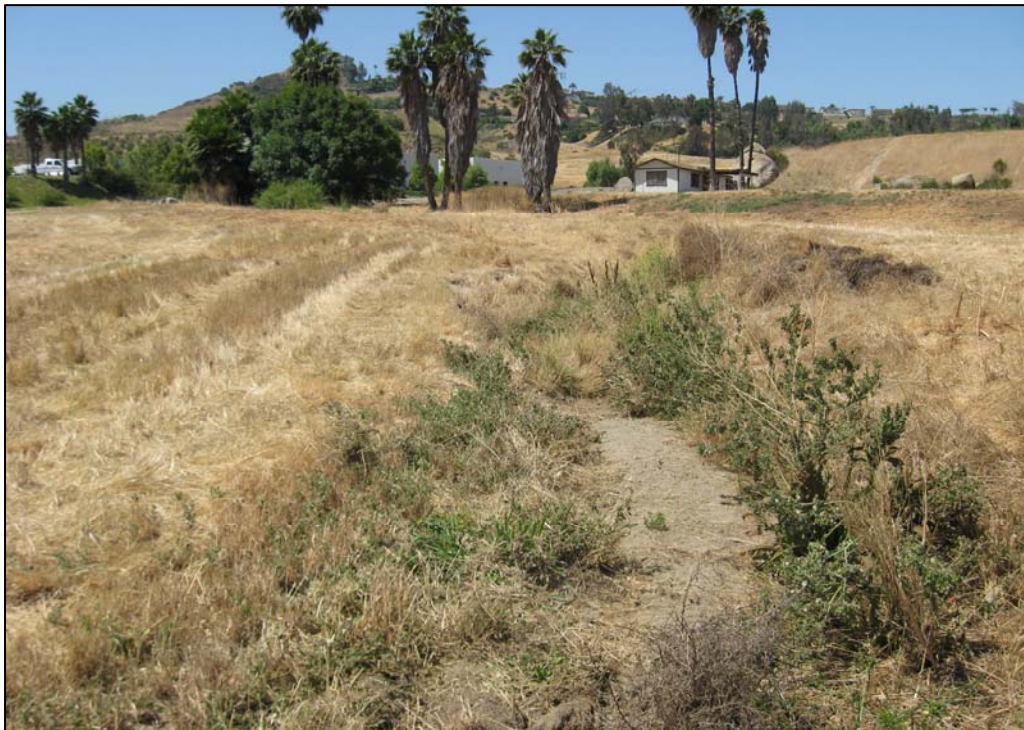
Photo A-6: Terminus of Drainage A looking upstream. The bank and bed dissipate to a swale-like feature. No functional wetland or riparian vegetation is present.

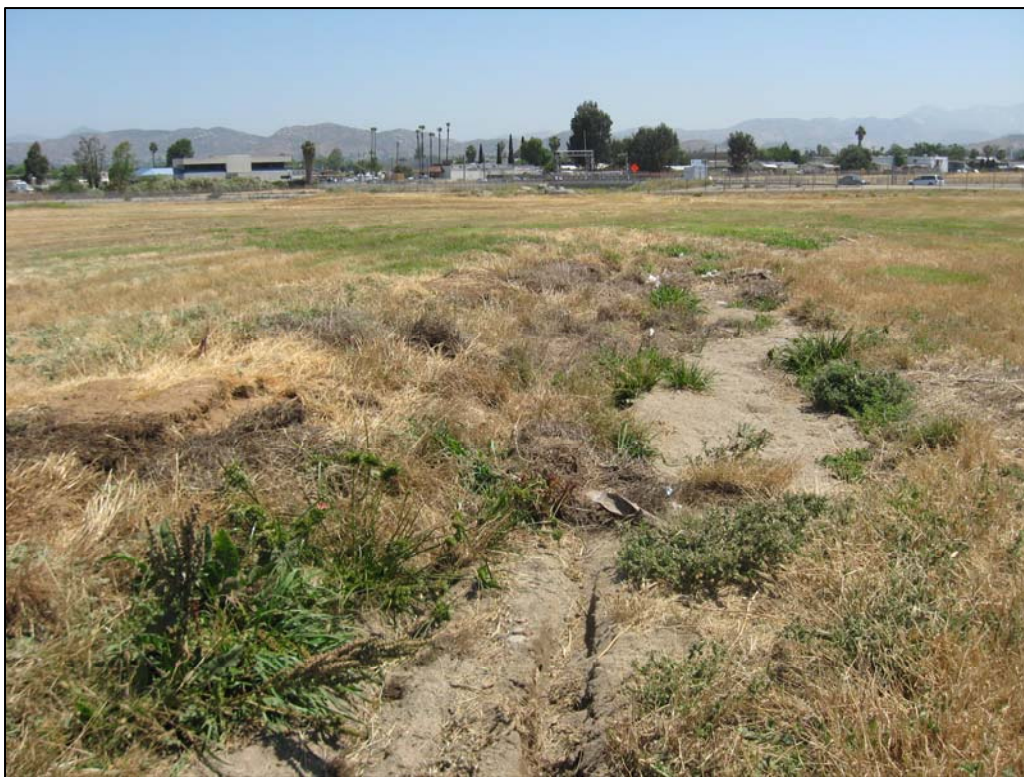
Photo A-7: Terminus of Drainage A looking downstream. Surrounding vegetation is non-native grassland. The rut in the central foreground is from a motorized vehicle.

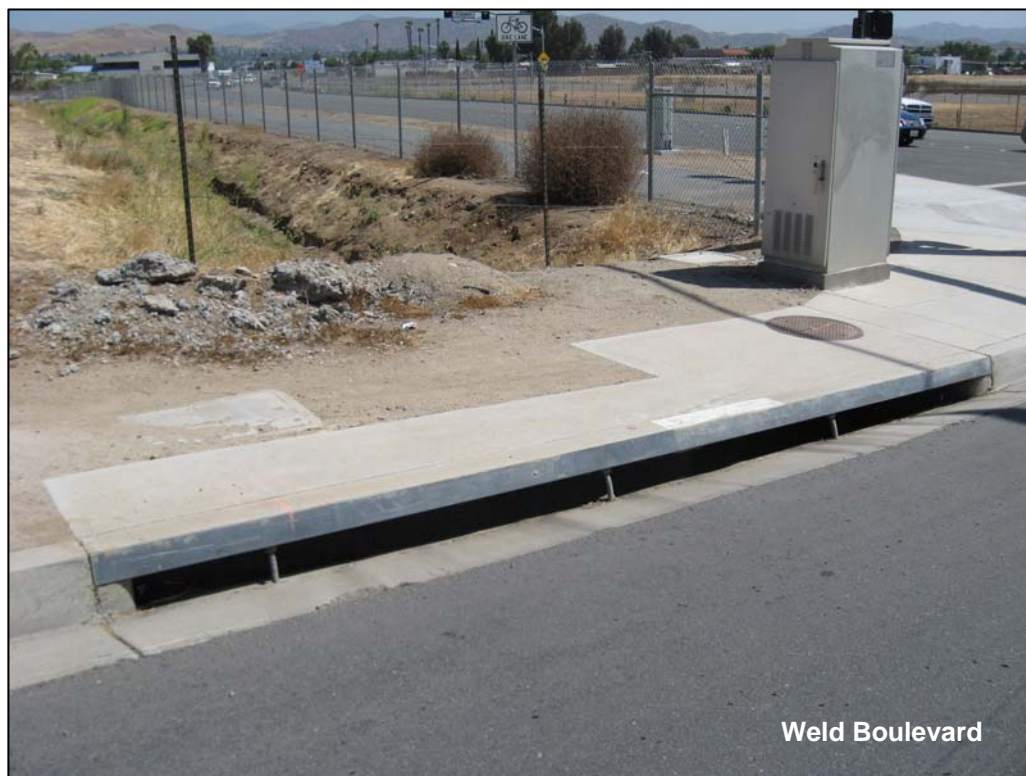
Photo B-1: Catch basin on Weld Boulevard that conveys off-site flows to Drainage B.

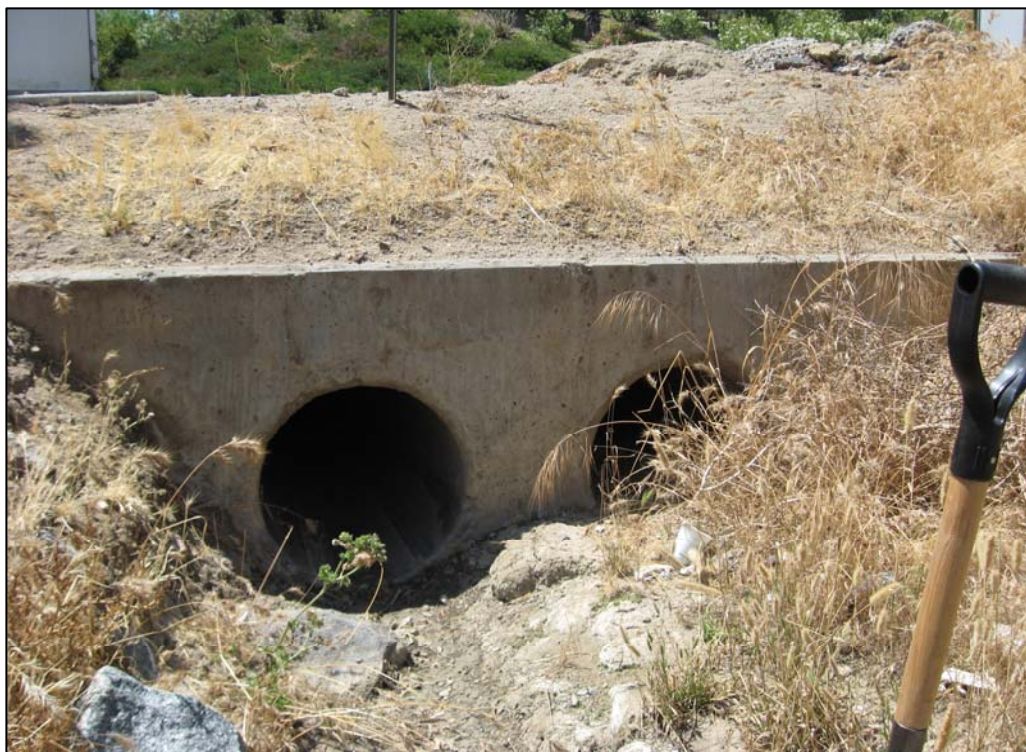
Photo B-2: Double concrete pipe culvert that conveys off-site flows to Drainage B, looking south. The bottom one-third of the western pipe (on right) is filled with sediment. Channel is centered on the eastern pipe (on left).

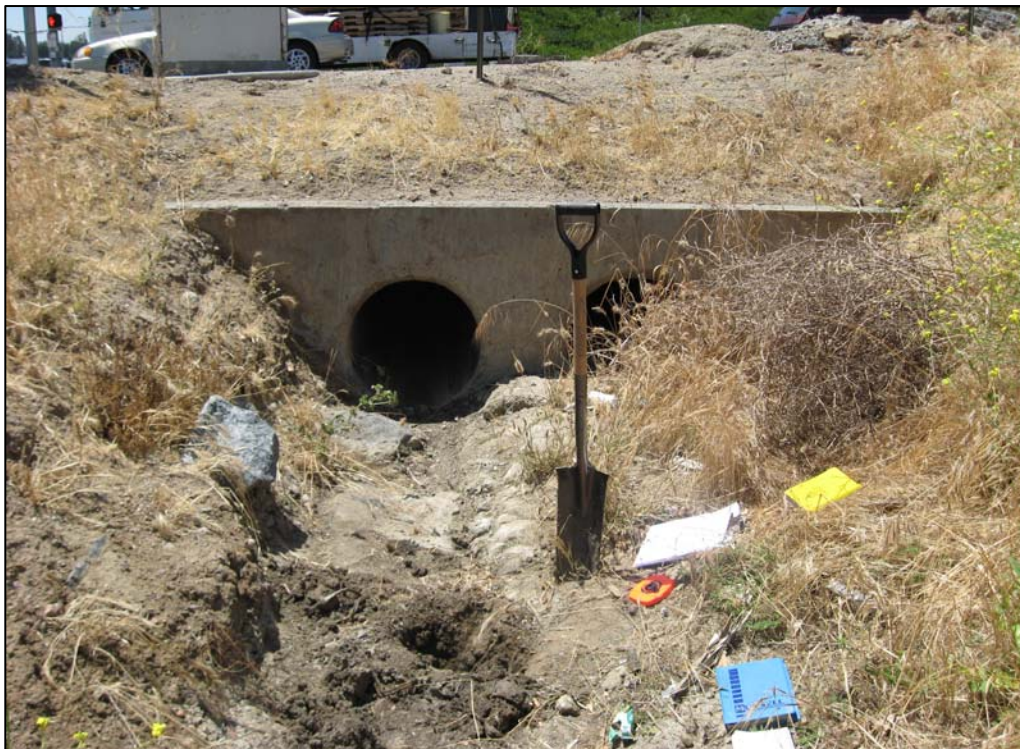
A soil pit was dug in the vicinity of the origin of Drainage B (Transect B-1) (Figure 6 and Photo B-3). The data sheet for this soil pit, available in Appendix A, concluded that hydrophytic vegetation, hydric soils, and wetland hydrology were present.

Photo B-3: Soil pit at Transect B-1 located downstream of culvert.

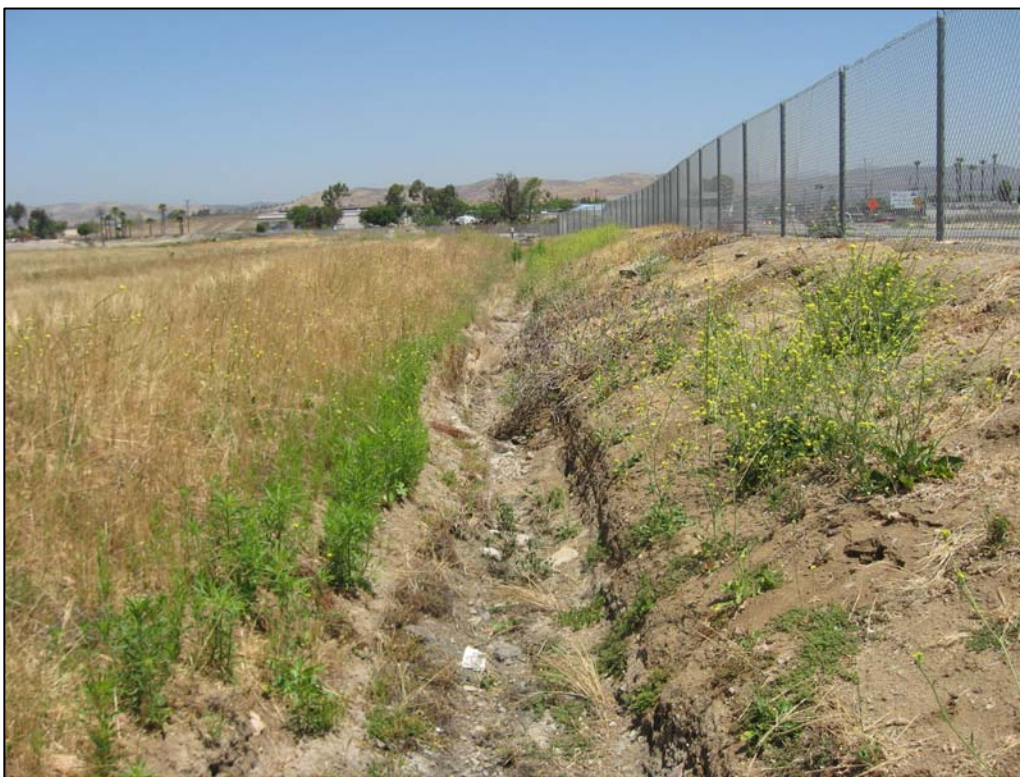
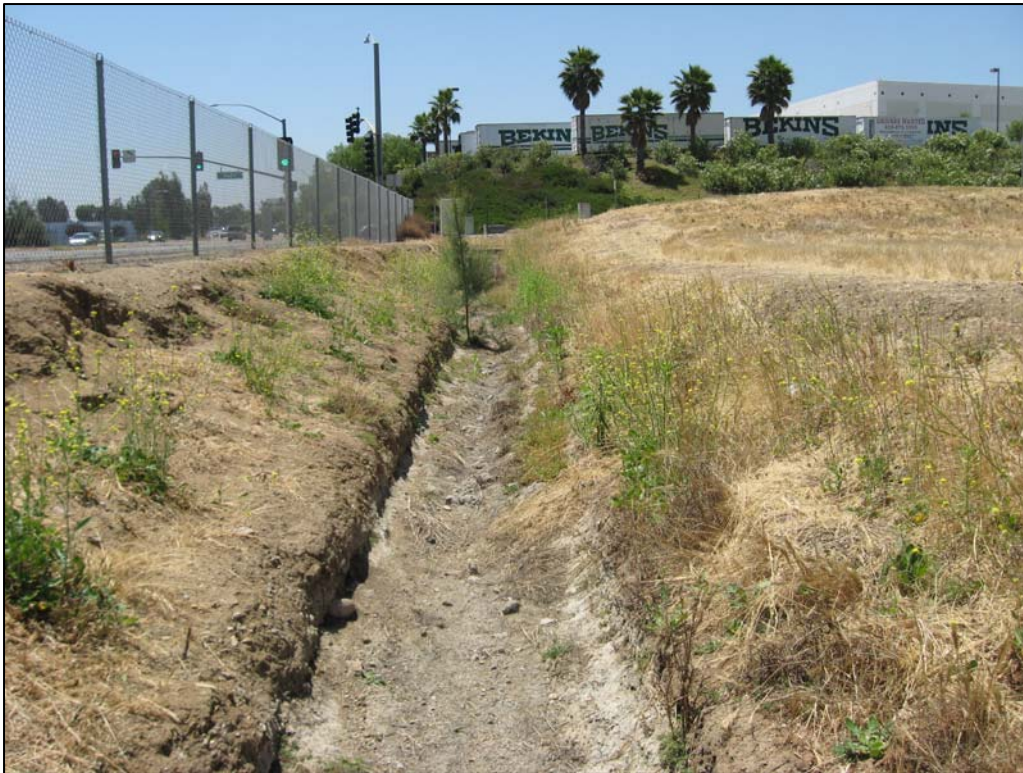
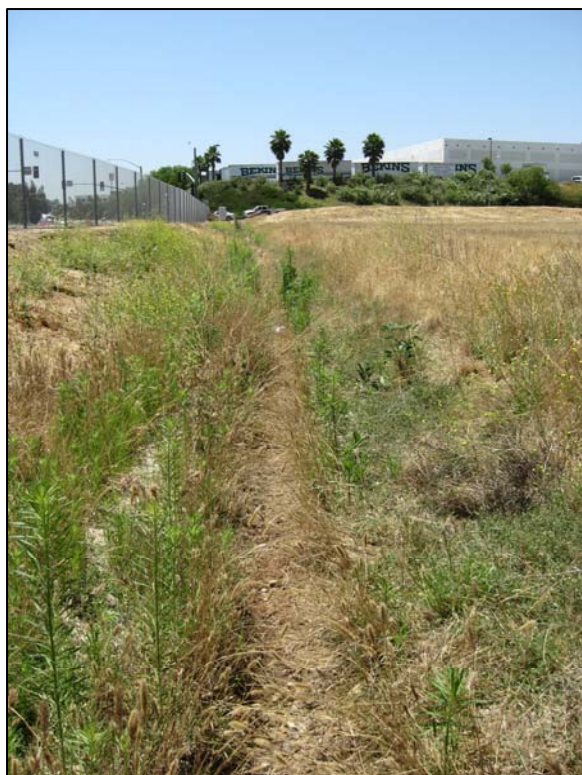
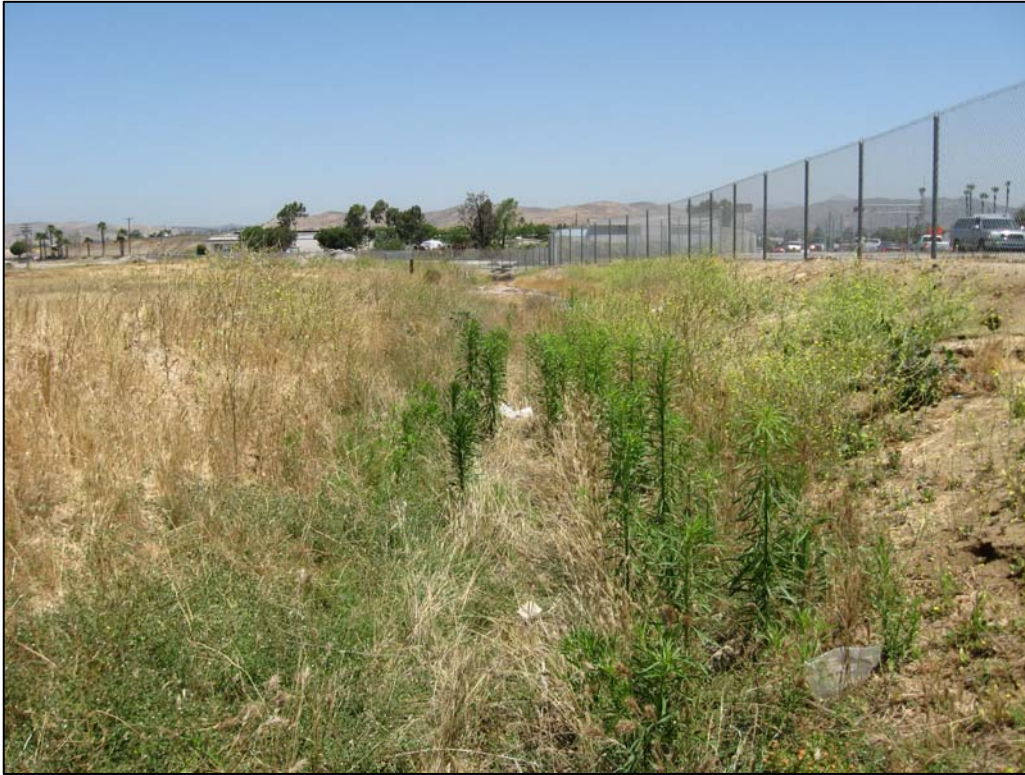
Toward the lower reach of Drainage B, the channel is less discernable. There is also more vegetative growth than is present in the upper and middle reaches. Dominant plant species in the middle reach is rooted flat-top vegetation approximately 1 inch tall and dominant species in the lower reach include black mustard, horseweed, and salt cedar (Photos B-4 through B-7).

Photo B-4: Middle reach of Drainage B, looking downstream.

Photo B-5: Middle reach of Drainage B, looking upstream.

Photo B-6: Lower reach of Drainage B, looking upstream.

Photo B-7: Lower reach of Drainage B, looking downstream.

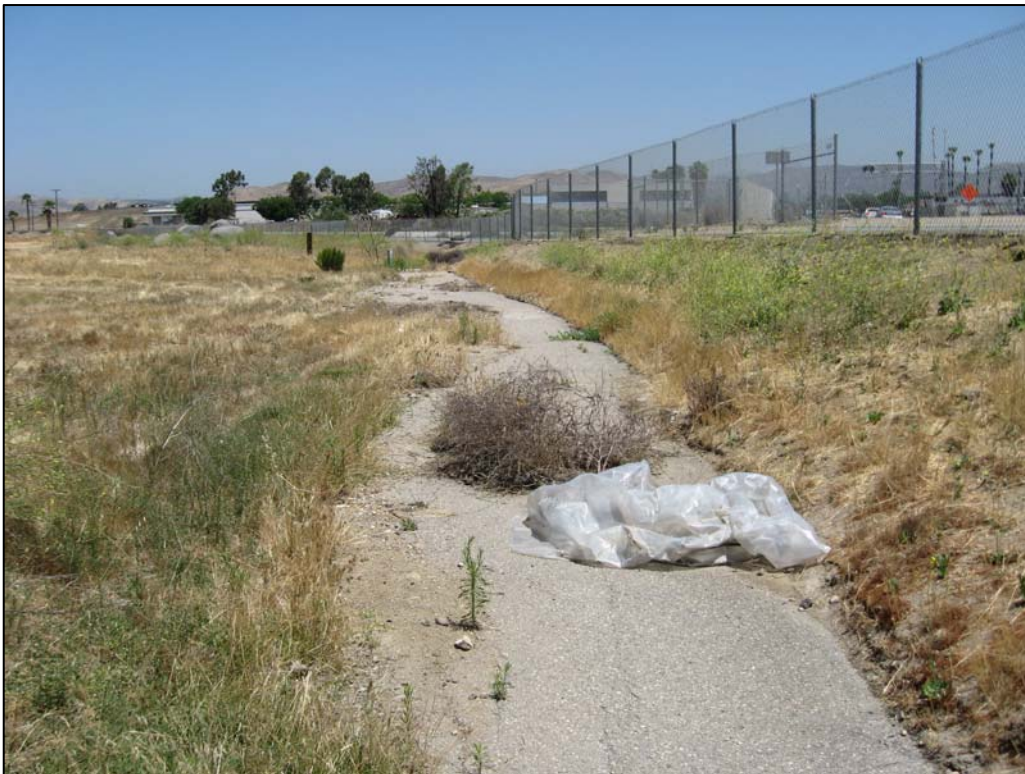
Drainage B ends at an asphalt path, where the flow potentially converts to sheet flow (Photo B-8).

Photo B-8: Asphalt path at terminus of Drainage B, looking north toward Drainage C.

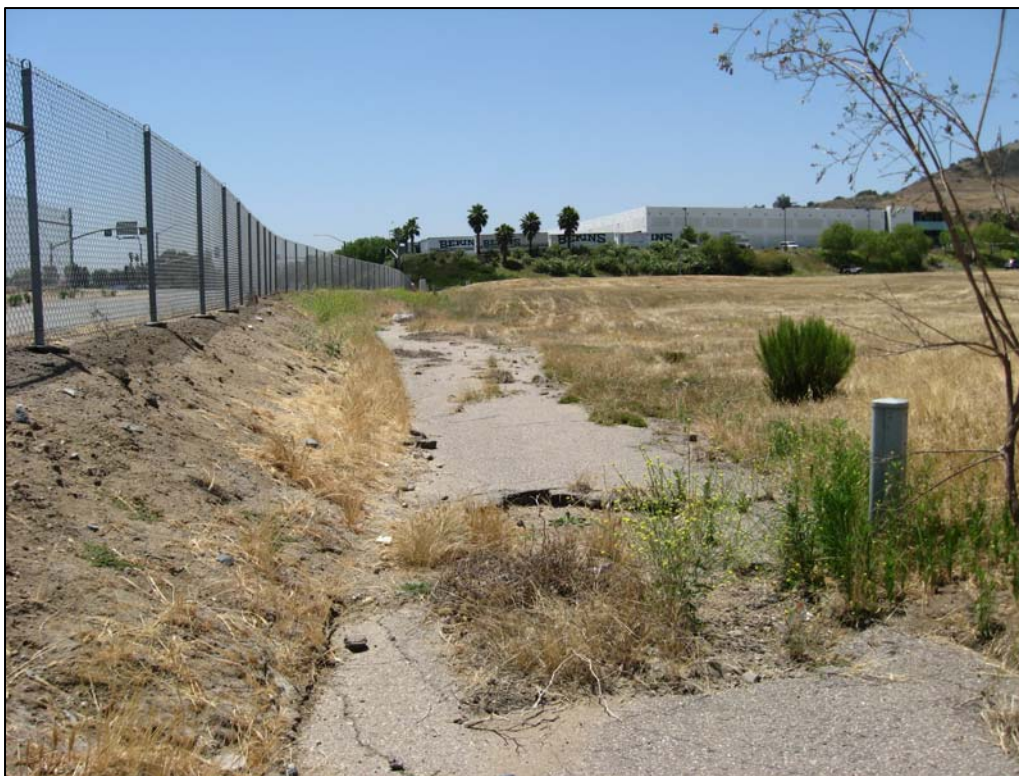
Photo C-1: Asphalt path at origin of Drainage C, looking south toward Drainage B.

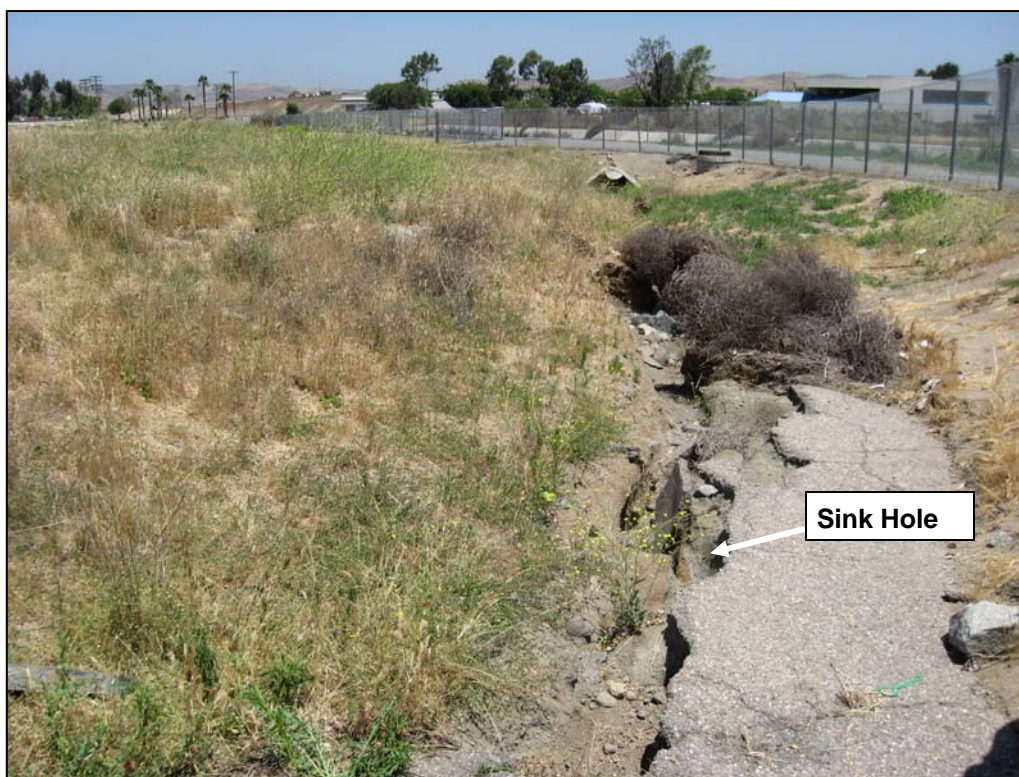
Photo C-2: Fifteen foot long by one foot wide asphalt sinkhole at terminus of Drainage C. Culvert at terminus of Drainage C can be seen in the background.

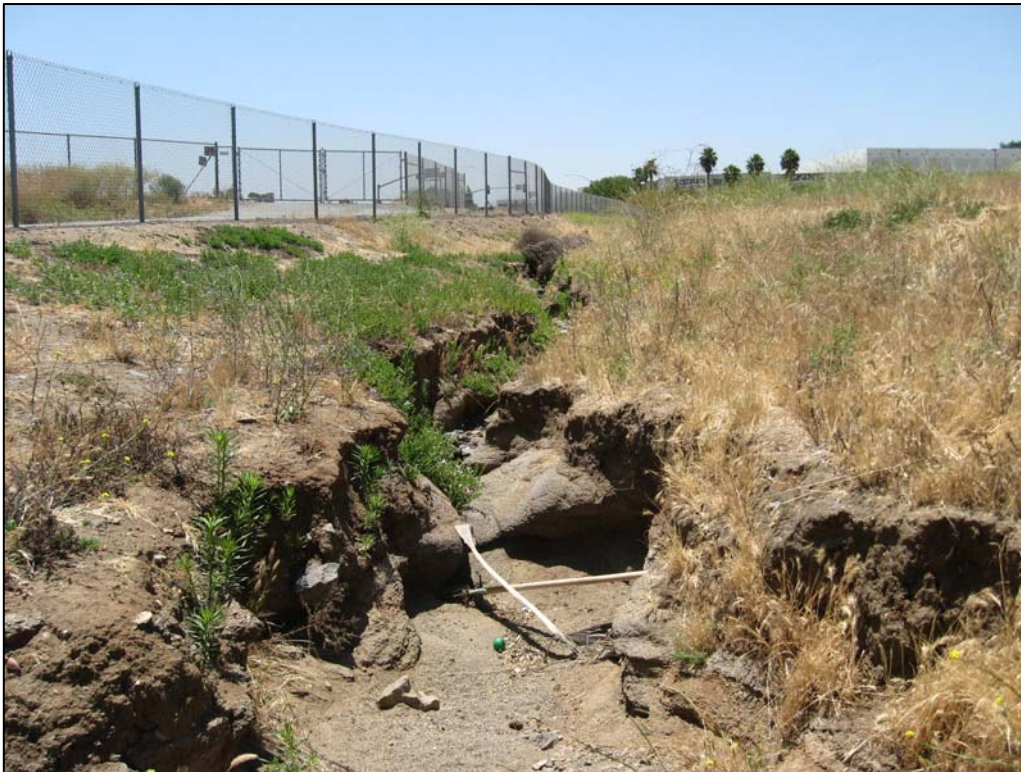
Drainage C is located in the east central portion of the site. The origin of Drainage C is located approximately 150 feet north of the terminus of Drainage B. The source of water to Drainage C appears to be potential sheet flow over the asphalt path from the terminus of Drainage B (Photo C-1). The origin is located at a sinkhole, approximately 10-15 feet long and one foot wide, within an asphalt path (Photo C-2). At the end of the asphalt path, the channel is a sandy bottom with cobbly sand and sparse vegetation (Photo C-3).

Photo C-3: Middle reach of Drainage C looking upstream.

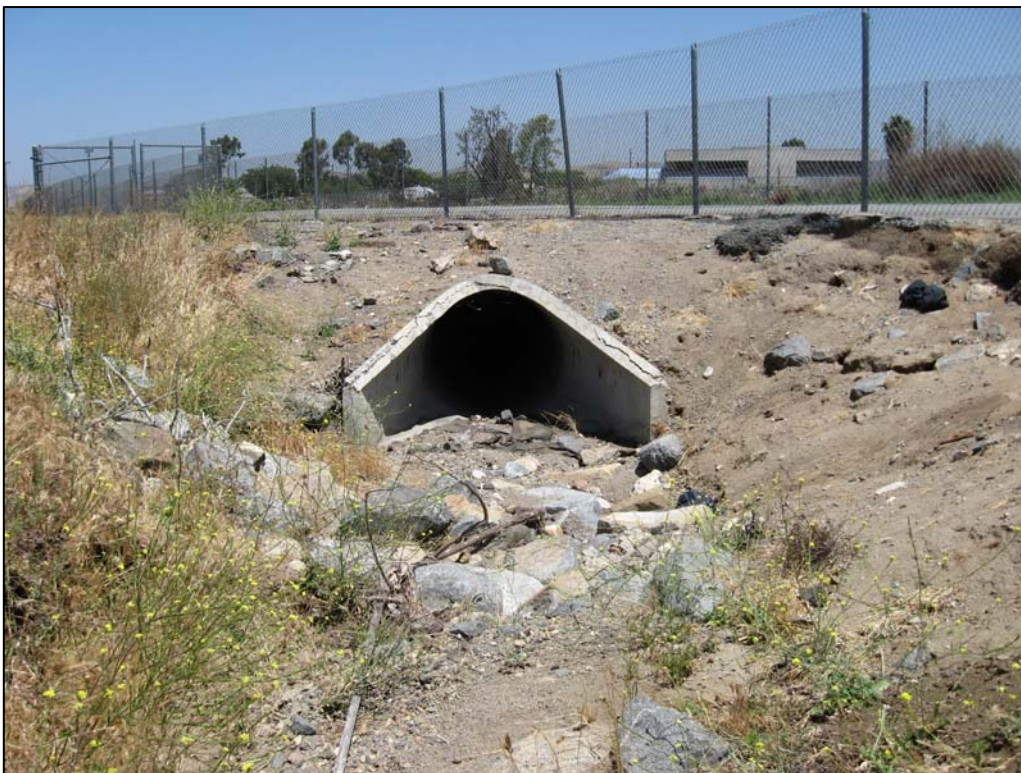
Photo C-4: Thirty-six inch concrete culvert located at the terminus of Drainage C. This culvert conveys flows from Drainage C to Forrester Creek.

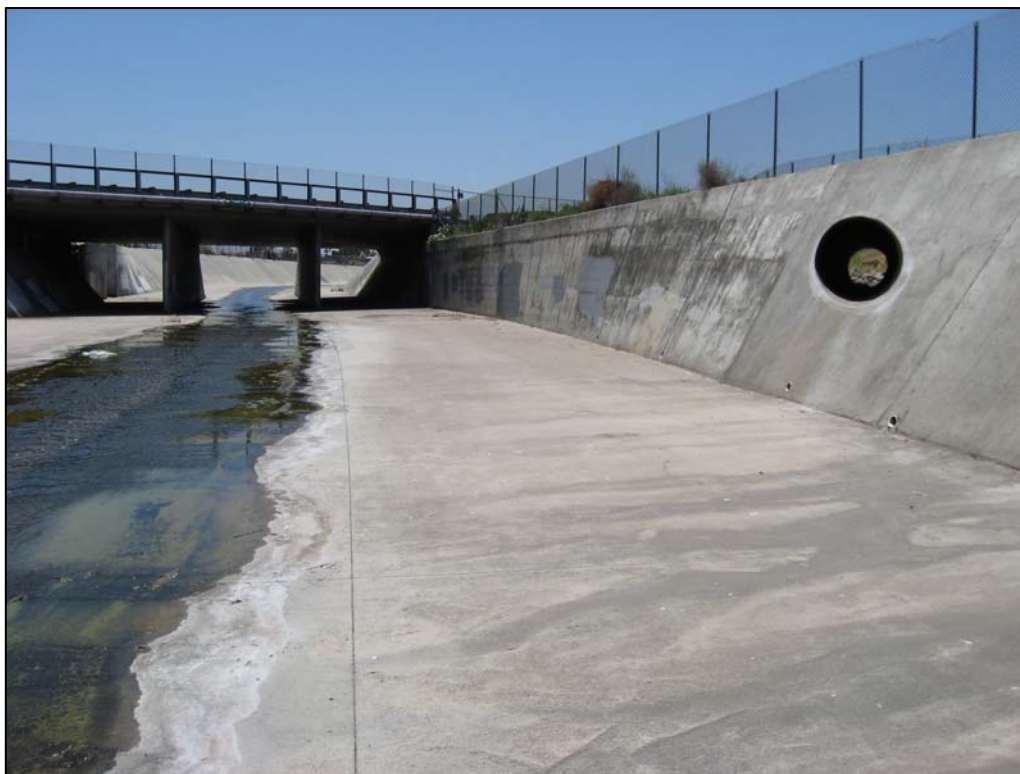
Photo C-5: Forrester Creek at terminus of Drainage C looking upstream. Culvert opening to Drainage C is visible on the right.

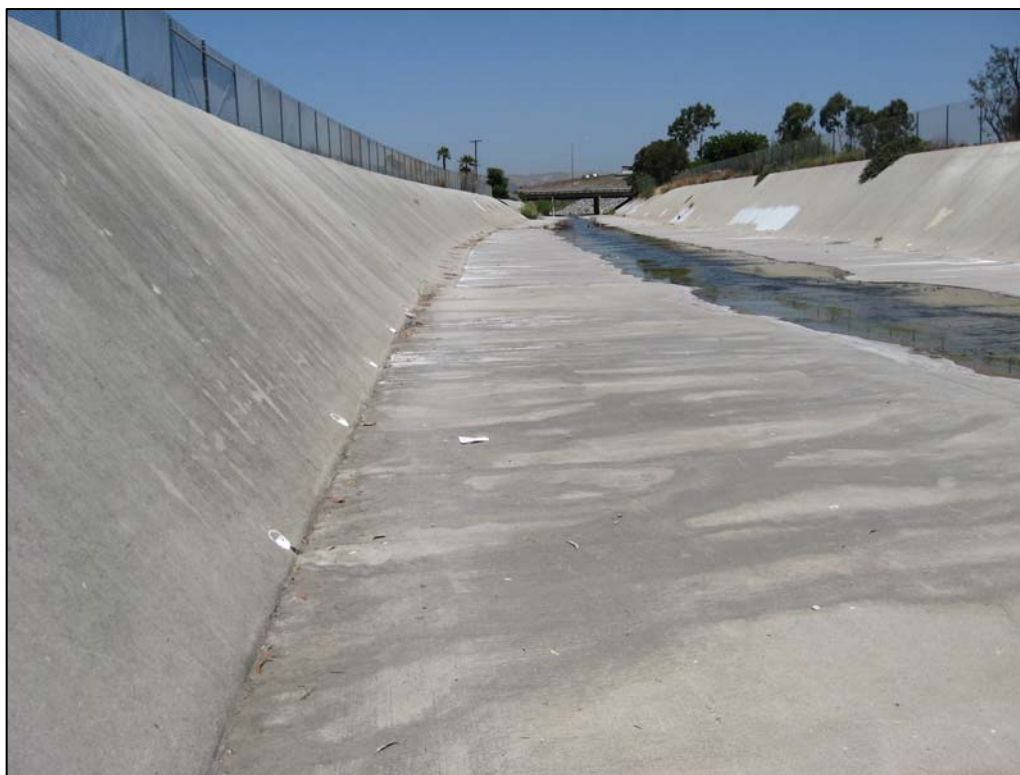
Photo C-6: Forrester Creek at terminus of Drainage C looking downstream.
