**JURISDICTIONAL DELINEATION
FOR THE FORRESTER CREEK INDUSTRIAL PARK
PBS&J, February 19, 2009**

Draft Jurisdictional Delineation
for the Proposed
Forrester Creek Industrial Park Project

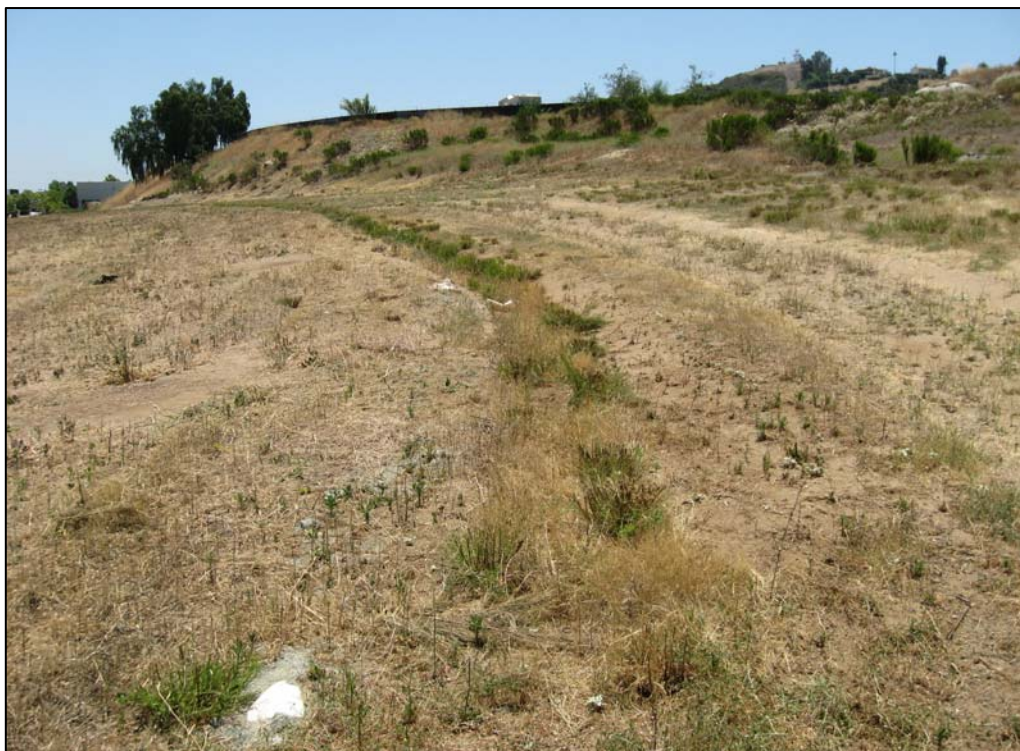
There is no defined bed and bank or OHWM at the northern end of the drainage (Photo D-1). Approximately in the middle of the drainage is an area of fill which would preclude flow to the southern section of the drainage. There is no culvert to allow flow and no evidence of ponding on either side of the filled in area. The southern end of the drainage shows evidence of limited flow. Drainage D is a non-

Photo D-1: Northern end of Drainage D. Foreground shows swale-like features and the background shows a channel with a somewhat defined bed and bank. No functional riparian or wetland vegetation is present. The surrounding vegetation is non-native grassland.

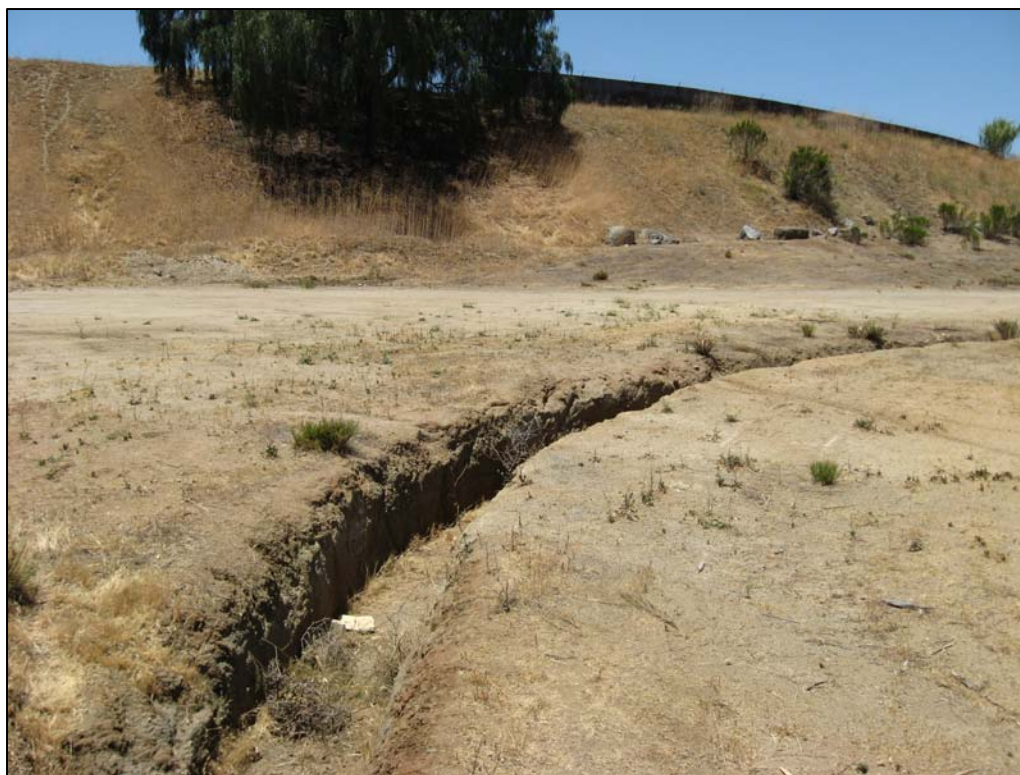
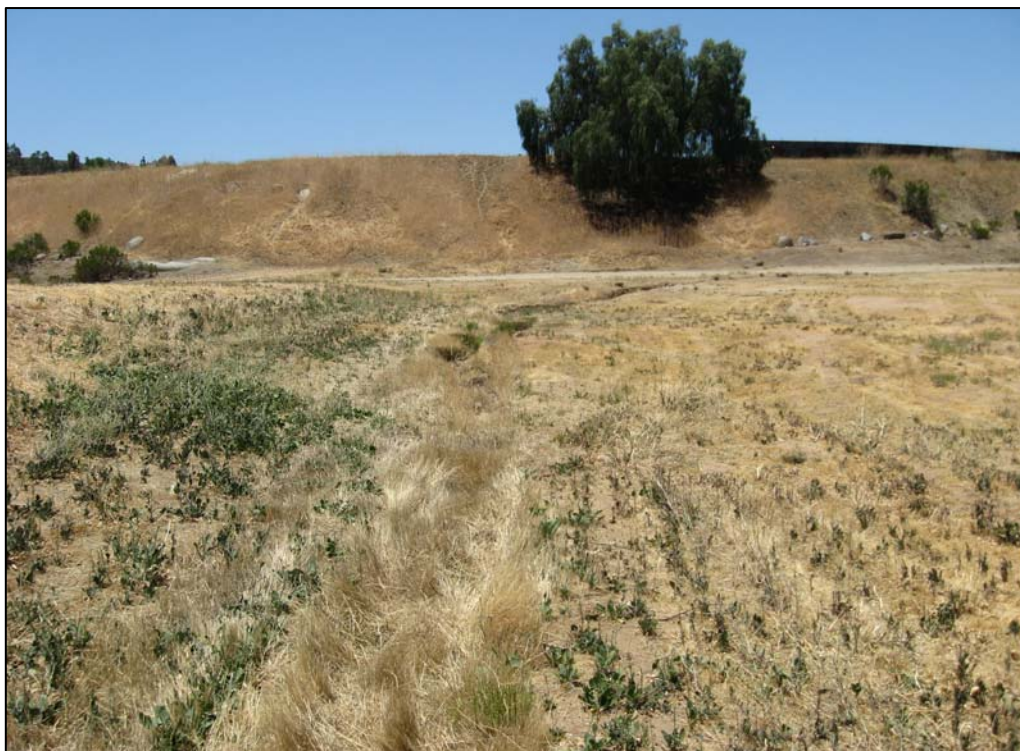
jurisdictional feature due to its isolation, lack of downstream connectivity, and field indicators. This feature would not be under the jurisdiction of ACOE, RWQCB, or CDFG. (Photos D-2 and D-3).

Photo D-2: Middle reach of Drainage D. No functional riparian or wetland vegetation is present.

Photo D-3: Southern end of Drainage D. Foreground shows swale-like features and the background shows an incised channel with a defined bed and bank. No functional riparian or wetland vegetation is present. The surrounding vegetation is disturbed habitat.

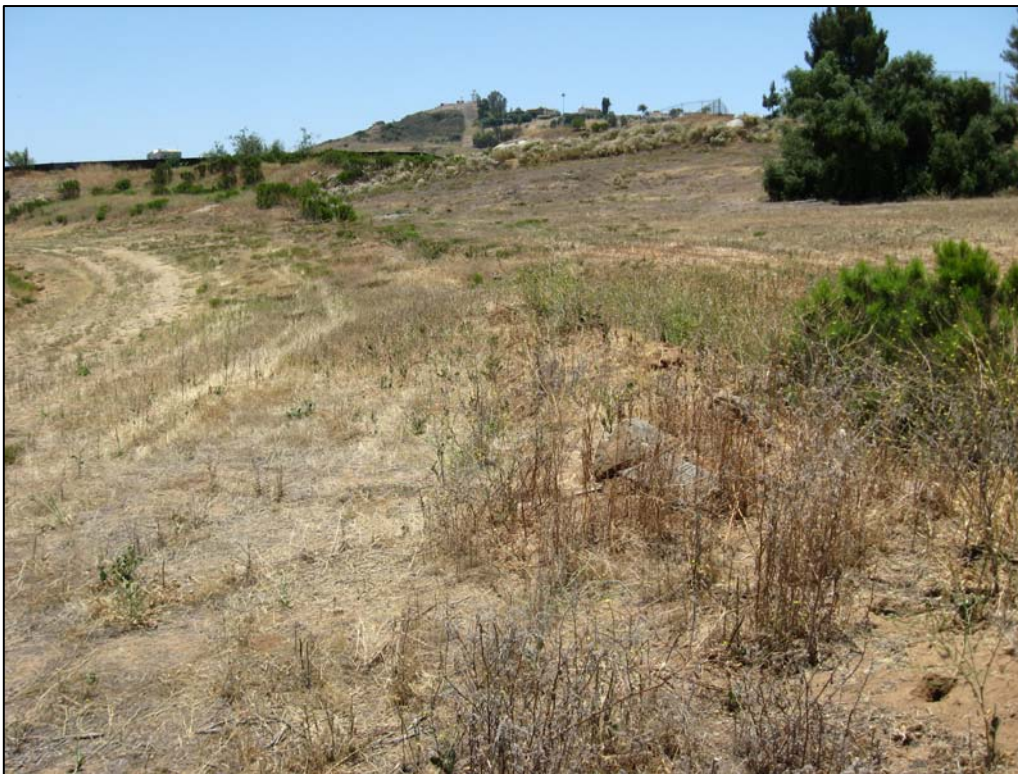
Photo E-2: Terminus of Drainage E, looking upstream. Drainage E transitions from a defined channel to swale-like features surrounded by non-native grassland.

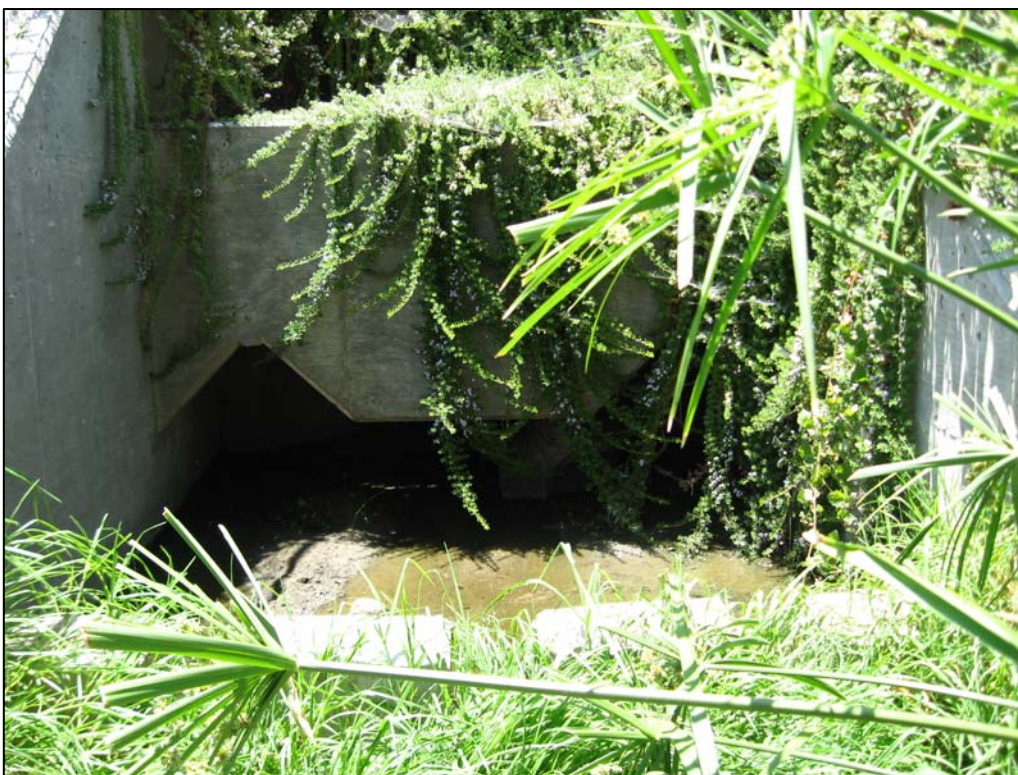
Photo F-1: Square concrete culvert and spillway that conveys off-site flows to Drainage F.

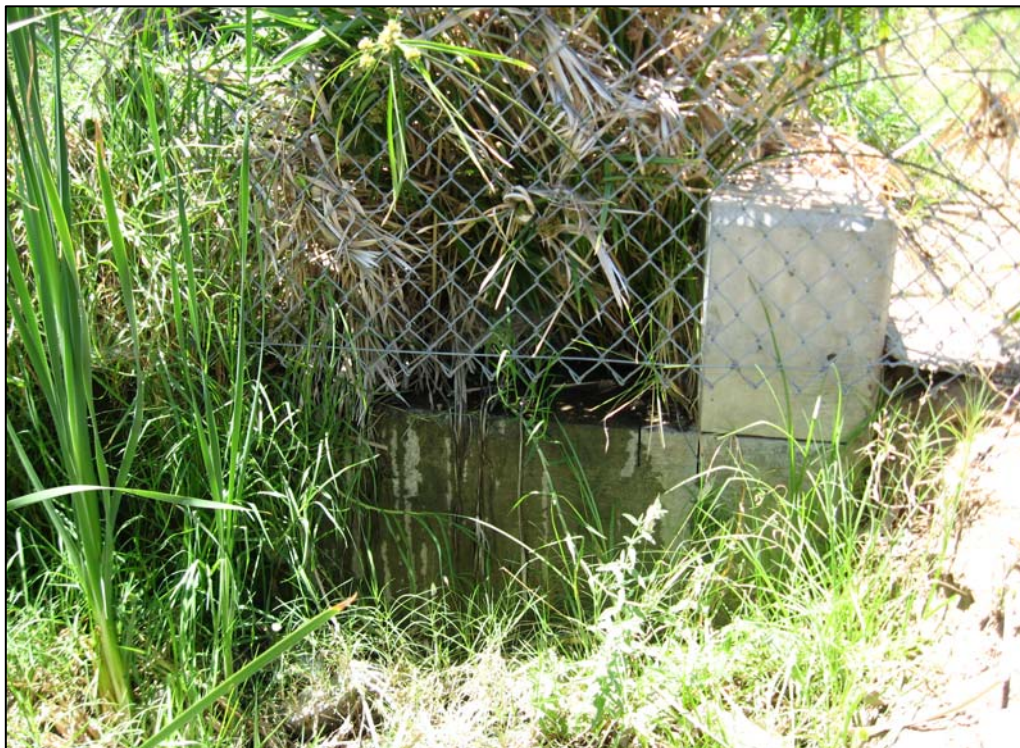
Photo F-2: Water is present in Drainage F due to overtopping of spillway.

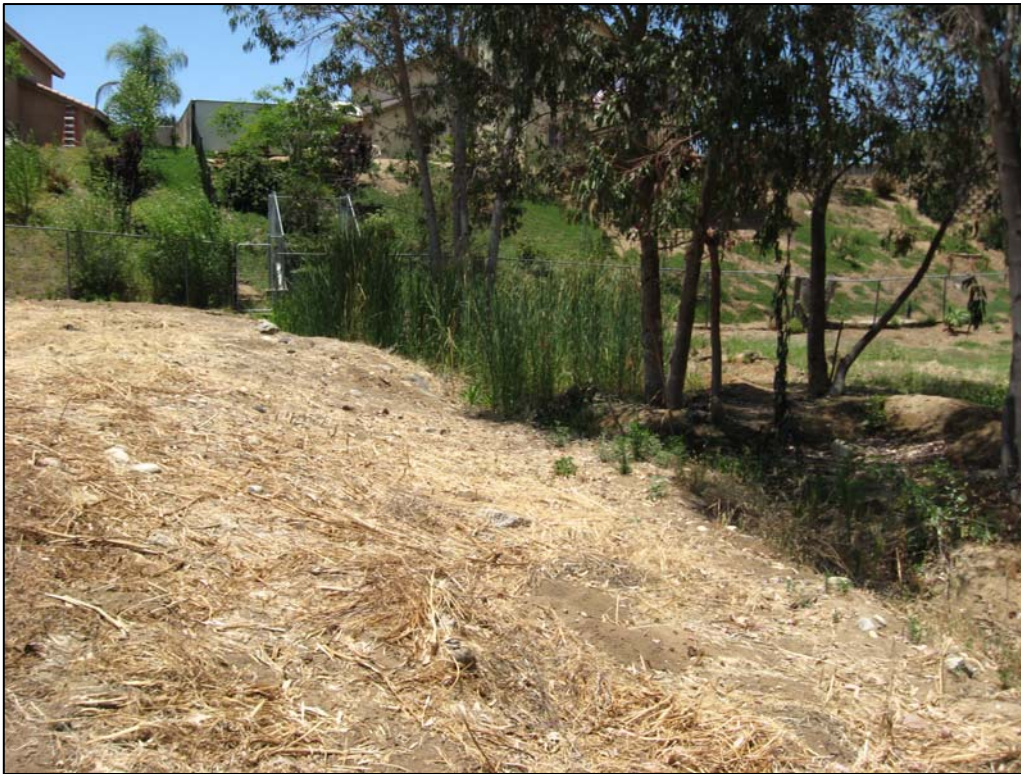
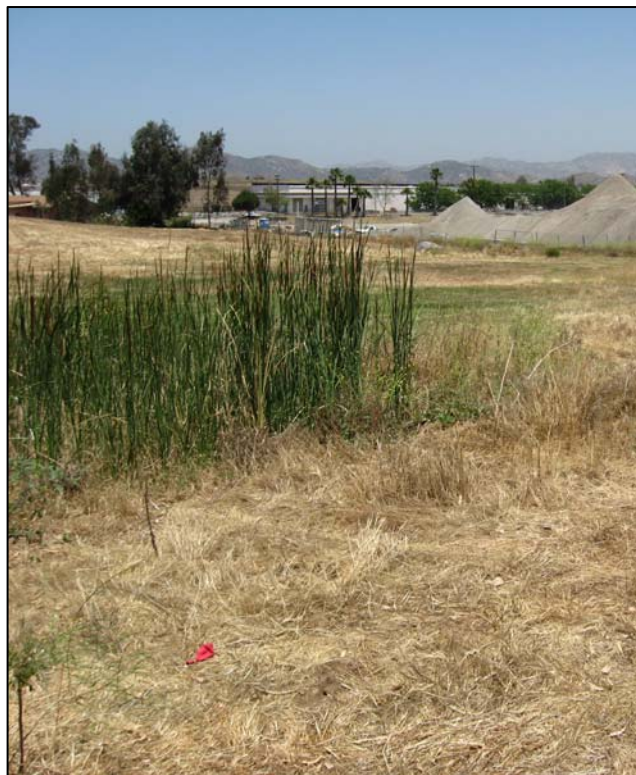
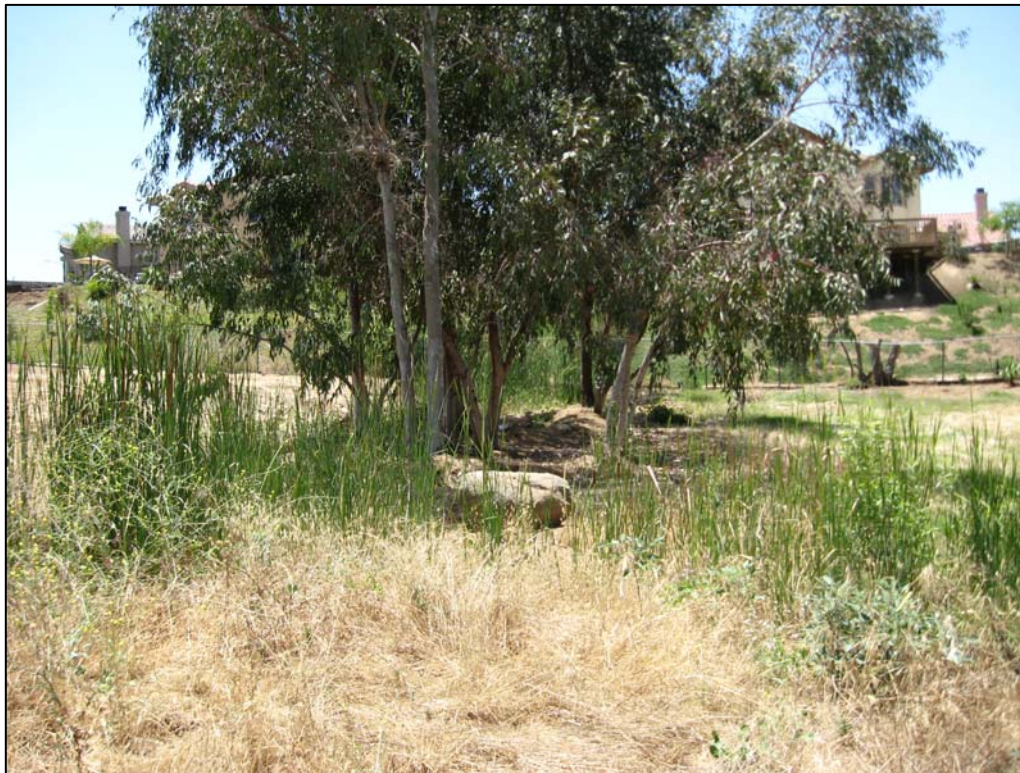
In the middle reach of the drainage, there is a eucalyptus overstory with an understory of disturbed habitat dominated by rabbitfoot, curly dock, and bristly ox-tongue (*Picris echioides*). Water was also present during the field visit in this area. In the lower reaches, from outside of the eucalyptus overstory to the terminus, broadleaf cattails are again the dominant vegetation. Other plant species include jimson weed (*Datura wrightii*) and small palms. The drainage transitions into a swale-like feature into non-native grassland vegetation (Figure 8 and Photos F-4 through F-6).

Photo F-4: Lower reach of Drainage F, looking upstream. The vegetation adjacent to this drainage is a mix of broadleaf cattails and eucalyptus.

Photo F-5: Lower reach of Drainage F, looking at the terminus. The dominant vegetation is broadleaf cattails and the terminus is surrounded by non-native grassland.

Photo F-6: Terminus of Drainage F, looking upstream.

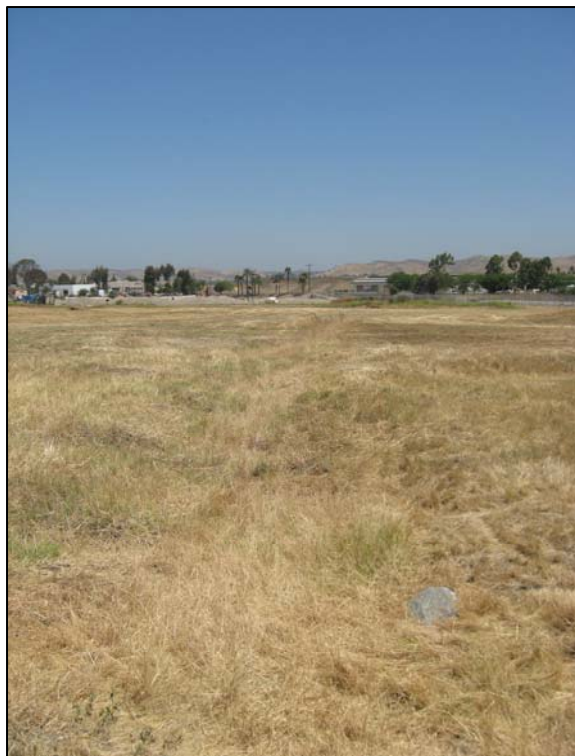
Drainage G is located in the east central portion of the site. The drainage is an isolated, swale-like feature with no discernable OHWM or bed and bank. The drainage is located in non-native grassland vegetation. No functional wetland or riparian vegetation is present (Photo G-1). Drainage G is a non-jurisdictional

Photo G-1: South end of Drainage G, an isolated swale-like feature. There is no defined bed and bank or OHWM. No functional riparian or wetland vegetation is present.
