## **APPENDIX E: 2015 RIPARIAN TREE ASSESSMENT REPORT**

# memorandum

subject    El Monte Valley Tree Assessment for the El Monte Sand Mining and Nature Preserve Project, PDS2015-MUP-98-014W2, PDS2014-RP-15-001, PDS2015-ER-98-14-016B

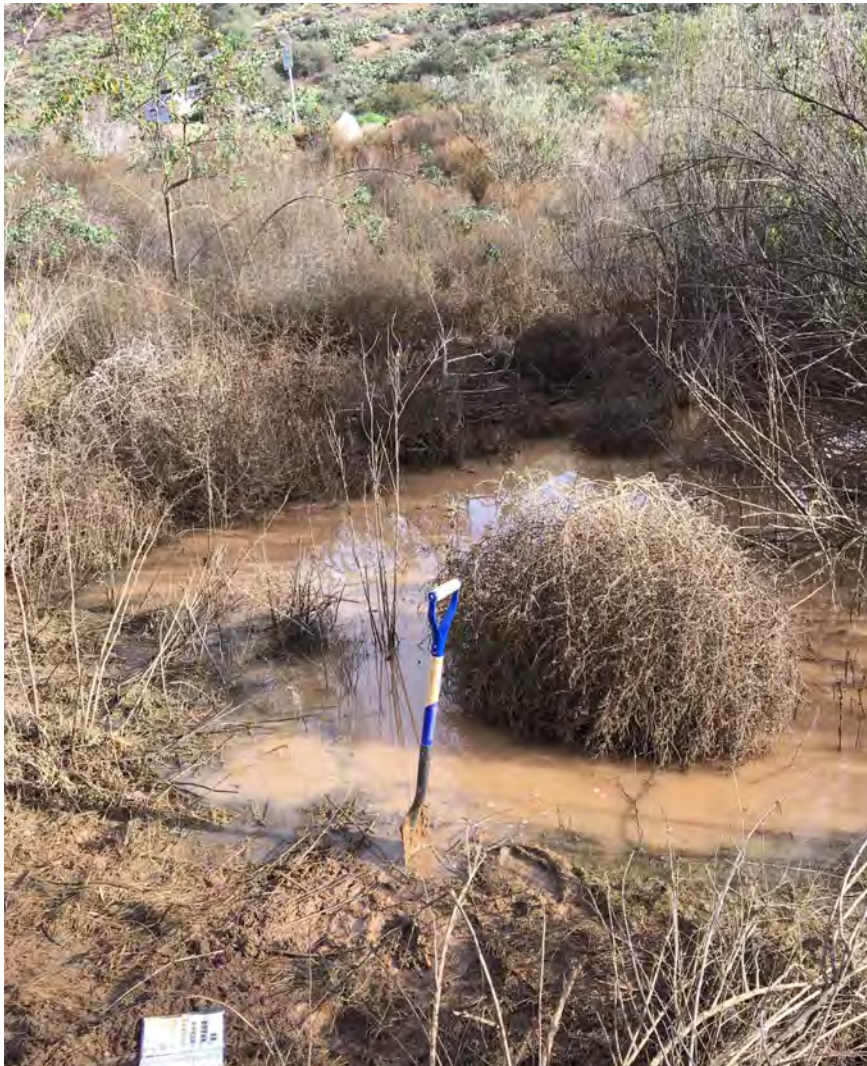
**Site Photograph 3:** Taken near the ponded area, facing northeast towards DP2. Note non-native vegetation surrounding ponded area.

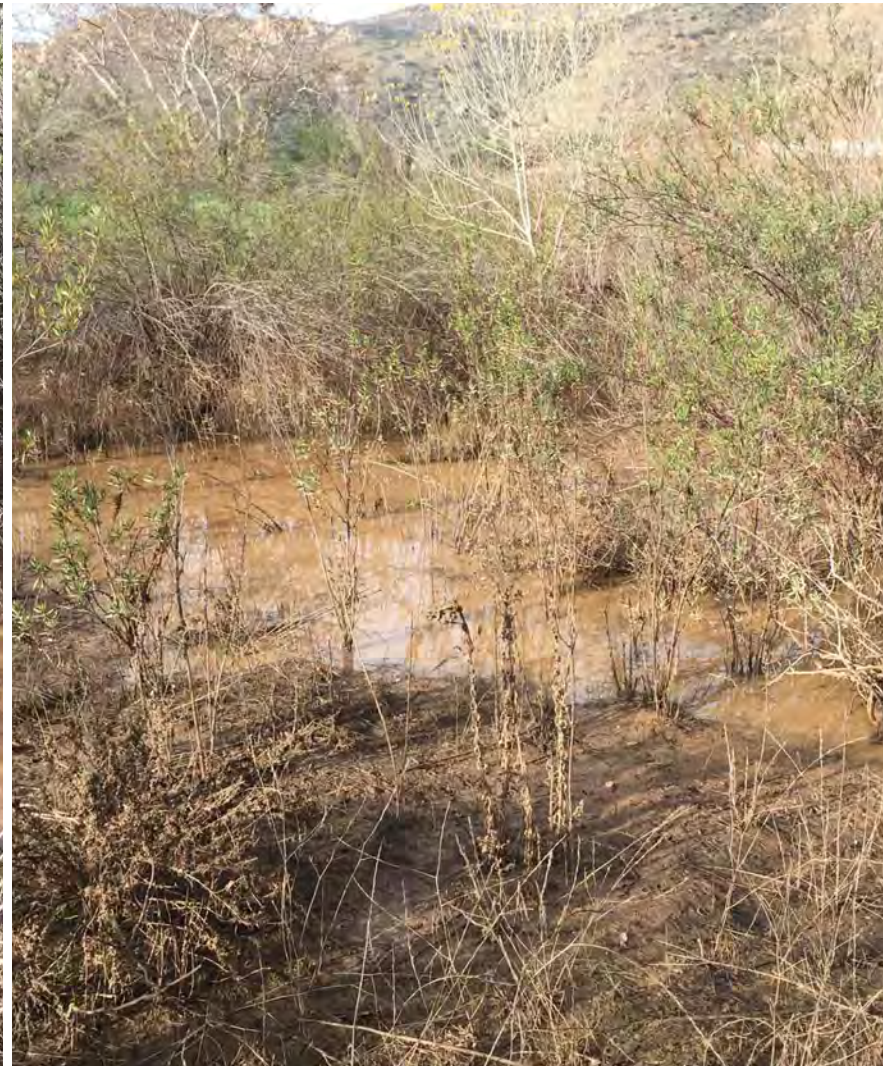
**Site Photograph 4:** Taken near the ponded area, facing northwest towards the pond and wetland area. Note native wetland vegetation within the ponded area.

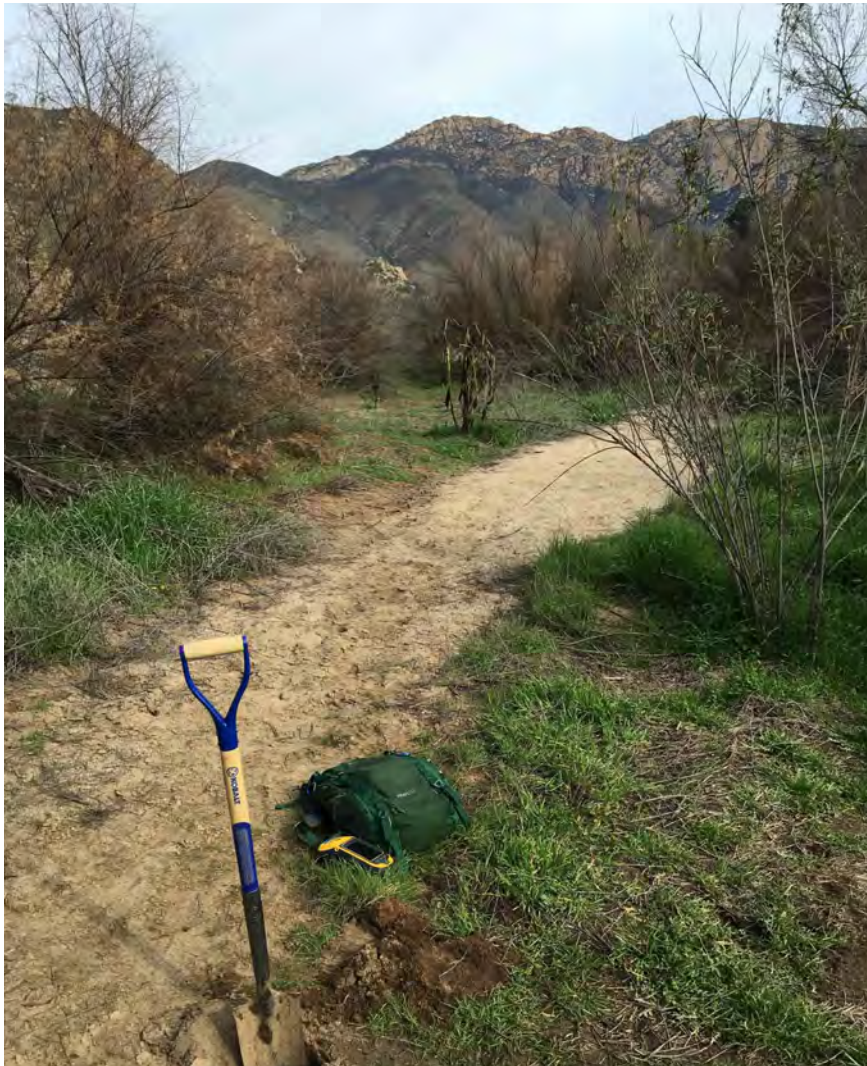
**Site Photograph 5:** Taken from the low-flow channel of the river, facing east towards DP3. Note channel is unvegetated and disturbed as a trail.

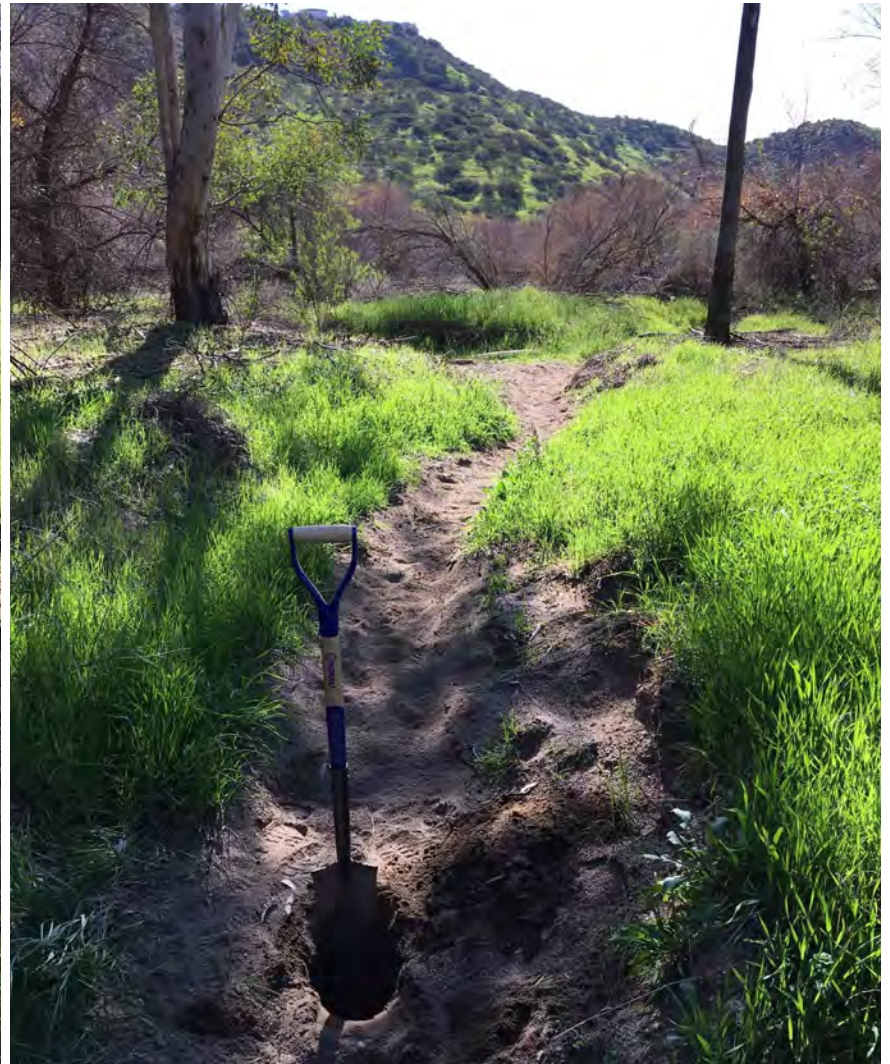
**Site Photograph 8:** Taken from the low-flow channel of the river, facing west towards DP5. Note non-native grasses dominate the adjacent upland areas.

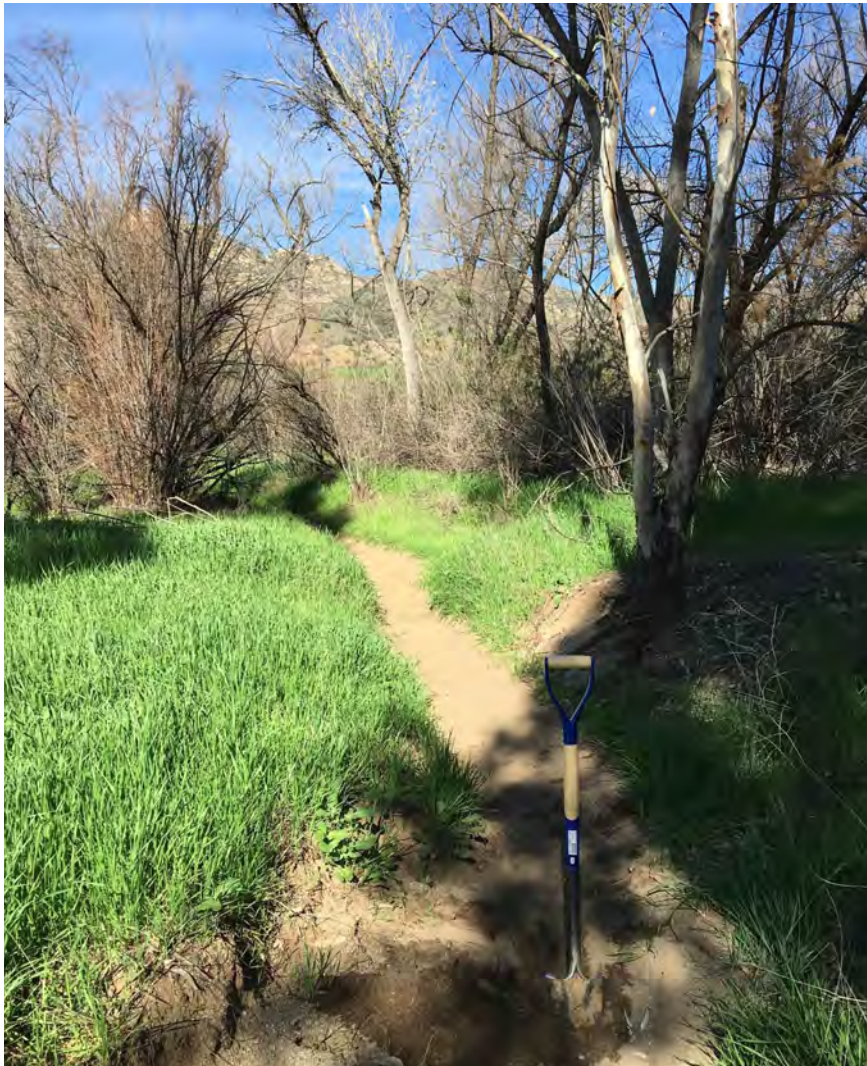
**Site Photograph 9:** Taken from the low-flow channel of the river, facing east towards DP5. Note non-native tree cover in background.
