Limited Phase II Soil Sampling

**Assessor's Parcel Numbers 395-250-08,
-09, -15, and -22, and 398-110-09, -10, and -75
14109, 14135, and 14173 Olde Highway 80,
and 14207 Rios Canyon Road
El Cajon, California**

Subject: Limited Phase II Soil Sampling (Assessment) Revised

**Site: Assessor's Parcel Numbers 395-250-08, -09, -15, and -22, and 398-110-09, -10, and -75
14109, 14135, and 14173 Olde Highway 80 and 14207 Rios Canyon Road
El Cajon, California**

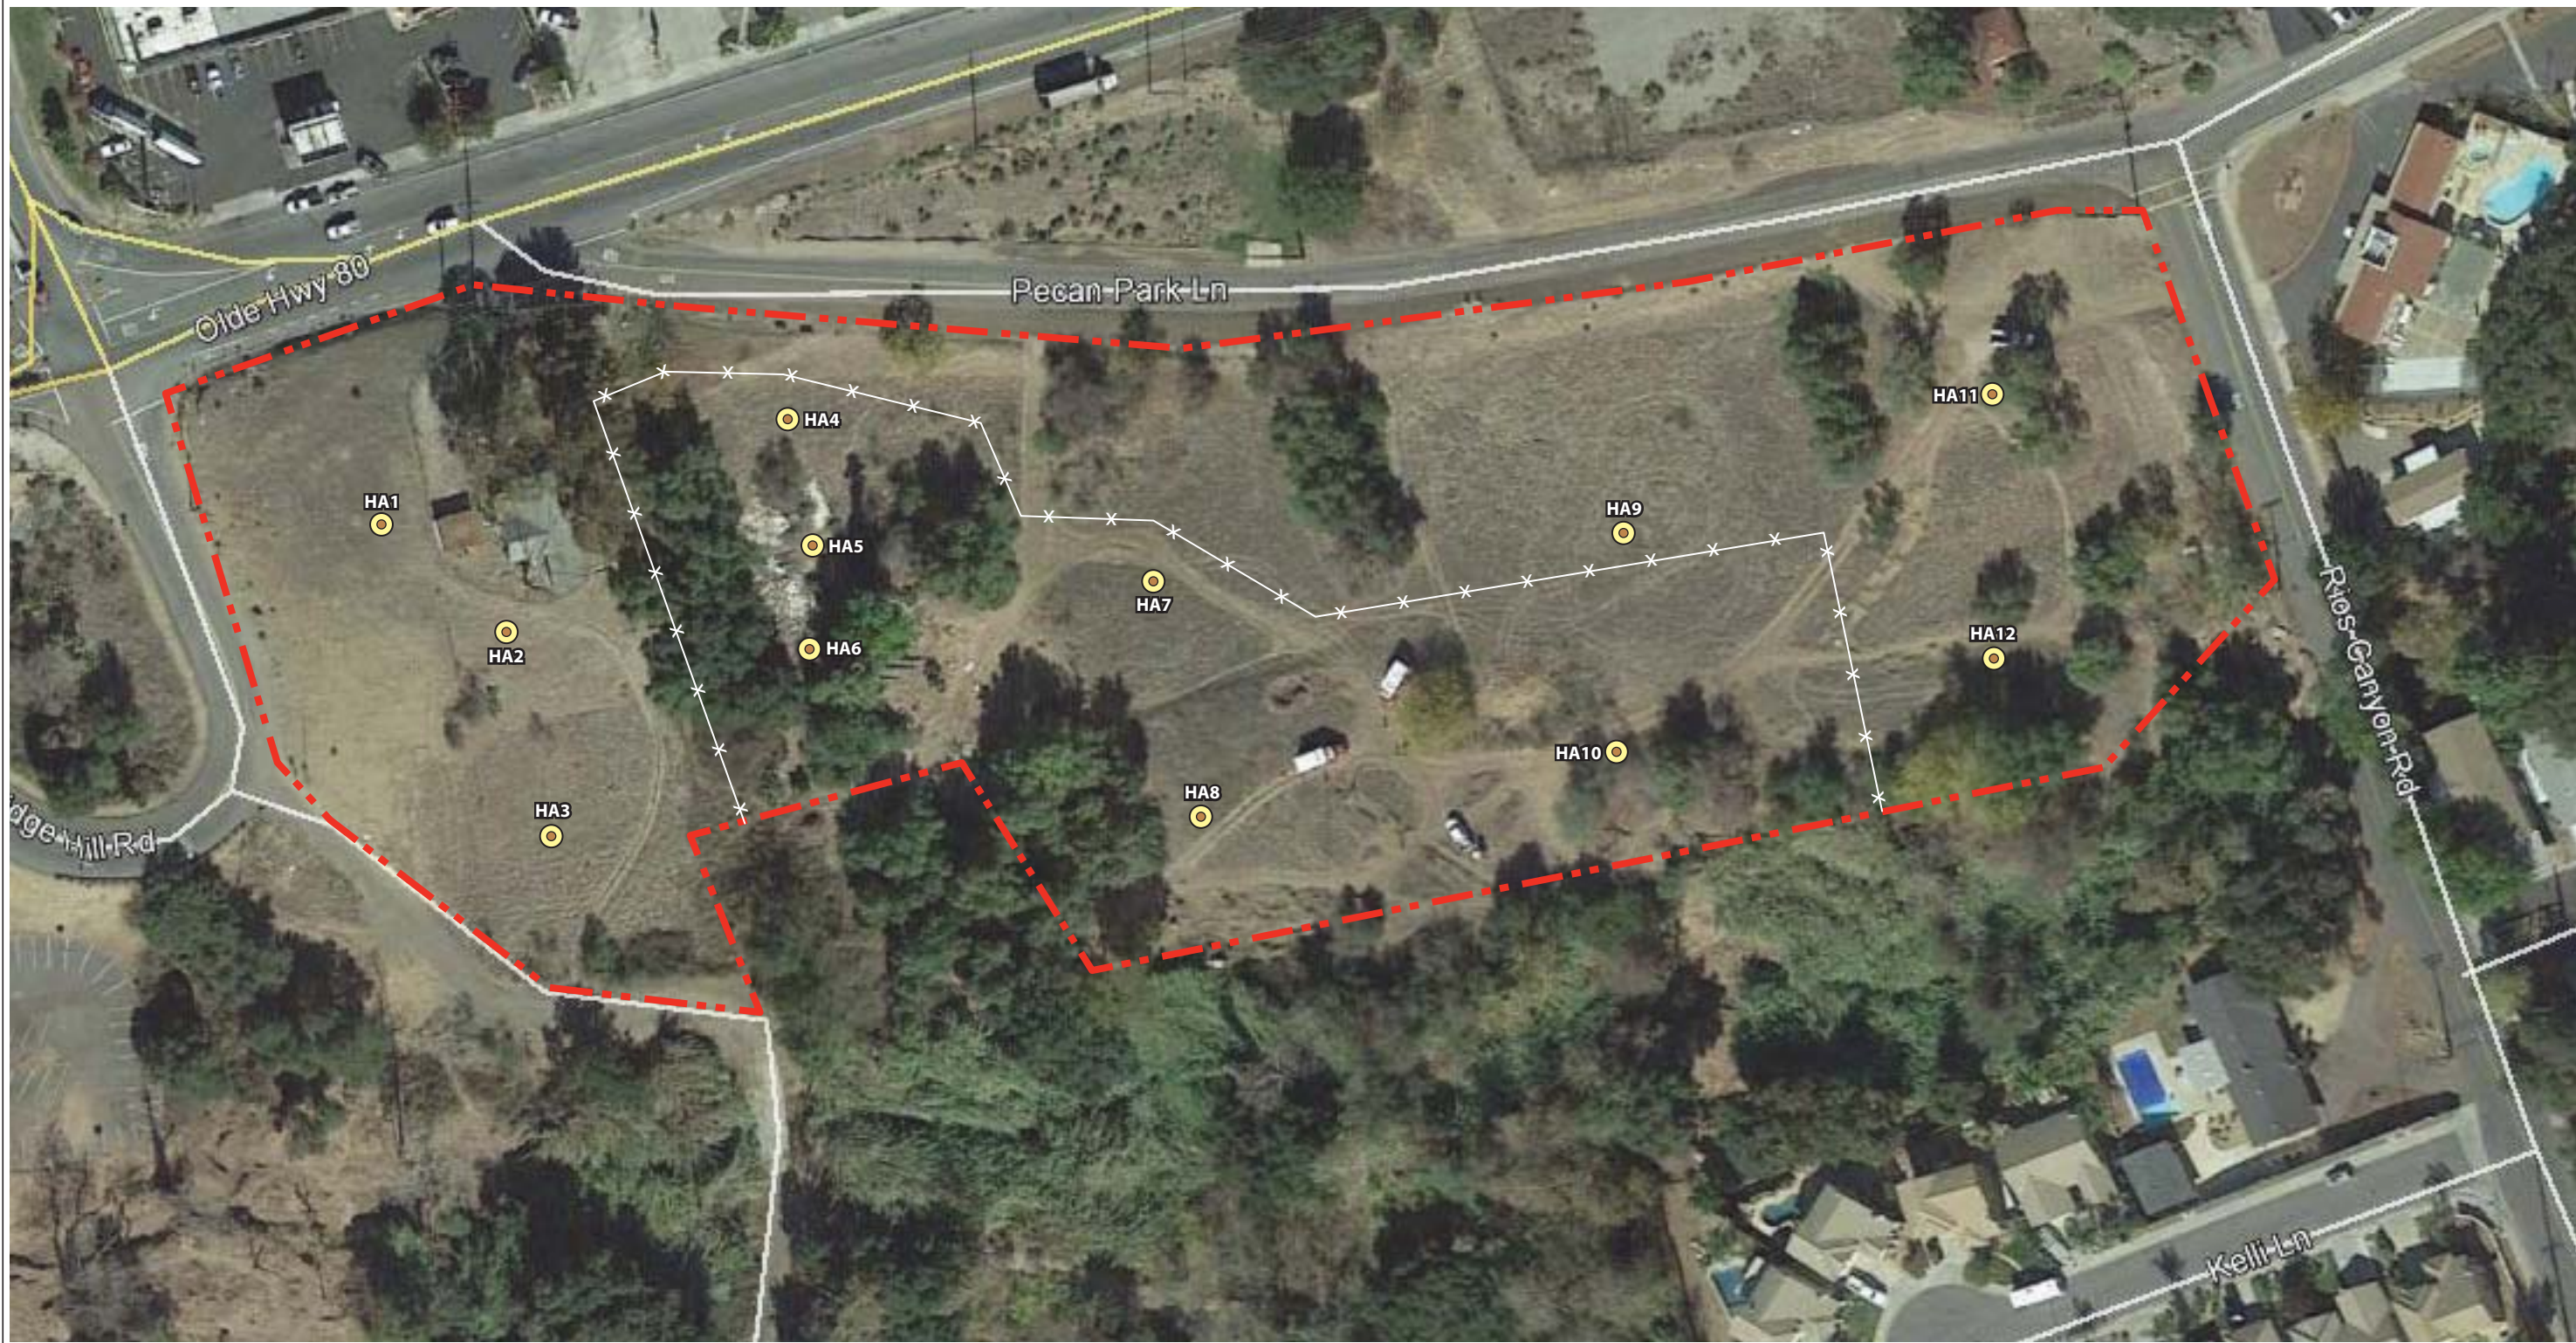
Figure 2

On October 13, 2014, SCS advanced 12 soil borings with the use of a hand auger, collecting samples at approximately 0.5 and 1.5 feet, to assess the extent of OCPs and arsenic in the shallow soil at the Site (Figure 2). The soil samples were placed directly from the hand auger into 4-ounce glass jars. The jars were closed, labeled, and placed in an ice-filled cooler for shipment to the laboratory. Chain-of-custody procedures were implemented for sample tracking.

Hand auger borings advanced by SCS on October 13, 2014

SITE PLAN WITH SOIL SAMPLING LOCATIONS

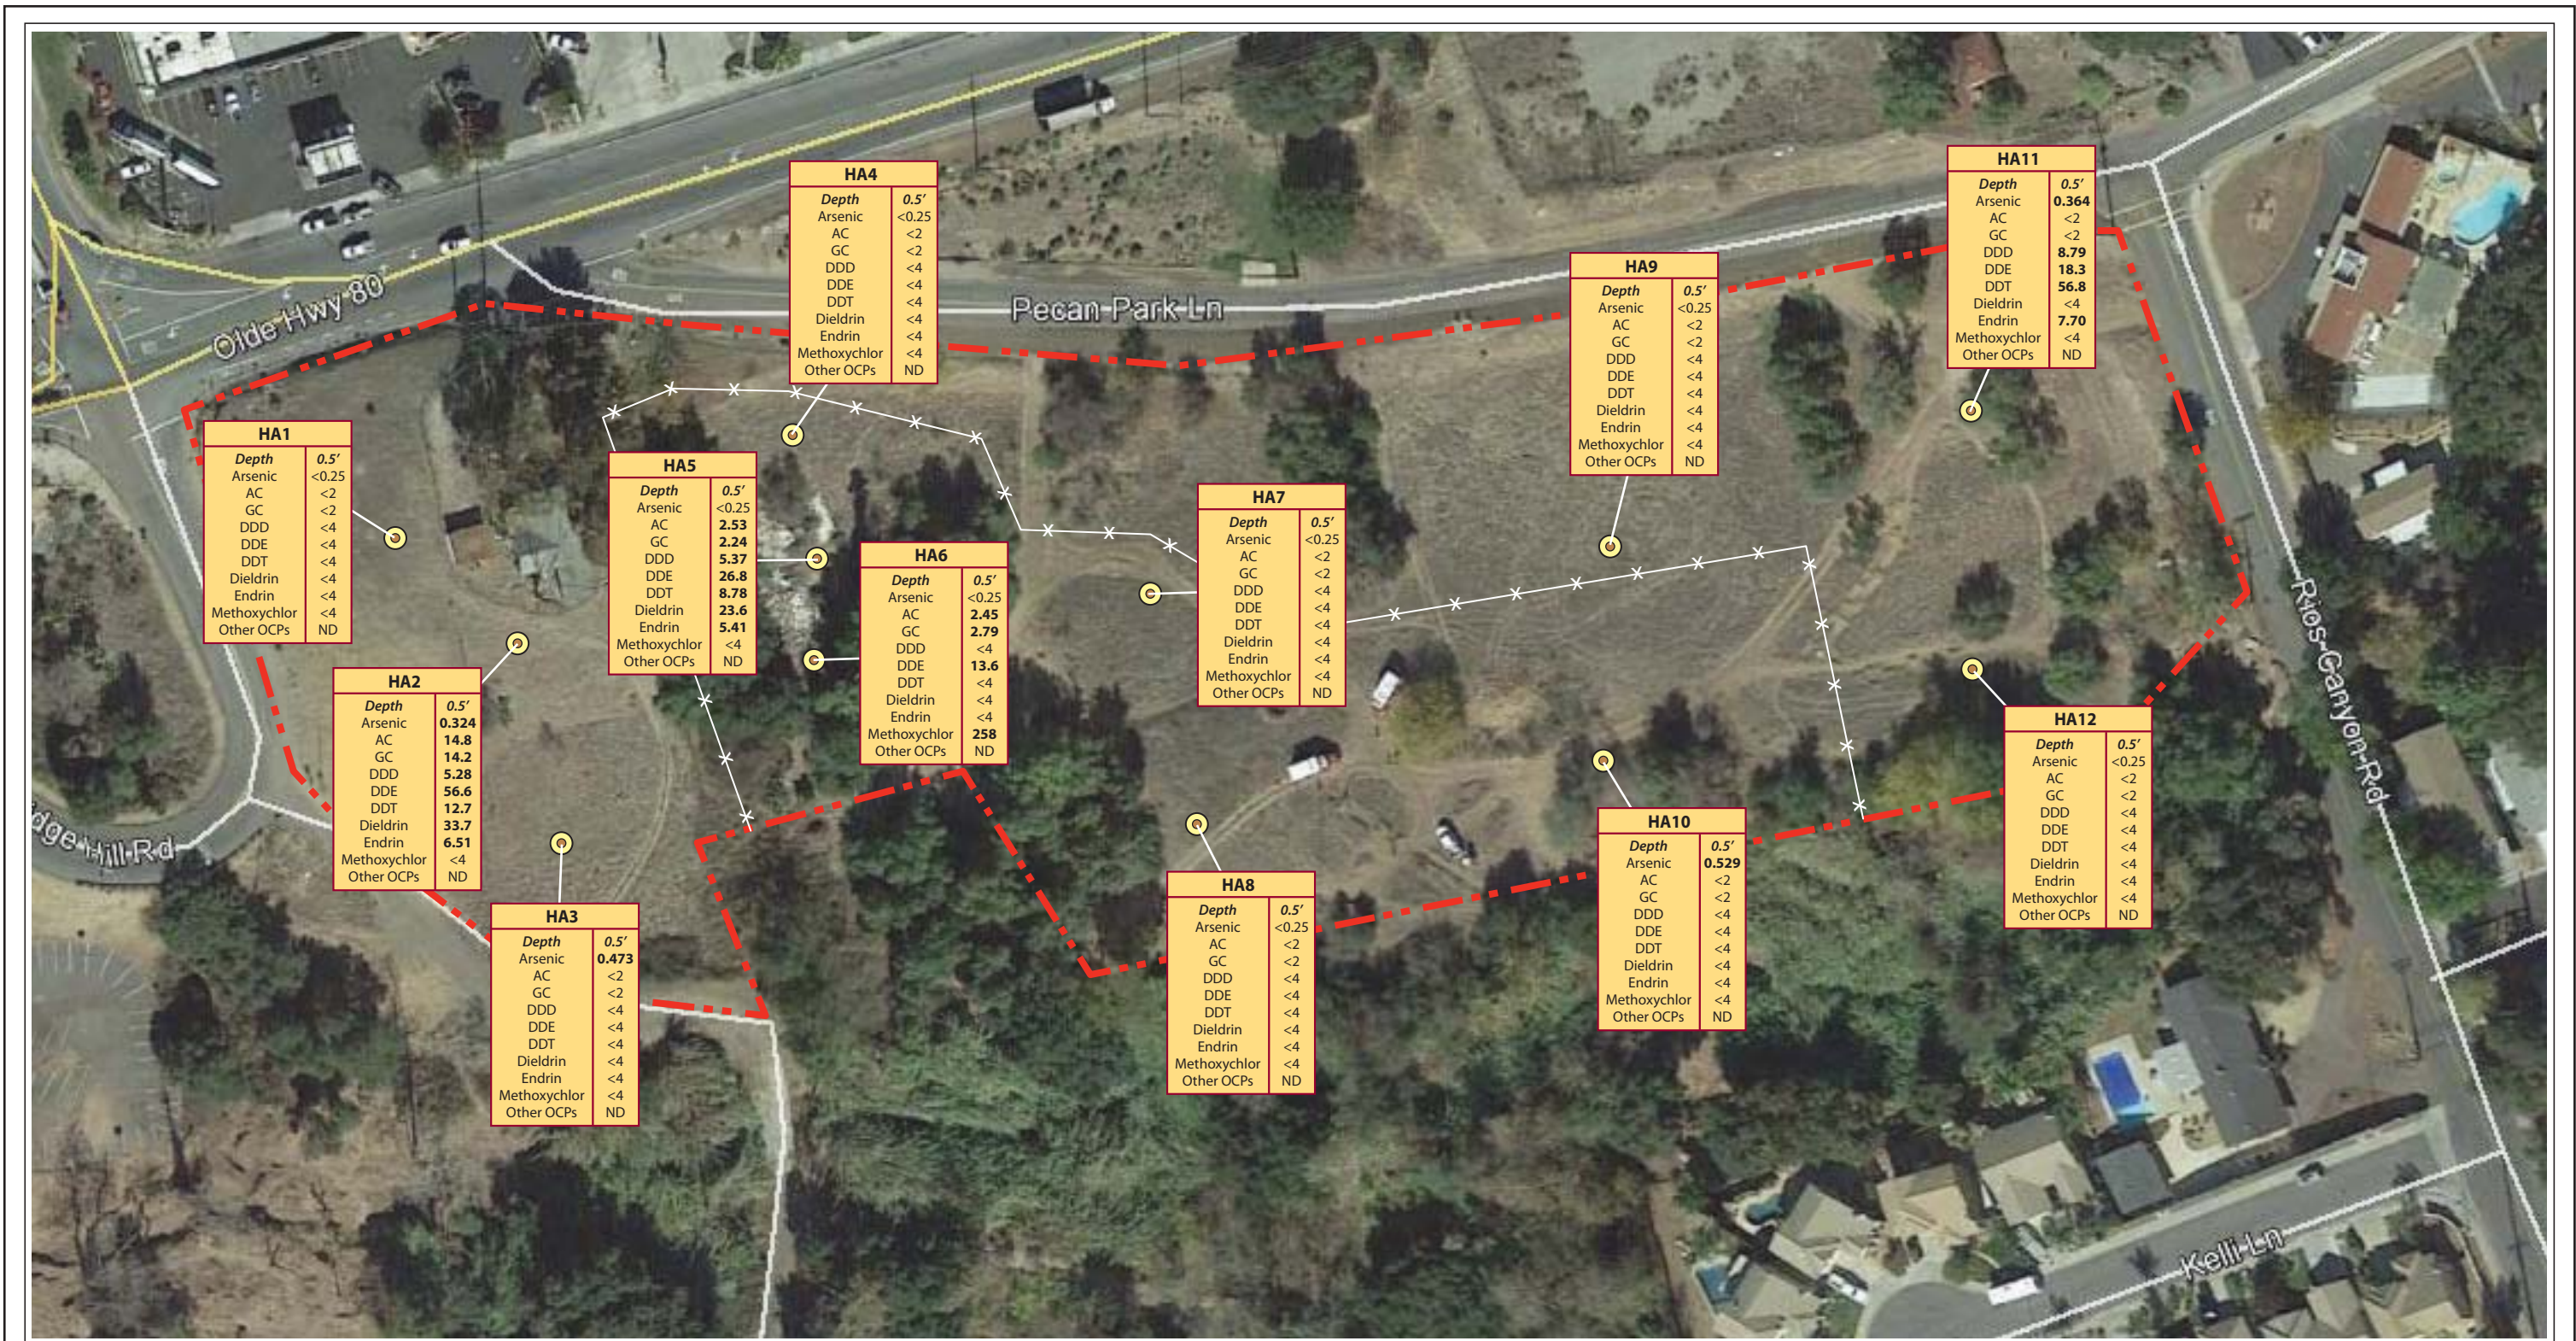
Figure 3

A summary of the laboratory results for arsenic and select OCPs from the soil samples analyzed are presented in Table 1 and depicted on Figure 3. A complete listing of the results of arsenic and OCPs analyzed are presented in Appendix B.

HA11	
Depth	0.5'
Arsenic	0.364
AC	<2
GC	<2
DDD	8.79
DDE	18.3
DDT	56.8
Dieldrin	<4
Endrin	7.70
Methoxychlor	<4
Other OCPs	ND

Soil samples, with depth in feet below grade, analyzed for arsenic by EPA Method 6010B with results reported in milligrams per kilogram (mg/kg); organochlorine pesticides (OCP) by EPA Method 8081A with results reported in micrograms per kilogram (µg/kg). **Bold** numbers indicate sample results above the laboratory reporting limit. < indicates results less than the laboratory reporting limit; number indicates individual analyte reporting limit.

SITE PLAN WITH SOIL SAMPLE ANALYTICAL RESULTS

- Based on the reported presence of low concentrations of OCPs in various areas of the Site, this report should be disclosed to construction/grading contractors that may disturb or excavate Site soils. We recommend the construction/grading contractors address possible worker exposures by using dust suppression or control measures (i.e., spraying dust with water), encouraging hygiene practices such as hand washing before eating and at the completion of the job, and washing clothes from the jobsite prior to engaging in other activities off the job site, as is appropriate.
