Appendix 3
Channel Screening Analysis

HYDROMODIFICATION SCREENING

NEWLAND SIERRA

January 14, 2015

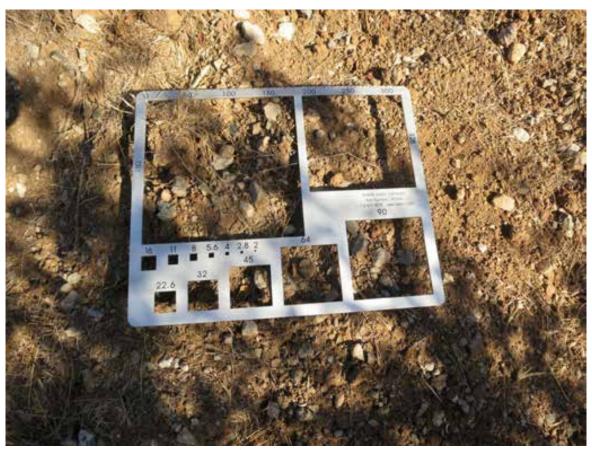
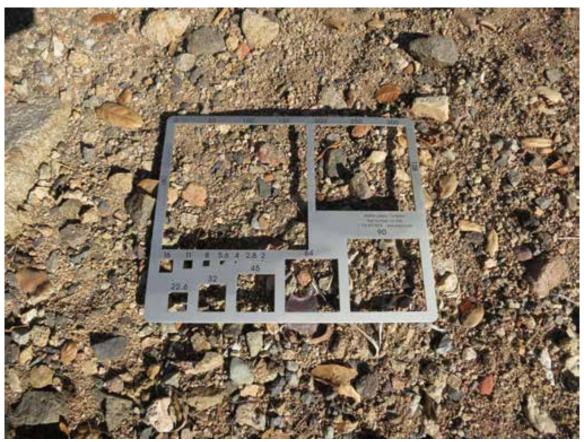
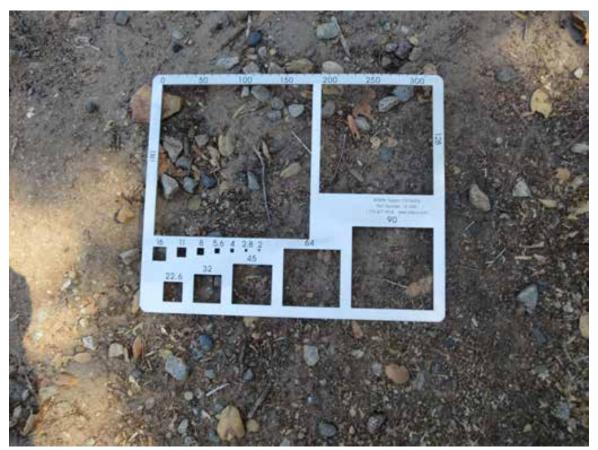
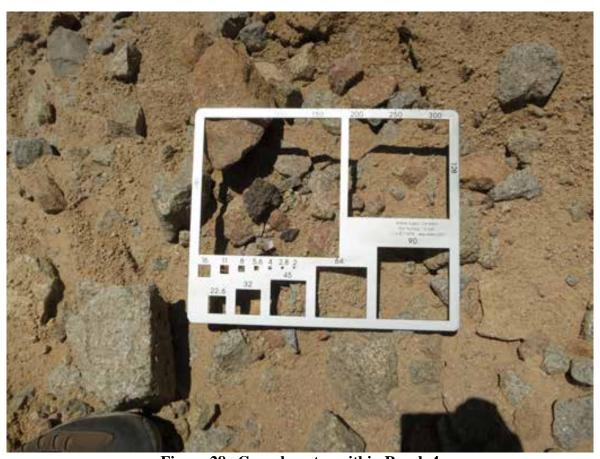
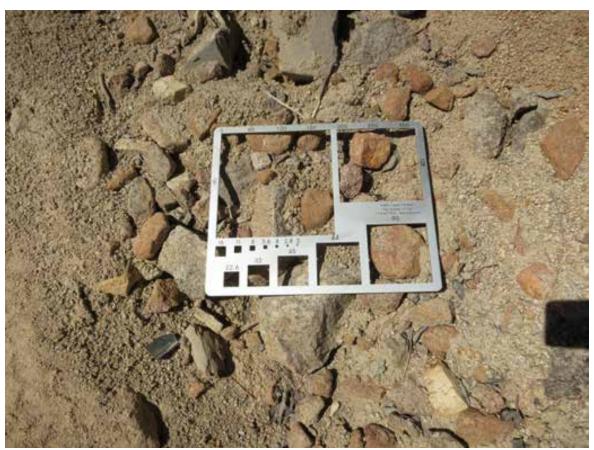
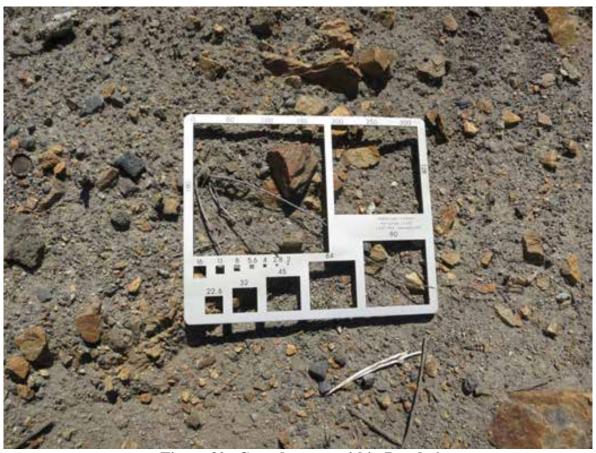
Figure 25. Gravelometer within Reach 1

Figure 26. Gravelometer within Reach 2

Figure 27. Gravelometer within Reach 3

Figure 28. Gravelometer within Reach 4

Figure 29. Gravelometer within Reach 5

Figure 30. Gravelometer within Reach 6

Figures 25 through 30 contain photographs of the bed material along each of the six study reaches. A gravelometer is included in the photographs for reference. Each square on the gravelometer indicates grain size in millimeters (the squares range from 2 mm to 180 mm). Based on the photographs and site investigation, the bed material and resistance is generally within the transitional/intermediate bed category in all reaches. There was no evidence of a threshold bed condition. However, some bed areas contained smaller grain sizes found in a labile bed and some areas contained large boulders. A pebble count was performed that determined the median (d₅₀) bed material sizes for Reaches 1 through 6 varies from 11 to 180 millimeters (see Appendix B). Figure 6-4 in the County HMP indicates that a d₅₀ of 16 mm or greater is within the transitional/intermediate bed category. Dr. Eric Stein from SCCWRP, who co-authored the *Hydromodification Screening Tools: Field Manual* in the *Final Hydromodification Management Plan* (HMP), indicated that it would be appropriate to analyze channels with multiple factors that impact erodibility using the transitional/intermediate bed procedure. This requires the most rigorous steps and will generate the appropriate results for the size range.

The d_{50} value is the particle size in which 50 percent of the particles are smaller and 50 percent are larger. The pebble count results for each study reach is included in Appendix B and summarized in Table 2. The screening index values (INDEX) for the reaches are tabulated on Form 1 in Appendix A and also included in Table 2. The Screening Index Threshold diagram in Appendix B provides 50% Risk values for various d_{50} values. These values are included in the last column of Table 2. If the INDEX value is less than the 50% Risk value, the reach has less than 50 percent probability of incising and falls within Category A. Table 2 shows that this is the case for all six study reaches.
