## PHOTOGRAPHIC RECORD

**Newland Sierra, LLC**

**San Diego County, California**

**10618.002**

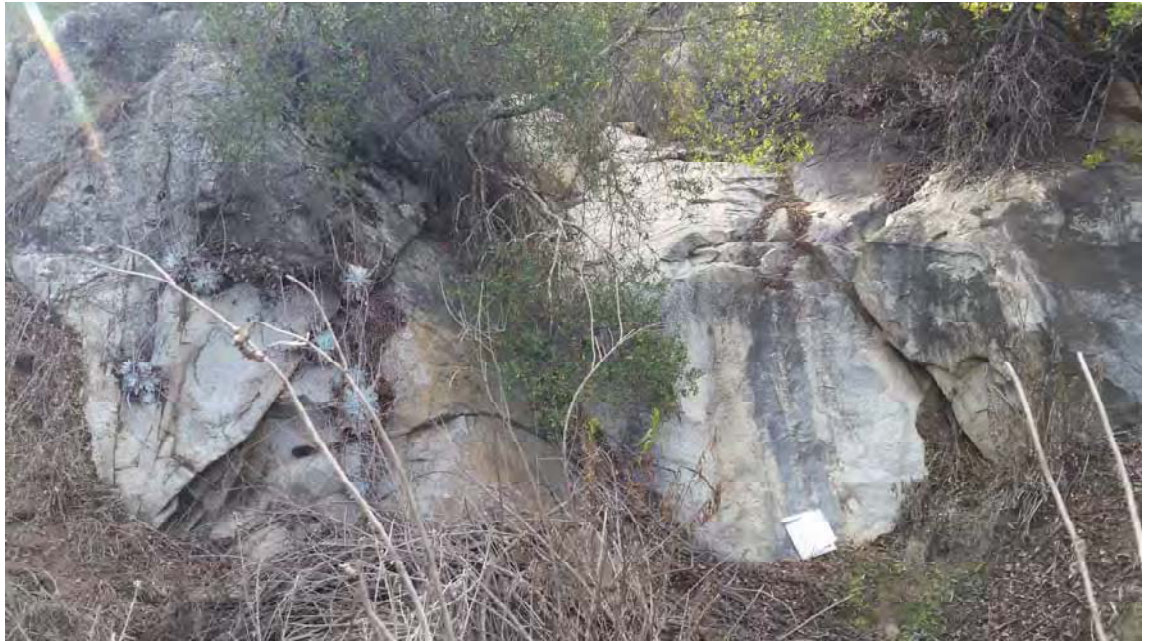
**Photo No. 1**

View of POC 19, hard rock waterfall and resulting grade control structure.

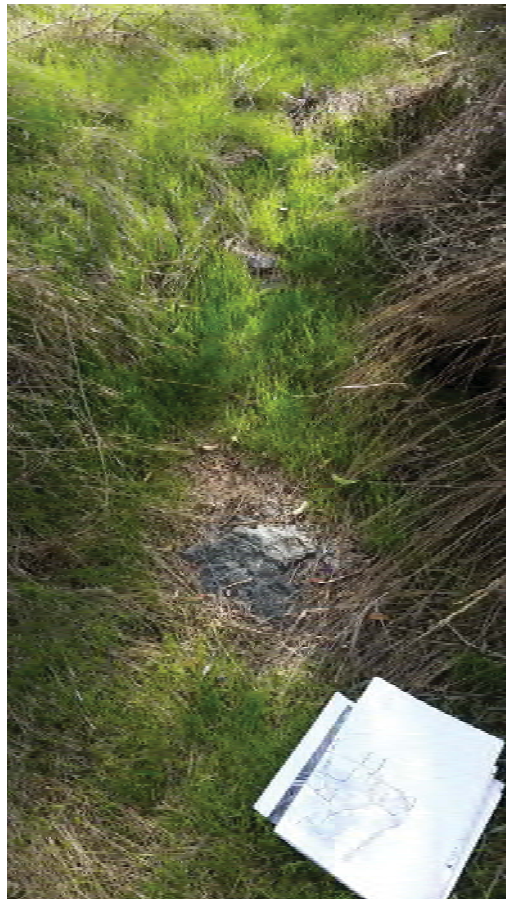
**Photo No. 2**

View of POC 19, Grass growing in hard rock channel with hard bedrock visible at surface of channel

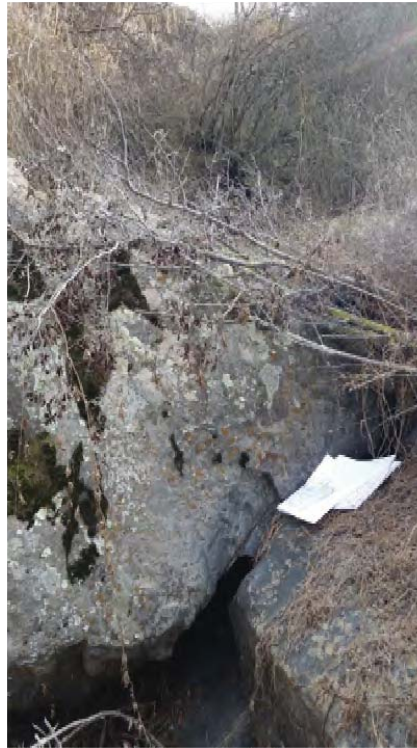
**Photo No. 3**

View of POC 19, Hard rock pile and resulting waterfall grade control structure.

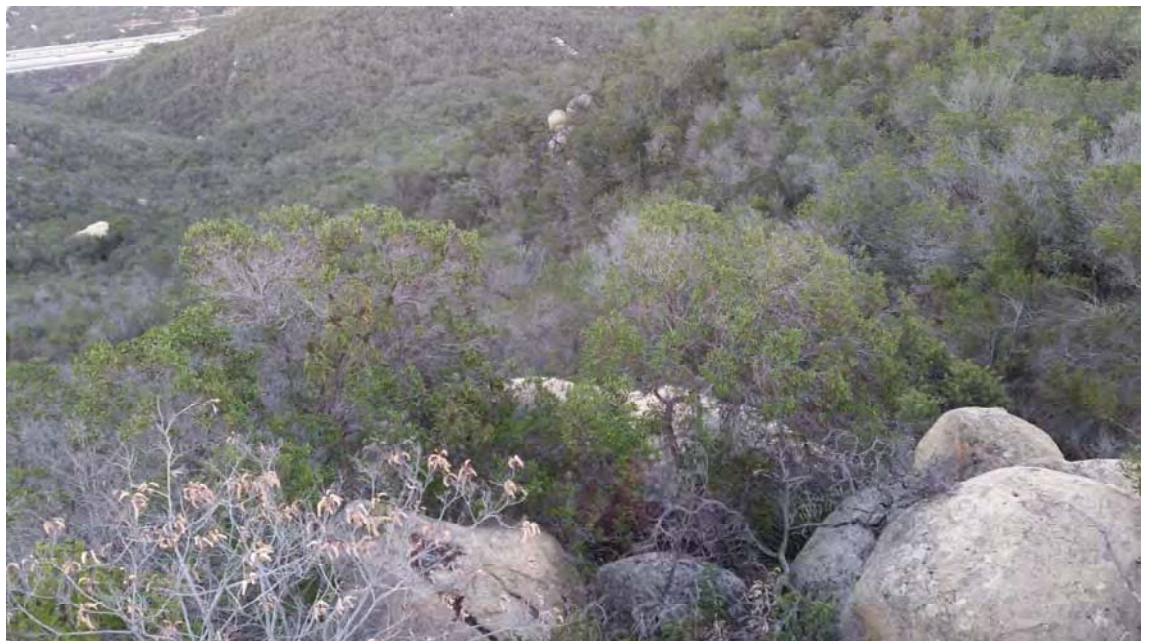
**Photo No. 4**

View of upper POC 13B Reach C with large boulders.

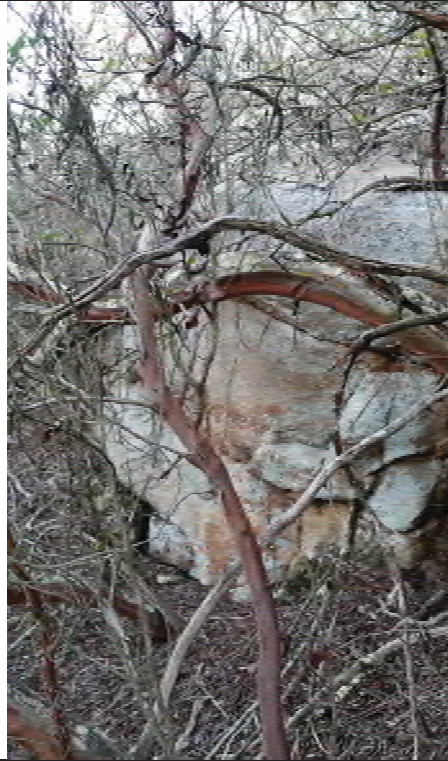
**Photo No. 5**

View of upper area of POC 13B Reach C, dense brush, large boulder control structure, dense brush and leaves

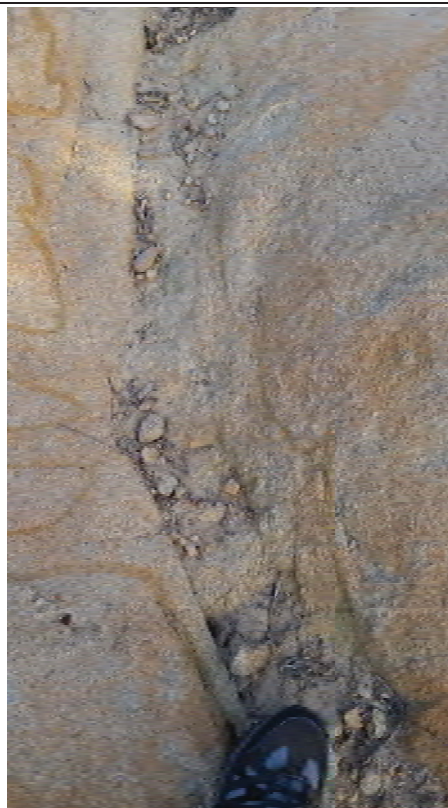
**Photo No. 6**

View of upper area of POC 13B Reach C, where very hard bedrock is exposed in channel bottom. Note a lack of sediment to sample.

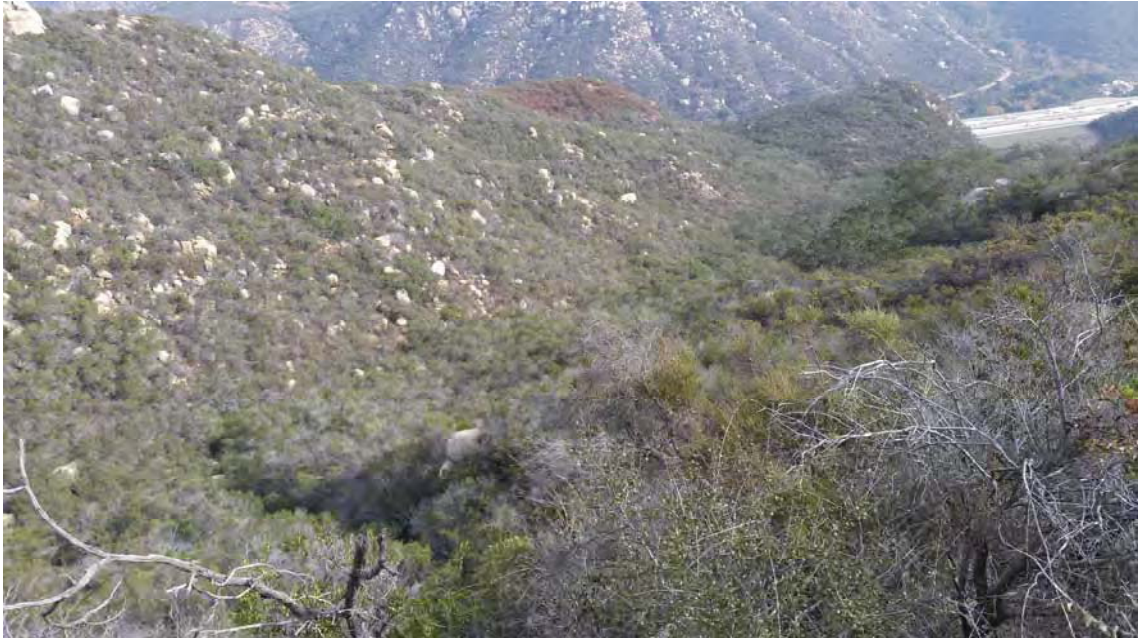
<b>Photo No. 8</b>

<b>Photo No. 7</b>	 	
<b>View Direction of Photo:</b> South		
<b>Description:</b> View of upper area of POC 13B Reach B, dense brush, large boulder control structure.

<b>View Direction of Photo:</b> East		
<b>Description:</b> View of upper area of POC 13B Reach B, standing above the dense brush and large boulder control structures.

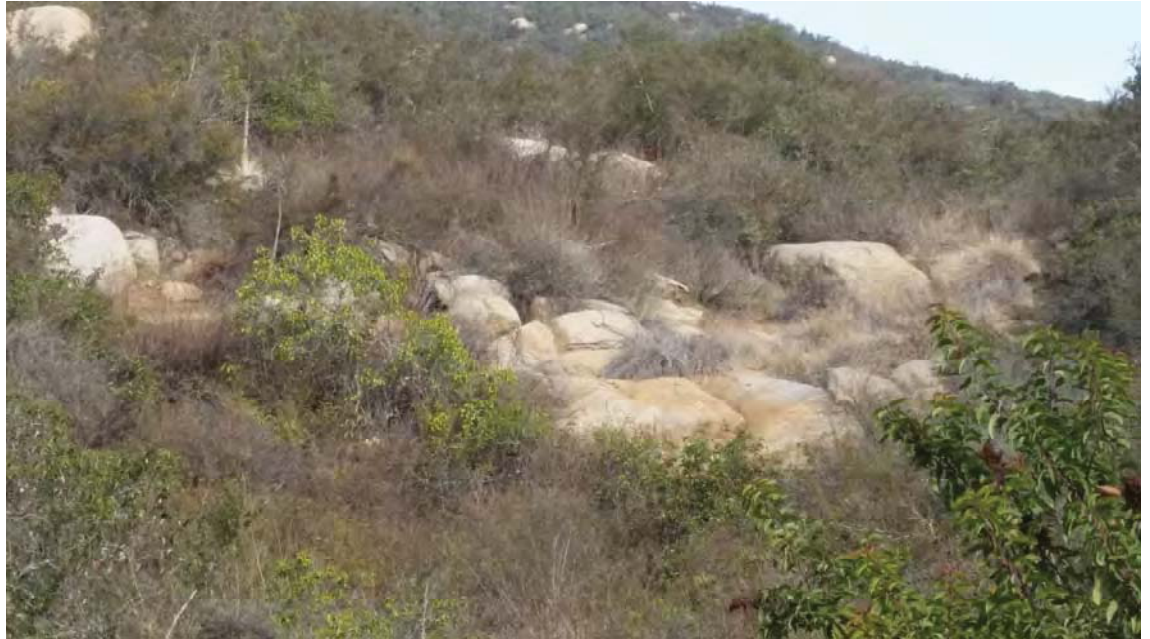
**Photo No. 9**

View of upper portion of POC 26, note large bedrock exposures at surface of channel creating a control structure. Also note very dense brush and a lack of sediment.

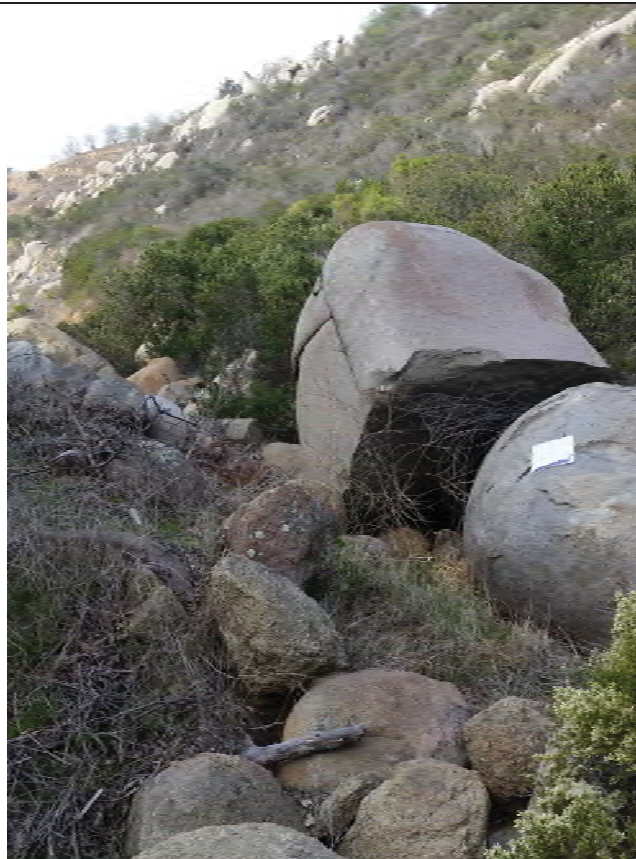
**Photo No. 10**

View of POC 26, note large boulders in channel creating a massive control structure through out the drainage. Also note very dense brush and a lack of sediment.
