OTAY 250, TRACT 5607 OTAY MESA, CALIFORNIA

HYDROMODIFICATION SCREENING FOR

OTAY 250

August 15, 2016

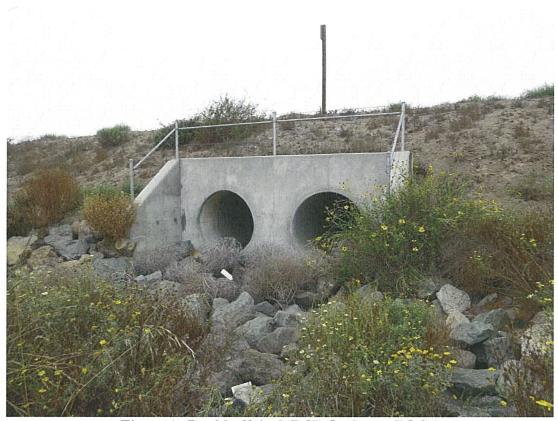
Figure 1. Double 60-inch RCP Outlets at POC 1

As mentioned in the Introduction, storm runoff from the easterly portion of the project will be conveyed to existing double 60-inch RCPs that cross Otay Mesa Road. The RCPs discharge into a natural drainage course on the south side of Otay Mesa Road. The RCP outlets correspond to POC 1. The downstream domain of analysis for the easterly project area is selected below POC 1.

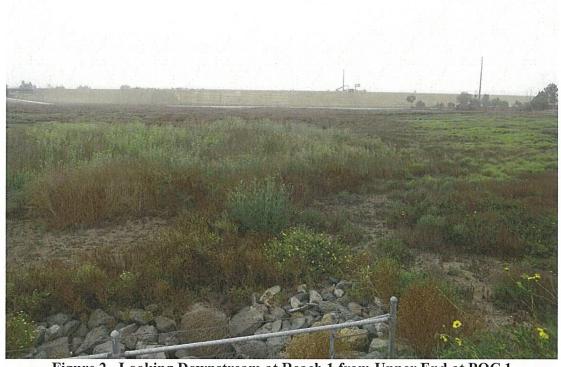
Figure 2. Looking Downstream at Reach 1 from Upper End at POC 1

For POC 1, the entire domain of analysis extends along the natural drainage course from the RCP outlets to Caltrans' concrete channel and covers approximately 1,208 feet. The domain of analysis was subdivided into two study reaches with similar characteristics (see the Study Area Exhibit). Reach 1 (upper reach) is 554 feet long and extends below POC 1. Reach 2 (lower reach) is 654 feet long and extends from the downstream end of Reach 1 to the concrete channel. Each reach is within the 656 feet maximum reach length specified by SCCWRP.
