# **HARMONY GROVE VILLAGE SOUTH**

### **HYDROMODIFICATION SCREENING ANALYSIS**

# HYDROMODIFICATION SCREENING FOR HARMONY GROVE VILLAGE SOUTH (PDS 2008-2700-15498 & PDS 2008-2140-5394-1)

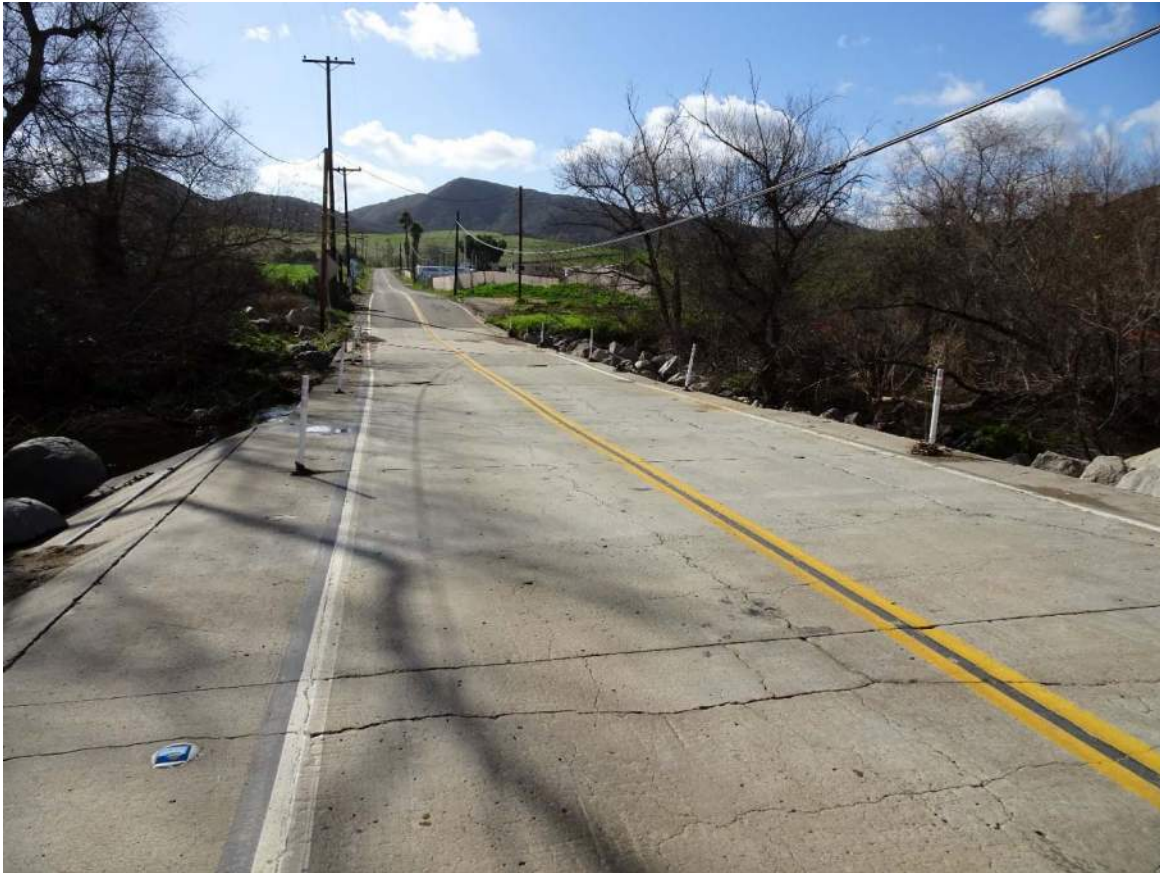
**Figure 1. Country Club Drive (Grade Control) at Upper End of POC 1**

POC 1 is just downstream of Country Club Drive. The Country Club Drive Arizona crossing is the first grade control point upstream of POC 1. Country Club Drive and its culverts will be replaced with a bridge as part of the project. However, the riprap grade control along Country Club Drive will remain. Since the grade control is immediately upstream of POC 1, the upstream domain of analysis location for POC 1 is at POC 1.

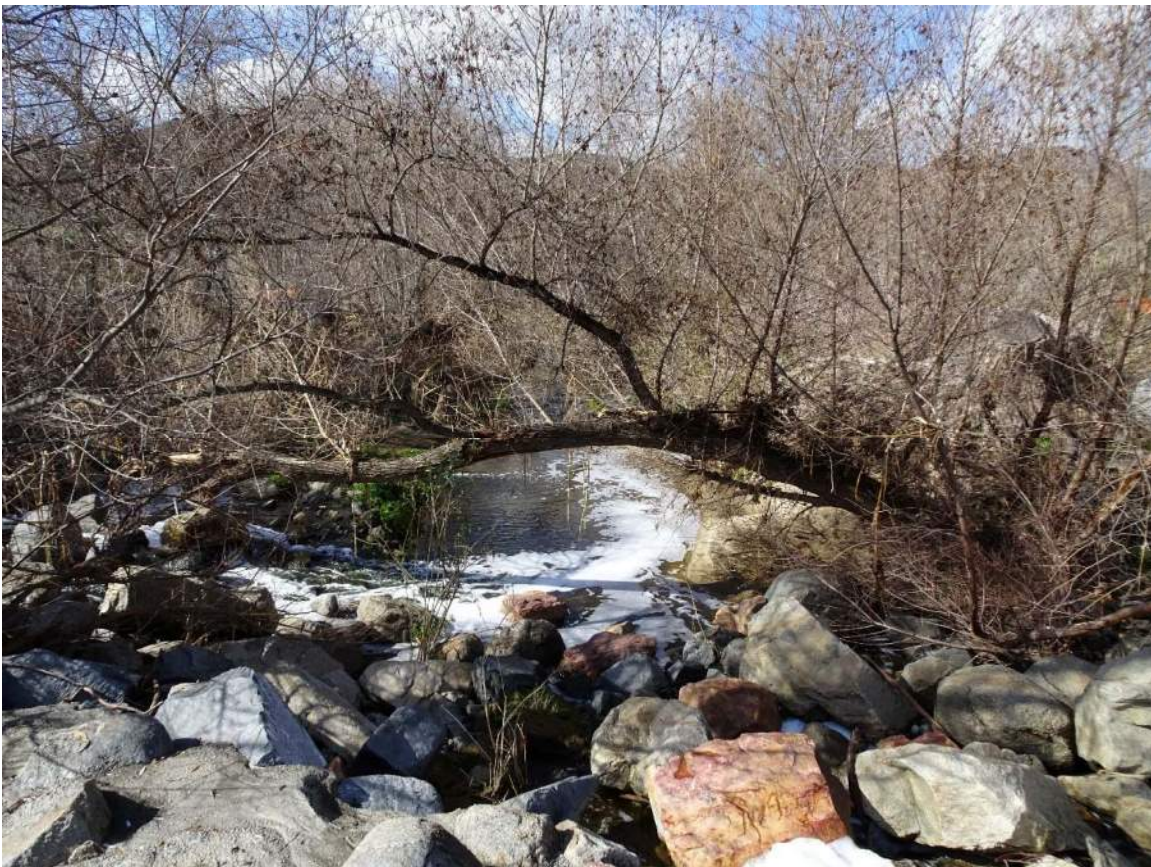
**Figure 2. Looking Downstream at Reach 1 from Upper End at POC 1**

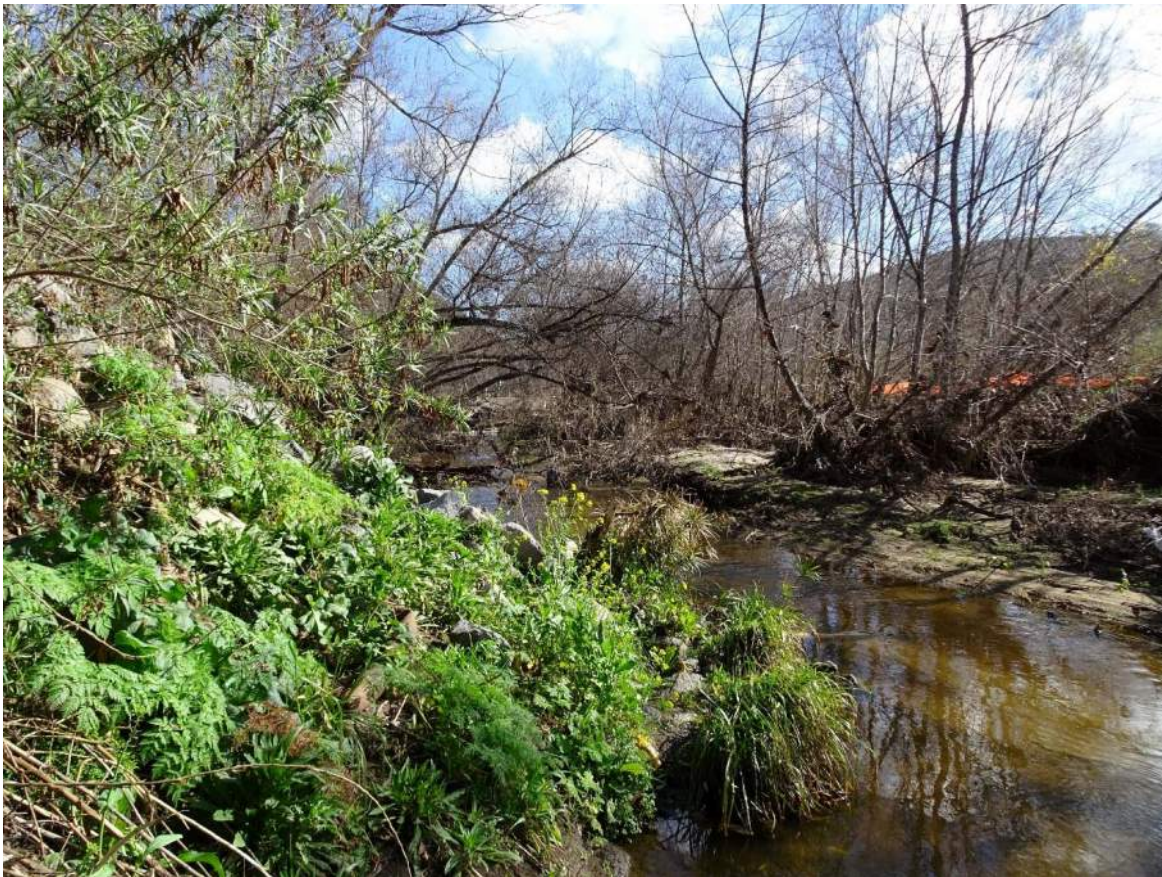
**Figure 3. Middle of Reach 1**

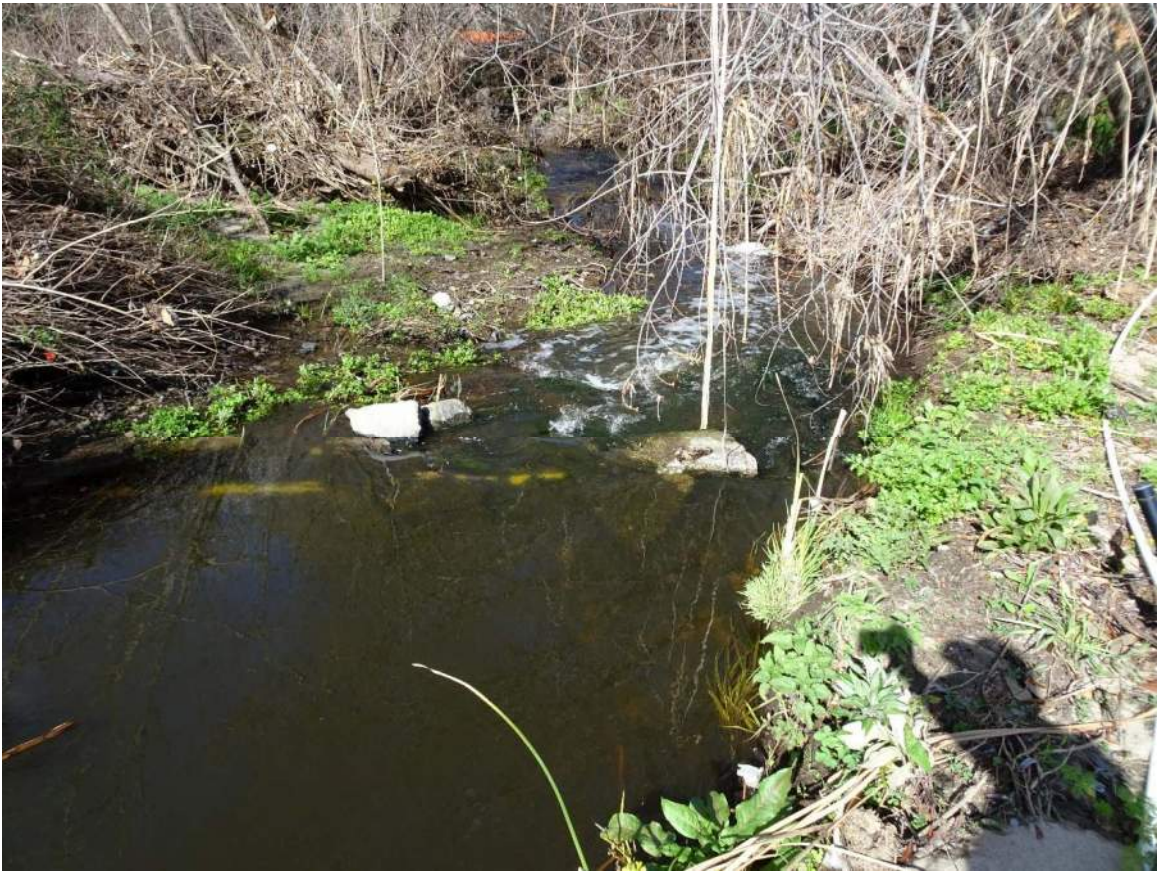
**Figure 5. Concrete Grade Control between Reach 1 and Reach 2**

Per the first bullet item, the first grade control in Escondido Creek below POC 1 and 2 were located. The runoff from POC 1 outlets directly into Escondido Creek. The channel reach below POC 1 was walked and a concrete grade control was discovered approximately 696 feet downstream (see Figure 5 and the Study Area Exhibit in Appendix A). Natural grade controls were also observed in Escondido Creek created by objects such as fallen tree trunks. However, these were not considered since they can be dynamic. The unnamed natural drainage course below POC 2 was also walked and a rock-lined grade control was observed approximately 190 feet downstream (see Figure 10). Cordrey Drive crosses the unnamed natural drainage course

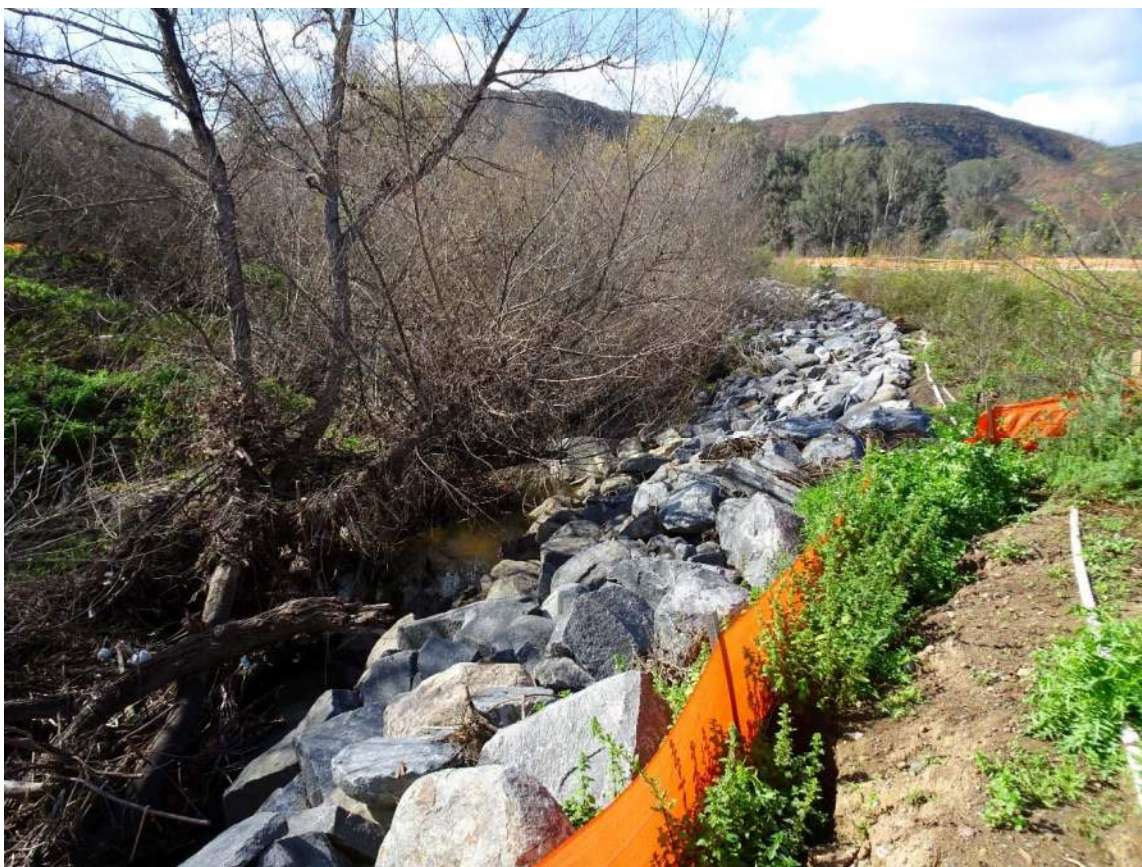
**Figure 7. Lower End of Reach 2**

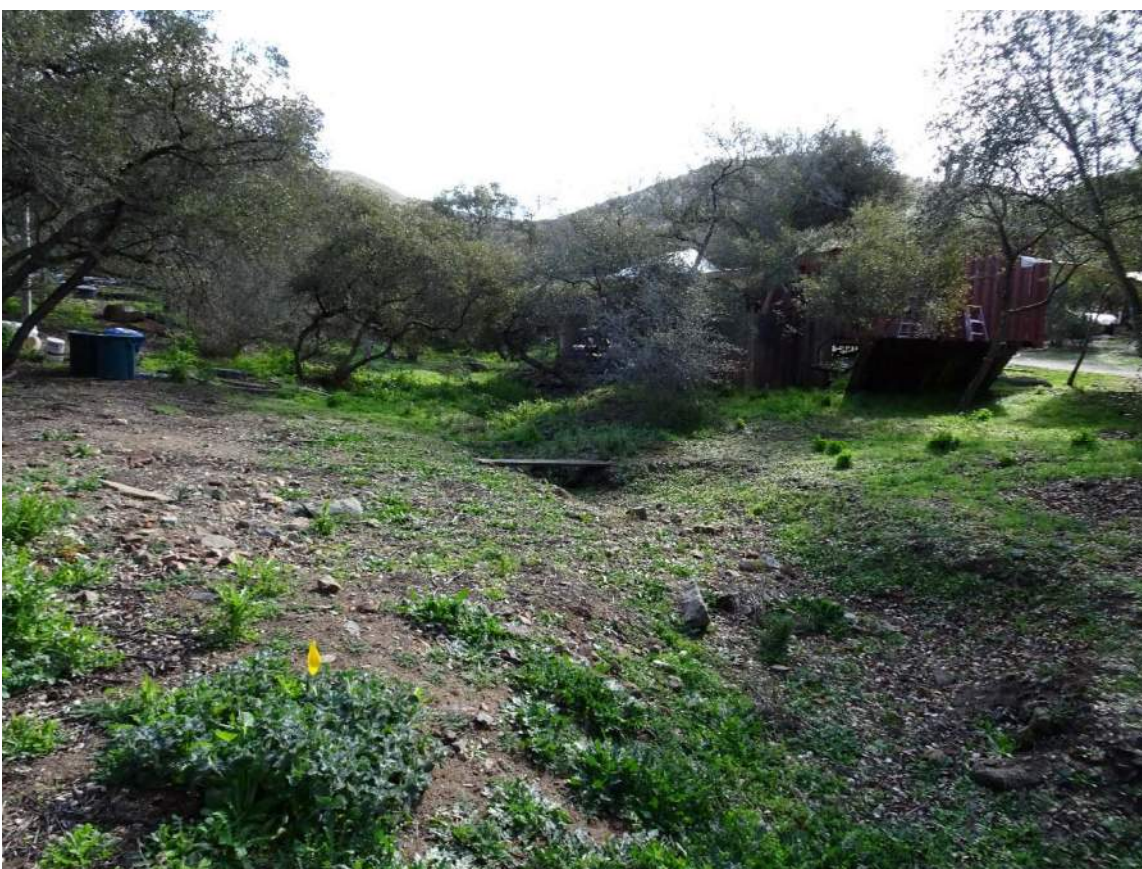
**Figure 8. Looking Upstream towards Reach 3**

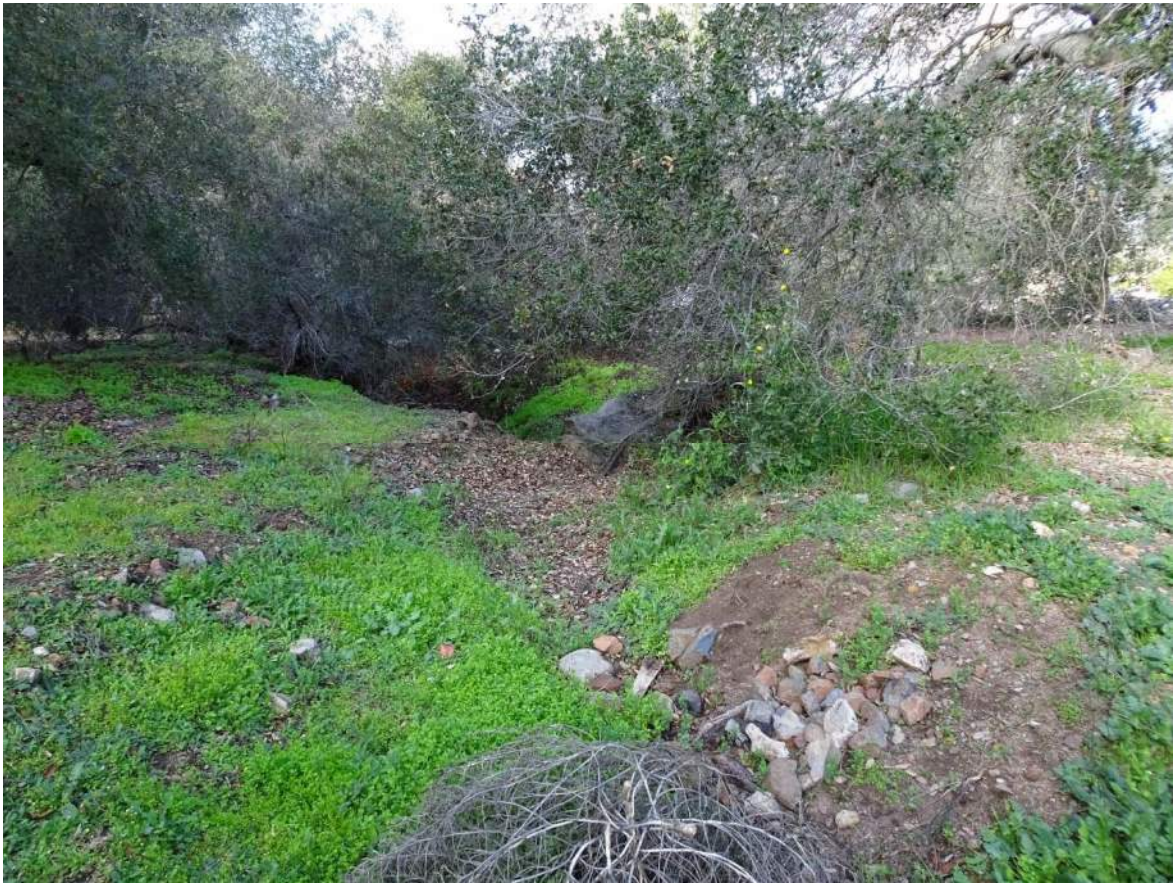
**Figure 9. Looking Downstream towards Reach 4**

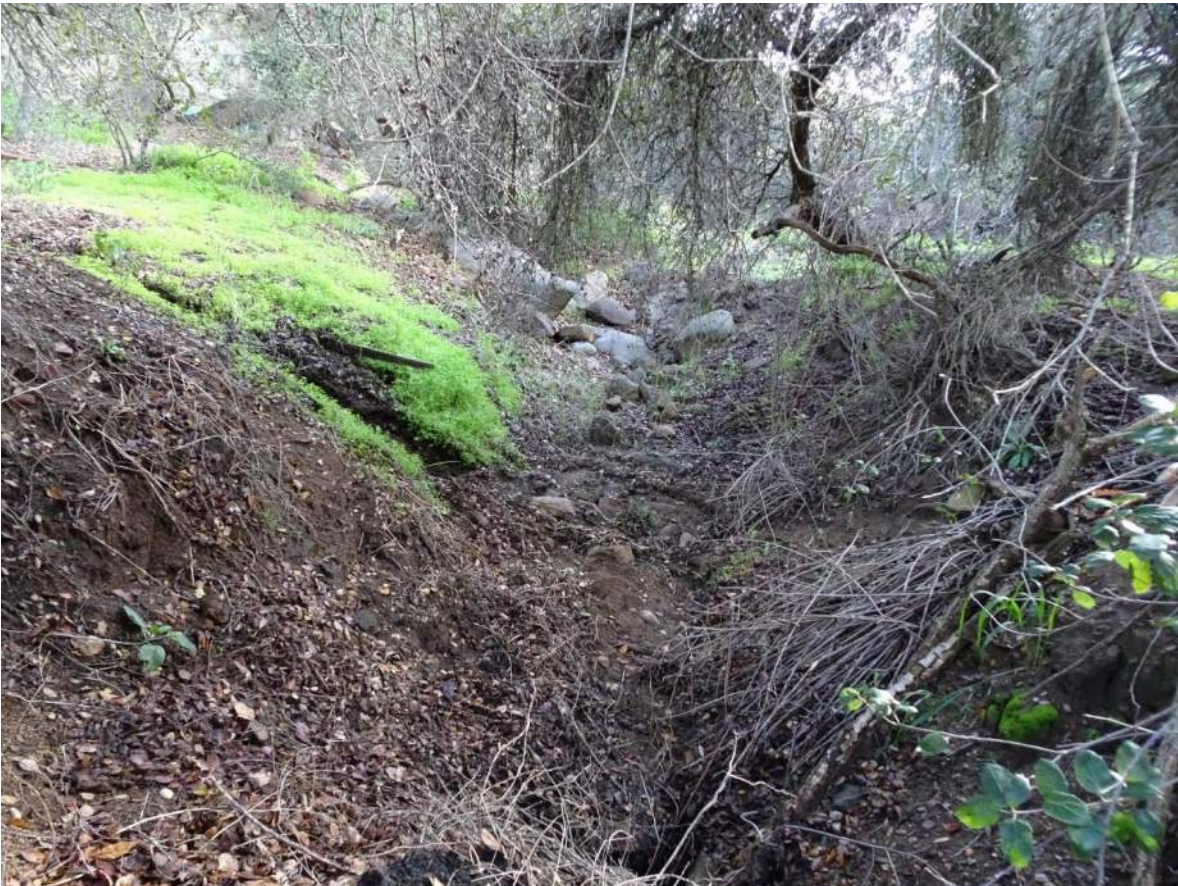
**Figure 10. Rock-Lined Grade Control in Reach 4**

For POC 2, the downstream domain of analysis criteria is first met at the rock-lined grade control. For this POC, a second grade control occurs 33 feet below the rock-lined grade control, i.e., the second grade control is at the Cordrey Drive culvert. Therefore, the downstream domain of analysis location was set at the entrance to the Cordrey Drive culvert.

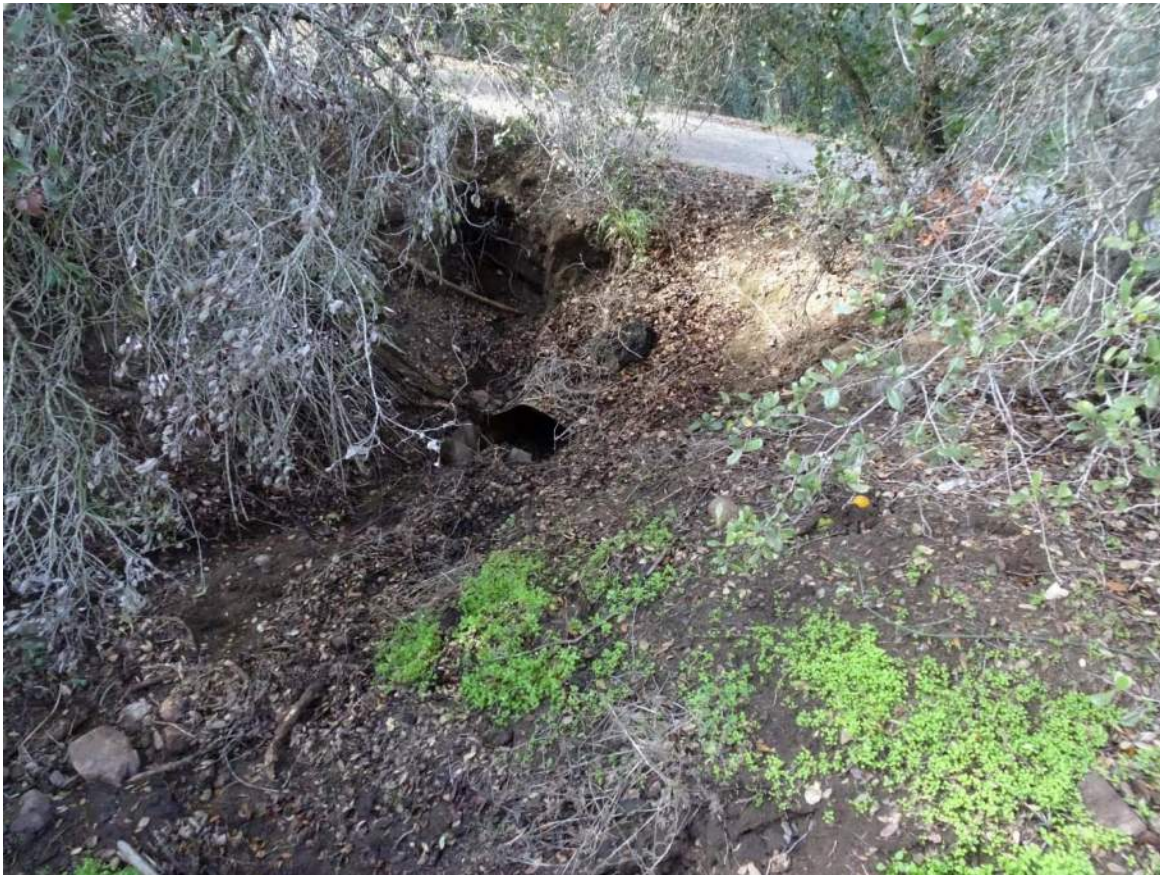
**Figure 11. Culvert (Grade Control) under Cordrey Drive at Downstream End of Reach 4**

approximately 33 feet below the rock-lined grade control. A culvert conveys flow under Cordrey Drive (see Figure 11). The culvert functions as a grade control.

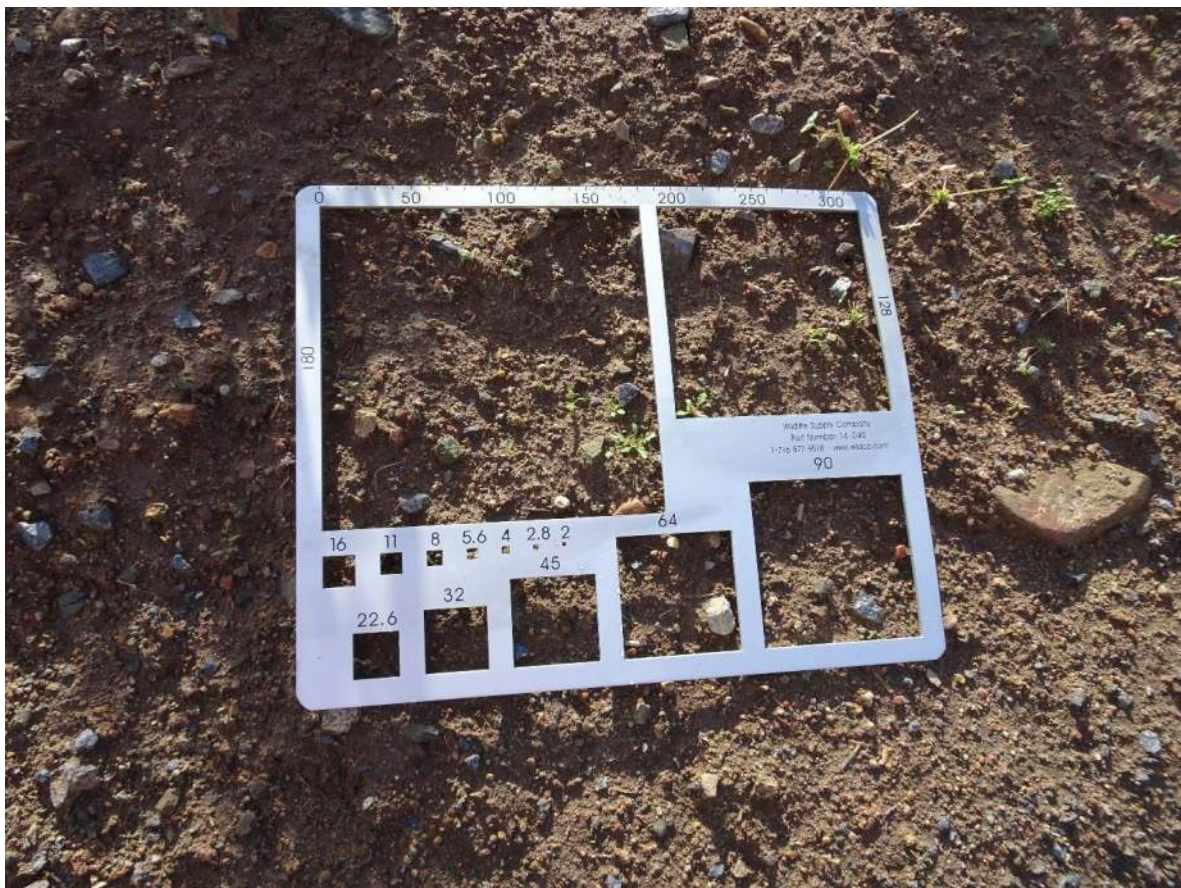
**Figure 12. Gravelometer along Reach 1**

The  $d_{50}$  value is the particle size in which 50 percent of the particles are smaller and 50 percent are larger. The pebble count results for each study reach are included in Appendix B and summarized in Table 3. The screening index values (INDEX) for the four reaches are tabulated on Form 1 in Appendix A and also included in Table 3. The Screening Index Threshold diagram (Checklist 3) in Appendix B provides 50% Risk values for various  $d_{50}$  values. These values are included in the last column of Table 3. If the INDEX value is less than the 50% Risk value, the reach has less than 50 percent probability of incising and falls within Category A. Table 2 shows that this is the case for all four study reaches.

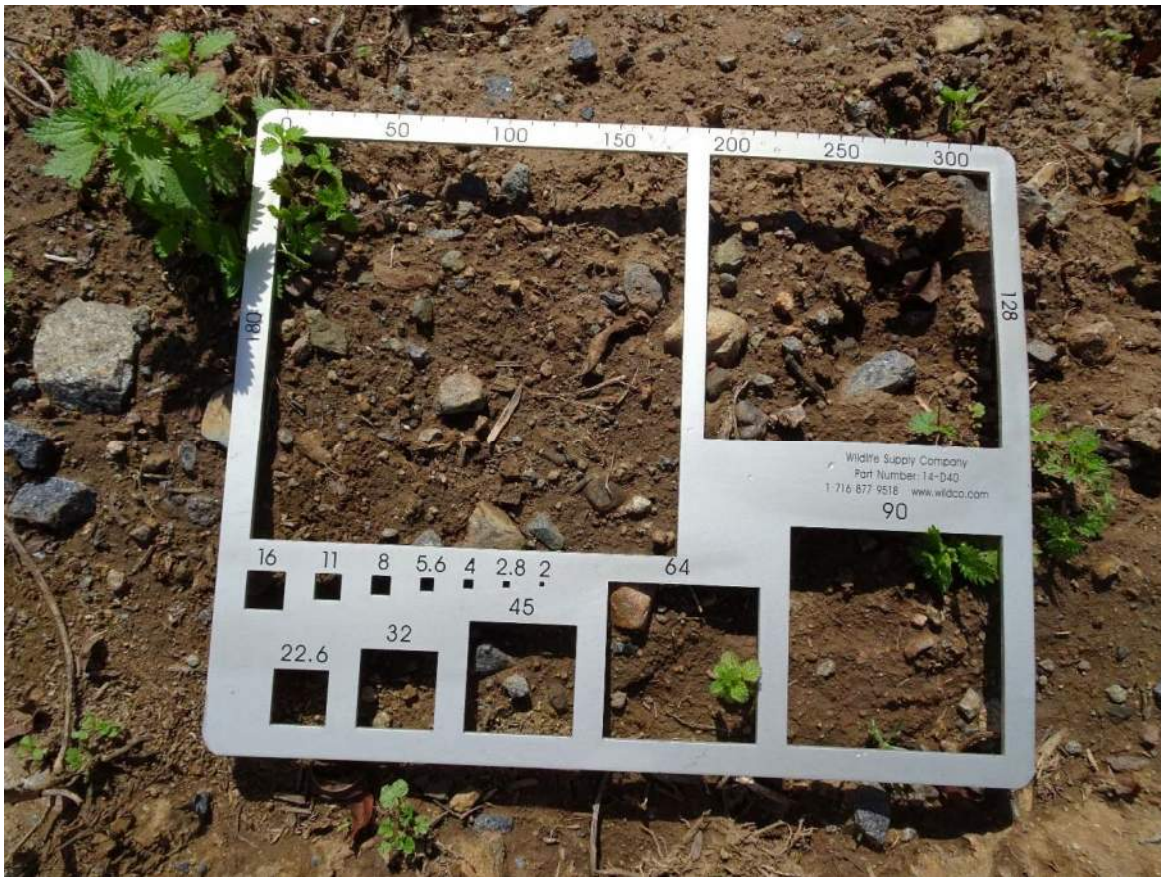
**Figure 13. Gravelometer along Reach 2**

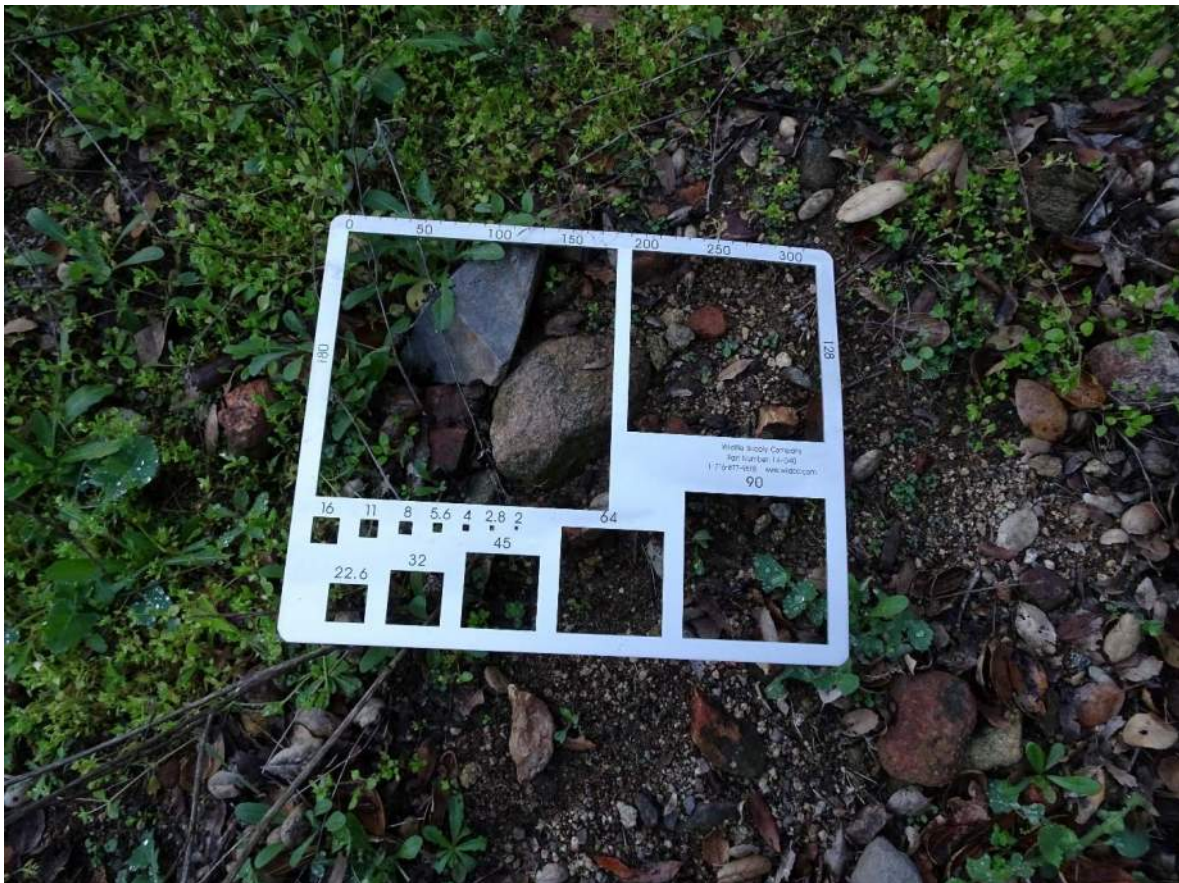
**Figure 14. Gravelometer along Reach 3**

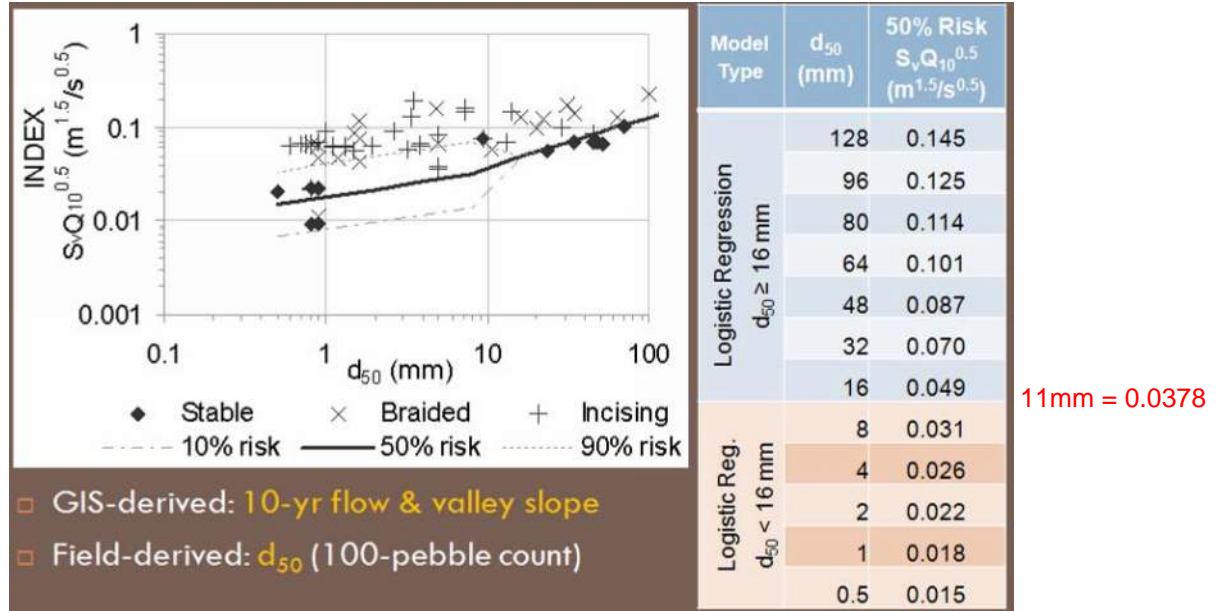
Form 3 Figure 4. Probability of incising/braiding based on logistic regression of Screening Index and  $d_{50}$  to be used in conjunction with Form 3 Table 1.

<sup>1</sup>The 50% Risk for 11 mm was interpolated from the 50% Risk for 8 mm and 16 mm from the Screening Index Threshold diagram in Appendix B.

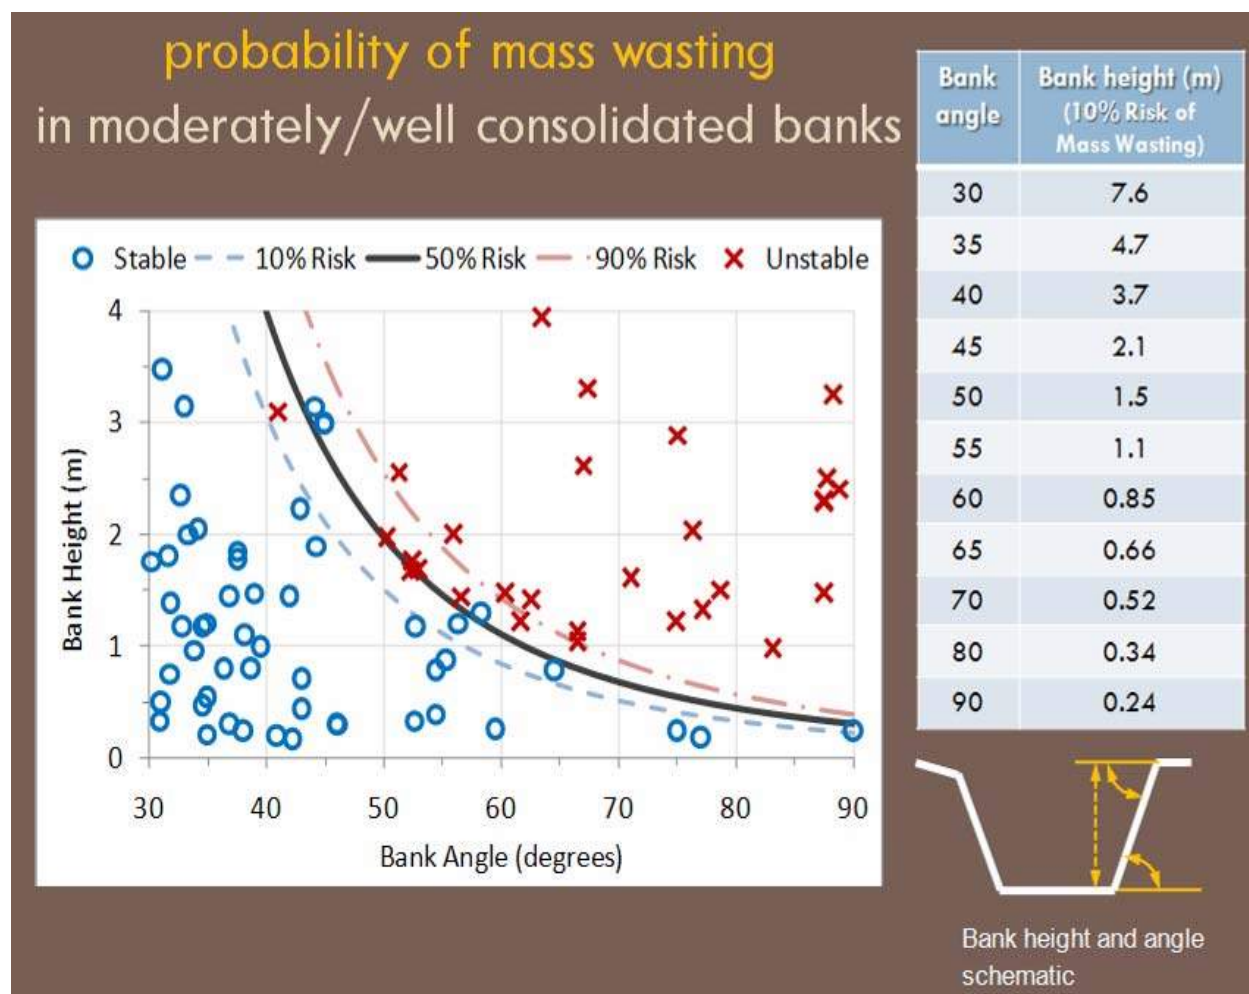
Form 6 Figure 1. Probability Mass Wasting diagram, Bank Angle:Height/% Risk table, and Bank Height:Angle schematic.

Form 6 (see Appendix B) is used to assess the probability of mass wasting. Form 6 identifies a 10, 50, and 90 percent probability based on the bank angle and bank height. The site visit and topographic mapping reveal that the channel banks within all four reaches average 2:1 (26.6 degrees) or less. Form 6 shows that the probability of mass wasting and bank failure has less than 10 percent risk for a 26.6 degree bank angle or less regardless of the bank height.
