SAMPLING POINT DATA SHEETS

SAMPLING POINT PHOTOS

JURISDICTIONAL DELINEATION REPORT FOR HARMONY GROVE

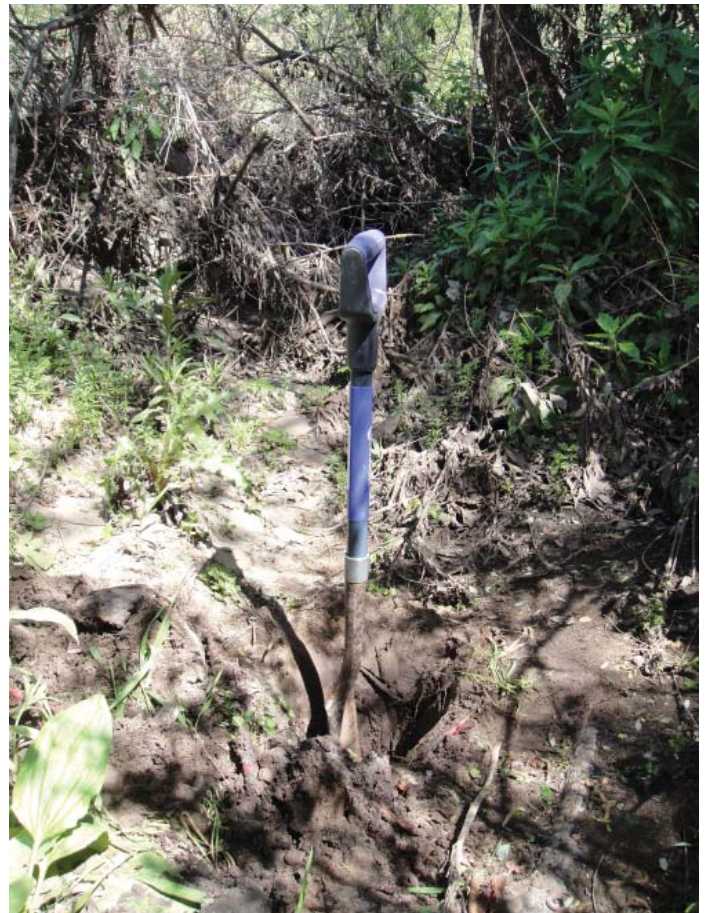
Sampling Point 4. This sampling point was located east of Country Club Drive in southern riparian forest. This location was on the first terrace above the open water in Escondido Creek, but below the elevation of Country Club Drive. The vegetation met the dominance test for wetland vegetation. No hydric soil indicators were present, but due to saturation present in the upper 12 inches of the soil profile, it appears to meet the National Technical Committee on Hydric Soil's definition for a wetland soil. Wetland hydrology was indicated by 1 primary and 2 secondary wetland hydrology indicators. This terrace is a wetland waters of the U.S. It is also a waters of the state.
