Waters of the State

HARMONY GROVE

Figure 8

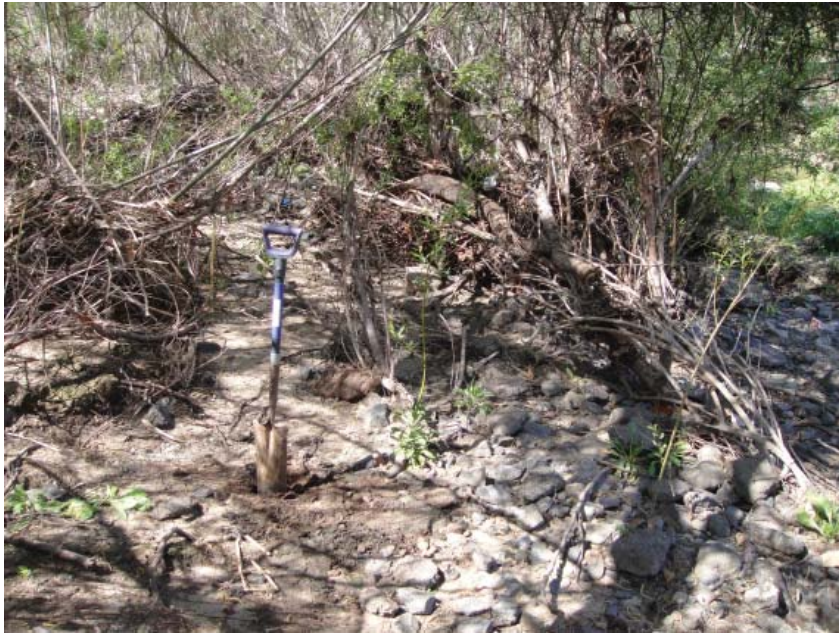
Sampling Point 1. This sampling point was taken on the first terrace above the unvegetated low-flow channel, along Escondido Creek west of Country Club Drive. The southern riparian forest at this location met the dominance test for wetland vegetation. The soil did not exhibit any of the hydric soil indicators, but is a candidate for a problematic hydric soil (i.e., sandy soils). Wetland hydrology was indicated by 2 primary and 2 secondary wetland hydrology indicators. The presence of wetland vegetation and hydrology at this location fulfills the requirements for concluding the soil at the sampling point is a problematic wetland soil. Therefore, this terrace is a wetland waters of the U.S. It is also a waters of the state.

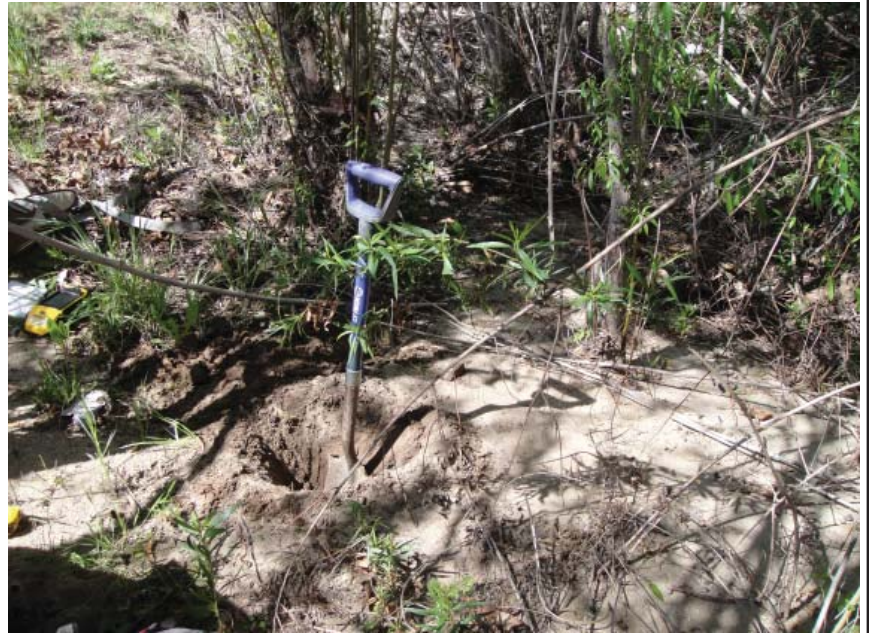
Sampling Point 2. This sampling point was located at the upper edge of the southern riparian forest. The vegetation at this location met the dominance test for wetland vegetation. The soil did not meet any of the hydric soil indicators, but is a candidate for a problematic hydric soil (i.e., sandy soils). Wetland hydrology was indicated by two secondary wetland hydrology indicators. The presence of wetland vegetation and hydrology at this location fulfills the requirements for concluding the soil at the sampling point is a problematic wetland soil. Given the landscape position of this sampling point, however, which is high enough above the low flow channel to preclude it from being inundated long enough to satisfy the definition of a wetland soil, it is not regarded as a wetland. It is, however, considered a waters of the state.

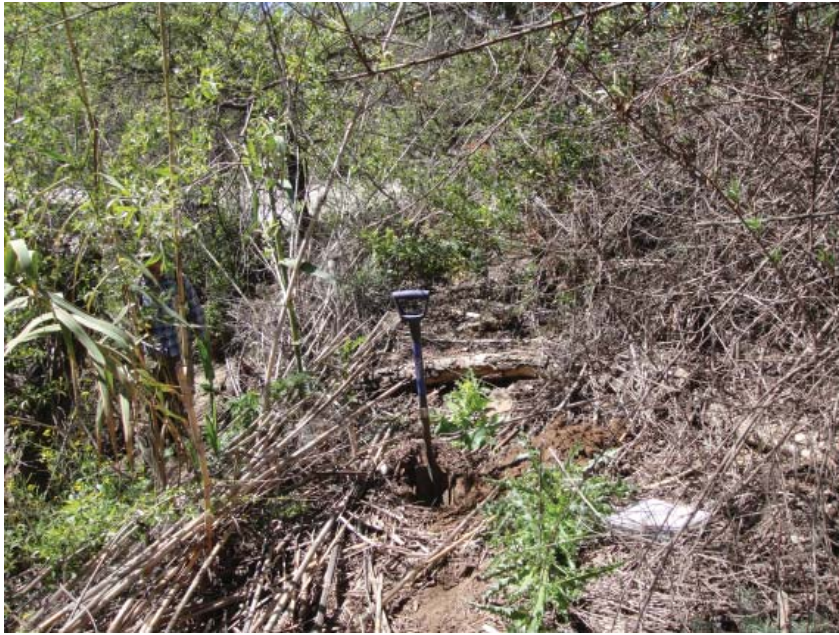
Sampling Point 3. This sampling point was located east of Country Club Drive, and approximately 5 feet above the water present in Escondido Creek. This location is also approximately 3 feet above the Country Club Drive. The southern riparian forest at this location met the dominance test for wetland vegetation. The soil did not exhibit any hydric soil indicators and, with only 1 secondary wetland hydrology indicator, there were insufficient indicators of wetland hydrology. This location is not regarded as a waters of the U.S., but is considered a waters of the state.

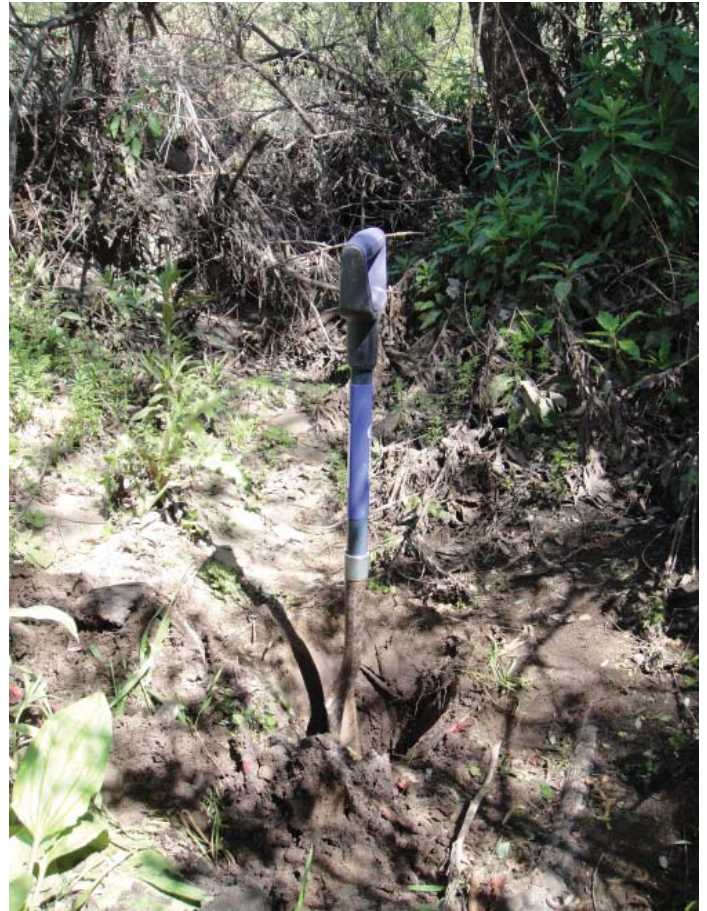
Sampling Point 4. This sampling point was located east of Country Club Drive in southern riparian forest. This location was on the first terrace above the open water in Escondido Creek, but below the elevation of Country Club Drive. The vegetation met the dominance test for wetland vegetation. No hydric soil indicators were present, but due to saturation present in the upper 12 inches of the soil profile, it appears to meet the National Technical Committee on Hydric Soil's definition for a wetland soil. Wetland hydrology was indicated by 1 primary and 2 secondary wetland hydrology indicators. This terrace is a wetland waters of the U.S. It is also a waters of the state.
